<b>California Public Utilities Commission</b> <b><i>Mitigation Monitoring, Compliance, and Reporting Program</i></b>
	<b>Cleveland National Forest Power Line Replacement Projects</b>  <b>Compliance Status Report: 027</b>  <b>October 2, 2017</b>

This compliance status report covers construction activities from September 18 through October 2, 2017.

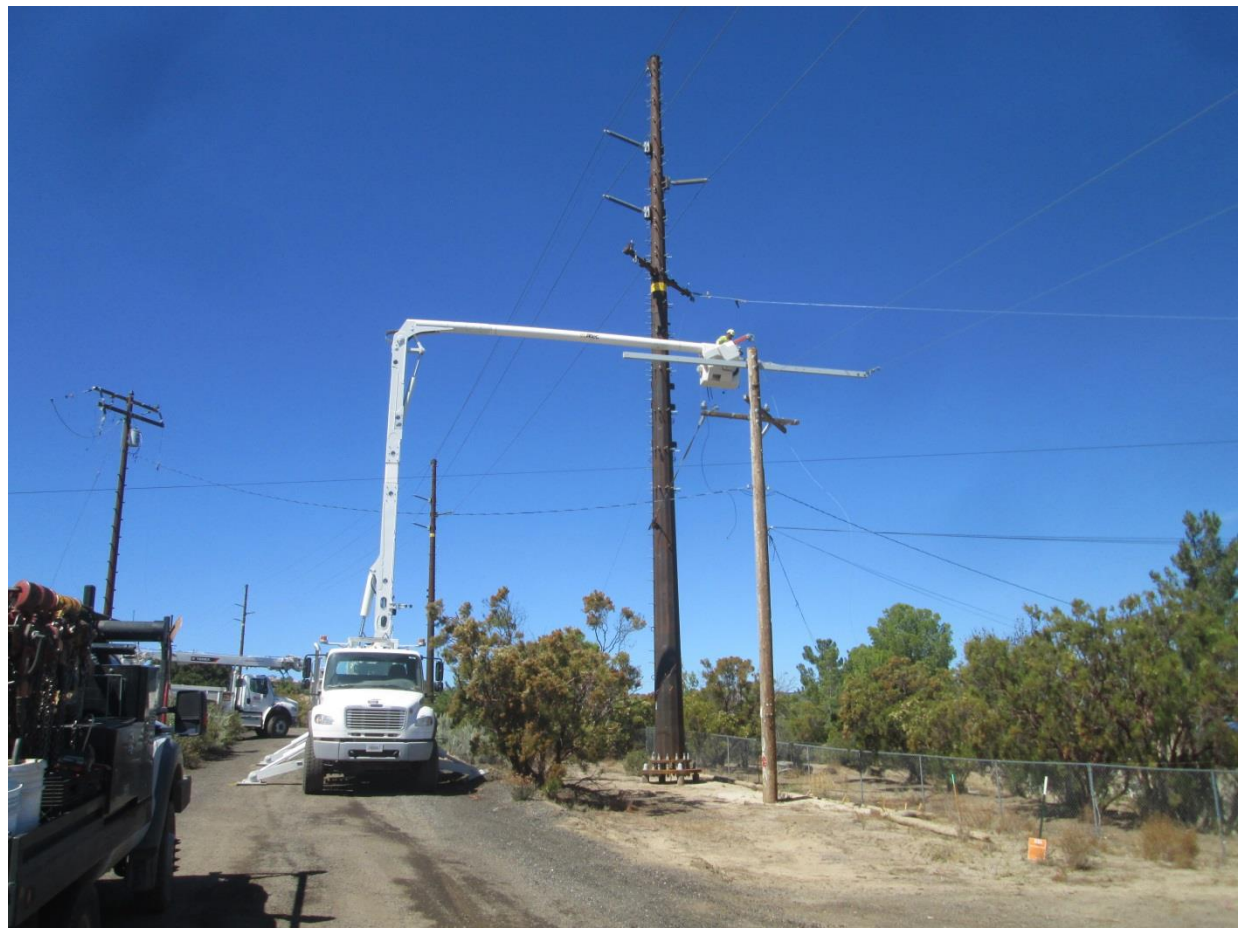
During this reporting period along TL 6931, CPUC ECMs observed construction crews conducting overhead work, conducting distribution wire stringing activities (See Photo 1—Attachment A), and

**Photo 1:** A construction crew observed conducting overhead line work in preparation for distribution line wire stringing at Pole P45927 (TL 6931).

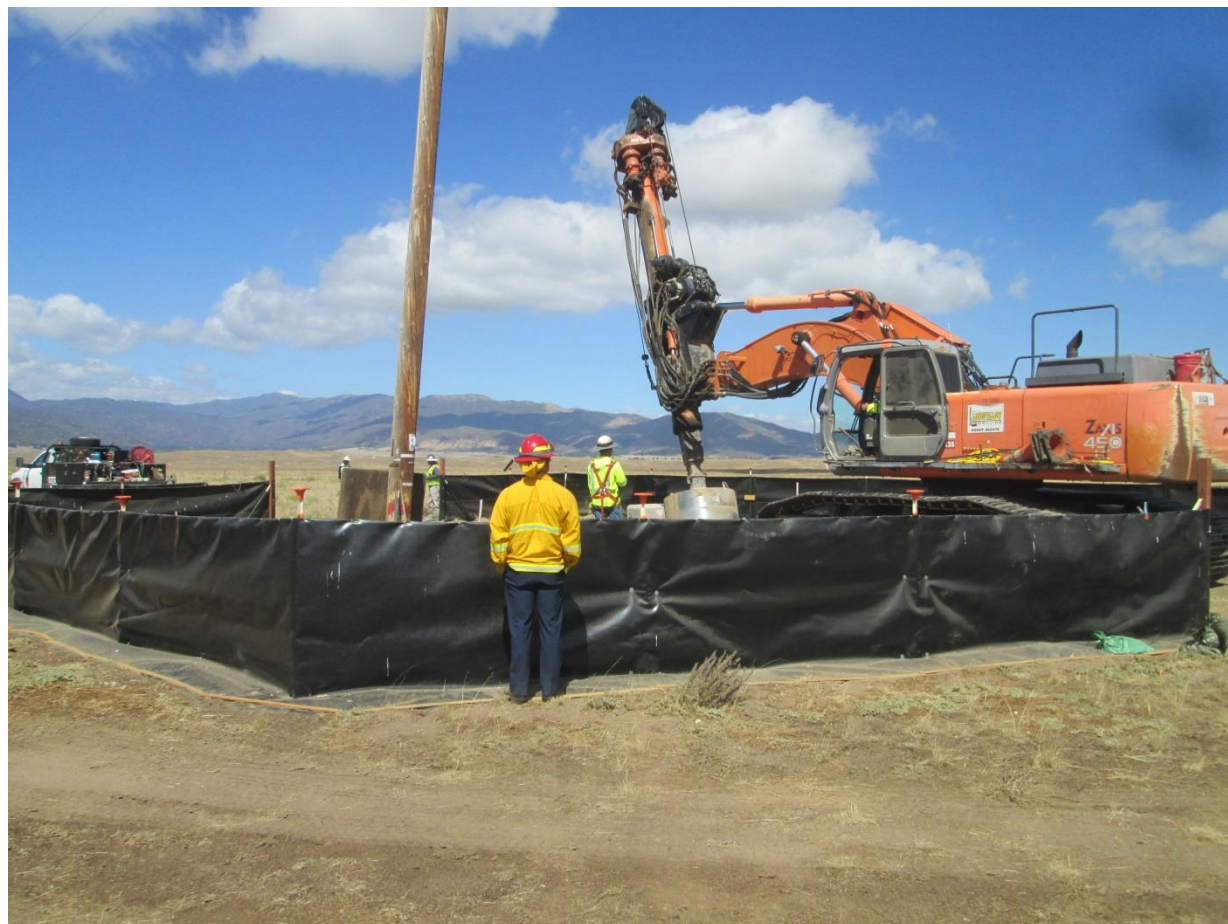
removing old wooden poles. Along TL 682, CPUC ECMs observed drilling and grouting for micropile foundations and drilling pole holes/installing direct embed poles (See Photo 2—Attachment A). Additionally crews were observed trimming oaks mid-span to maintain required transmission line clearances, clearing vegetation and installing sediment and erosion control Best Management Practices (BMPs), installing Stephens' kangaroo rat exclusion barrier around pole replacement workspaces, and refueling helicopters at Mendenhall Fly Yard. Along C 78, crews were observed clearing vegetation and installing erosion control BMPs (See Photo 3—Attachment A), and digging/drilling pole holes.

During construction activities along all rights-of-way, construction fire patrols were observed inspecting sites for compliance with the Construction Fire Prevention/Protection Plan (CFPPP) (MM FF-1) (See Photo 2—Attachment A). Crews were observed staging the required fire tools and equipment based on the Project Activity Level (on CNF land)/Fire Potential Index (off CNF land) and the construction activity being performed as allowed in the Fire Prevention Matrices CFPPP (MM FF-1, APM HAZ-01). On September 27, a CPUC third party ECM notified the SDG&E Lead Environmental Inspector (LEI) that an SKR exclusion barrier installation crew at Pole Z118194 (TL 682) had a square point shovel instead of the required round point shovel staged with their other fire tools (i.e. a 5 gallon backpack pump, round point shovel, Pulaski, and 2A10BC fire extinguisher). The SDG&E LEI said that he would remind the crew of the round point shovel requirement and remedy the issue.

**Photo 2:** Pole hole drilling observed at Pole Z118221 (TL 682) within Stephens' kangaroo rat exclusion barrier (MM BIO-31). A fire patrol was observed monitoring construction activities in accordance with the Construction Fire Prevention/Protection Plan (MM FF-1, APM HAZ-1).

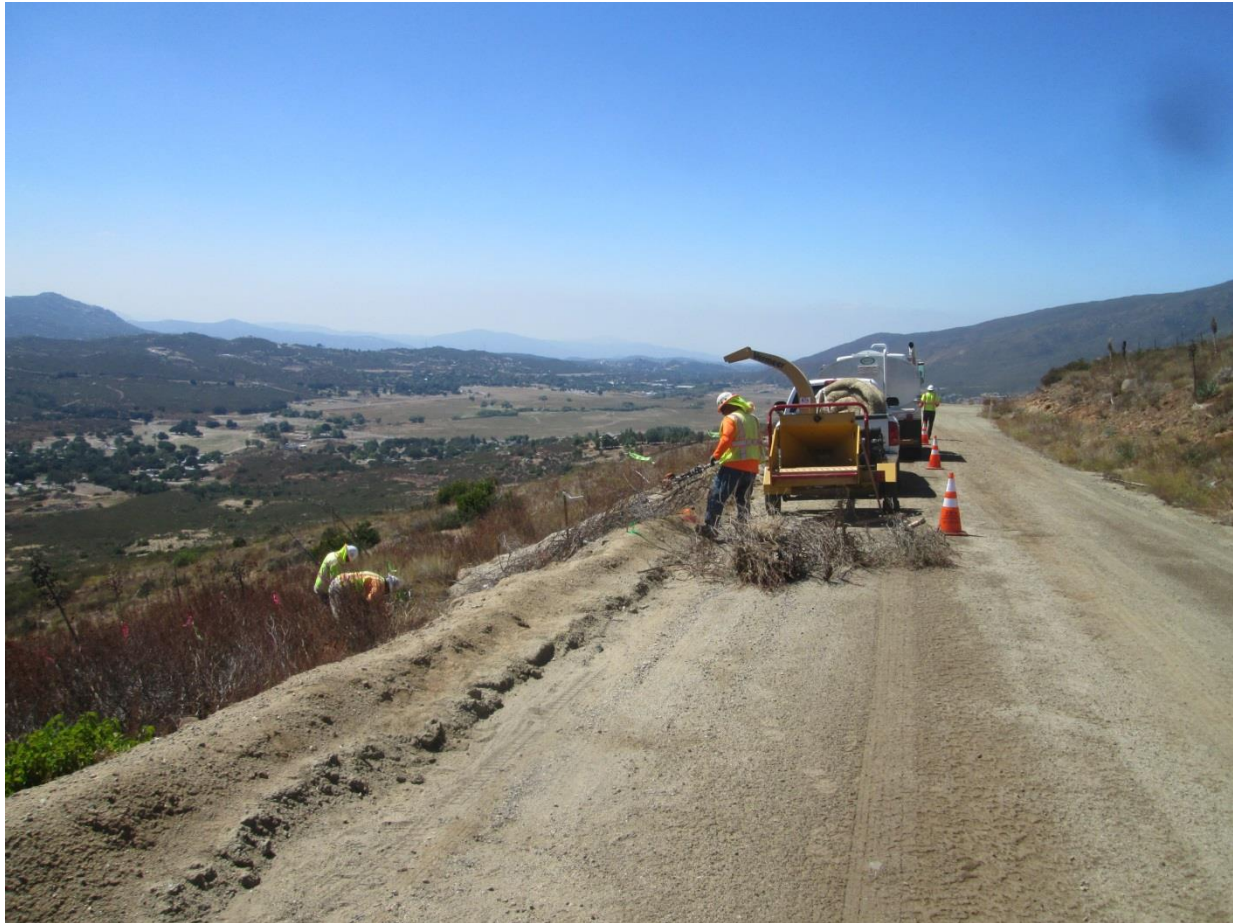
Implementation of traffic control measures continued to be observed in this reporting period. Traffic control measures, such as the placement of signage and cones as well as the use of flagpersons were observed in accordance with APM TRANS-02. During helicopter external load operations along TL 682, traffic control notification signs, cones, and flagpersons were observed being utilized to temporarily stop traffic when loads were transported over public roads, including Highway 76 and East Grade Road. Signage, cones, and flagperson were also utilized along C 78 to direct traffic around construction vehicles and equipment staged on one side of Viejas Grade Road (See Photo 3—Attachment A).

**Photo 3:** Vegetation clearing activities observed along C78. Traffic control notification signage, cones, and flagpersons were observed along Viejas Grade Road in accordance with APM TRANS-02.

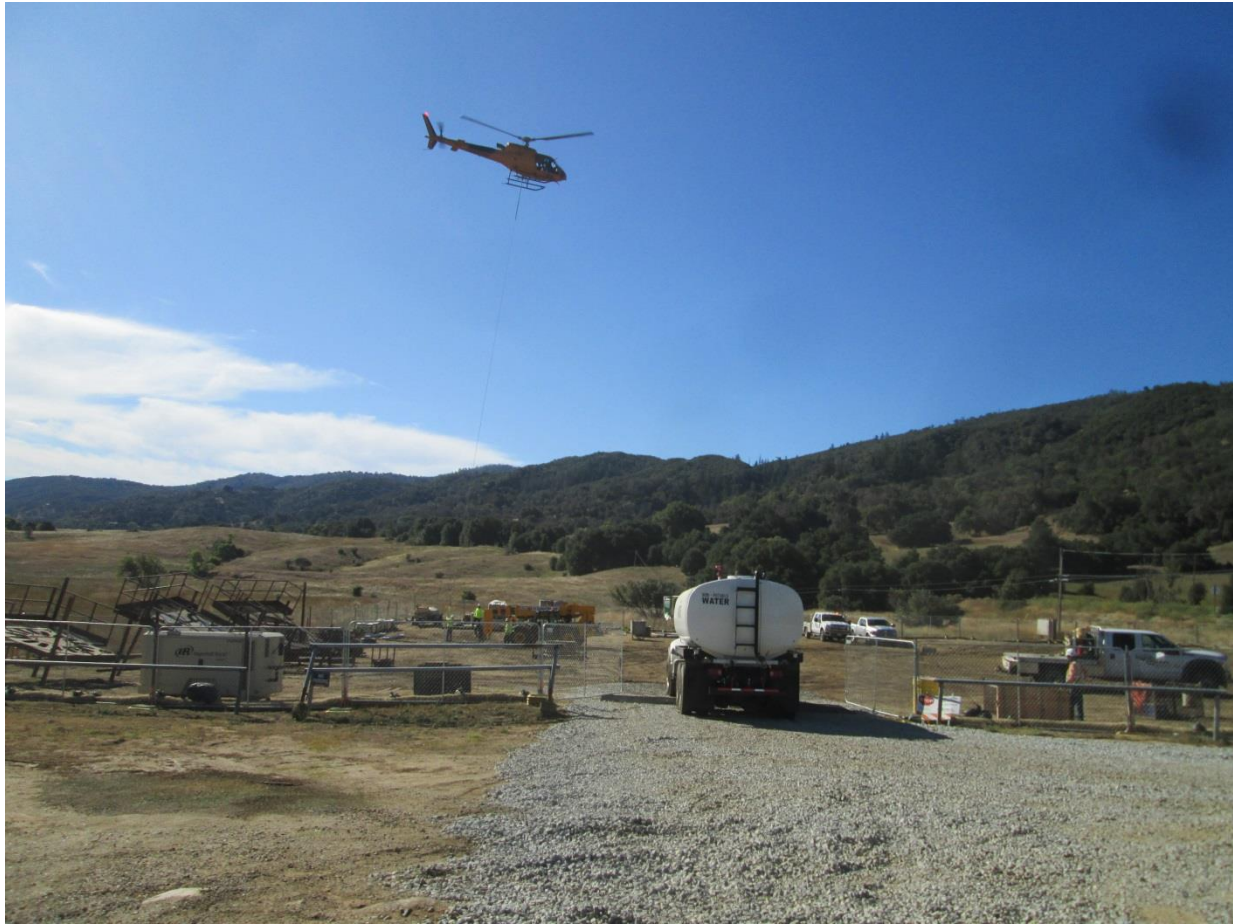
During this reporting period, CPUC ECMs observed implementation of dust control measures along the rights-of-way, including application of water to control dust on access roads and in pole replacement workspaces and staging yards (APM AIR-02). Project personnel were observed maintaining posted speeds of 15 miles per hour on unpaved roads in accordance with APM AIR-03 and MM BIO-24. BMPs designed to minimize dirt trackout onto public roads such as rattle plates and rock aprons were observed at the ingress and egress of staging yards in accordance with the project's Storm Water Pollution Prevention Plan (SWPPP) (MM HYD-1, APM HYD-09, and MM BIO-7). During helicopter external load operations at the Lake Henshaw Staging Yard (TL 682), which included mobilization of equipment and materials for transport to remote pole replacement work sites, watering occurred to manage and control dust in accordance with the Aviation Safety Plan (MM PHS-5) (See Photo 4—Attachment A).

**Photo 4:** Helicopter external load operations were observed being conducted out of Lake Henshaw Staging Yard (TL 682) to assist foundation drilling and grouting operations at remote site along the project alignment. To prevent potential dust emissions from rotor wash in accordance with the Aviation Safety Plan (MM PHS-5), a water truck was utilized to apply water within the work area.

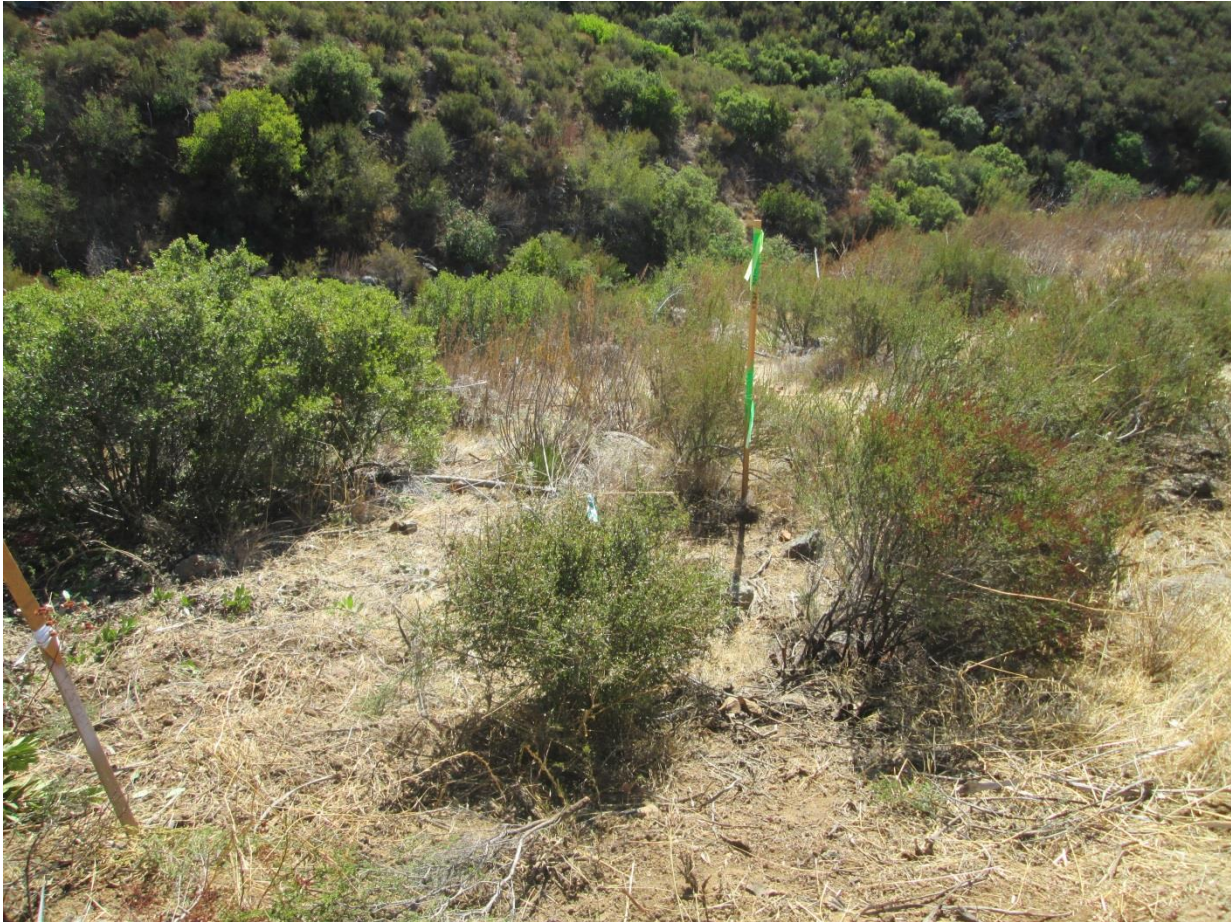
**Photo 5:** During vegetation clearing along C 78, a spiny redberry was flagged and avoided to prevent impacts to butterfly host plants in accordance with MM BIO-16.

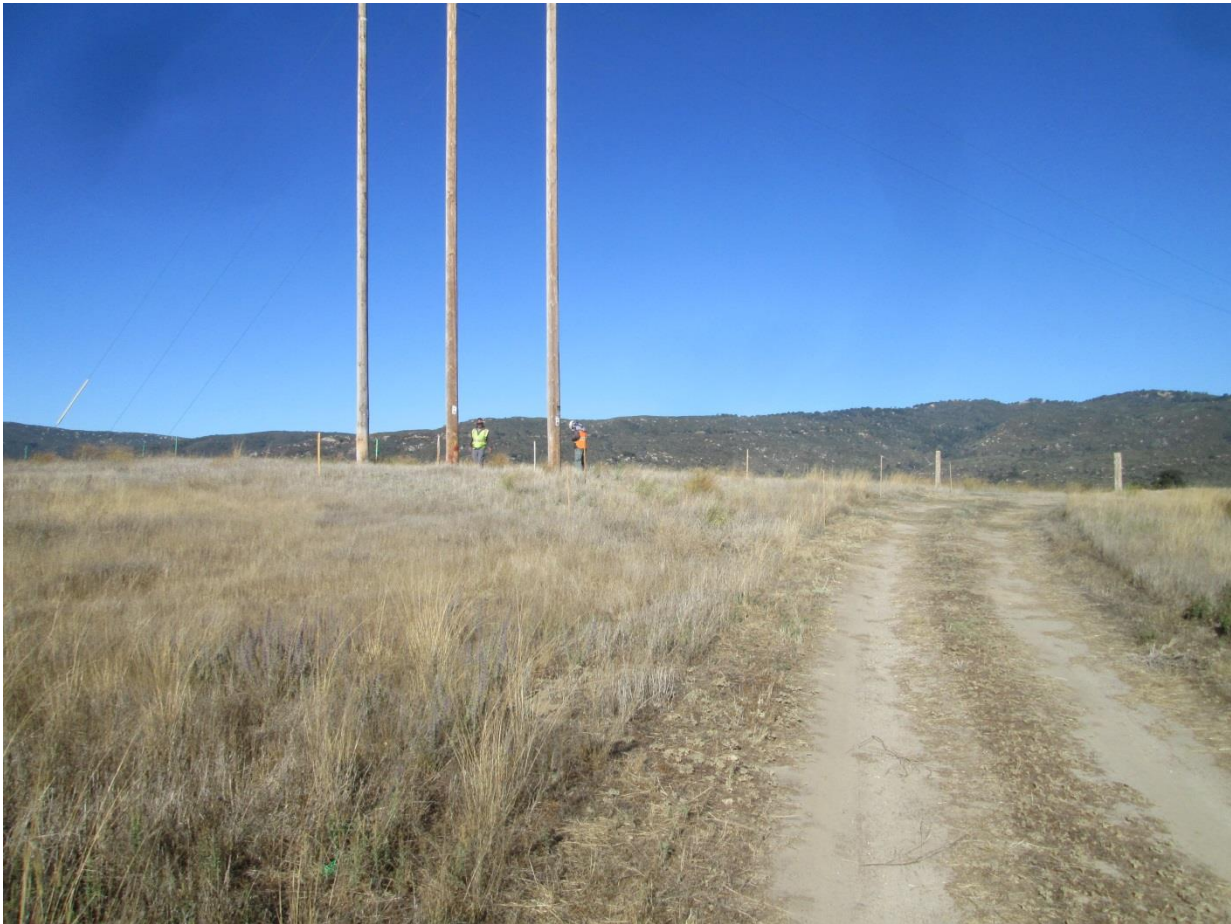
soils for potential sensitive cultural resources along TL 682 in accordance with MM CUL-1. Cultural resource monitors were also observed surveying workspaces for sensitive cultural resources prior to construction activities (See Photo 6—Attachment A) and were observed spot checking cultural ESA fencing installed to prevent unauthorized access into areas with previously recorded cultural resources in accordance with the Historic Properties Management Plan (HPMP). Signage indicating where old poles would be cut at the base and remain in place to prevent undue ground disturbance in accordance with the HPMP recommendations were observed. In accordance with APM CUL-08, a paleontological monitor was observed monitoring pole hole drilling/auguring along both TL 682 and C 78 and inspecting excavated soils for the presence of fossils.

**Photo 6:** Cultural resource monitors were observed surveying the pole replacement workspace along TL 682 for sensitive cultural resources ahead of planned ground disturbing construction activities in accordance with the Historic Properties Management Plan, MM CUL-1, and APM CUL-04.
