California Public Utilities Commission <i>Mitigation Monitoring, Compliance, and Reporting Program</i>
	Cleveland National Forest Power Line Replacement Projects Compliance Status Report: 036 February 4, 2018

SUMMARY

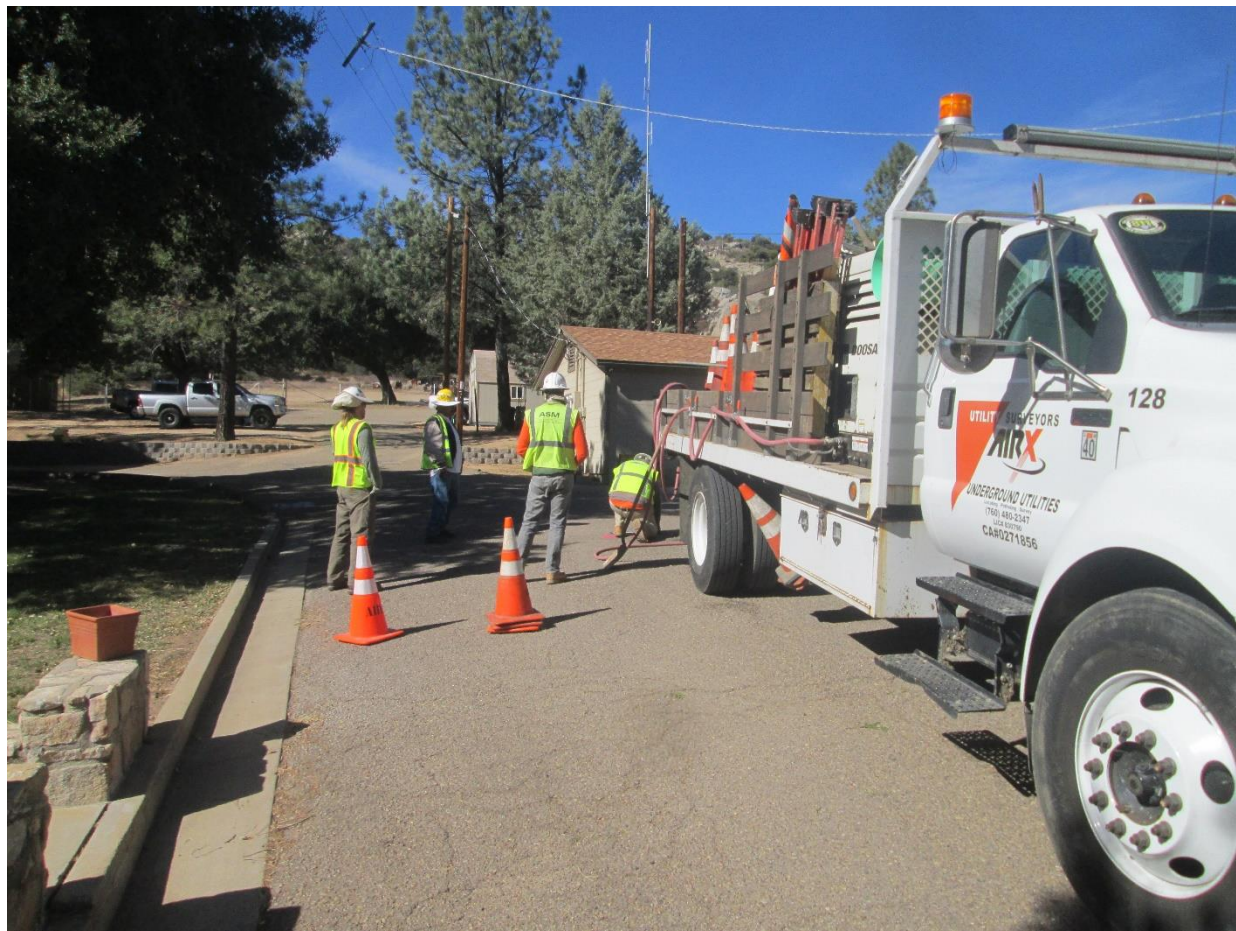
Photo 1: During potholing near P222133 (C 449), a biological monitor, archeological monitor, and Native American monitor were present, in accordance with MM-BIO-03, MM-BIO-22, MM-CUL-3, APM-CUL-04, and the HPMP.

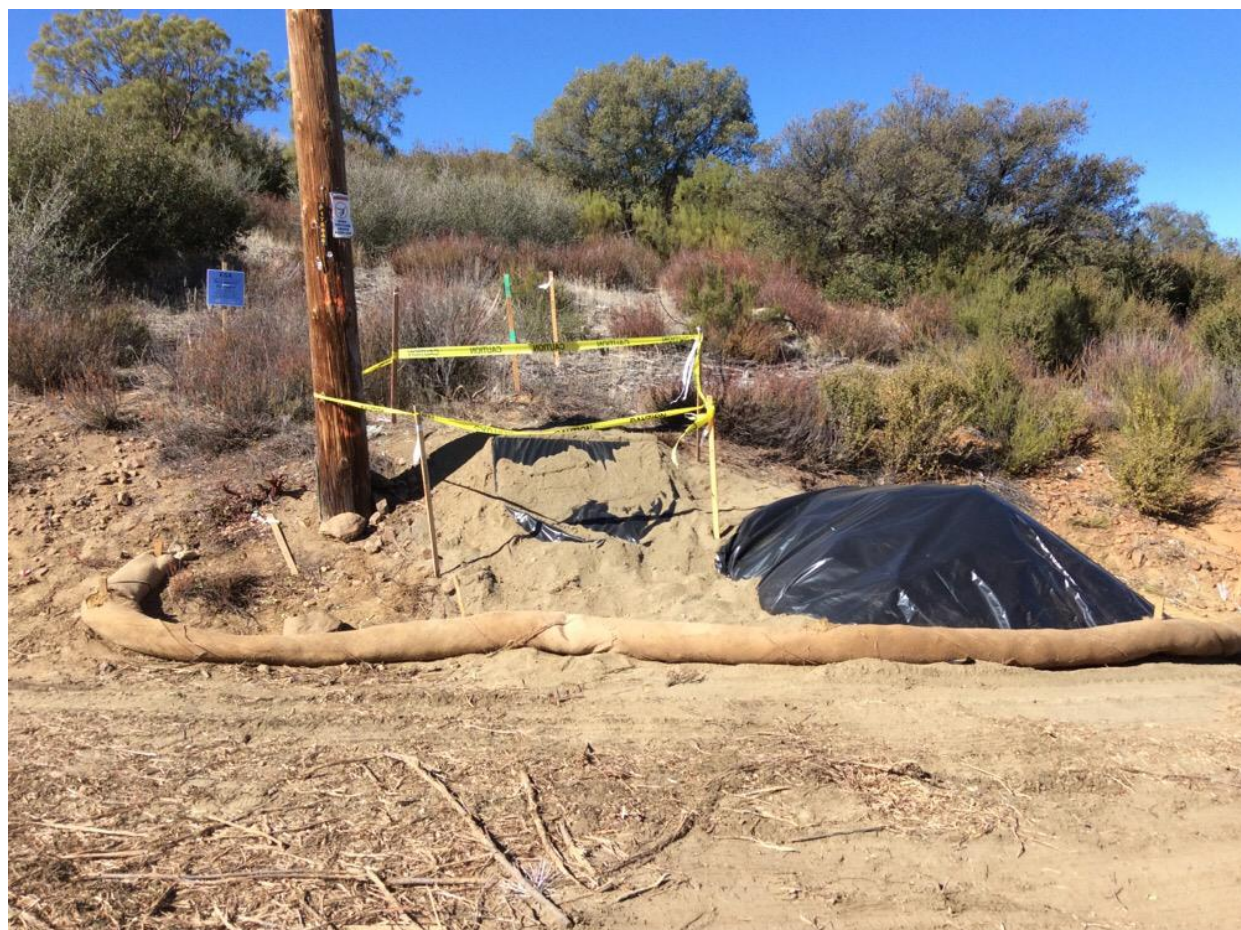
Photo 2: Following drilling at pole P176946 (C 442), the pole hole was securely covered in accordance with MM-BIO-23 and spoils were contained within a tarp in accordance with the Erosion Control Plan.

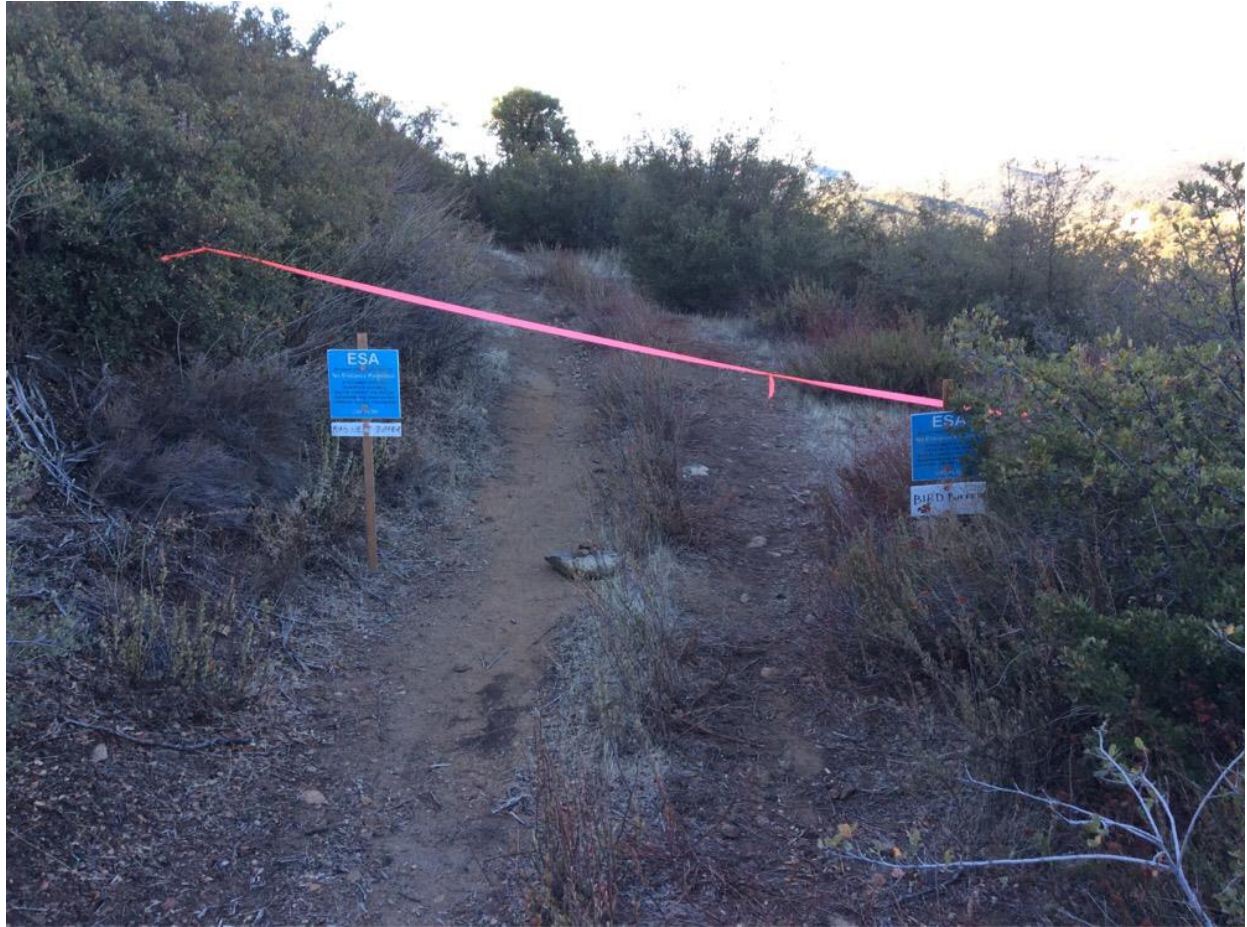
In accordance with MM BIO-3 and MM BIO-22, Biological Monitors were observed conducting full time monitoring of initial ground-disturbing activities as well as vegetation clearing. To prevent wildlife entrapment, completed pole holes along C 442 were observed to be securely covered or an earthen ramp was constructed (for shallow excavations) in accordance with MM BIO-23 (See Photo 2 – Attachment A). In accordance with the Avian Protection Plan/Nesting Bird Management Plan and MM BIO-28, avian biologists were observed surveying for nesting raptors ahead of scheduled work activities along C 442, and C 449. No-disturbance buffers were established around active nests and nest sites were monitored while work occurred within the vicinity (See Photo 3 – Attachment A).

Photo 3: On January 22, a 500-foot nest buffer was established around a Red-tailed hawk nest near pole P176950 (C 442) in accordance with the Avian Protection Plan/Nesting Bird Management Plan and MM BIO-23.

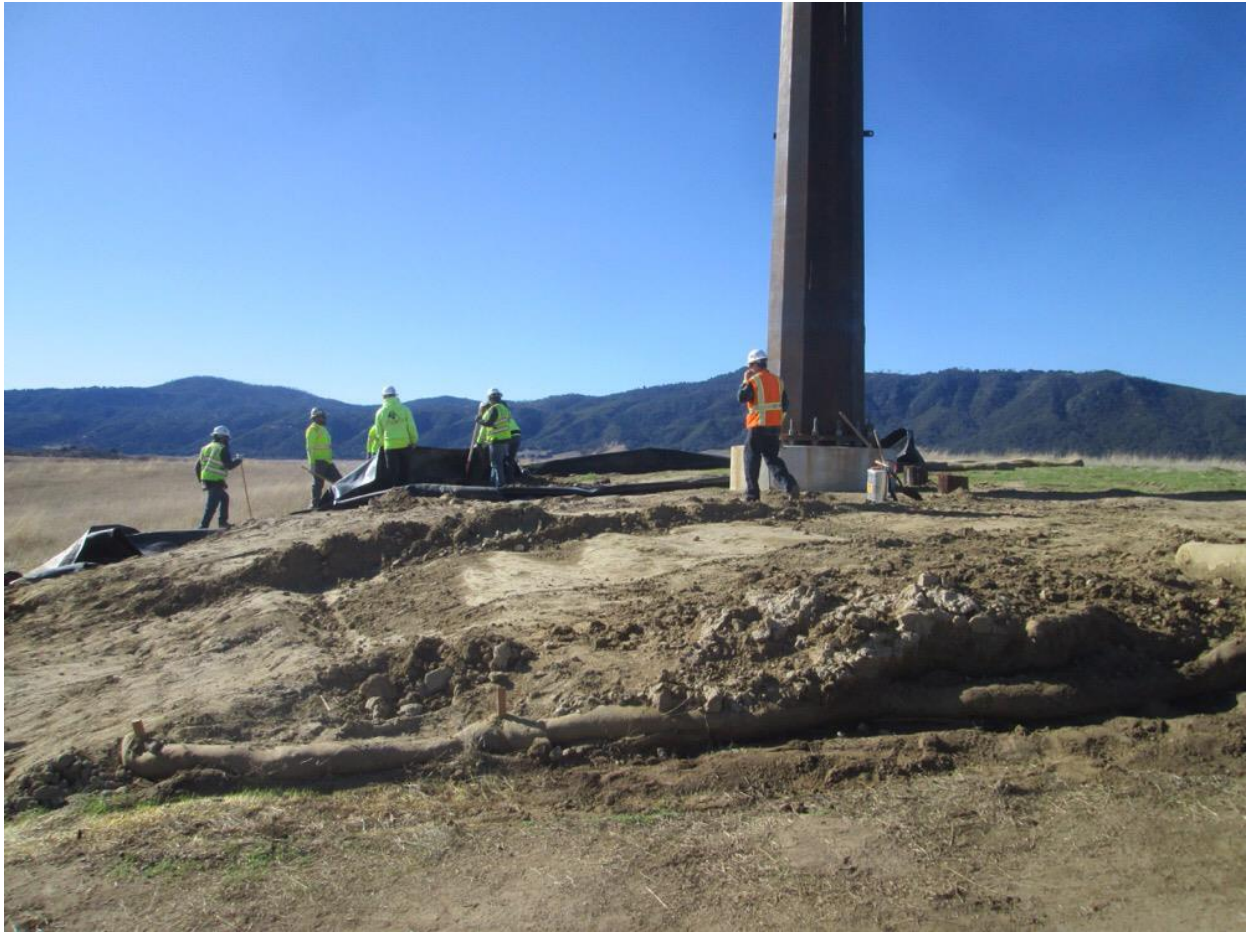
During this reporting period, ECMs observed crews removing SKR barriers, along TL 682 (See Photo 4 – Attachment A). The ECM was informed that after barrier removal, additional crews would be conducting site cleanup, BMP removal, and any necessary soil removal and re-contouring.

Photo 4: An Icon crew observed deconstructing and removing SKR exclusion barrier at Z118190 (TL 682).

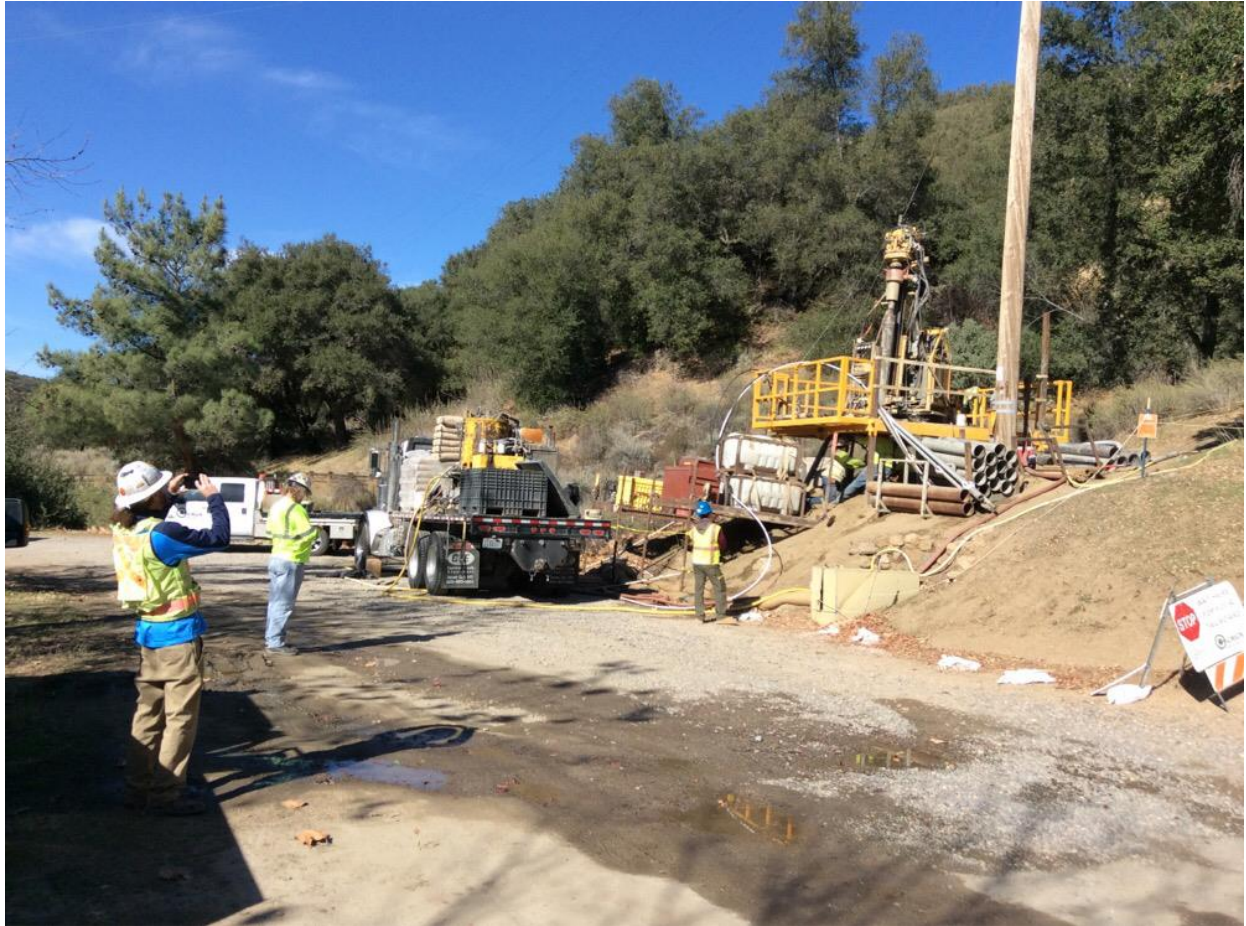
Cultural resource monitors, including Archaeological and Native American Monitors, were observed monitoring ground disturbing activities, such as vegetation clearing, BMP installation, and pole hole drilling (See Photo 5 – Attachment A). Cultural resources monitors inspected excavated soils for potential sensitive cultural resources in accordance with the Historic Properties Management Plan

Site-specific erosion and sediment control BMPs continued to be observed along the project rights-of-way in accordance with the project Storm Water Pollution Prevention Plan (SWPPP), MM HYD-1, MM BIO-7, and APM HYD-09. Sediment control BMPs included fiber rolls, silt fencing, and prowattle were observed to be in good condition at pole replacement sites and staging yards. During drilling and excavating of pole holes, dirt spoil was covered and fiber rolls were in place (See Photo 5 – Attachment A).

Photo 5: Biological and archeological monitors were observed monitoring the grouting activity at pole Z118106 (TL 682).
