<p><b>California Public Utilities Commission</b>  <b><i>Mitigation Monitoring, Compliance, and Reporting Program</i></b></p>
	<p><b>Cleveland National Forest Power Line Replacement Projects</b></p> <p><b>Compliance Status Report: 041</b></p> <p><b>April 15, 2018</b></p>

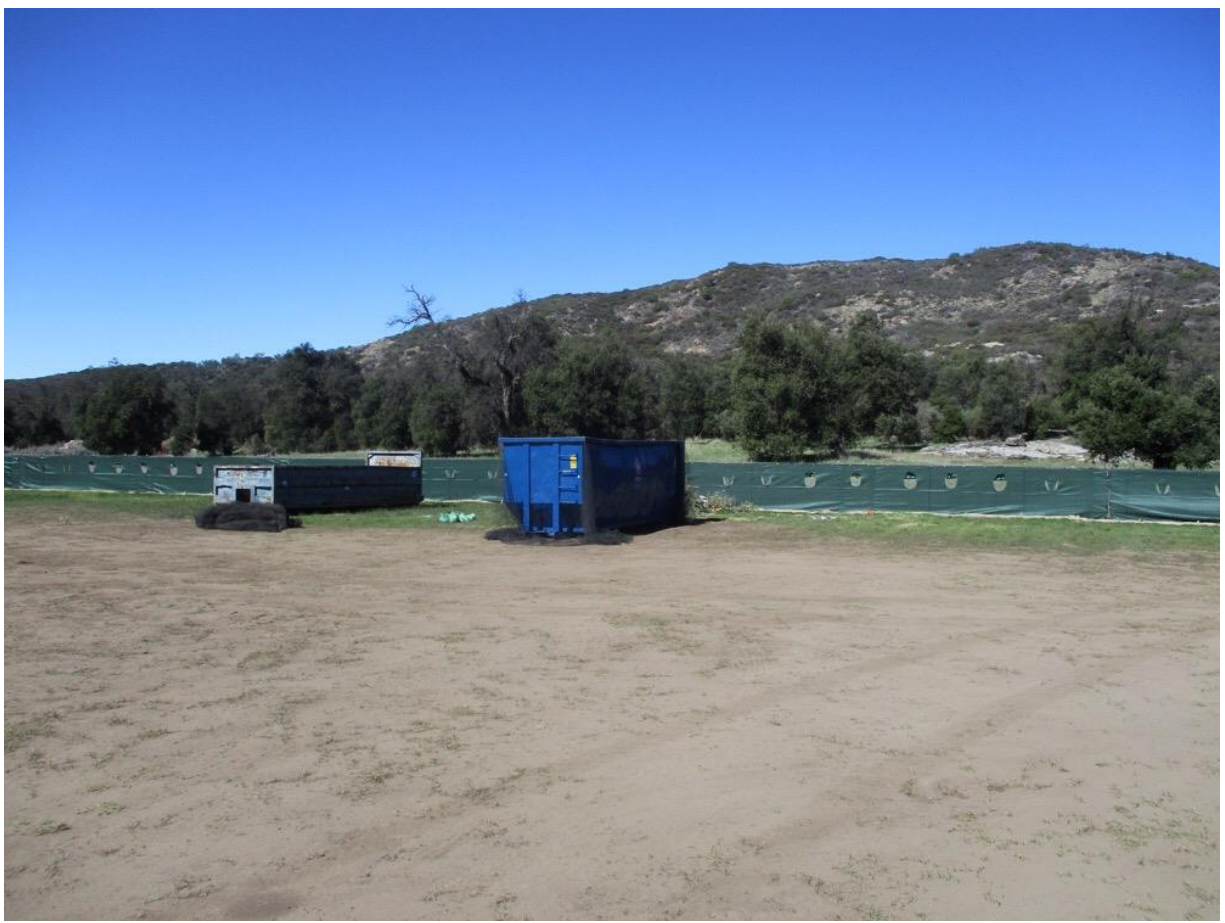
**Photo 1:** Bird deterrent netting was observed over a scrap container at the Corte Madera Staging Yard in accordance with the Avian Protection Plan/Nesting Bird Management Plan and MM BIO-28.

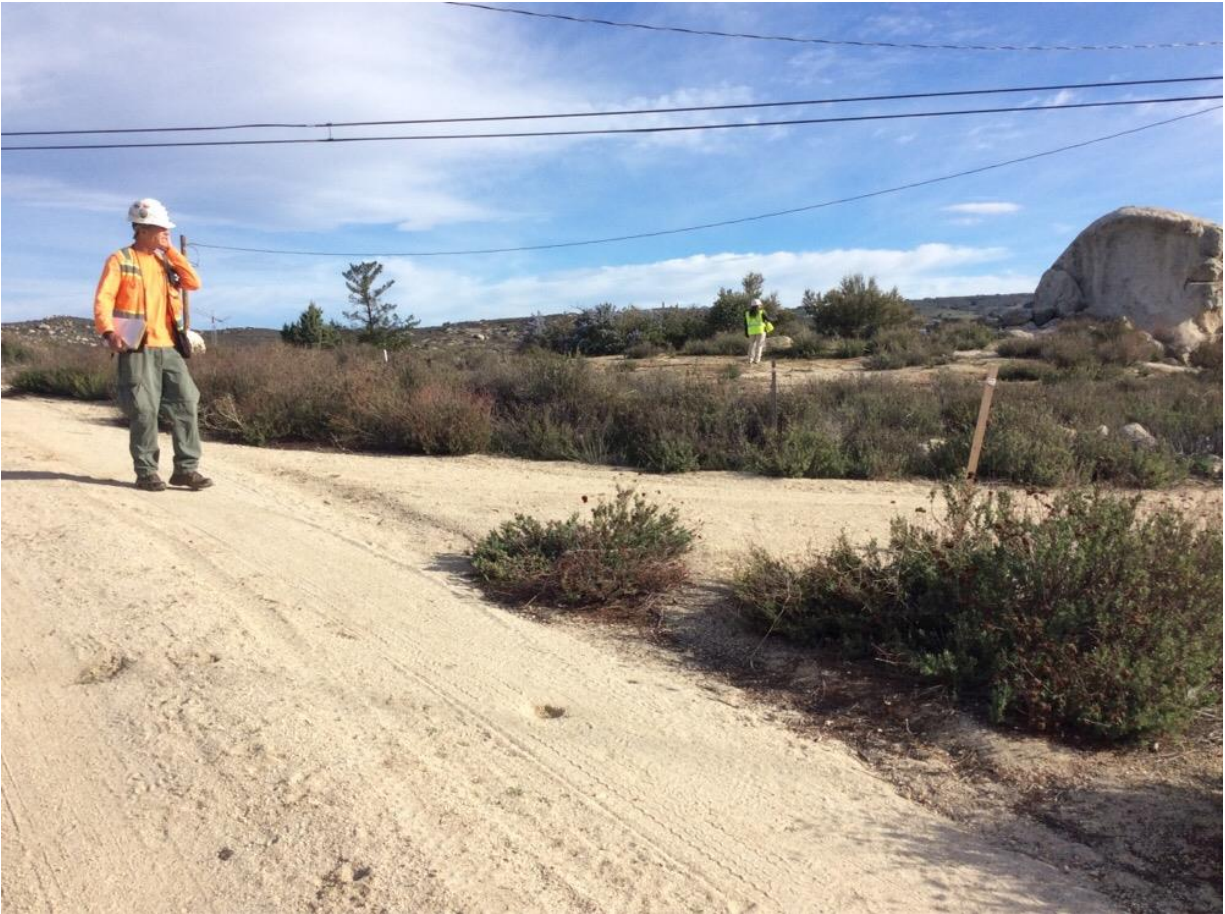
**Photo 2:** Archaeological and Native American monitors survey Location 81 (TL629E) and take baseline photographs of best management practices (BMPs) near the site, in accordance with MM CUL-1 and the HPMP.

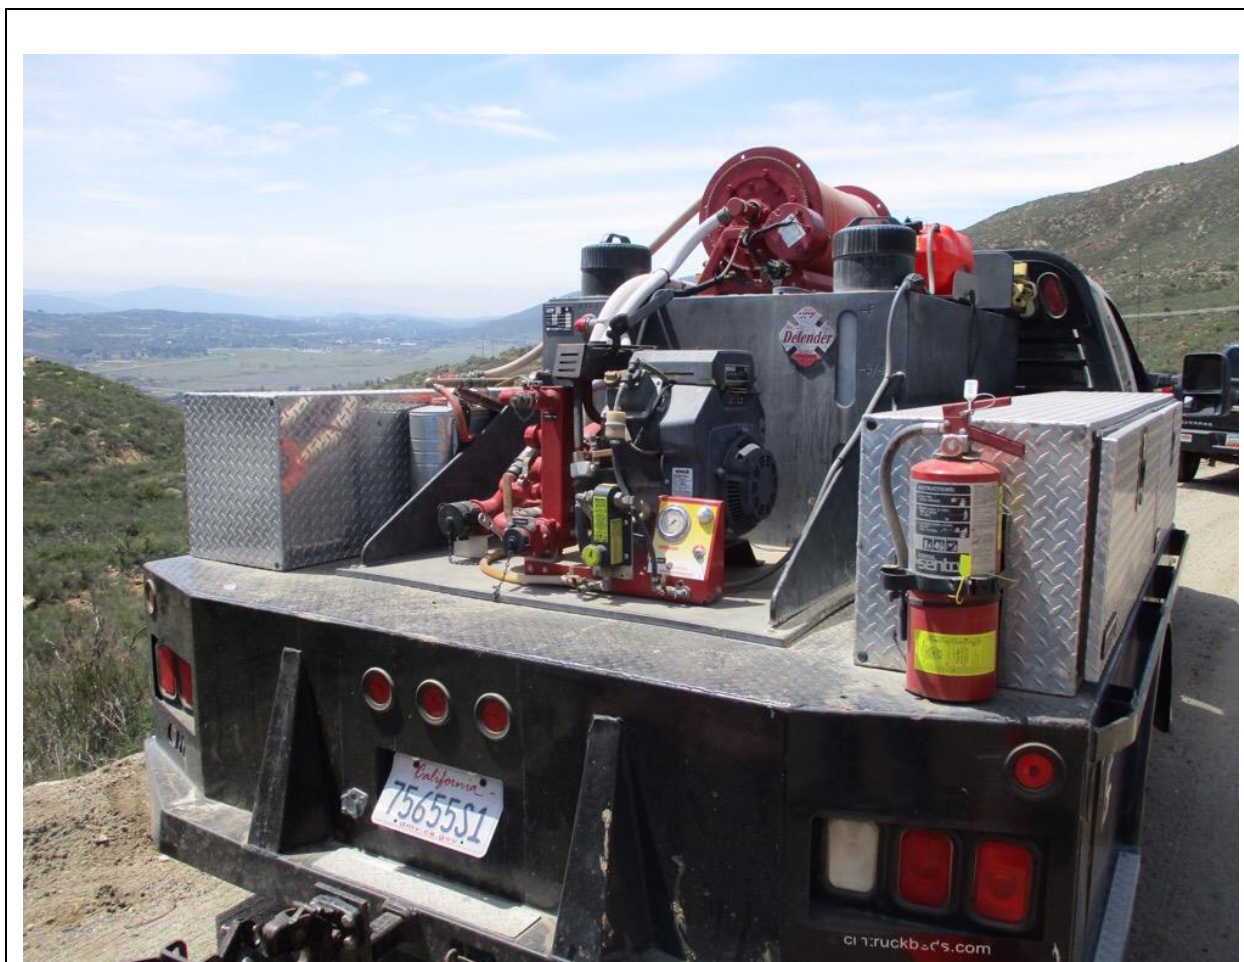
During construction activities, construction fire patrols were observed inspecting sites for compliance with the Construction Fire Prevention/Protection Plan (CFPPP) and MM FF-1. Construction crews were observed staging the required fire tools and equipment based on the Project Activity Level (on CNF land)/Fire Potential Index (off CNF land) and the construction activity being performed as allowed in the CFPPP Fire Prevention Matrices. A set of fire tools (5-gallon backpack pump, round point shovel, Pulaski, and 2A10BC fire extinguisher) was observed at active construction sites in accordance with APM HAZ-01 and APM HAZ-04 (See Photo 3—Attachment A).

**Photo 3:** The required fire tools (such as 5 gallon backpack pump, Pulaski, round point shovel, and 2A10BC fire extinguisher) were observed on-site in accordance with the CFPPP, MM FF-1, MM BIO-6, and APM HAZ-4.

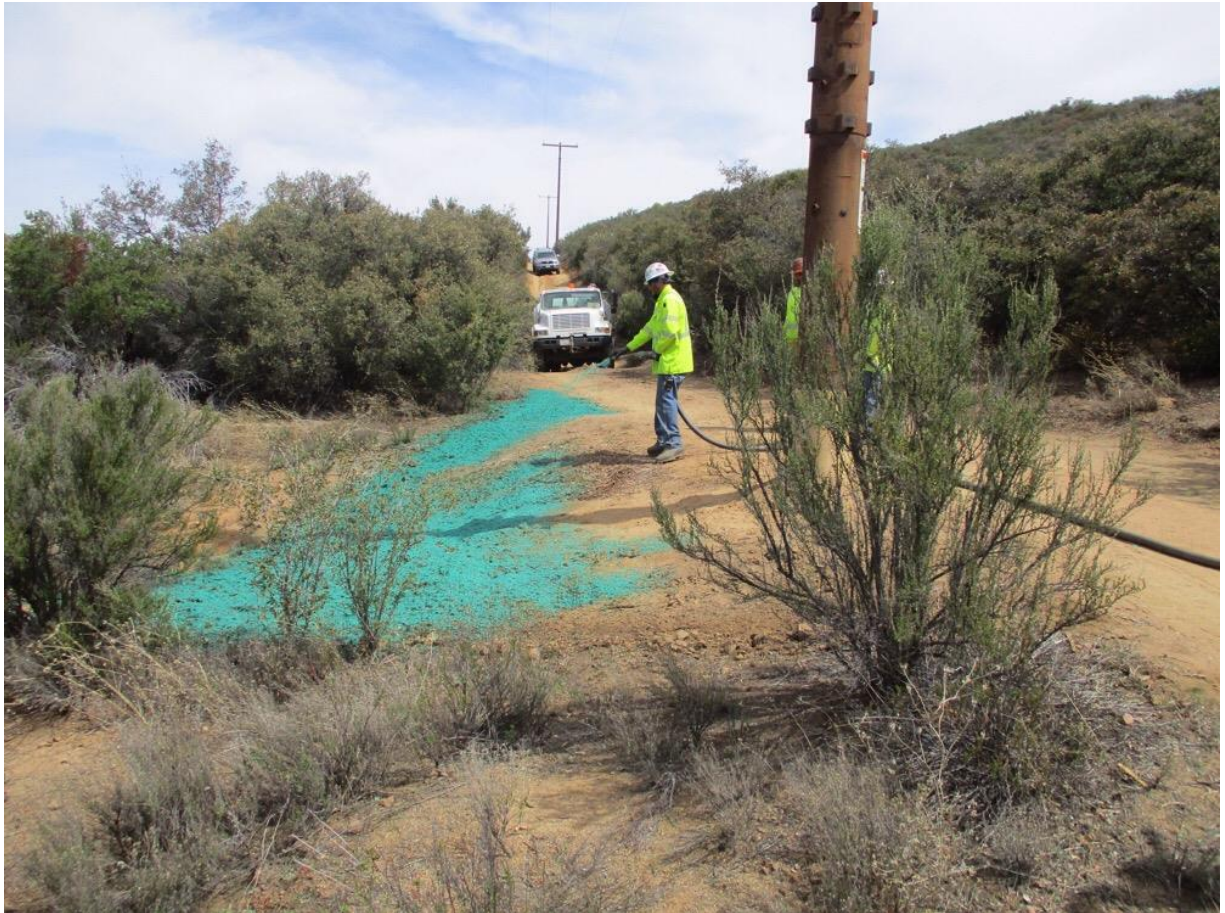
**Photo 4:** A crew is observed applying hydro-mulch at P176976 (C442) in accordance with the Erosion Control Plan and SWPPP.

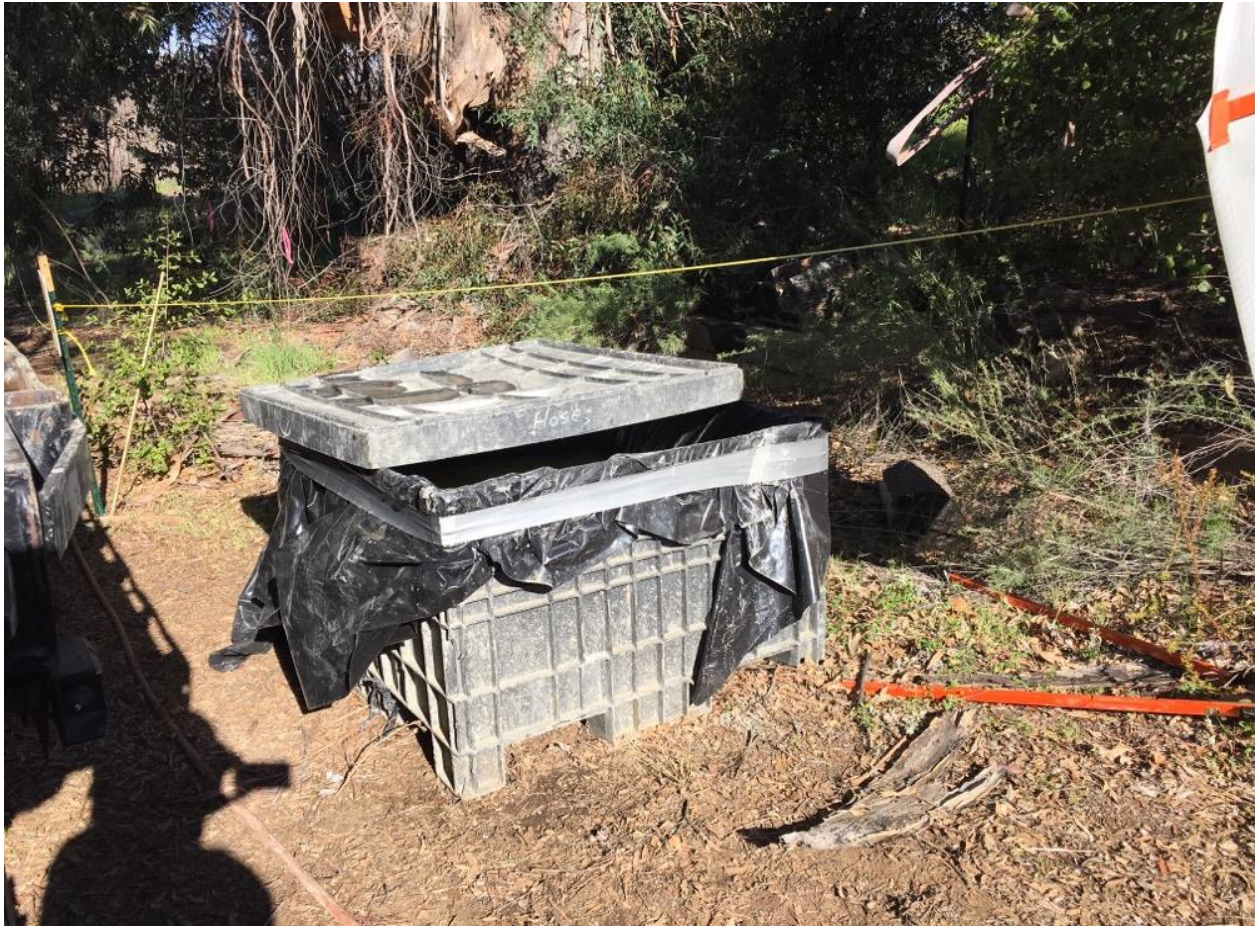
**Photo 5:** A lined concrete washout basin with cover observed near grouting operations at Pole Z118037 (TL 682), in accordance with APM HYD-01.

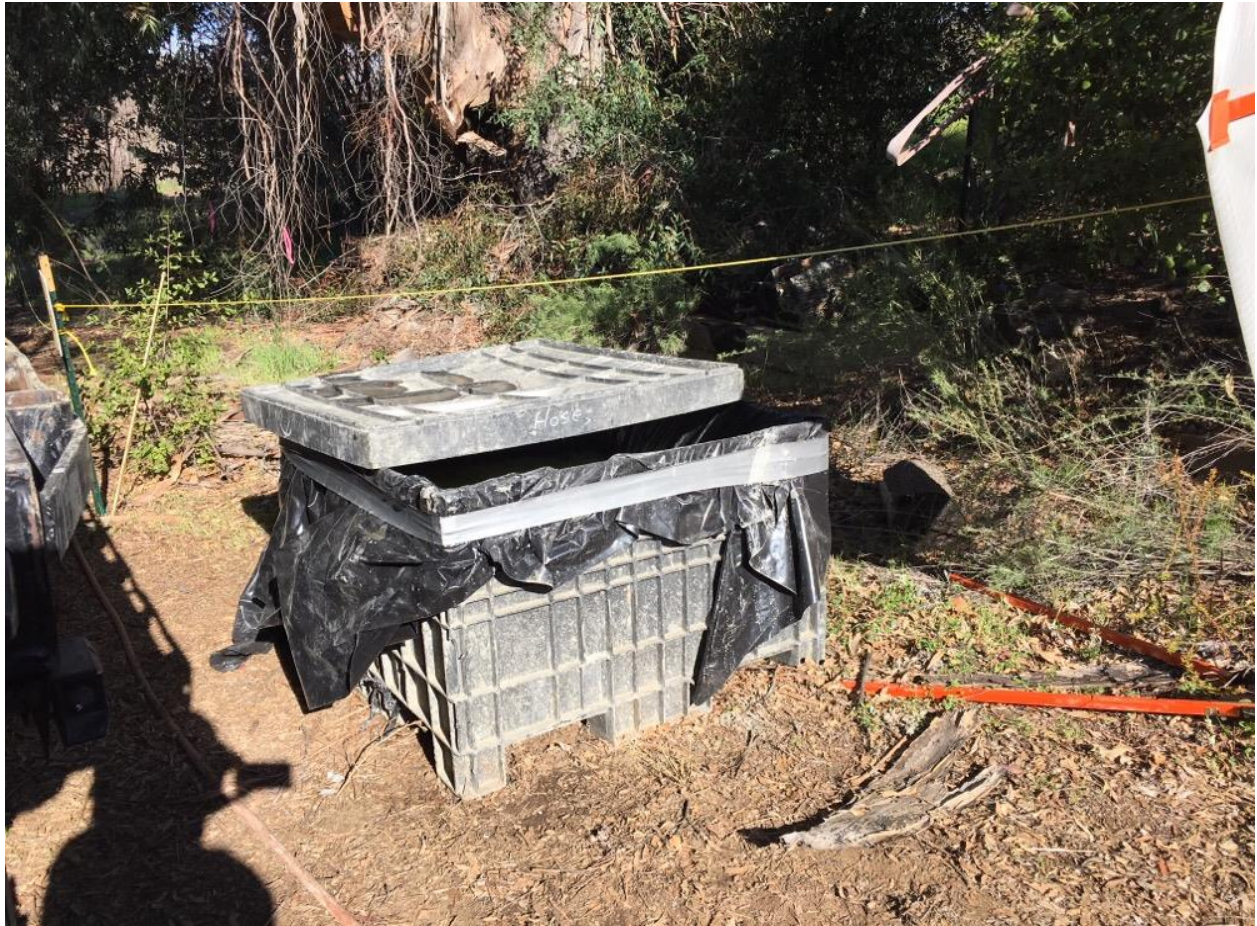
**Photo 5:** A lined concrete washout basin with cover observed near grouting operations at Pole Z118037 (TL 682), in accordance with APM HYD-01.

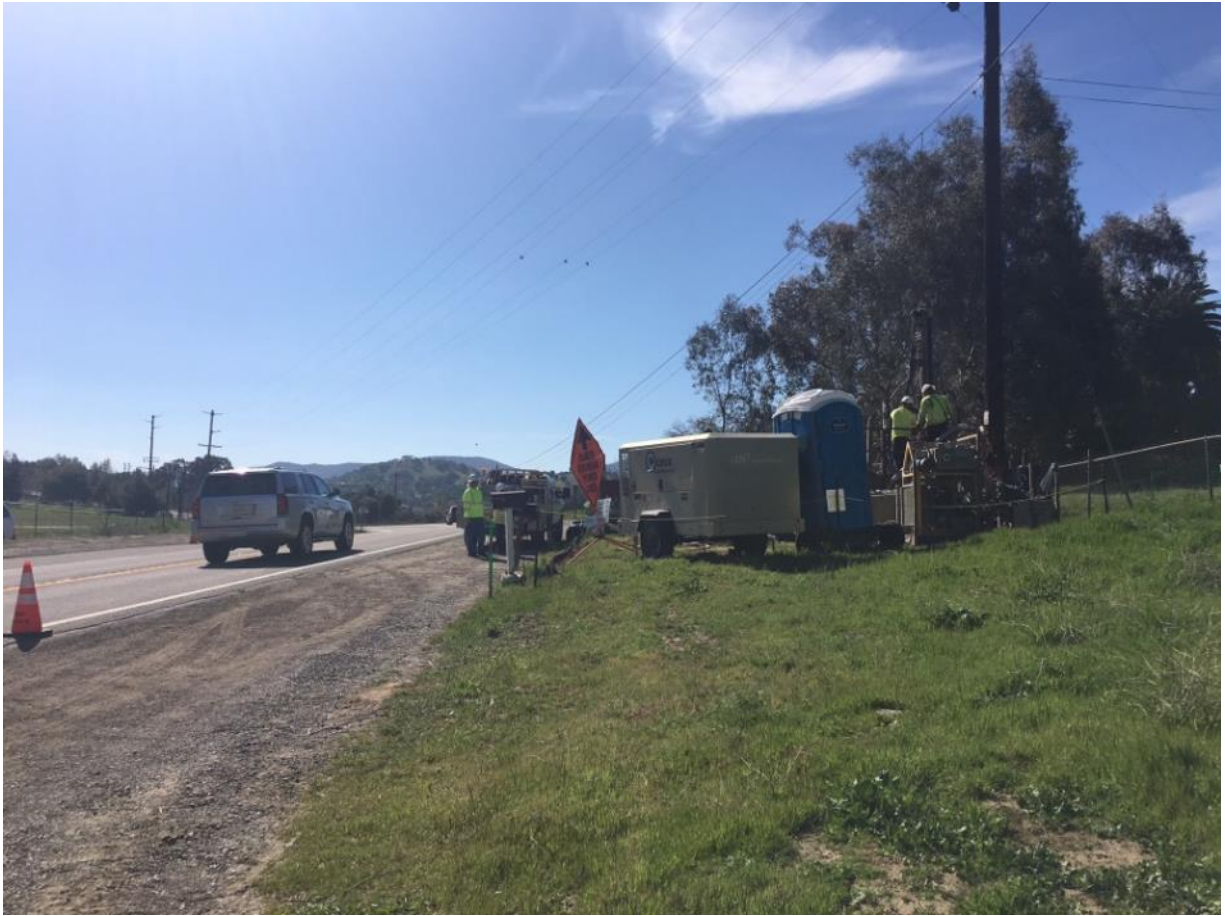
**Photo 6:** Crews were observed drilling micropile foundations at Pole Z118034 (TL682). Work activities remained within the work limits per MM BIO-1A. Traffic control crews were observed near the work limits with traffic cones and signs to direct traffic if required, per APM TRANS-02.
