California Public Utilities Commission <i>Mitigation Monitoring, Compliance, and Reporting Program</i>
	Cleveland National Forest Power Line Replacement Projects Compliance Status Report: 007 December 25, 2016

This compliance status report covers construction activities from December 12 through December 25, 2016.

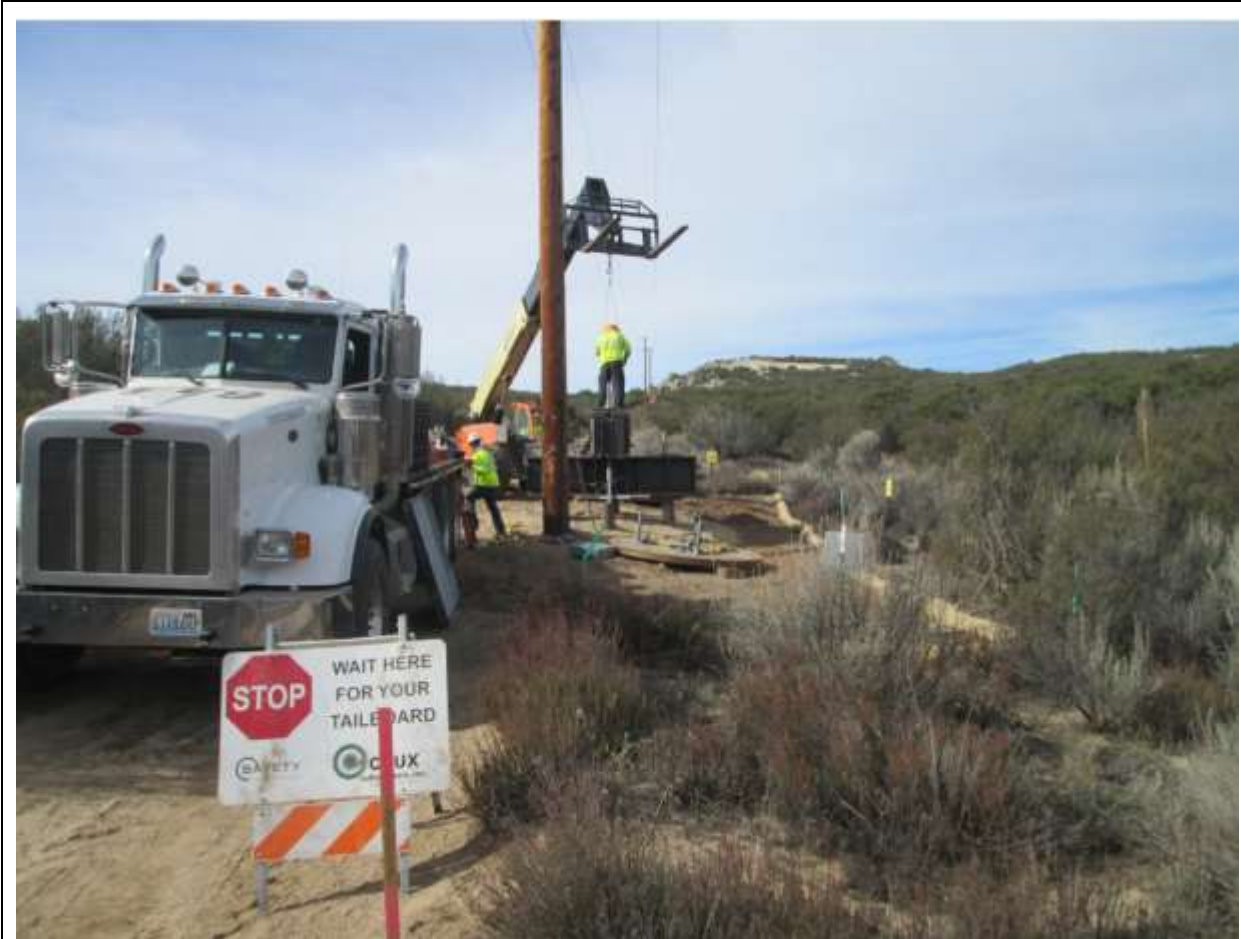
Photo 1: Crews were observed strength testing micropile foundations along TL 629E (Pole Z44169, above). Crews were observed staying within the delineated work limits (MM BIO-1) and ESAs were observed marked for avoidance in Quino Checkerspot Butterfly habitat (MM BIO-21).

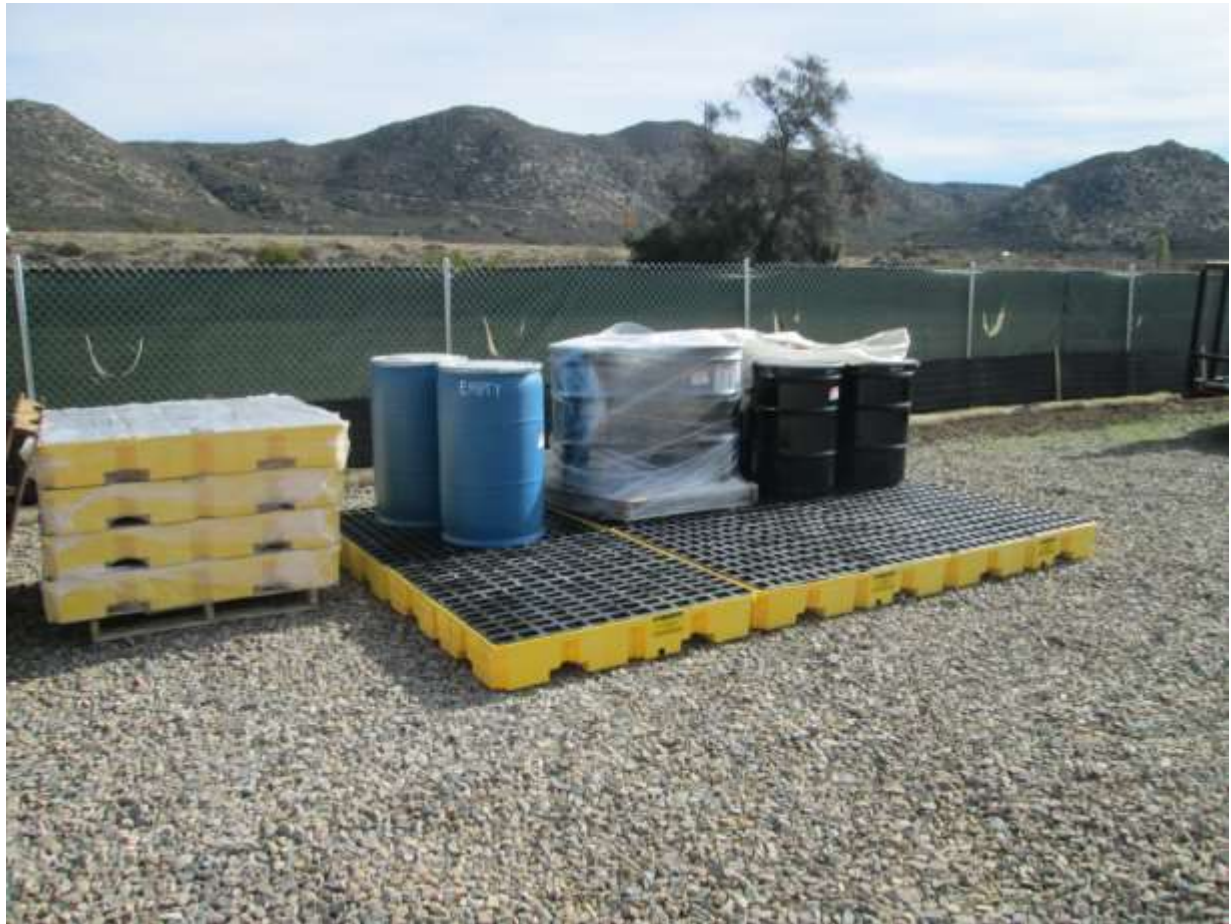
During foundation installation activities, crews were observed carrying required fire equipment in vehicles and staging required tools adjacent to work areas and fire patrols were observed along the project alignment in accordance with the CFPPP (MM FF-1). Drip pans and absorbent materials were observed under staged equipment such as generators adjacent to work sites in order to prevent soil staining in accordance with the SWPPP. Spill kits were observed staged adjacent to work areas and hazardous materials were observed stored at the staging yards in accordance with MM PHS-2 (See Photo 2—Attachment A).

Photo 2: Hazardous materials were labeled and stored at staging yards in accordance with MM PHS-2.

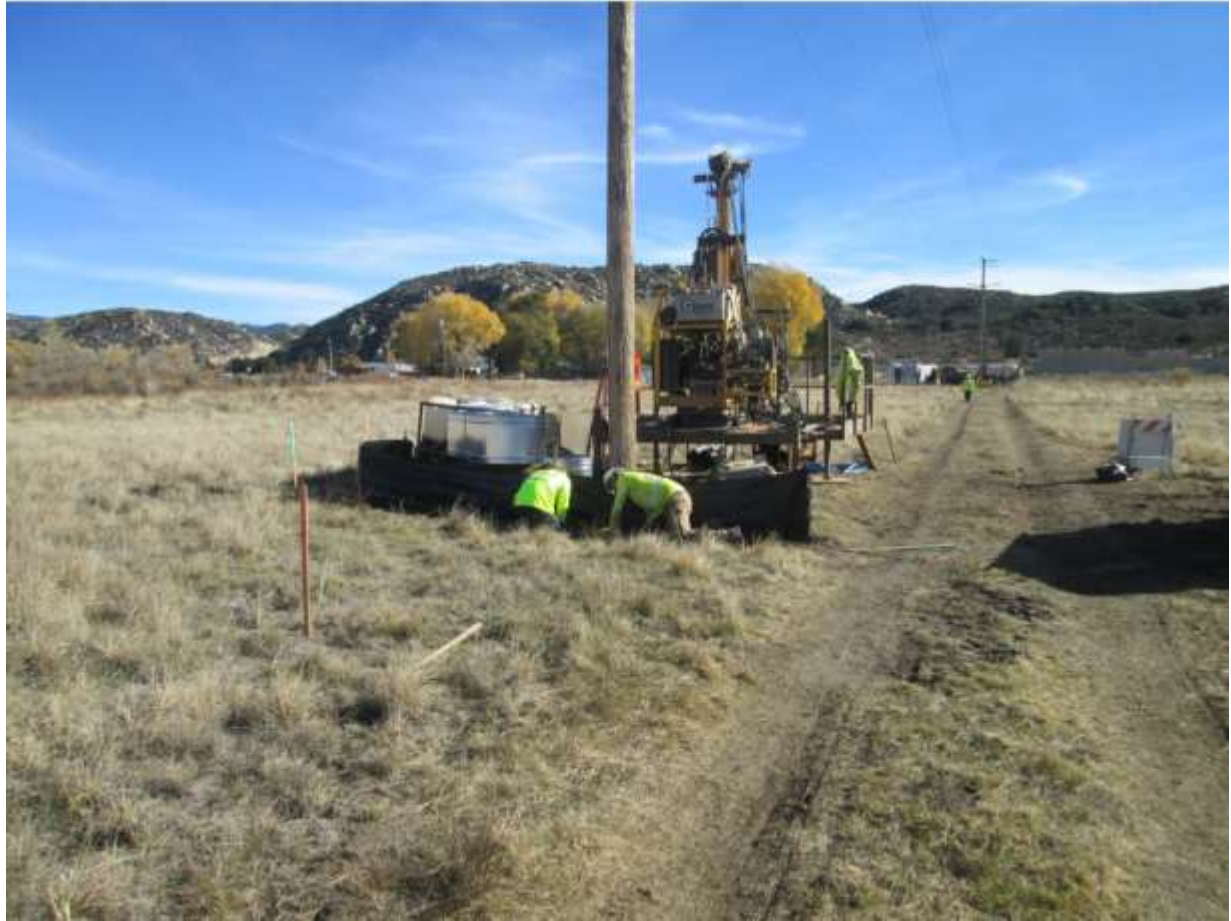
Photo 3: Crews were observed preparing for microile drilling activities along TL 629E (Pole Z44158, above) and installing silt fencing in accordance with the SWPPP.

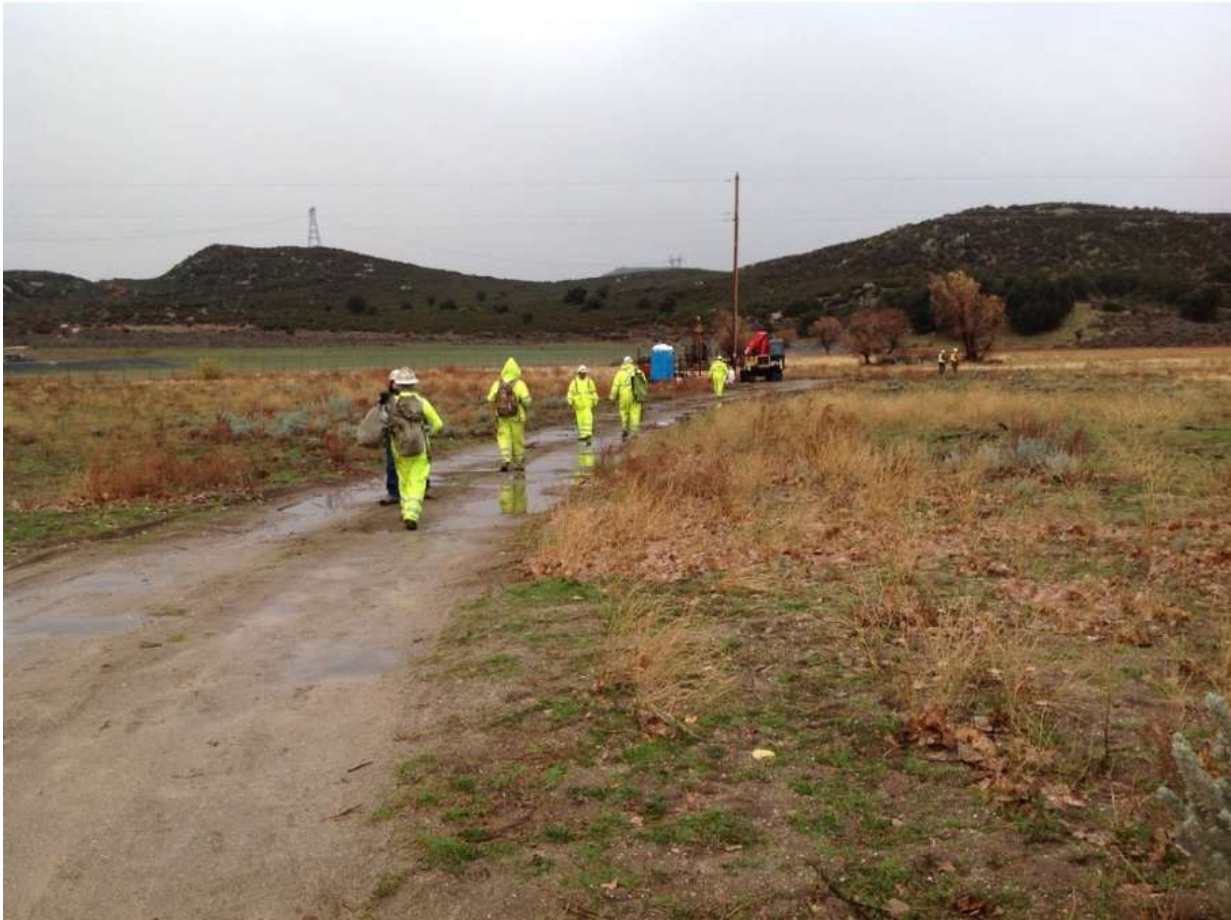
Photo 4: During days where roads were deemed too wet to adequately support vehicles, crews accessed active construction sites (such Pole Z44159, above) on foot in accordance with APM HYD-03.

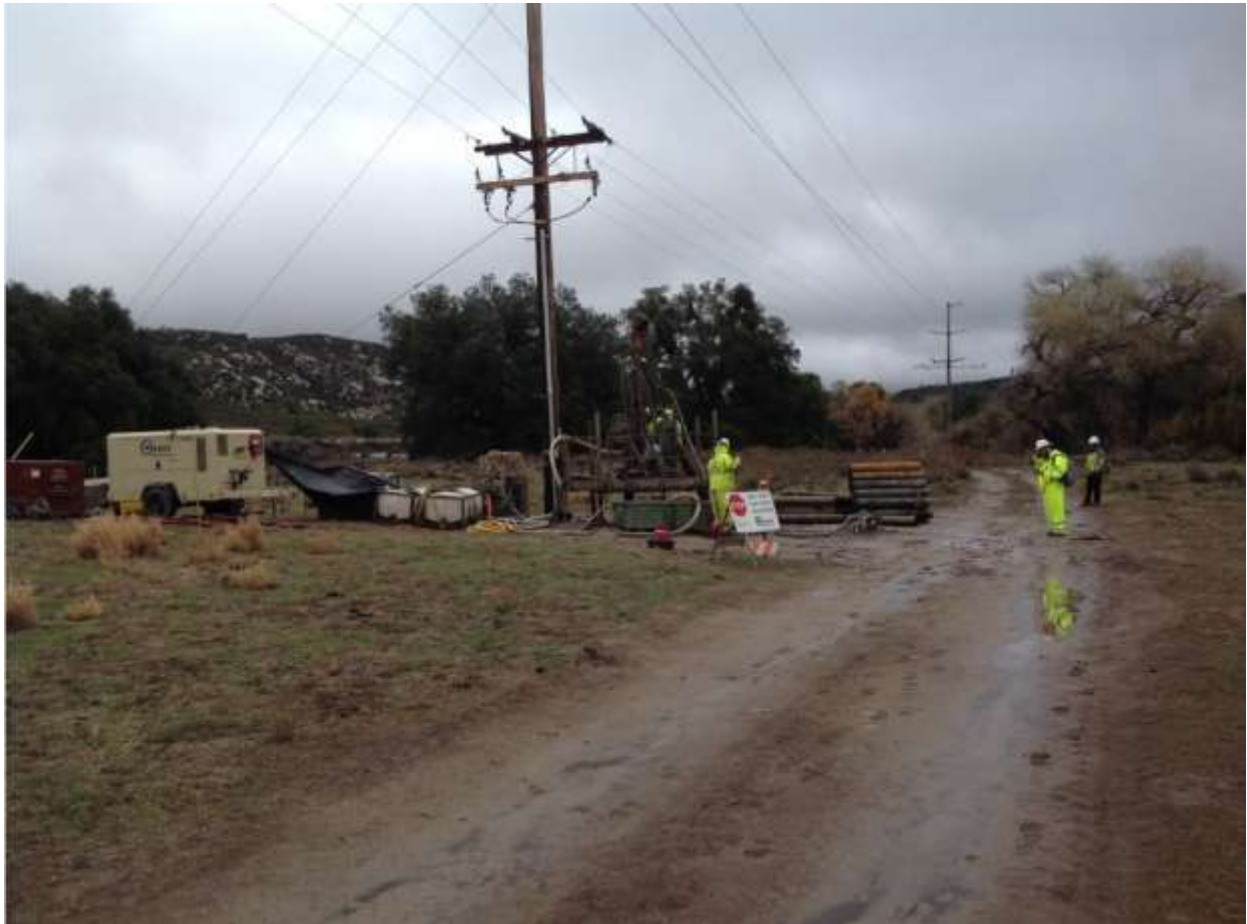
Photo 5: Sediment rotary tanks were observed installed at work sites to assist with drilling and to alleviate pooling groundwater within workspaces along TL 629E (Pole location Z40582, above).

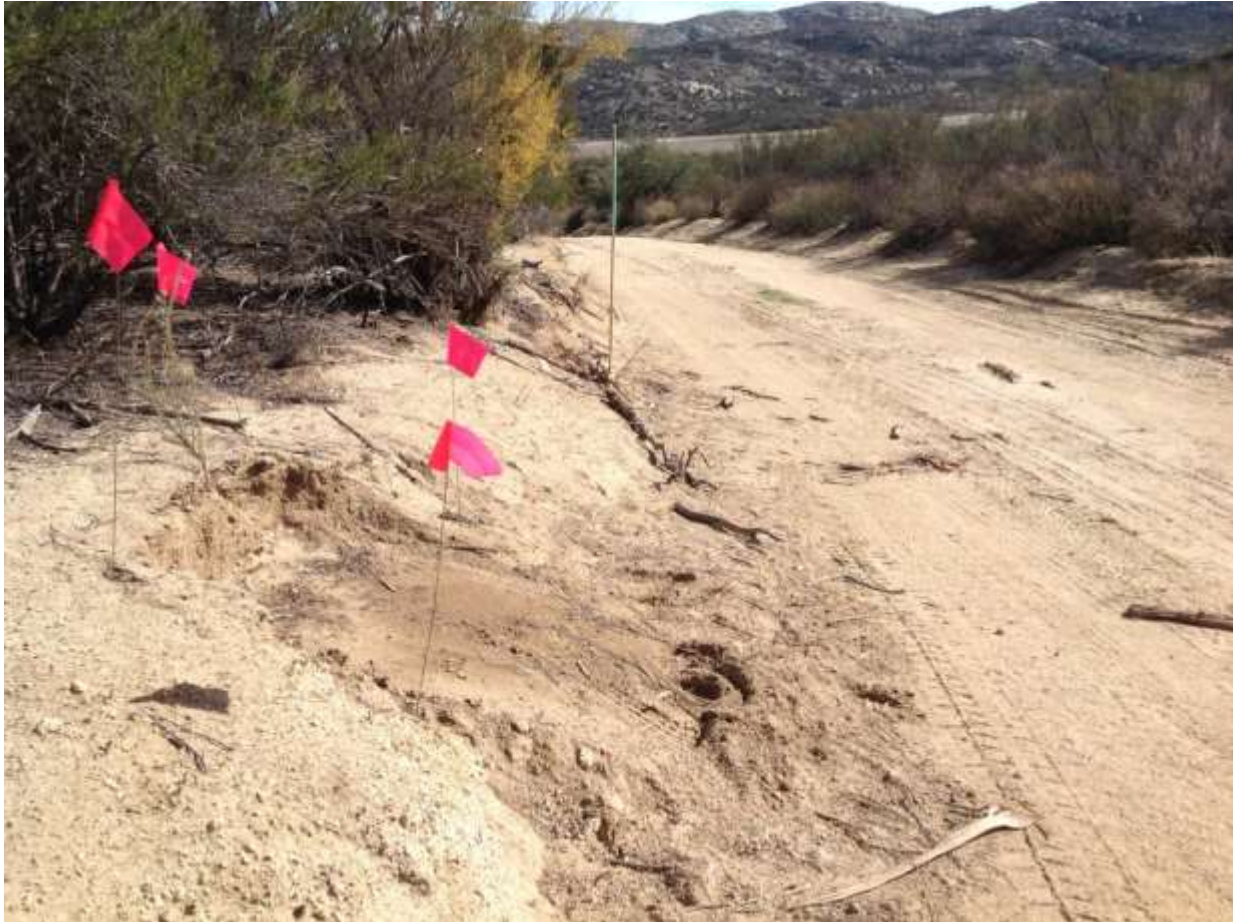
A minor deviation was issued by the CPUC on December 12, 2016 as a follow up to field observations discussed in Weekly Report 6. As a corrective action, SDG&E will provide CPUC with additional work areas needed to support equipment footing beyond existing access roads and has flagged the areas noted in the minor deviation to ensure restoration and compensation for impacts in accordance with APM BIO-3, and MM BIO-4 and 5 (See Photo 6—Attachment A).

Photo 6: Following the Minor Deviation issued by CPUC on December 12, 2016, monitors flagged areas where crane foot pads were staged in order to ensure compensation and restoration was tracked in accordance with APM BIO-3, and MM BIO-4 and 5 (above, adjacent to Pole Z44199).
