California Public Utilities Commission <i>Mitigation Monitoring, Compliance, and Reporting</i> <i>Program</i>
	Cleveland National Forest Power Line Replacement Projects Compliance Status Report: 060 January 13, 2019

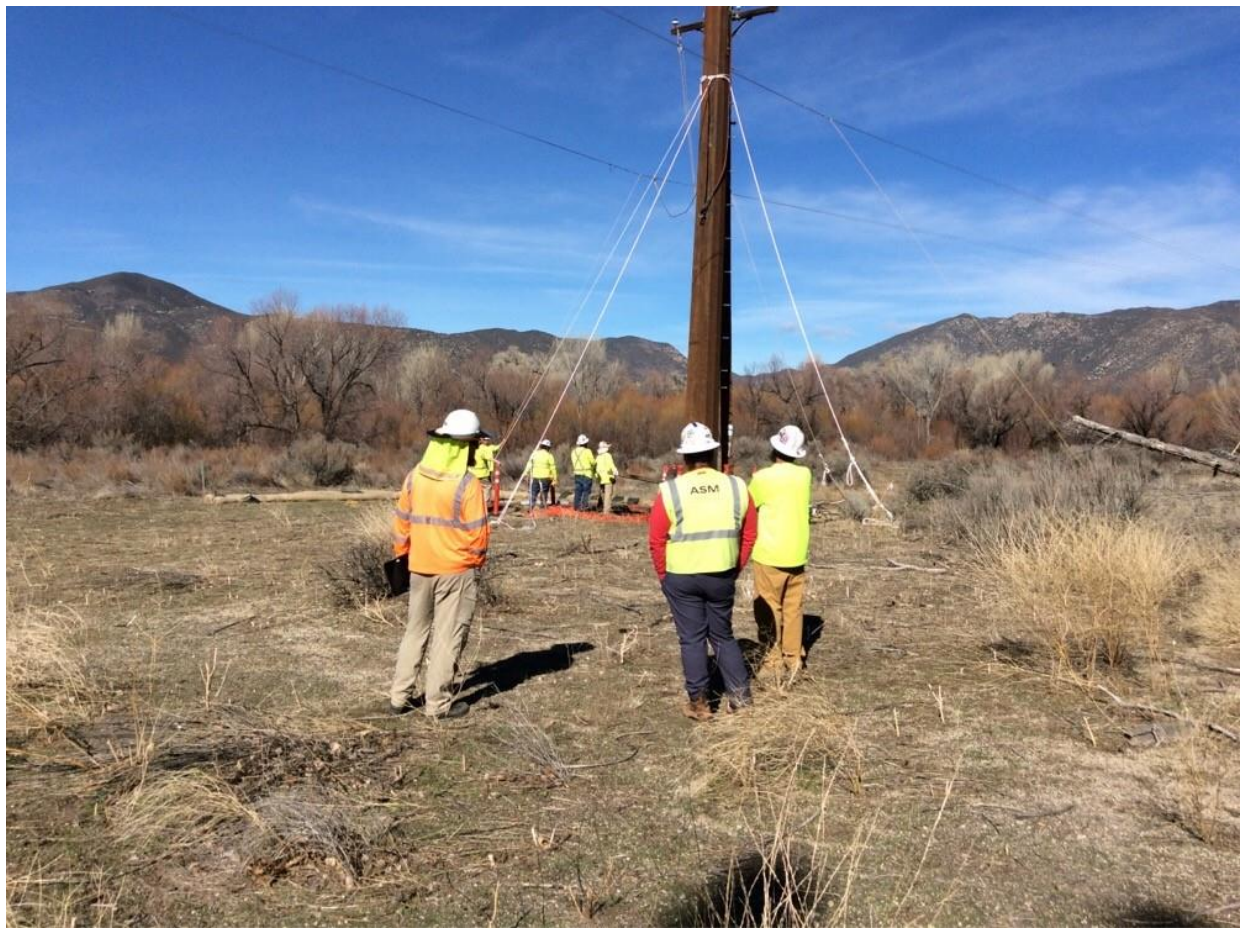
Photo 1: During pole setting at Pole Z100055 (TL 629C), biological, archeological, and Native American monitors were present in accordance with MM BIO-22, the HPMP, MM CUL-1, and APM CUL-04.

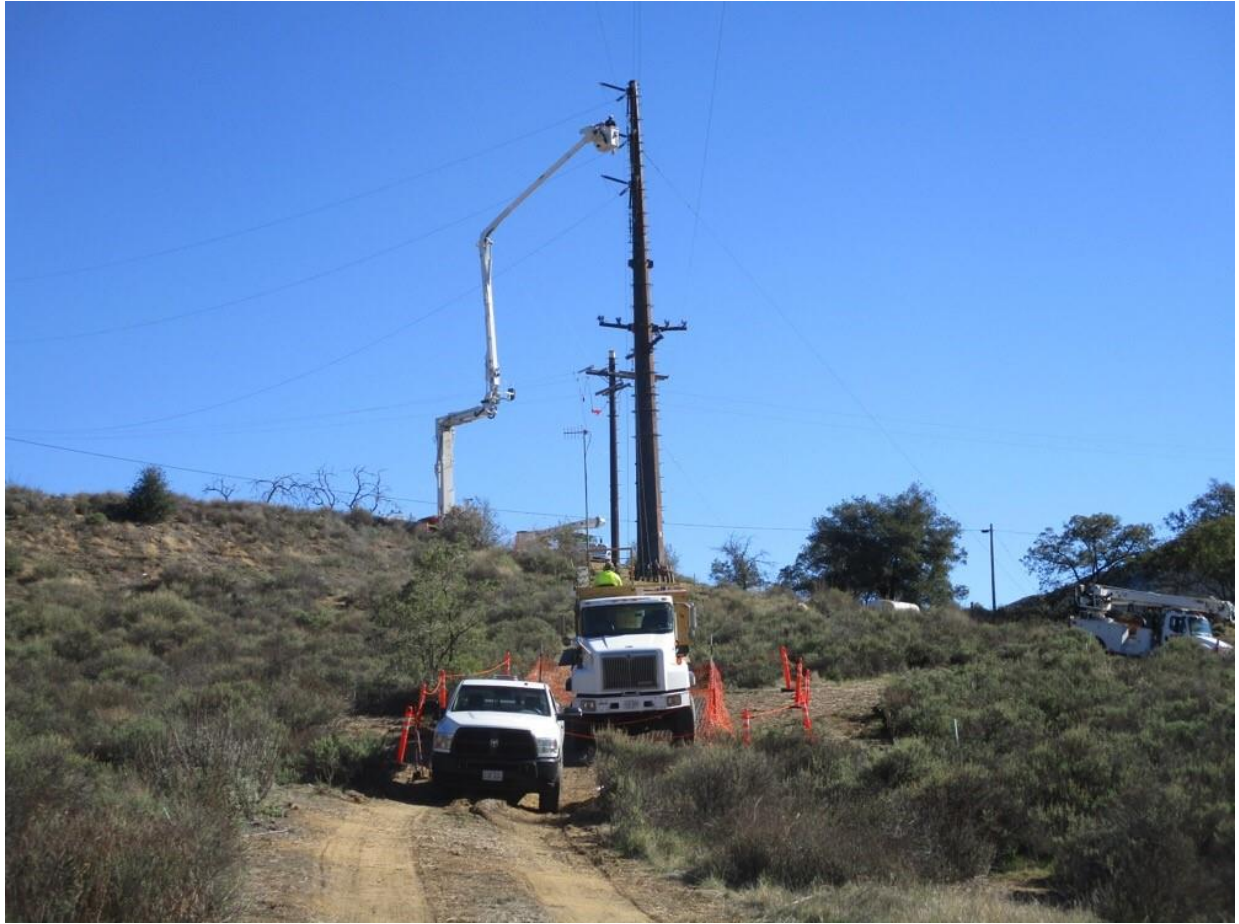
Photo 2: During 69 kV transmission line stringing operations at TL 682, a crew was observed sagging and dead ending wire at Pole Z118076 and the associated stringing site.

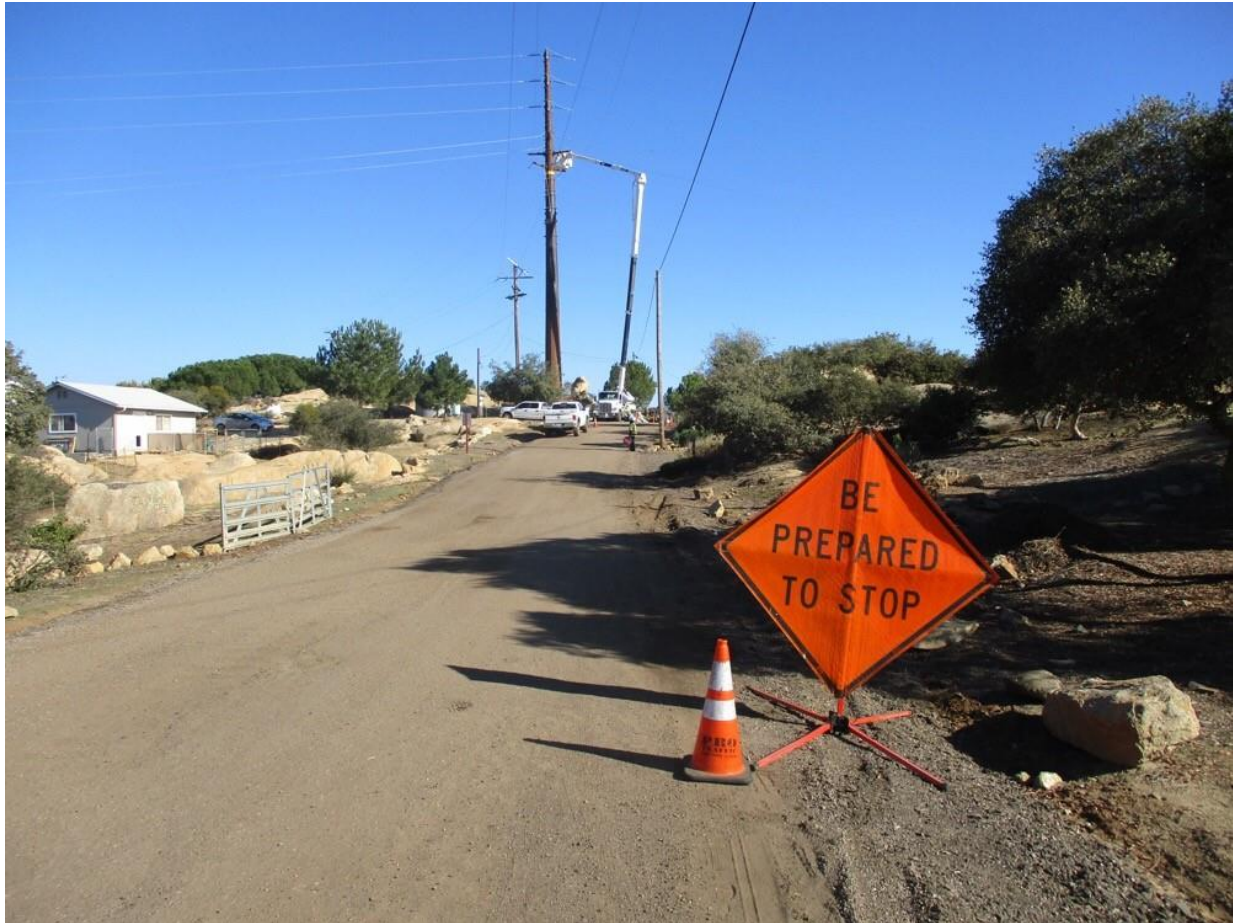
Traffic control measures were observed being implemented in accordance with APM TRANS-02. Signage and cones were used for shoulder closers and flaggers were utilized to temporarily hold traffic when needed (See Photo 3 – Attachment A) or when helicopter operations crossed or occurred next to public roadways.

Photo 3: During 12 kV distribution line stringing activities along TL 6957, such as sagging and dead ending wire at Pole Z571424 (pictured), traffic notification signage was set out and traffic control personnel were observed flagging traffic around staged equipment along Carveacre Road in accordance with APM TRANS-02.

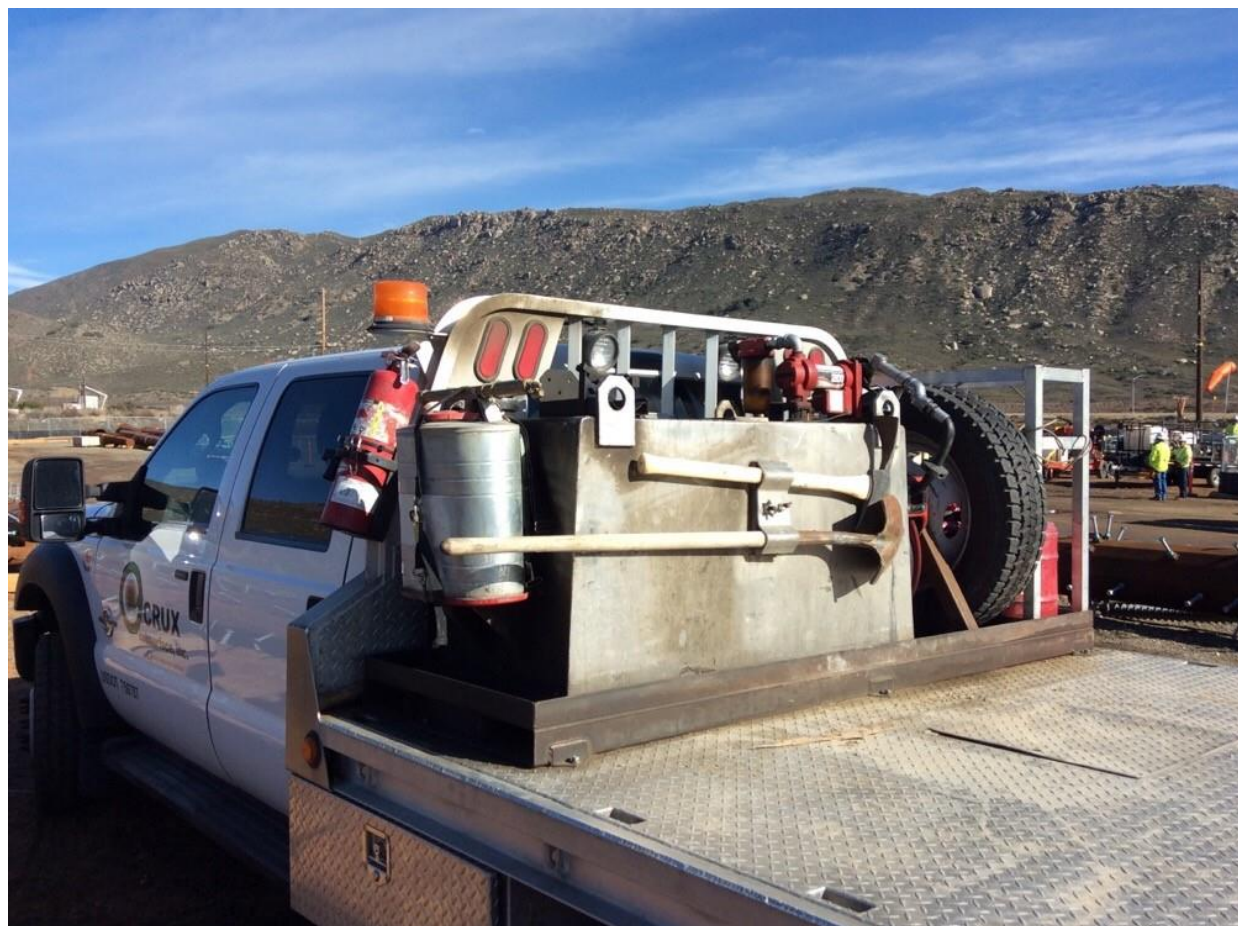
In accordance with the Construction Fire Prevention/Protection Plan (CFPPP) (MM FF-1), all project related vehicles and equipment were observed carrying the required complete set of fire tools (i.e. 5 gallon backpack pump, round point shovel, Pulaski, and 2A10BC fire extinguisher) (See Photo 4 – Attachment A). Complete sets of fire tools were observed within 50 feet of work activities, and additional fire safety and compliance requirements, stipulated in the CFPPP Fire Prevention Matrices, were observed being implemented along rights-of-way. Designated fire patrols monitored construction activities with a higher fire risk, such as work with energized lines, and inspected fire tools and equipment to ensure it was up to date and functional.

Photo 4: In accordance with the CFPPP, all project vehicles were observed with a complete set of fire tools, including a 5 gallon backpack pump, round point shovel, pulaski, and 2A10BC fire extinguisher. Picture taken at Buckman Springs Staging Yard (TL 629C).

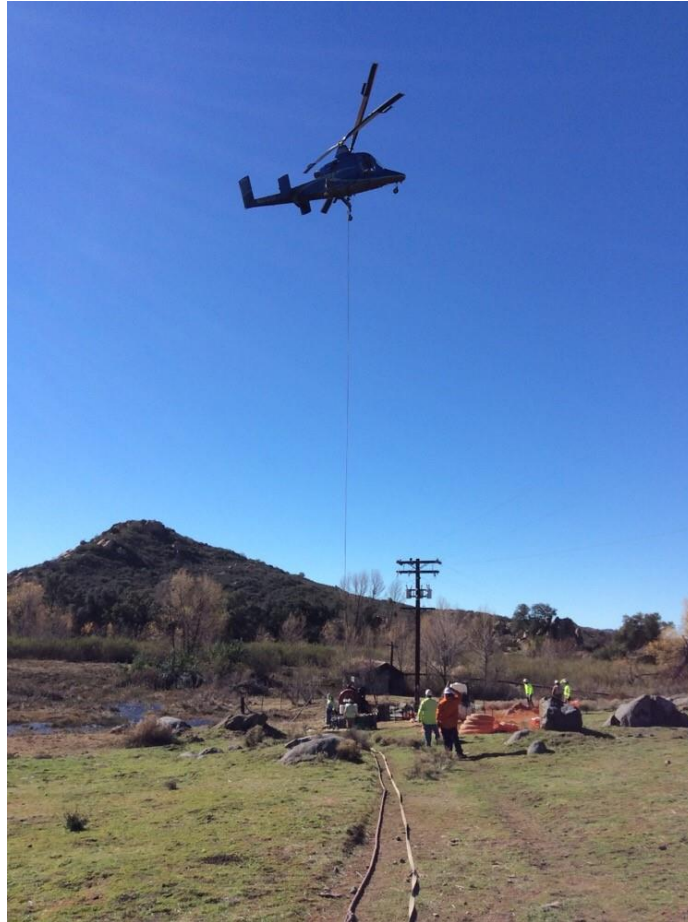
Photo 5: During pole hole excavation and anchor hole backfilling at Pole P278750 (C 157), a helicopter was utilized to transport equipment to and from the remote site using helicopter external load operations in accordance with the Aviation Safety Plan and MM PHS-5.

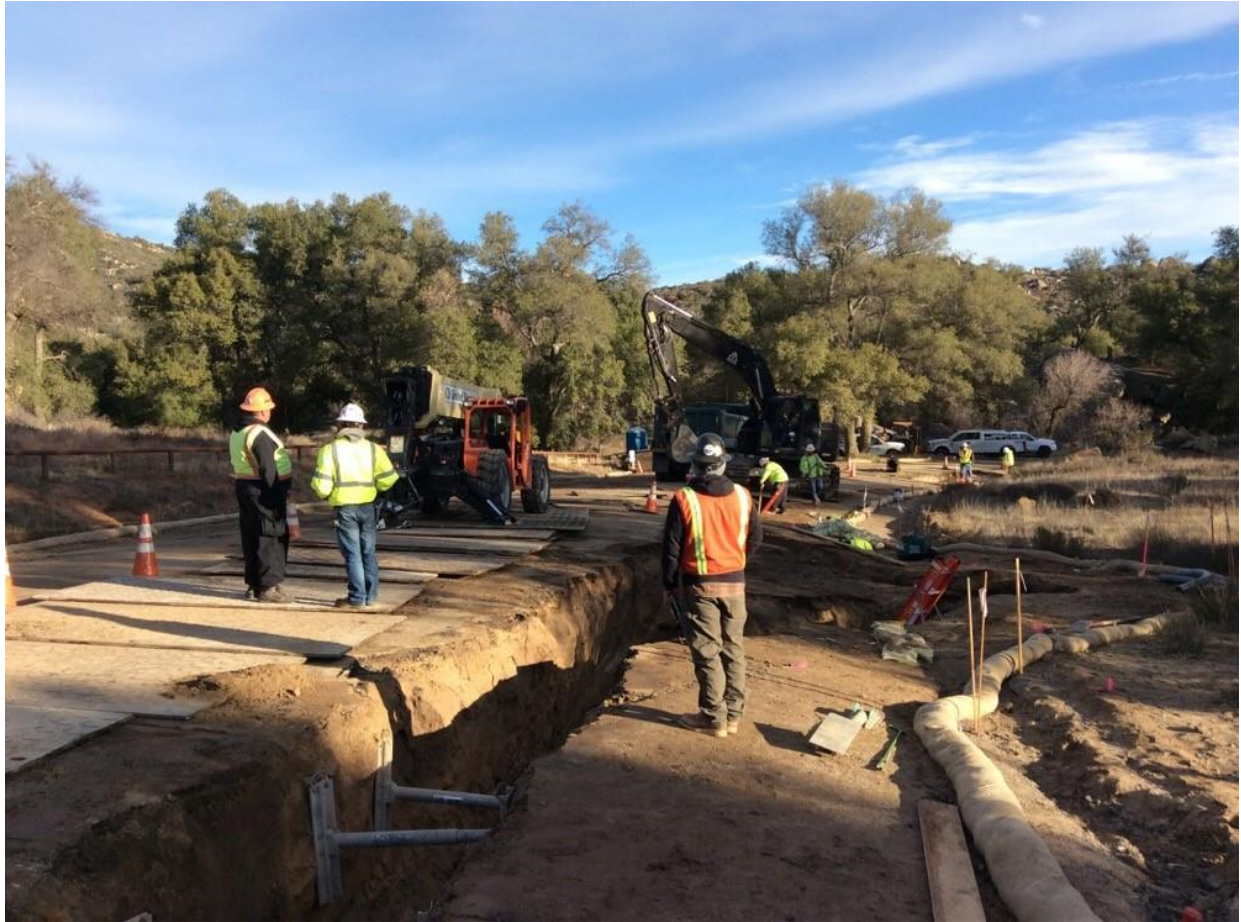
Photo 6: During trenching for the installation of underground conduit along C 449, biological, archeological, and Native American monitors were present in accordance with MM BIO-22, the HPMP, MM CUL-1, and APM CUL-04. Fiber rolls, installed as a sediment control BMP along the limits of construction, were observed in functional condition in accordance with the ECP, SWPPP, and APM HYD-09.
