<p>California Public Utilities Commission <i>Mitigation Monitoring, Compliance, and Reporting Program</i></p>
	<p>East County (ECO) Substation Project</p> <p>Compliance Status Report: 036</p> <p>August 17, 2014</p>

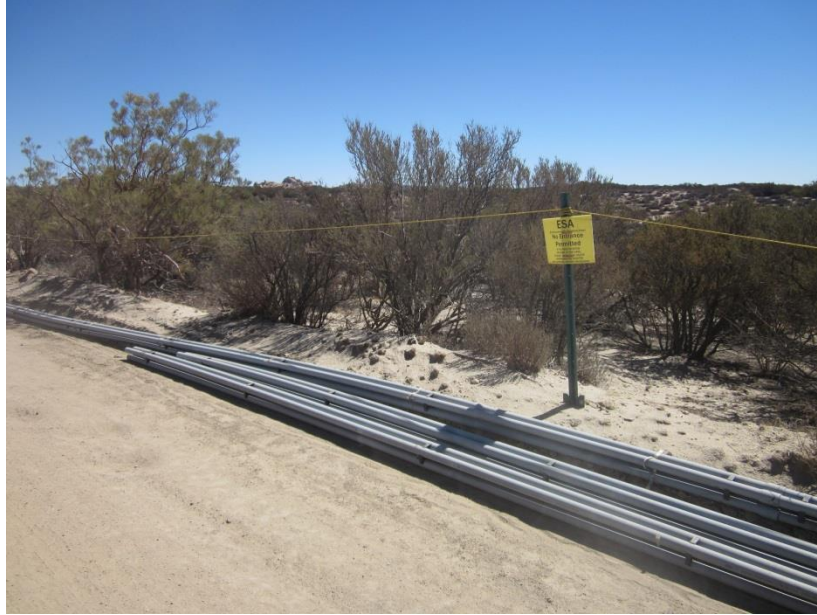
In accordance with MM-BIO-1c and MM-BIO-1a, biological monitors were onsite to ensure crews remained within the approved work limits (See Attachment A- Photo 1). Topsoil was observed staged along the limits of work that will be utilized for restoration activities in accordance with MM-BIO-1d. Trenches and excavations were being covered to prevent wildlife entrapment in accordance with MM-BIO-7a.

Photo 1: In accordance with MM-BIO-1c and MM-BIO-1a, biological monitors were onsite to ensure construction remained within the approved work limits.

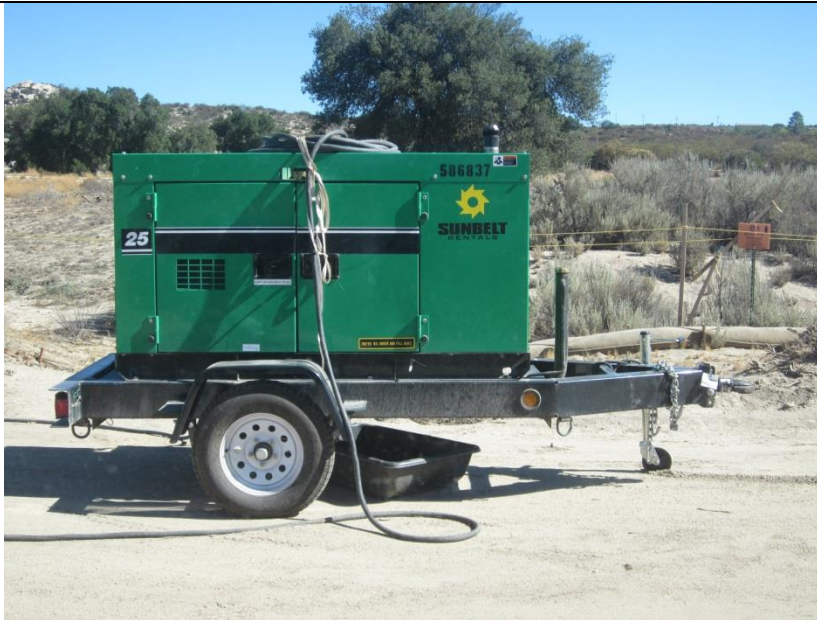
Drip pans were observed beneath equipment staged along the ROW in accordance with MM-HAZ-1a and spill kits were accessible in case of hazardous materials leak (See Attachment A- Photo 2).

Photo 2: Drip pans were observed beneath equipment staged along the ROW in accordance with MM-HAZ-1a.

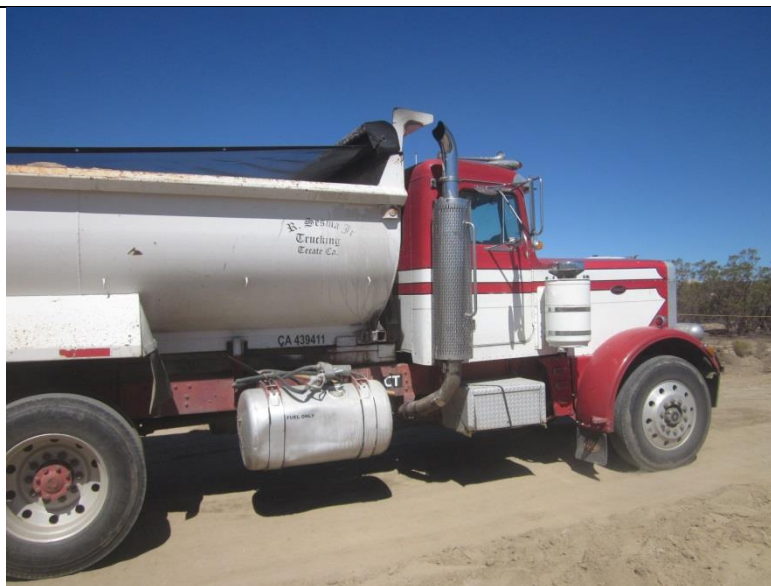
Water trucks were being utilized along access roads to minimize fugitive dust emissions in accordance with the Dust Control Plan and MM-BIO-4a. Trucks used during spoil removal associated with excavation were observed covering loads prior to entering publicly accessed roads in accordance with MM-BIO-4a and MM-AQ-1 (See Attachment A- Photo 3).

Photo 3: Trucks used during spoil removal associated with excavation were observed covering loads prior to entering publicly accessed roads in accordance with MM-BIO-4a and MM-AQ-1.

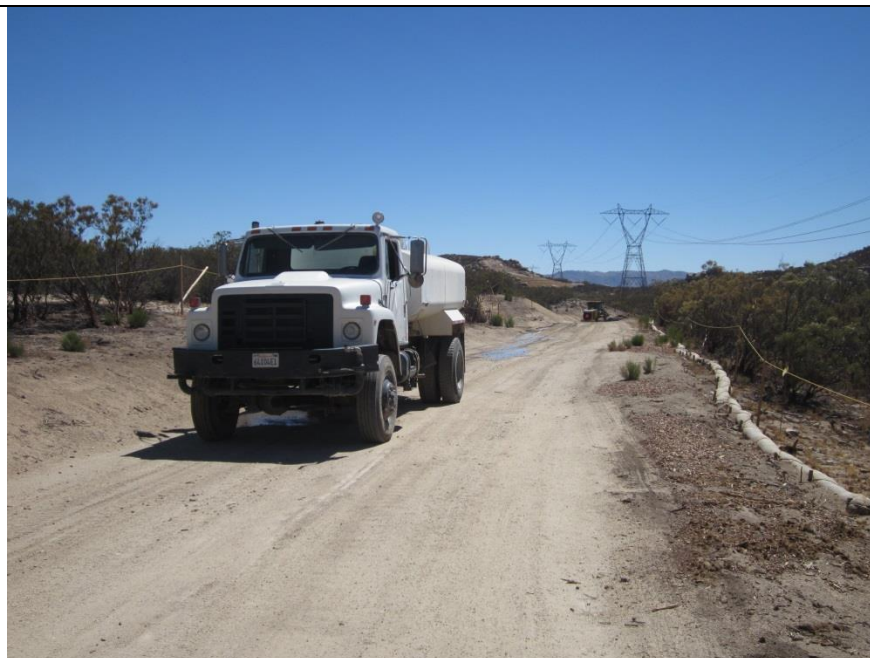
Dust control measures in line with MM-AQ-1 and MM-BIO-4a were observed to be effective (See Attachment A- Photo 4). Track-out measures consisting of rumble plates and rock aprons were in place and maintained.

Photo 4: Water trucks were observed being utilized to minimize fugitive dust emissions in accordance with MM-AQ-1 and MM-BIO-4a.

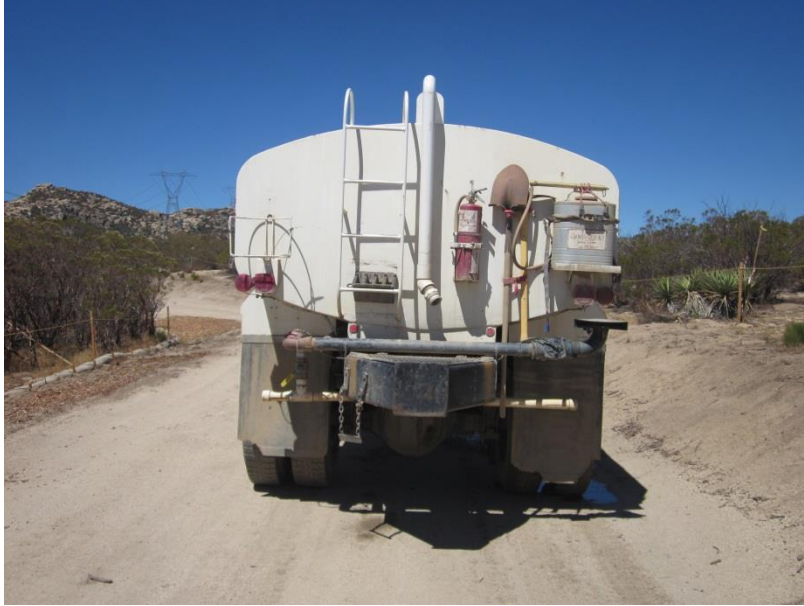
Per the Construction Fire Prevention/Protection Plan, SDG&E was observed inspecting equipment along the ROW to ensure fire suppression equipment was present. Routine patrols were completed by the fire inspection team throughout the construction activities and fire tools were observed at all construction sites as required by MM-FF-1 (See Attachment A- Photo 5).

Photo 5: Fire tools were observed at all construction sites and on equipment as per MM-FF-1.

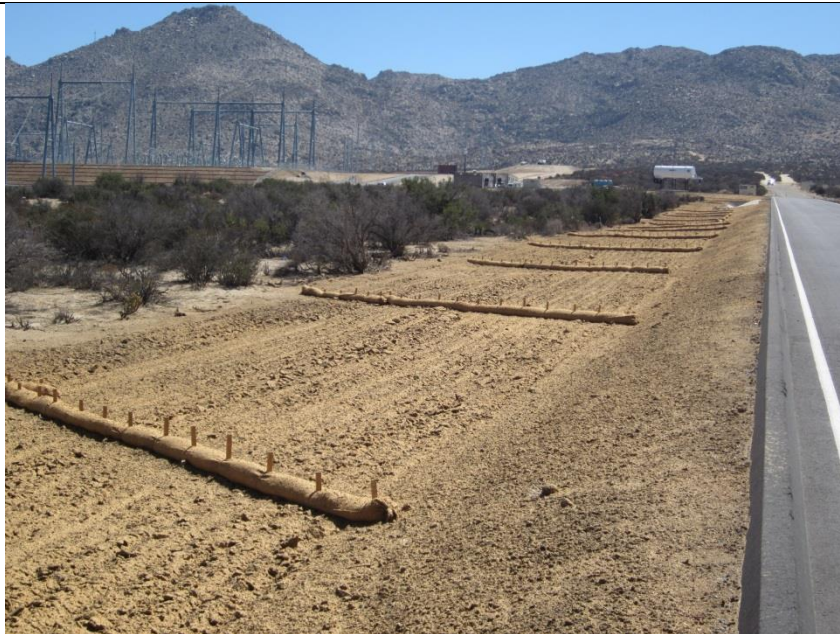
In accordance with MM-BIO4-A and MM-AQ-1, water trucks were used to minimize dust along access roads, work areas, and commonly used routes within the substation boundaries. Erosion control measures consisting of straw wattles, silt fence and gravel bags are being maintained along the ROW in accordance with the SWPPP and MM-HYD-1 (See Attachment A- Photo 6).

Photo 6: Erosion control measures consisting of straw wattles and hydro-mulch are being maintained along the access road to the East County Substation in accordance with the SWPPP and MM-HYD-1.
