<p><b>California Public Utilities Commission</b>  <b><i>Mitigation Monitoring, Compliance, and Reporting Program</i></b></p>
	<p><b>East County (ECO) Substation Project</b></p> <p><b>Compliance Status Report: 040</b></p> <p><b>October 12, 2014</b></p>

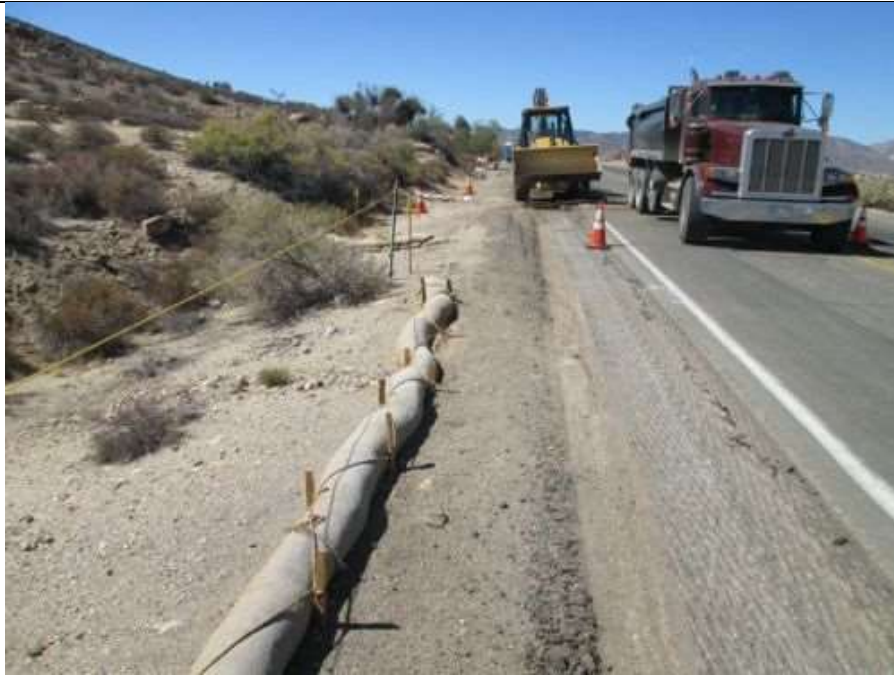
CPUC third-party monitors observed construction crews continuing to execute road shoulder repairs and paving along Old Highway 80 (see Attachment A—Photo 1) and conducting finish-grading activities along roads north and south of Jewel Valley Road. Prior to the use of a street sweeper to clean work areas, trucks were observed applying water in order to prevent dust emissions in accordance with MM-AQ-1 and MM BIO-4a. Traffic control measures including informational signs were observed in place along Jewel Valley road during those activities in accordance with MM-TRA-1. Work limits were observed to be delineated and adhered to in accordance with MM-BIO-1a and perimeter sediment controls (i.e. straw wattles and gravel bag berms) were observed in good condition in accordance with MM-HYD-1.

**Photo 1:** During road improvements along Section 3 of the underground transmission line, crews were observed staying within the work limits and erosion control devices were observed intact in accordance with MM-HYD-1.

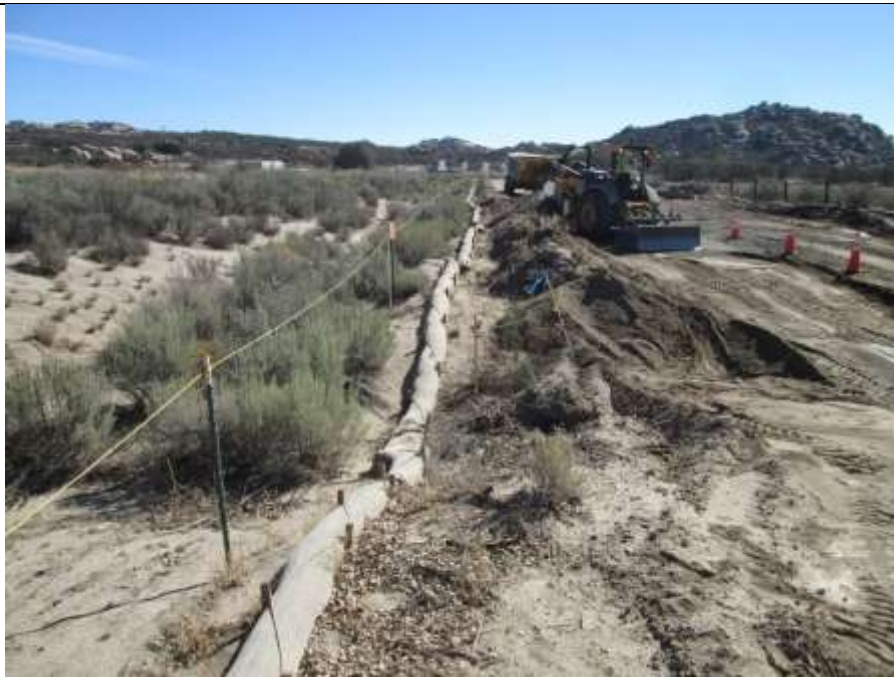
CPUC third party monitors observed excavation activities associated with installation of a storm drain pipe under an access road (see Attachment A—Photo 2). All work was observed being conducted within delineated work limits in accordance with MM-BIO-1a. Erosion control devices were observed intact in accordance with MM-HYD-1 and water was observed being applied to prevent fugitive dust in accordance with MM-AQ-1. Other erosion and sediment control BMPs observed along the right-of-way included velocity dissipaters, water bars, site perimeter straw wattles, gravel bag berms, and perimeter straw wattles around stockpiles in accordance with MM-HYD-1.

**Photo 2:** Along Section 1 of the underground transmission line, excavation in preparation for the storm drain pipe installation was observed being conducted within delineated work limits. Erosion control devices were observed intact in accordance with MM-HYD-1 and water was

observed being applied to prevent fugitive dust in accordance with MM-AQ-1.

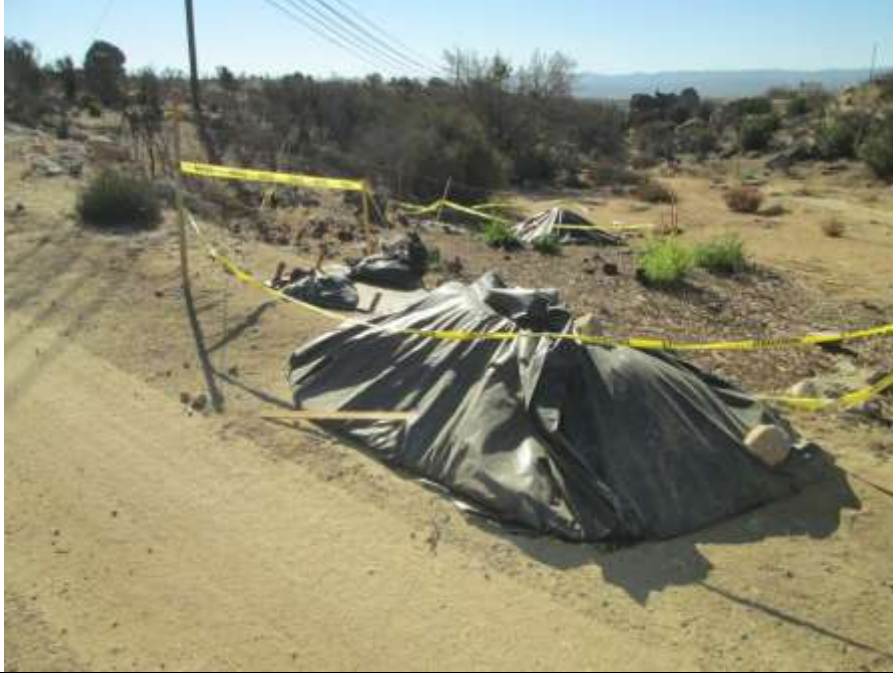
**Photo 3:** Previously drilled holes at a guard structure location for an underground distribution line were observed covered to prevent wildlife entrapment in accordance with MM-BIO-7a. Additionally, spoil piles were observed covered with visqueen to prevent erosion in accordance with MM-HYD-1.

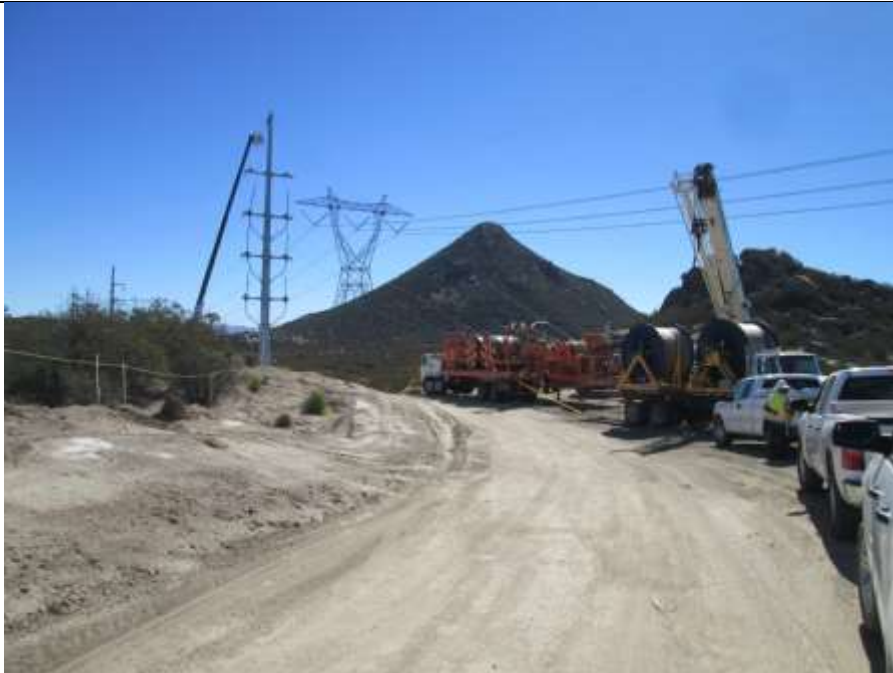
**Photo 4:** Work limits were observed delineated and intact during fiber optic stringing activity at SP 38. Biological monitors were observed monitoring activities in accordance with MM-BIO-

1c.

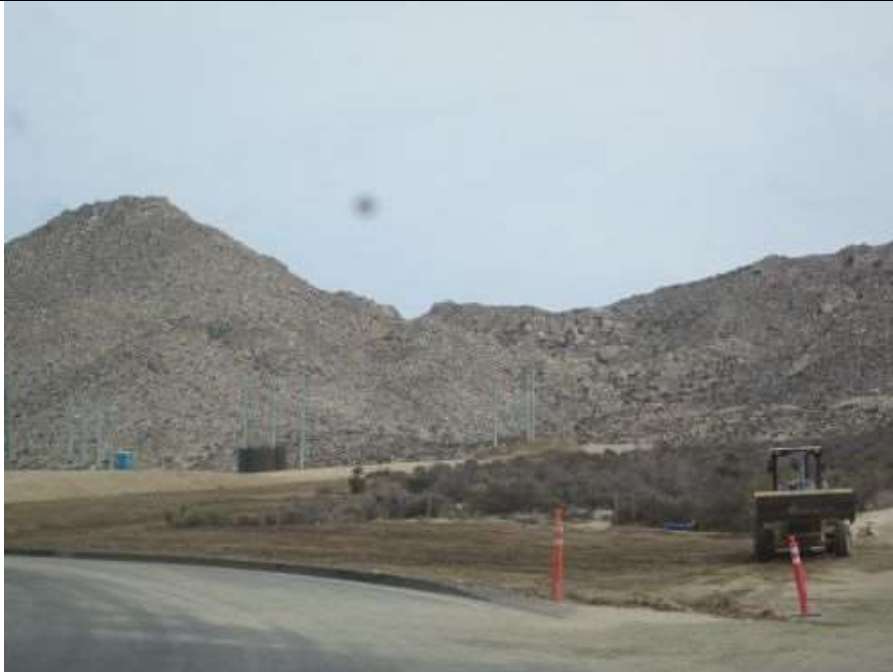
In accordance with MM-BIO-1d, crews were observed re-distributing topsoil where temporary trailers were staged (see Attachment A—Photo 5), as well as staking locations for potted plants. During other activities, speed limits along the southern access route were observed being adhered to in accordance with MM-BIO-7b and erosion control devices throughout the site were observed in good condition in accordance with MM-HYD-1.

**Photo 5:** Topsoil was observed being distributed where temporary trailers were staged at the ECO substation in accordance with MM-BIO-1d.

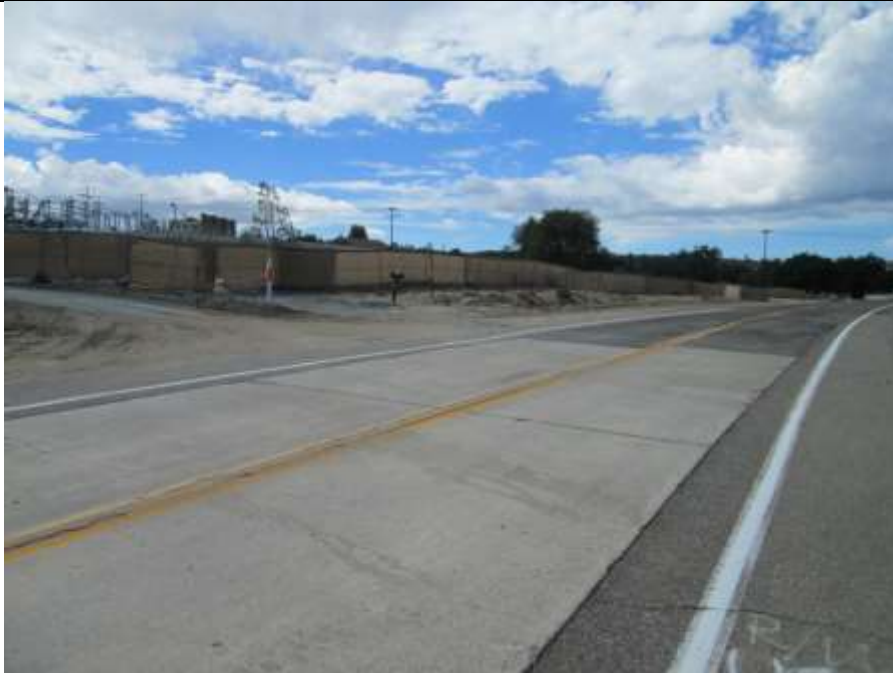
Rattle plates have been installed at the point of ingress/egress to Old Highway and were observed in good working condition, as sediment track-out was not observed. On October 1, CPUC third-party monitors noted that the visual screening materials along the northern perimeter fence had been damaged and were in need of repair. This item was communicated to the lead Environmental Inspector, who confirmed that the material would be fixed by October 6th. The screening material was observed in good condition at the Boulevard Substation location subsequent to the notification (see Attachment A – Photo 6).

**Photo 6:** At the Boulevard Substation rebuild site, the point of ingress and egress connecting to Old Highway was observed free of sediment track-out in accordance with the SWPPP and MM-HYD-1. Additionally, in accordance with MM-VIS-3a, the perimeter security fence's screening material was observed intact upon repair.
