California Public Utilities Commission *Mitigation Monitoring, Compliance, and Reporting Program*

East County (ECO) Substation Project

Compliance Status Report: 050

March 1, 2015

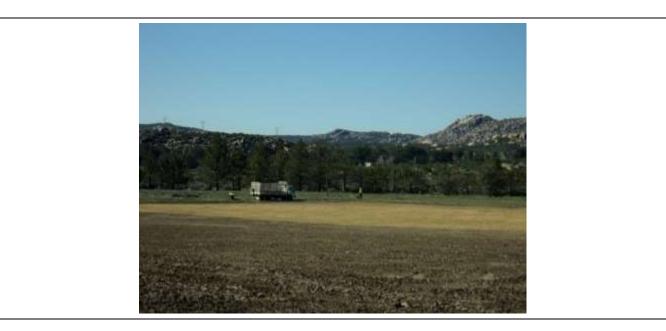
Temporary work areas at the Jewel Valley Yard were restored in accordance with MM-BIO-1d and the Habitat Restoration Plan. Crews removed all erosion control devices and debris from the site prior to final hydro-seeding (See Attachment A- Photo 1). Portable facilities were equipped with drip pan containment as required by MM-HAZ-1a.

Photo 1: Temporary work areas at the Jewel Valley Yard were restored in accordance with MM-BIO-1d and the Habitat Restoration Plan. Crews removed all erosion control devices and debris from the site prior to hydro-seeding.

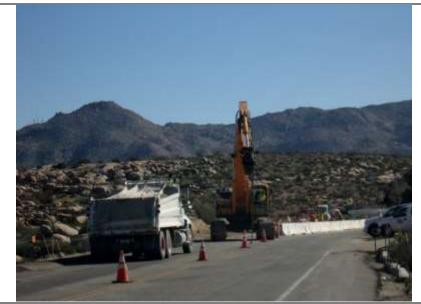
In accordance with MM-TRA-1, traffic control was being implemented along Old Highway 80 during bore pit work at the Carrizo Gorge Bridge. In accordance with MM-BIO-4a and MM-AQ-1, crews were diligent in covering spoil loads leaving the work area (See Attachment A- Photo 2).

Photo 2: In accordance with MM-BIO-4a and MM-AQ-1, crews were observed covering spoil loads leaving Section 3 of the underground alignment.

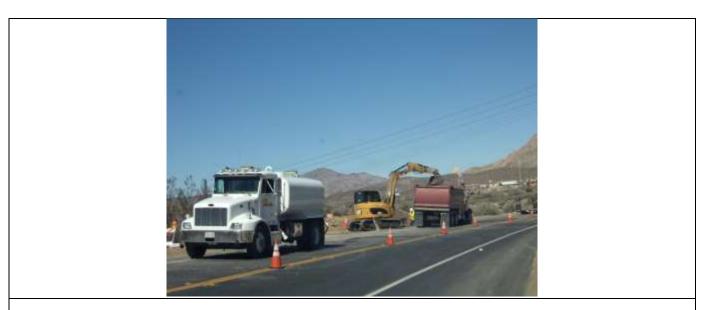
Water trucks were on site to suppress dust emissions during curb work at SP-91 in compliance with MM-BIO-4a and MM-AQ-1 (See Attachment A- Photo 3). Crews were diligent in removing trackout along Old Highway 80.

Photo 3: Water trucks were on site to suppress dust emissions during curb work at SP-91 in compliance with MM-BIO-4a and MM-AQ-1.

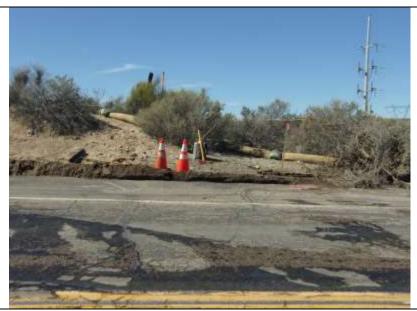
Drainages and erosion control devices along the ROW were in good condition according to the Project SWPPP and MM-HYD-1. Fire tools and fire watch were on site along curb work at Weeping Willow Road as stipulated by MM-FF-1 (See Attachment A- Photo 4).

Photo 4: Drainages and erosion control devices along the ROW were in good condition according to the Project SWPPP and MM-HYD-1. Fire tools and fire watch were on site at curb work near Weeping Willow Rd along the overhead ROW as stipulated by MM-FF-1.
