## California Public Utilities Commission Mitigation Monitoring, Compliance, and Reporting Program

East County (ECO) Substation Project

Compliance Status Report: 051

March 15, 2015

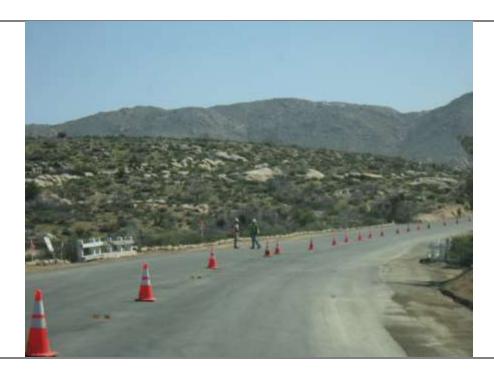
In accordance with MM-TRA-1, traffic control was being implemented along Old Highway 80 during placement of asphalt (See Attachment A - Photo 1). Drainages and erosion control devices along the ROW were in good condition according to the Project SWPPP and MM-HYD-1.

**Photo 1:** In accordance with MM-TRA-1, traffic control was in effect along Old Highway 80 during placement of asphalt and final punch list item work at the Carrizo Gorge Bridge.

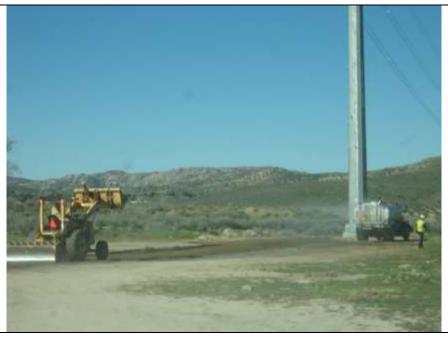
Water trucks were present to suppress dust emissions during final grading at SP-88 in compliance with MM-BIO-4a and MM-AQ-1 (See Attachment A - Photo 2). High wind conditions were in affect during grading activities at SP-88. The biological monitor was observed working with crews to minimize dust emissions in accordance with MM-BIO-1c.

**Photo 2:** Water trucks were on site to suppress dust emissions during final grading at SP-88 in accordance with MM-BIO-4a and MM-AQ-1.

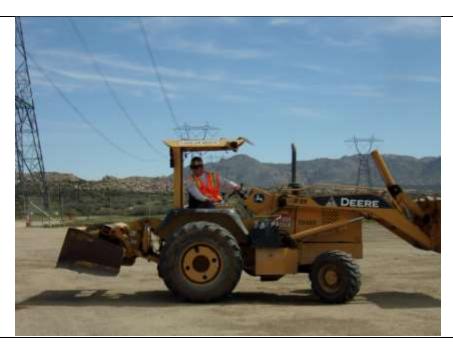
Fire tools were observed present on equipment and fire watch was on site at Carrizo Gorge Yard restoration activities as stipulated by MM-FF-1 (See Attachment A - Photo 3).

**Photo 3:** Fire tools were observed present on equipment and fire watch was on site at Carrizo Gorge Yard as stipulated by MM-FF-1.

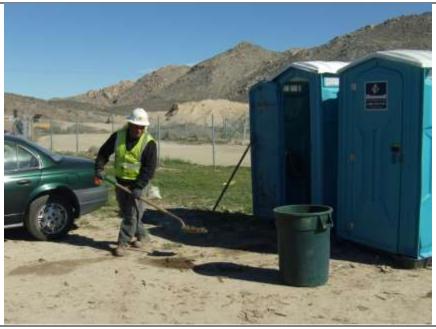
Crews cleaned up a spill from a portable restroom facility at the Carrizo Gorge Yard in accordance with MM-HAZ-1a and MM-HAZ-1c (See Attachment A - Photo 4). Portable facilities were tied down subsequent to this event to ensure high wind conditions would not topple portable restroom facilities and produce a subsequent spill.

**Photo 4:** Crews cleaned up a spill from a portable restroom facility at the Carrizo Gorge Yard in accordance with MM-HAZ-1a and MM-HAZ-1c.
