| | <p>California Public Utilities Commission <i>Mitigation Monitoring, Compliance, and Reporting Program</i></p> |
| | <p>East County (ECO) Substation Project</p> <p>Compliance Status Report: 015</p> <p>October 27, 2013</p> |

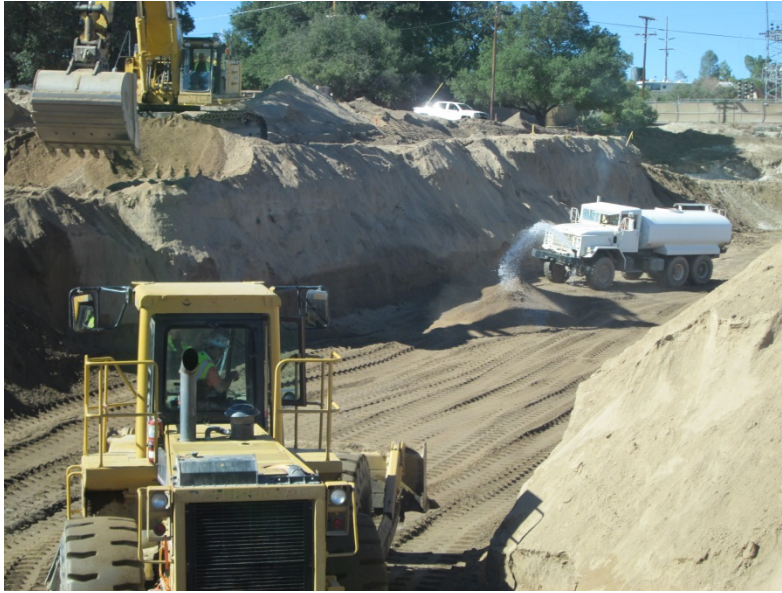
Construction activities at the Boulevard Substation Rebuild site consisted of rough grading and excavation. Water trucks were observed alongside graders and scrapers to prevent fugitive dust in accordance with Mitigation Measure BIO-4A and the Dust Control Plan (see photo 1 –Attachment A).

Photo 1: In accordance with the Dust Control Plan (Mitigation Measure BIO-4A), water trucks are utilized to minimize fugitive dust emissions during earthwork activities at the Boulevard Substation.

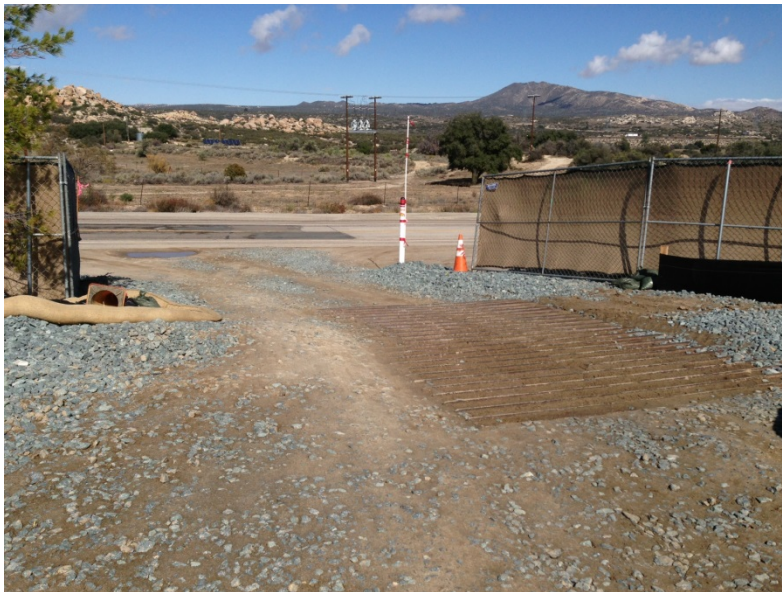
In accordance with Mitigation Measures BIO-4A, track out measures consisting of a rock apron and rattle plate have been installed and were observed to be maintained in good working order at the access road entrance along Old Highway 80 (see photo 2 –Attachment A).

Photo 2: In accordance with the Dust Control Plan (Mitigation Measure BIO-4A), rattle plates have been installed at the Boulevard Substation where the dirt access road intersects paved surfaces associated with Old Highway 80.

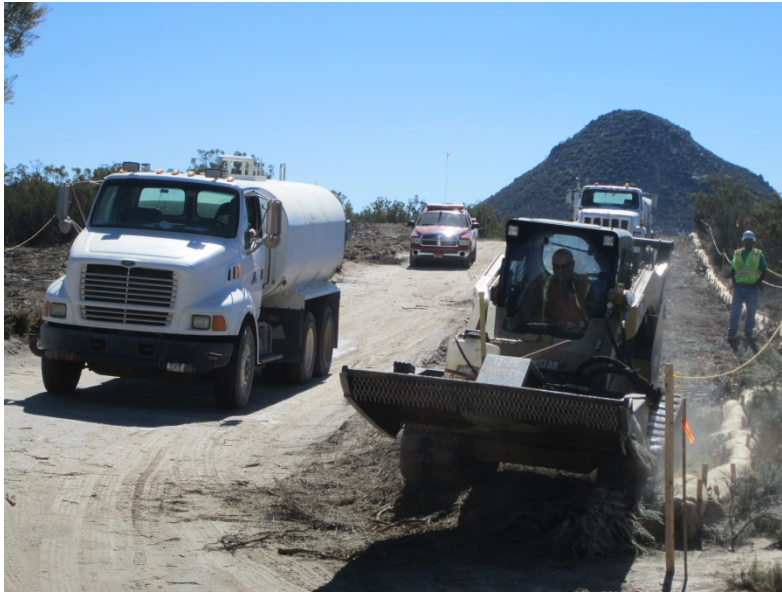
During vegetation removal for establishing the work limits along the Underground Transmission Line route, Archaeological, Native American, and biological monitors were observed present during all ground-disturbing activities in accordance with Mitigation Measure BIO-1c and CUL-1d (see Photo 3 – Attachment A). In addition, water trucks were present to minimize fugitive dust emissions in accordance with the Dust Control Plan and Mitigation Measures BIO-4a.

Photo 3: Construction crews complete vegetation removal along the 138 kV Underground Transmission Line from the Boulevard Substation to the 138 kV Overhead Transmission Line. Archaeological, Native American, and biological monitors were observed present during all ground-disturbing activities in accordance with Mitigation Measure BIO-1c and CUL-1d

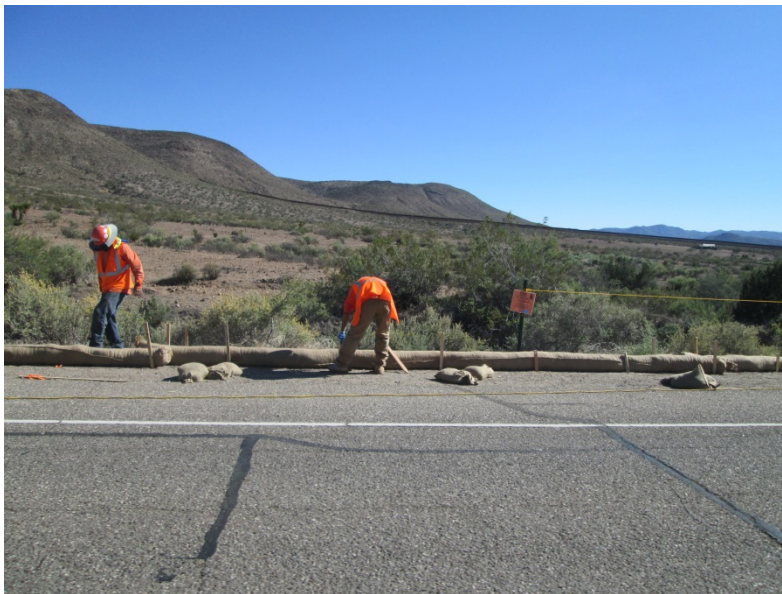
Construction crews were observed installing straw wattles along Old Highway 80 adjacent to limits of work prior to construction activities (see Photo 3 – Attachment A). Straw wattles were observed being secured in place via use of wood stakes in accordance with the SWPPP (Mitigation Measures HYD-1). ESA signage identifying sensitive environmental resources was also observed to be in place prior to construction activities being completed in accordance Mitigation Measures CUL-1A.

Photo 4: In accordance with the Storm Water Pollution Prevention Plan (SWPPP) (Mitigation Measures HYD-1), straw wattles are placed along the limits of work prior to construction activities being completed along Old Highway 80.

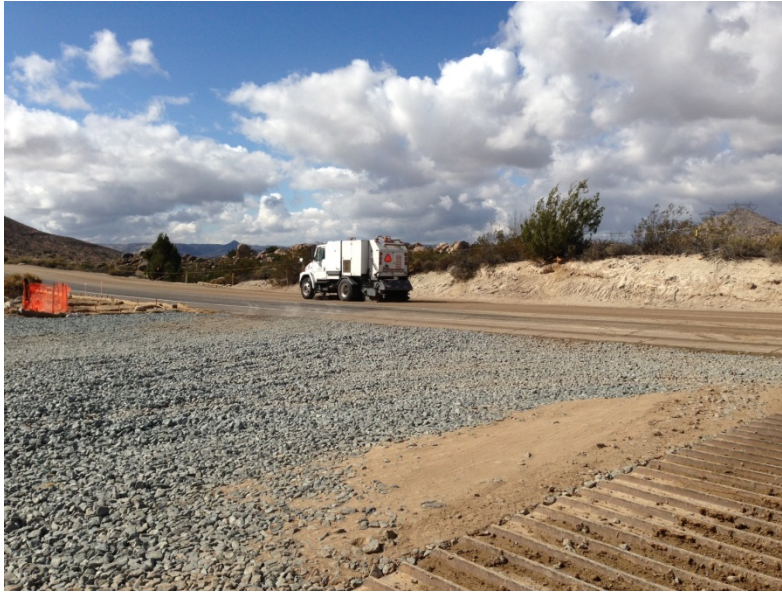
Photo 5: In accordance with the Dust Control Plan (Mitigation Measure BIO-4A), a mechanical sweeper cleans visible soil material along Old Highway 80 at the point of ingress/egress to the ECO substation.

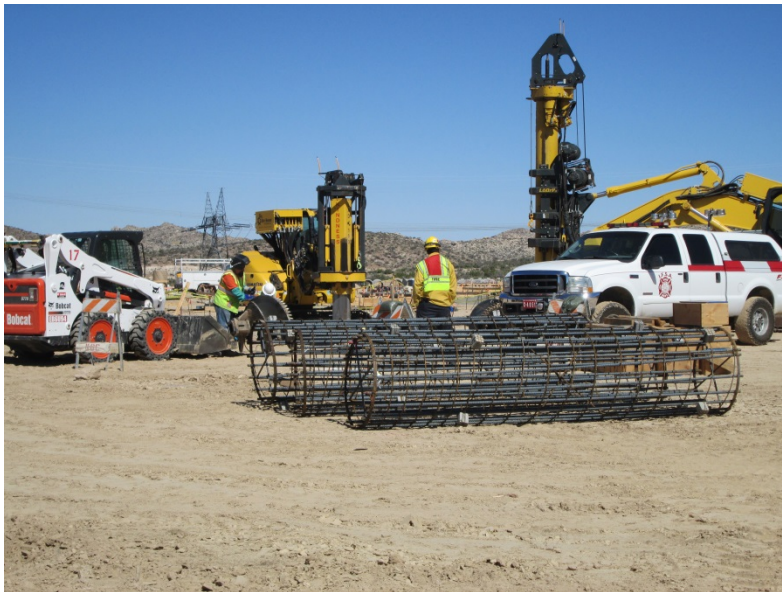
Fire patrols were observed on site during construction activities to ensure construction equipment and vehicles had the required fire safety equipment and provided ongoing fire patrols in accordance with MM-FF-1.

Photo 6: In accordance with the Construction Fire Prevention Plan (Mitigation Measure FF-1), a fire watch oversees welding activities at the ECO substation pad to ensure required fire tools and equipment are on site and that a Hot Work Permit has been obtained as described in NFPA 51B.
