| | <p><b>California Public Utilities Commission</b><br/> <b><i>Mitigation Monitoring, Compliance, and Reporting Program</i></b></p> |
| | <p><b>East County (ECO) Substation Project</b></p> <p><b>Compliance Status Report: 016</b></p> <p><b>November 10, 2013</b></p> |

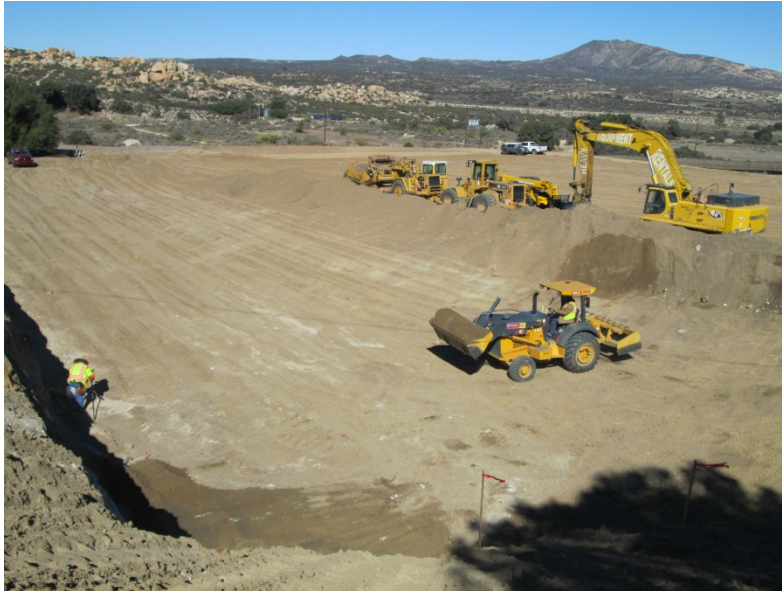
Construction activities at the Boulevard Substation Rebuild site consisted of rough grading and initiating fine grading of the substation pad (see photo 1 – Attachment A). Dust control measures were observed being implemented in accordance with Mitigation Measures BIO-4A. Measures being implemented consisted of watering areas of active construction via use of water trucks, rattle plates at the point of ingress/egress, and street sweeping along Old Highway 80.

**Photo 1:** Construction activities continued at the Boulevard Rebuild Substation consisting of rough-grading the substation pad.

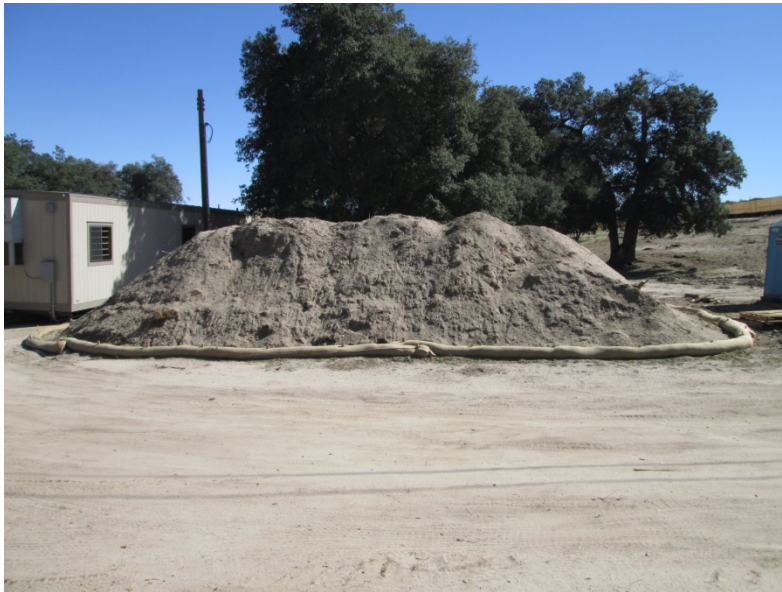
In accordance with Mitigation Measure BIO-1a, an environmental monitor was onsite to ensure all work was completed within the approved work limits. Topsoil was observed being stored onsite that will be utilized at a future date for restoration activities in accordance Mitigation Measure BIO-1D (see photo 2 – Attachment A).

**Photo 2:** In accordance with Mitigation Measure BIO-1D, topsoil is being salvaged for future restoration efforts at the Boulevard Rebuild Substation.

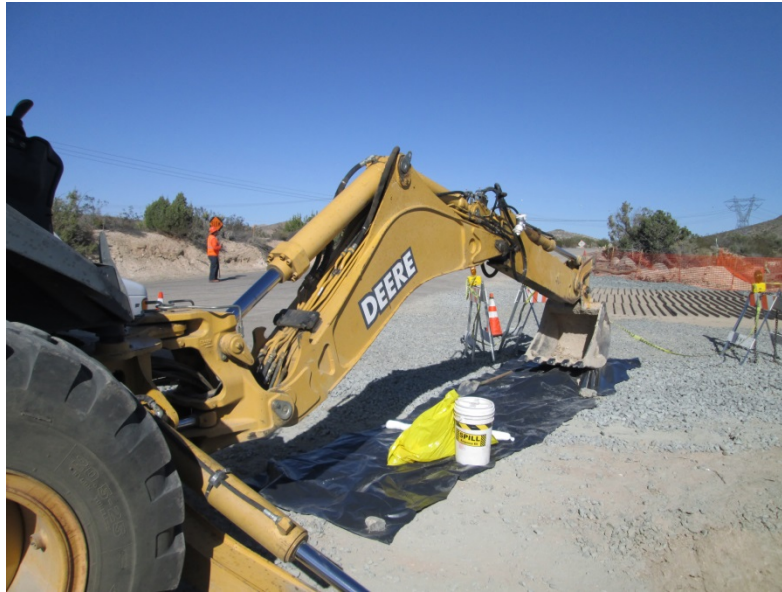
Crews were observed utilizing spill kits to clean-up hazardous materials associated with construction activities along the right-of-way (see Photo 3 – Attachment A). Containment bins were also observed being placed beneath construction equipment when not in use.

**Photo 3:** Spill kits are utilized during construction to manage hazardous materials in accordance with Mitigation Measures HAZ-1a.

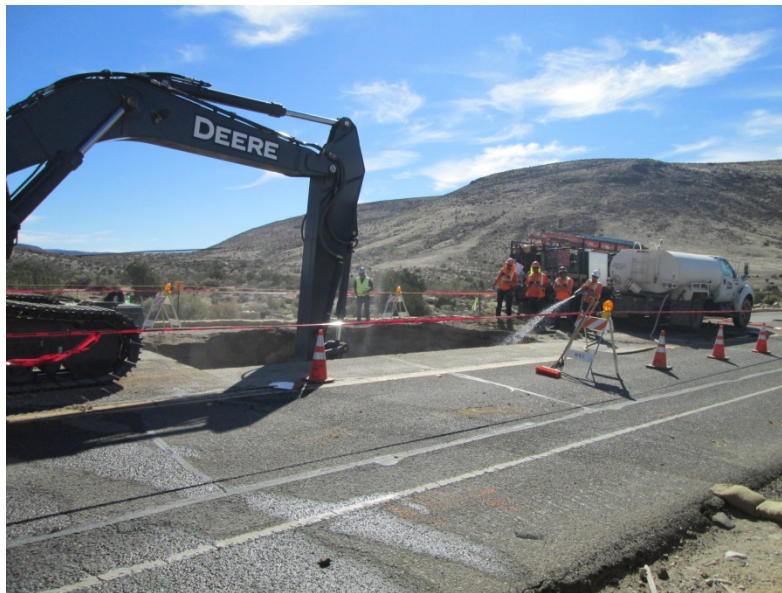
Water trucks were present to minimize fugitive dust emissions in accordance with the Dust Control Plan and Mitigation Measures BIO-4a during excavation activities (see Photo 4 – Attachment A). Flagging of special-status plant species to be avoided during construction was observed being completed prior to construction in accordance with Mitigation Measure BIO-5a. Flagging consisted of pin flags that identified the location of special-status plant species.

**Photo 4:** Construction activities associated with vault excavations for the 138 kV Underground Transmission Line component were completed along Old Highway 80 during this reporting period. A water truck is utilized to reduce fugitive dust emissions in accordance with Mitigation Measure 4a and the Dust Control Plan.

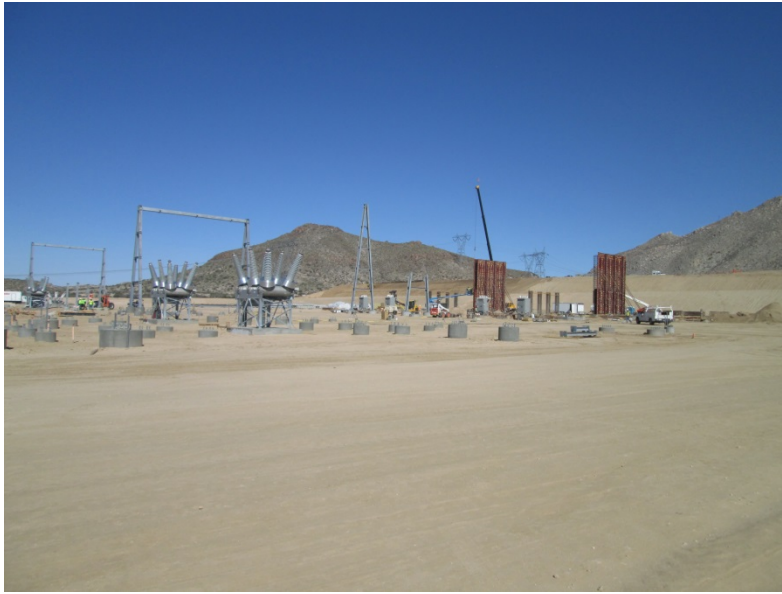
Construction activities at the ECO Substation site consisted of installing above grade substation components at the 138/230 kV pad site and completion of fine grading at the 500 kV pad site (see Photo 5 – Attachment A).

**Photo 5:** Construction activities associated with foundation drilling, concrete form building and firewall construction continue at the ECO Substation pad site.

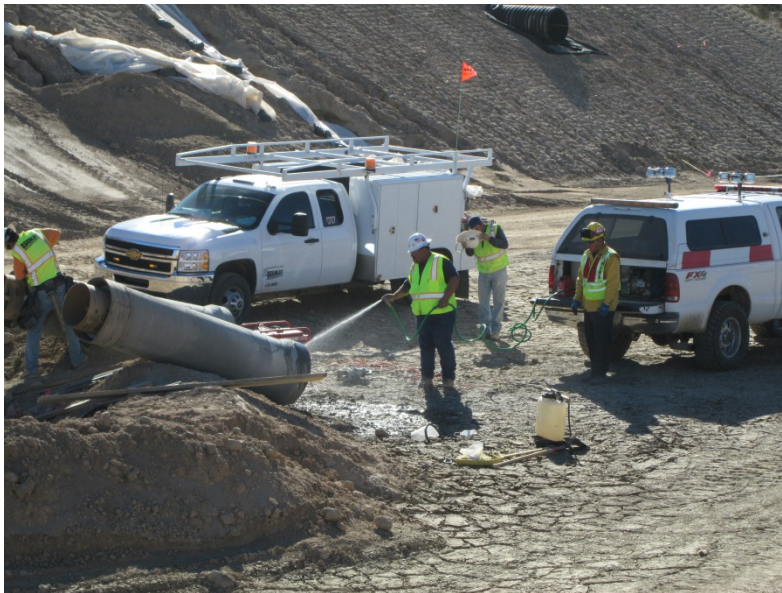
Fire patrols were observed on-site during construction activities to ensure construction equipment and vehicles had the required fire safety equipment and provided ongoing fire patrols in accordance with MM-FF-1 (see Photo 6 – Attachment A).

**Photo 6:** In accordance with the Construction Fire Prevention Plan (Mitigation Measure FF-1), a fire watch waters down concrete piping following cutting activities at the ECO substation pad.
