California Public Utilities Commission <i>Mitigation Monitoring, Compliance, and Reporting Program</i>
	Lassen Substation Project Compliance Status Report: 04 August 31, 2021

This compliance status report covers construction activities from August 1- August 31, 2021.

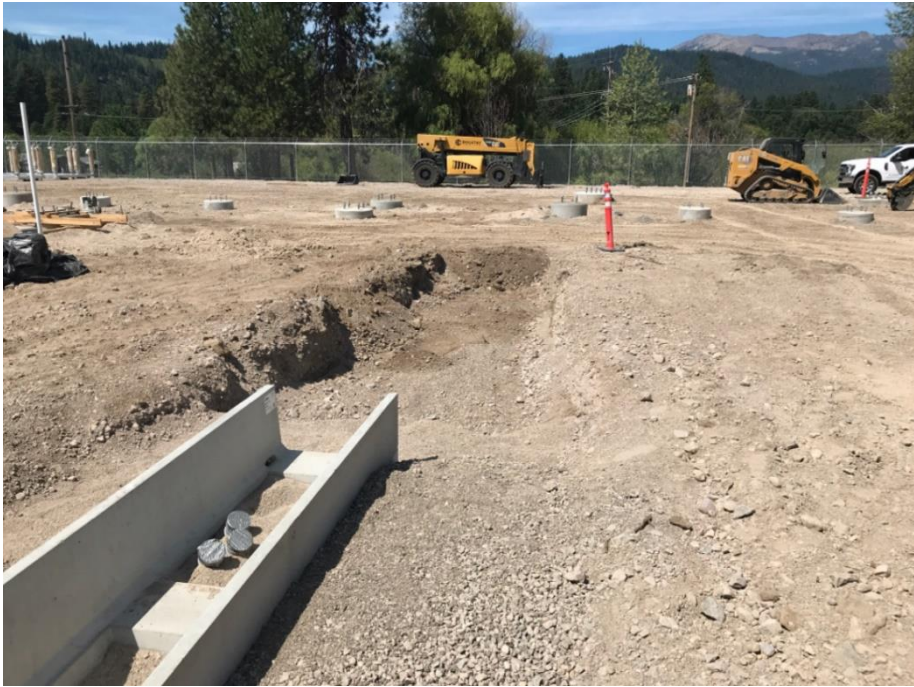
Photo 1: Excavated areas were ramped to prevent entrapment (APM BIO-6).

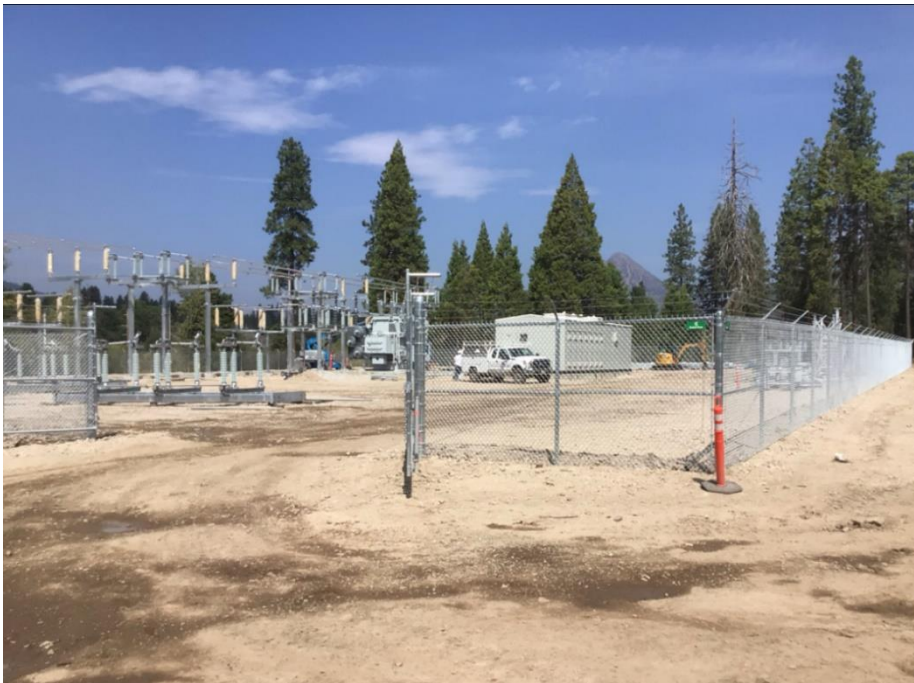
Photo 2: A water buffalo was observed on site and has been actively wetting roads and unpacked construction areas, in compliance with SWPPP and dust (APM AQ-1).

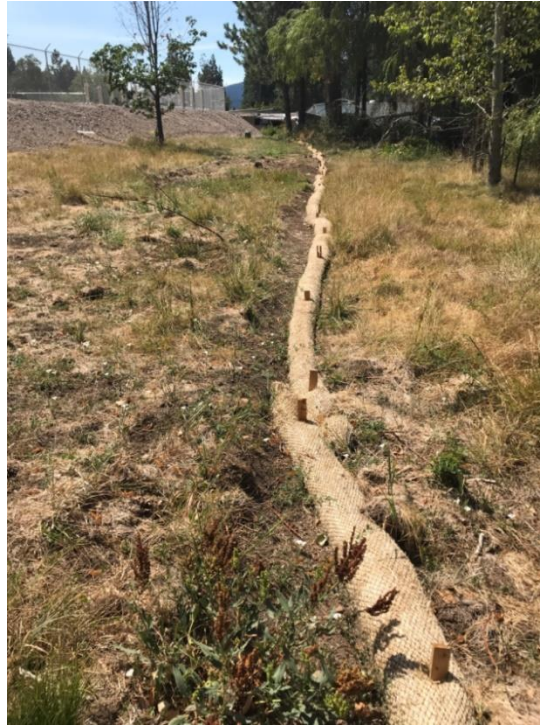
Erosion control best management practices (BMPs), such as fiber rolls were observed to be in good condition in accordance with the locations identified in the project's SWPPP (APM WQ-1) (see Photo 3—Attachment A) and topsoil piles were observed stabilized in accordance with the SWPPP. During a site inspection, the ECM observed that the integrity of the concrete washout liner was compromised and discussed it with the onsite EM (see Photo 4—Attachment A). The EM confirmed the liner had been damaged the previous day and because concrete work had concluded, once the concrete dried, the crews would remove the solidified concrete and re-line the washout area prior to use.

Photo 3: SWPPP erosion control BMPs (fiber rolls) were observed in good condition along the project boundary in accordance with APM WQ-1.

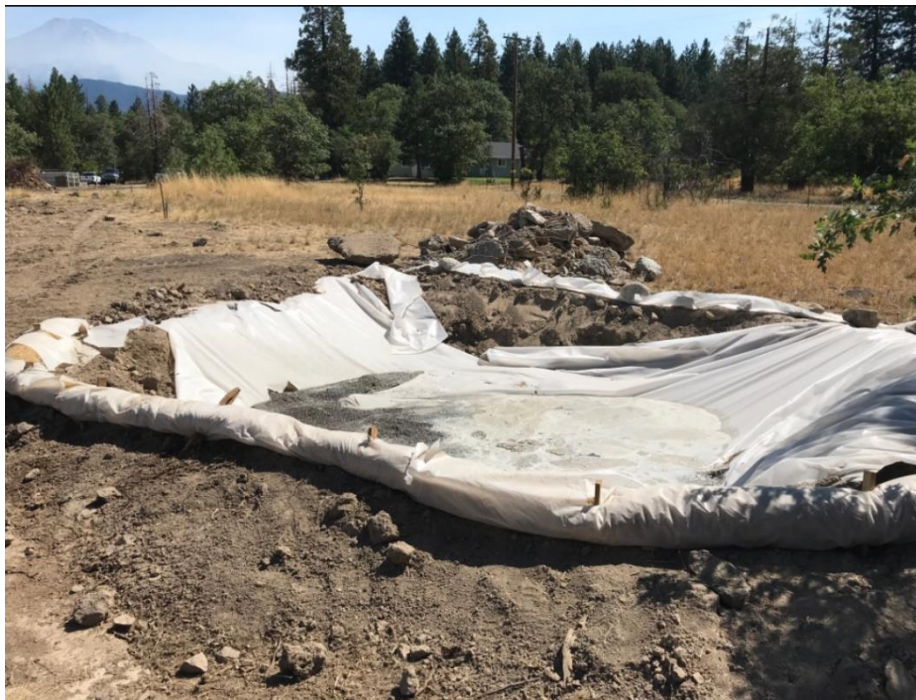
Photo 4: Concrete washout (SWPPP) liner was observed damaged and scheduled for repair.

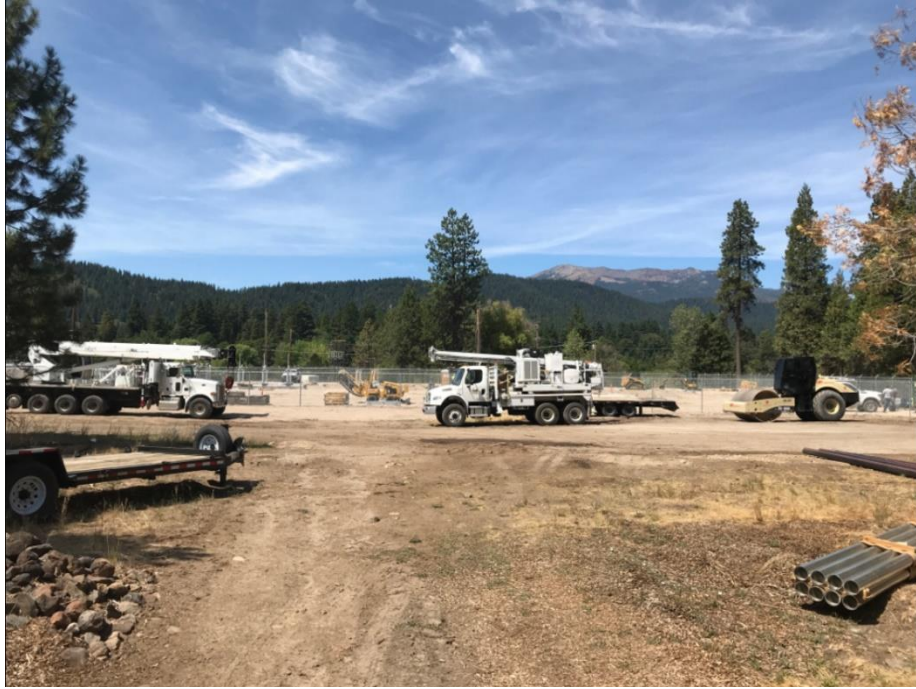
Per the Fire Plan for the project (MM HAZ-2) fire suppression tools, including extinguishers, Pulaski's, and 5-gallon pumps were observed staged on site in accordance with MM HAZ-2. Vehicles were observed parked on previously disturbed areas in accordance with the Fire Plan (See Photo 5—Attachment A).

Photo 5: Vehicles were observed being parked in previously disturbed areas in accordance with the project's Fire Plan (MM HAZ-2).
