<p>California Public Utilities Commission <i>Mitigation Monitoring, Compliance, and Reporting Program</i></p>
	<p>Tie Line (TL) 637 Wood-to-Steel Pole Replacement Project</p>
	<p>Compliance Status Report: 001 March 2, 2014</p>

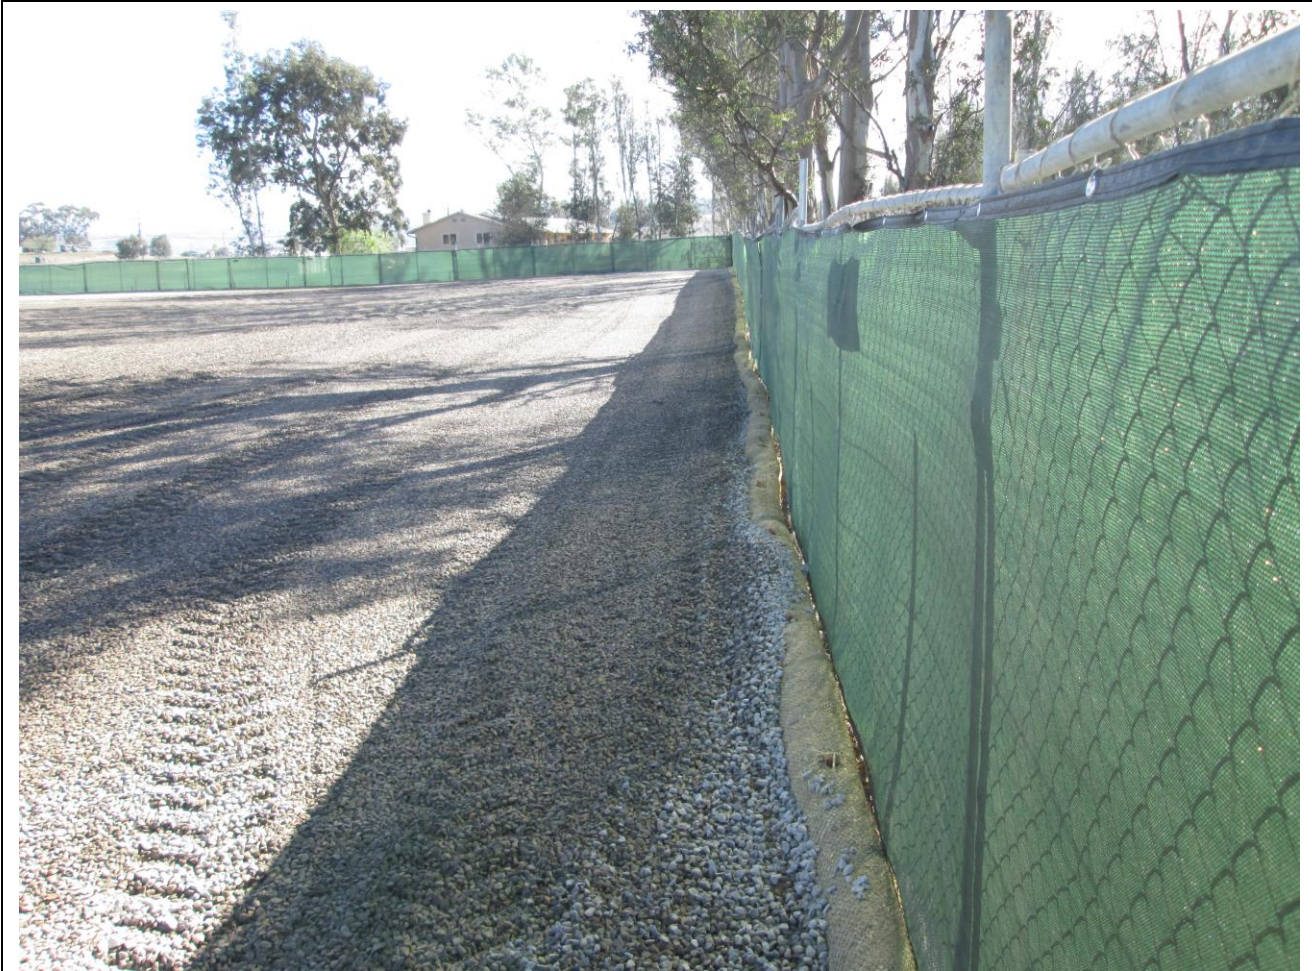
Prior to initiating construction activities, CPUC–approved biological monitors were observed flagging vernal pools in accordance with MM-BIO-7. Upon installation, opaque green screening material was observed being placed along the perimeter chain-link fence in accordance with APM AES-1 (see Photo 1—Attachment A).

Photo 1: Opaque mesh screening material has been placed along the perimeter chain-link fence at the Warnock Staging Yard in accordance with APM AES-1.

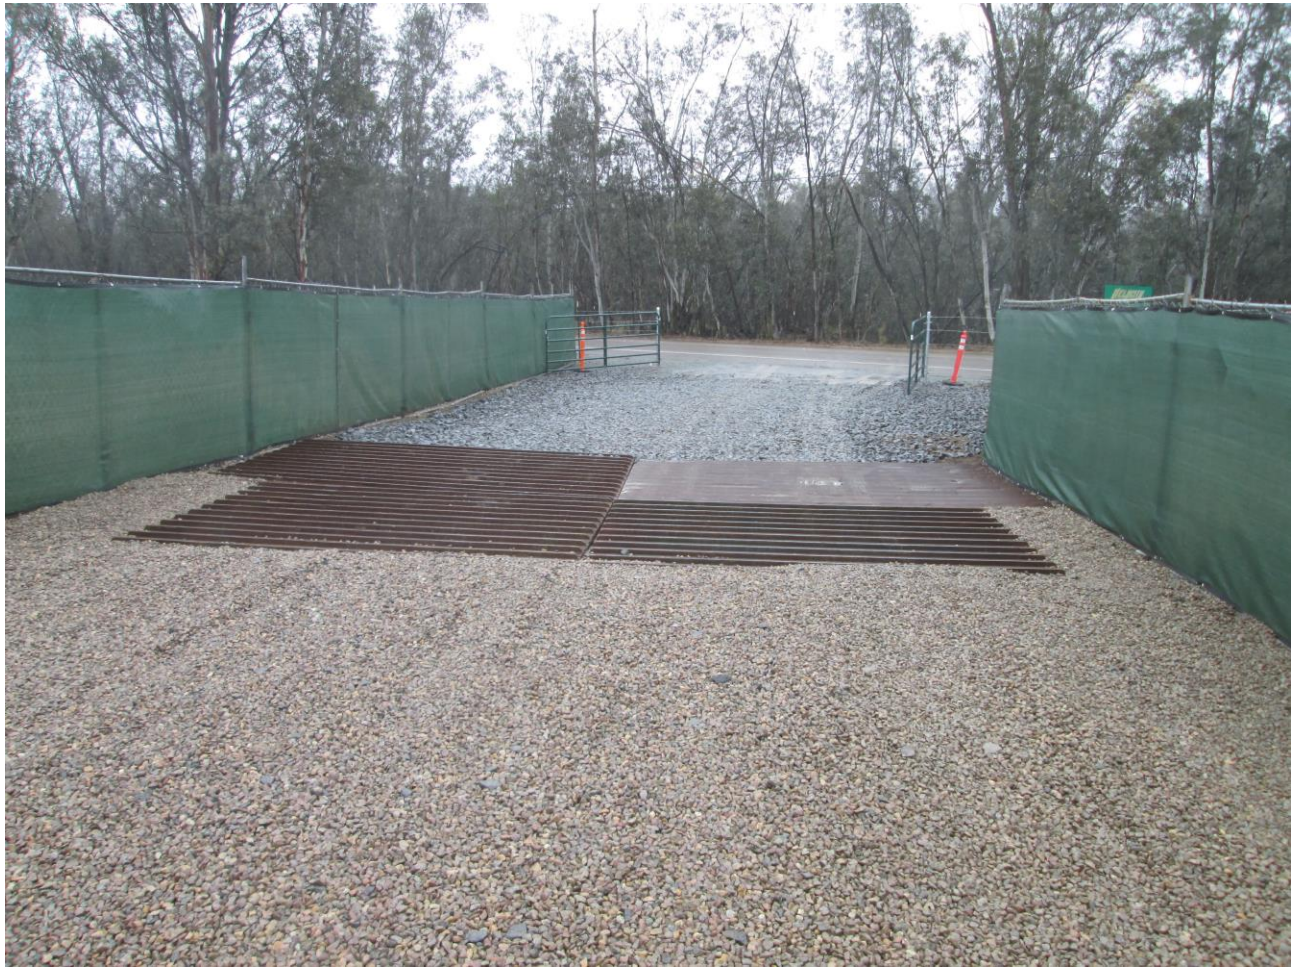
Per MM HYD-1 and APM HYD-1, crews were observed installing tracking control measures (rock aprons and rumble plates) to minimize potential for track-out onto adjacent public roads (see Photo 2—Attachment A).

Photo 2: Track-out control measures (rock aprons and rumble strips) have been installed at the entrance of the Warnock Staging Yard in accordance with the SWPPP and MM-HYD-1.

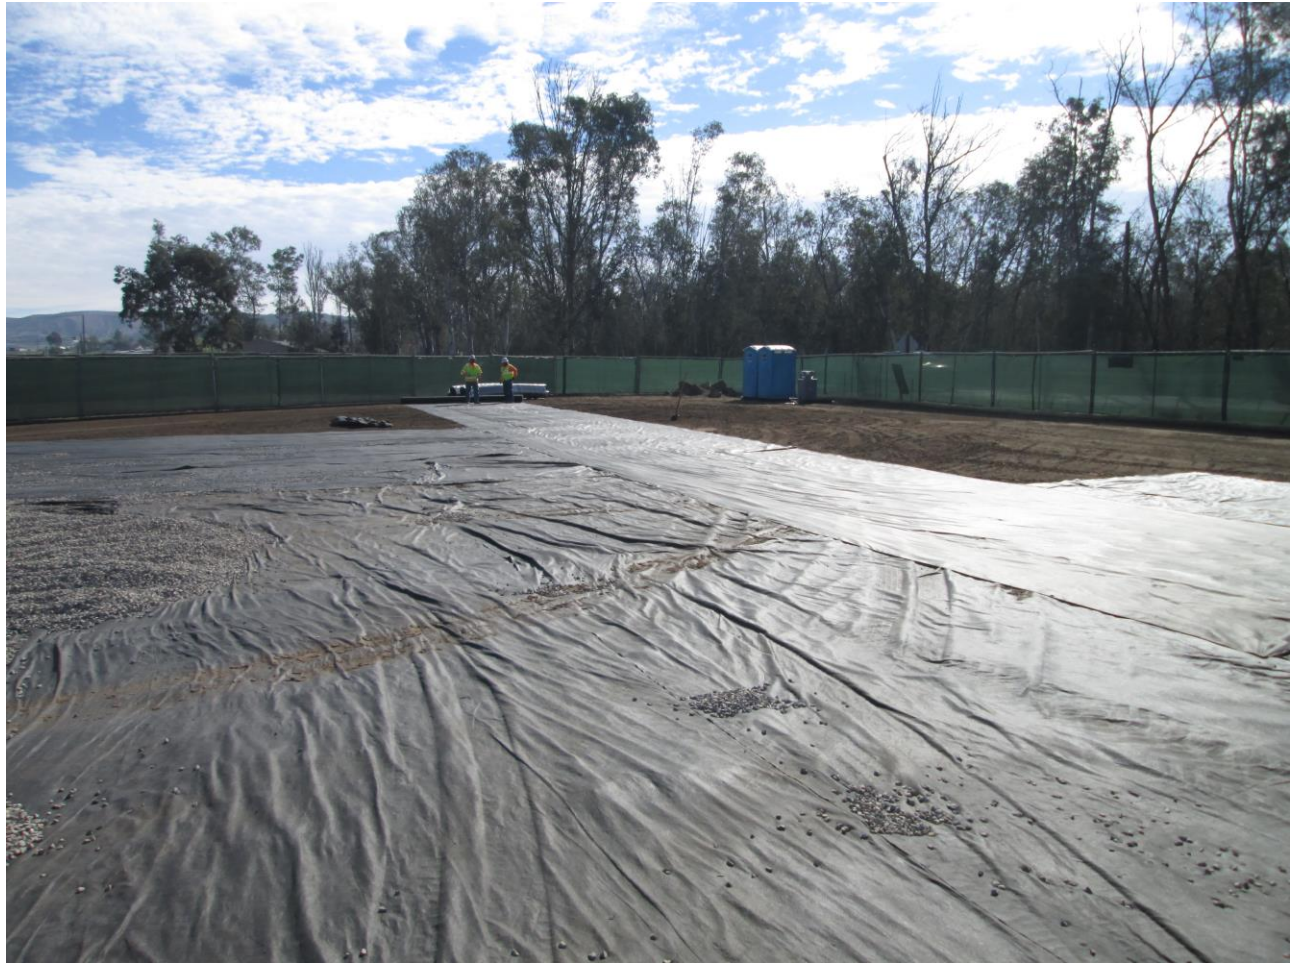
Crews were observed installing Mirafi fabric prior to gravel spread and conducting gravel compaction activities in order to aid with silt and erosion control (see Photo 3—Attachment A). A water truck was utilized to control potential fugitive dust emissions by watering the work area prior to grading in accordance with APM BIO-1 (see Photo 4—Attachment A).

Photo 3: Mirafi material was observed placed on the surface of the Warnock Staging Yard prior to gravel installation in accordance with BMPs for erosion and sediment control.

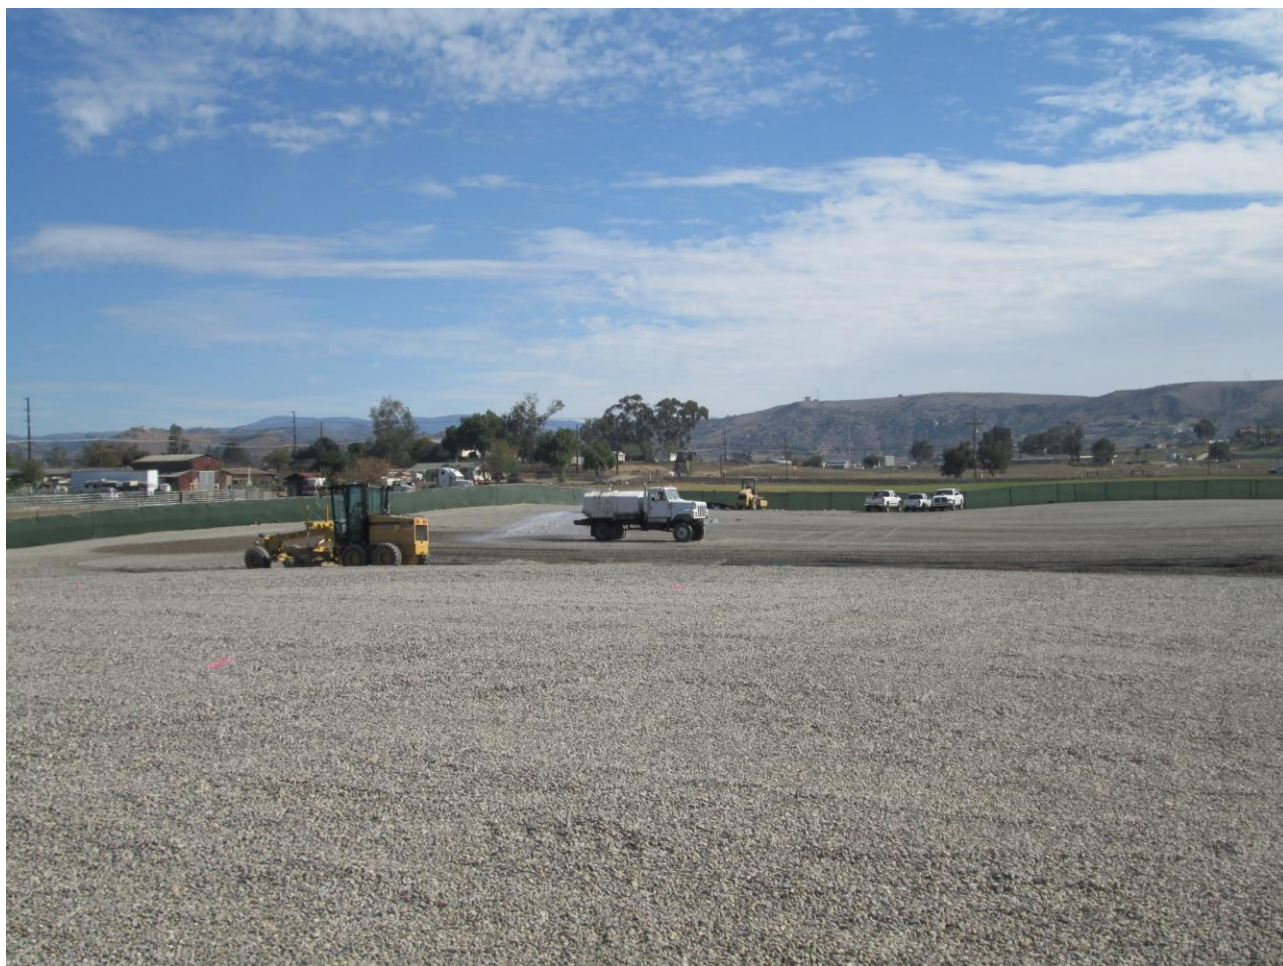
Photo 4: Water trucks were observed at the Warnock Staging Yard applying water prior to grading activities and during gravel spread to prevent fugitive dust in accordance with APM BIO-1.

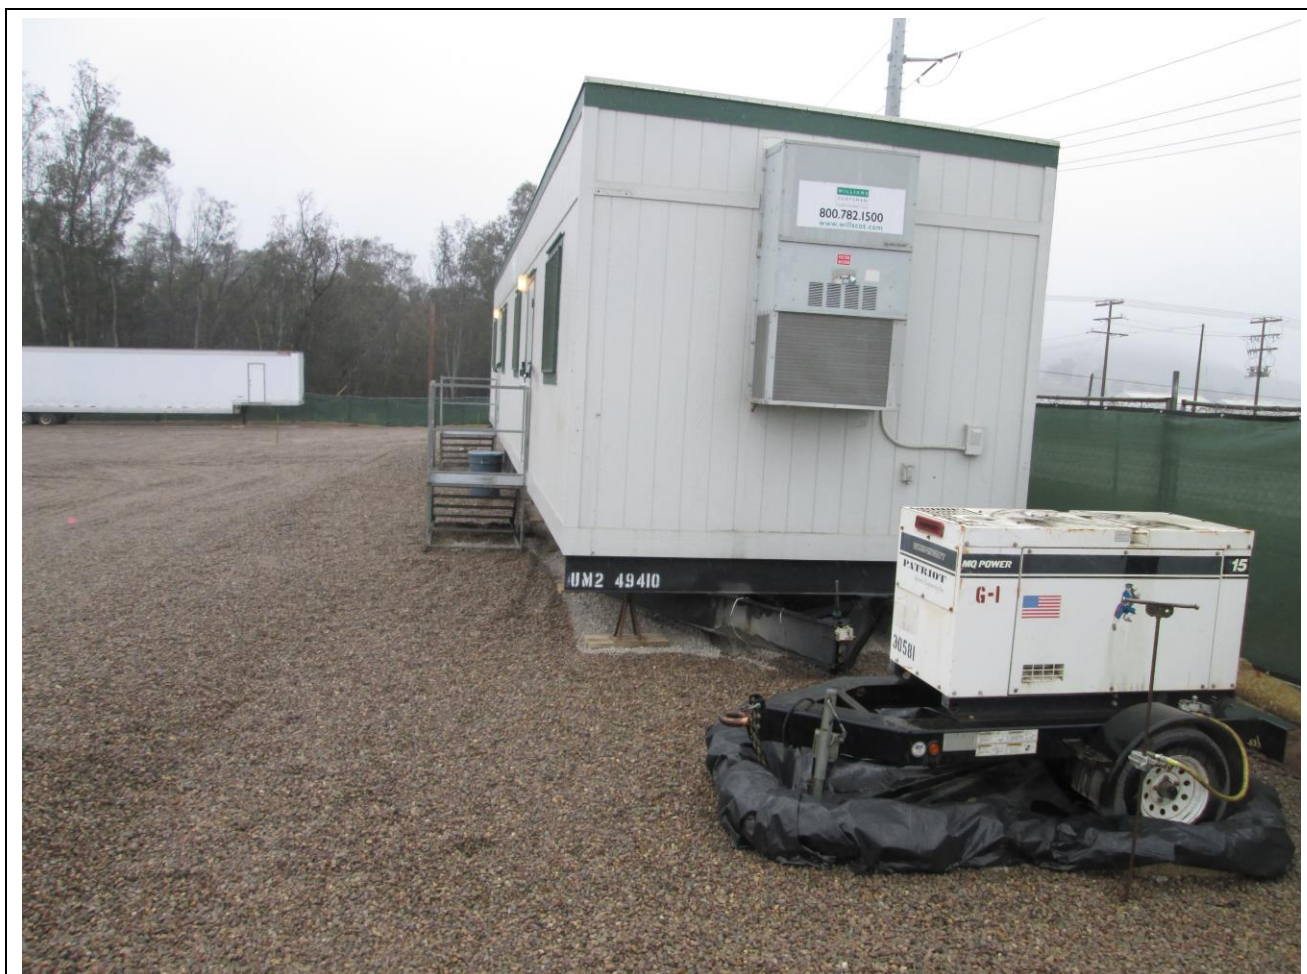
Equipment was observed being delivered and staged throughout the reporting period. Per MM-HAZ-2, to prevent leaks or spills from being discharged into the soil, construction equipment (such as skid steers) and temporary structures (such as generators) were observed staged on visqueen (see Photo 5—Attachment A). Portable restroom facilities were also observed staged above containment bins.

Photo 5: Temporary equipment at the Warnock Staging Yard (such as generators, above) were observed staged on visqueen for secondary containment in accordance with MM HYD-2.

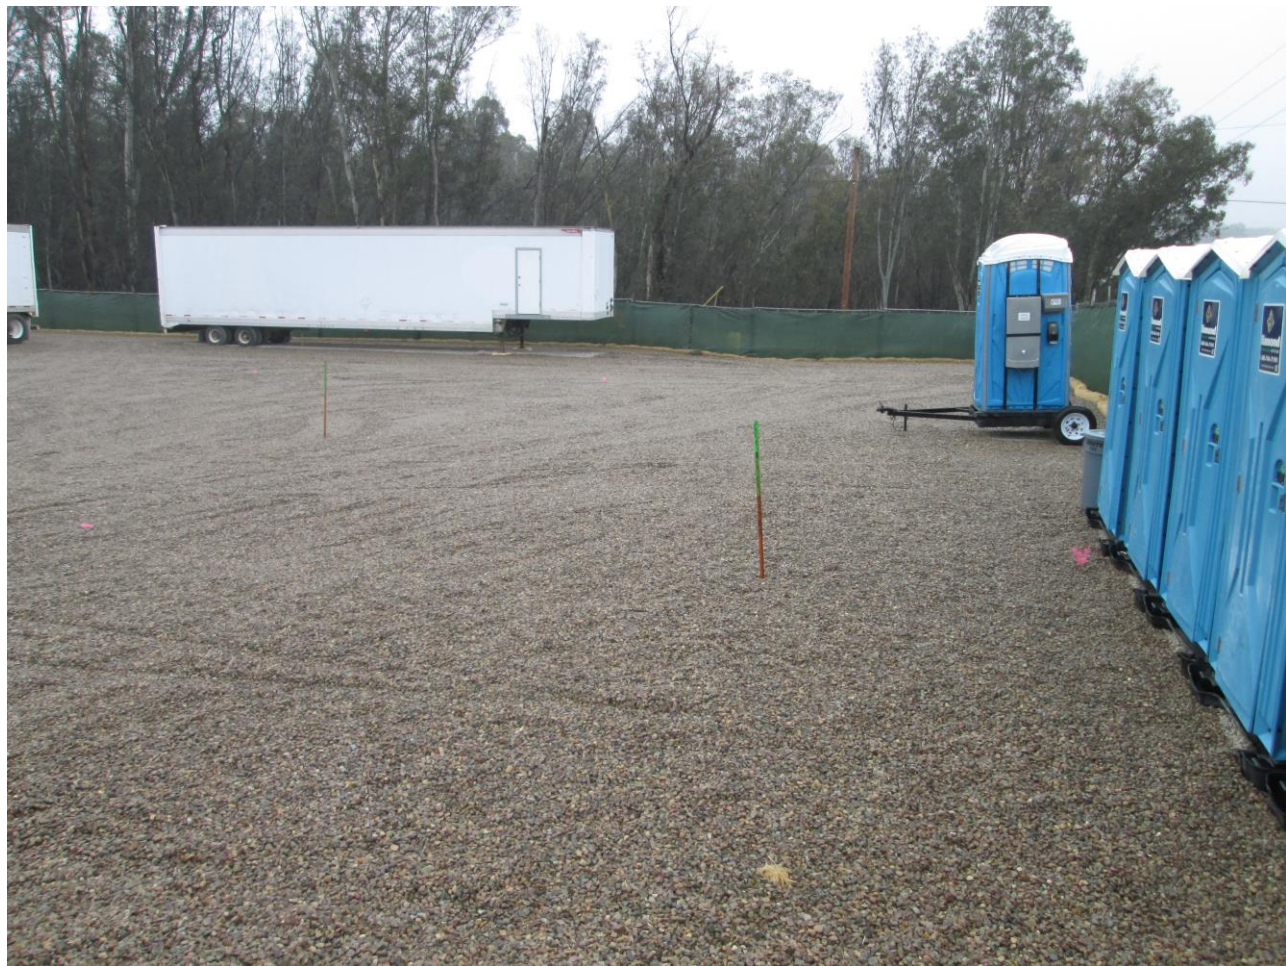
Throughout the reporting period, biologists were observed on site monitoring activities and conducting nesting bird surveys in accordance with MM BIO-4. During the latter part of the reporting period, in accordance with MM-BIO-4, a nesting bird buffer was implemented in the southeast corner of the Warnock staging yard due to an American Kestrel nesting in a steel pole just outside of the yard. The buffer was delineated with wooden stakes that were painted green and had the words "do not enter without bio" (see Photo 6—Attachment A).

Photo 6: In accordance with MM-BIO-4, a nesting bird buffer was implemented in the southeast corner of the Warnock Staging Yard. The buffer was delineated with green wooden stakes and was avoided by crews in accordance with mitigation.

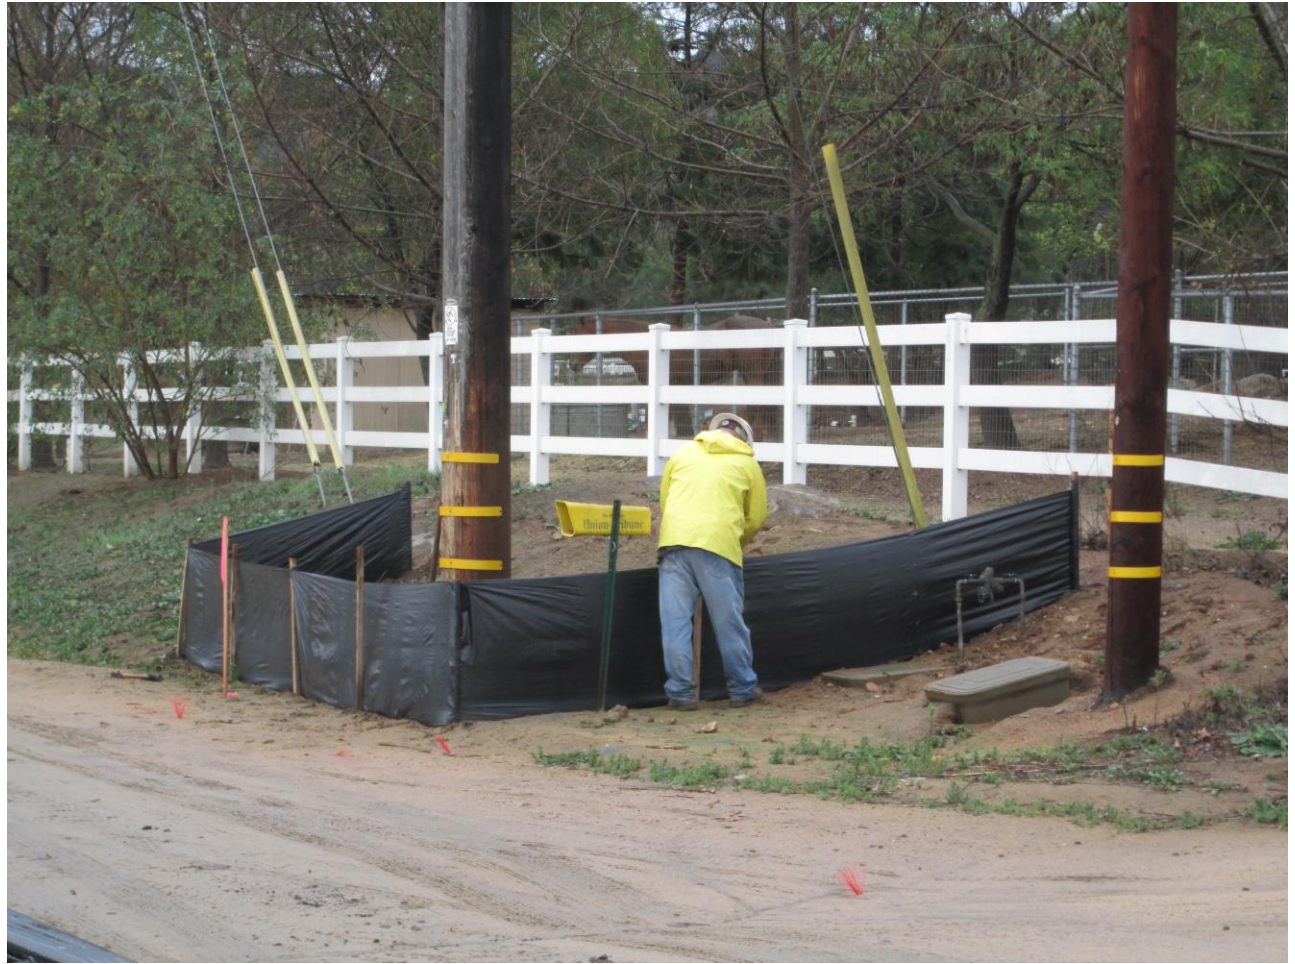
Crews were observed installing erosion control BMPs such as silt fencing (see Photo 7—Attachment A) and straw wattles (see Photo 8—Attachment A) in accordance with APM-HYD-1.

Photo7: Silt Fence was observed being installed around pole locations in accordance with the SWPPP.

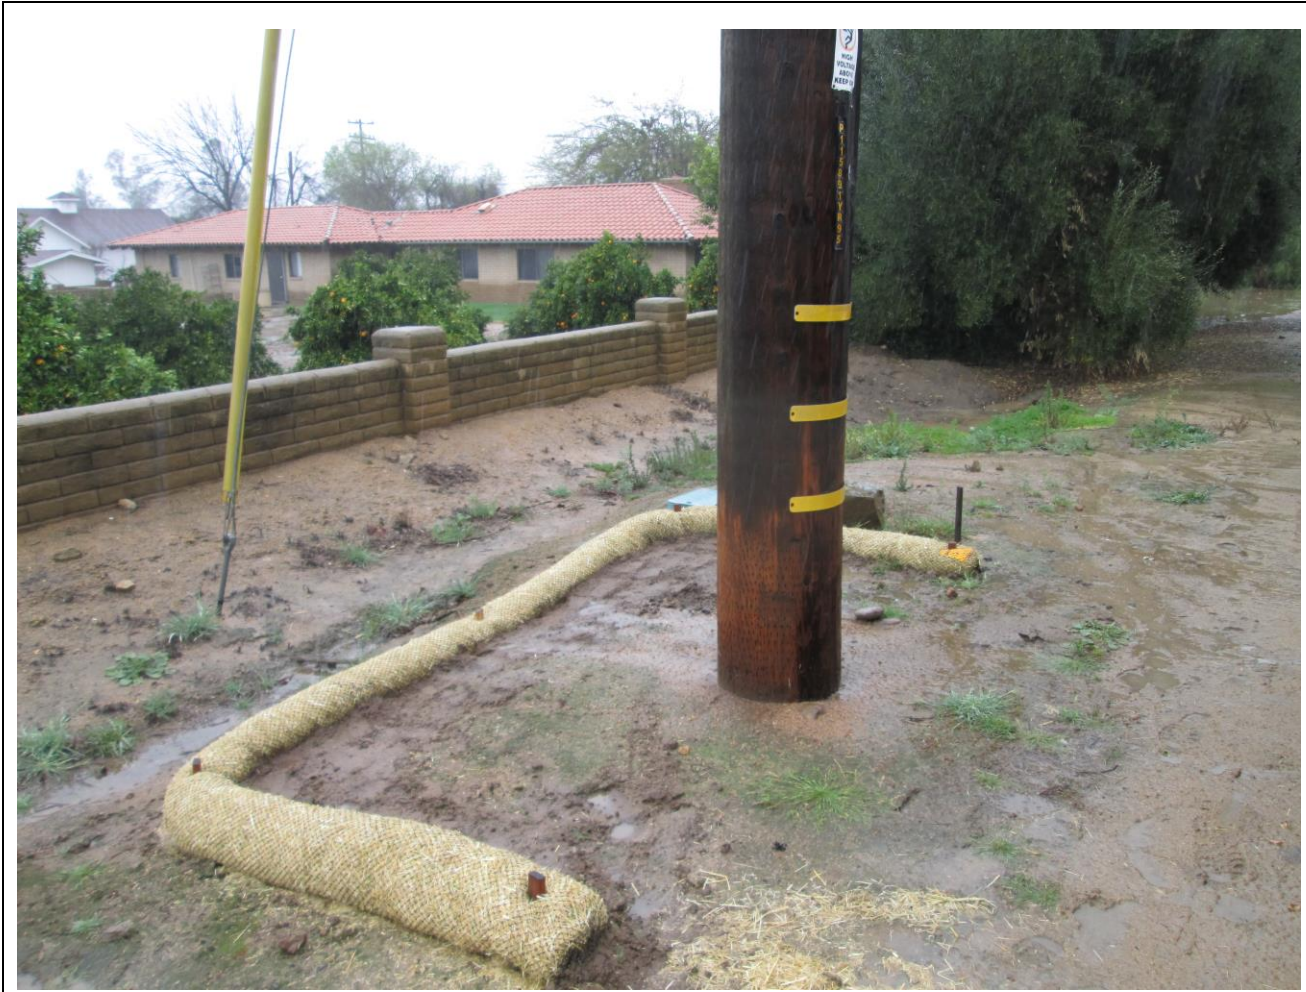
Photo 8: A Straw Wattle was observed installed around a pole replacement location in accordance with the SWPPP.
