<p>California Public Utilities Commission <i>Mitigation Monitoring, Compliance, and Reporting Program</i></p>
	<p>Tie Line (TL) 637 Wood-to-Steel Pole Replacement Project</p>
	<p>Compliance Status Report: 013 August 17, 2014</p>

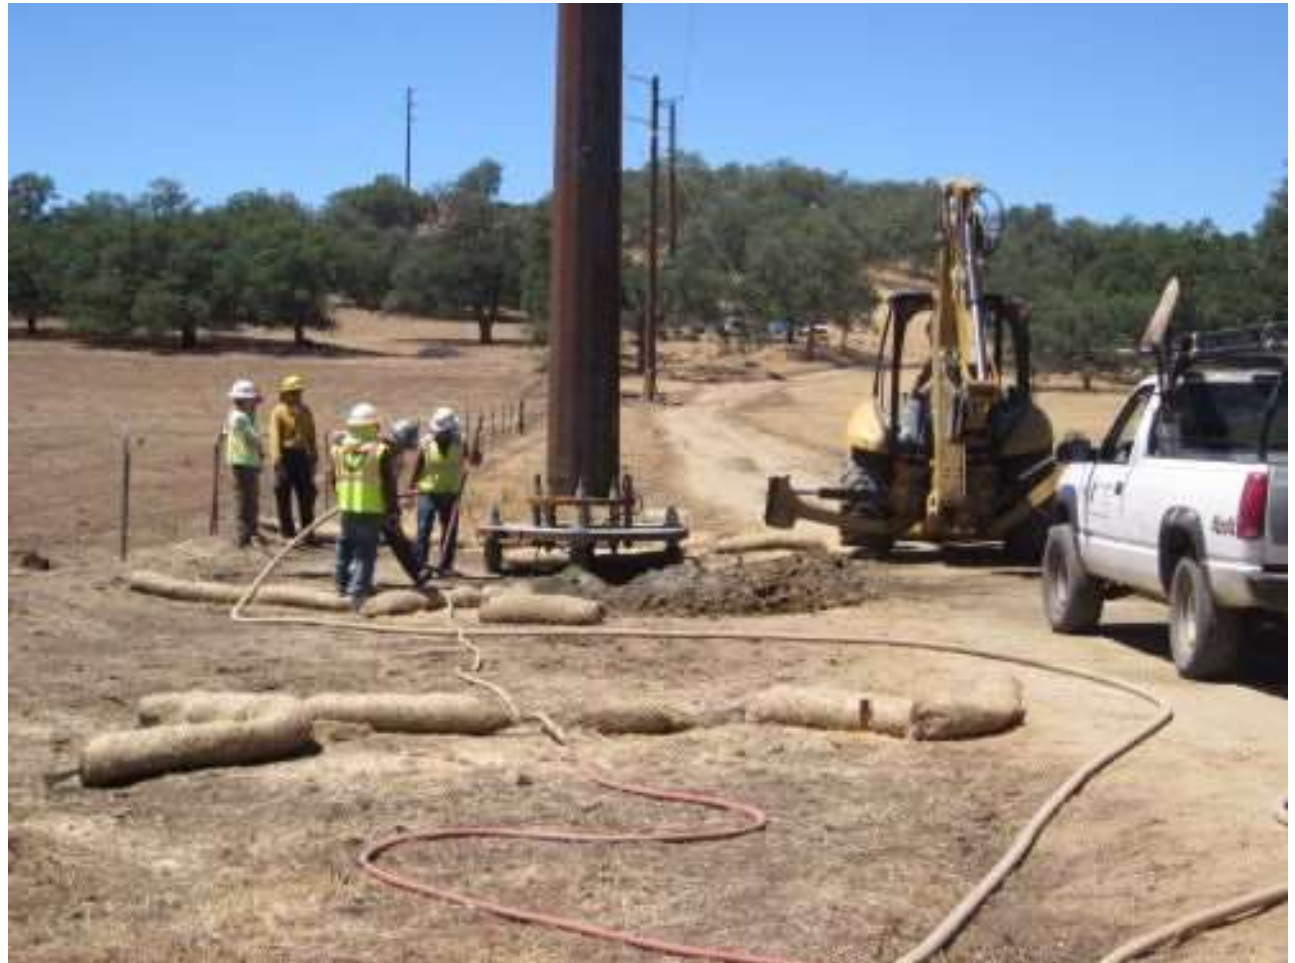
During this reporting period, work crews were observed conducting numerous activities associated with wooden pole removals. During wooden pole butt removal at Location 146, a biological monitor and aquatic resources monitor were observed on site (See Photo 1—Attachment A), and fire tools/water supply were observed staged on site in accordance with the Project Fire Plan (APM HAZ-2). After the pole was excavated and removed from the site location, the excavated area was backfilled and compacted and erosion control devices (straw wattles) were repaired post-excavation in accordance with the Storm Water Pollution Prevention Plan (SWPPP) (APM HYD-1) (See Photo 2—Attachment A). The reclaimed site was observed clear of remnant construction debris and trash.

Photo 1: A biological monitor and aquatic resources monitor observe wooden pole butt excavation removal at Location 146 in accordance with MM BIO-2 and APM HYD-1.

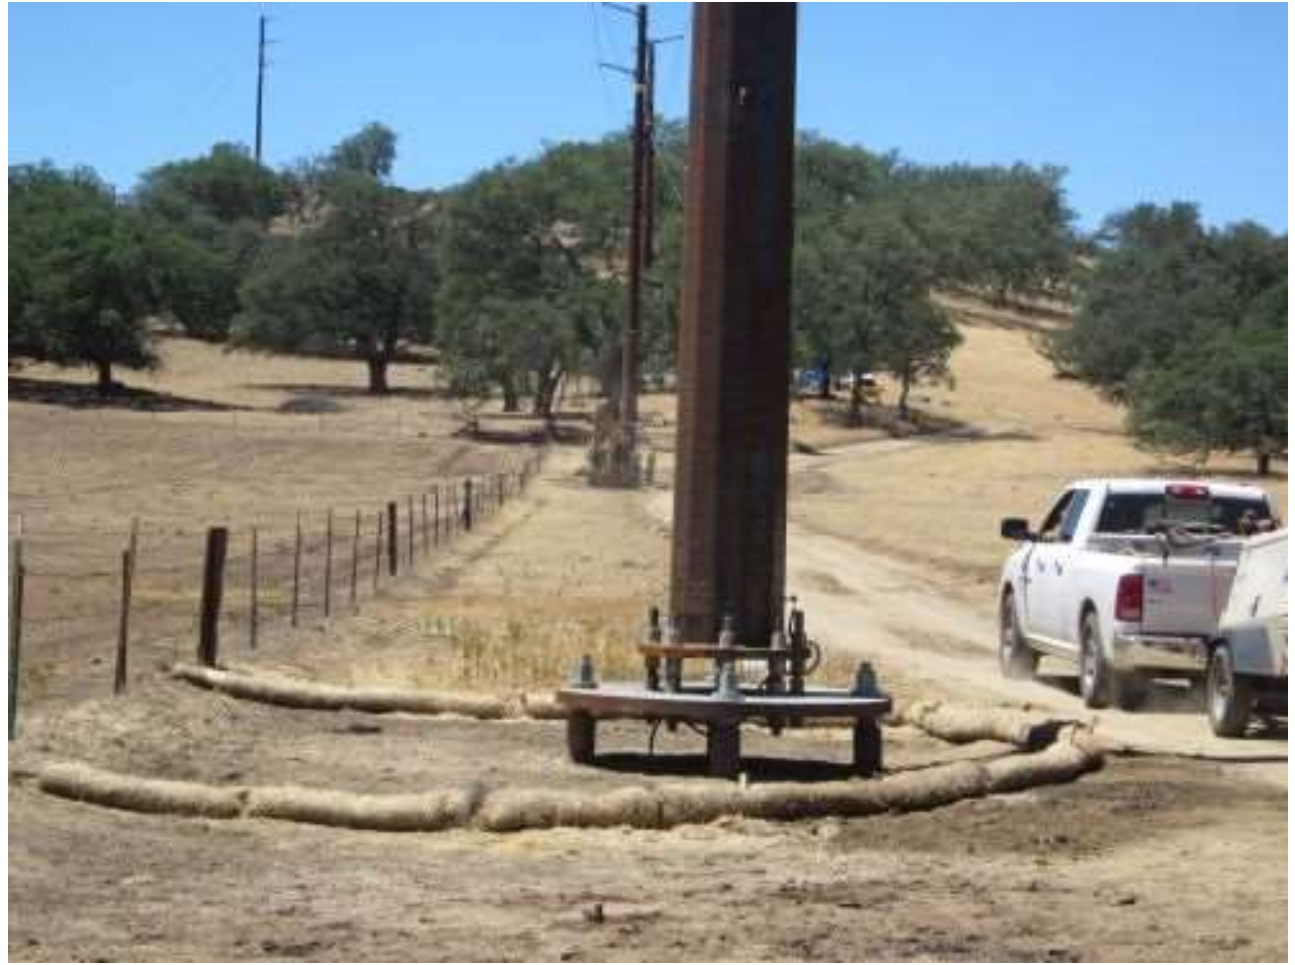
Photo 2: After wooden pole butt excavation occurred at Location 146, erosion control BMPs (straw wattles) were observed replaced in accordance with the project SWPPP.

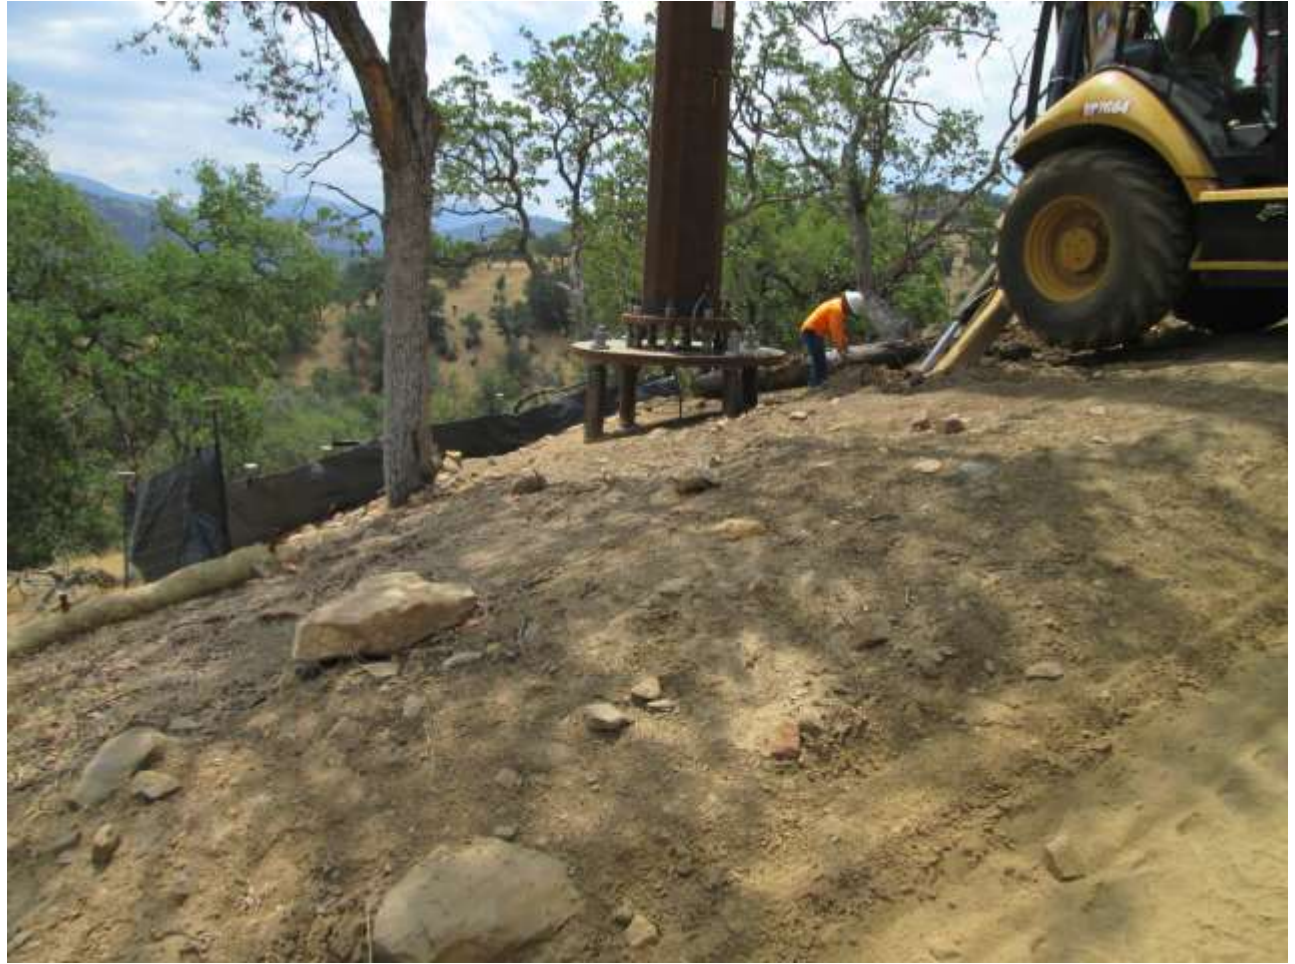
During wooden pole removal at Location 139 (see Photo 3—Attachment A), a biological monitor was observed spot checking the work activity in accordance with MM BIO-2, as well monitoring for nesting bird activity in adjacent future work areas in accordance with MM BIO-4. Prior to excavating the wooden pole, water was observed being sprayed in the work area in order to reduce potential fugitive dust (APM BIO-1). Straw wattles and silt fencing were observed to be in good working condition in accordance with the project SWPPP (APM HYD-1). A fire patrol was observed patrolling the project alignment to ensure all vehicles contained the required fire response equipment and that work sites had designated “fire watch” as applicable, as required in the Project Fire Plan (APM HAZ-2).

Photo 3: Erosion control BMPs (straw wattles and silt fencing) were observed intact during wooden pole butt excavation and removal at Location 139.

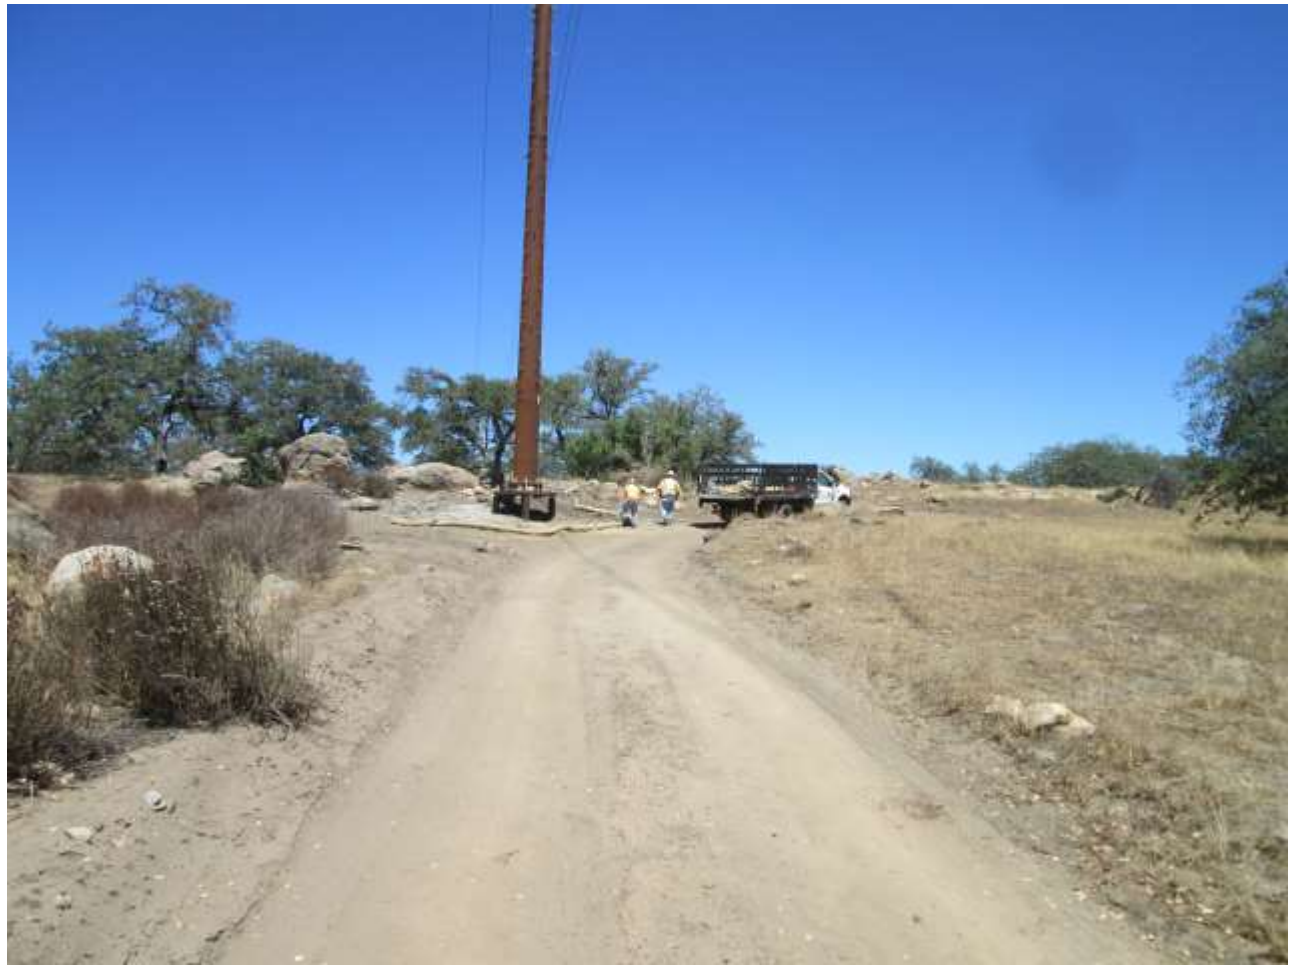
Crews devoted to BMP inspections and repair were observed repairing/replacing sediment controls along the right of way (See Photo 4—Attachment A). During repair activities, crews were observed carrying spill kits in vehicles in accordance with MM HAZ-2, and fire safety tools in accordance with the Project Fire Plan (APM HAZ-2). Additionally, crews were observed staying on approved access roads (APM BIO-1).

Photo 4: A dedicated team in charge of inspecting and replacing erosion control BMPs were observed on site performing repairs as necessary.

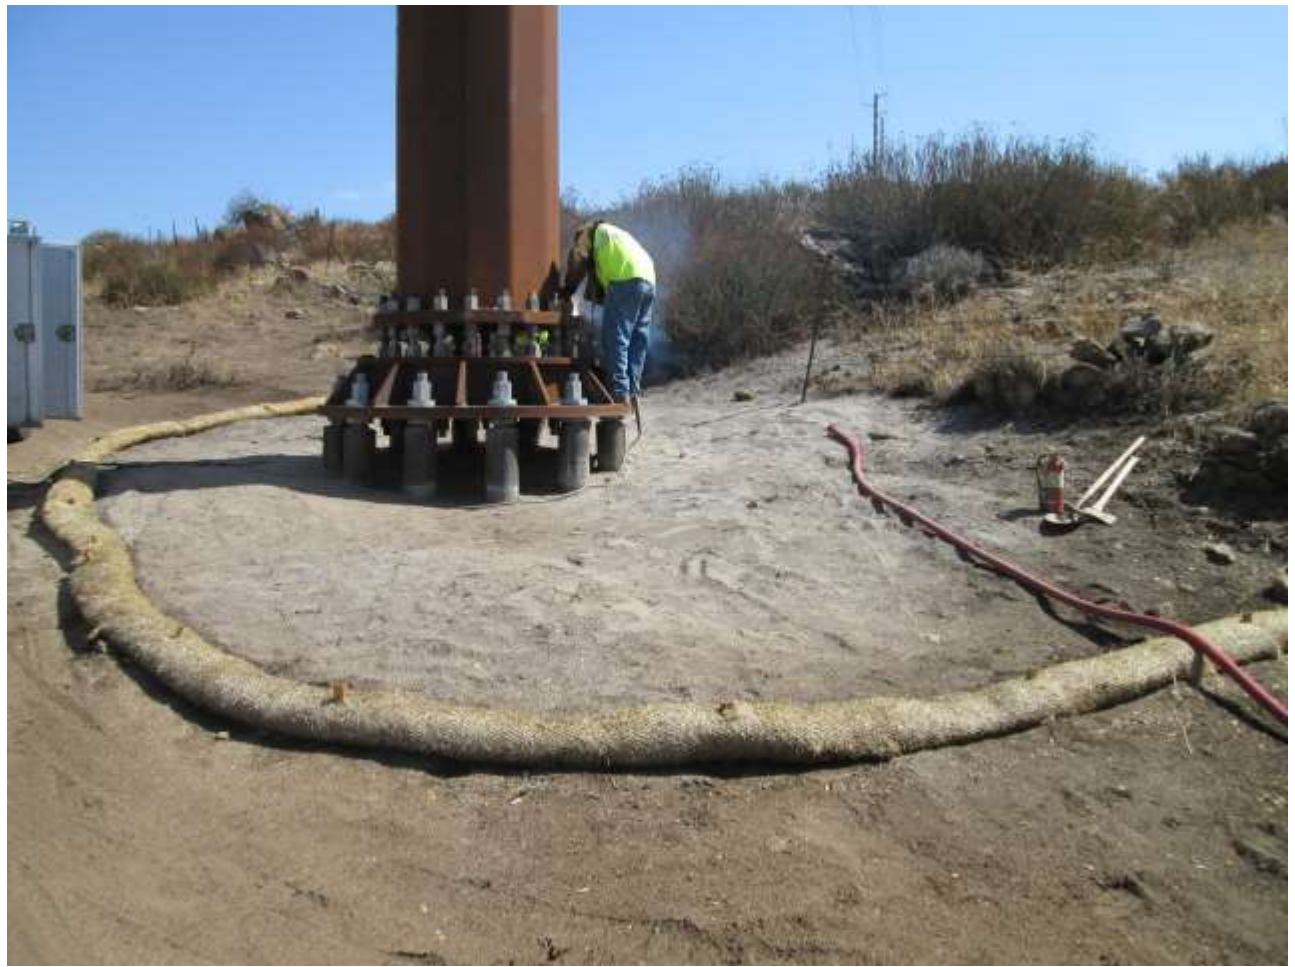
Crews were observed conducting welding activities for micropile foundations during this reporting period. At location 117 (See Photo 5—Attachment A), at least 10 feet of bare ground surrounded welding activities, fire tools (a fire extinguisher, shovel, and pulaski) were staged at the work area, and a

water truck with a connected hose was within 25 feet during activities in accordance with the Project Fire Plan (APM HAZ-2). Straw wattles surrounding the pole location were observed in good condition (APM HYD-1).

Photo 5: Crews were observed welding micropile foundation nuts. Preventative fire measures including carrying fire equipment (fire extinguisher, shovel, and pulaski), performing work in cleared spaces, and having a water tender with hose mobilized adjacent to the work space were observed during welding activities in accordance with the Project Fire Plan.

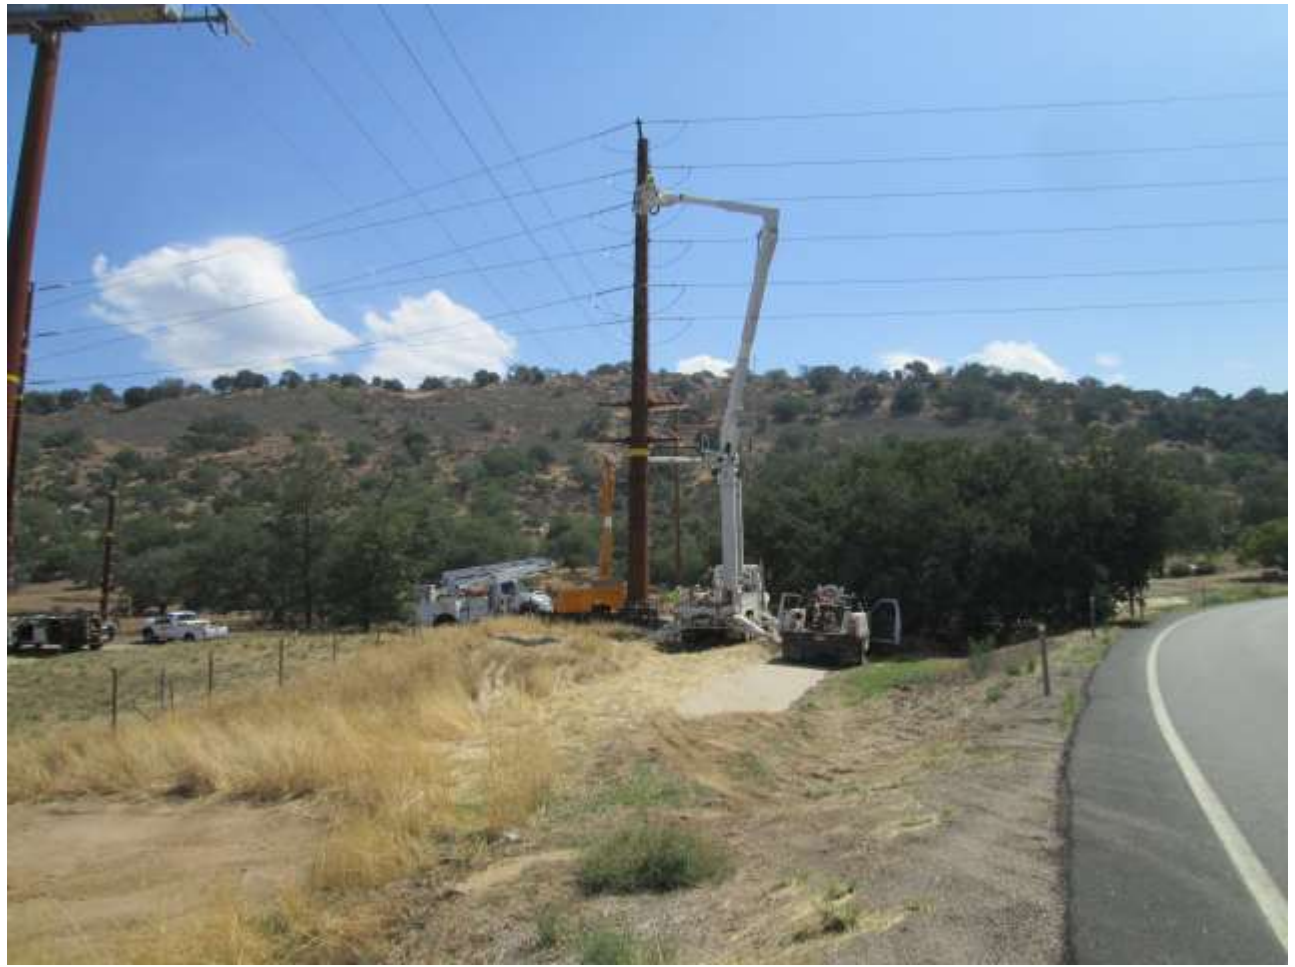
Crews were observed checking and x-raying dead end pole locations throughout the transmission line (see Photo 6—Attachment A). During these activities, a water tender was observed on site for fire safety in accordance with the Project Fire Plan (APM HAZ-2) and was observed applying water in the work area for dust suppression (APM BIO-1). Installed sediment controls on site consisted of perimeter straw wattles and silt fence, which were both observed to be in good condition (APM HYD-1).

Photo 6: Crews were observed conducting overhead line work inspections, such as x-raying dead-end poles.

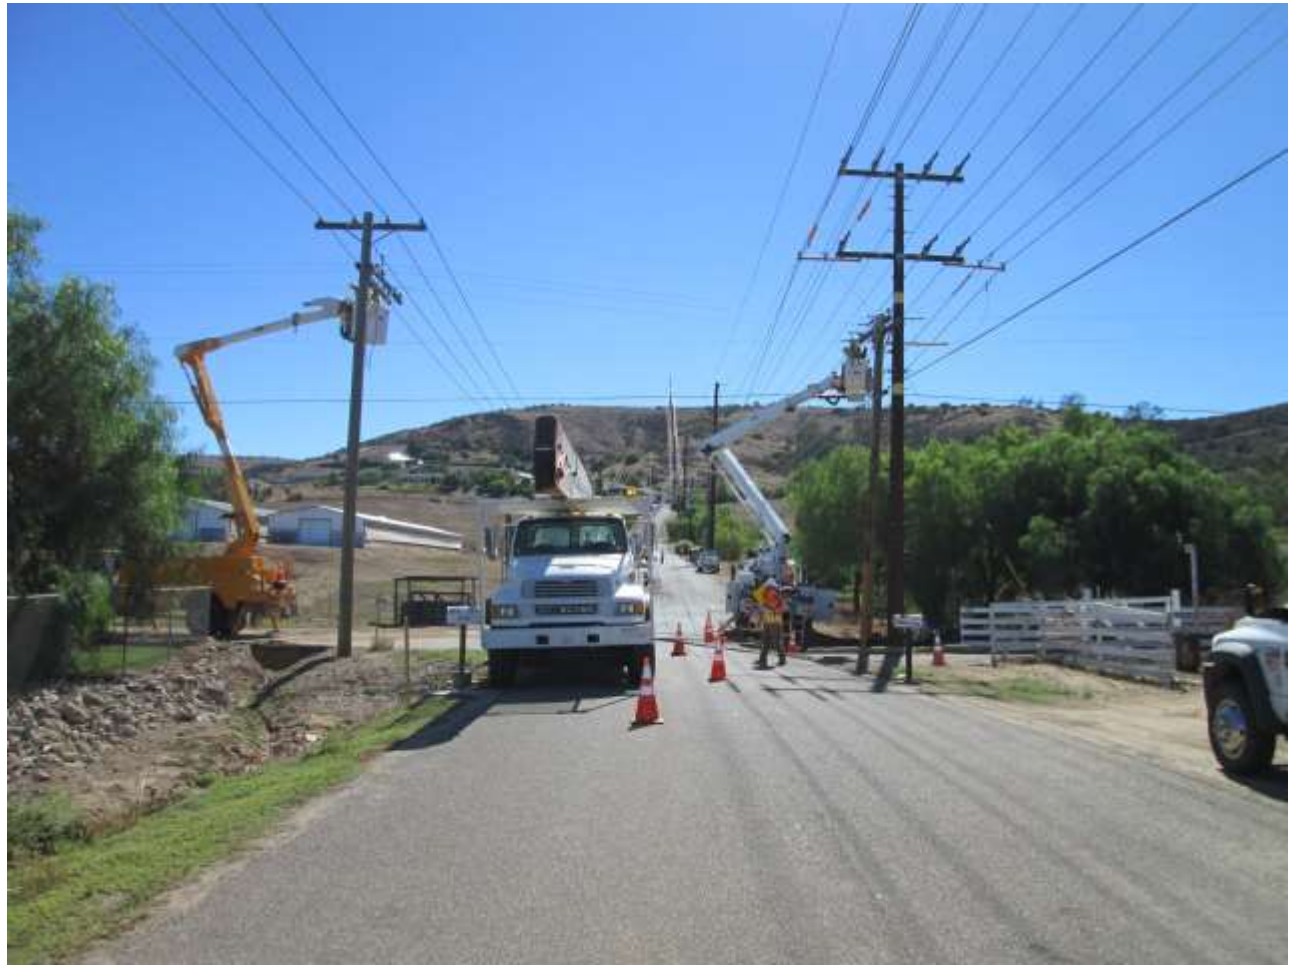
Crews were observed wrecking- out wooden poles and removing part of the 12kV conductor line at Locations 15, 171, and 172, adjacent to Creelman Lane. Traffic control procedures were observed being implemented along Creelman Lane during these activities, and included the use of flaggers, orange cones, and signage (APM TRA-1) (see Photo 7—Attachment A). A fire patrol was observed on site with a fire engine, and construction crews carried required fire safety equipment in vehicles in accordance with the Project Fire Plan (APM HAZ-2). An aquatic resource monitor was observed inspecting pole locations near or in jurisdictional waterways where future work was planned in accordance with MM HYD-4 and a biological monitor was also observed spot-checking the work activity in accordance with MM BIO-2.

Photo 7: Crews were observed wrecking-out poles and replacing a 12kV conductor line while implementing traffic control measures (APM TRA-1) and fire prevention measures (APM-HAZ-2).

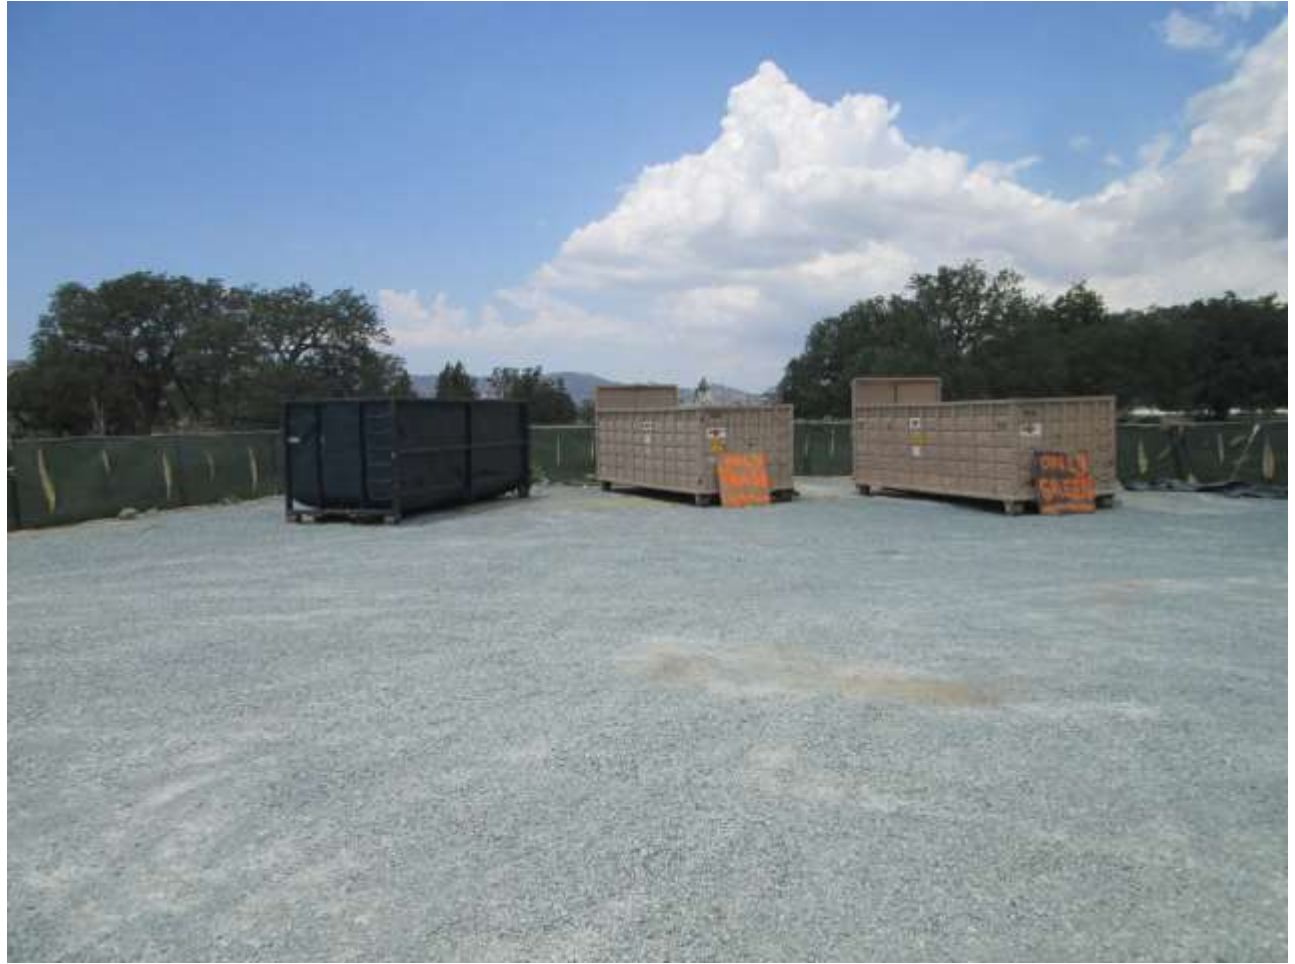
Construction equipment continued to be demobilized at staging yards after phases of construction were completed. At the Santa Ysabel Staging Yard, generators and portable toilets were observed to be staged over visqueen and secondary containment (MM HAZ-2), visual screening (APM AES-1) and straw wattles along the perimeter fence (APM HYD-1) remained in working condition, and no track out was observed at the point of ingress and egress (APM HYD-1). The staging yards were observed to be in tidy condition and trash was observed contained (APM BIO-1) (see Photo 8—Attachment A).

Photo 8: Trash was observed contained at the Santa Ysabel Staging Yard in accordance with APM BIO-1.
