<p><b>California Public Utilities Commission</b> <i>Mitigation Monitoring, Compliance, and Reporting Program</i></p>
	<p><b>Tie Line (TL) 637 Wood-to-Steel Pole Replacement Project</b></p>
	<p><b>Compliance Status Report: 015</b> <b>September 14, 2014</b></p>

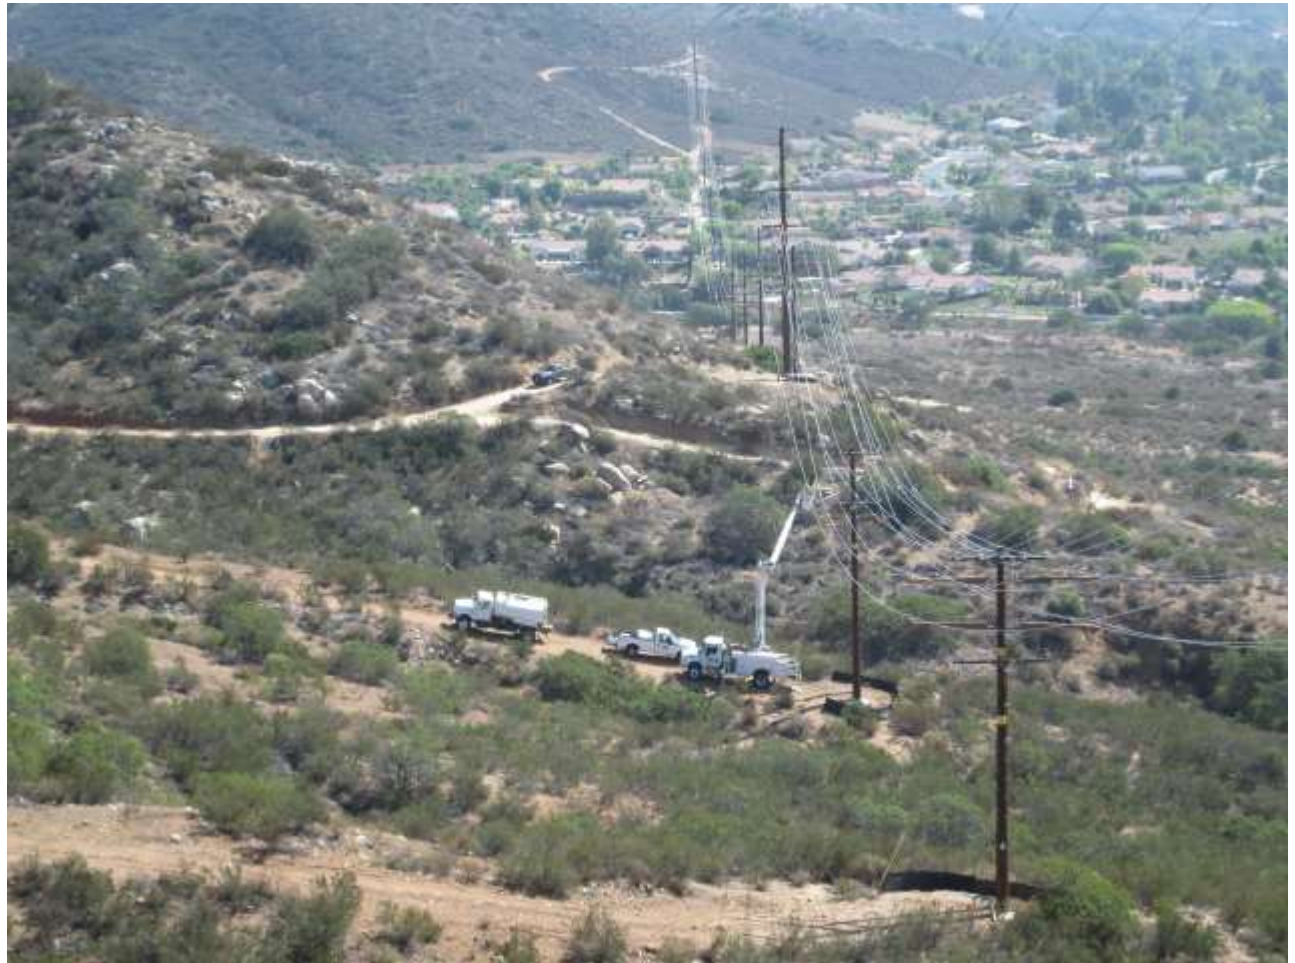
The majority of activities along the project right-of-way consisted of overhead construction activities (setting pole tops and wrecking out old 12kV wire and poles,), and overhead stringing activities including prepping for wire pulling activities (See Photo 1—Attachment A),

**Photo 1:** As crews were preparing for wire pulling activities at Location D34, water tenders were staged in accordance with the Project Fire Plan.

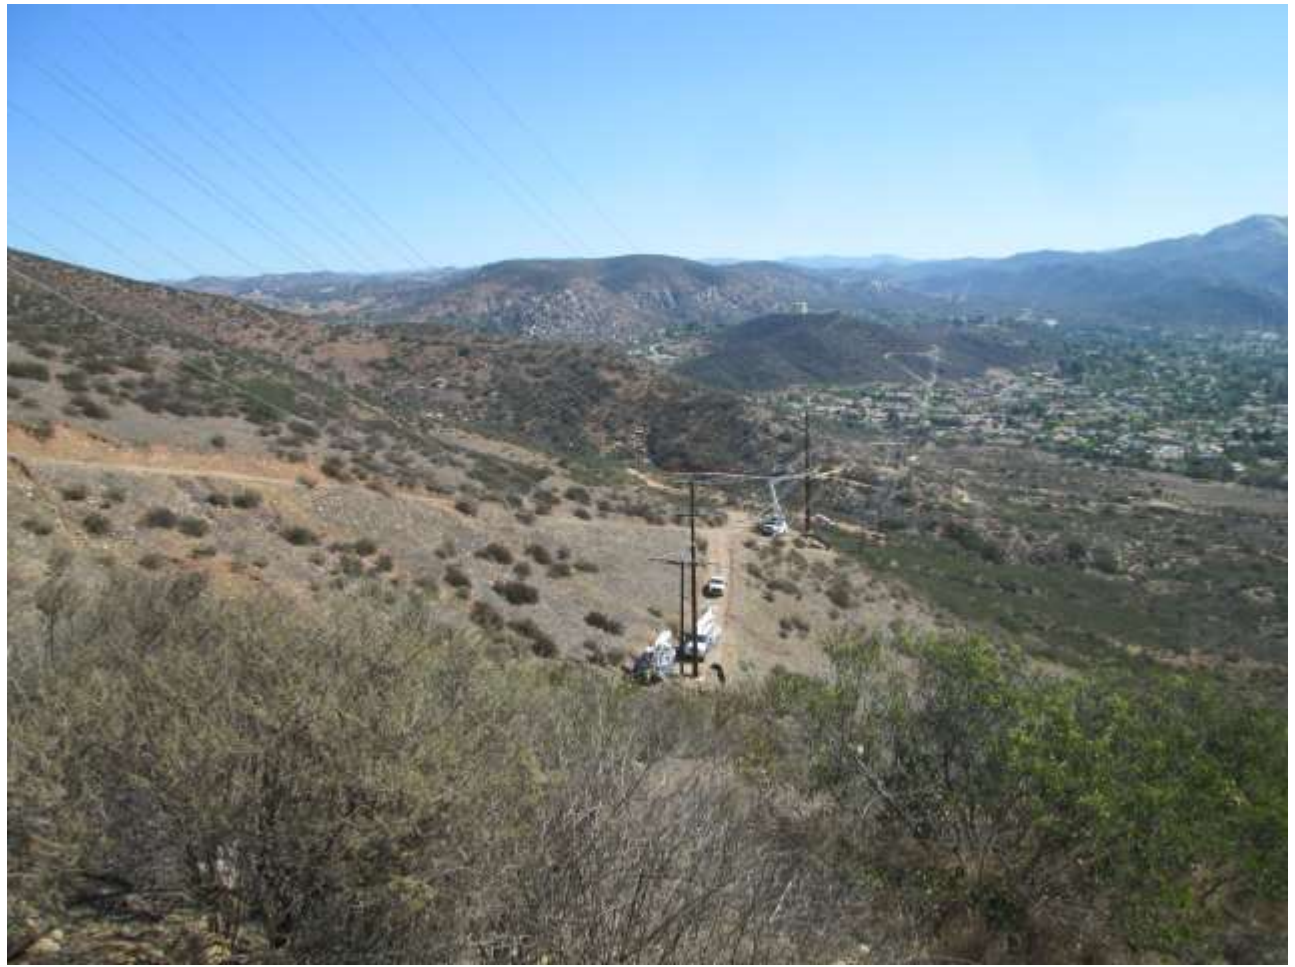
pulling/sagging/clipping/dead-ending wire associated with the 12kV line (See Photo 2—Attachment A); hanging fiber optic travelers on poles within the western/central segment of the right-of-way; and installing fiber optic line in the western portion of the right-of-way (See Photos 3 and 4—Attachment A).

**Photo 2:** Construction crews were observed staying on approved access roads during wire sagging and dead- ending activities at Locations D31 and D33.

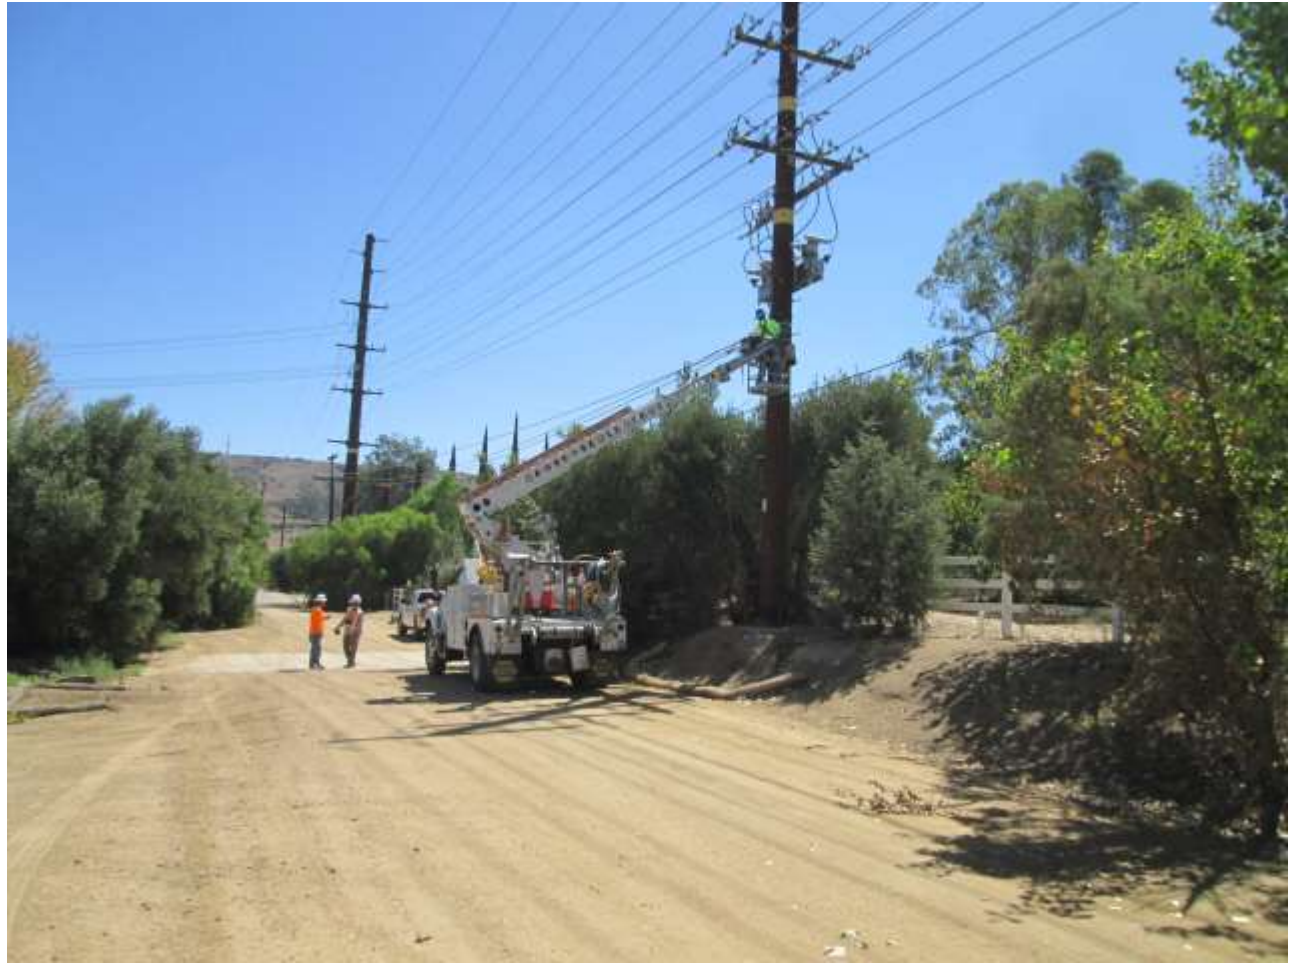
**Photo 3:** Construction crews were observed preparing for fiber optic installation at Location D7. SWPPP BMPs, such as straw wattles and silt fencing were observed intact and functional.

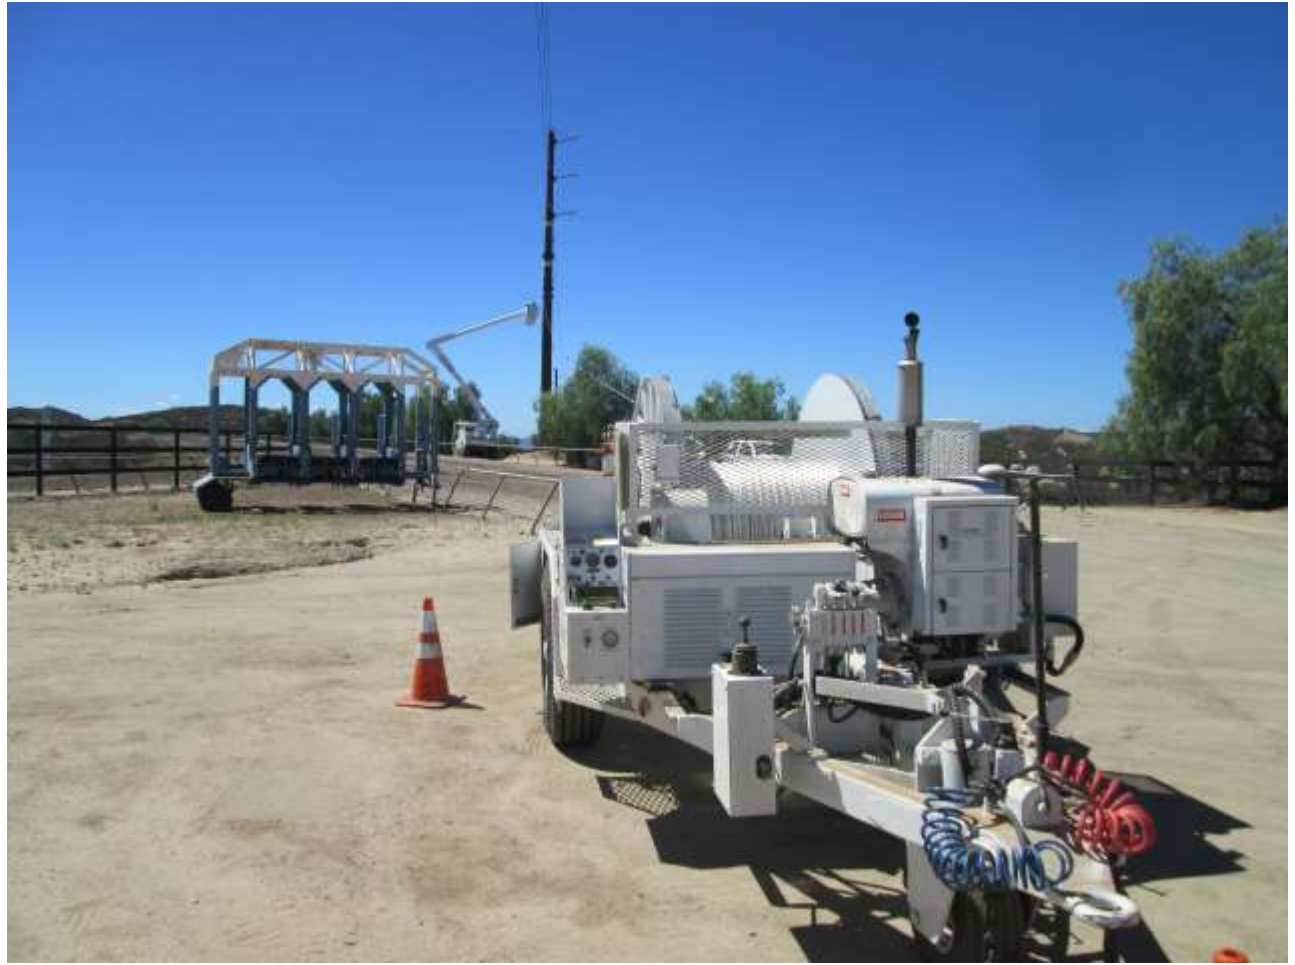
**Photo 4:** Fiber optic wire pulling at Stringing Site 13.

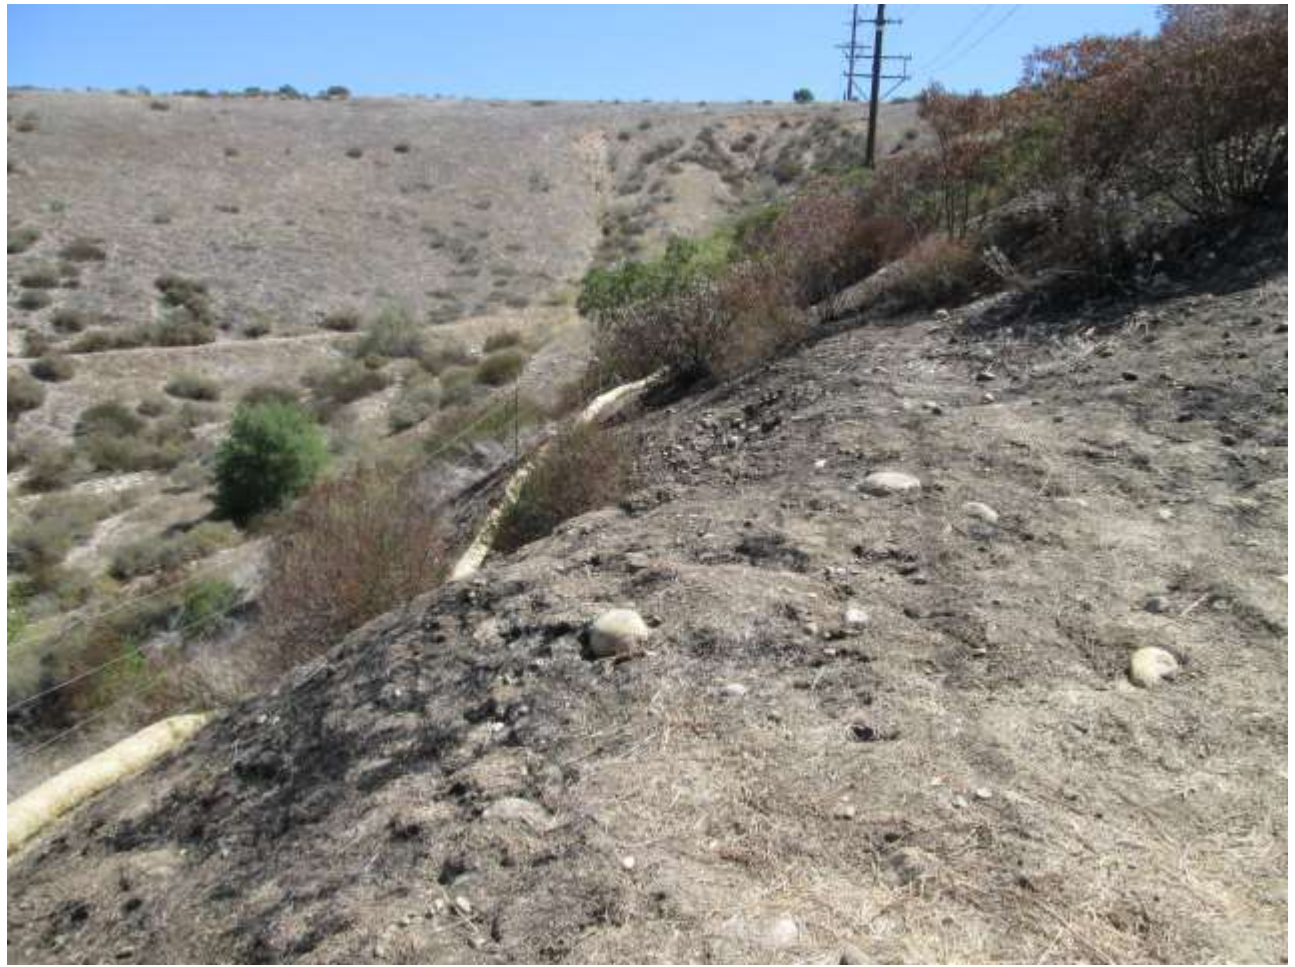
Construction crews were observed inspecting and maintaining Storm Water Pollution Prevention Plan (SWPPP) BMPs along the project right of way and installing straw wattle BMPs at the localized burn area adjacent to P22, reported in CPUC Weekly Report (WR) 014 (See Photo 5—Attachment A).

**Photo 5:** Construction crews installed sediment control BMPs (straw wattles) at the localized burn area (adjacent to Location P22) identified in CPUC WR 014.

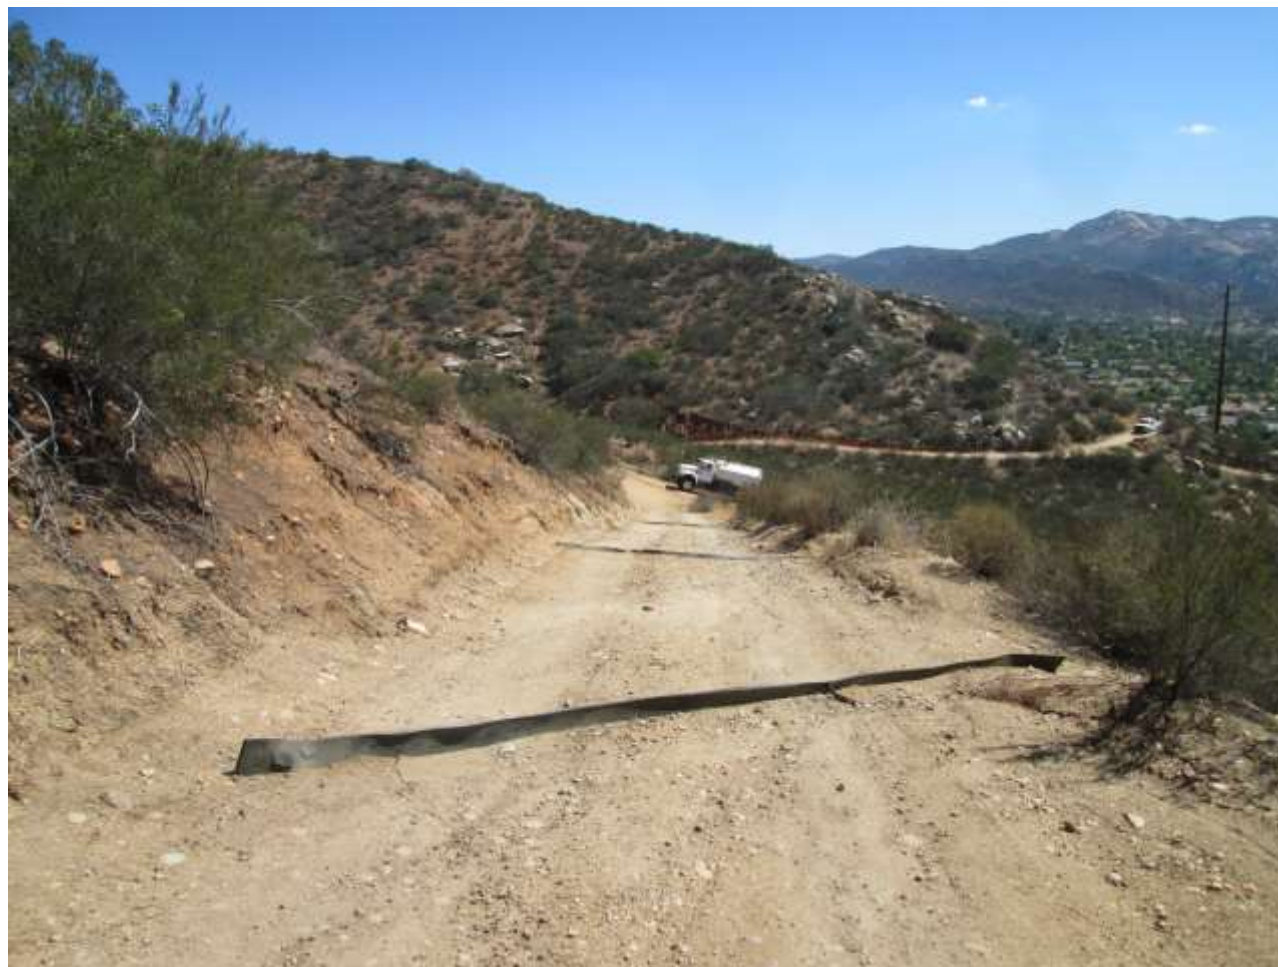
**Photo 6:** Water bars installed for erosion control along the access road between Locations P32 and D34 were observed in good condition (APM-HYD-1).

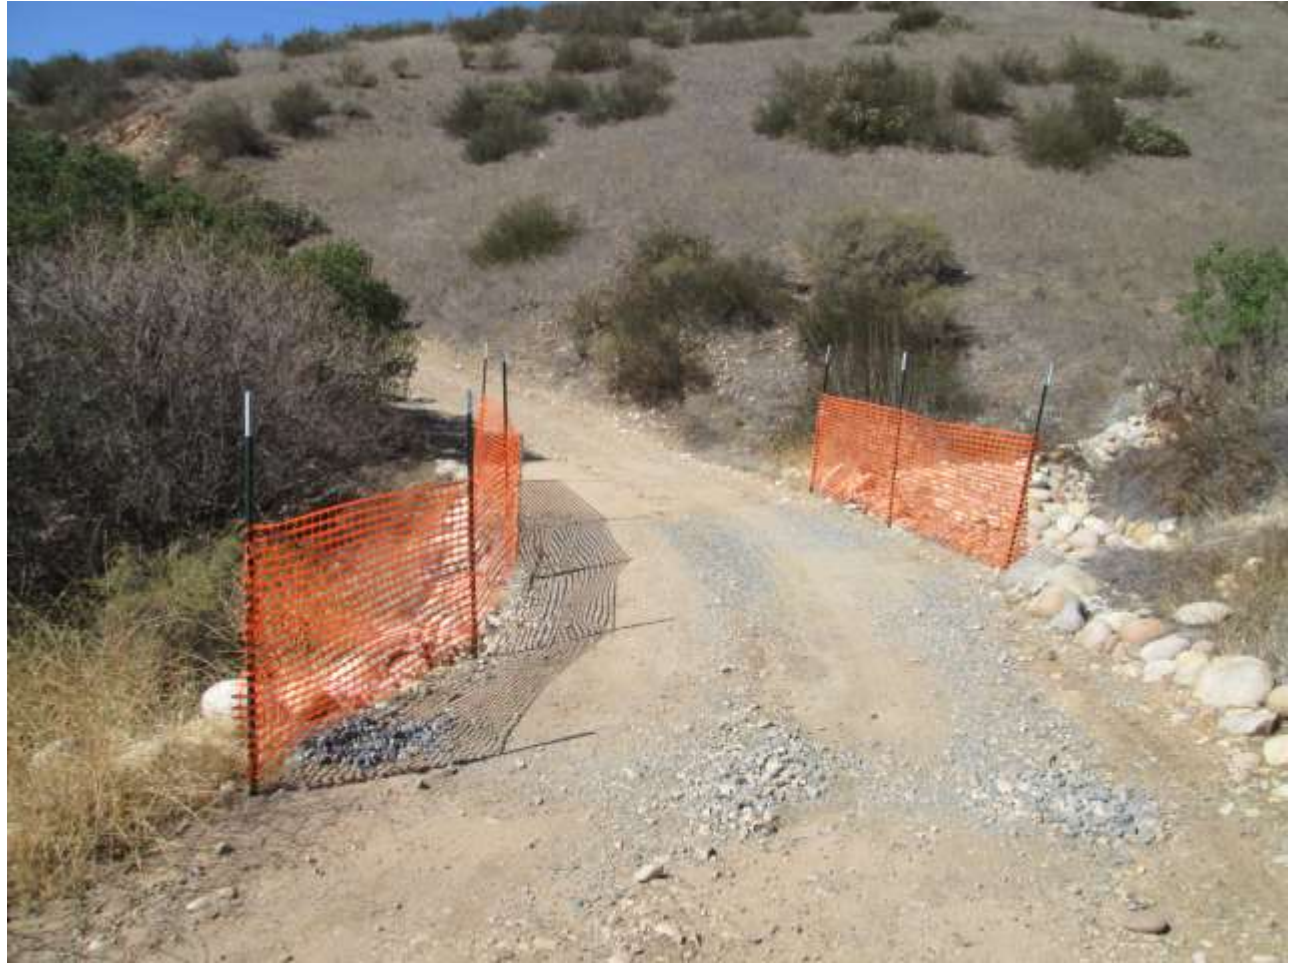
**Photo 7:** Between pole sites P32 and D34, temporary orange fencing used to guide vehicles away from the road ledge and preserve integrity of an adjacent drainage was observed intact and functional (APM-HYD-1).

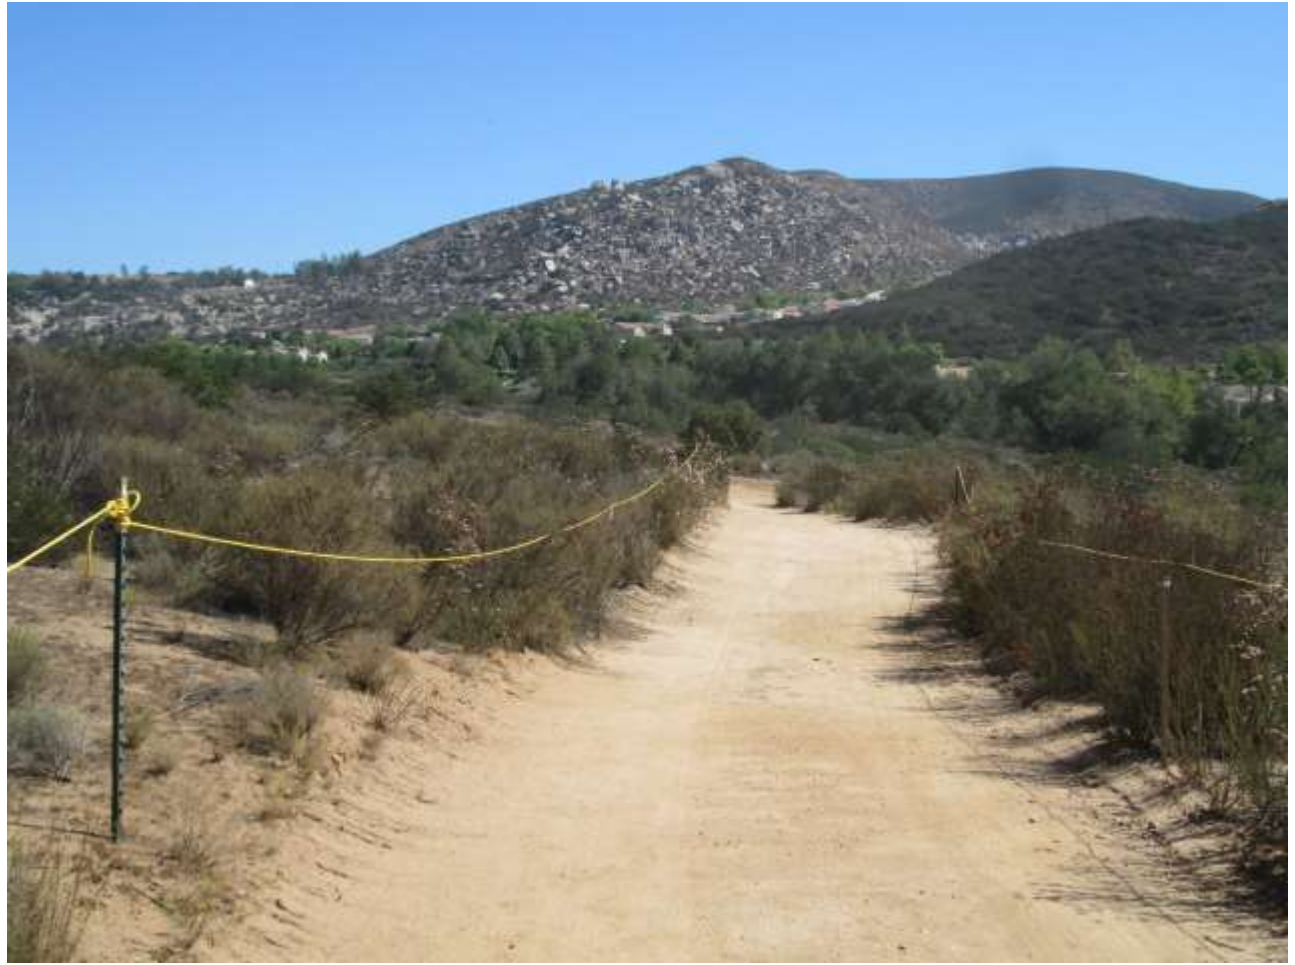
**Photo 8:** Environmentally Sensitive Areas were roped off along access roads to ensure construction crews avoided these areas (MM-CUL-1).
