<p>California Public Utilities Commission <i>Mitigation Monitoring, Compliance, and Reporting Program</i></p>
	<p>Tie Line (TL) 637 Wood-to-Steel Pole Replacement Project</p>
	<p>Compliance Status Report: 002 March 16, 2014</p>

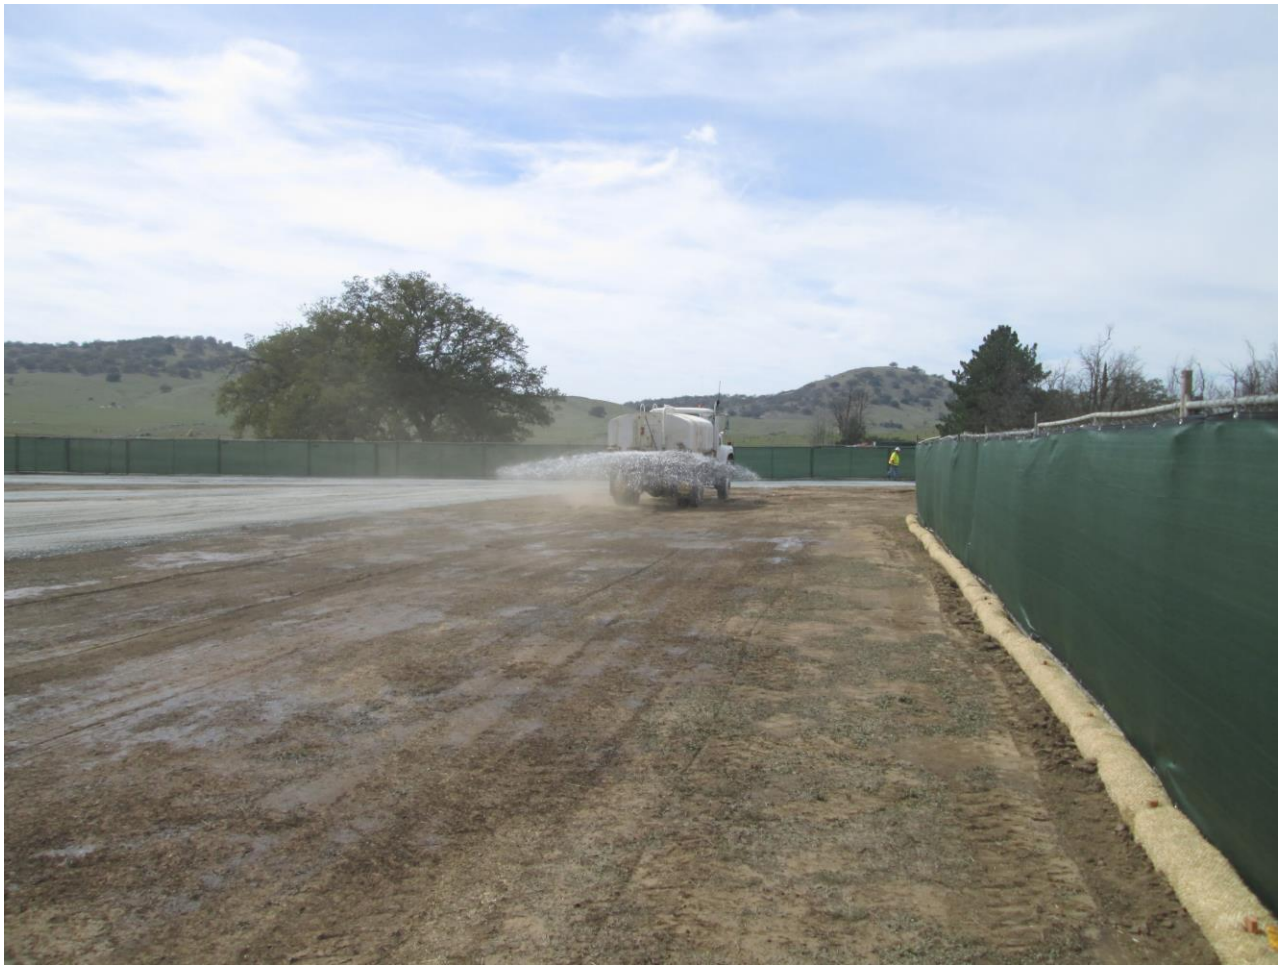
Crews were observed initiating set-up activities at the Santa Ysabel Staging Yard (see Photo1— Attachment A), which consisted of installing perimeter chain-link fence and opaque green mesh for visual screening purposes in accordance with Applicant Proposed Measure (APM) AES-1. Crews were also observed installing Storm Water Pollution Prevention Plan (SWPPP) Best Management Practices

(BMPs) consisting of straw wattles along the perimeter of the staging yard. Water trucks were observed applying water to minimize fugitive dust emissions in accordance with APM BIO-1. Portable equipment and temporary structures were also observed staged on secondary containment as required by the SWPPP (APM HYD-1).

Photo 1: Opaque mesh screening material has been placed along the perimeter chain-link fence at the Santa Ysabel Staging Yard in accordance with APM AES-1. Straw Wattles have also been installed along the perimeter of the staging yard in accordance with the SWPPP and MM HYD-1. A water truck was observed applying water and preventing fugitive dust in accordance with APM BIO-1 during application of Class II road base.

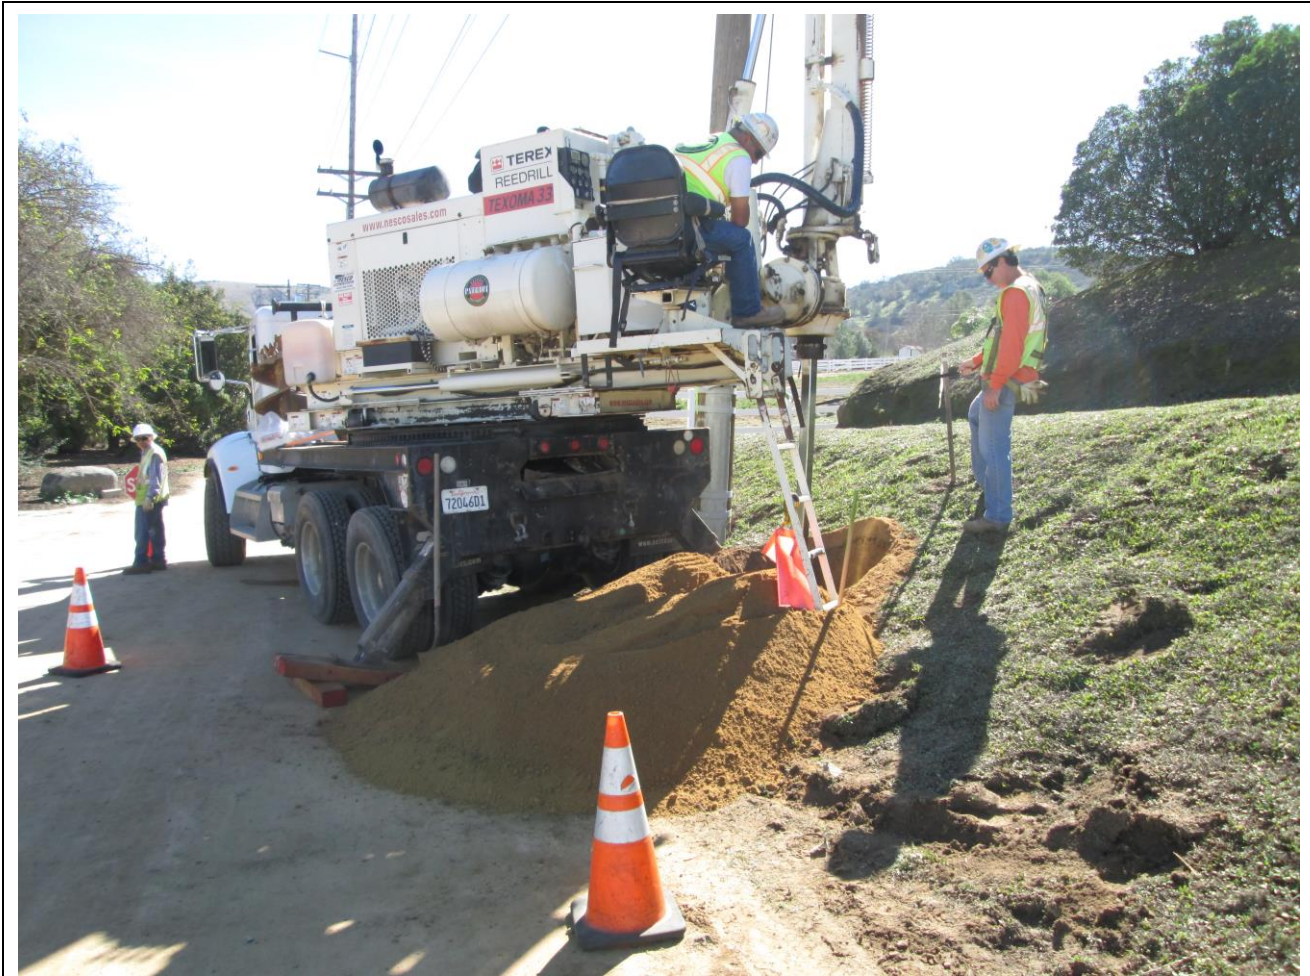
Traffic control measures were observed being implemented at locations where crews were accessing pole locations from public roadways in accordance with the Traffic Control Plan (APM TRA-1). Traffic control measures included placement of cones to direct motorists, traffic signage alerting motorists of construction traffic in the area, and flaggers directing construction crews and motorists travelling along public roads (see Photo 2—Attachment A).

Photo 2: Crews were observed staging traffic control equipment (cones) and a flagger (left) during excavation work along Creelman Lane in accordance with APM TRA-1.

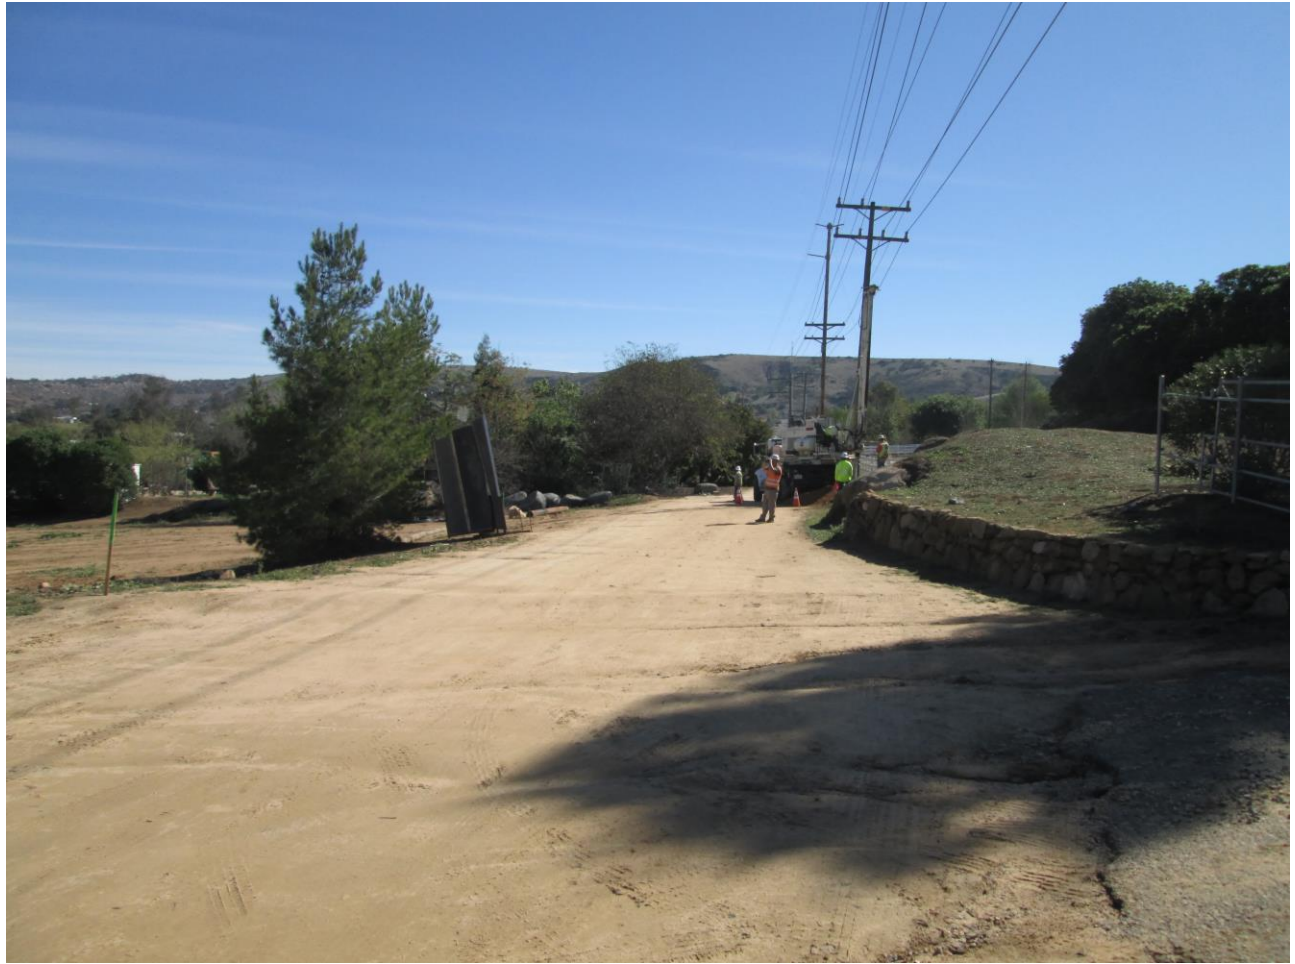
CPUC-approved biological monitors were observed monitoring construction activities and conducting nesting bird surveys in accordance with Mitigation Measure (MM) BIO-4. Nest buffers were delineated with wooden stakes that were painted green and had the words “do not enter without bio.” Additionally, biological monitors were observed on site monitoring nests for potential disturbance from construction activity taking place near 100-foot nest buffers, and noise barriers were placed near nests as determined necessary to mitigate potential auditory and visual impacts from adjacent construction activity. Construction personnel were directed to walk along opposite sides of roads adjacent to nests to prevent any disturbance from foot-traffic to nests (see Photo 3—Attachment A).

Photo 3: CPUC–approved biological monitors were observed on site monitoring nest buffers. Buffers were delineated with wooden stakes (photo, left) that were painted green and had the words “do not enter without bio.”

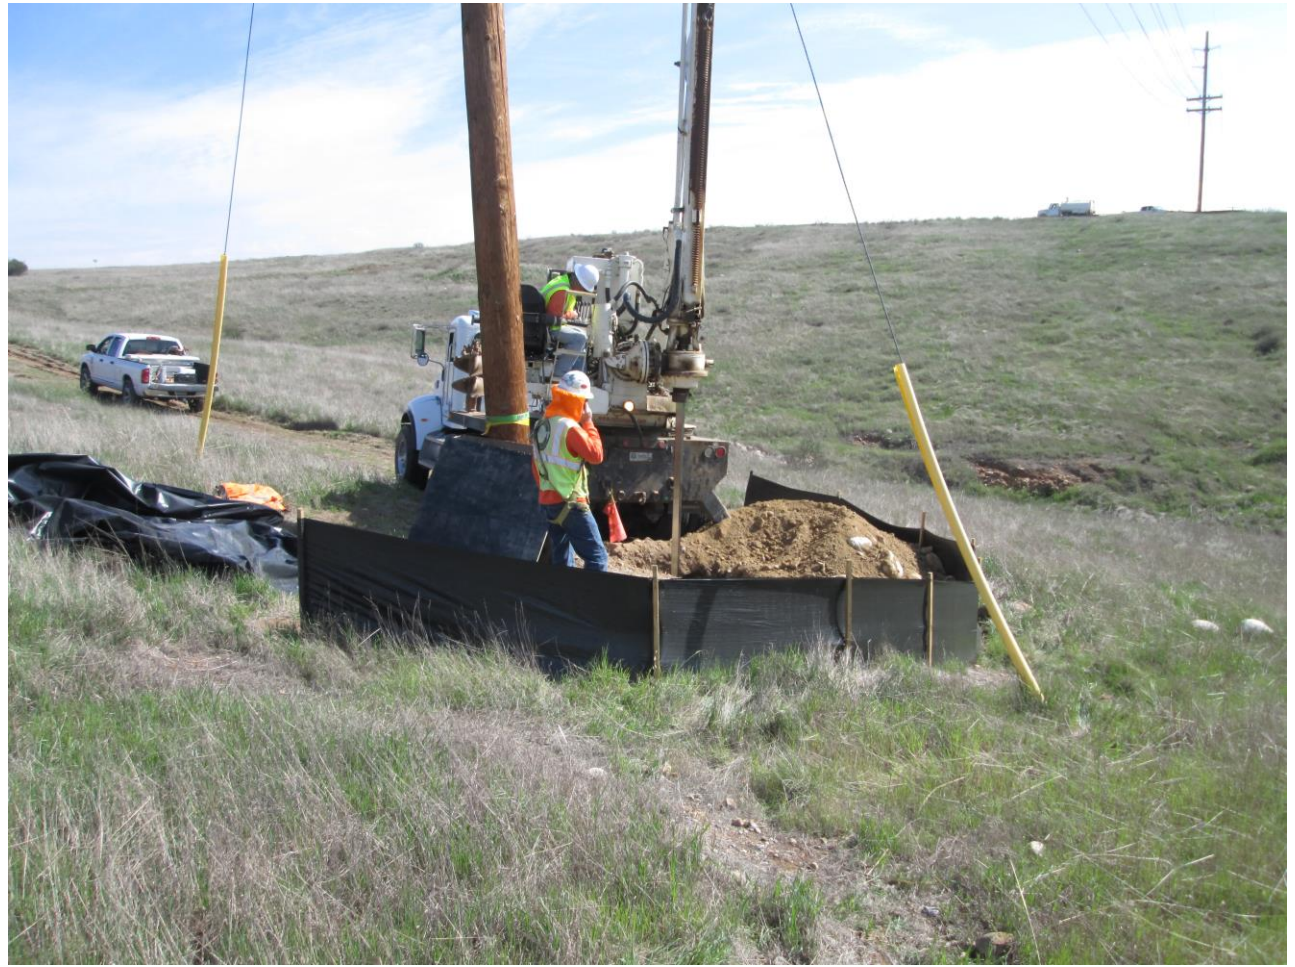
Paleontological monitors were observed inspecting excavated soils for the presence of fossils in accordance with APM CUL-6 during excavations at direct-bury pole locations. Excavated soil was contained by a silt fence in accordance with the Project SWPPP and APM HYD-1 (see Photo 4—Attachment A).

Photo 4: Paleontological monitors were observed inspecting excavated soils for the presence of fossils in accordance with APM CUL-6 during conventional pole hole digging. Excavated soil was contained by erosion- control silt fence in accordance with the Project SWPPP and APM HYD-1.

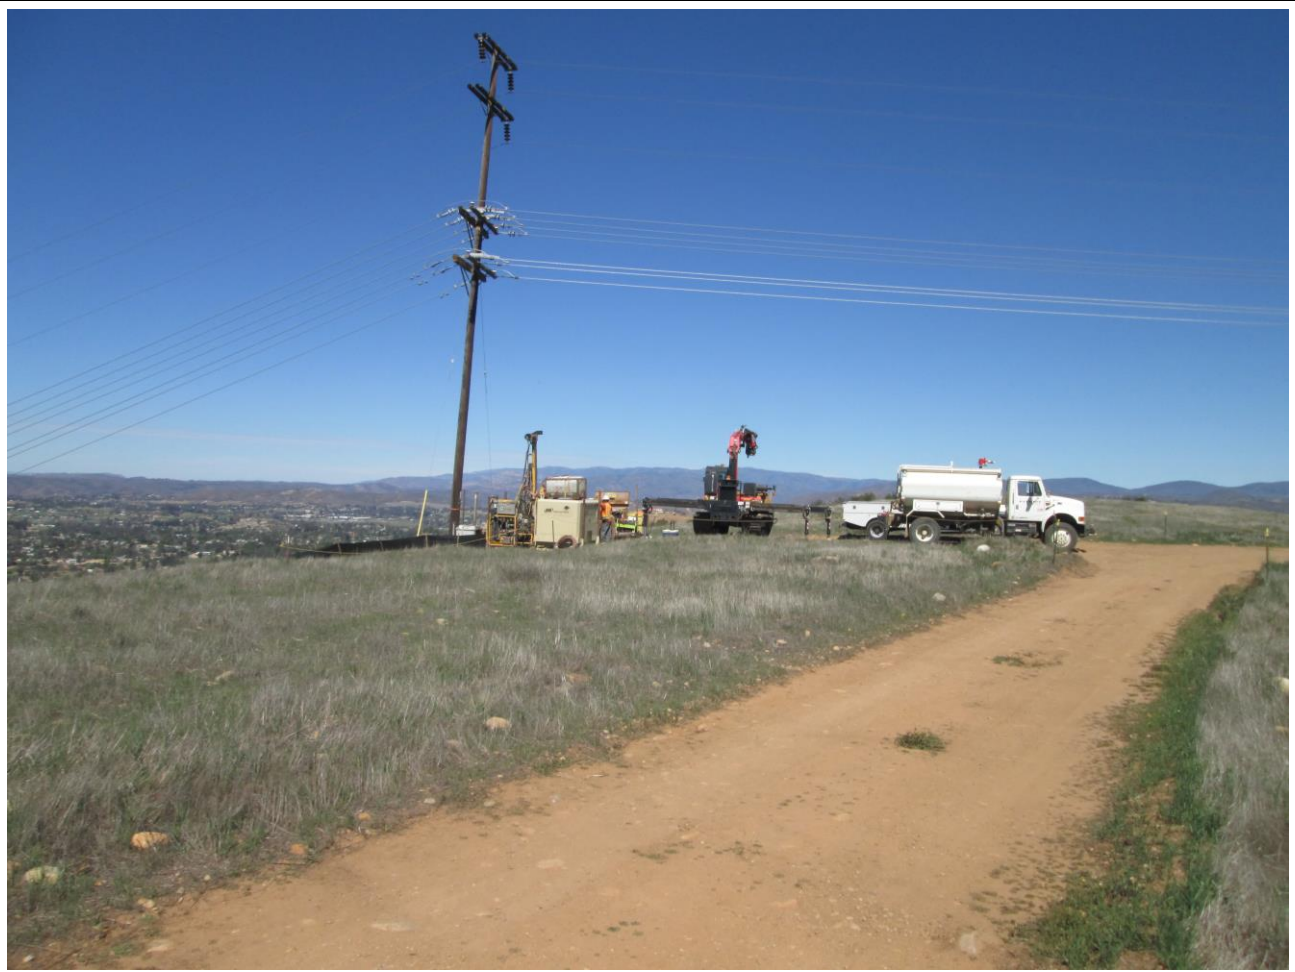
Activities associated with micro-pile drilling pole replacements were also observed along the sides of existing access roads (paved and unpaved). Crews were observed staging preventative fire equipment per the Project Fire Plan (APM HAZ-2), which included both water tenders and construction equipment that contained shovels, Pulaskis, and backpack water pumps (see Photo 5—Attachment A).

Photo 5: Crews were observed excavating at pole locations with fire watch/water tenders present within 50 feet of construction activity in accordance with the Project Fire Plan and APM HAZ-2.

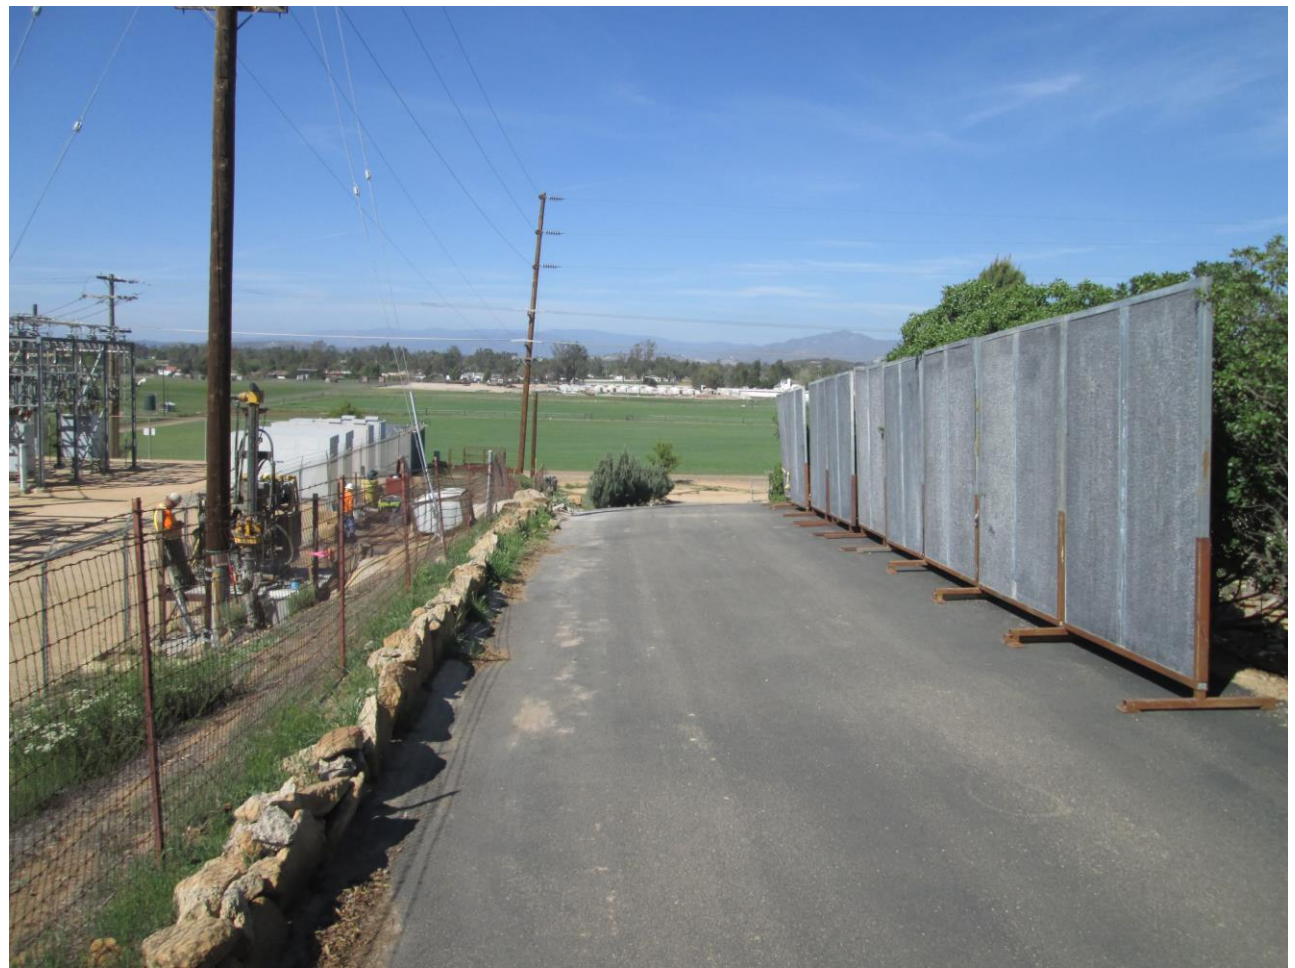
Crews were observed installing noise monitoring devices and noise barriers adjacent to sensitive receptors to reduce construction-related noise at sensitive receptor locations to below required noise thresholds in accordance with MM NOI-2 (see Photo 6—Attachment A).

Photo 6: Noise Monitoring Equipment and sound walls were observed in place adjacent to micro pile drilling to ensure that noise levels during construction activities did not exceed thresholds at the nearest property line or adjacent to noise sensitive areas in accordance with MM NOI-1.

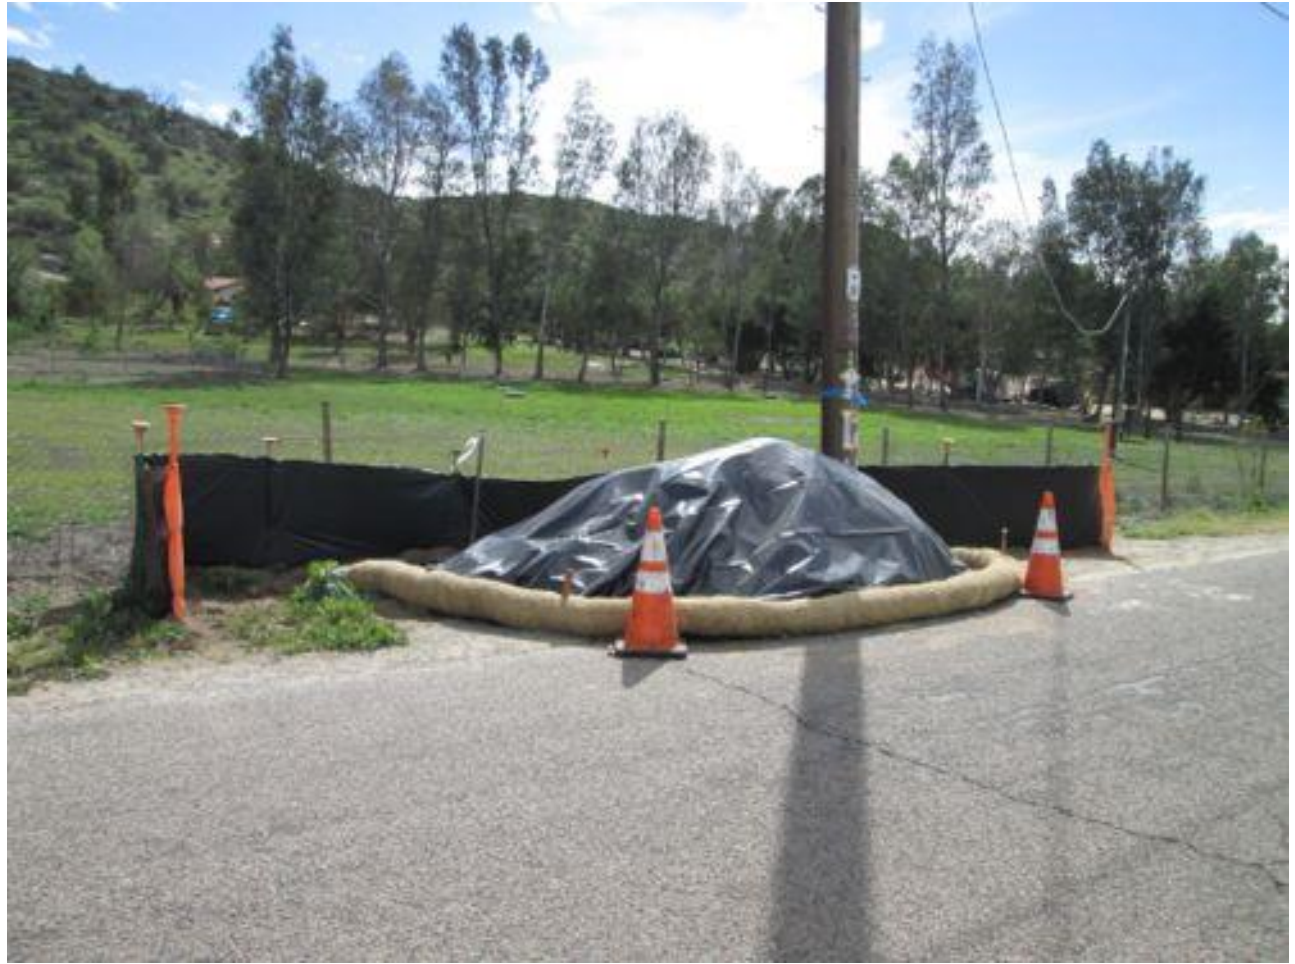
Following the installation of poles adjacent to roadways, crews were observed sweeping and clearing roads of any remnant soils/dirt in accordance with SWPPP BMPs (APM HYD-1). Additionally, crews were observed excavating at pole locations and implementing SWPPP BMPs, such as placing visqueen

below and on excavated dirt spoils (see Photo 7—Attachment A). An aquatic resource monitor was observed on site during work activities being completed adjacent to jurisdictional waters in accordance with the Regional Water Quality Control Board (RWQCB) Clean Water Act 401 Certification and MM HYD-4. Silt fencing and straw wattles were observed installed around the perimeter of the work area.

Photo7: Crews were observed placing visqueen in over spoil staged on site adjacent to a jurisdictional waterway in accordance with the project SWPPP and APM HYD-1. An aquatic resource monitor was on-site in accordance with the RWQCB Clean Water Act 401 Certification and MM HYD-4.

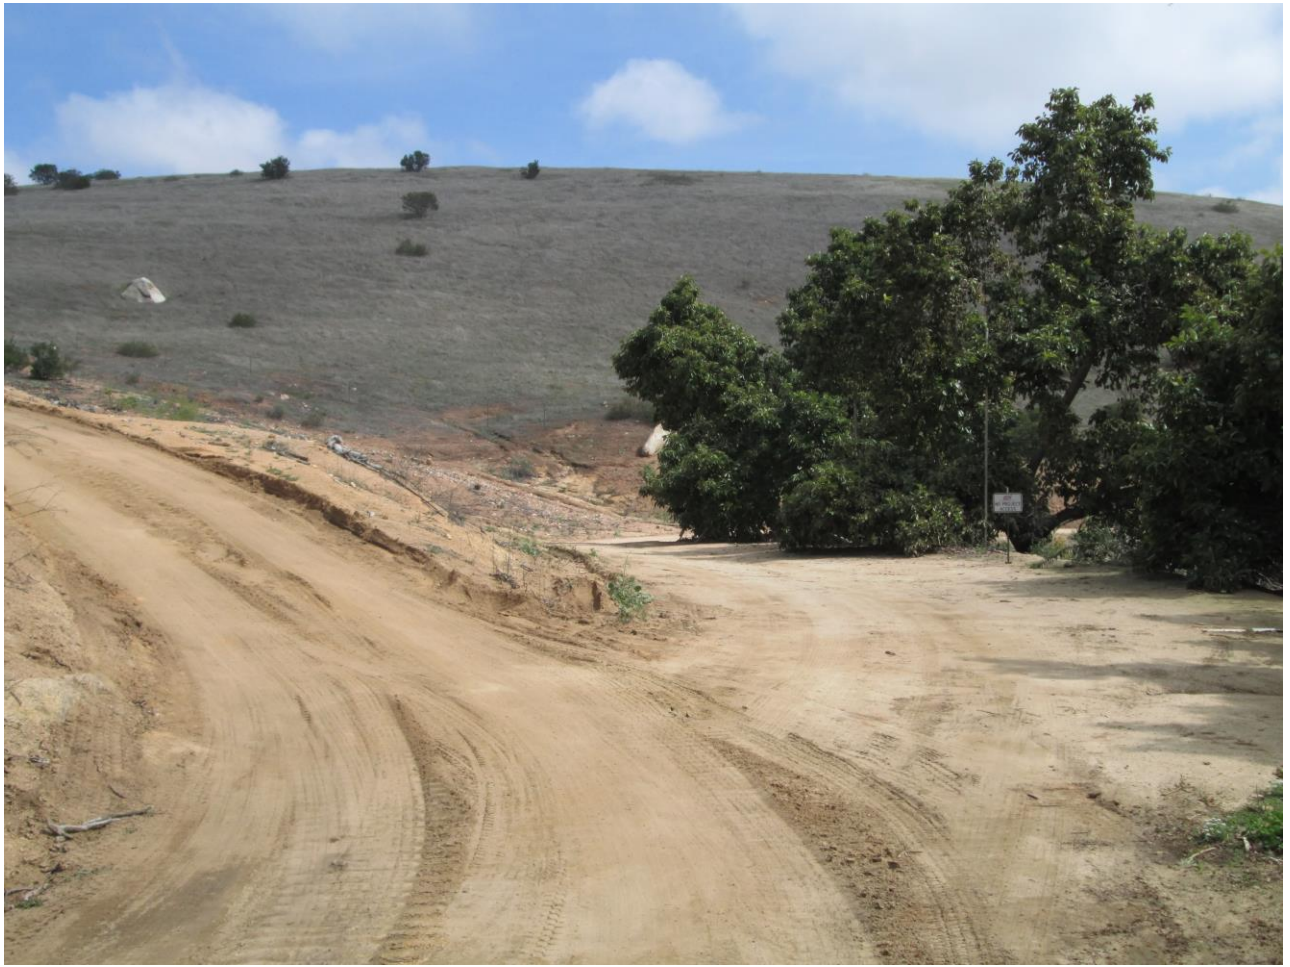
A third Level 1 Minor Deviation was reported by SDG&E when a crew member was observed parking on an access road that was not designated for the project. Additional reinforcement of this issue will occur at weekly compliance and construction meetings as well as at daily morning tailboard meetings to ensure compliance. A no access sign has also been installed at road junctions to ensure crews continue to use designated access roads for the project and that unintentional use of other existing access roads does not occur in the future (see Photo 8—Attachment A).

Photo 8: A “No Project Access” sign (photo, right) was installed at the junction of two existing access roads in order to ensure crews utilized approved exiting access roads.
