<p><b>California Public Utilities Commission</b>  <b><i>Mitigation Monitoring, Compliance, and Reporting Program</i></b></p>
	<p><b>Tie Line (TL) 637 Wood-to-Steel Pole Replacement Project</b></p>
	<p><b>Compliance Status Report: 003</b>   <b>March 30, 2014</b></p>

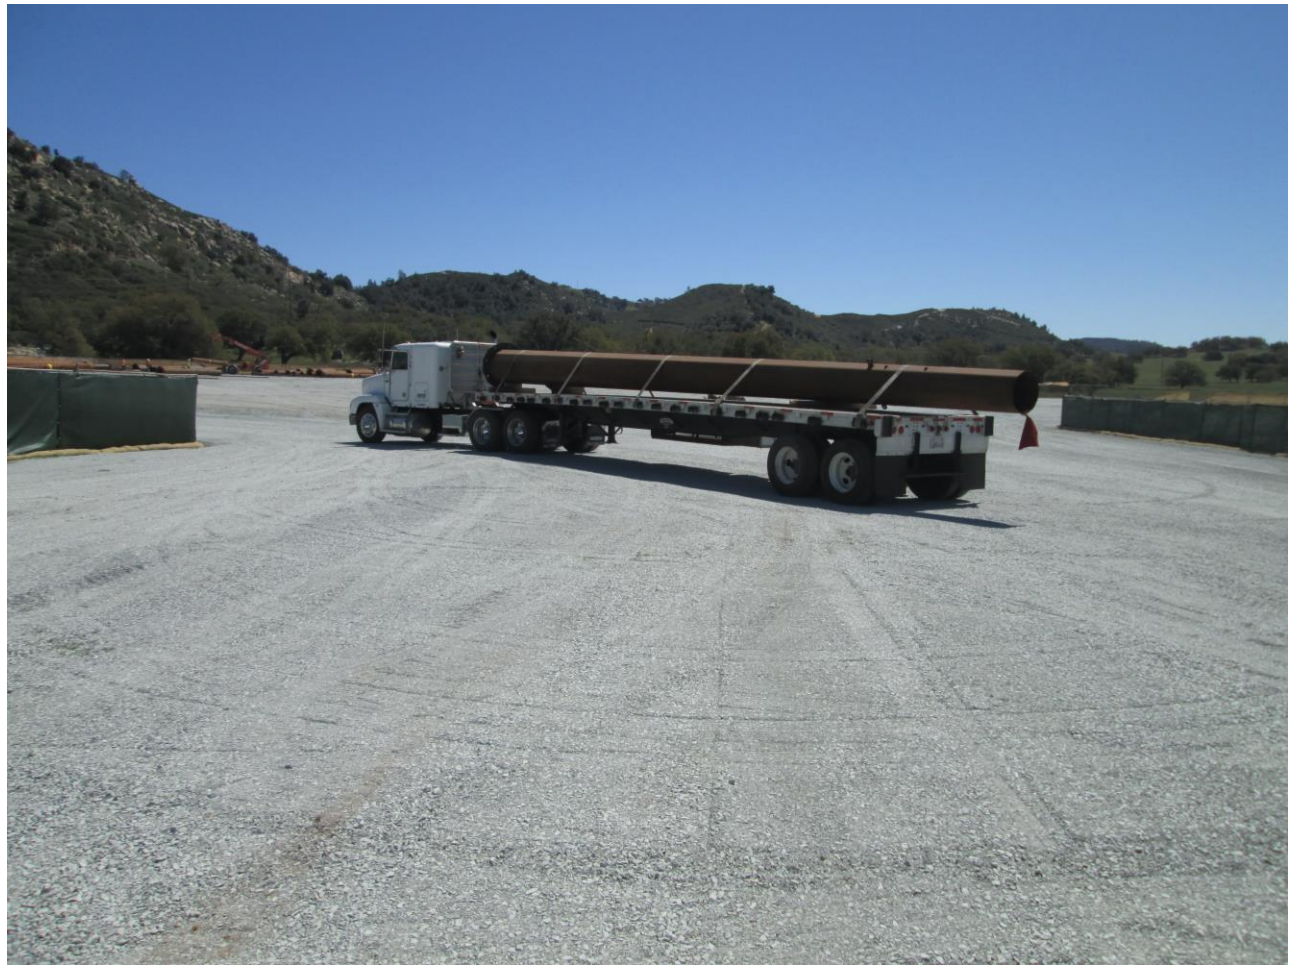
Delivery of materials for pole replacement and Storm Water Pollution Prevention Plan (SWPPP) Best Management Practices (BMPs) was observed throughout the reporting period (see Photo 1—Attachment A). Installation of perimeter fencing, gravel base, opaque green mesh screening material, straw wattles and rock aprons occurred at the Warnock, Creelman, and Santa Ysabel Staging Yards.

Crews were observed finalizing opaque green mesh for visual screening purposes in accordance with Applicant Proposed Measure (APM) AES-1 at the Santa Ysabel Staging Yard. SWPPP BMPs (APM HYD-1) including straw wattles were observed being maintained at all Staging Yards and track-out was not observed at points of ingress/egress. Portable equipment and temporary structures were observed staged on secondary containment as required by the project SWPPP.

**Photo 1:** Staging Yards have been established and visual mitigation (opaque green mesh) and SWPPP mitigation (straw wattles, rock aprons, and gravel base) were observed installed. Deliveries for pole installation were observed at the staging yards.

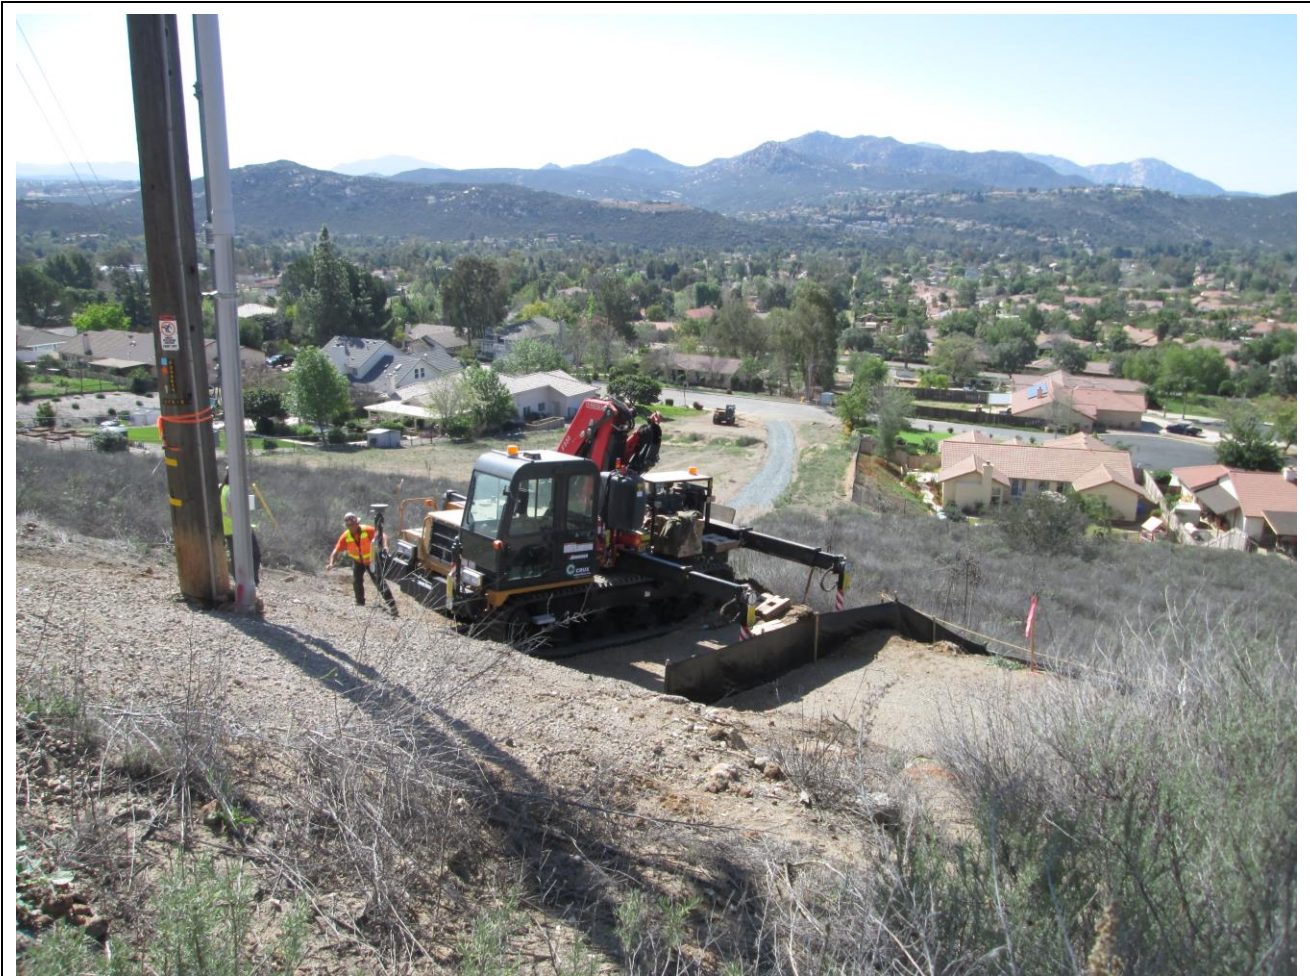
Crews were observed conducting the following activities associated with micro pile sites: setting up and demobilizing equipment at pole locations (see Photo 2—Attachment A), grouting operations (see Photo 3—Attachment A), vegetation trimming at sites and along access roads, wire spreading, capping micro pile foundations and compacting spoils on existing access roads.

**Photo 2:** Crews were observed setting up equipment for micro pile foundation installation. Silt fencing was observed in the work area in accordance with the project SWPPP.

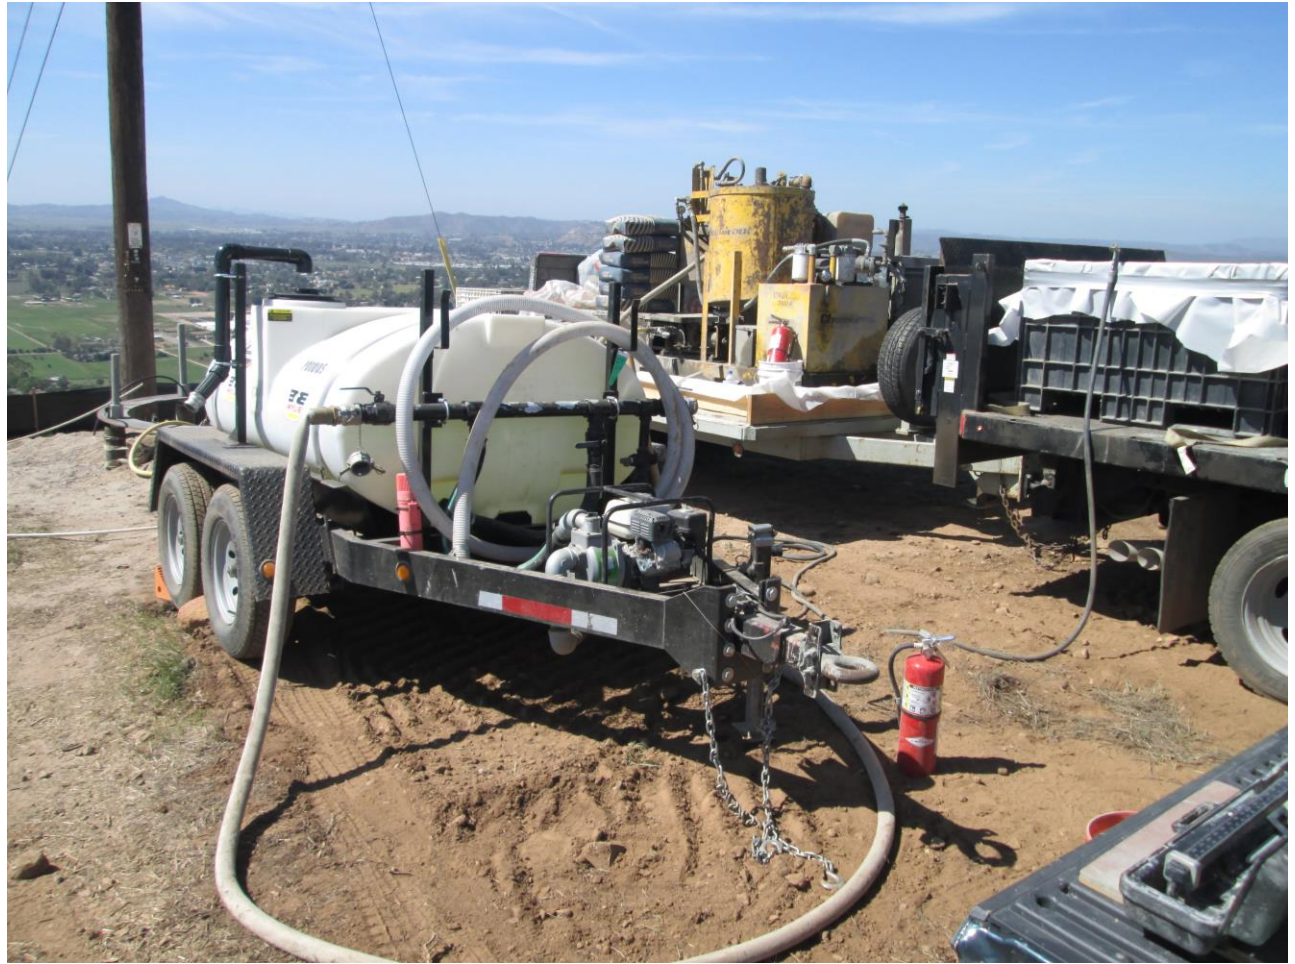
**Photo 3:** Crews were observed staging grouting equipment for micro pile foundations within approved work areas.

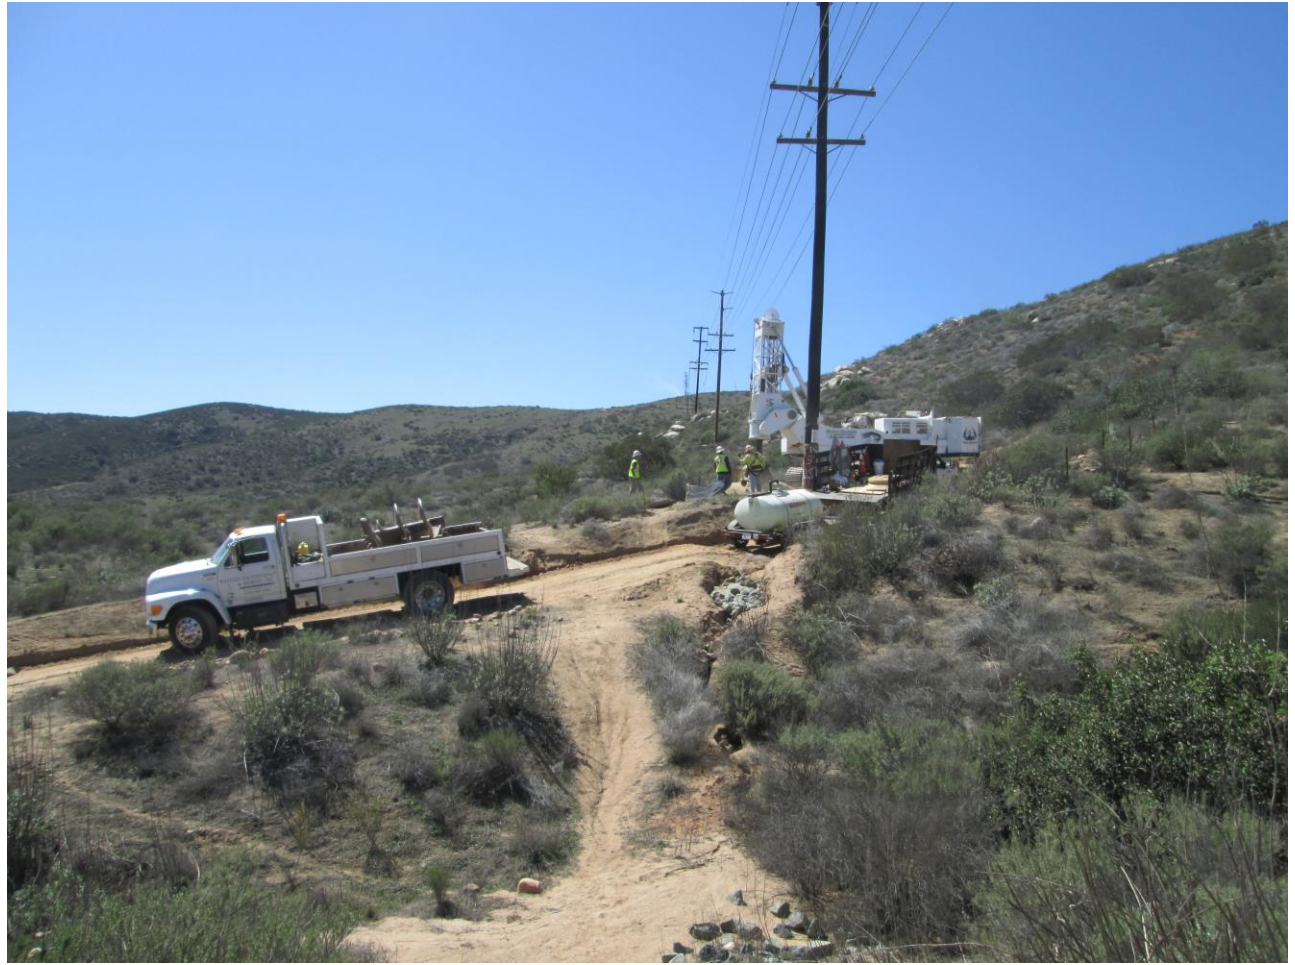
Crews were observed conducting the following activities associated with conventional pole replacement sites: machine auguring pole holes (see Photo 4—Attachment A), hand digging pole holes (see Photo 5—Attachment A), installation of BMPs, vegetation trimming, and refreshing access roads to pole sites.

**Photo 4:** Crews were observed using approved access roads to mobilize conventional drilling equipment.

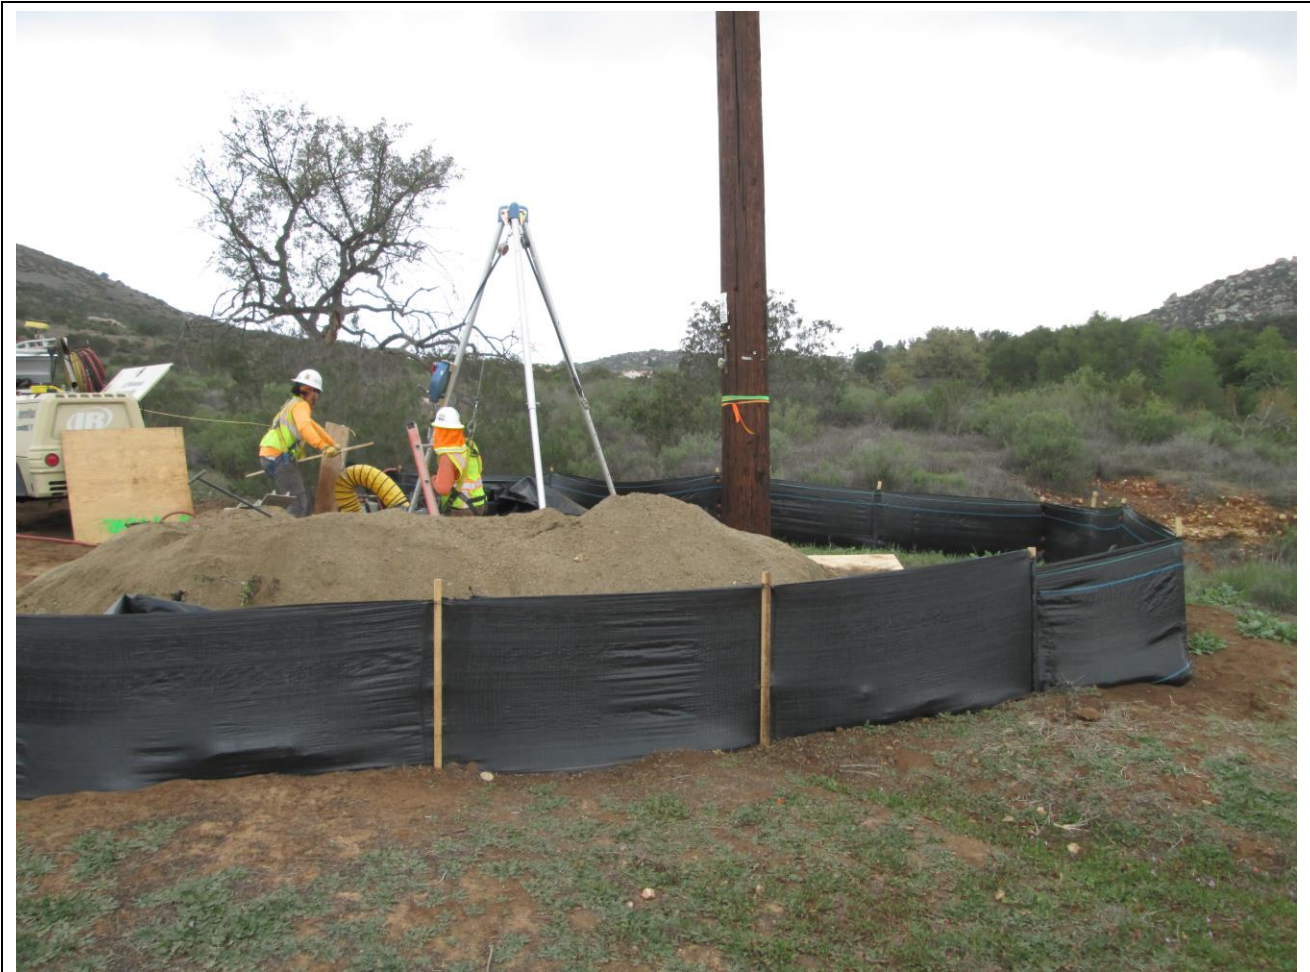
In accordance with the project SWPPP and APM-HYD-1, erosion control BMPs such as silt fencing were observed being maintained at all sites (see Photo 5—Attachment A), and water bars were observed along the access road to appropriately divert running water. In accordance with the RWQCB Clean Water Act Section 401 Certification and MM-HYD-4, an aquatic resource monitor was observed stationed at designated work location sites that were adjacent to jurisdictional waterways. Crews were observed staging equipment on visqueen to ensure containment of any potential mechanical leaks. On March 28, a small leak/spill was observed by a CPUC third-party monitor following the completion of a micro pile drill at location 59 and was reported to the Lead Environmental Inspector (LEI), who communicated the issue at the following morning tailboard. The leak was reported to be cleaned by crews in the weekly report.

**Photo 5:** Crews were observed hand-digging pole sites within installed silt fencing required by the SWPPP.

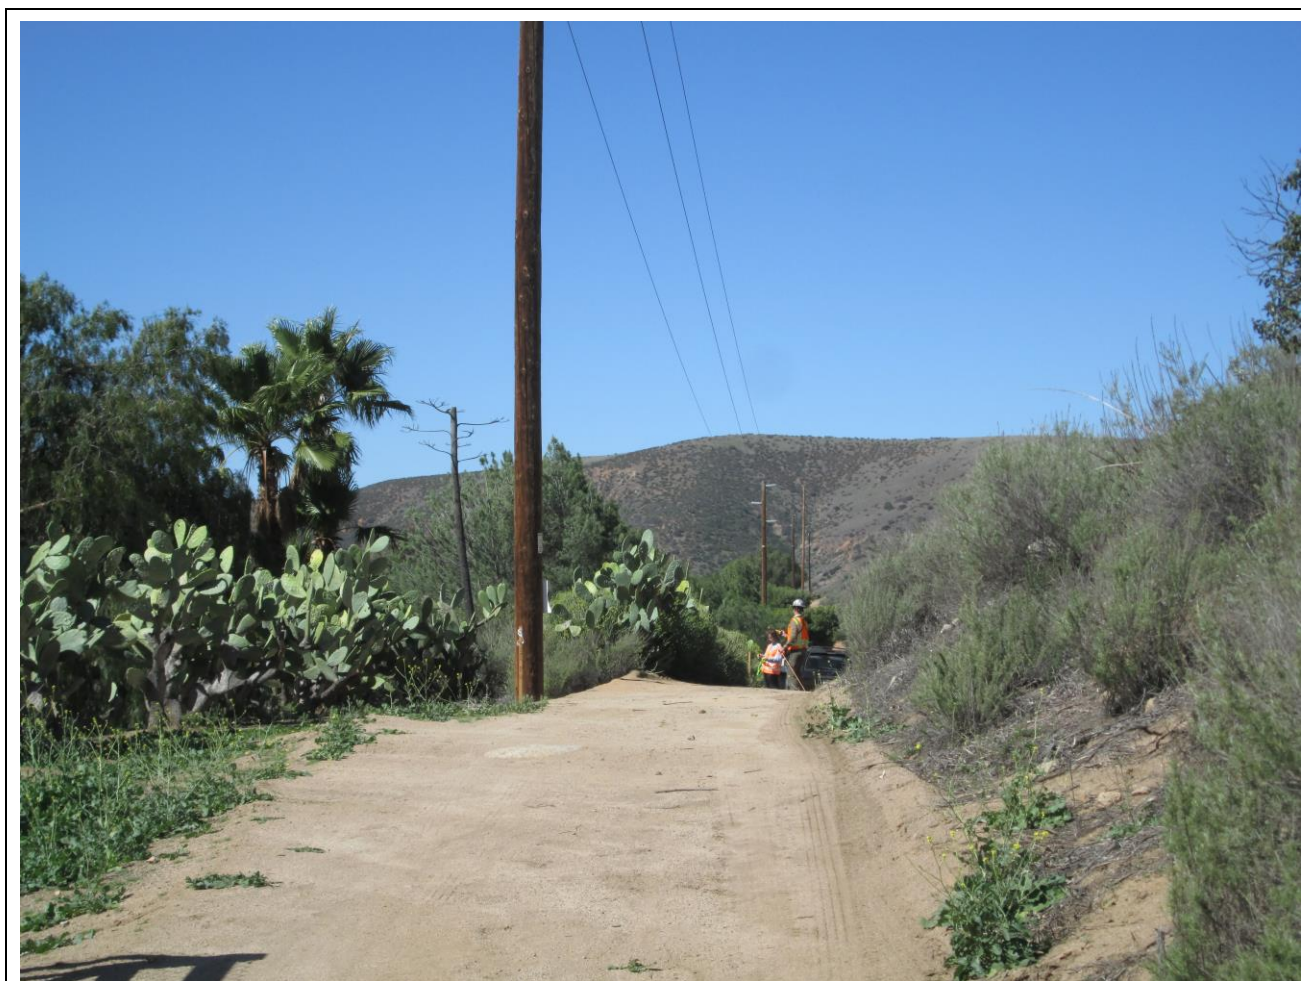
During wood pole replacement activities, CPUC third-party monitors observed biological, archaeological, and aquatic monitoring as required under MMs BIO-2, MM CUL-1, and MM HYD-4. In accordance with MM BIO-4, prior to activities commencing at work sites, CPUC-approved biological monitors conducted nesting bird surveys and staked buffers around active nest areas for avoidance. Nest buffers were delineated with wooden stakes that were painted green and had the words “do not enter without bio.” CPUC-approved biological monitors were also observed sweeping for nests immediately prior to work occurring in areas (see Photo 6—Attachment A) and monitored buffer zones to ensure full avoidance by crews.

**Photo 6:** CPUC-approved biological monitors were observed conducting nesting bird surveys in accordance MM BIO-4 and conducting additional clearance sweeps prior to initiating ground work at pole locations.

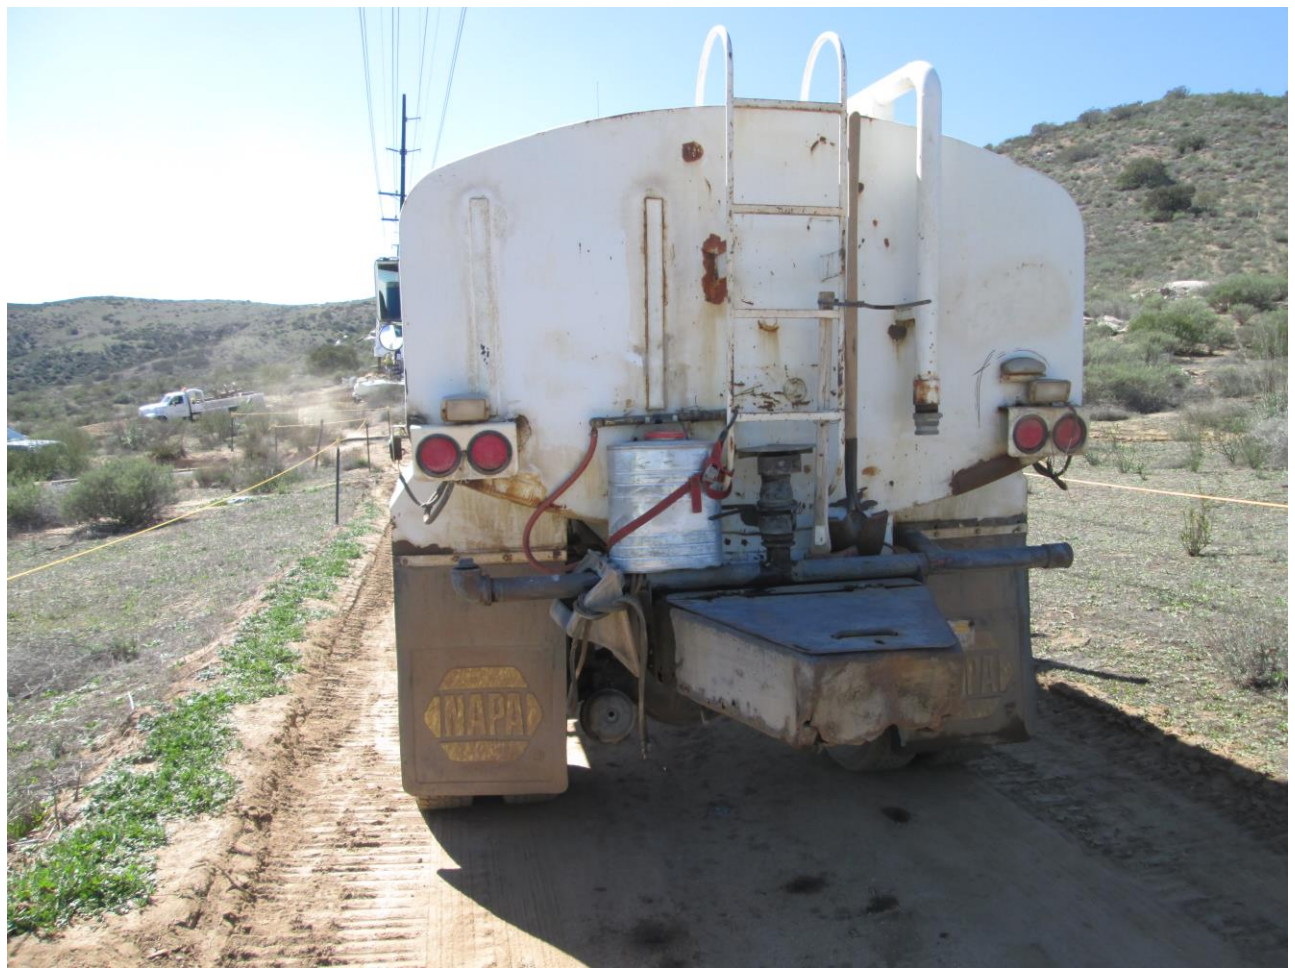
In order to minimize fire risk during pole replacement activities or BMP installation, vegetation trimming was scheduled and was observed being conducted by crews. In accordance with the project Fire Plan (APM HAZ-2), CPUC third-party monitors observed crews carrying backpack water pumps and serving as immediate fire watch during vegetation trimming (such as weed whacking). Water tenders were observed adjacent to these activities and during other site work, such as constructing micro

pile foundations (see Photo 7—Attachment A). Other equipment such as backpack pumps, fire extinguishers, and shovels were observed mounted on vehicles and/or available at each work site.

**Photo 7:** Fire Watch/water tenders were observed adjacent to vegetation trimming activities and construction activity in accordance with the project Fire Plan and APM HAZ-2.

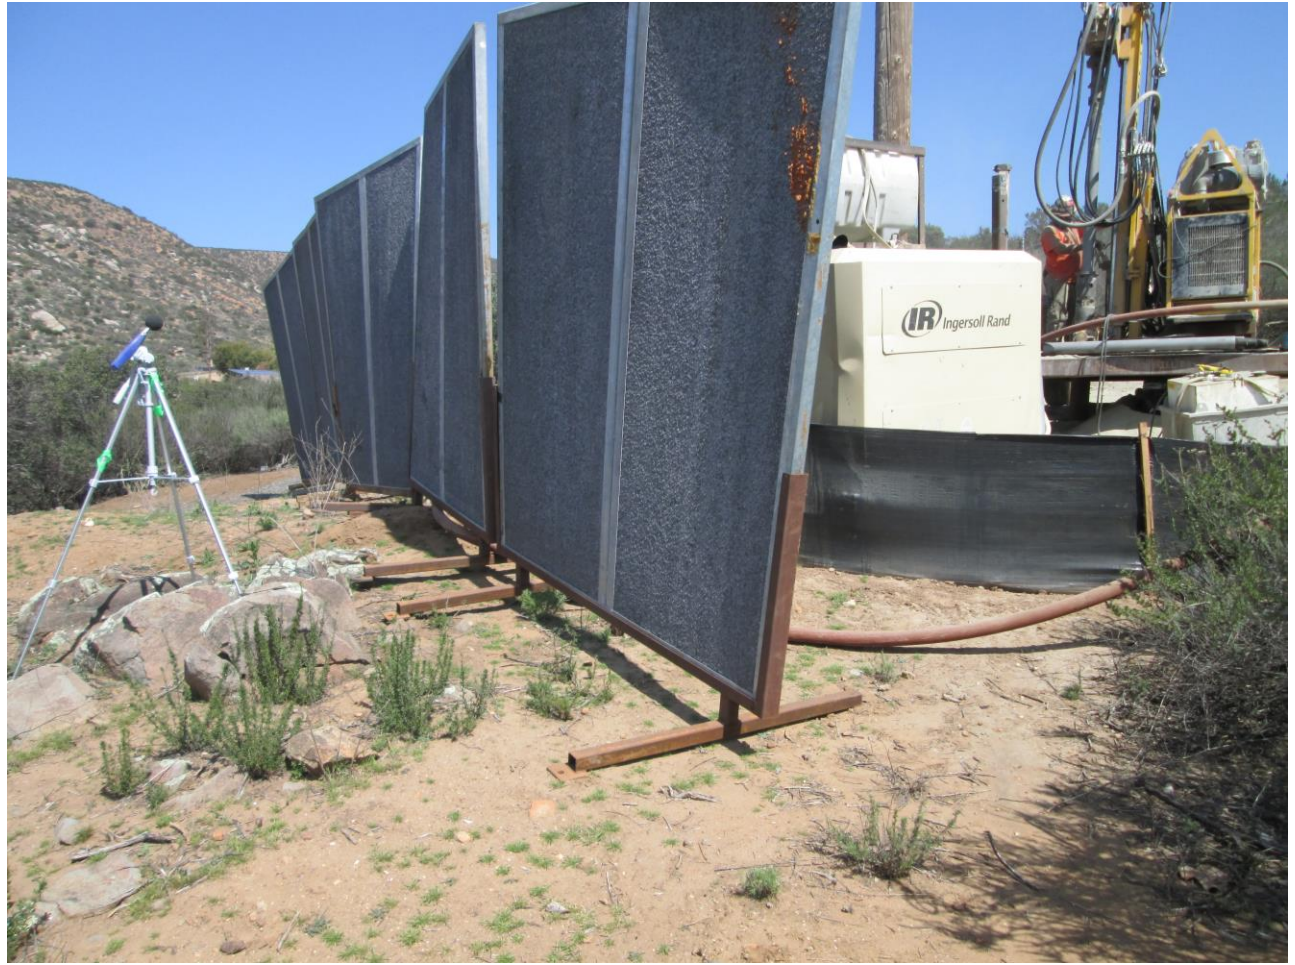
In accordance with MM NOI-2, CPUC third-party monitors continued to observe noise monitoring at work sites. Noise meters were observed stationed adjacent to work sites behind installed noise barriers, recording noise levels behind the barriers and along the property line of adjacent residences (see Photo 8—Attachment A).

**Photo 8:** Noise Monitoring Equipment and sound walls were observed in place adjacent to micro pile drilling activities to ensure that noise levels during construction activities did not exceed thresholds at the nearest property line or adjacent to noise sensitive areas in accordance with MM NOI-2.
