<p><b>California Public Utilities Commission</b>  <b><i>Mitigation Monitoring, Compliance, and Reporting Program</i></b></p>
	<p><b>Tie Line (TL) 637 Wood-to-Steel Pole Replacement Project</b></p>
	<p><b>Compliance Status Report: 005</b>   <b>April 27, 2014</b></p>

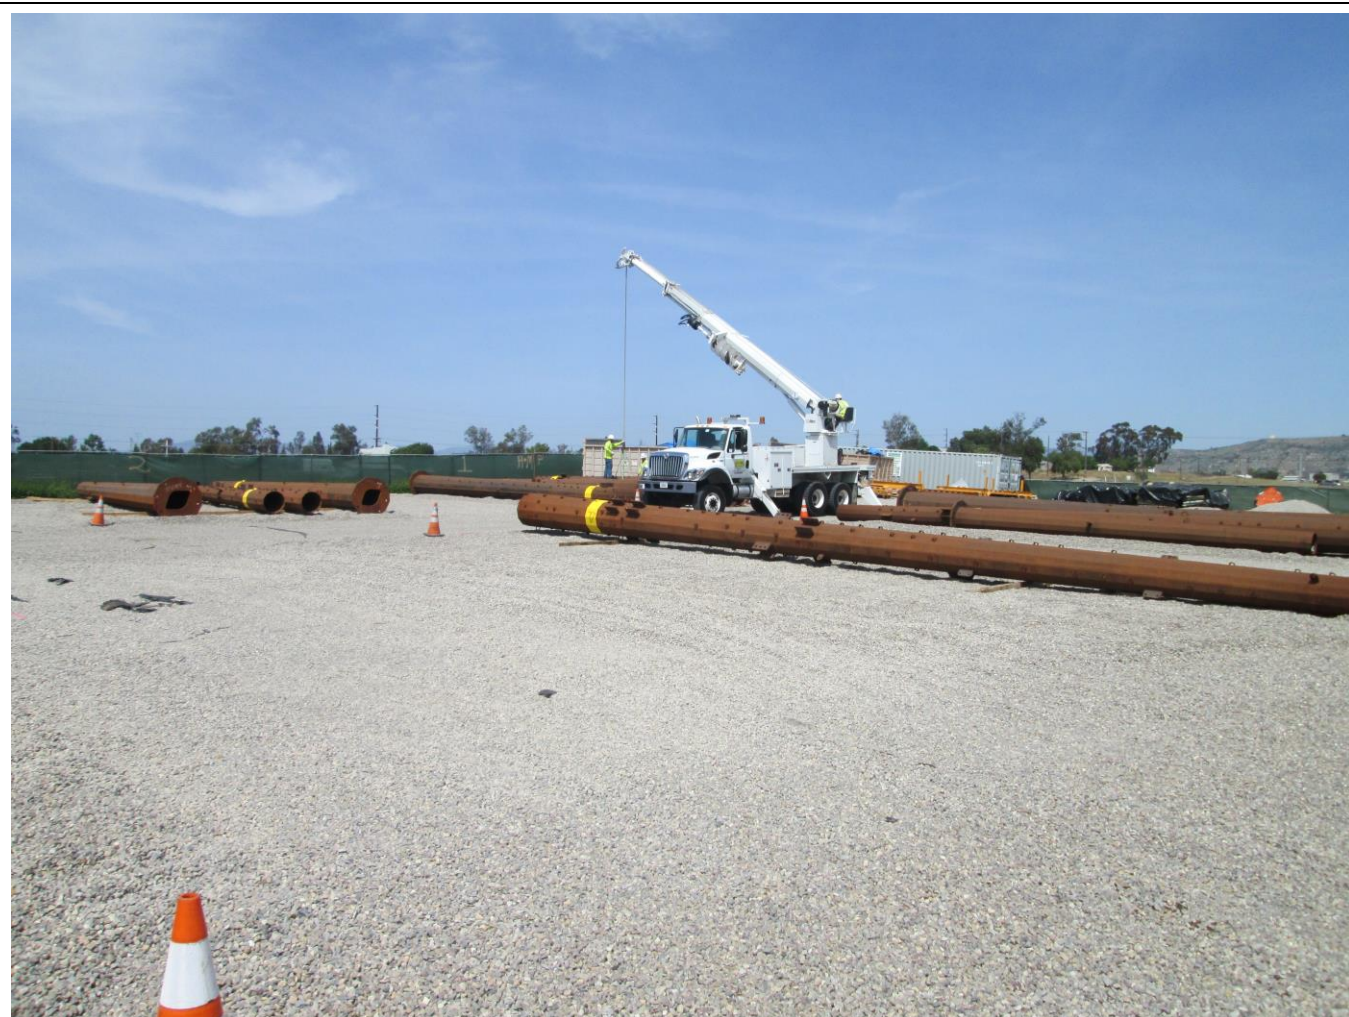
Delivery and staging of steel poles and construction material continued at the Warnock and Santa Ysabel Staging Yards during this reporting period (see Photo 1 – Attachment A).

Due to high winds during this reporting period, areas of visual screening opaque mesh installed along the Santa Ysabel staging yard perimeter fence (APM-AES-1) were observed in need of repair. The issue/concern was communicated by the CPUC environmental monitor to the LEI and construction crews were subsequently observed repairing the opaque mesh. Visual screening around the Warnock Staging Yard remained intact during the reporting period (see Photo 1 – Attachment A).

**Photo 1:** Delivery of steel poles and construction materials continued during the reporting period (above, Warnock Staging Yard). In accordance with APM-AES-1, the opaque mesh used as visual screening remains intact around the perimeter of the yard.

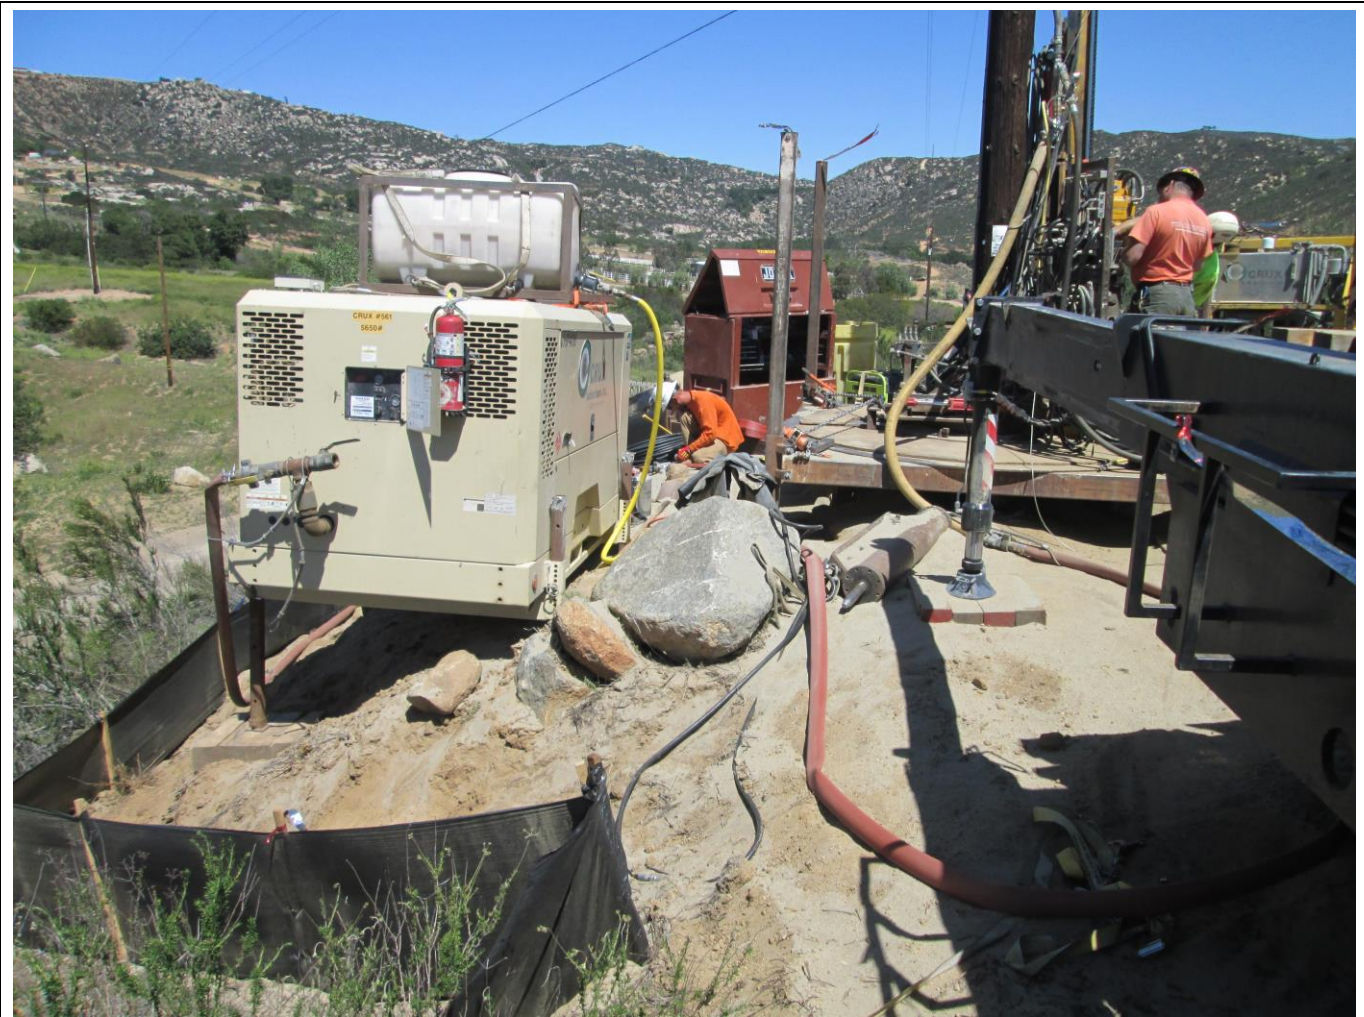
At micropile drill sites, construction crews were observed setting up and demobilizing equipment at pole locations, drilling micropile foundation holes (see Photo 2 – Attachment A), installing rebar, grouting, and strength testing micropiles.

mounted on or next to staged internal combustion engines and generators (see Photo 2 – Attachment A). Assigned ‘Fire Patrols’ were also observed along the project throughout the reporting period.

**Photo 2:** In accordance with APM-HYD-1 and the Project SWPPP, silt fencing installed around work areas was observed in good condition and functional. In accordance with APM-HAZ-2 and the Project Fire Plan, fire safety equipment was staged on site and a fire extinguisher was mounted on the compressor.

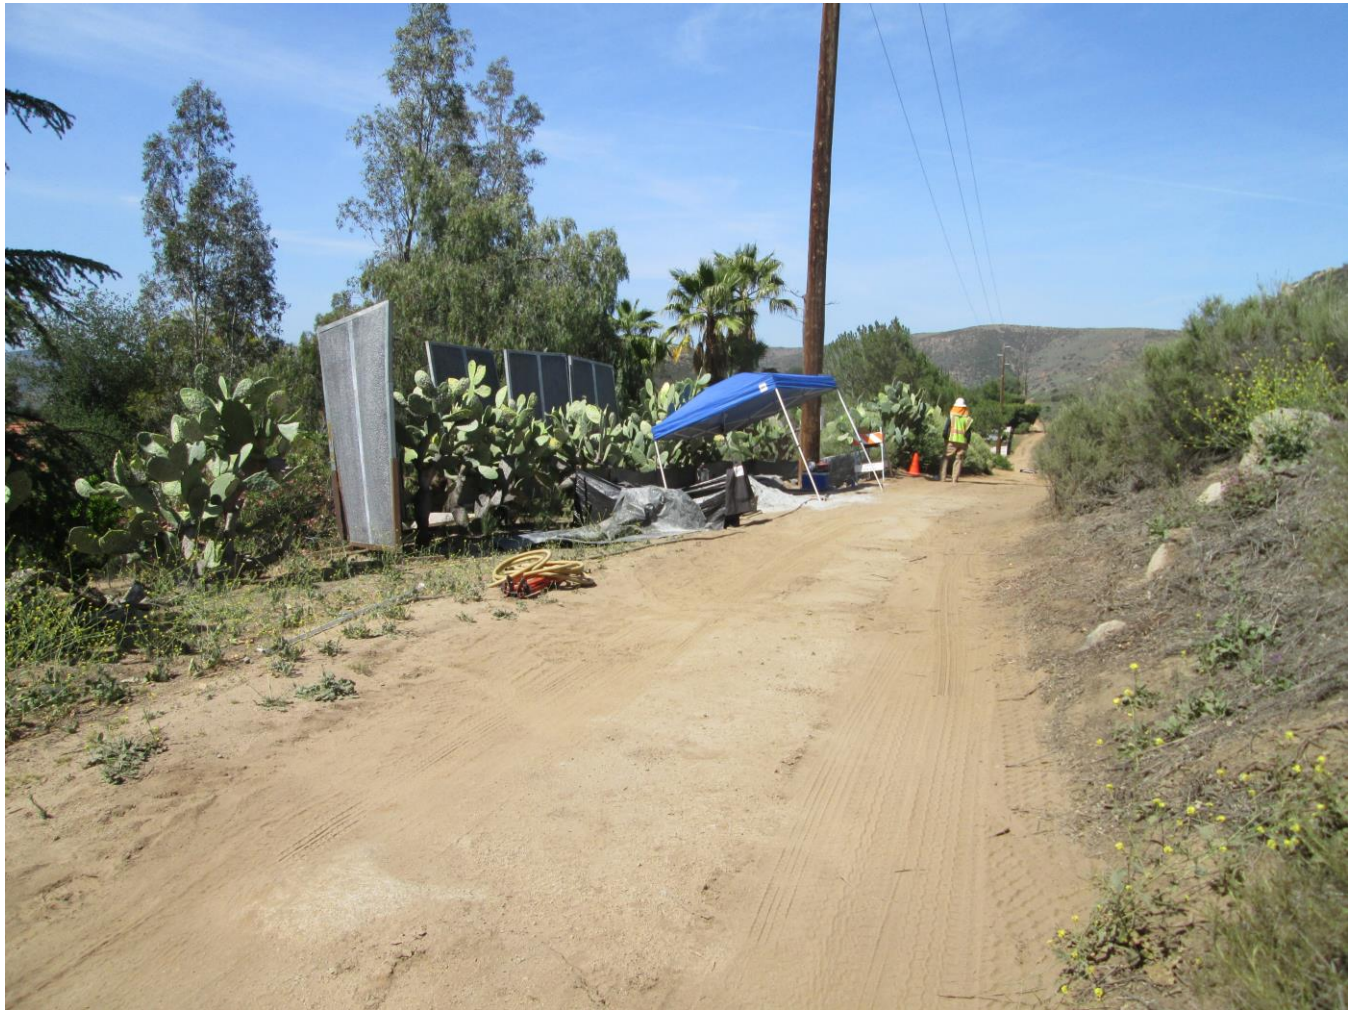
At conventional drill sites, construction crews were observed machine auguring, air track drilling, and hand digging pole holes (see Photo 3 – Attachment A).

Noise barriers were observed being utilized during pole hole drilling to reduce noise at adjacent residences (see Photo 3 – Attachment A). A noise meter was also utilized by the LEI to record noise levels and to ensure they did not exceed limits allowable in mitigation (MM-NOI-2).

**Photo 3:** In accordance with MM-NOI-2, a noise barrier was observed being implemented adjacent to sensitive receptors (above, Location 56) during pole hole hand digging. Silt fencing on site was observed in good condition and functional in accordance with APM-HYD-1 and the Project SWPPP.

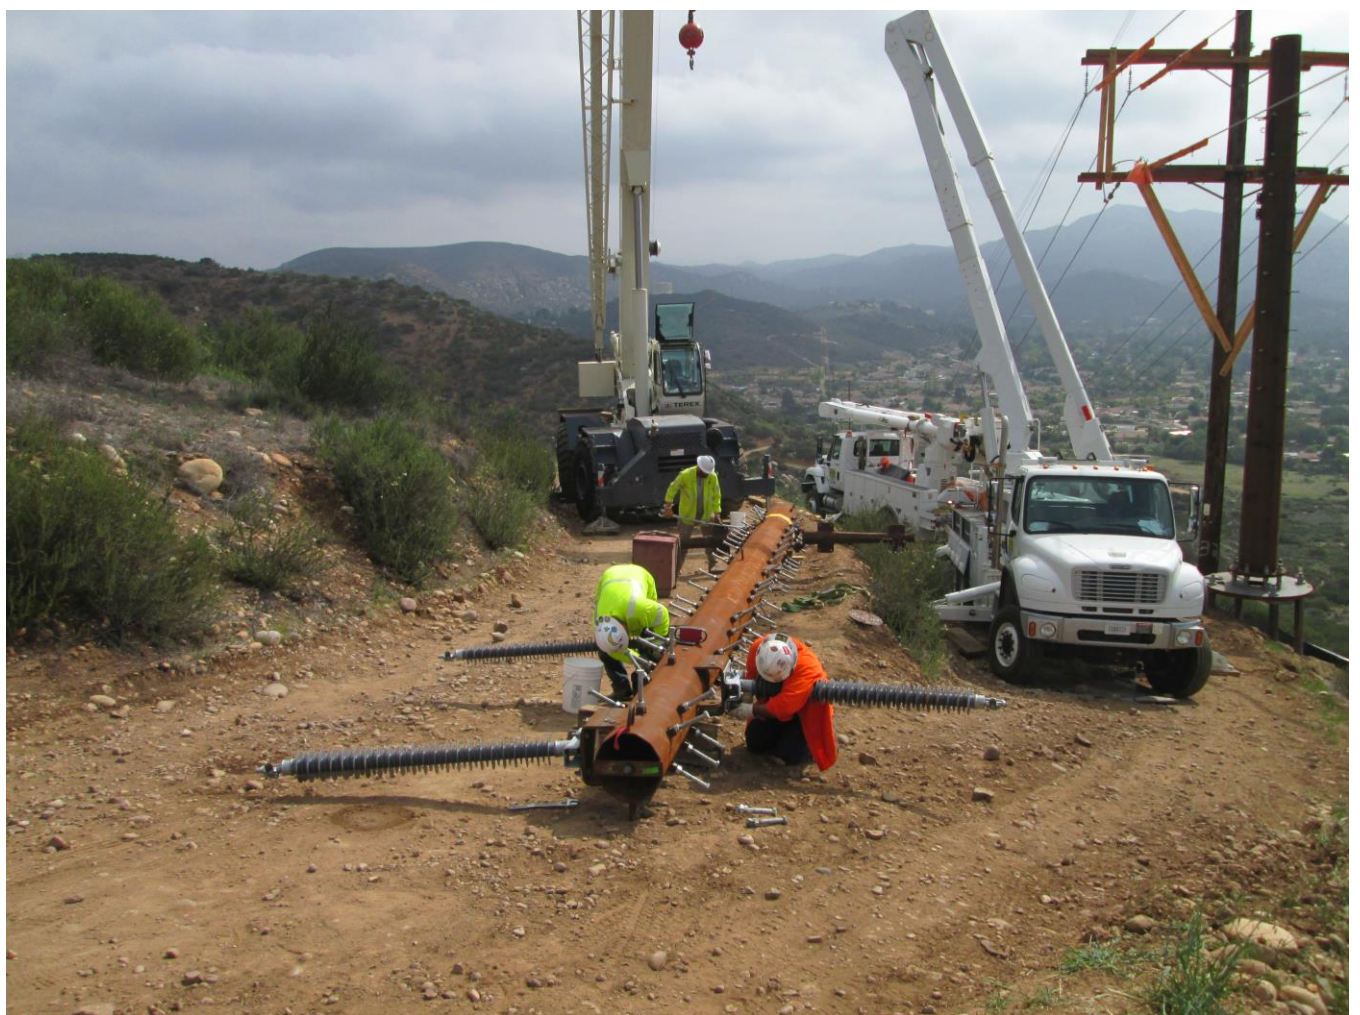
Construction crews were observed carrying spill kits, and staging equipment over visqueen sheets to prevent leaks and spills from being discharged into the soil per the requirements in MM HAZ-2 (see Photo 4 – Attachment A).

**Photo 4:** Construction crews were observed installing steel poles (above, Location 32). In accordance with MM-HAZ-2, visqueen was observed beneath staged equipment to prevent leaks/spills from being discharged into the soil.

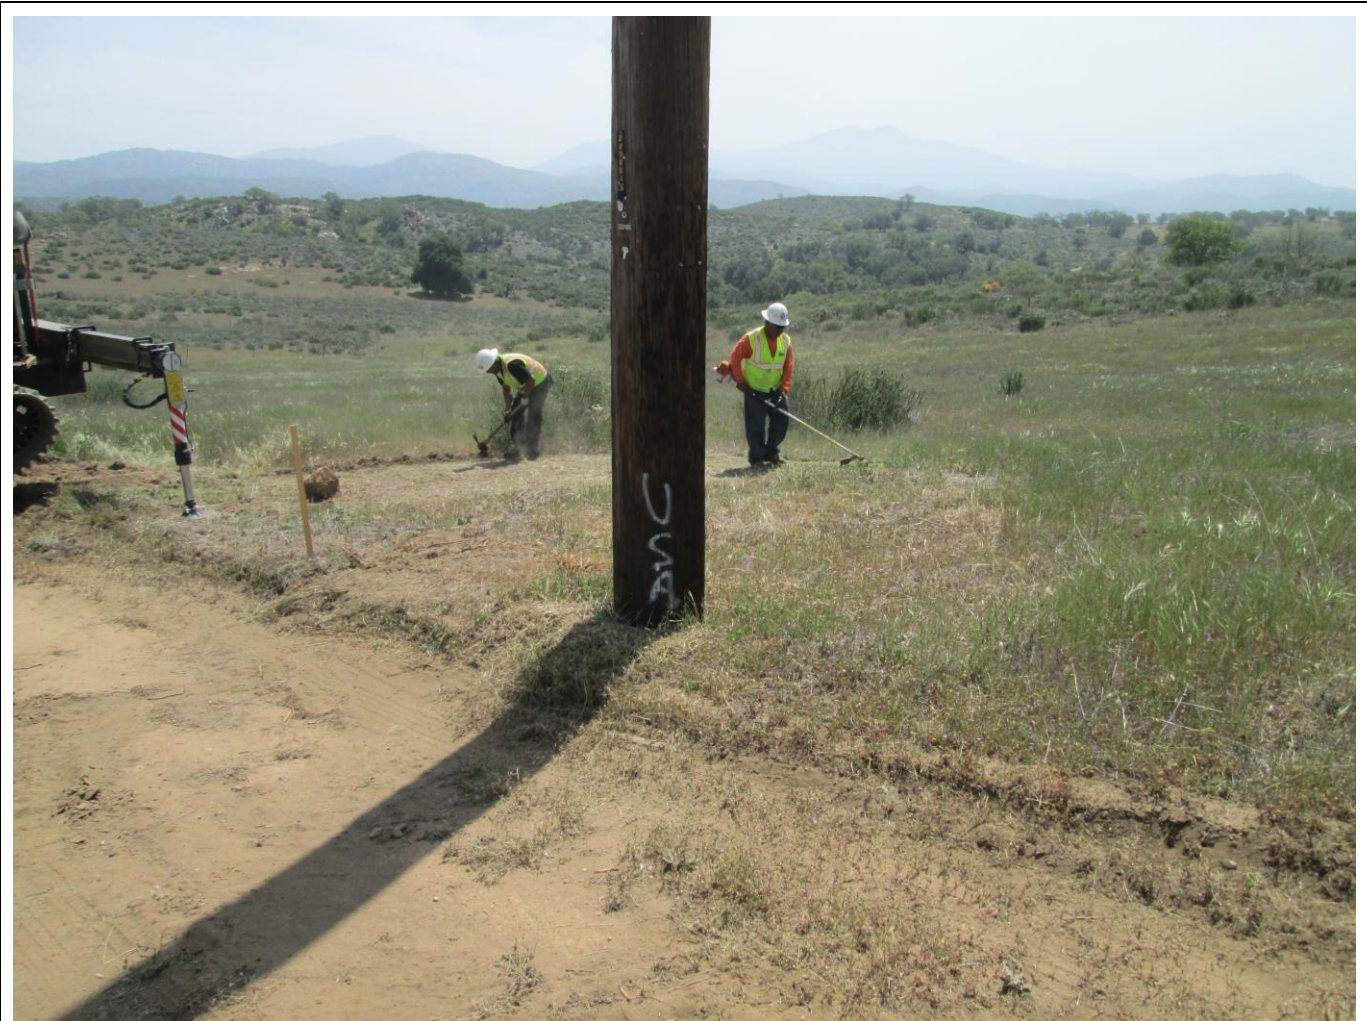
As described in the SWPPP required by APM HYD-1, new erosion control BMPs such as silt fencing and straw wattles were observed being installed at pole replacement work sites prior to pole hole drilling (see Photo 5 – Attachment A). Previously installed erosion control and stockpile management BMPs, including water bars along access roads (see Photo 6 – Attachment A), silt fencing (see Photo 2 – Attachment A), straw wattles, and visqueen stockpile covers, were observed being maintained. Third-party monitors inspected public roadways for construction related dirt/mud trac-out, and ensured trac-out control BMPs such as rattle plates and rock aprons were in good condition. In accordance with MM HYD-4 and the Clean Water Act Section 401 Certification, an aquatic resource monitor was observed monitoring construction activity near adjacent waterways helping to prevent or minimize impacts to jurisdictional features.

**Photo 5:** Construction crews were observed trimming vegetation at pole replacement work areas in accordance with APM-HAZ-2 and Project Fire Plan, and installing erosion control BMPs including silt fencing and/or straw wattles in accordance with APM-HYD-1 and the Project SWPPP (above, Location 97).

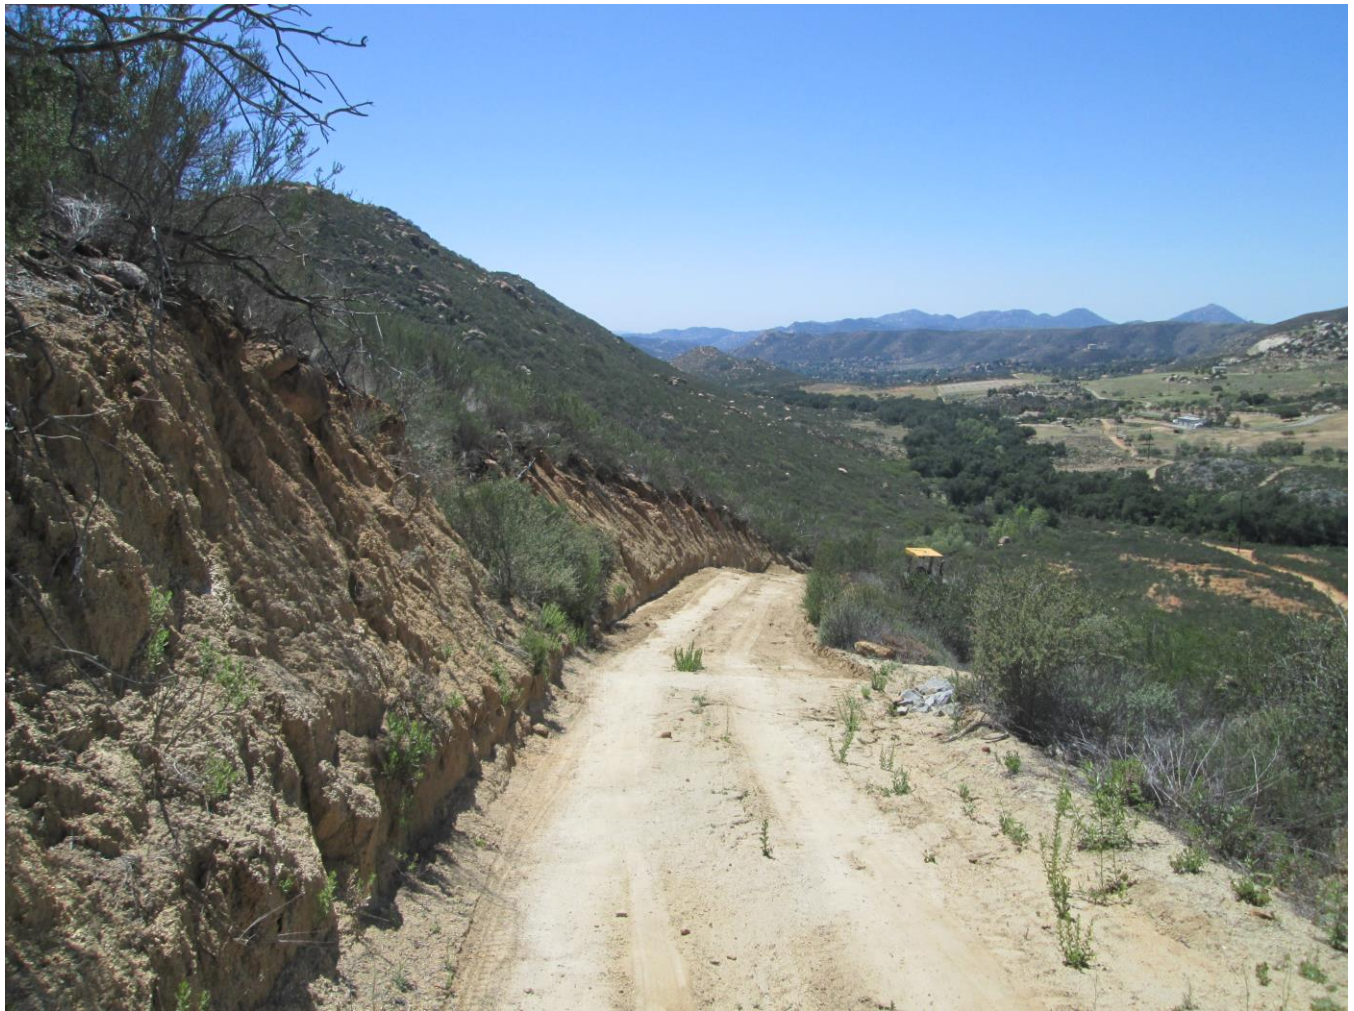
**Photo 6:** Construction crews were observed refreshing the main access road and maintaining existing water bars in accordance with APM-HYD-1 and Project SWPPP.

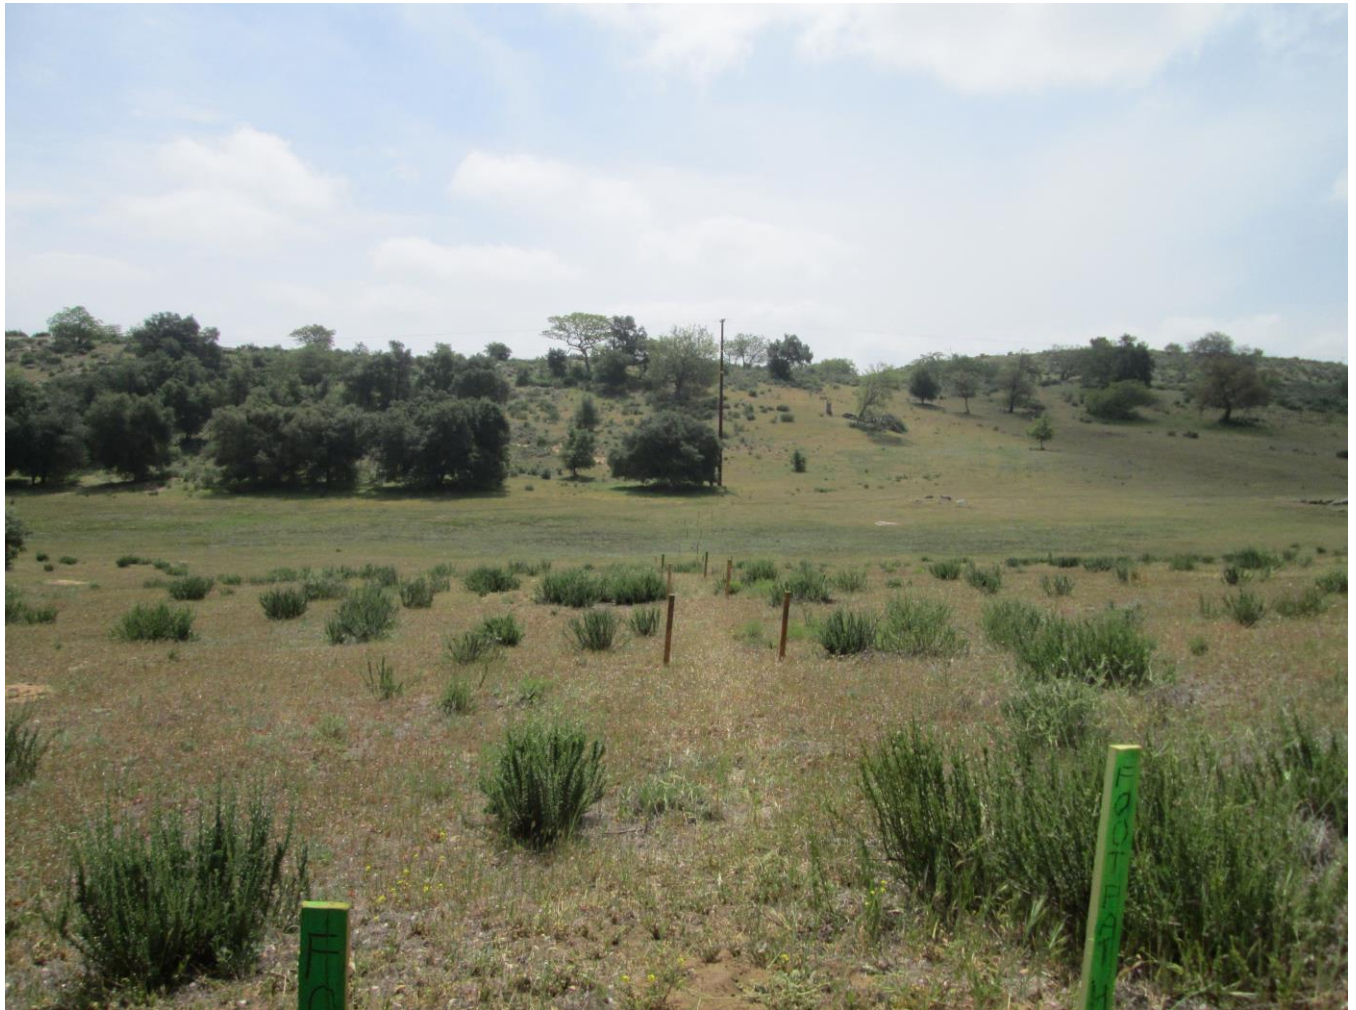
**Photo 7:** Construction crews were observed staying within the project approved access, and limits were clearly delineated via signage and colored posts. An approved footpath to Location 106 (above) was marked using green-colored posts.

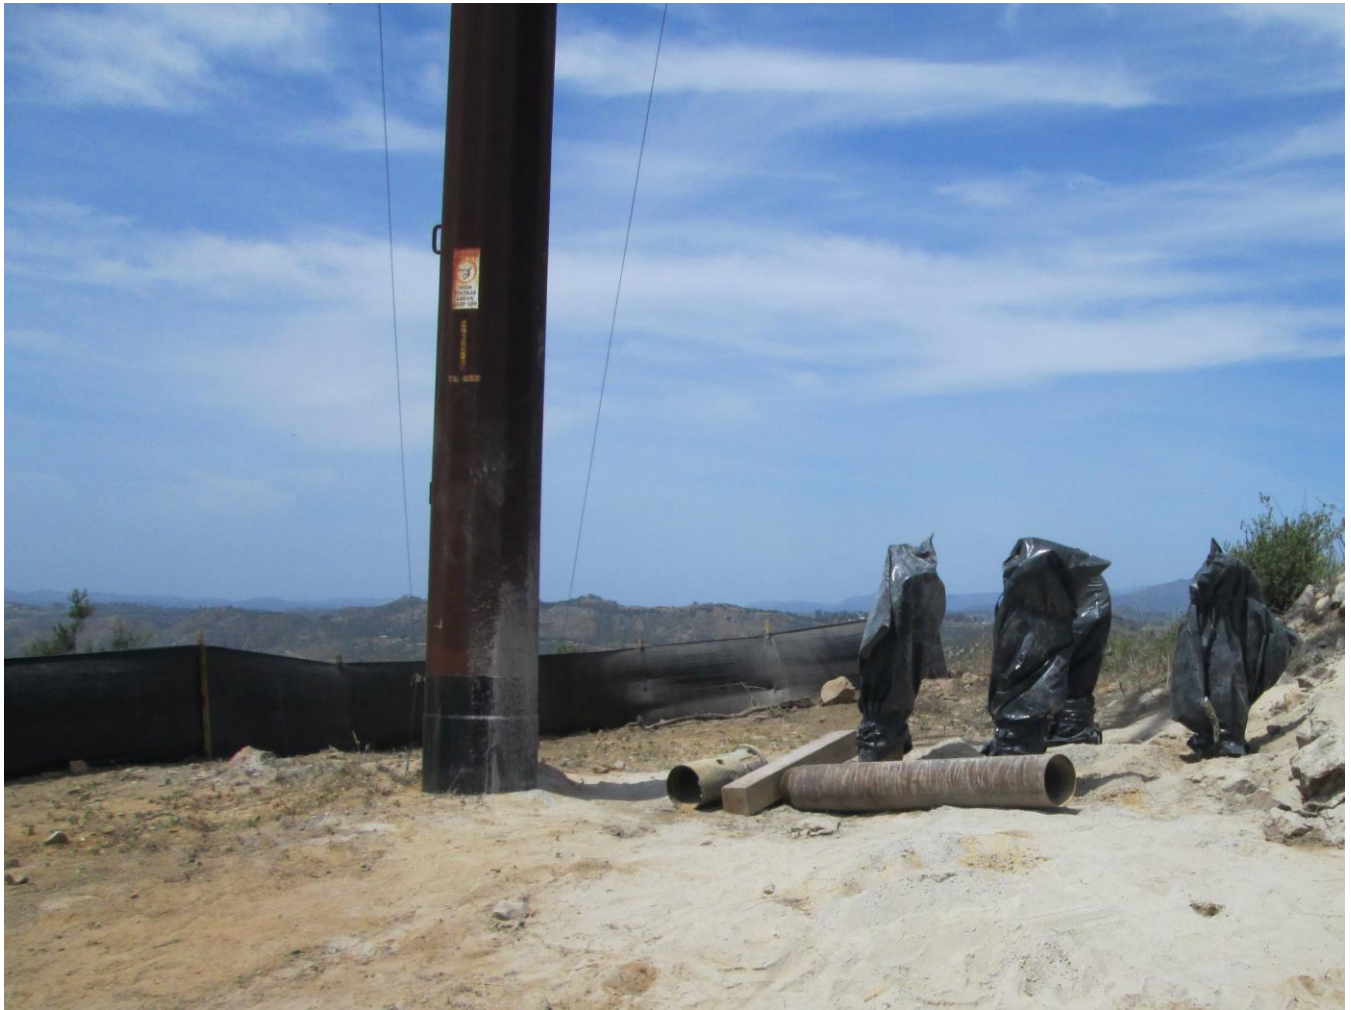
**Photo 8:** In accordance with MM-BIO-3, open holes and micropile foundations were covered to prevent wildlife entrapment.
