<p>California Public Utilities Commission <i>Mitigation Monitoring, Compliance, and Reporting Program</i></p>
	<p>Tie Line (TL) 637 Wood-to-Steel Pole Replacement Project</p>
	<p>Compliance Status Report: 007 May 25, 2014</p>

SUMMARY

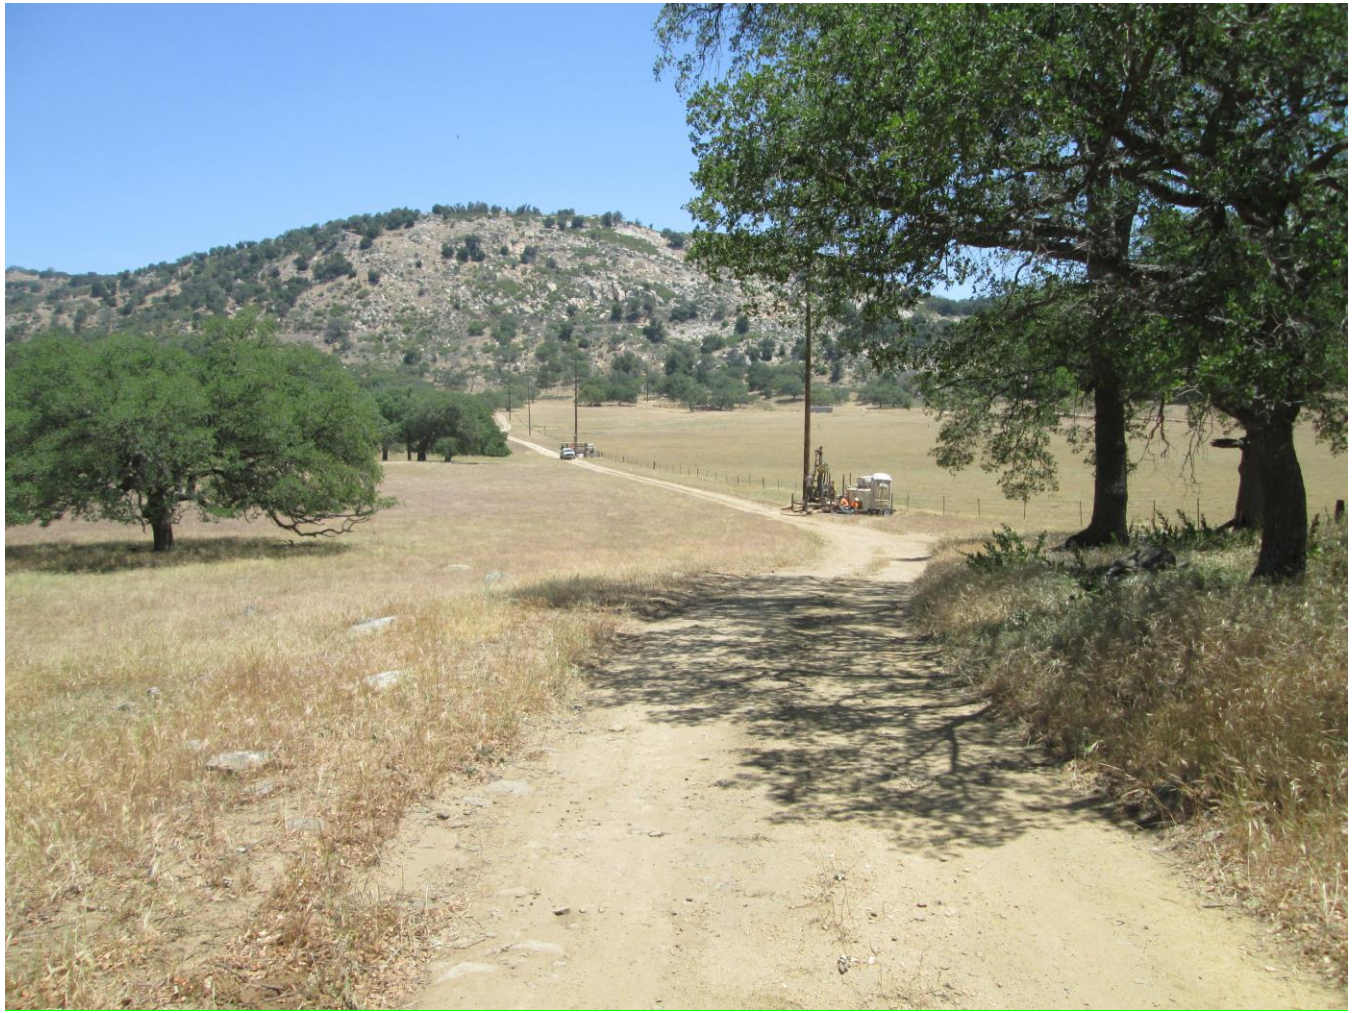
At micropile drill sites, construction crews were observed drilling and performing strength tests of constructed piles (see Attachment A – Photo 1).

Photo 1: Micropile construction crews were observed drilling micropiles (pictured), and strength testing micropile foundations during the reporting period.

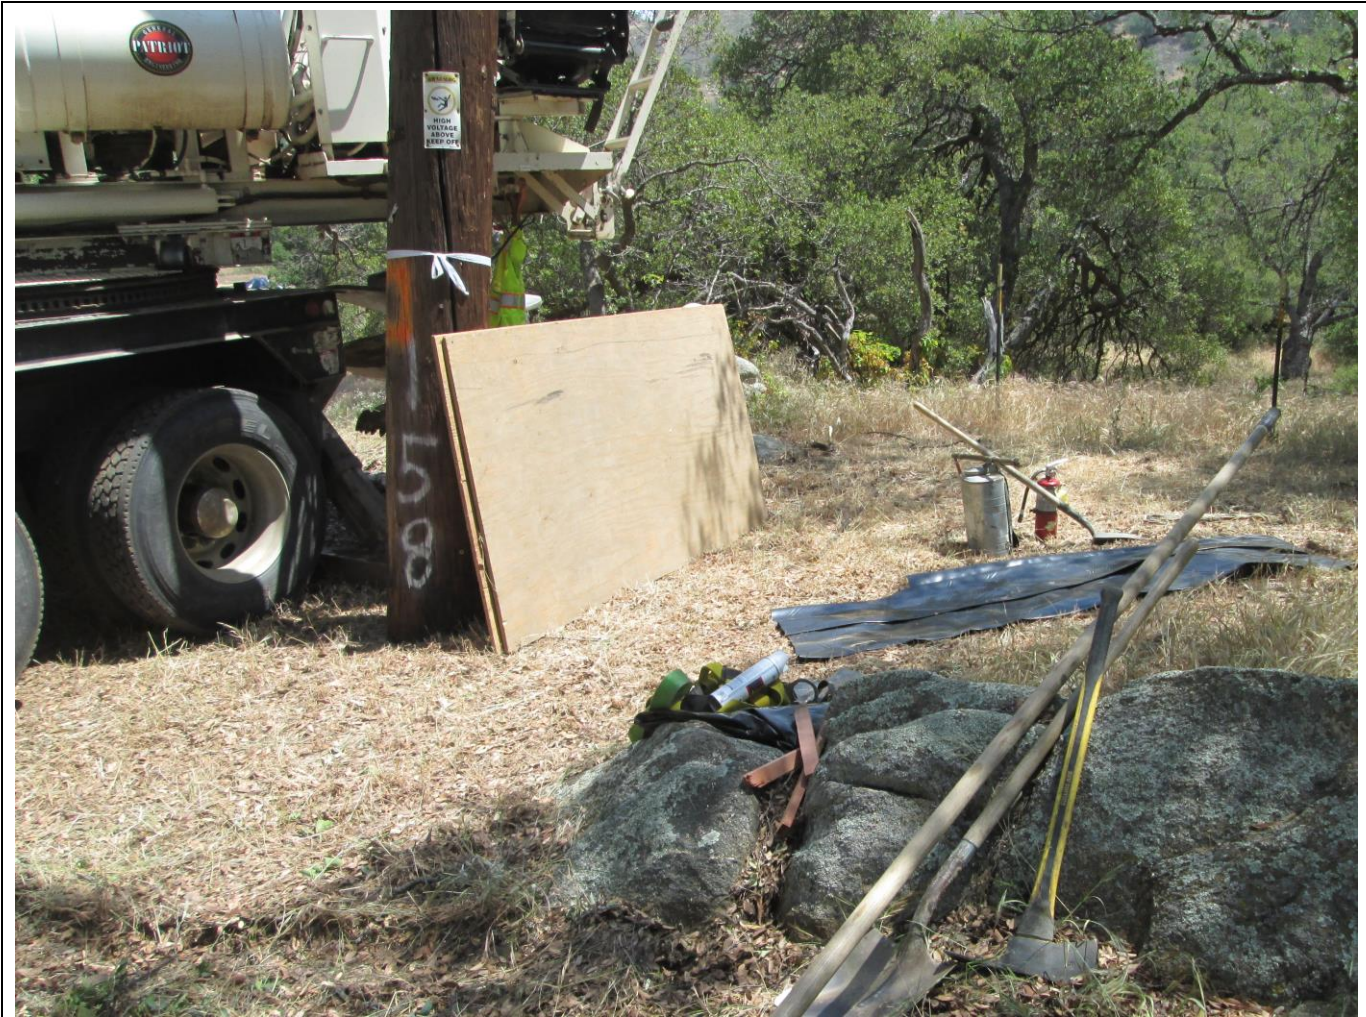
At conventional drill sites, construction crews were observed machine auguring and air track drilling pole holes (see Attachment A – Photo 2).

In accordance with APM CUL-3, an archeological monitor was observed monitoring construction work near an adjacent environmentally sensitive area (ESA). Metal T-posts were used to delineate the ESA to ensure avoidance by construction personnel in accordance with MM CUL-1 (see Attachment A – Photo 2).

Photo 2: During air track drilling activities, fire tools were staged on site in accordance with APM HAZ-2 and the Project Fire Plan. Environmentally Sensitive Areas were delineated with metal T-posts for avoidance in accordance with MM CUL-1.

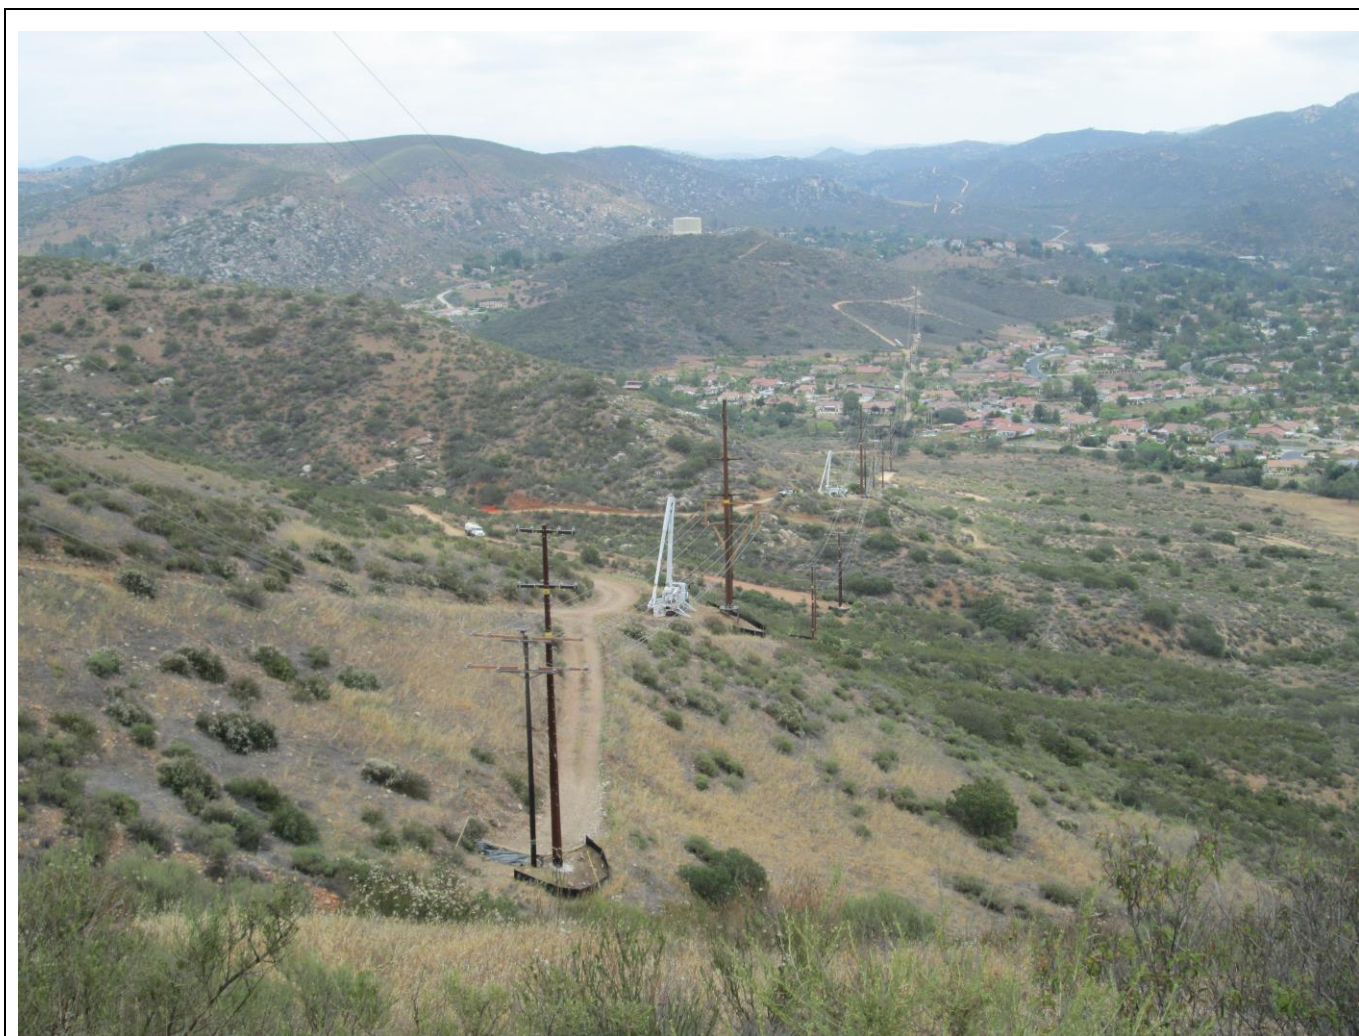
Photo 3: Wire stringing activities were observed during the reporting period, and water tenders were observed within 2 minutes travel time of work locations in accordance with APM-HAZ-2 and the Project Fire Plan.

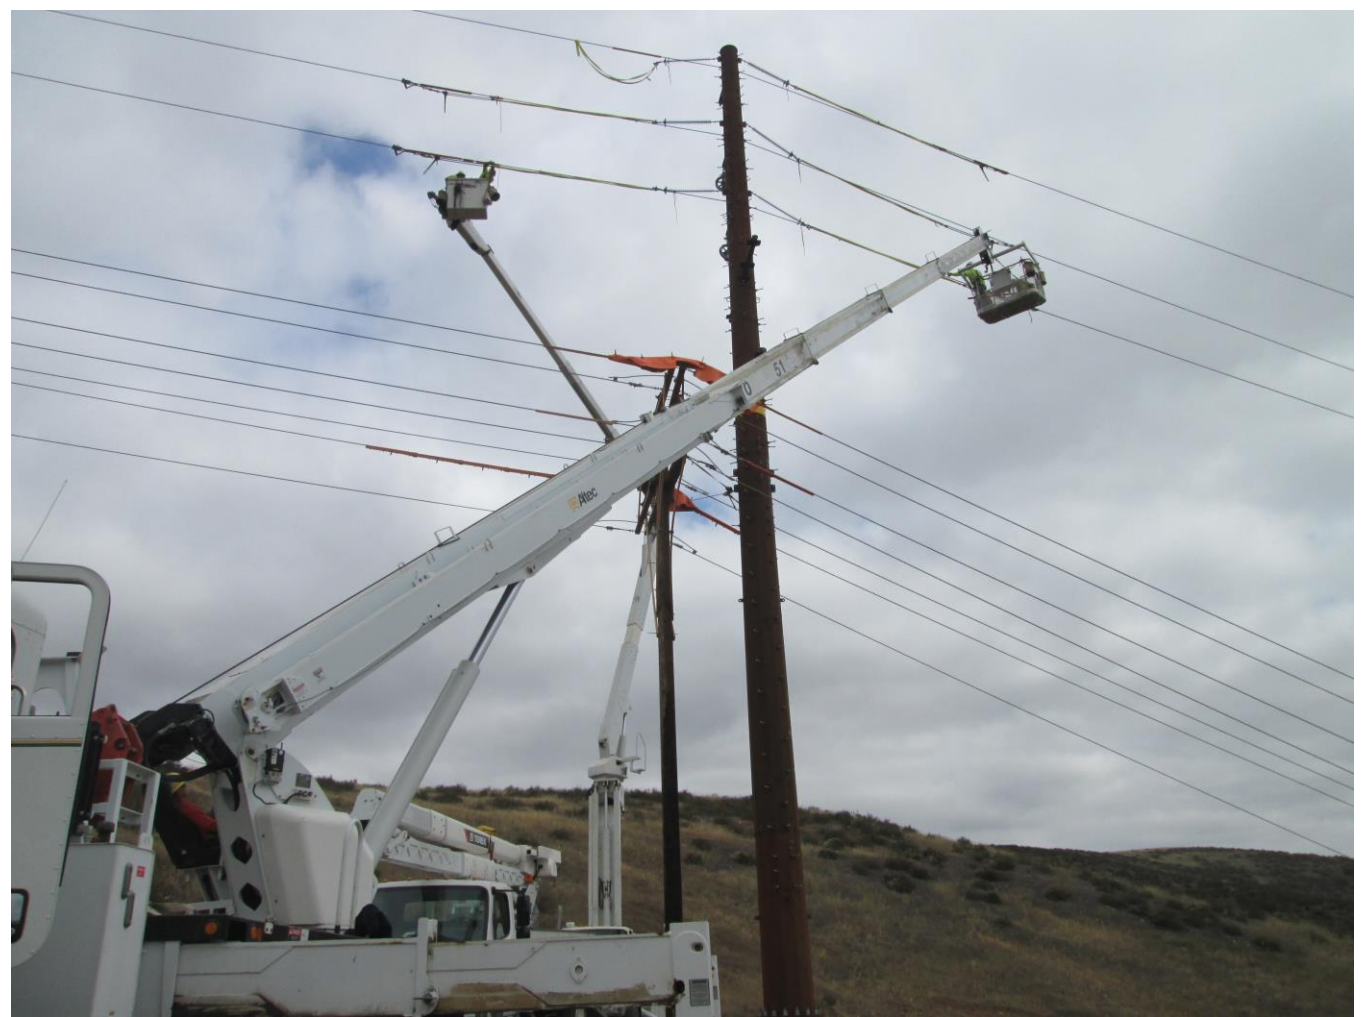
Photo 4: Construction crews were observed adjusting conductor line sag and clipping-in conductor lines.

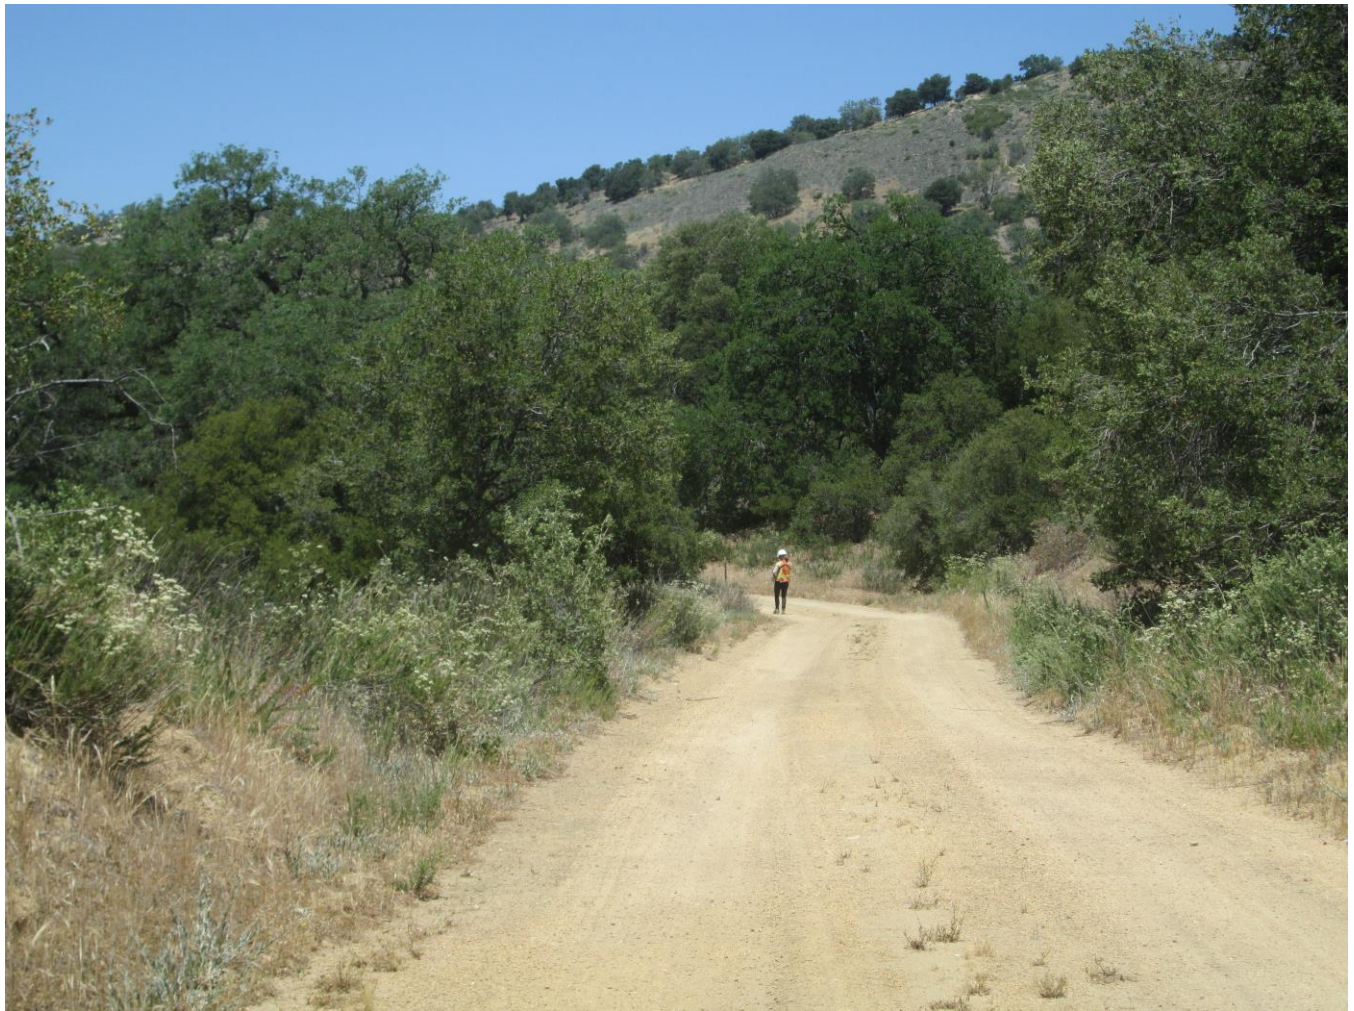
Photo 5: Biological monitors were observed conducting nesting bird surveys along the project alignment in accordance with MM-BIO-4.

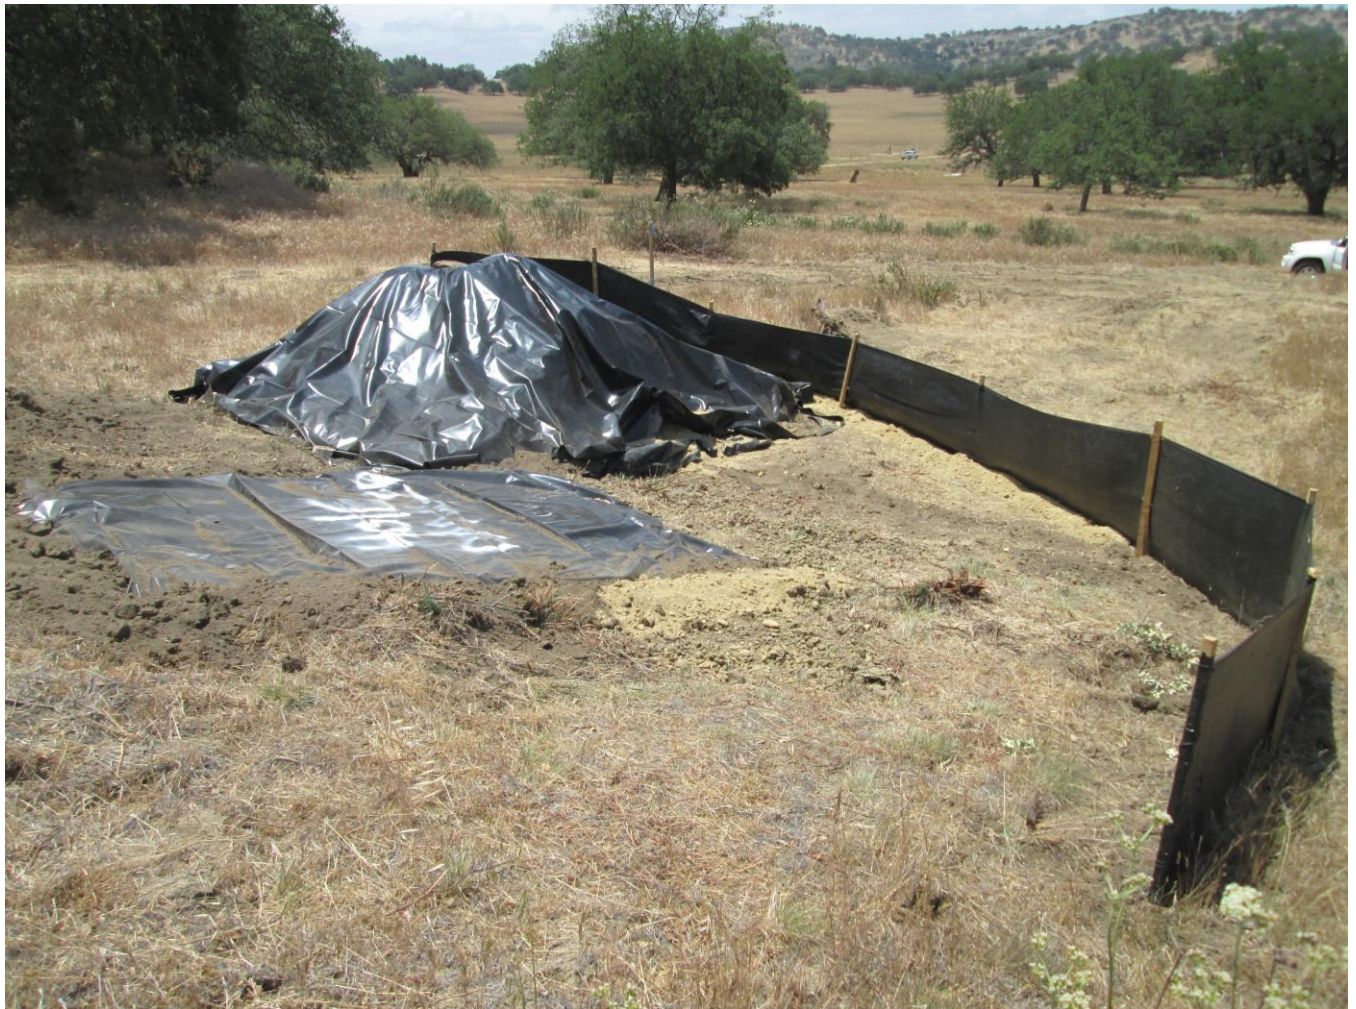
Photo 6: Sediment control BMPs implemented along the project alignment included the use of silt fencing and the covering of dirt stockpiles in accordance with the Project SWPPP and APM-HYD-1. Previously drilled pole holes were observed covered to prevent potential wildlife entrapment in accordance with MM-BIO-3.

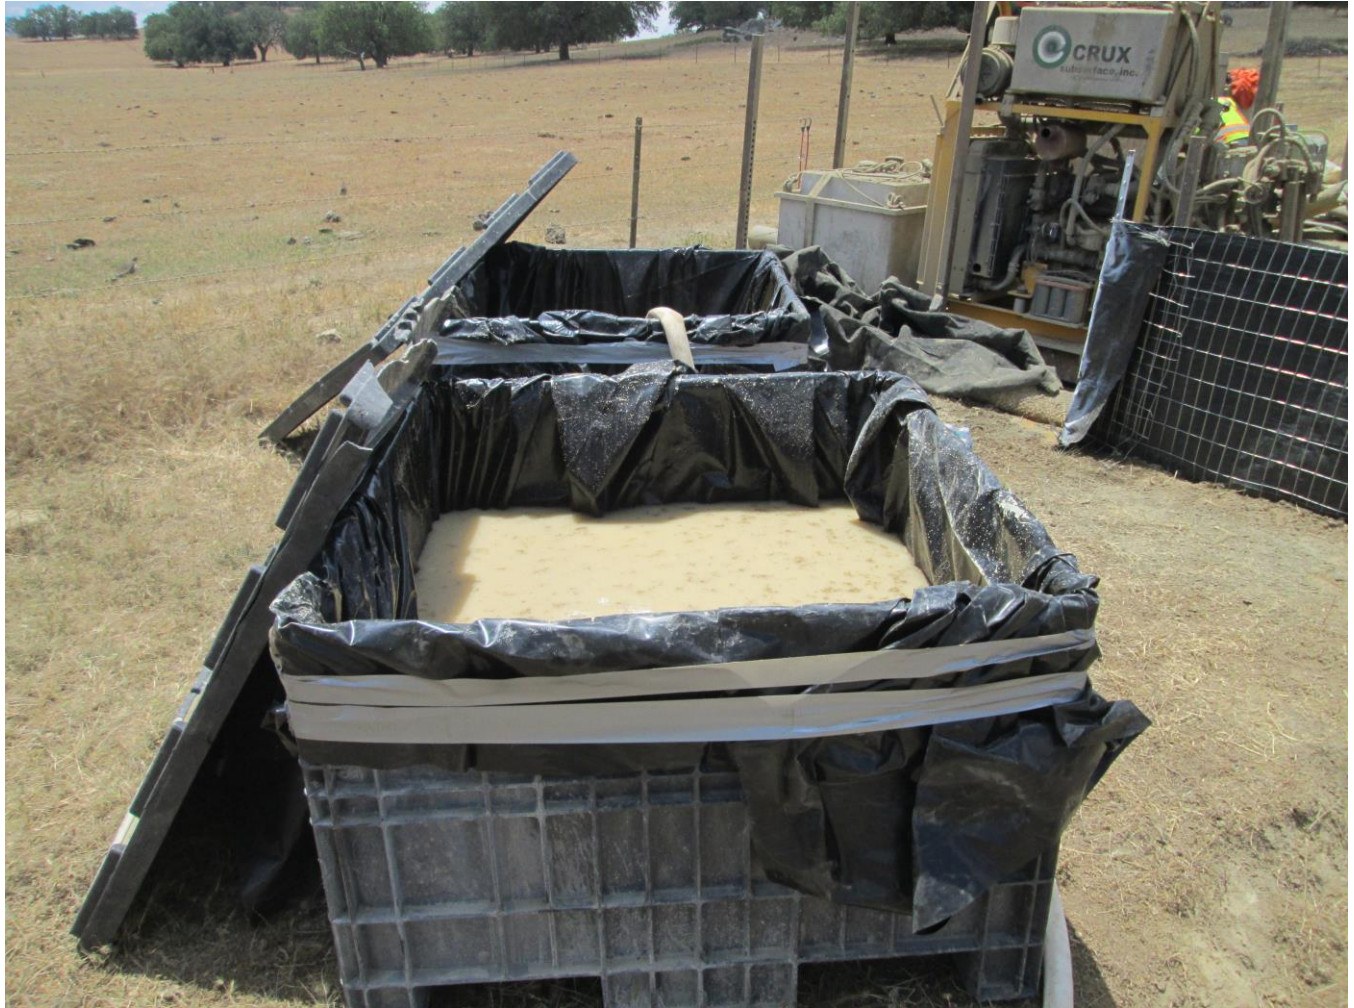
Photo 7: In accordance with the Project SWPPP and APM-HYD-1, groundwater encountered during micropile foundation hole drilling was contained with silt fencing, and transferred into containment boxes (pictured) that were emptied into a retention basin at the Santa Ysabel Staging Yard.
