<p>California Public Utilities Commission <i>Mitigation Monitoring, Compliance, and Reporting Program</i></p>
	<p>Tie Line (TL) 637 Wood-to-Steel Pole Replacement Project</p>
	<p>Compliance Status Report: 008 June 8, 2014</p>

SUMMARY

The California Public Utilities Commission (CPUC) is responsible for overseeing implementation of the mitigation measures set forth in the Final Mitigated Negative Declaration (MND) for the TL 637 Wood-to-Steel Pole Replacement Project. The CPUC has established a third-party monitoring program and adopted a Mitigation Monitoring, Compliance, and Reporting Program (MMCRP) to ensure that measures approved in the MND to mitigate or avoid impacts are implemented in the field. This MMCRP status report is intended to provide a description of construction activities on the project, a summary of site inspections conducted by the CPUC’s third-party monitors, the compliance status of mitigation measures required by the MMCRP, and anticipated construction activities. This compliance status report covers construction activities from May 26 through June 8, 2014.

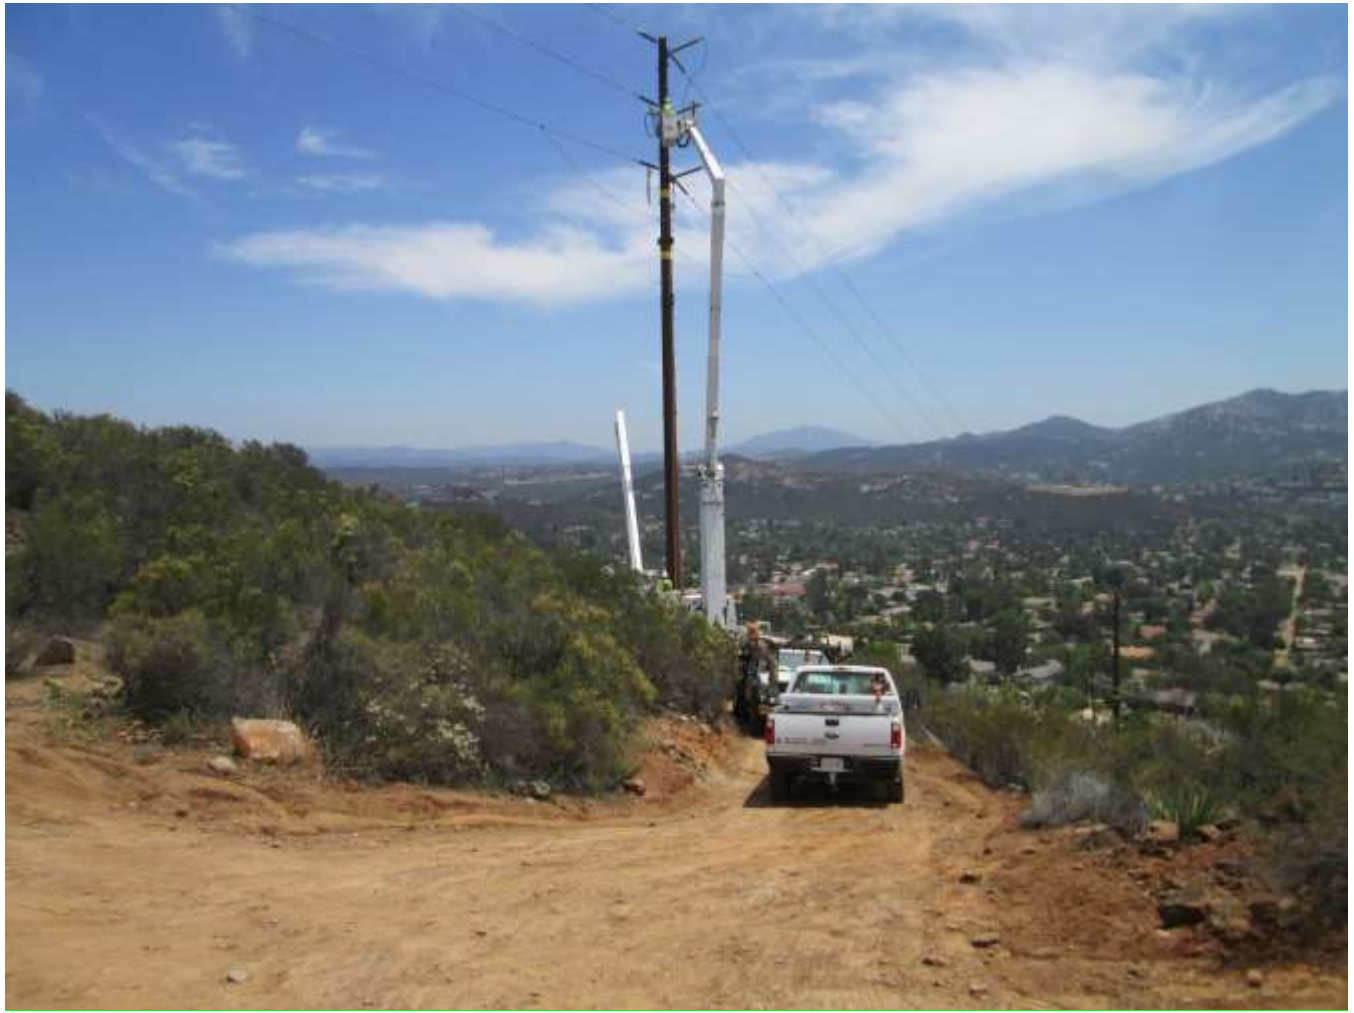
Construction crews were observed stringing, sagging, clipping-in, and dead-ending conductor wire, and installing ground rods (see Photo 1—Attachment A).

Photo 1: Construction crews were observed conducting wire stringing activities, which included dead-ending and sagging the wire (pictured above).

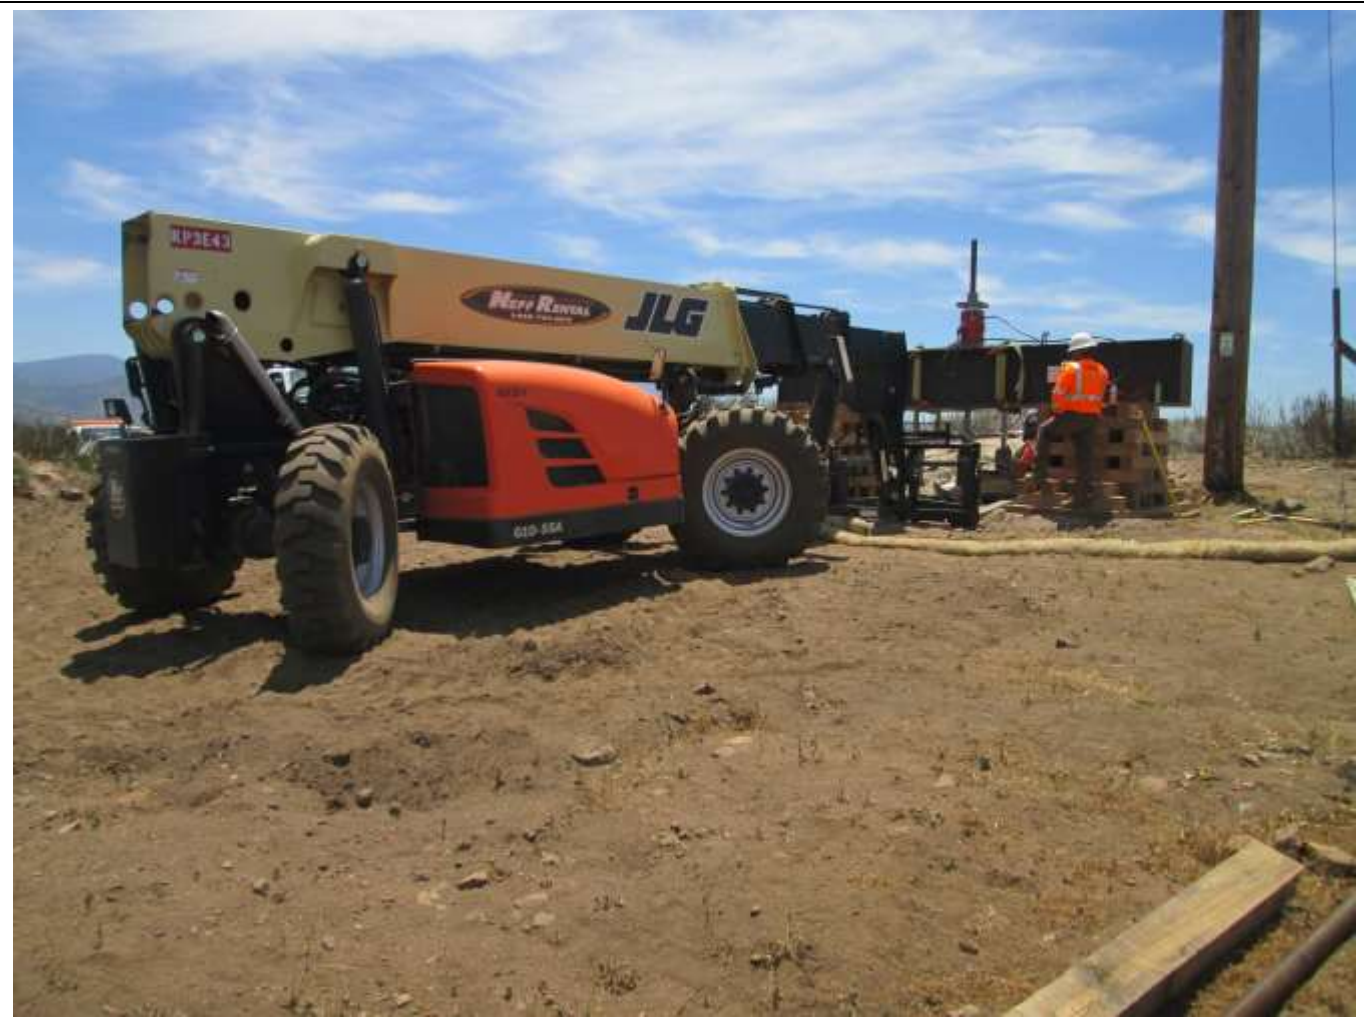
At micropile drill sites, construction crews were observed mobilizing/setting-up at pole locations, drilling, grouting, capping, trimming, and strength testing micropile foundations (see Photo 2—Attachment A).

Photo 2: Micropile foundation strength testing was observed during the reporting period, which involves the use of a wooden cribbing, a steel beam, and a forklift.

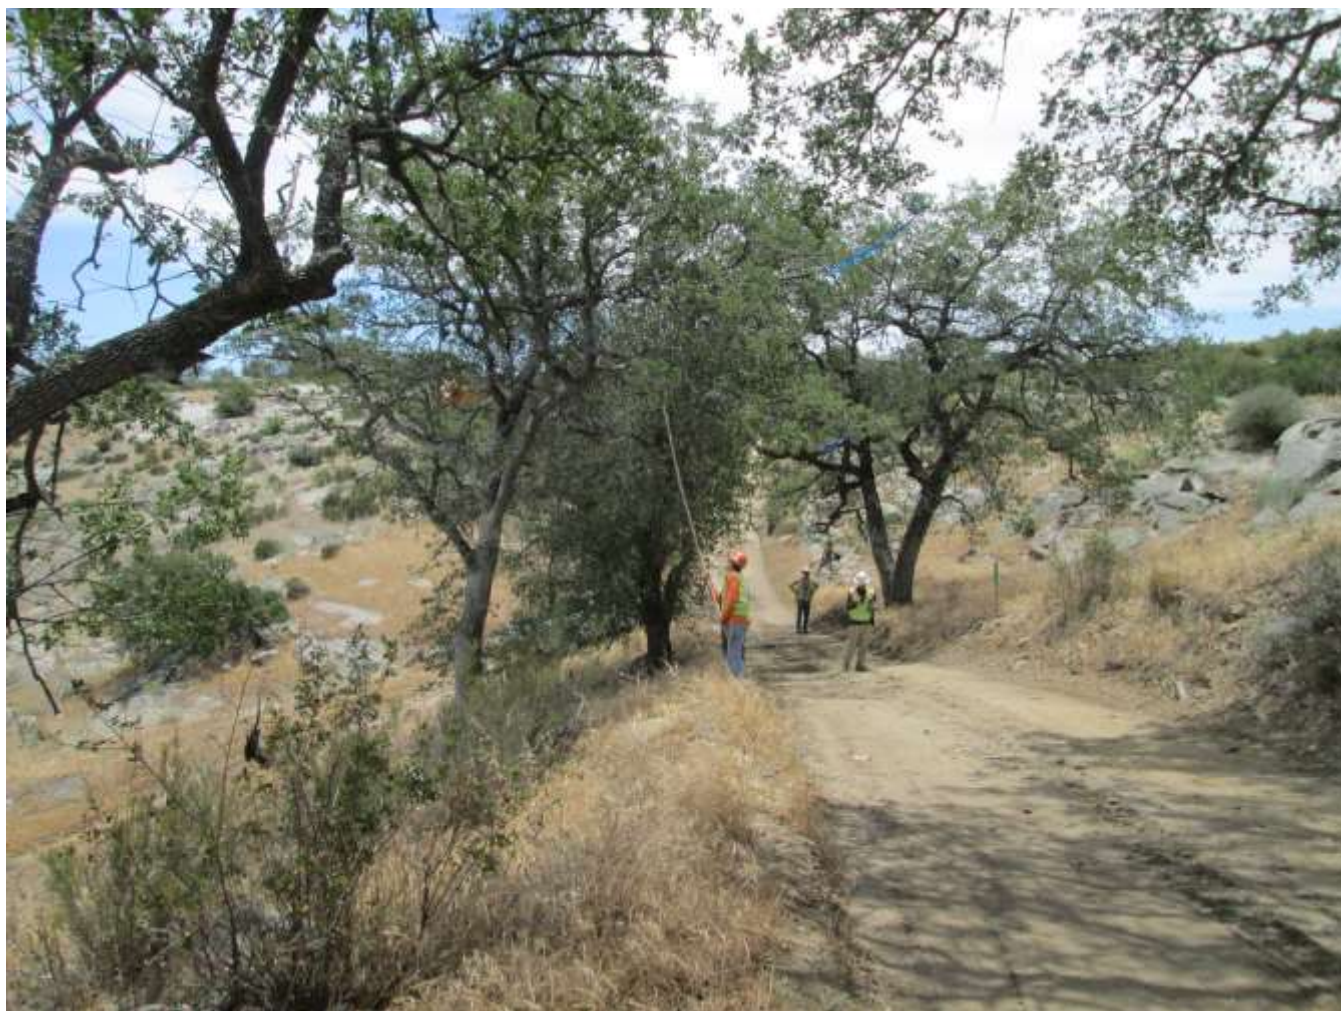
Photo 3: In accordance with APM BIO-1, MM BIO-2, and MM BIO-4, a tree trimming crew, with direction from the on-site biological monitor, was observed using a hand saw for tree trimming activities to limit noise that could potentially disturb to an active bird's nest located just off the access road.

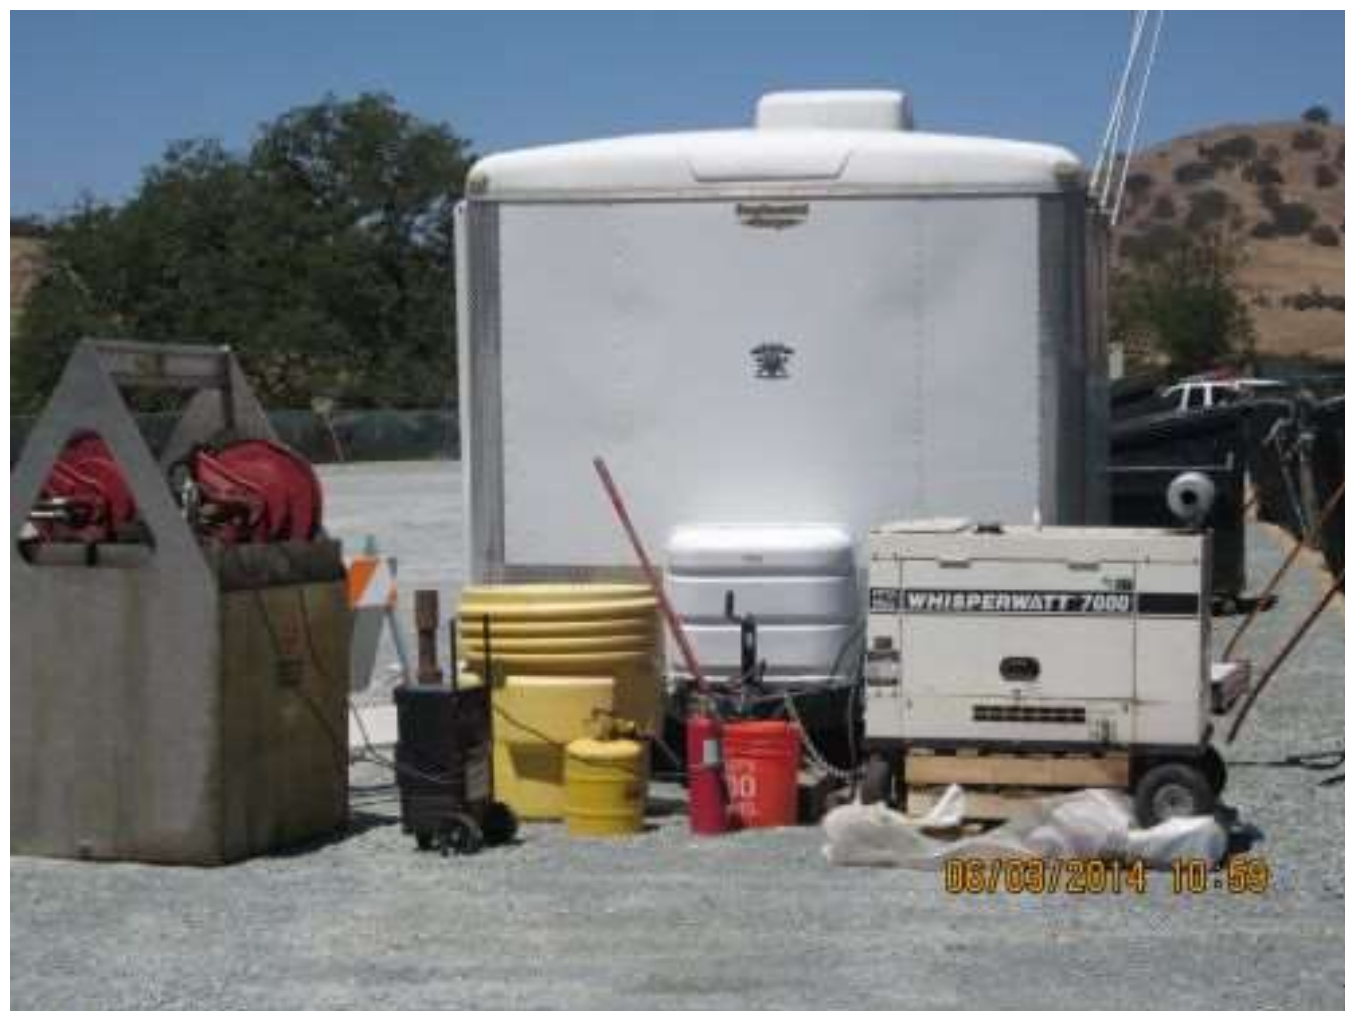
Photo 4: Fire tools and spill kits were staged at the Santa Ysabel Staging Yard and visqueen was staged under equipment to prevent potential soil contamination in accordance with APM HAZ-2.

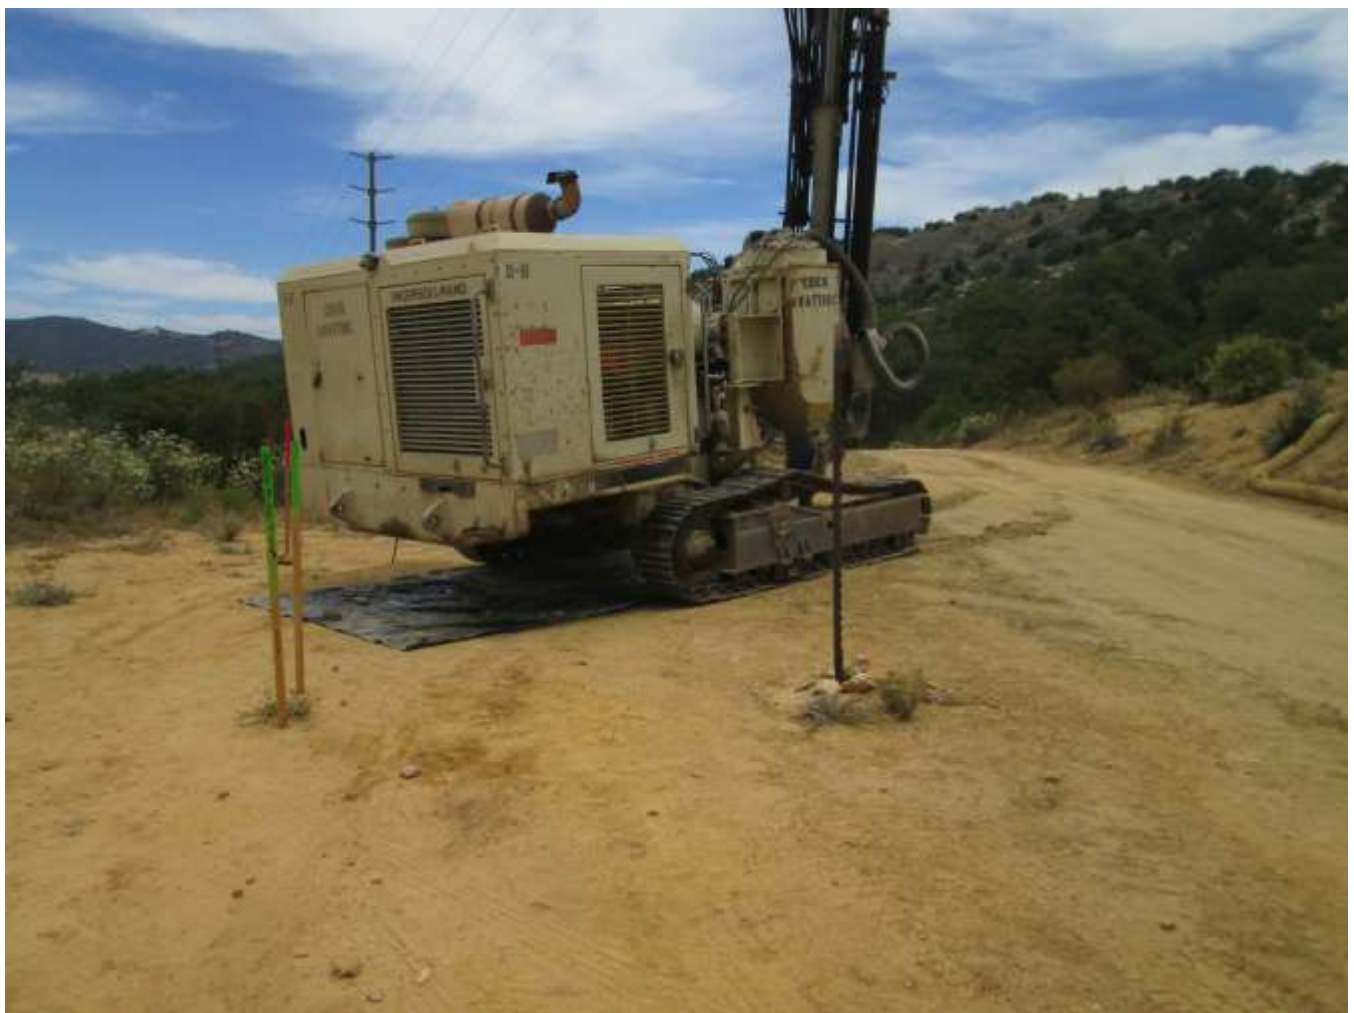
Photo 5: Sensitive plant species were marked for avoidance with green colored stakes in accordance with APM BIO-1, and visqueen was observed being used beneath staged equipment to prevent potential leaks/spills from being discharged into the soil in accordance with MM HYD-2.

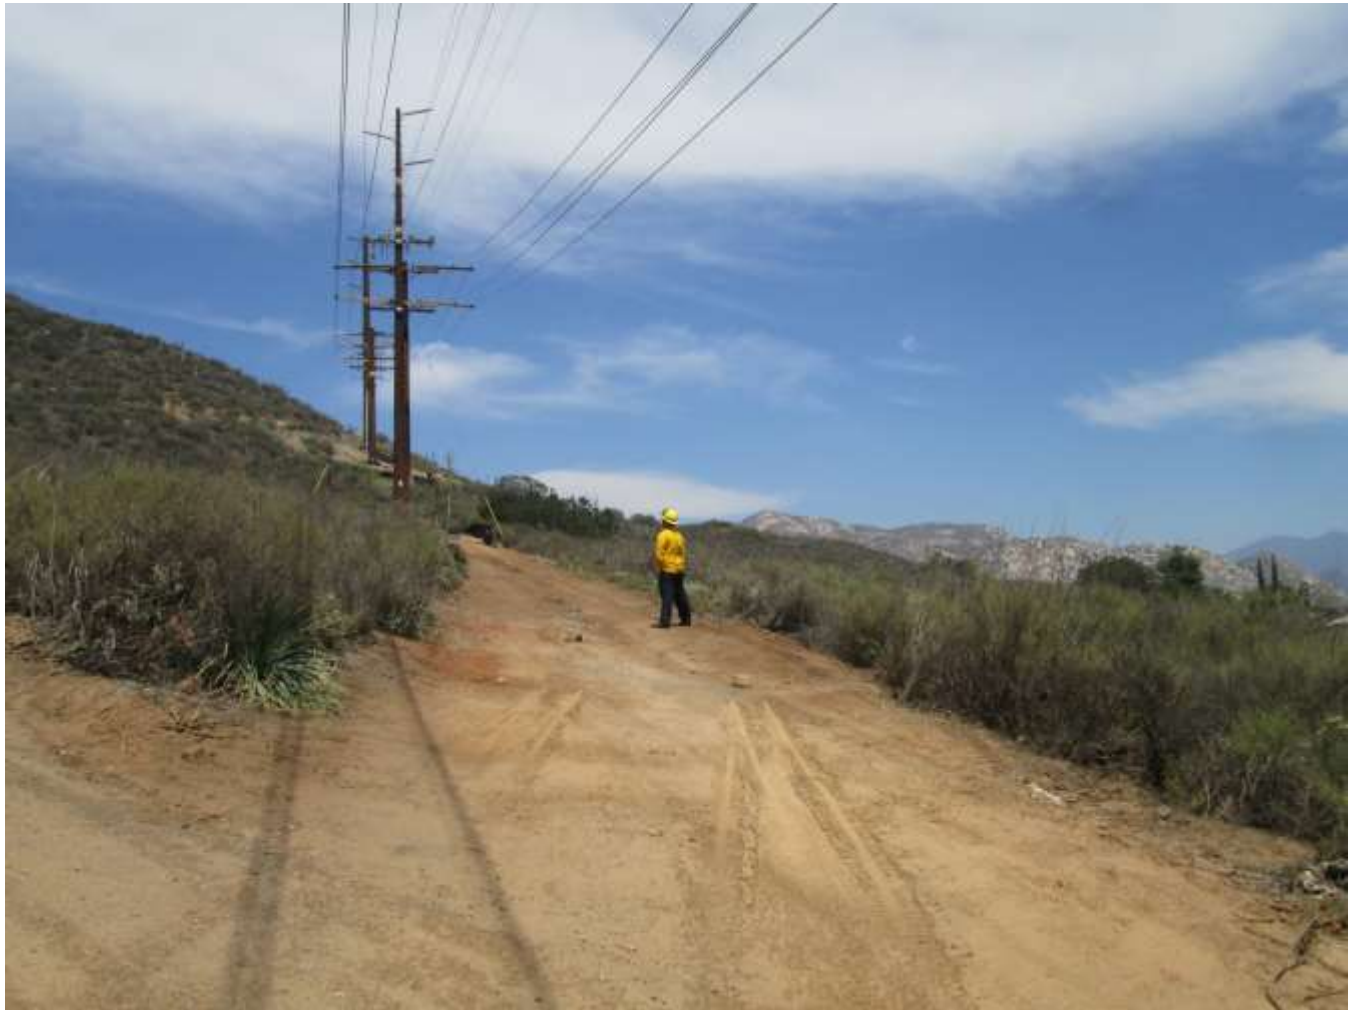
Fire risk was observed being minimized during project construction through the implementation of measures in the Project Fire Plan and APM HAZ-2. Fire patrols carrying fire suppression tools and water for firefighting were observed monitoring work activity and inspecting work locations for fire safety compliance (see Photo 7—Attachment A). Construction crews were observed carrying fire tools (backpack pump, fire extinguisher, shovel, and Pulaski), and staging tools on site at work locations. Fire extinguishers were observed next to or mounted on internal combustion engines. Water tenders were staged within two minutes travel time of construction activities involving energized wire.

Photo 7: In accordance with the Project Fire Plan and APM HAZ-2, fire patrols were observed monitoring construction activities and inspecting work locations for fire safety compliance.

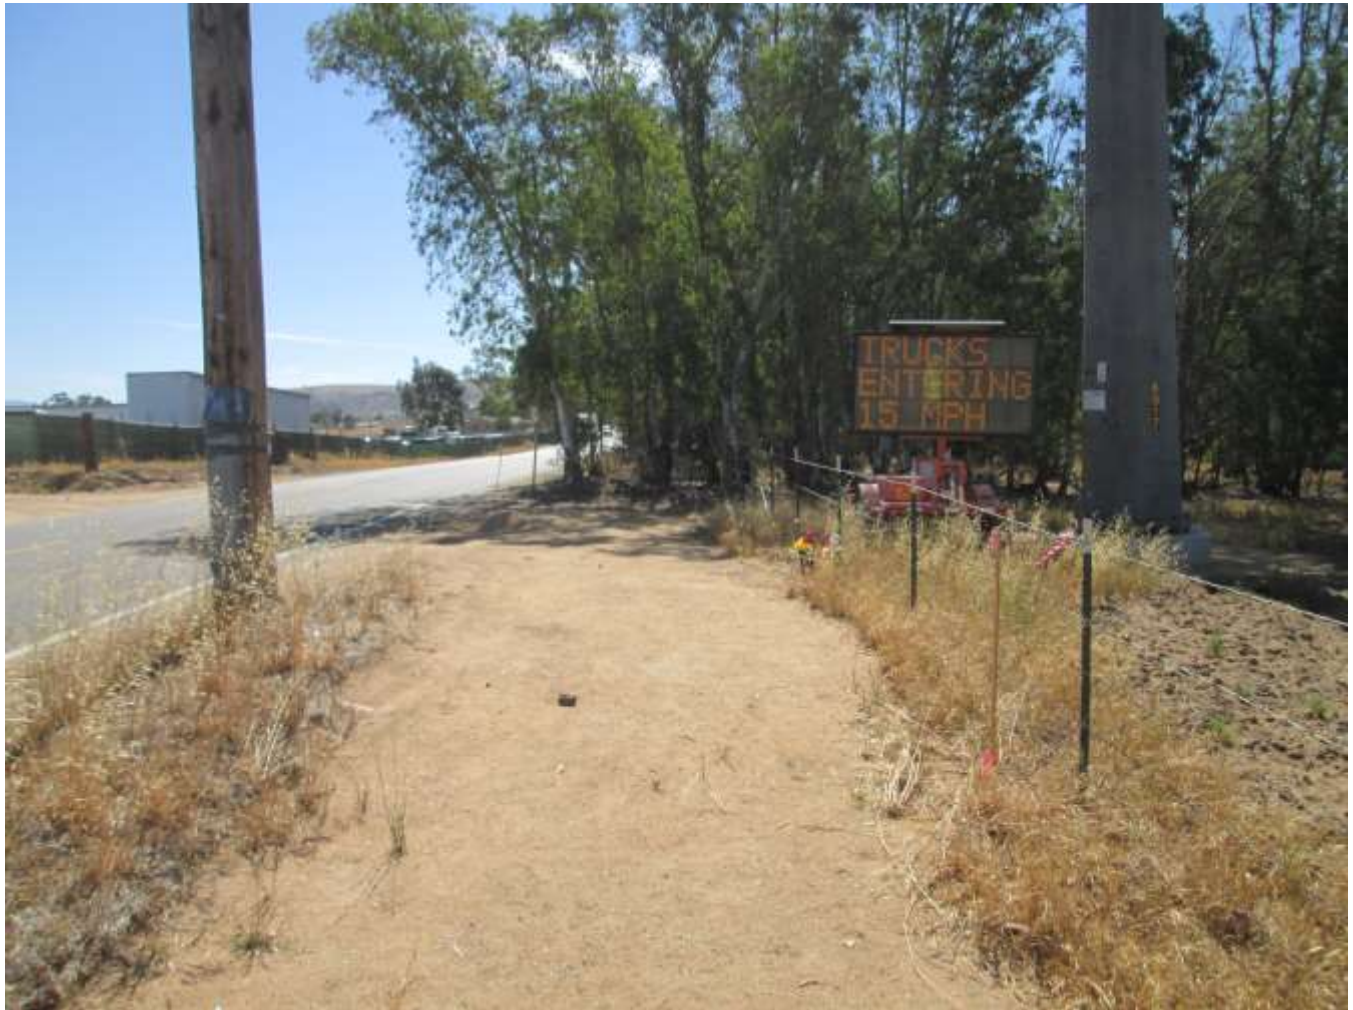
In accordance with APM TRA-1, traffic control flaggers, construction notification signage, and cones were observed along public roadways with construction activity. Construction notification signs advising vehicles of the potential for trucks to be entering ahead remain along Warnock Road in both directions of the Warnock Staging Yard (see Photo 8—Attachment A).

Photo 8: In accordance with APM TRA-1, construction notification signage remains along Warnock Road leading up to the Warnock Staging Yard.
