<p><b>California Public Utilities Commission</b> <b><i>Mitigation Monitoring, Compliance, and Reporting Program</i></b></p>
	<p><b>East County (ECO) Substation Project</b></p> <p><b>Compliance Status Report: 029</b></p> <p><b>May 11, 2014</b></p>

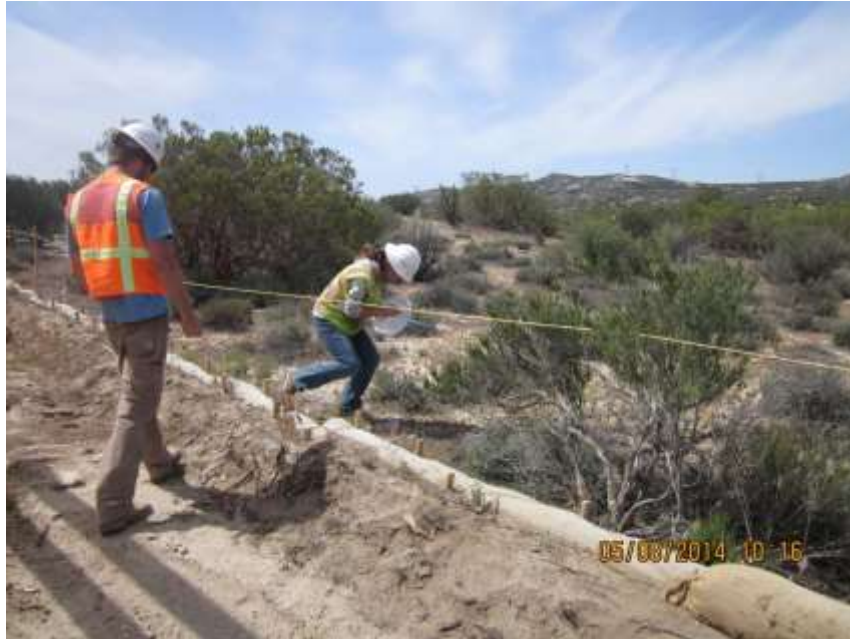
Biological monitors were onsite throughout construction activities to ensure work remained within the approved work limits and to monitor for sensitive wildlife species (MM-BIO-1a and MM-BIO-1c). All excavations were inspected daily prior to construction activities and throughout the day to ensure that no wildlife species had become entrapped in accordance with MM-BIO-7e. Any wildlife found entrapped was removed safely from the right of way and relocated by the biological monitor (see Photo 1 – Attachment A).

**Photo 1:** All excavations were inspected daily prior to and during construction activities to ensure that no wildlife species had become entrapped in accordance with MM-BIO-7e. The photo above shows a biological monitor relocating a small rabbit found during morning inspection.

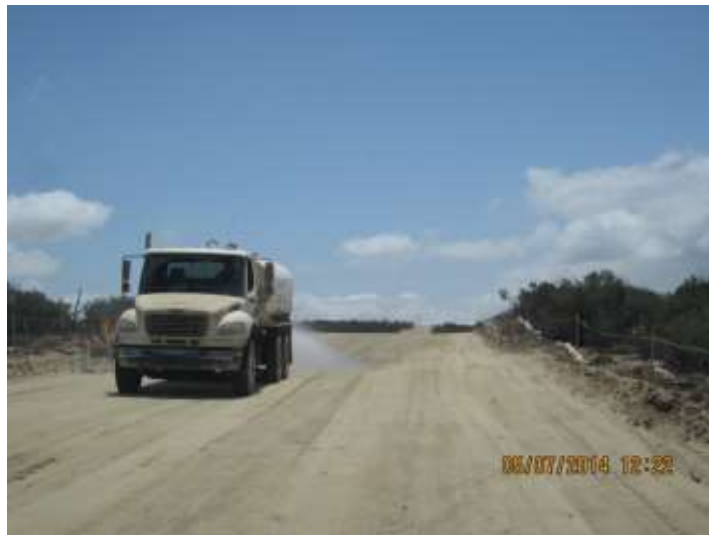
Dust control measures in accordance with MM-AQ-1 and MM-BIO-4a, were observed being implemented including watering during rough grading and access road maintenance activities (see Photo 2 – Attachment A). Track-out measures consisting of rumble plates and rock aprons were in place and maintained, and traffic control crews were observed manually sweeping project related track-out throughout and at the end of the day.

**Photo 2:** Water trucks are being utilized to minimize dust emissions in accordance with MM-AQ-1 and MM-BIO-4a.

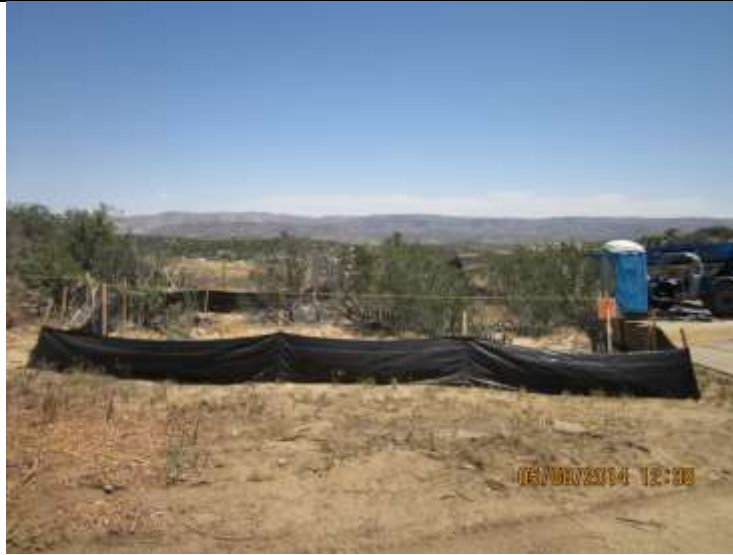
Archaeological and Native American observers were onsite monitoring ground disturbance and construction activities in proximity to Environmentally Sensitive Areas in accordance with MM-CUL-1d. Additionally, the limits of work and Environmentally Sensitive Areas were clearly marked in the field per MM-CUL-1a (see Photo 3 – Attachment A).

**Photo 3:** Environmentally Sensitive Areas are clearly marked in the field per MM-CUL-1a.

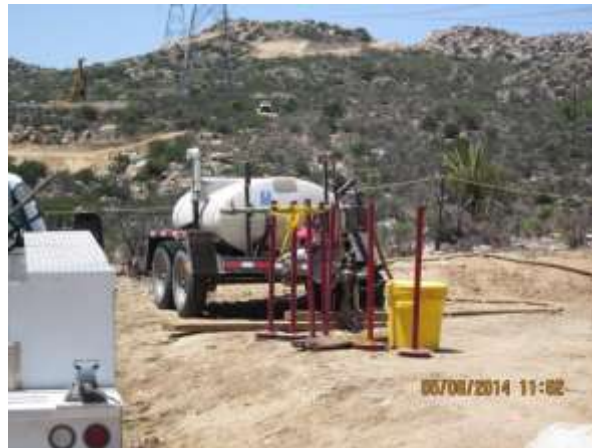
In accordance with MM-BIO-1c, biological monitors were onsite to survey areas of active construction for compliance with biological mitigation measures. Topsoil was observed staged along the limits of work that will be utilized for restoration activities in accordance with MM-BIO-1d. Drip pan containment bins were observed beneath equipment staged along the right-of-way in accordance with MM-HAZ-1a and spill kits were accessible in case of hazardous materials leak (see Photo 4 – Attachment A).

**Photo 4:** Drip pan containment bins is placed beneath equipment staged along the right-of-way in accordance with MM-HAZ-1a and spill kits were accessible in case of hazardous materials leak.

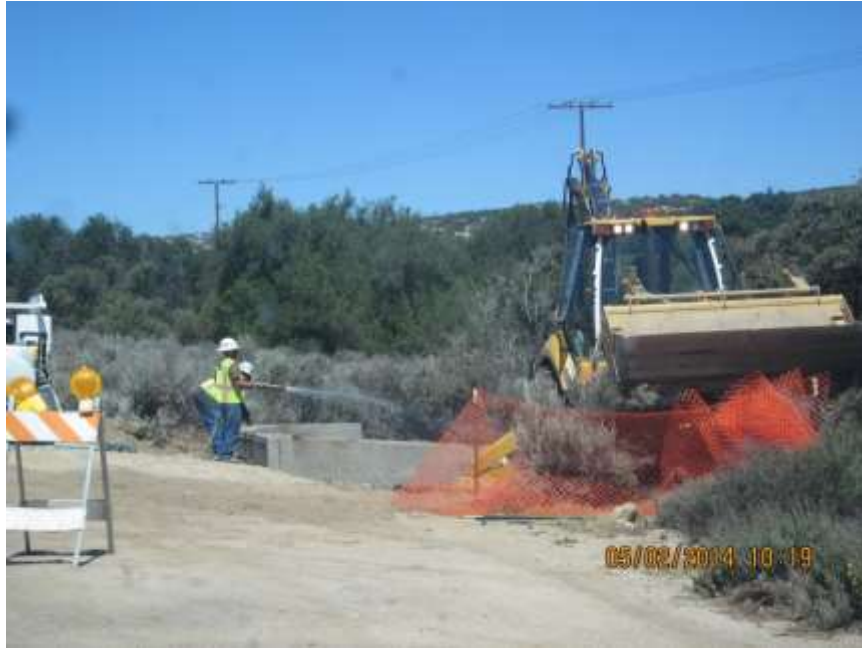
In accordance with MM-BIO4-A and MM-AQ-1, water trucks were used to control dust along access roads, work areas, and commonly used routes within the substation boundaries (see Photo 5 – Attachment A). A rock apron and rattle plate was also observed being maintained at the primary point of ingress/egress along Old Highway 80 to minimize the potential for track-out and associated fugitive dust emissions.

**Photo 5:** In accordance with MM-BIO4-A and MM-AQ-1, water trucks equipped with hoses are utilized to control dust in areas of active construction.

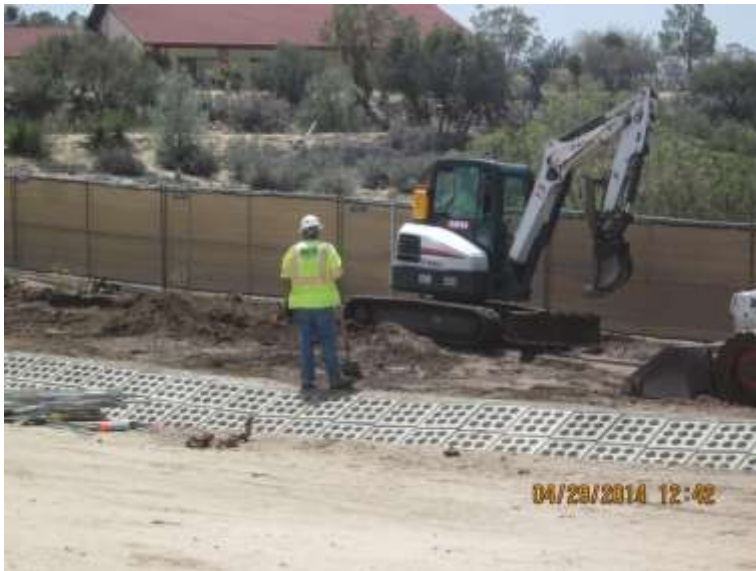
In accordance with MM-VIS-3c, opaque visual screening fence was routinely maintained to ensure areas of public visibility were screened (see Photo 6 – Attachment A).

**Photo 6:** In accordance with MM-VIS-3c, opaque visual screen fencing was routinely maintained at the Boulevard Substation.
