<p>California Public Utilities Commission <i>Mitigation Monitoring, Compliance, and Reporting Program</i></p>
	<p>East County (ECO) Substation Project</p>
	<p>Compliance Status Report: 030</p> <p>May 25, 2014</p>

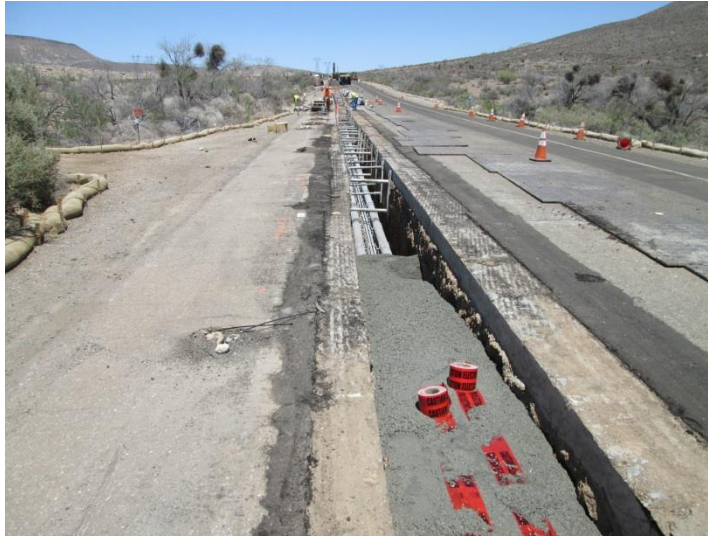
Construction activities during this reporting period consisted of repair and maintenance of erosion control devices along the right-of-way; excavation, conduit placement, backfilling and paving; installation of duct bank; and vault installation and in-and-out conduit installation (see Photo 1 – Attachment A).

Photo 1: Construction activities during this reporting period consisted of excavation, conduit placement, backfilling and paving; installation of duct bank; and vault installation and in-and-out conduit installation. All work was observed being completed within the approved work limits.

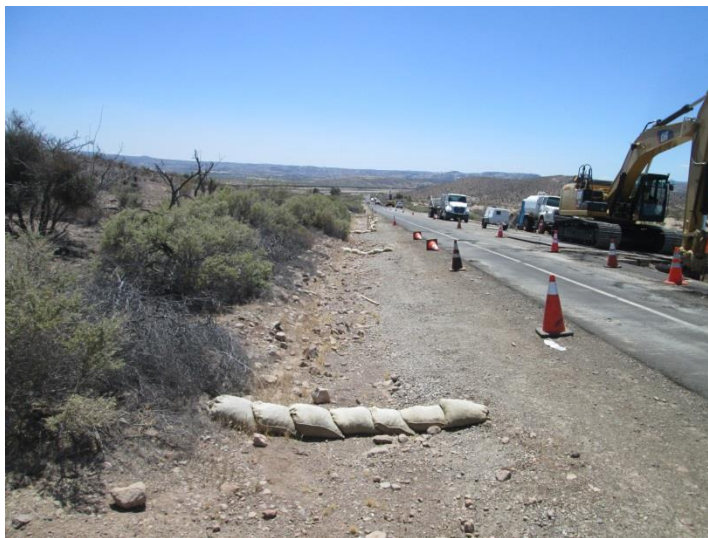
Erosion control measures consisting of straw wattles, silt fence and gravel bags are being maintained along the right-of-way in accordance with the SWPPP and MM-HYD-1 (see Photo 2 – Attachment A). Dust control measures were observed being implemented including watering during excavation activities and along access roads. Track-out measures consisting of rumble plates and rock aprons were in place and maintained.

Photo 2: Erosion control measures consisting of straw wattles and gravel bags are being maintained along the right-of-way in accordance with the SWPPP and MM-HYD-1.

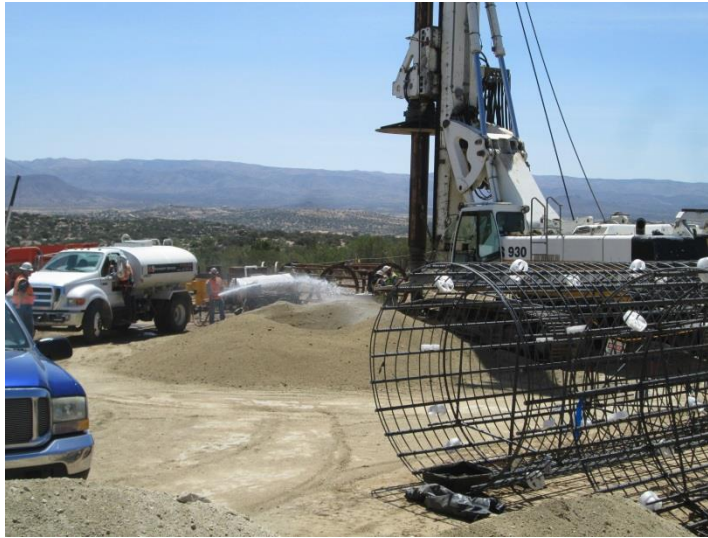
Water trucks were observed being utilized during excavation and backfilling activities and along commonly used access roads to minimize fugitive dust emissions in accordance with the Dust Control Plan and MM-BIO-4a (see Photo 3 – Attachment A). Concrete washouts are being utilized for cement truck operators to washout equipment following concrete pours (see Photo 4 – Attachment A). The concrete washout bins ensure concrete waste is not discharged onto bare soils in accordance with the SWPPP and MM-HYD-1. In addition, drip pan containment bins were observed beneath equipment staged along the right-of-way in accordance with MM-HAZ-1a and spill kits were accessible in case of hazardous materials leak.

Photo 3: Water trucks were observed being utilized during foundation drilling in accordance with MM-BIO-4a and the Dust Control Plan.

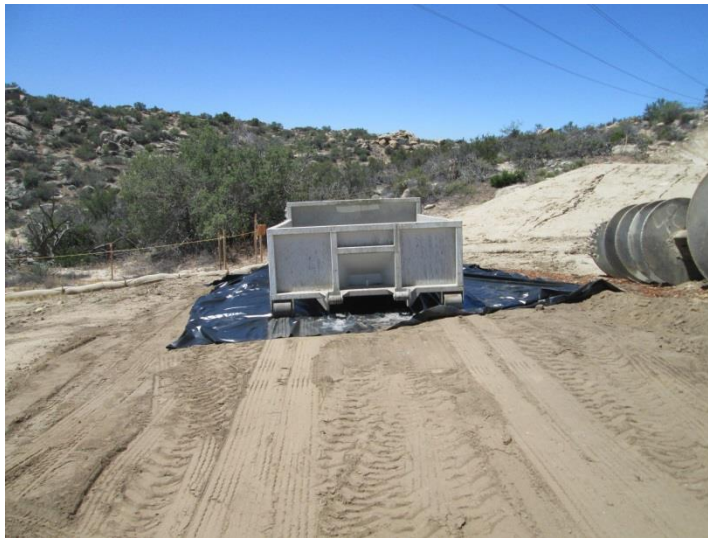
Photo 4: In accordance with MM-HYD-1 and the SWPPP, concrete washouts are utilized during concrete pours associated with steel pole foundations.

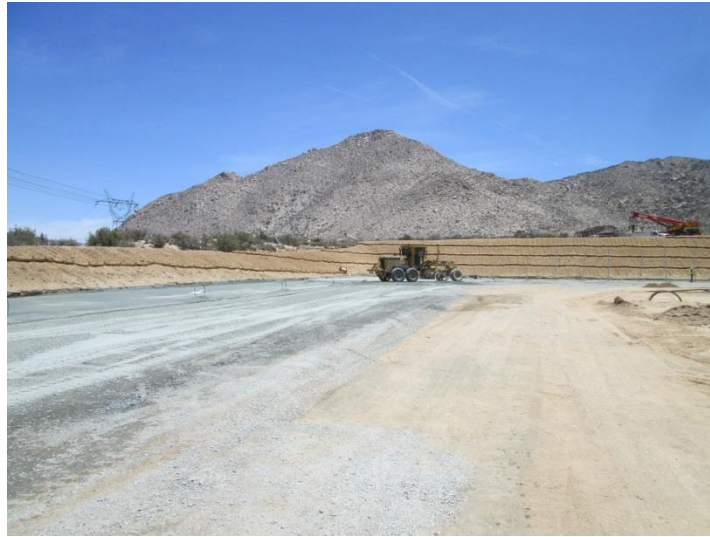
Photo 5: Class II fill being placed within the approved work limits at the ECO Substation.

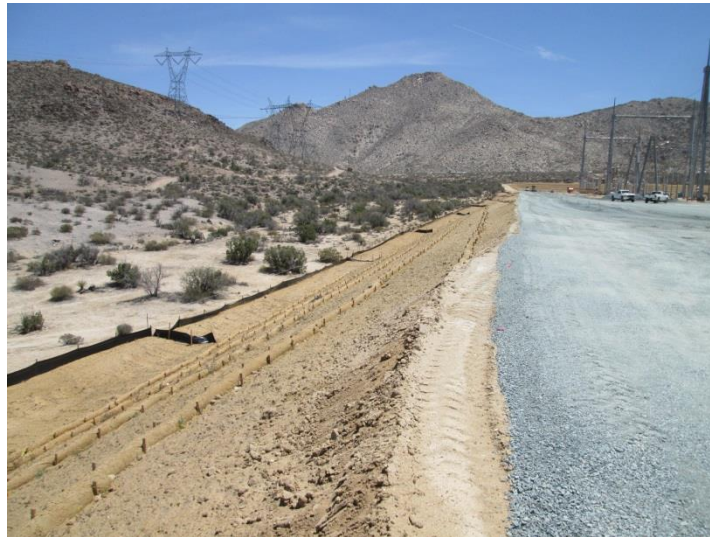
Erosion control measures consisting of straw wattles, soil stabilizer and silt fencing were observed installed and being maintained in accordance with MM-HYD-1 and the Project SWPPP (see Photo 6 – Attachment A).

Photo 6: BMP's consisting of straw wattles, silt fence and soil stabilizer have been put in place along slopes of the ECO Substation to minimize erosion in accordance with MM-HYD-1 and the SWPPP.

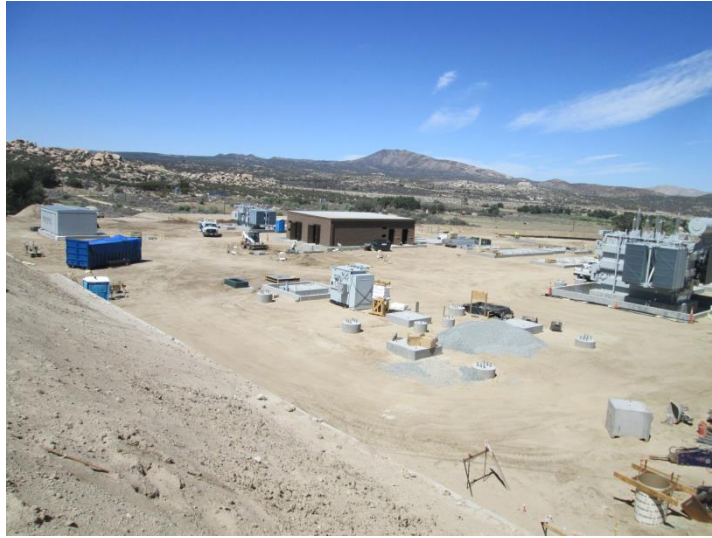
In accordance with MM-VIS-3g and the Surface Treatment Plan, the control shelter at the Boulevard Rebuild Substation has been treated with an Otay Brown color treatment (see Photo 7 – Attachment A). In addition, opaque visual screening fence was observed being routinely maintained to ensure areas of public visibility were screened (see Photo 8 – Attachment A).

Photo 7: The control shelter at the Boulevard Rebuild Substation has been treated with an Otay Ranch Brown color tone in accordance with the Surface Treatment Plan and MM-VIS-3g.

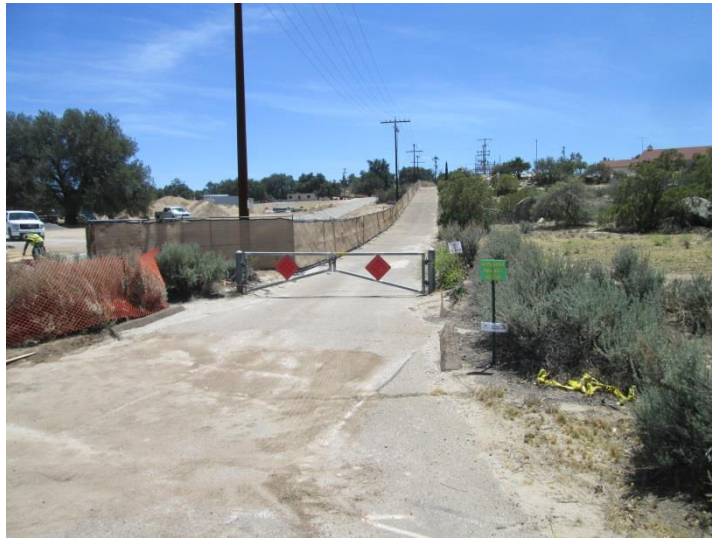
Photo 8: Opaque visual screen fencing was observed being routinely maintained at the Boulevard Rebuild Substation in accordance with MM-VIS-3c.
