<p><b>California Public Utilities Commission</b>  <b><i>Mitigation Monitoring, Compliance, and Reporting Program</i></b></p>
	<p><b>East County (ECO) Substation Project</b></p> <p><b>Compliance Status Report: 035</b></p> <p><b>August 3, 2014</b></p>

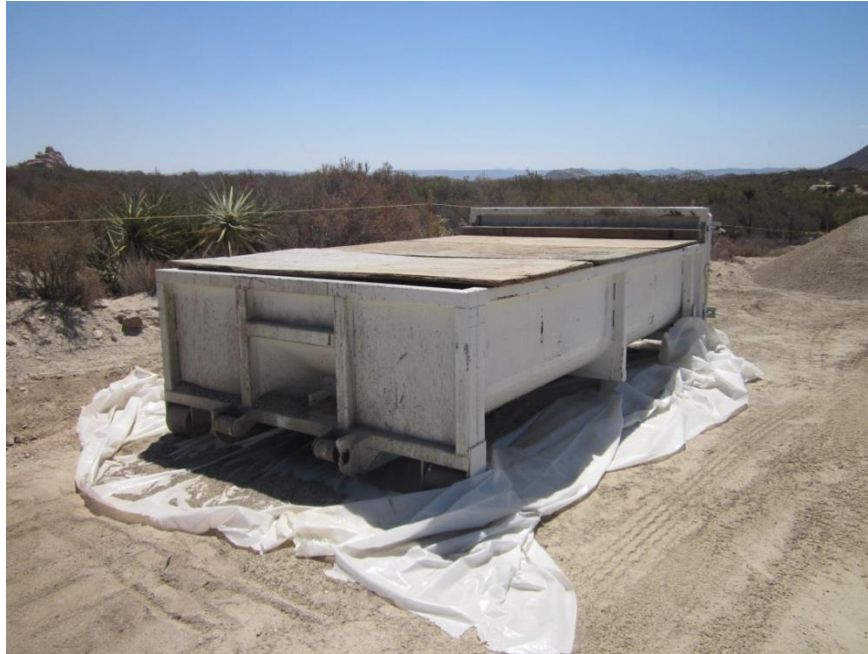
Erosion control measures consisting of straw wattles, silt fence and gravel bags are being maintained along the ROW in accordance with the SWPPP and MM-HYD-1. Staged and active stationary equipment featured containment as required by MM-HAZ-1a and a concrete washout basin was observed in good condition (See Attachment A- Photo 1).

**Photo 1:** A concrete washout basin was observed in good condition along the ROW.

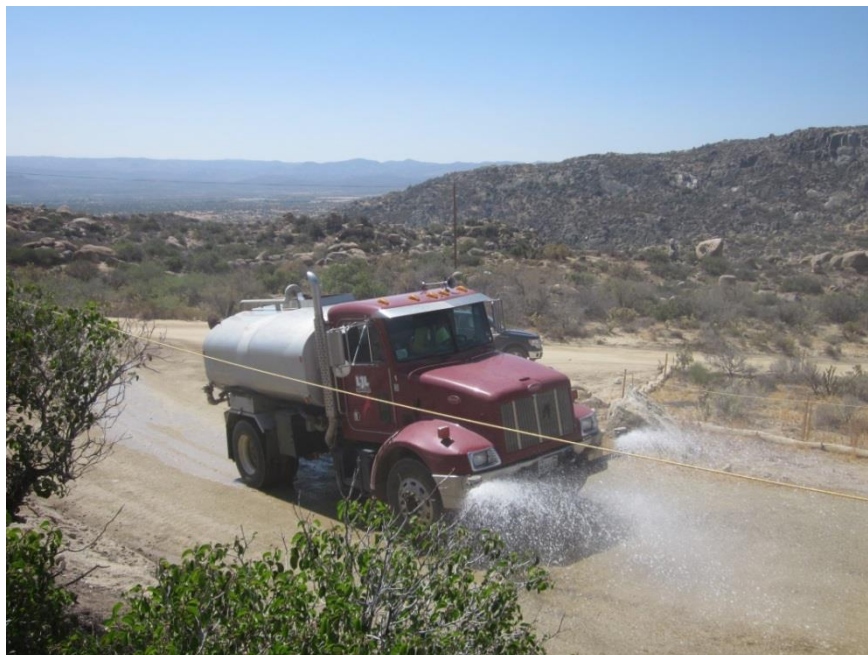
Water trucks were being utilized to minimize fugitive dust emissions in accordance with the Dust Control Plan and MM-BIO-4a (See Attachment A- Photo 2). Trucks used during spoil removal associated with excavation were observed covering loads prior to entering publicly accessed roads in accordance with MM-BIO-4a and MM-AQ-1.

**Photo 2:** Water trucks being utilized to minimize fugitive dust emissions in accordance with the Dust Control Plan and MM-BIO-4a.

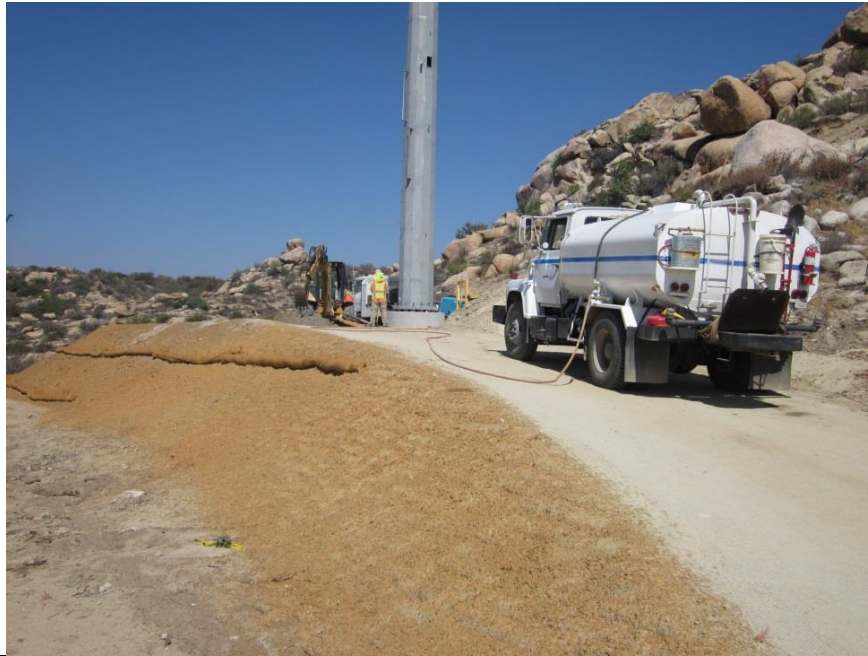
Erosion and sediment controls included the use of straw wattles along the work area perimeter and hydro-mulch on graded slopes (MM HYD-1), and fire tools and water supply were observed on site

(FF-1) (See Attachment A- Photo 3). A rattle plate remains at the access road ingress/egress to Old Highway 80, and the paved highway was observed free of track-out in accordance with MM AQ-1, MM BIO-4a, and MM HYD-1.

**Photo 3:** Erosion and sediment controls included the use of straw wattles along the work area perimeter and hydro-mulch on graded slopes (MM HYD-1), and fire tools and water supply were observed on site (FF-1).

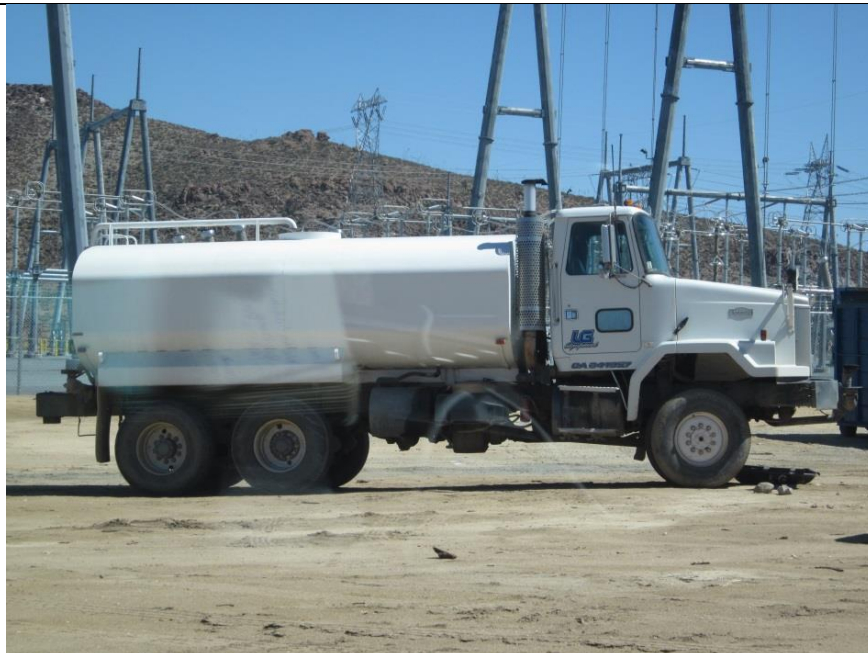
Erosion control measures consisting of straw wattle, silt fencing, and extensive hydromulched slopes were observed to be in good condition in accordance with MM-HYD-1. Staged equipment was equipped with drip pan containment in accordance with HAZ-1a (See Attachment- Photo 4). Hazardous materials staged on site were placed within proper containment and labeled in accordance with MM-HAZ-1a. No smoking signs were clearly marked and adjacent to the hazardous waste areas.

**Photo 4:** Staged equipment was equipped with drip pan containment in accordance with HAZ-1a.

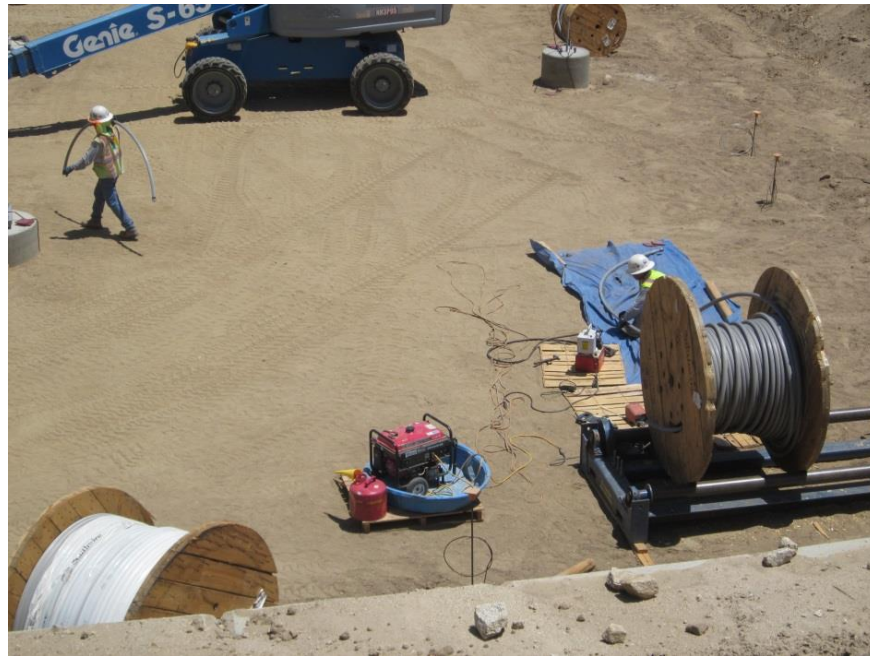
At the Boulevard substation rebuild site construction, crews were observed conducting framing activities around the 69 kV circuit breakers and building foundations. Staged generators and equipment were equipped with drip pan containment (MM HAZ-1a) (See Attachment- Photo 5), and portable facilities were tied down and placed within secondary containment. Trash was not observed on site during this reporting period, and trash storage was covered to minimize wildlife attractants in accordance with BIO-7d.

**Photo 5:** Staged generators and equipment were equipped with drip pan containment in compliance with MM HAZ-1a.

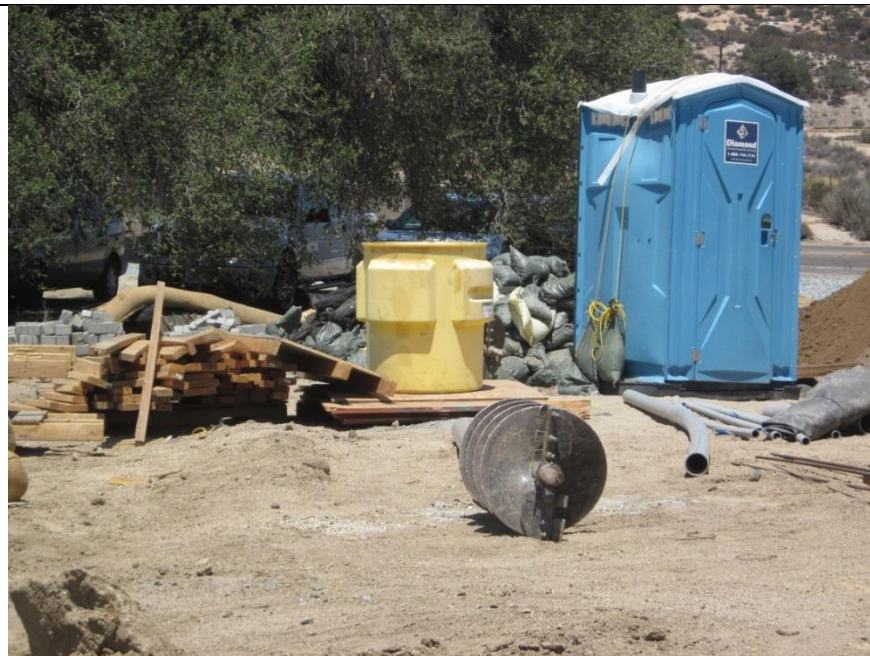
A spill kit was on site in the case of a hazardous materials spill in compliance with MM HAZ-1a (See Attachment A- Photo 6). Perimeter sediment controls in the form of silt fence and straw wattles were in good working condition in accordance with MM HYD-1, and visual screening along the perimeter of the work area was in good condition in accordance with VIS-3a.

**Photo 6:** Spill kit observed on site in the case of a hazardous materials spill in compliance with MM HAZ-1a.
