| | California Public Utilities Commission <i>Mitigation Monitoring, Compliance, and Reporting Program</i> |
| | East County (ECO) Substation Project |
| | Compliance Status Report: 044 December 7, 2014 |

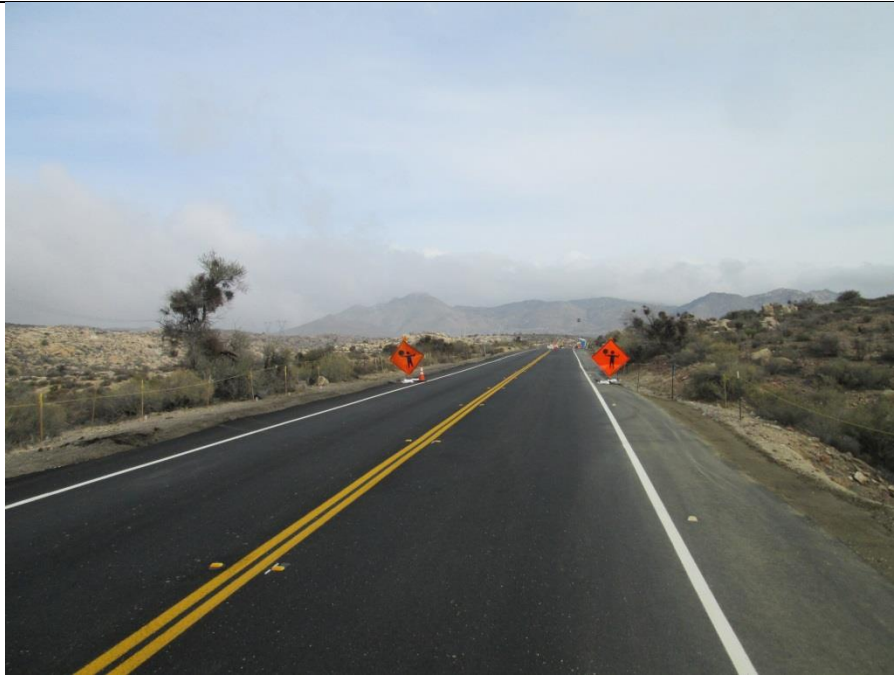
Traffic safety measures included the use of signage, a pilot car, and traffic control flaggers to direct one-way traffic through the work area in accordance with MM-TRA-1 (see Attachment A – Photo 1).

Photo 1: Traffic control measures consisting of signage was observed being implemented along Old Highway 80 in accordance with MM-TRA-1.

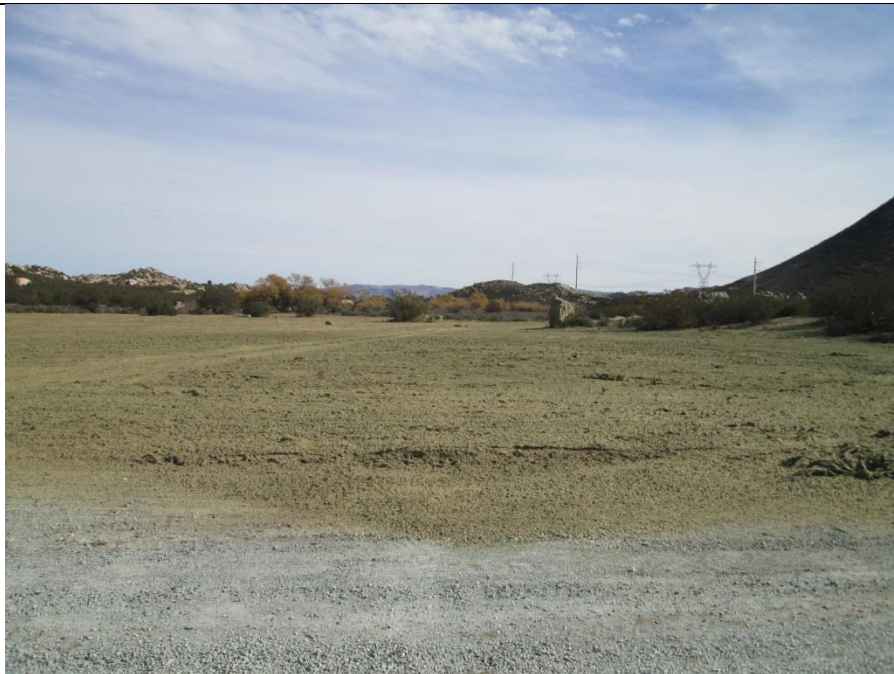
Temporary impact areas are in the process of being decompacted and seeded in accordance with MM-BIO-1d and the Habitat Restoration Plan (see Attachment A – Photos 2 and 3). Erosion control BMP's were observed being maintained at the pad sites and along the perimeter of temporary staged spoil piles in accordance with MM-HYD-1 (see Attachment A – Photo 4). Temporary impact areas along access roads and adjacent to pad sites were observed to have been hydro-seeded from SP-42 to SP-47. A crew was also observed installing ground rods for the protective fence at SP-42.

Photo 2: Restoration activities were observed being completed at the Lake Domingo Construction Yard during this reporting period. Crews were observed decompacting soils prior to applying a seed mix in accordance with MM-BIO-1D and the Habitat Restoration Plan.

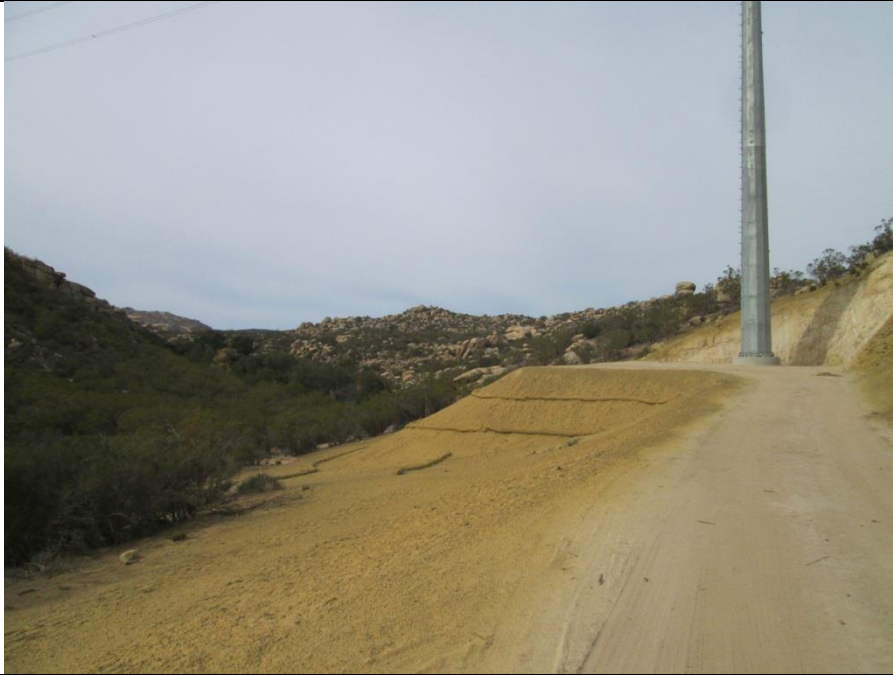
Photo 3: In accordance with MM-BIO-1D and the Habitat Restoration Plan, temporary work areas are stabilized and a seed mix will be applied in the near future. Monitoring to meet the success criteria is required to be completed as described in Section 6.0 of the Habitat Restoration Plan.

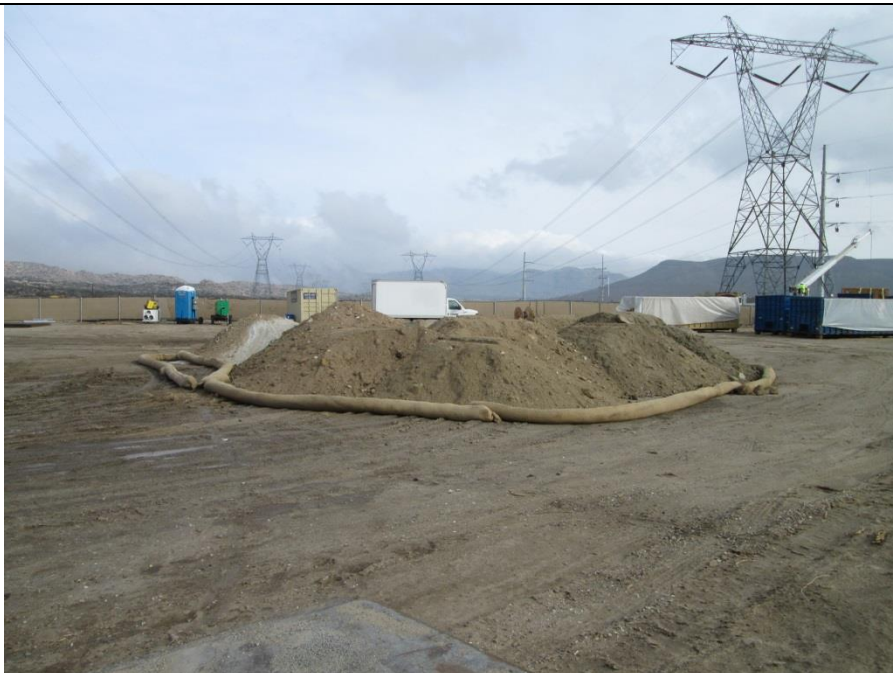
Photo 4: In accordance with MM-HYD-1, straw wattles are placed along the perimeter of spoil piles staged onsite to minimize the potential for erosion.

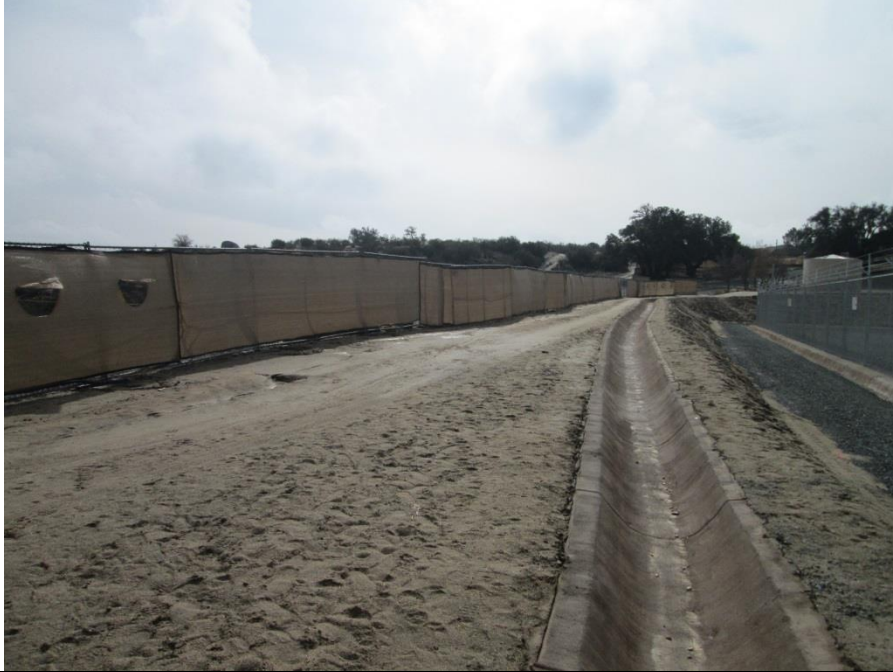
In accordance with MM-VIS-3A, temporary fences along the perimeter of the Boulevard Substation Rebuild were observed lined with screening material to reduce visibility of construction activities for motorists passing along Old Highway 80 (see Photo 5 – Attachment A).

Photo 5: In accordance with MM-VIS-3A, temporary fences along the perimeter of the Boulevard Substation Rebuild are lined with screening material to reduce visibility of construction activities for motorists passing along Old Highway 80.

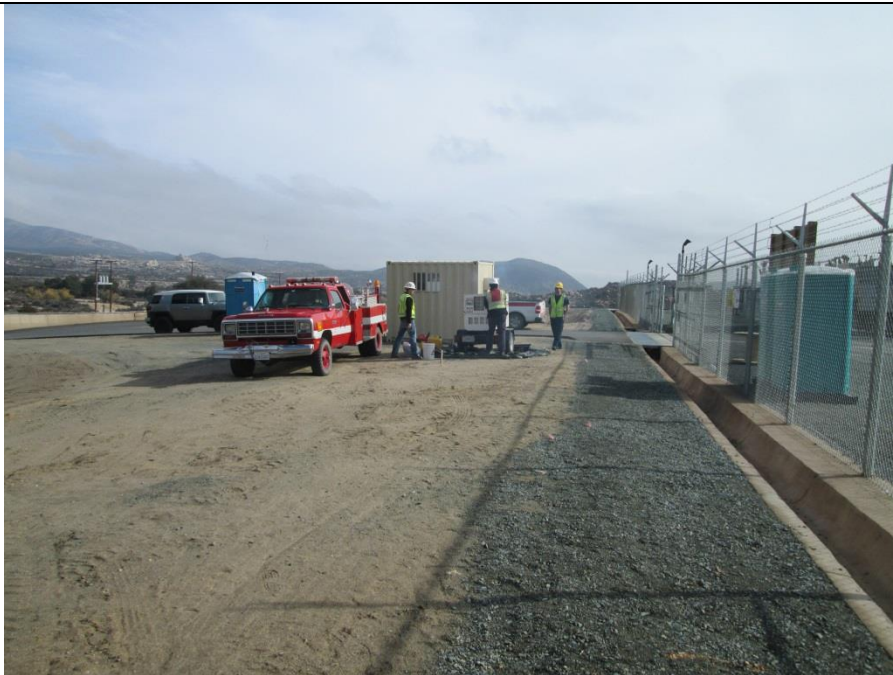
Fire patrols were observed on-site to ensure construction equipment and vehicles had the required fire safety equipment and provided ongoing fire patrols in accordance with MM-FF-1 (see Photo 6 – Attachment A).

Photo 6: Fire patrols were observed to be present during construction activities at the Boulevard Substation Rebuild in accordance with MM-FF-1.
