<p><b>California Public Utilities Commission</b>  <b><i>Mitigation Monitoring, Compliance, and Reporting Program</i></b></p>
	<p><b>East County (ECO) Substation Project</b></p>
	<p><b>Compliance Status Report: 046</b></p> <p><b>January 4, 2015</b></p>

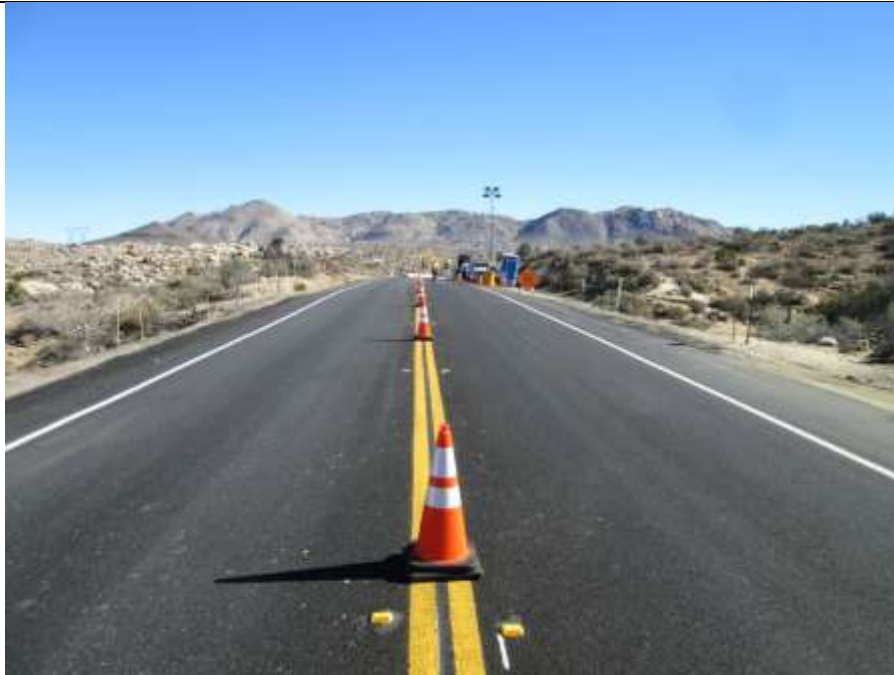
Traffic safety measures observed being implemented included the use of traffic cones, signs, and flaggers to direct motorists along Carrizo Gorge Road during work activities in accordance with MM-TRA-1 (see Attachment A – Photo 1).

**Photo 1:** Traffic control measures consisting of traffic cones, signs, and flaggers were observed being utilized to direct motorists along Carrizo Gorge Road during work activities in accordance with MM-TRA-1.

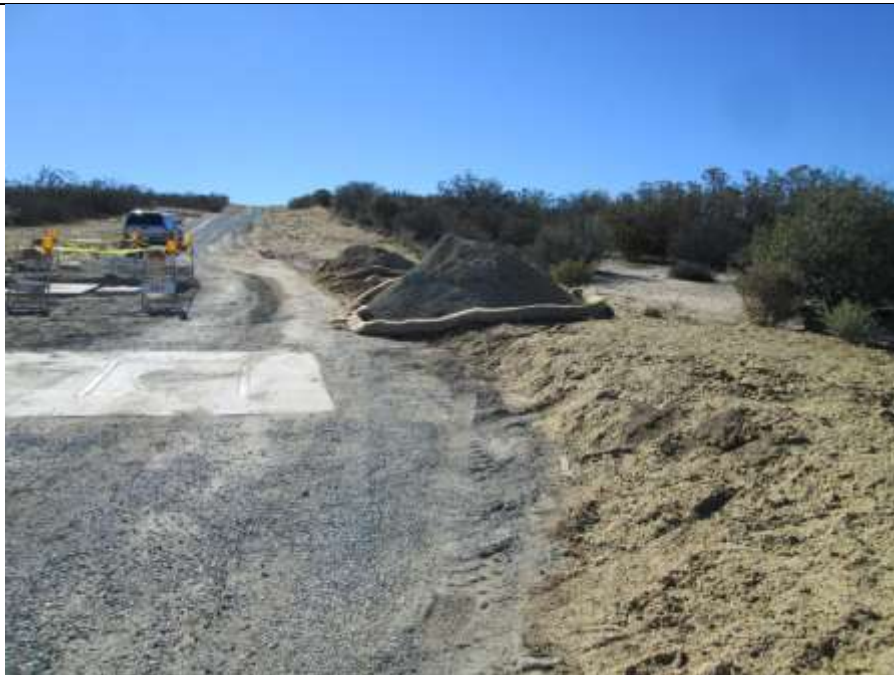
Work limits were observed being clearly delineated with flagging in accordance with MM-BIO-1A and a biological monitor was present per MM-BIO-1C. Sediment control BMPs, including straw wattles and gravel bag berms, were observed in good condition along the perimeter of the work limits (MM-HYD-1) and were observed around stockpiles adjacent to gate installation areas (see Attachment A – Photo 2).

**Photo 2:** Erosion and sediment control devices (straw wattles) were observed implemented around stockpiles (MM-HYD-1) during construction along the 138 kV underground line.

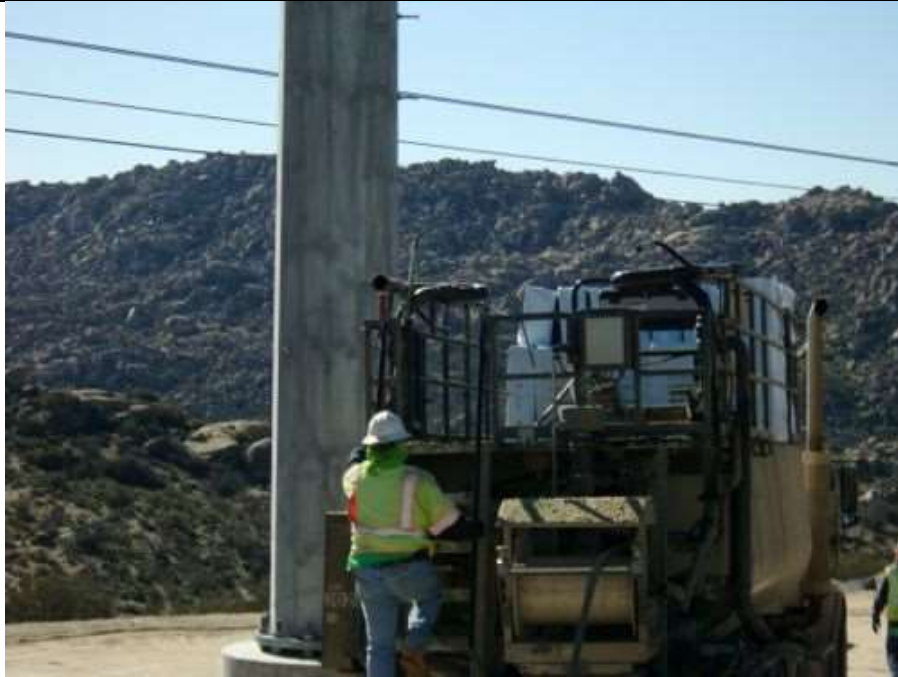
During hydroseeding activities, crews were observed carrying required fire response tools in work vehicles and fire patrols/inspectors were present on-site in accordance with MM-FF-1 (see Attachment A – Photo 3).

**Photo 3:** During hydroseeding along the pad slopes of temporary work areas along the 138kV overhead line, crews were observed carrying required fire equipment in work vehicles in accordance with MM FF-1.

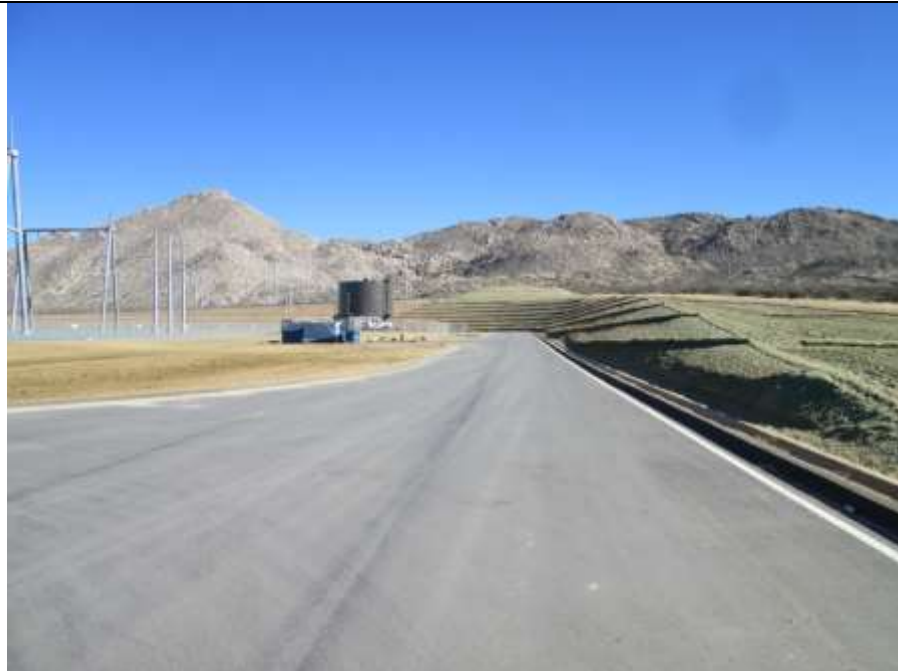
Construction activities during this reporting period consisted of continued work on punch list items; removing, installing, or replacing erosion and sediment control devices; continuing to install the security system; continuing to install the permanent water tank; and implementation of the Landscaping Plan (ECO-AES-1), including hydroseeding and spreading spoils. Hydroseeding crews were observed applying approved mixtures adjacent to the ECO substation (see Attachment A – Photo 4). The temporary work areas were decompacted prior to the seed application in accordance with MM-BIO-1D. Restoration activities were also observed being performed under the direction of a habitat restoration specialist in accordance with MM-BIO-1D. Slope stabilization BMPs, including installation of straw wattles were observed implemented (MM-HYD-1).

**Photo 4:** Restoration activities at the ECO substation this reporting period consisting of applying approved hydroseed mixtures on slopes adjacent to the substation. Slope stabilization BMPs, including straw wattles, were observed to be installed and in working condition(MM-HYD-1).
