<p><b>California Public Utilities Commission</b> <b><i>Mitigation Monitoring, Compliance, and Reporting Program</i></b></p>
	<p><b>East County (ECO) Substation Project</b></p> <p><b>Compliance Status Report: 048</b></p> <p><b>February 2, 2015</b></p>

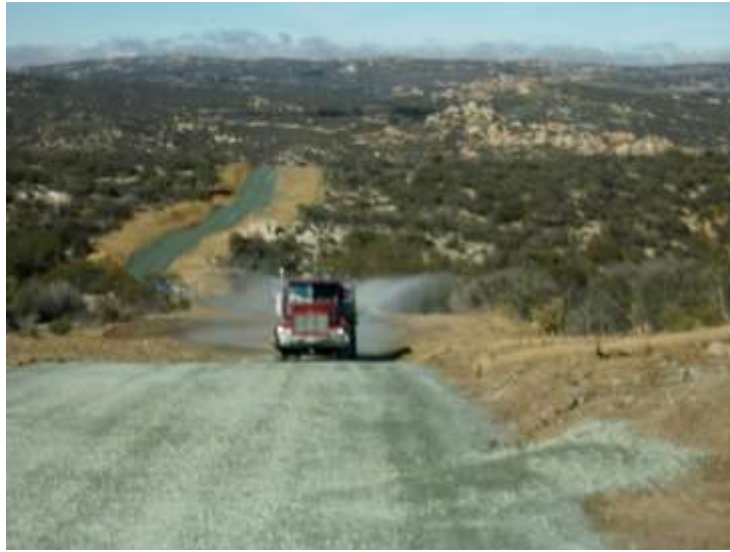
In accordance with MM-BIO-4a and MM-AQ-1, water trucks were observed watering down commonly used access roads to minimize dust emissions (see Attachment A – Photo 1). Single lane traffic control was in effect along Old Highway 80 as required by MM-TRA-1.

**Photo 1:** In accordance with MM-BIO-4a and MM-AQ-1, water trucks were diligent in watering down commonly used access roads along the underground alignment.

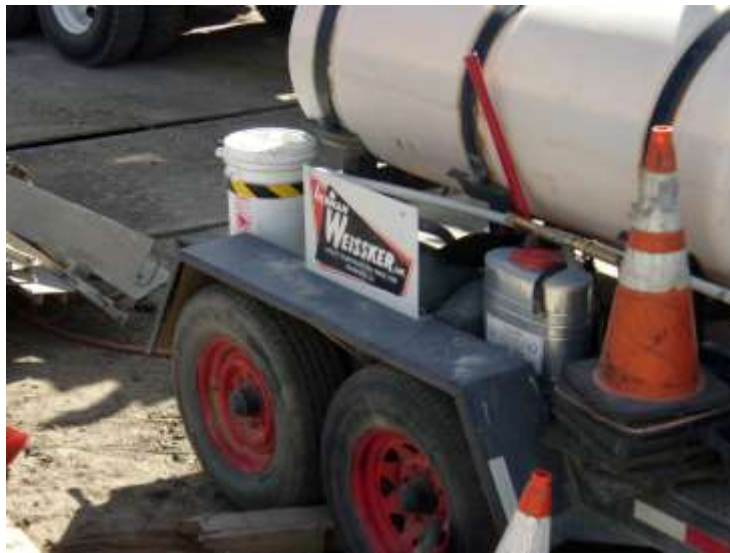
Fire tools and fire watch were on site as stipulated by MM-FF-1, and a biological monitor was present during bore pit drilling per MM-BIO-1C. Spill kits were stationed onsite and easily accessible in accordance with MM-HAZ-1a (see Attachment A – Photo 2).

**Photo 2:** Spill kits were stationed onsite and easily accessible in accordance with MM-HAZ-1a.

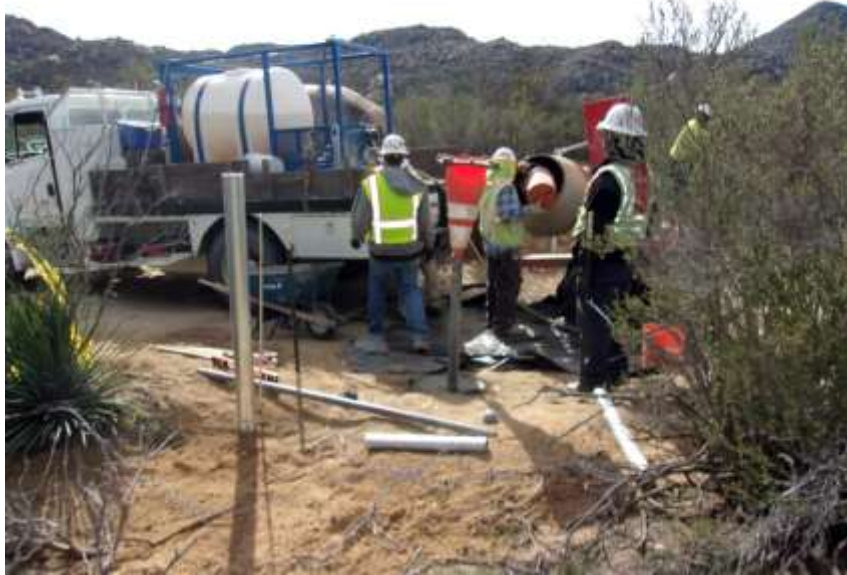
As required by MM-FF-1, fire tools and fire watch were present during fence installation along the overhead alignment. To minimize the potential for concrete spills, sheets of Vizqueen were placed under the hand concrete mixer during fence installation (see Attachment A – Photo 3).

**Photo 3:** To minimize the potential for concrete spills on, sheets of Vizqueen were placed under the hand concrete mixer during fence installation along the overhead ROW. Fire watch was on site with fire tools in accordance with MM-FF-1.

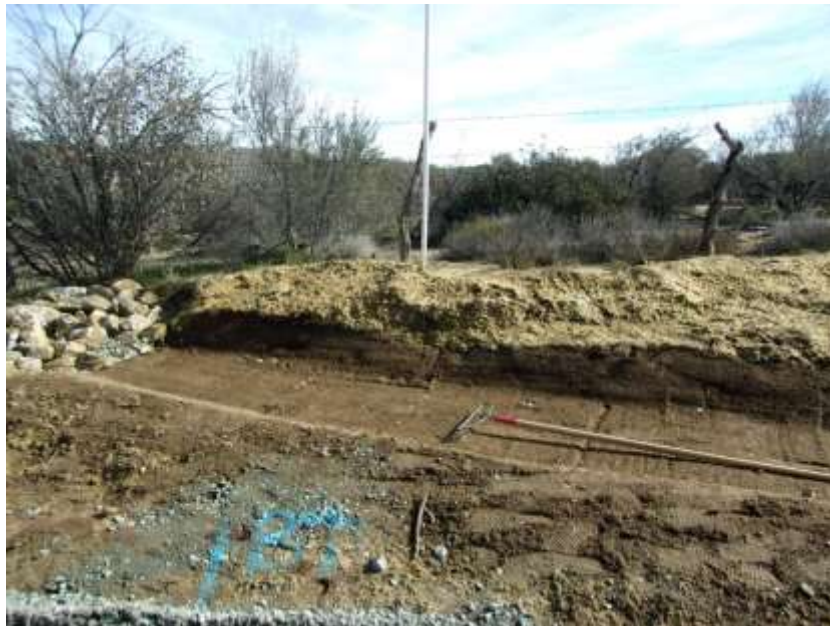
Speed limits along the overhead access road were maintained at 15mph in compliance with MM-BIO-4a and MM-AQ-1. Drainages and erosion control devices along the ROW were completed and maintained according to the Project SWPPP and MM-HYD-1 (see Attachment A – Photo 4).

**Photo 4:** Rock drainages, water bars, and other erosion control devices along the ROW were completed and maintained according to the SWPPP and MM-HYD-1.
