<p><b>California Public Utilities Commission</b>  <b><i>Mitigation Monitoring, Compliance, and Reporting Program</i></b></p>
	<p><b>East County (ECO) Substation Project</b></p> <p><b>Compliance Status Report: 018</b></p> <p><b>December 8, 2013</b></p>

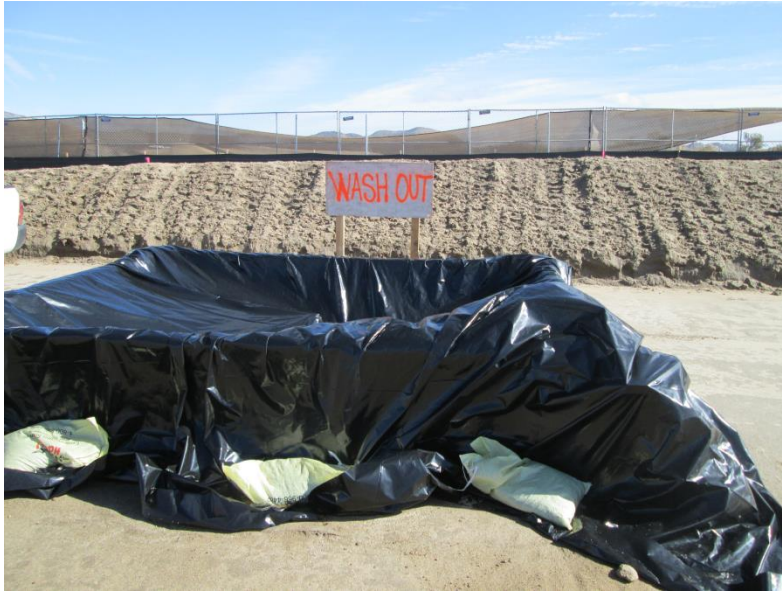
Concrete washout stations were being utilized by construction crews during foundation pours in accordance with the Stormwater Pollution Prevention Plan (SWPPP) and Mitigation Measure HYD-1 (see photo 1 – Attachment A). In addition, containment bins were observed to be placed under staged equipment, hazardous materials, and portable sanitary facilities.

**Photo 1:** A concrete washout is utilized at the Boulevard Substation Rebuild site during concrete pours associated with substation foundations in accordance with MM-HYD-1 and the SWPPP.

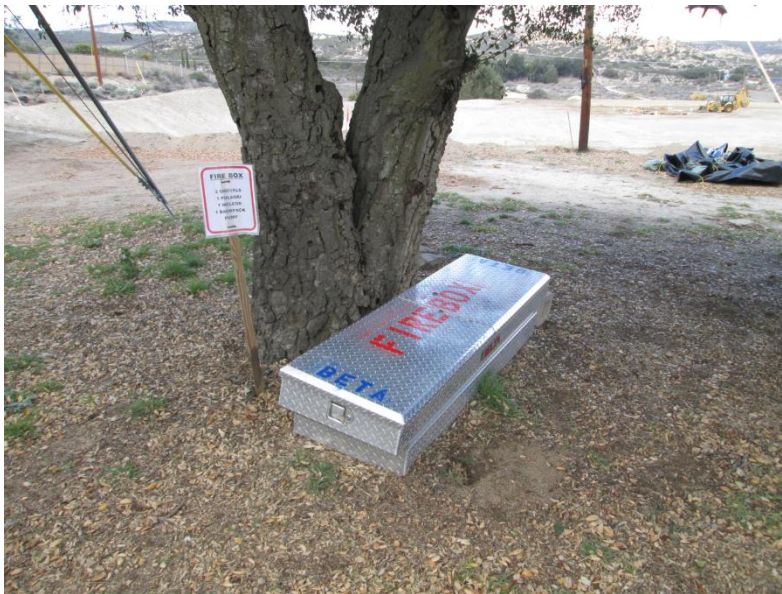
A fire box containing fire equipment was observed to be maintained on-site at the Boulevard Substation Rebuild Site and fire patrols were on-site during construction activities to provide ongoing fire patrols in accordance with the Construction Fire Prevention Plan (Mitigation Measure FF-1) (see photo 2 – Attachment A).

**Photo 2:** A Fire Box containing fire equipment is maintained onsite at the Boulevard Substation Rebuild Site in accordance with the Construction Fire Prevention Plan (Mitigation Measure FF-1).

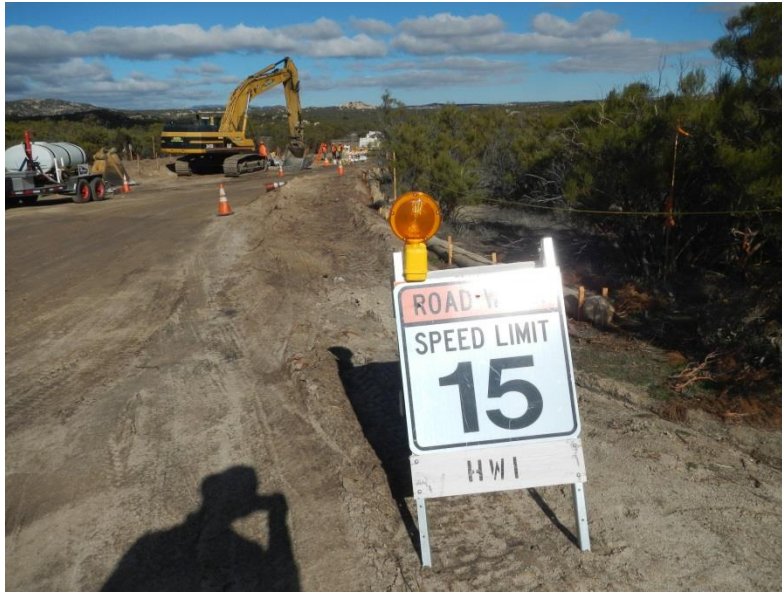
Speed limit signs were observed to be posted along access roads during construction (see photo 3 – Attachment A). In accordance with Mitigation Measure BIO-7b, construction vehicles are not to exceed 15 miles per hour on unpaved roads and the right-of-way accessing the construction site. Third-party environmental compliance monitors observed construction vehicles adhering to the posted speed limits.

**Photo 3:** In accordance with MM-BIO-7b, speed limit signage is posted along access roads during construction of the 138 kV underground alignment. Construction vehicles are not to exceed 15 miles per hour on unpaved roads and the right-of-way accessing the construction site.

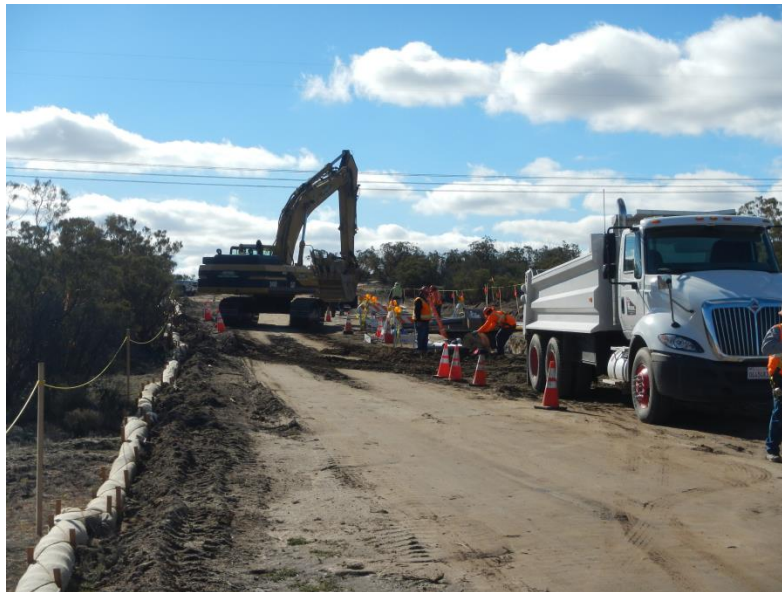
Erosion control devices including silt fence and straw wattles have been placed along the limits of work to minimize the potential for pollutants and sediment to be discharged offsite. The erosion control features have been observed to be maintained in accordance with the SWPPP and Mitigation Measure HYD-1. In addition, yellow ropes have been installed to delineate the approved project work limits during construction activities associated with underground transmission line alignment in accordance with Mitigation Measure BIO-1a (see photo 4 – Attachment A).

**Photo 4:** Yellow ropes are utilized to delineate the approved work limits during construction activities associated with the underground alignment in accordance with MM-BIO-1a. BMPs consisting of straw wattles are also placed along the work limits in accordance with MM-HYD-1 and the SWPPP.

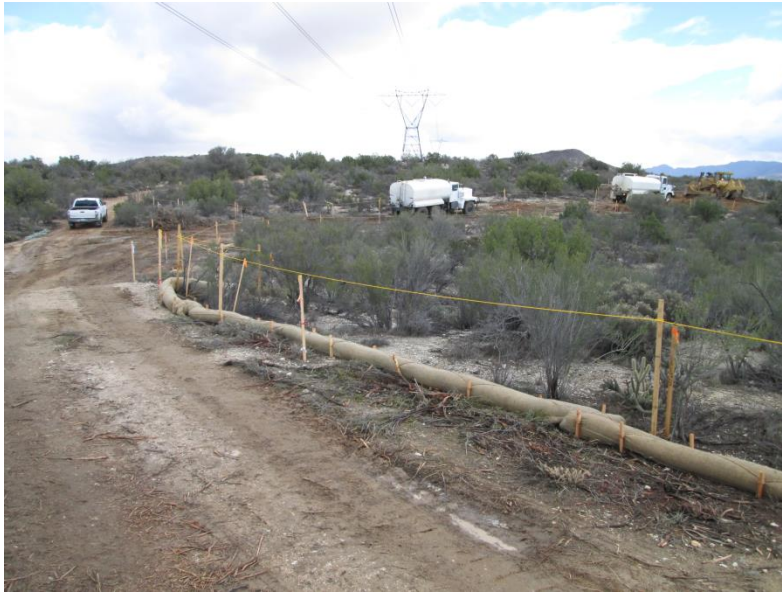
Construction crews were observed grading the pad site for Steel Pole 75. In accordance with the Dust Control Plan and Mitigation Measure BIO-4a, water trucks were observed watering down areas of active construction to prevent fugitive dust (see photo 5 – Attachment A).

**Photo 5:** Water trucks are utilized during clearing and grading activities associated with steel pole pad sites for the overhead alignment in accordance with MM-BIO-4a.

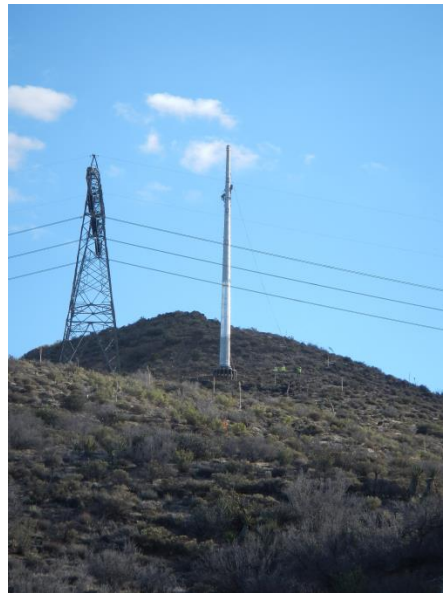
Steel Pole 75 was fully erected during this reporting period on Friday, December 6. An Air Crane helicopter was used to set the steel pole due to the weight of the pole and accessibility to the site (see photo 6 – Attachment A).

**Photo 6:** Steel pole 75 was erected during this reporting period. Work activities were observed being completed within the approved work limits as required in MM-BIO-1a.

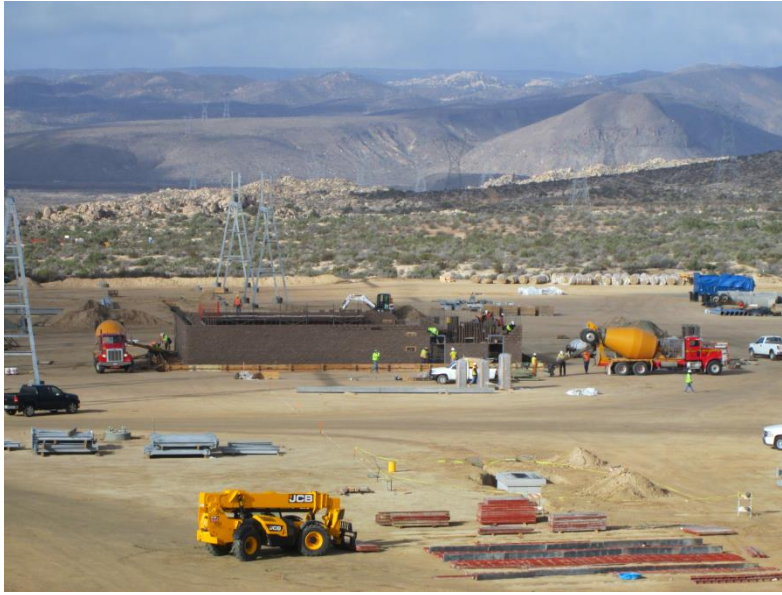
**Photo 7:** The control shelter at the ECO substation was observed being constructed with an Otay Ranch Brown-colored split face concrete block in accordance with the Surface Treatment Plan and MM-VIS-3g.

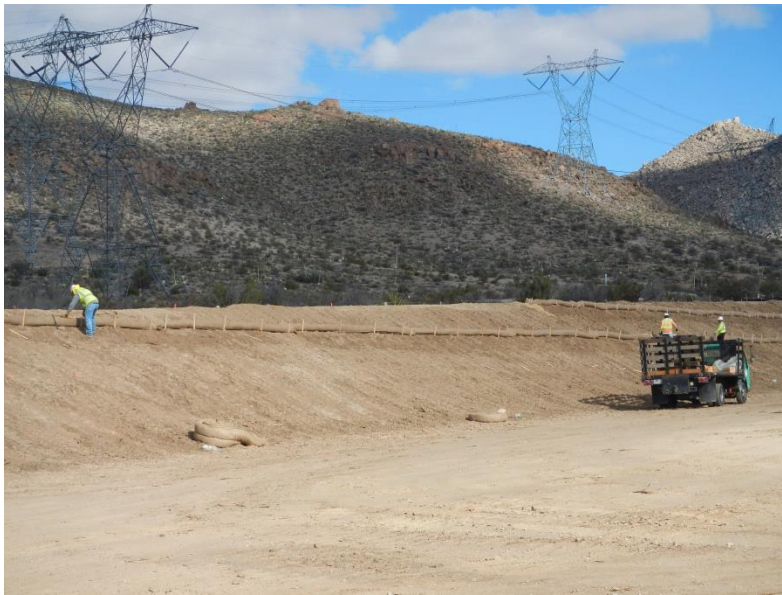
**Photo 8:** BMPs consisting of straw wattles were observed being placed along slopes at the ECO substation site in accordance with the SWPPP and MM-HYD-1.

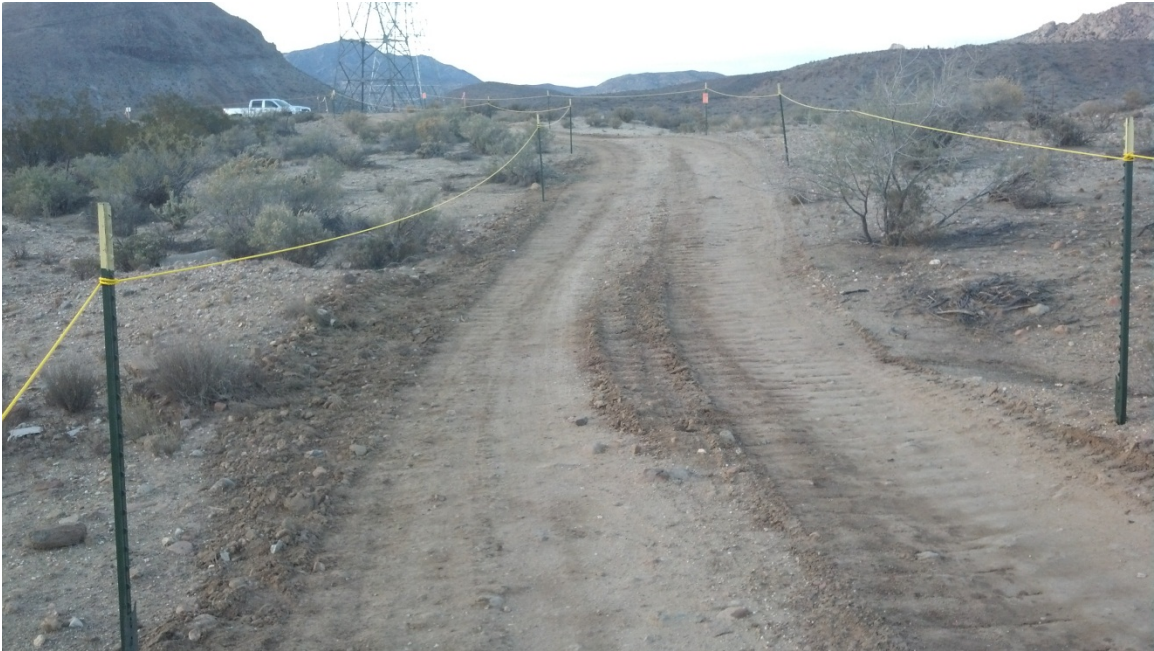
On November 26, 2013, at approximately 1000, Steve Diaz (Lead Environmental Inspector [LEI], Insignia Environmental [Insignia]) was informed by Dean DiTommaso (Lead Avian Biologist/Environmental Inspector, Insignia) that while mobilizing to the Section 2 138 kilovolt (kV) Overhead Transmission Line steel pole (SP-) 86 work site, a tracked Caterpillar D-8 bulldozer traveled off of the approved access road for the East County Substation Project (Project). The bulldozer disturbed an area measuring approximately three by six feet that was adjacent to the access road.

The EI and the on-site Archaeological Monitor determined that there was no visible damage to sensitive resources. Approximately 25 square feet of native salt bush scrub was disturbed outside of the access road limits. The root systems remained intact, and little soil disturbance occurred. No rare plant species were impacted and no drainages under the jurisdiction of the United States Army Corps of Engineers, California Department of Fish and Wildlife, or Regional Water Quality Control Board were disturbed.

This incident was documented as a non-compliance because there was ground disturbance within an ESA and there was minor damage to a native vegetation community outside of the approved work limits. MMs BIO-1A and CUL-1A of the Project's Mitigation Monitoring, Compliance, and Reporting Program require that all construction-related activities be limited to approved work limits and outside of ESAs.

Photograph 1: View facing west of the area of disturbance along the left-hand side of the road.

Upon review of the area by the on-site Archaeological Monitor, it was determined that additional roping and signage would be prudent to avoid additional off-road travel along the access road. The entire access road was roped off and additional ESA signs were installed at consistent intervals along the access road. At approximately 1700, the LEI contacted Marshall Paymard (California Public Utilities Commission [CPUC] Third-Party Environmental Monitor, Dudek) and Ed Iglesias (CPUC Third-Party Archeological Monitor, Dudek) to inform them of the off-road activity and potential encroachment into the ESA that occurred. At approximately 1730, Kirstie Reynolds (Environmental Compliance Lead, San Diego Gas & Electric Company [SDG&E]) contacted, via telephone, Lisa Orsaba (Project Manager, CPUC), David Hochart (Third-Party Project Manager, Dudek), and Keith Carwana (Third-Party Project Manager, Dudek) to inform them of the incident. In addition, Nicole Morgan (Lead Archaeologist, SDG&E) contacted, via telephone, Micah Hale (Third-Party Archaeological Project Manager, Dudek), Jeffrey Sahagun (Archaeologist, Bureau of Land Management [BLM]), and Carrie Simmons (Resource Branch Supervisor, BLM) to report the incident.

A follow-up meeting will be held between SDG&E and its contractors within one week (by December 6, 2013) to review mobilization procedures and the importance of remaining within approved work areas and on approved access roads. Extensive tailboard training will be conducted for the operators and other crew personnel that are primarily responsible for the mobilization of heavy equipment to the various work areas associated with the Section 2 138 kV Overhead Transmission Line. In addition, ESAs along narrow roads will be roped off, even if ground disturbance is not anticipated, to visually reinforce the importance of all equipment remaining within the limits of existing access roads.

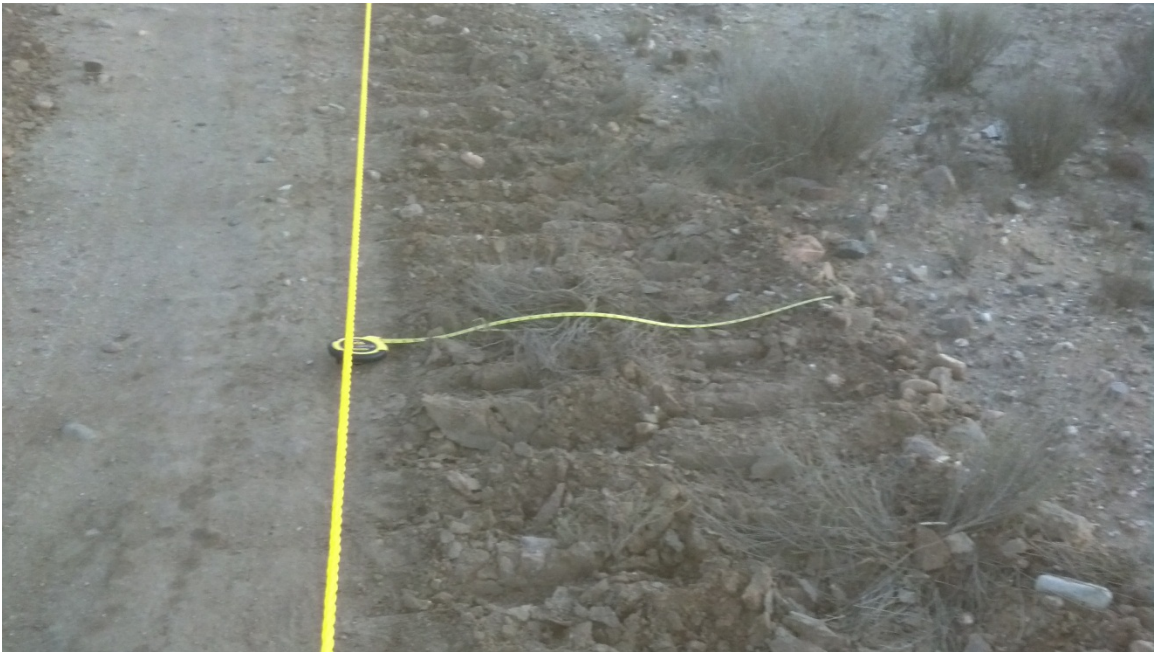
Photograph 2: View of the area of disturbance outside of the existing road limits.
