<p>California Public Utilities Commission <i>Mitigation Monitoring, Compliance, and Reporting Program</i></p>
	<p>East County (ECO) Substation Project</p> <p>Compliance Status Report: 020</p> <p>January 5, 2014</p>

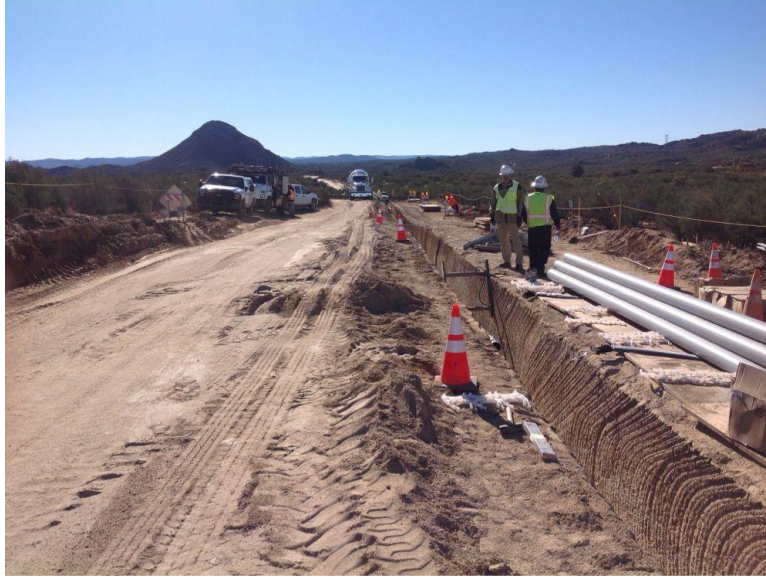
Archaeological and Native American monitors were observed monitoring construction activities along the underground 138kV underground transmission in accordance with CUL-1D. Crews were observed wearing personal protective equipment as required by the Health and Safety Program (MM-HAZ-1b). Additionally, yellow ropes have been installed to delineate the approved project work limits during construction activities associated with underground transmission line alignment in accordance with MM-BIO-1a (see photo 1- Attachment A).

Photo 1: Archaeological and Native American monitors were observed monitoring construction activities along the 138kV underground transmission line in accordance with CUL-1D.

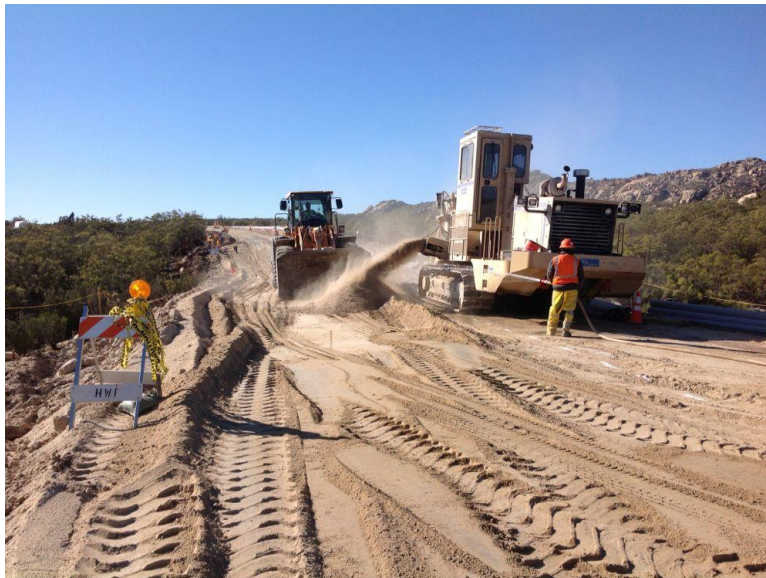
Dust control measures consisting of watering areas of active construction (see photo 2 – Attachment A), and maintaining speed limits below 15 miles per hour were observed being adhered to along unpaved roads.

Photo 2: Water was observed being utilized during excavations to minimize fugitive dust emissions in accordance with MM AQ-1 and MM BIO-4a.

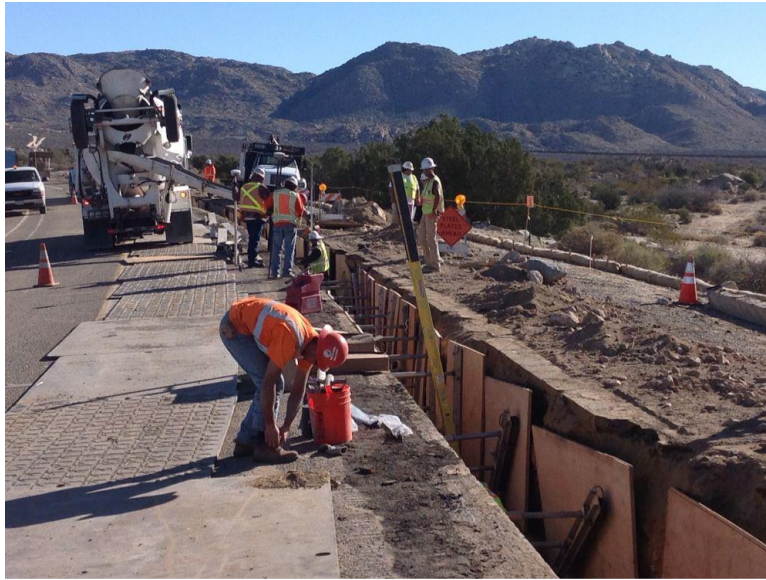
Traffic signage was observed along Old Highway 80 notifying motorists of construction activities. Steel plates were also observed being placed across the excavated trench in areas of inactive construction in accordance with the Traffic Control Plan (MM TRA-1) (see photo 3 – Attachment A).

Photo 3: Traffic signage and steel plates were observed in place in areas of inactive construction in accordance with the MM TRA-1.

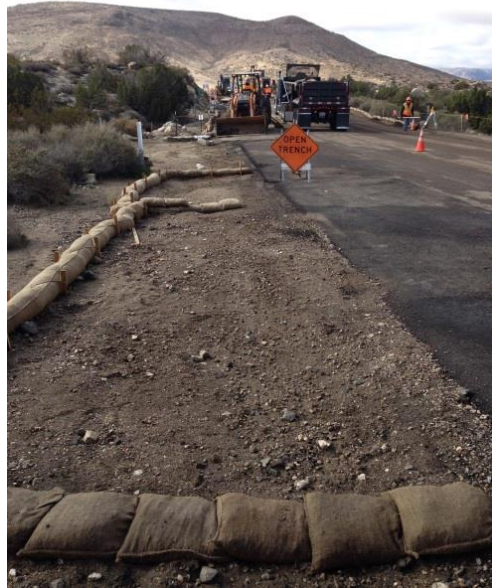
Erosion control devices including gravel bags and straw wattles were observed being maintained along the limits of work to minimize the potential for pollutants and sediment to be discharged offsite. The erosion control features are being maintained in accordance with the SWPPP Best Management Practices (BMPs) and MM-HYD-1 (see photo 4- Attachment A).

Photo 4: Erosion control devices consisting of gravel bags and straw wattles were observed installed and secured along Old Highway 80 in accordance with MM HYD-1.

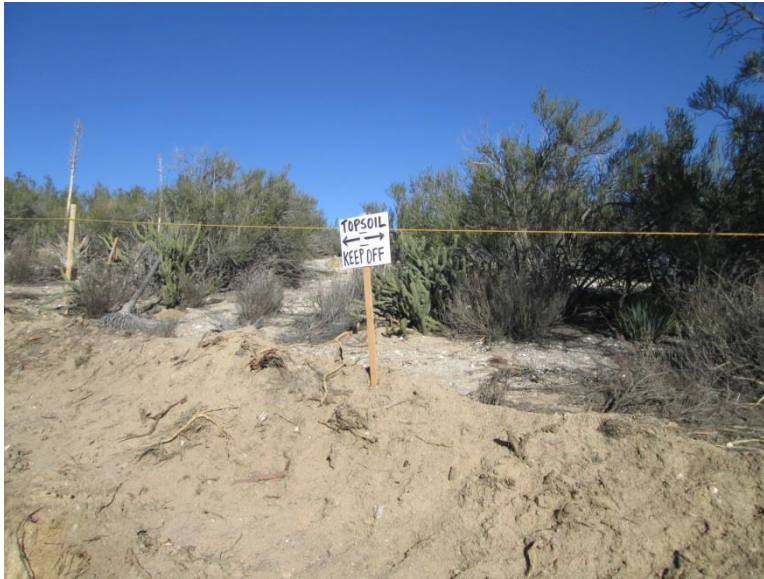
Topsoil continued to be salvaged during excavation activities and clearly marked for avoidance in accordance with the MM-BIO-1D (see photo 5- Attachment A).

Photo Topsoil was salvaged during excavation activities and clearly marked in accordance with MM-BIO-1d.

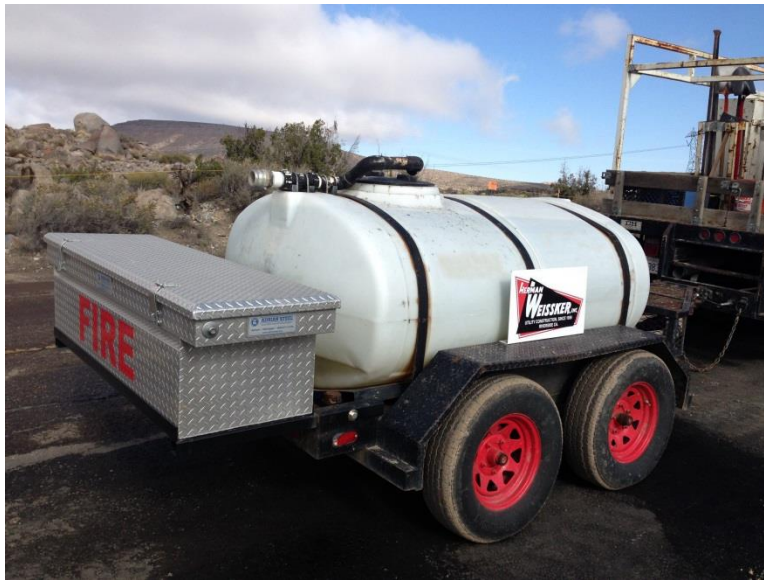
Fire boxes containing fire equipment and water trucks were observed on-site during construction activities in accordance with the Construction Fire Prevention Plan (MM-FF-1) (see photo 6- Attachment A). Fire patrols were also present during construction activities in accordance with the Construction Fire Prevention/Protection Plan and MM-FF-1.

Photo 6: In accordance with Construction Fire Prevention Plan, fire equipment boxes were observed on site during construction activities.

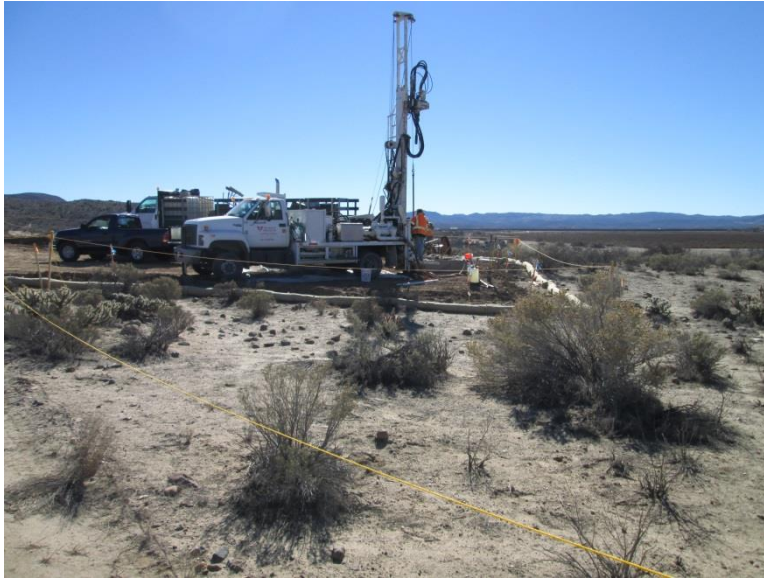
Crews performing geotechnical investigations at steel pole pad sites were observed utilizing heavy plastic under drill rigs and deploying straw wattles to prevent potential leaks from being discharged into the soil (MM HYD-1). Archaeological monitoring was observed during geotechnical activities in accordance with MM CUL-1D and work limits were delineated in accordance with MM BIO-1A (see photo 7- Attachment A). ESAs were also observed flagged for avoidance during micro pile construction in accordance with MM CUL-1D (see photo 8- Attachment A).

Photo 7: Archaeological monitors were observed present during geotechnical activities in accordance with MM CUL-1D. The drill rig shown above is staged over heavy plastic and straw wattles are in place to prevent potential leaks from being discharged into the soil.

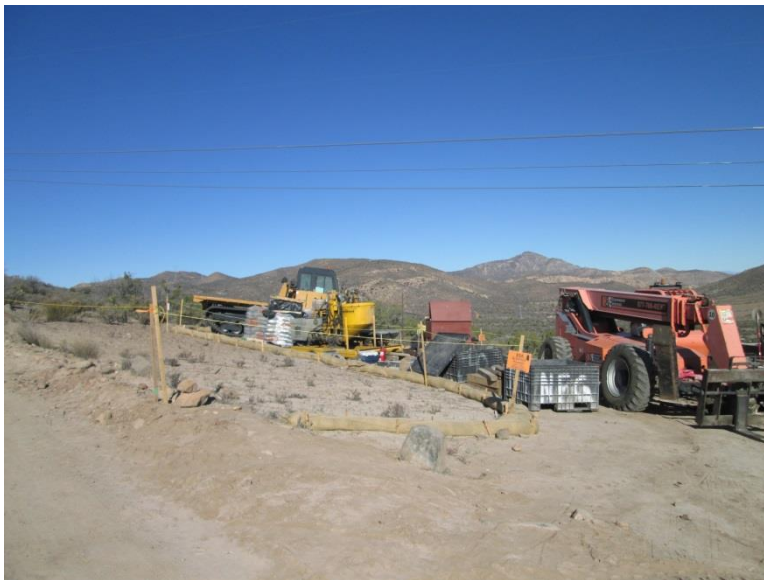
Photo 8: ESAs were observed flagged for avoidance during micro pile construction at SP- 76 in accordance with MM-CUL-1D.
