<p>California Public Utilities Commission <i>Mitigation Monitoring, Compliance, and Reporting Program</i></p>
	<p>South Bay Substation Relocation Project</p> <p>Compliance Status Report: 016</p> <p>October 31, 2015</p>

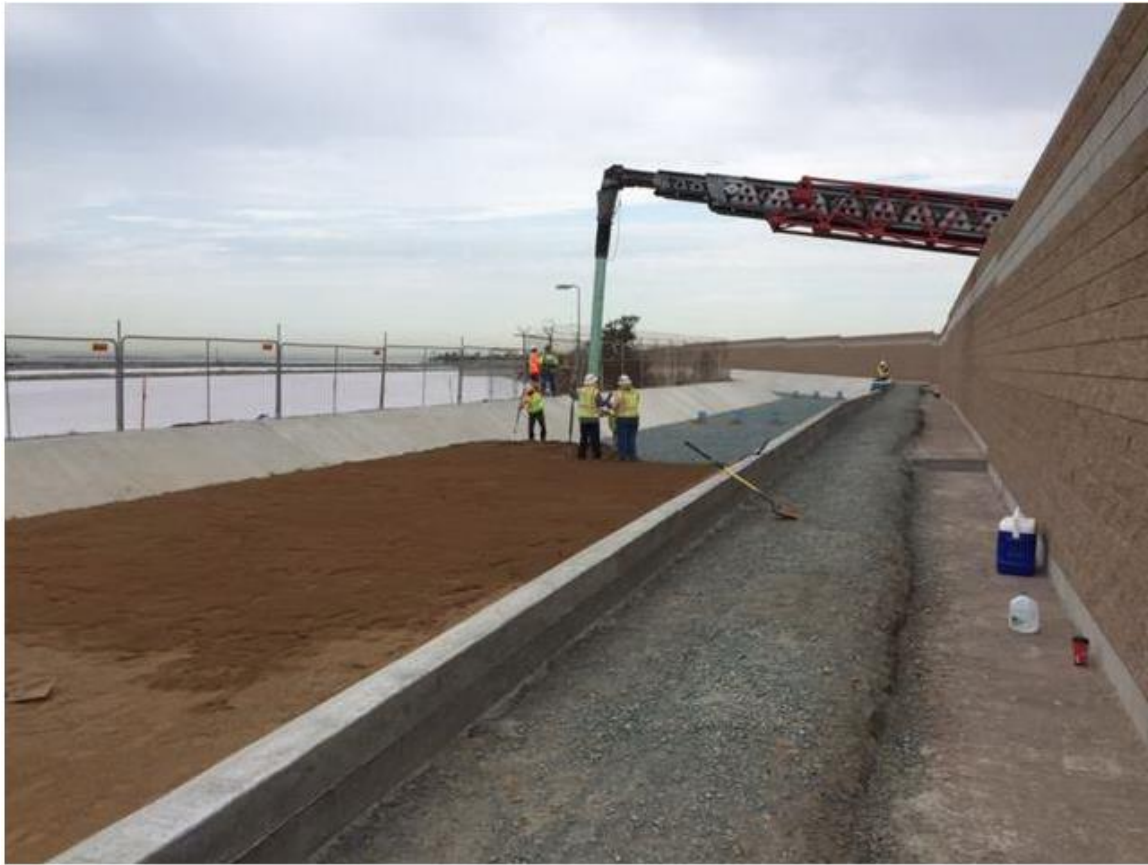
- Placing the 69 kilovolt (kV) and 230 kV transformers onto transformer pads, assembling and dressing the 230kV transformer
- Drilling for and setting foundations, setting rebar cages, and pouring concrete
- Placed engineered fill in the bioretention basin (See Photo 1—Attachment A)

Photo 1: Construction crews were observed placing engineered fill in the bioretention basin during this reporting period.

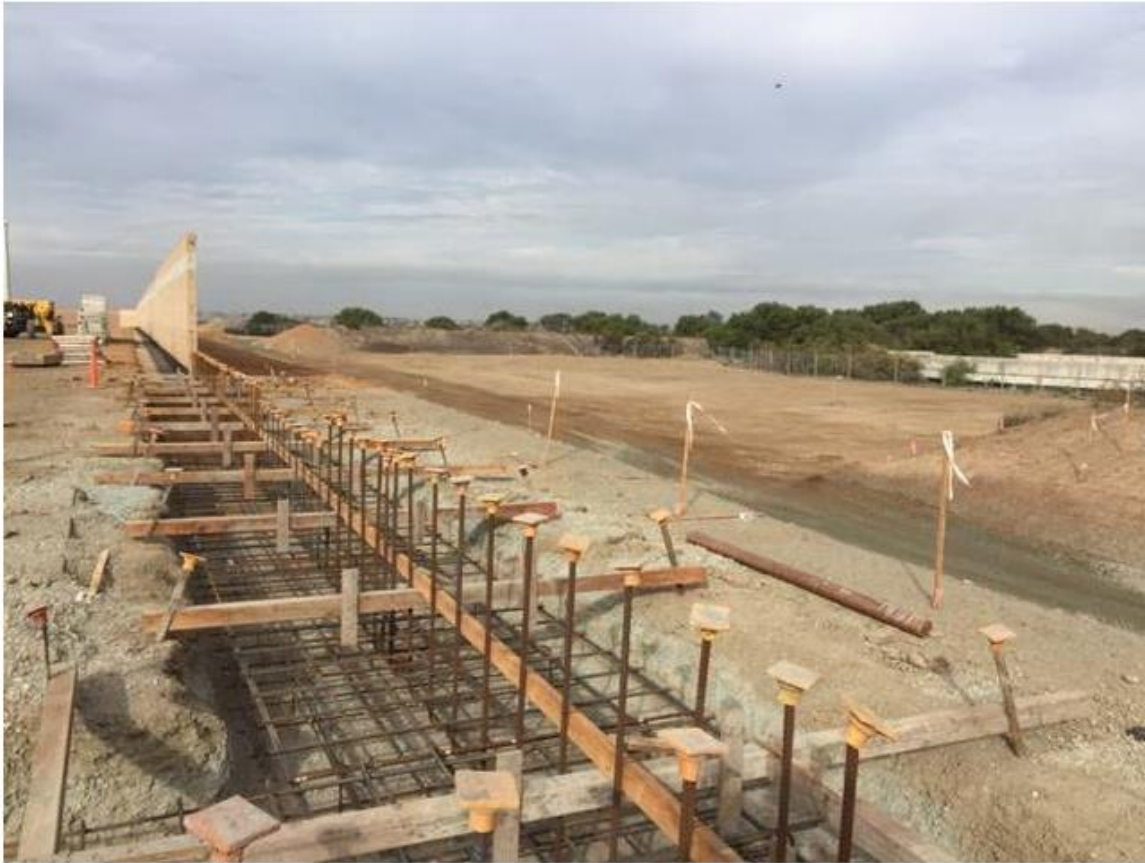
- Excavating and setting rebar for the screen wall footing on the eastern side of the substation and conducting masonry work on the wall and control shelter (See Photo 2—Attachment A)
- Erecting steel structures
- Trenching and installing duct bank within the middle and northern driveway and within the substation site; pouring concrete for wing walls for the box culvert at the southern driveway; and installing forms, pouring concrete and backfilling the box culvert at the southern driveway (See Photo 3—Attachment A)
- Installing and testing dewatering wells at pole foundation locations within the Substation
- Drilling foundation holes for the microwave tower

Photo 2: Foundation and masonry work on the construction screening wall (above) and control shelter continued this reporting period.

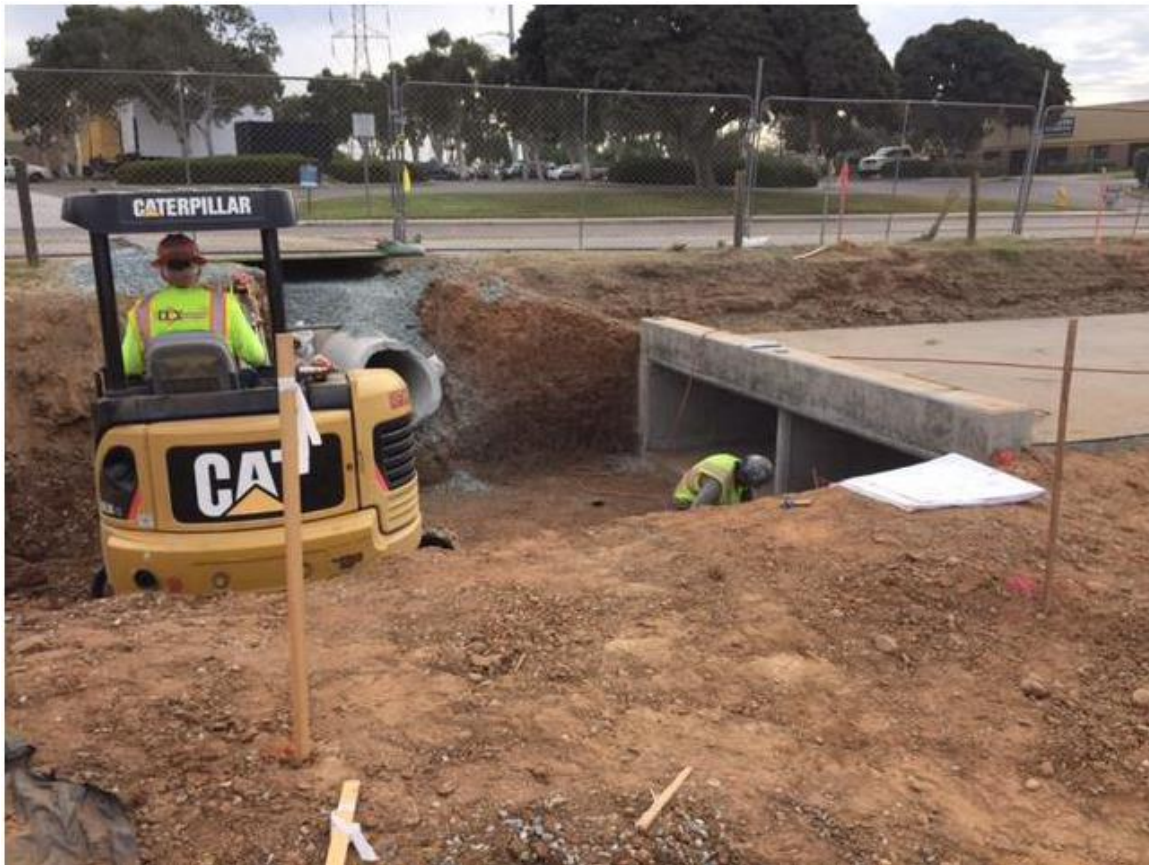
Installed gravel bag dams were observed upstream and downstream of excavation grading activities within the drainage swale for the southern driveway and associated box culvert were intact. In preparation for rain events that occurred this reporting period, visqueen was observed installed along the box culvert trench and secured with gravel bags in accordance with the SWPPP. Stockpiles were observed covered and secured with gravel bags and lined with straw wattles at the base. The qualified SWPPP Practitioner (QSP) was observed onsite conducting inspections ranging from checking equipment for leaks to checking effectiveness of BMP installation. The gravel bag dam located at the southwestern corner of the Bay Boulevard Substation appeared to be intact.

Photo 3: Continuing construction of the box culvert and excavation for the wing walls upstream of the box culvert at the Bay Boulevard Substation southern driveway site was observed this reporting period.

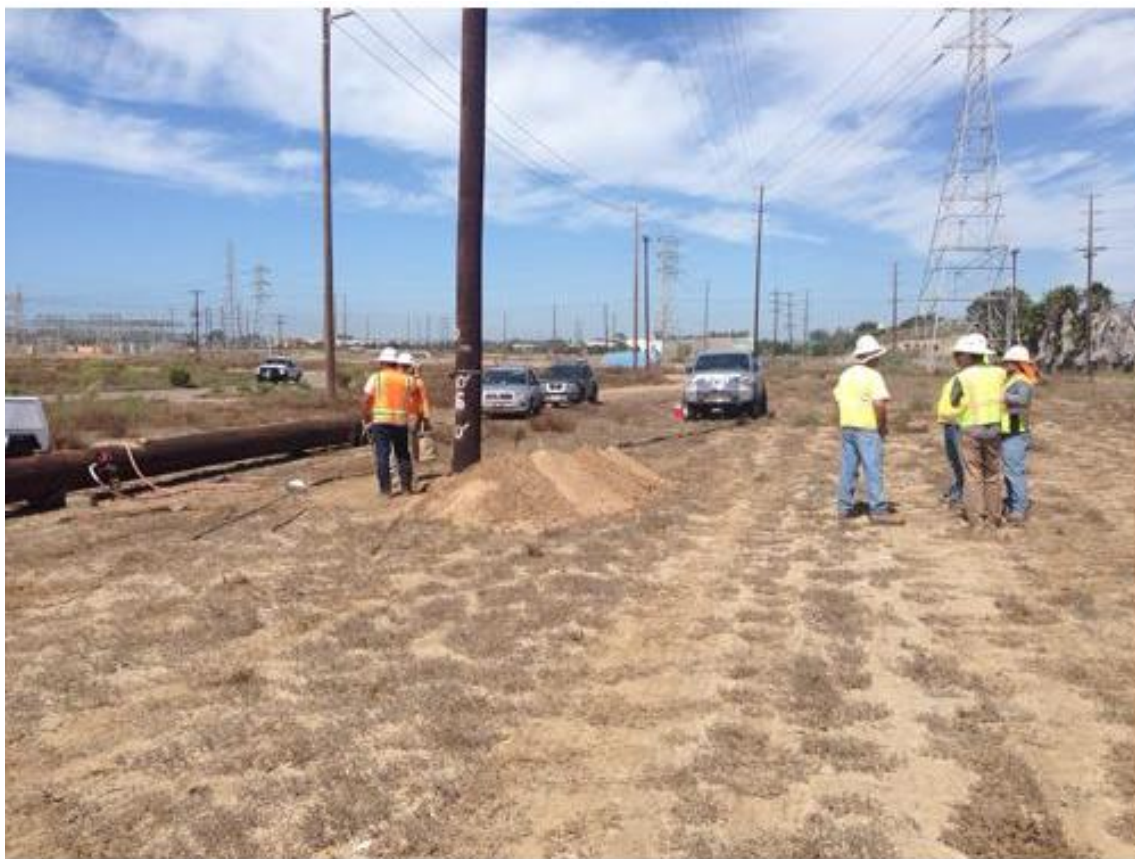
Biological, paleontological, and archaeological monitors were observed onsite during construction activities along the transmission alignment in accordance with APM-BIO-01, APM-BIO-02, MM-CUL-01, and APM-CUL-05 (See Photo 4—Attachment A). Biological monitors were observed checking heavy equipment to ensure they were free of debris prior to departure to minimize potential for off-site transport of noxious weeds in accordance with MM-BIO-04. Because initial ground-disturbing activities occurred, archaeological monitors were at the site in accordance with MM-CUL-01 and paleontological monitors were on site during drilling or ground disturbing activities having potential to impact the Bay Point Formation in accordance with APM-CUL-05.

Photo 4: During pole removal and installation along the transmission alignment, biological and archaeological monitors were observed on site in accordance with APM-BIO-01, APM-BIO-02, and MM-CUL-01, and APM-CUL-05. Paleontological monitors were observed in areas potentially affecting the Bay Point Formation in accordance with APM-CUL-5.

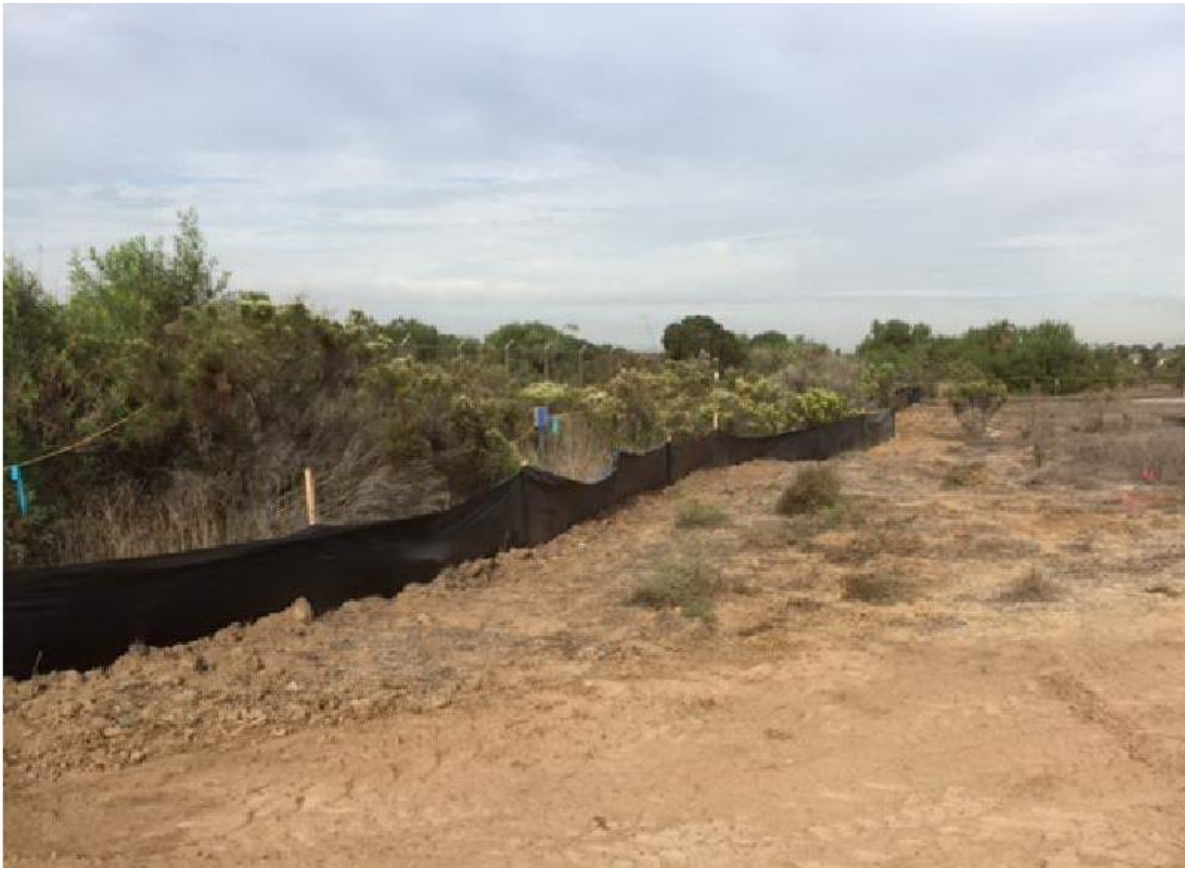
SWPPP BMPs installed at the Bay Boulevard Substation site, including silt fencing and straw wattles around the temporary perimeter fence, as well as the rock apron/rattle plates at the entrance of the Substation site and the transmission alignment, were observed to be intact and in good functioning condition. Silt fencing was also installed at the southern part of the transmission alignment, along with “Environmentally Sensitive Area” signs to protect a jurisdictional feature (See Photo 5—Attachment A). Sediment track out onto Bay Boulevard was not observed at the times of inspection.

Photo 5: Silt fencing and “Environmentally Sensitive Area” signs were used to protect jurisdictional features along the transmission line alignment.

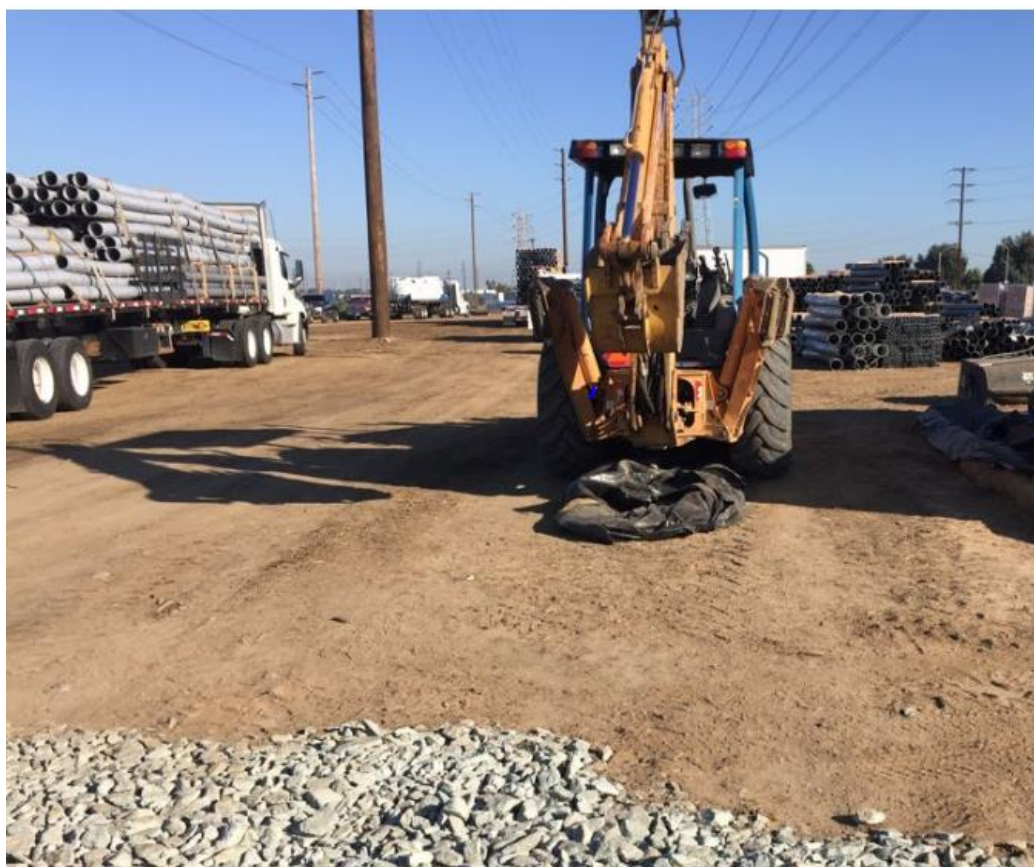
Crews were observed mobilizing and staging materials and equipment within the transmission alignment. Absorbent materials were observed under staged heavy equipment in order to prevent potential equipment leaks from penetrating soil, and waste bins were contained in accordance with the SWPPP and APM-HAZ-01. Dumpsters were observed secured and covered in order to prevent attracting wildlife or causing litter within the work area (See Photo 6—Attachment A).

Photo 6: Equipment including dumpsters, heavy vehicular equipment, building materials, etc. was staged along the transmission line alignment. Silt fencing was installed around staging areas, waste bins were observed contained, absorbent material was observed under staged vehicular equipment (above), and dumpsters were observed covered and secured to prevent attracting wildlife.
