Re: Monthly Report Summary #20 for Aliso Canyon Turbine Replacement Project

CPUC Site Inspection Reports and Site Visit Report
November 5, 12, 19, and 24, 2015

Aliso Canyon Turbine Replacement Project CPUC Site Inspection Form

Project:	Aliso Canyon Turbine Replacement	Date:	November 5, 2015
Project Proponent:	Southern California Gas Company and Southern California Edison	Report #:	VS078
Lead Agency:	California Public Utilities Commission	Monitor(s):	Vince Semonsen
CPUC PM:	Andrew Barnsdale, Energy Division	AM/PM Weather:	Clear, mild temperatures, and a light breeze.
E & E CM:	Lara Rachowicz	Start/End time:	0730 to 1130 at TSPs 14 through 35. 1130 to 1330 at the Aliso Storage Field and Telecommunications Route.
Project NTP(s):	Guard House and Road Widening (NTP-1). The new Admin/IM Building (NTP-2) and Central Compressor Station (CCS) (NTP-3). P-41 Fill Site (NTP-2), PS-42 Fill Site, P-32 Fill Site (NTP-3), and the Natural Substation (NTP-3, NTP-D). TSPs 2 through 42 (NTPs A, C, and D) and the SCE 210 Freeway Yard. Telecommunications Route 2 (NTP-E).

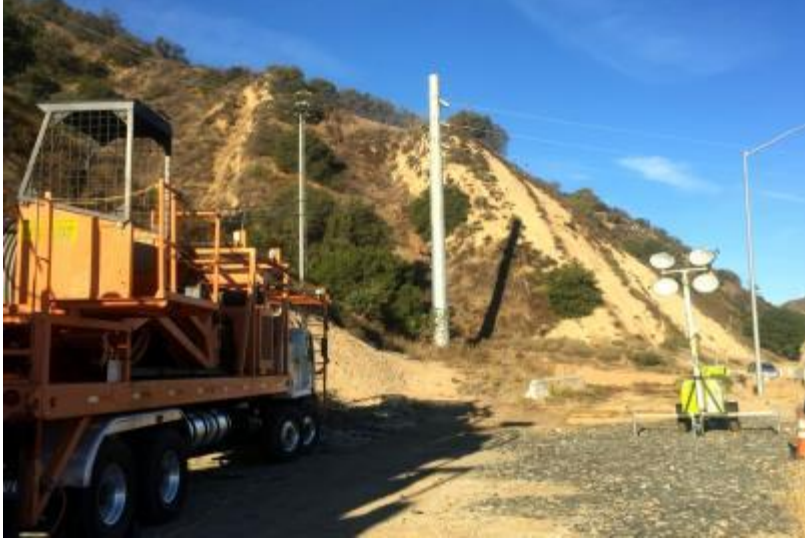
At 0730, I arrived at TSP 35 where a wire pulling rig was parked and set up to pull wire to the pole. There were no crew members onsite; however, drip pans were in place under the rigs.

Pulling wire.
11/05/15	Drainage #4 TSP 24/25 access road

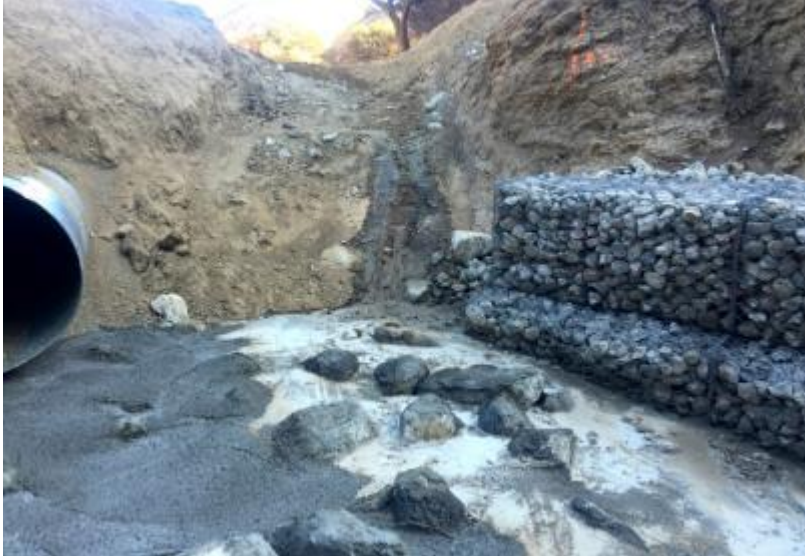
I hiked into Drainage #4 (access road to TSP 25) to check on work being conducted for the culvert. A crew was working on the header wall on the upstream side of the road crossing – see photo. The crew had previously poured concrete at the site, and it appeared that the crew had washed out the concrete truck on the creek bank, with the washout water running down into the stream channel (APM HZ-3) – see photos. I noted several other issues that would need to be addressed. Construction materials and trash were still in the drainage below the culvert work, and someone had defecated in the stream channel. In addition, a gas can was within the drainage sitting on a drip pan when it should have been within some type of containment. I spoke with Todd White (Arcadis) and Lucy Cortez (SWPPP) about these issues and they stated they would check on them and talk to the crew later in the day.

Date	Non-compliance issue and resolution	Relevant Mitigation Measure	NC Report #
11/05/15	Concrete equipment was washed out in Drainage #4.	APM HZ-3, APM HZ-5	NCR-09

Concrete washout.
11/05/15	Drainage #4 TSP 24/25 access road

Check on clean-up of the concrete washout in Drainage #4.

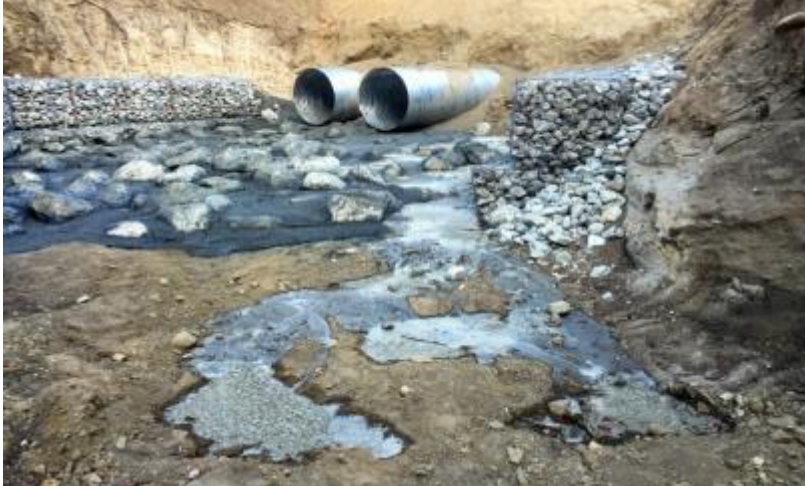
Concrete washout.

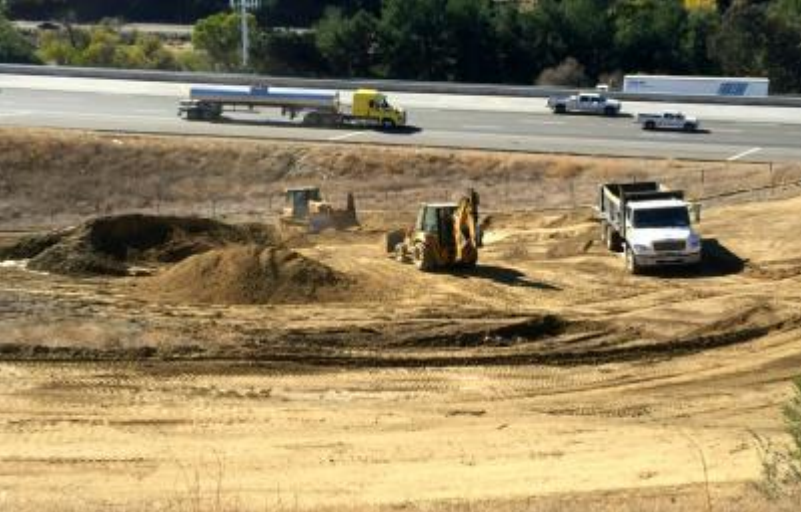
Lucy Cortez (SWPPP) drove me to TSP 14 where crews were installing two McCarthy drains – see photos. We observed the crew loading the topsoil at TSP 15 – see photo. We stopped at TSP 19 where a crew was completing the final grading of the pole site and installing a McCarthy drain. Biological monitor Shannon Dye (APM BR-1d and APM BR-6) and paleontological monitor Leann Hirsch (MM CR-1, MM CR-3, MM CR-6, and MM CR-8) were observing this activity. A water truck was wetting the access road (APM AQ-3 and APM AQ-6), and a fire crew was onsite (MM HZ-2).

Stockpiled topsoil is being loaded and transported for restoration.
11/05/15	Pull station between TSPs 21 and 22

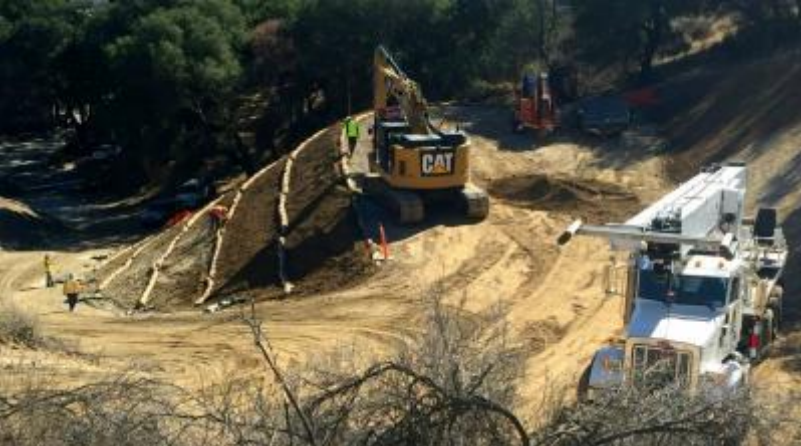
At 0930, I met with Todd White and Arcadis botanist Mary Carroll at TSP 21. Todd and Mary discussed topsoil replacement for site restoration with Lucy Cortez (SWPPP), specifically where to place the topsoil and how to stabilize the soil on the slopes. The preferred method of topsoil stabilization could be a combination of jute netting and hydromulch. Topsoil had been stockpiled at TSP 15, and this topsoil was now being loaded and transported to the pull station between TSPs 21 and 22 – see photo. An excavator was placing the topsoil on the pull station fill slope – see photo. The SWPPP crew was spreading the topsoil (APM BR-3, APM GE-2). There were large quantities of stockpiled topsoil, and the expectation is that this topsoil will be spread at the TSP 22 and TSP 21 pull stations, as well.

Placing topsoil on the pull station fill slope.

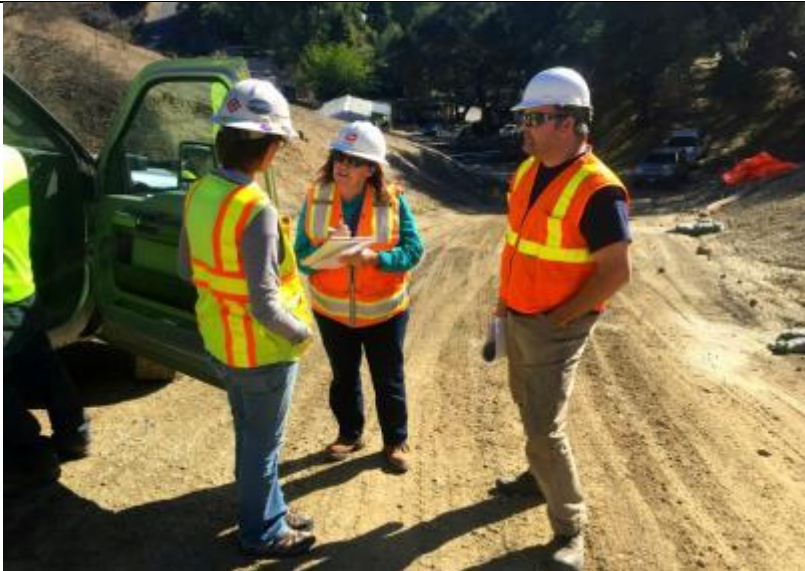
Todd White, Lucy Cortez, and Mary Carroll discussing topsoil placement and stabilization.
11/05/15	TSP 14	 	McCarthy drain installation.
11/05/15	TSP 14	 	McCarthy drain installation.

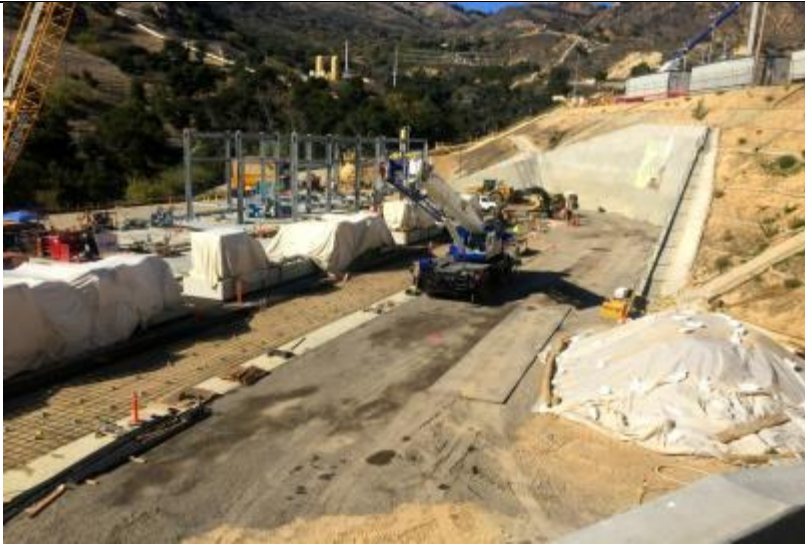
conducted, including equipment installation and forming/pouring foundations – see photos.

A wide-angle photograph of a construction site. In the foreground, there are large piles of material covered with white plastic sheeting. A blue crane is positioned in the middle ground, and another yellow crane is visible in the background. The site is surrounded by a dirt embankment and some vegetation.	Ongoing construction.
11/05/15	CCS

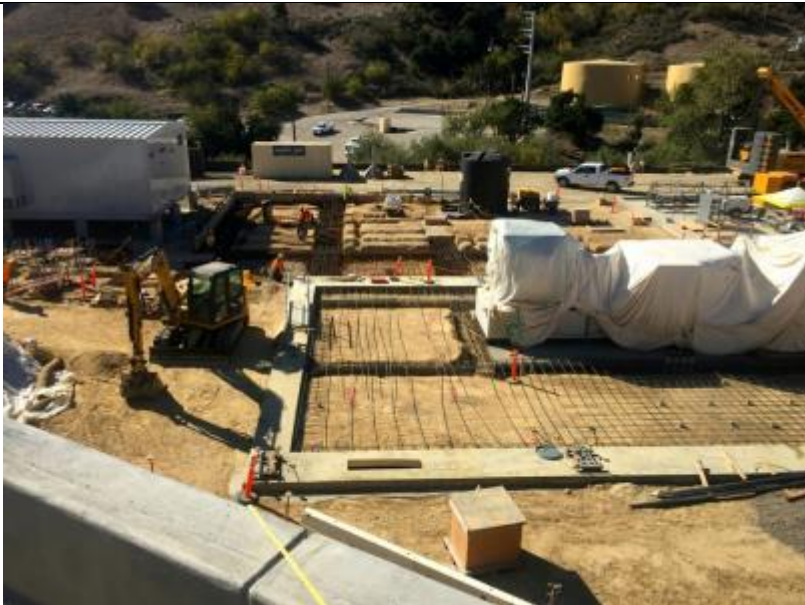
A photograph showing a construction site with a large rectangular area of rebar laid out on the ground, ready for a concrete pour. A yellow excavator is visible on the left side of the frame. In the background, there are yellow storage tanks and other construction materials. The site is bordered by a concrete wall in the foreground.	Ongoing construction.

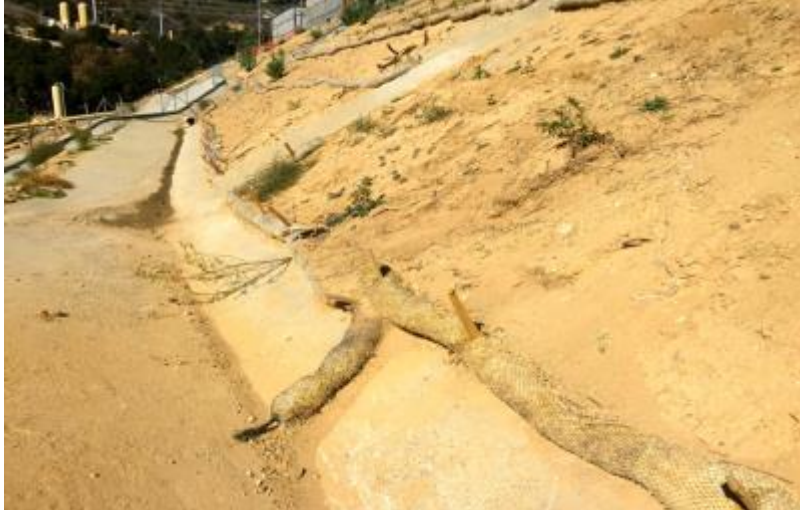
At the CCS, work continued on equipment installation and foundations – see photo. I checked the slopes above and below the CCS and evaluated the BMPs. Most of the wattles, drains, and catch basins need to be repaired, upgraded, or replaced – see photos. Weeds are growing on the slopes, including Russian thistle (aka tumbleweed), castor bean, and fountain grass. The castor bean is especially abundant on the slope below the CCS – see photo. While weedy vegetation can help to stabilize the slopes, the Russian thistle will soon die, break off, and spread seed.

Slope above the main CCS area – note the BMPs in need of repair or replacement.
11/12/15	CCS

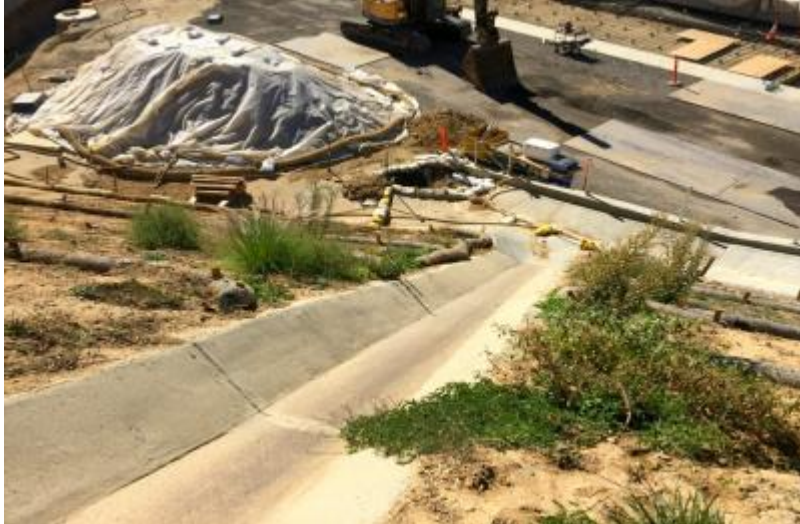
Slope above the main CCS area – note the weeds, as well as the BMPs in need of repair or replacement.
11/12/15	CCS

Removal of Russian thistle is recommended since it will soon die, dry out, break off, and begin spreading seed.

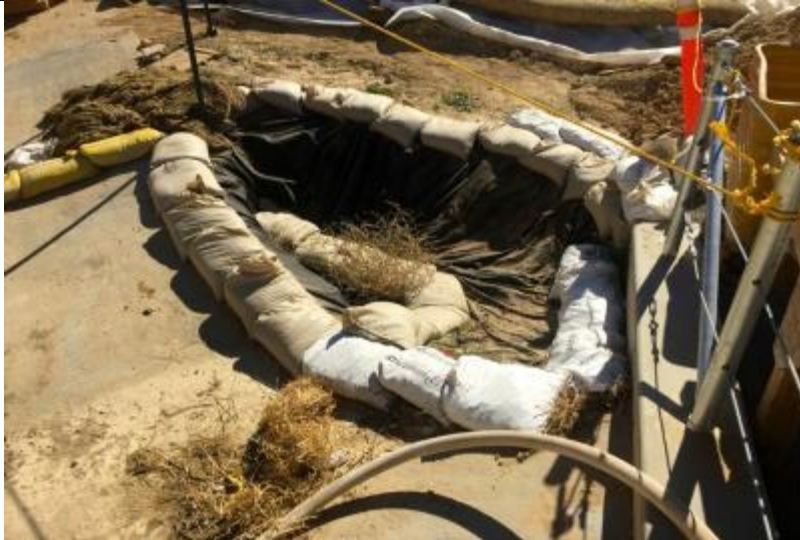
Drain catching runoff from the slopes above the CCS site; needs BMP repairs and/or upgrades.

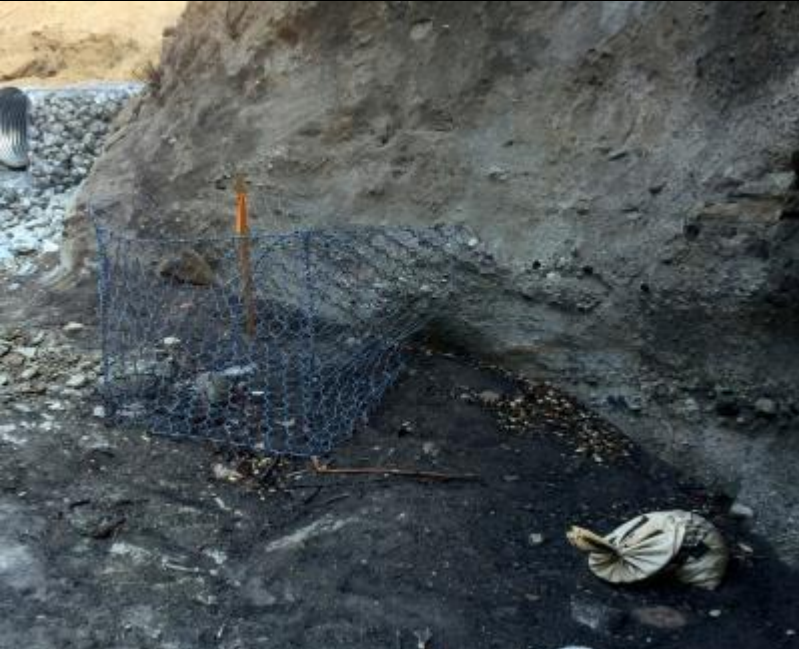
Construction materials in the drainage.

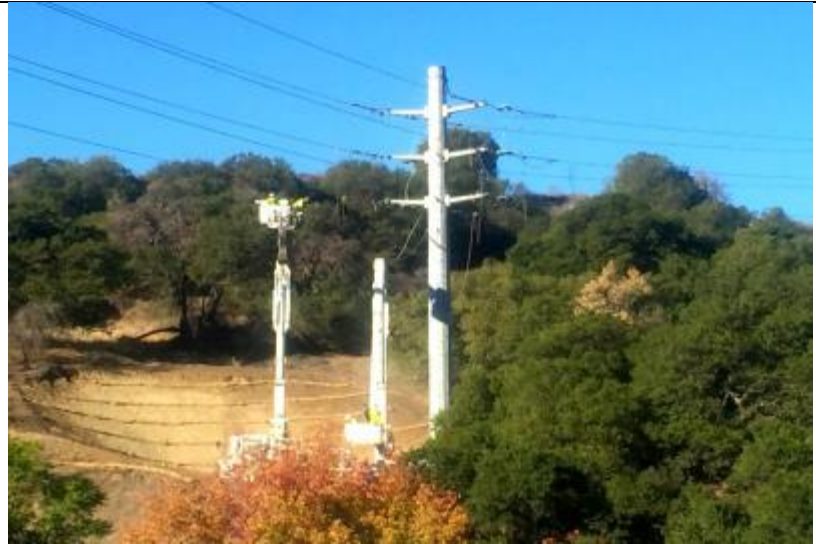
Crews are stringing wire.
11/19/15	TSP 21 and pull station

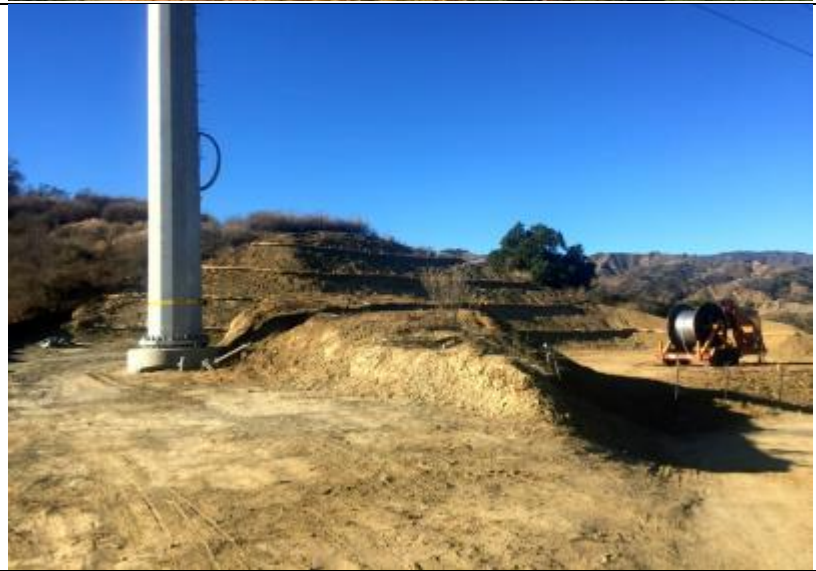
I drove to TSP 21 where I checked on the restoration work at TSPs 21 and 22 and at the three pull sites – see photos. All of the stockpiled topsoil had been replaced covering most of the pull site slopes. Stabilization of the topsoil had not been completed. I spoke with a SWPPP crew member, Mark (unknown last name), and he stated that they are waiting on a determination as to what materials they will use. We also discussed the BMP work needed at TSP 32 and at the entrance to the TSP 12 through 22 access road at the Mobile Estates. The crew had already placed gravel check dams along the access road.

Topsoil restoration.
11/19/15	TSP 21/22 pull station

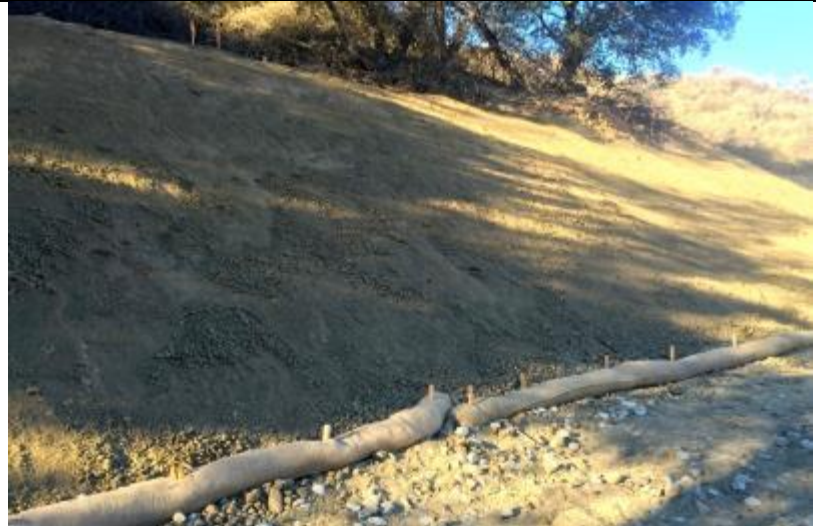
Restored slope above the pull station.

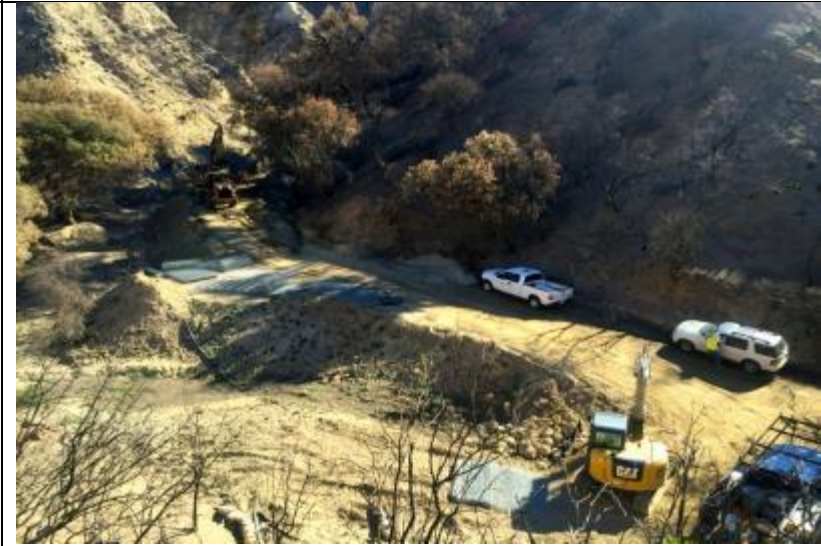
I met with Todd White (Arcadis) at the Mobile Estates and we drove into the TSP 24/25 area. The entrance road was in good condition and a large crew was working on installation of a Hilfiker wall along the access road to TSP 25 – see photos. The work was being conducted in Drainage #4, which runs along the access road; both biological (APM BR-1d and APM BR-6) and paleontological (MM CR-1, MM CR-3, MM CR-6, and MM CR-8) monitoring is being conducted at this site. A soil plug remained in the drainage; the drainage was being used as a parking and stockpile area. A concern is whether road stabilization drainage restoration can be completed before the winter rains. I spoke with Todd White about this and suggested they consider removing the soil plug as soon as possible; Todd said he had these same concerns and had passed them along to Lucy Cortez.

Installation of a Hilfiker wall.
11/19/15	Drainage #4 TSP 24/25 access road

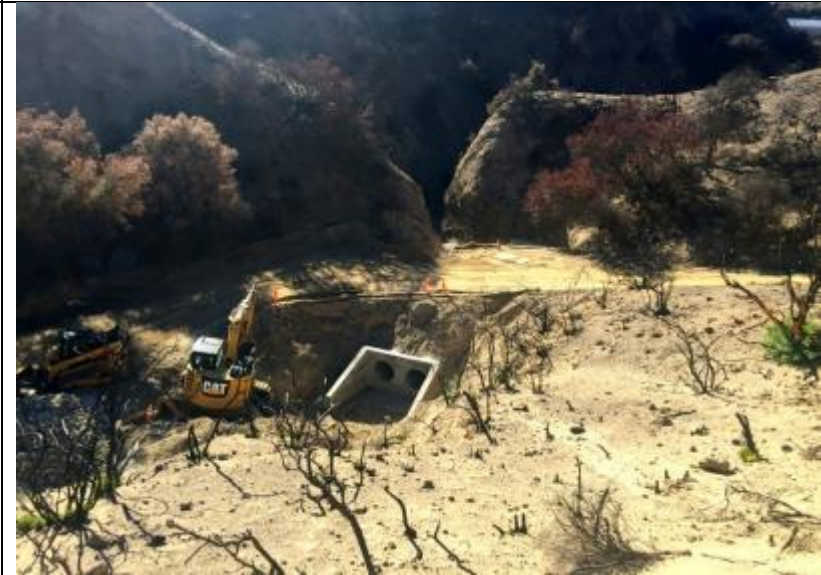
Equipment and materials are parked/stored in the drainage.
11/19/15	Admin/IM Building

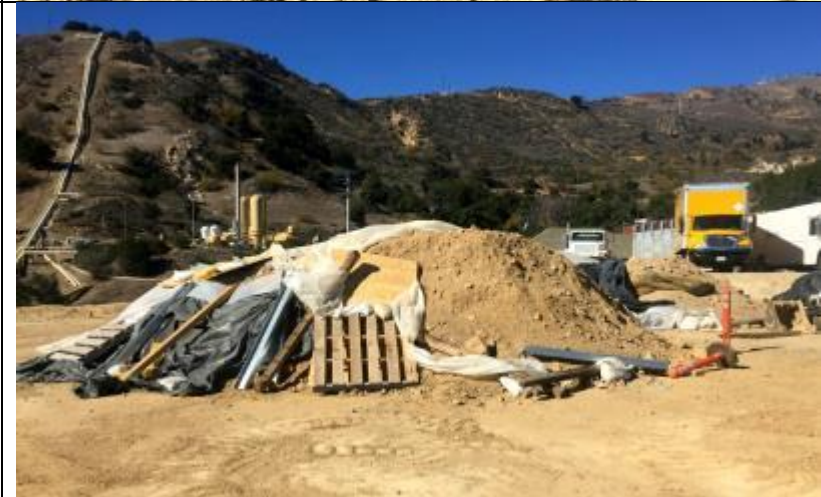
Trenching activity continued at the new Admin/IM Building site; there were several open trenches and a large stockpile of soil – see photos. Coverage of some of the stockpiled soil needs repair. BMPs on one of the slopes needs maintenance.

Soil pile with what appears to be numerous attempts to cover it.

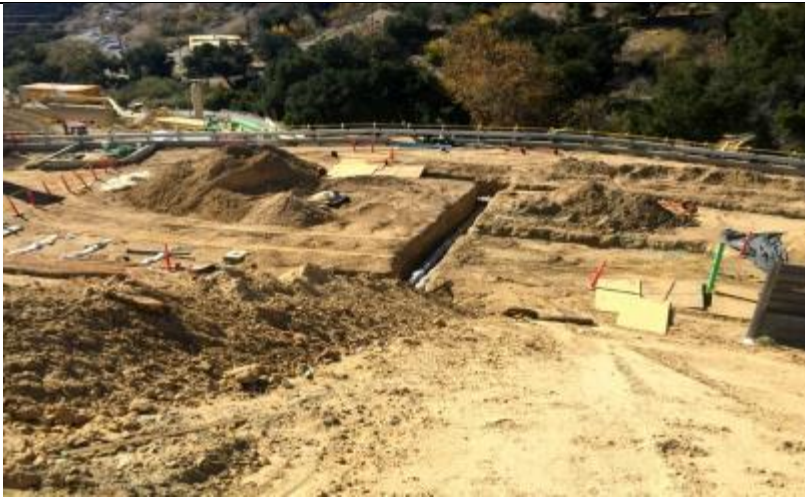
Trenching and earthen piles.
11/19/15	Admin/IM Building

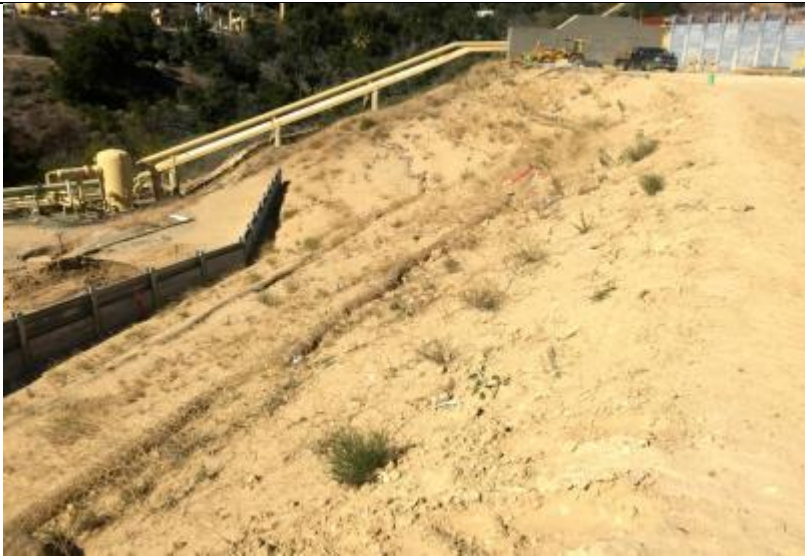
Slope between the two aspects of the new Admin/IM Building – showing BMPs.
11/19/15	CCS

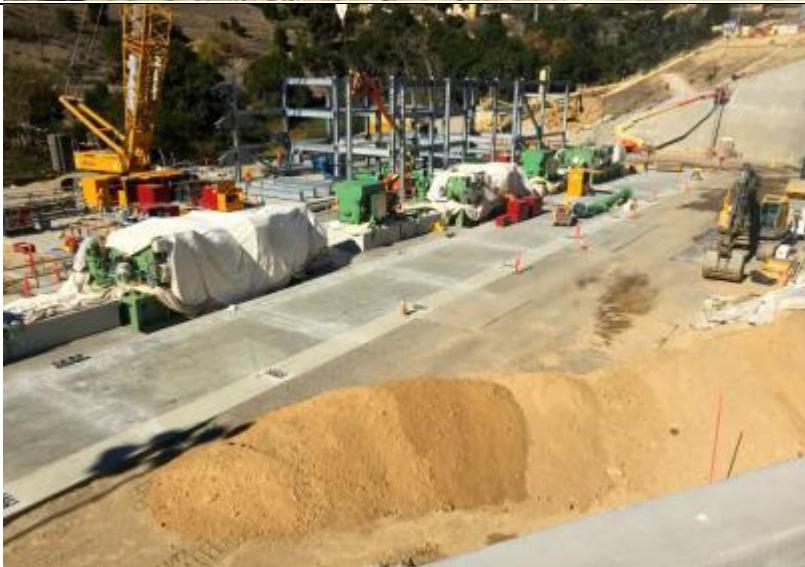
At the CCS, work continues on equipment installation and foundations, and more of the area now paved – see photo. BMPs above and below the CCS need repair and/or upgrades; site drainage remains a concern.

Site overview.
