Re: Monthly Report Summary #21 for Aliso Canyon Turbine Replacement Project

CPUC Site Inspection Reports and Site Visit Report
December 3-4, 8, 23, and 30, 2015

Aliso Canyon Turbine Replacement Project CPUC Site Inspection Form

Project:	Aliso Canyon Turbine Replacement	Date:	December 3 and 4, 2015
Project Proponent:	Southern California Gas Company and Southern California Edison	Report #:	VS082
Lead Agency:	California Public Utilities Commission	Monitor(s):	Vince Semonsen, Lara Rachowicz, Andres Estrada, Jenny Vick
CPUC PM:	Andrew Barnsdale, Energy Division	AM/PM Weather:	Partly cloudy and cool with some gusty winds on the morning of 12/4/15.
E & E CM:	Lara Rachowicz	Start/End time:	12/3: 0930 – 1600 (Telecommunications Route 2 and 66-kV line). 12/4: 0800 – 1230 (Aliso Canyon Natural Gas Storage Field).
Project NTP(s):	Guard House and Road Widening (NTP-1). The new Admin/IM Building (NTP-2) and Central Compressor Station (CCS) (NTP-3). P-41 Fill Site (NTP-2), PS-42 Fill Site, P-32 Fill Site (NTP-3), and the Natural Substation (NTP-3, NTP-A). TSPs 2 through 42 (NTPs A, C, and D) and the SCE 210 Freeway Yard. Telecommunications Route 2 (NTP-E).

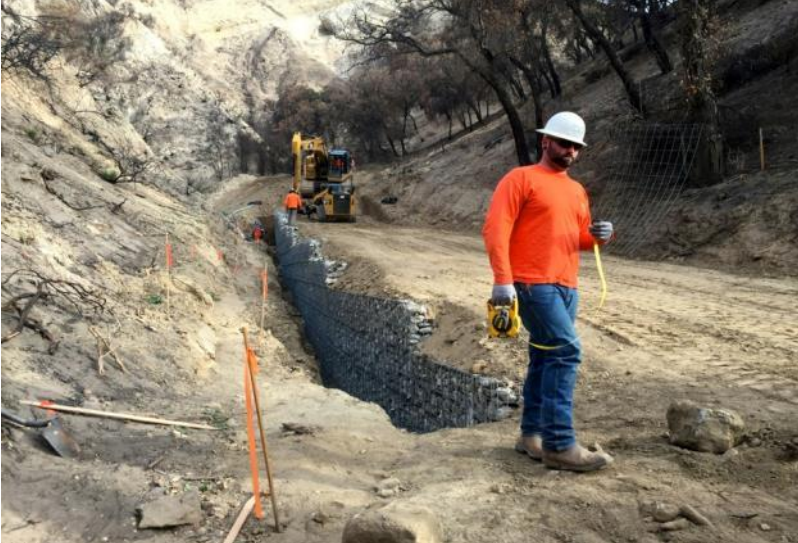
We walked to the TSP 24/25 access road and observed the road stabilization work that has been conducted in Drainage #4. The Hilfiker wall has been completed, and the crew was backfilling the area around and over the wall (see photo). The work was being overseen by biological monitor Shannon Dye (APM BR-1d and APM BR-6). During the site visit, there were no issues with soil being tracked out onto the paved road (APM AQ-7) or with dust (APM AQ-6). The crew indicated that they had several more weeks of work, as creek restoration was yet to be completed (see photo).

Hilfiker wall has been installed; crews are backfilling the area over and around the wall.
12/03/15	Drainage #4 TSP 24/25 access road

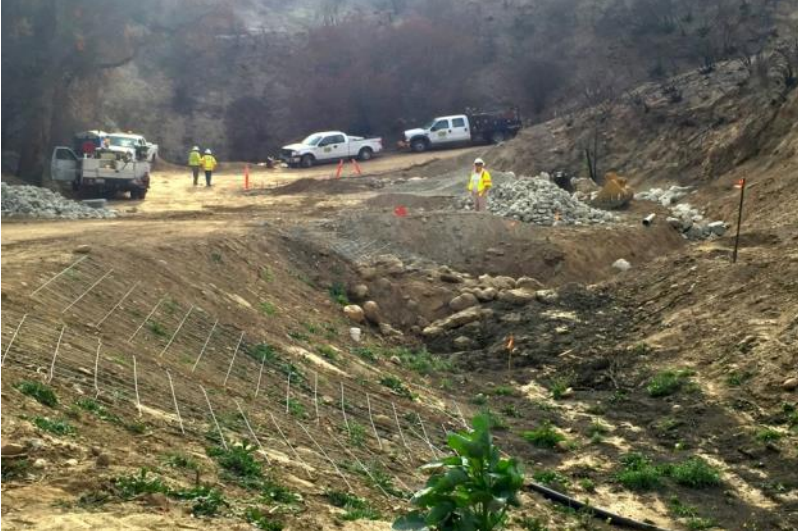
Looking down Drainage #4; restoration of the creek channel still remains.
12/03/15	Drainage #3 TSP 24/25 access road

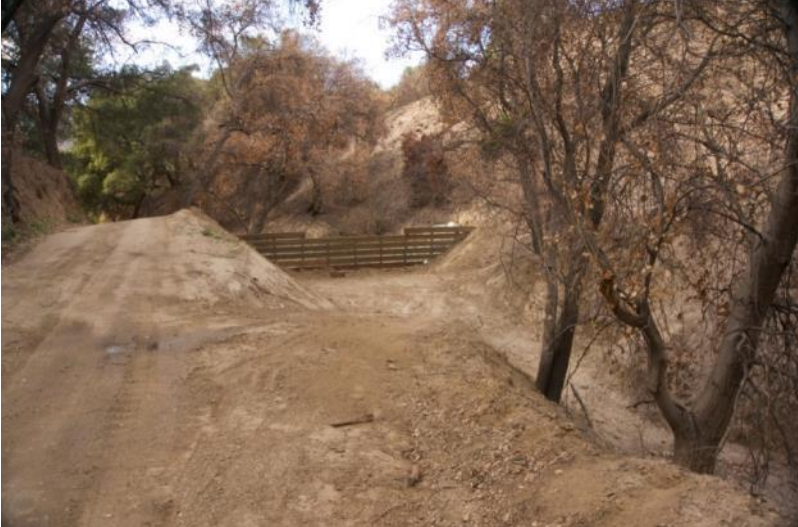
We checked the Los Angeles County Department of Public Works' (LADPW) progress in the drainage along the TSP 24/25 access road. LADPW crews had left a short dirt access road in the creek channel; this road will likely will erode during the next rain event (see photo).

LA County's road and debris dam in drainage.

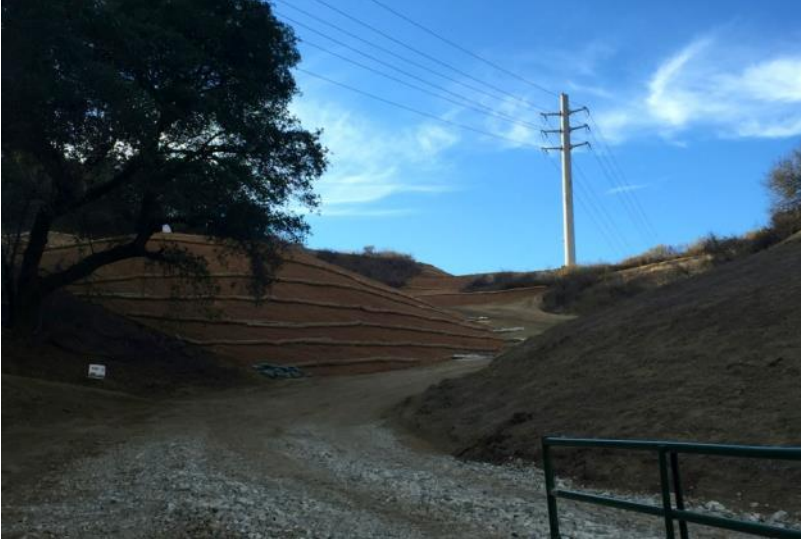
We drove through the TSP 21/22 area, noting the addition of coconut matting covering the restored topsoil areas (see photos). A number of the old steel lattice towers remain at several TSP locations; these are scheduled to be removed within the next several weeks. According to Todd White (Arcadis), once the old towers are removed, additional jurisdictional drainage work will begin.

Slope protection has been installed on all the areas with restored topsoil.
12/03/15	Sunshine Canyon Landfill

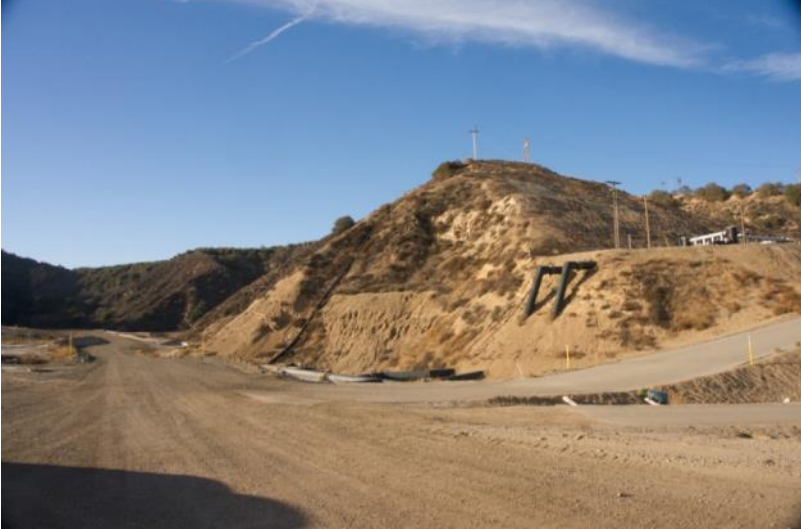
Later in the afternoon (approximately 1500), we drove through the Sunshine Canyon landfill to check an additional proposed temporary telecommunications route. The temporary line would be routed from an existing 66-kV line pole on the eastern side of the landfill, travel west along the northern rim of the landfill, and then reconnecting with the existing 66-kV line poles on the western end of the landfill. This activity is under review by the CPUC in SCE's MPR-I (see photo).

Northern ridge of the landfill where temporary poles are proposed for telecommunications stringing in MPR-I.
12/04/15	Natural Substation

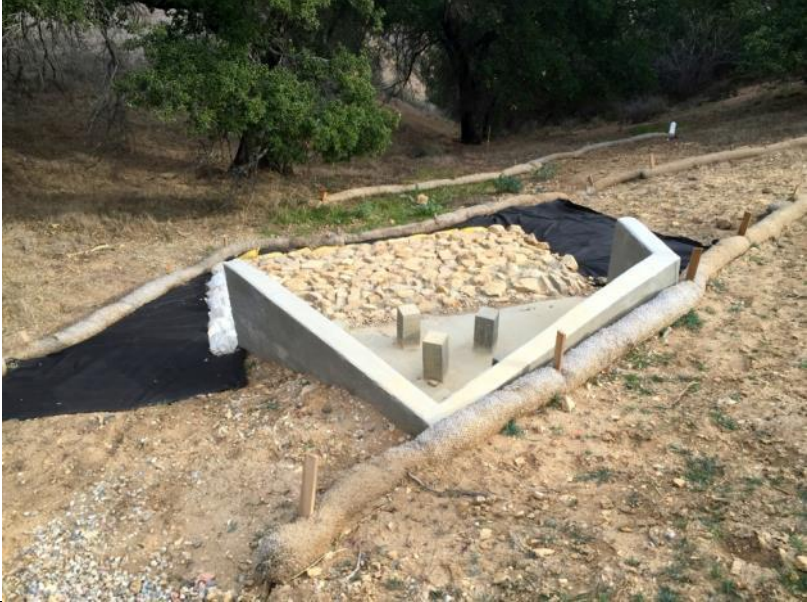
Additional gravel bags and fiber fabric has been installed at the Natural Substation biofiltration overflow drain.
12/04/15	PS-42 Fill Site

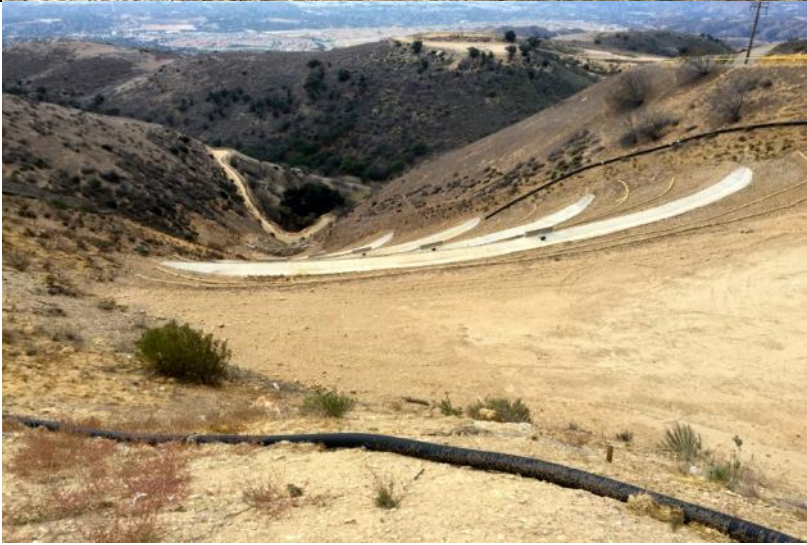
We checked the PS-42 Fill Site; final restoration/erosion control work was scheduled to begin in the following week (see photo). The P-41 Fill Site showed good revegetation growth on the soil slopes. A motor grader was reworking the P-43 Fill Site access road, and Seth Rosenberg (SCG) said they will be installing additional drainage piping.

Overview of the site; final stabilization work is being planned for the fill site.

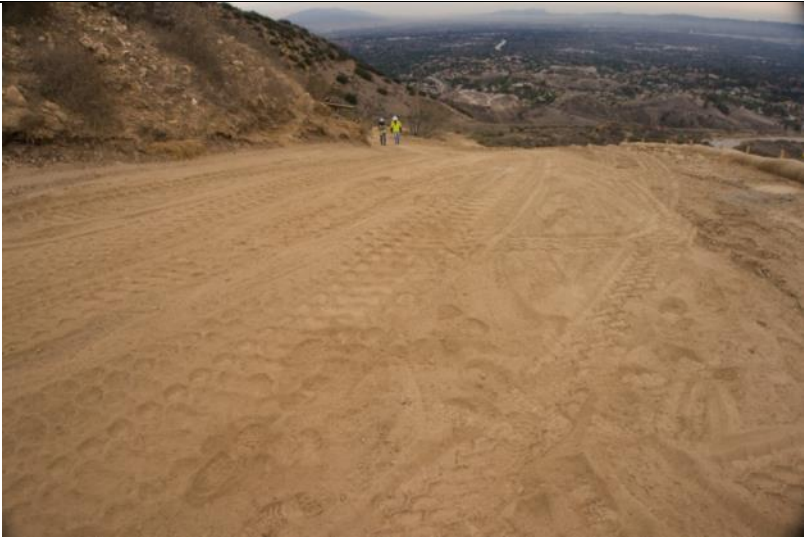
Several inches of dust have accumulated on the access road; additional watering is necessary.
12/04/15	TSP 43

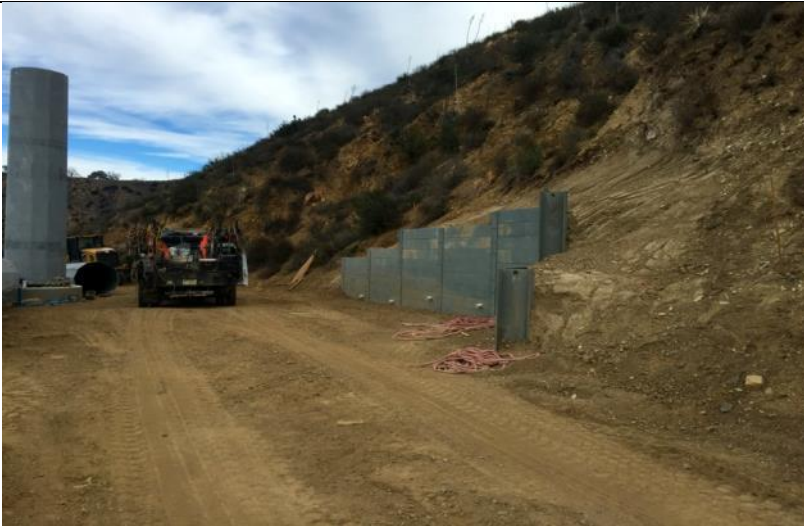
Partially installed TSP 43; Hilfiker walls on both sides of the TSP protect the site.

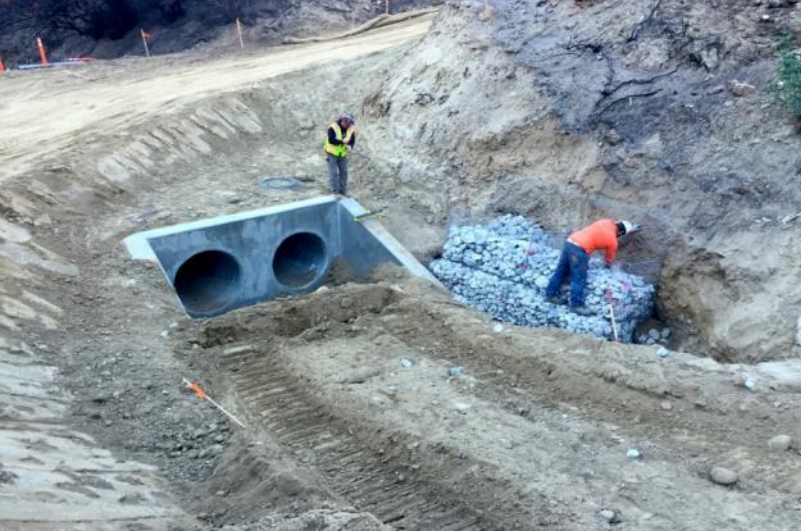
Crews are installing rock gabions around the culvert inlet.
12/08/15	Drainage #4 TSP 24/25 access road	 	Final backfilling and compaction around the Hilfiker wall is being completed.
12/08/15	Drainage #4 TSP 24/25 access road	 	Looking downstream from the Hilfiker wall work; soil removal and recontouring of the drainage has begun.

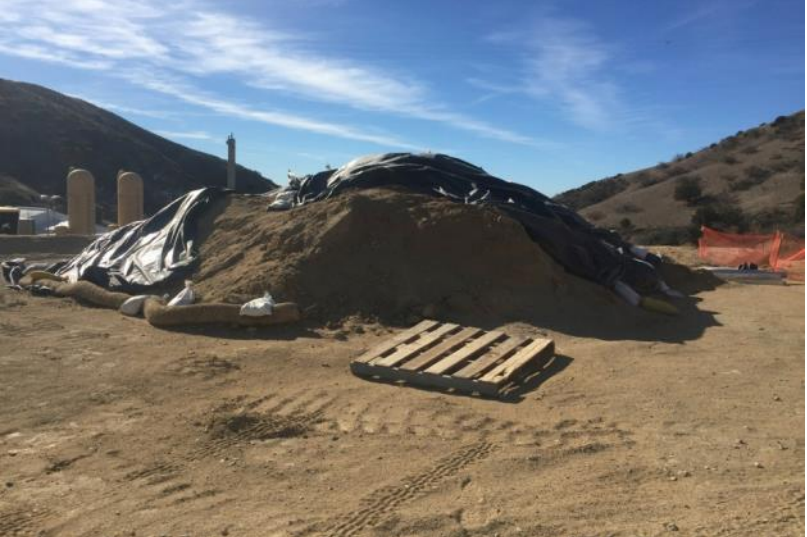
<p>Keeping spoil piles covered is difficult during times of high wind conditions; covering must be regularly maintained.</p>
12/08/15	CCS

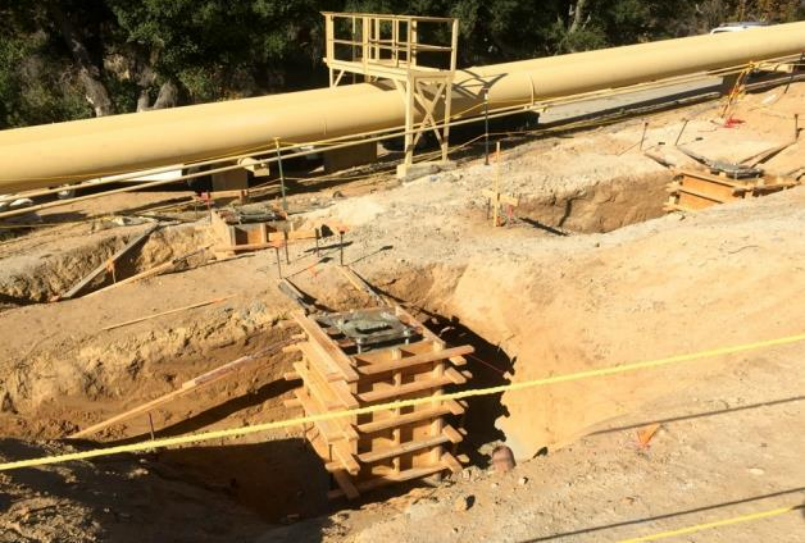
<p>Forming and pouring work continues in the CCS area.</p>
12/08/15	CCS

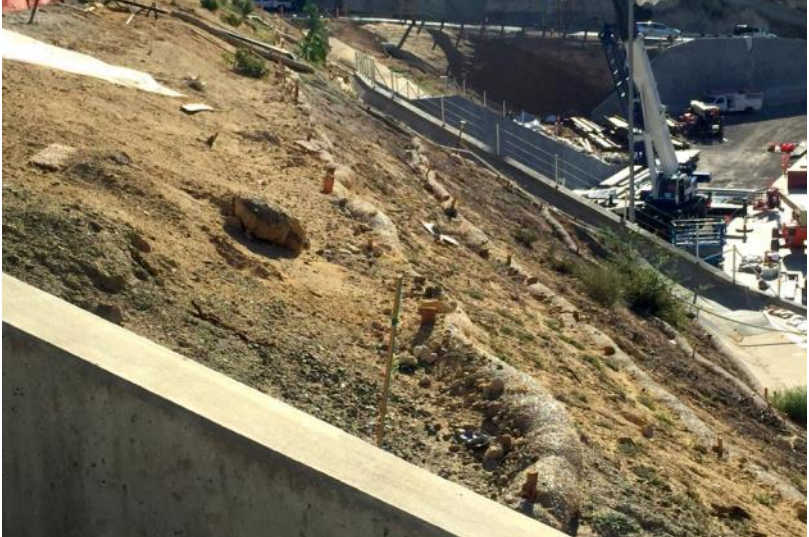
At the CCS, work continued on excavation and pouring of foundations and support beams (see photo). I walked around the slopes above the CCS and noted a number of areas where BMPs needed maintenance (see photos); specifically, the upslope side of the wattles needed to be cleaned out (APM GE-2). These wattles are the older plastic-covered type, and replacement may be a practical option.

<p>BMPs above the CCS require maintenance or need to be replaced.</p>
12/08/15	CCS

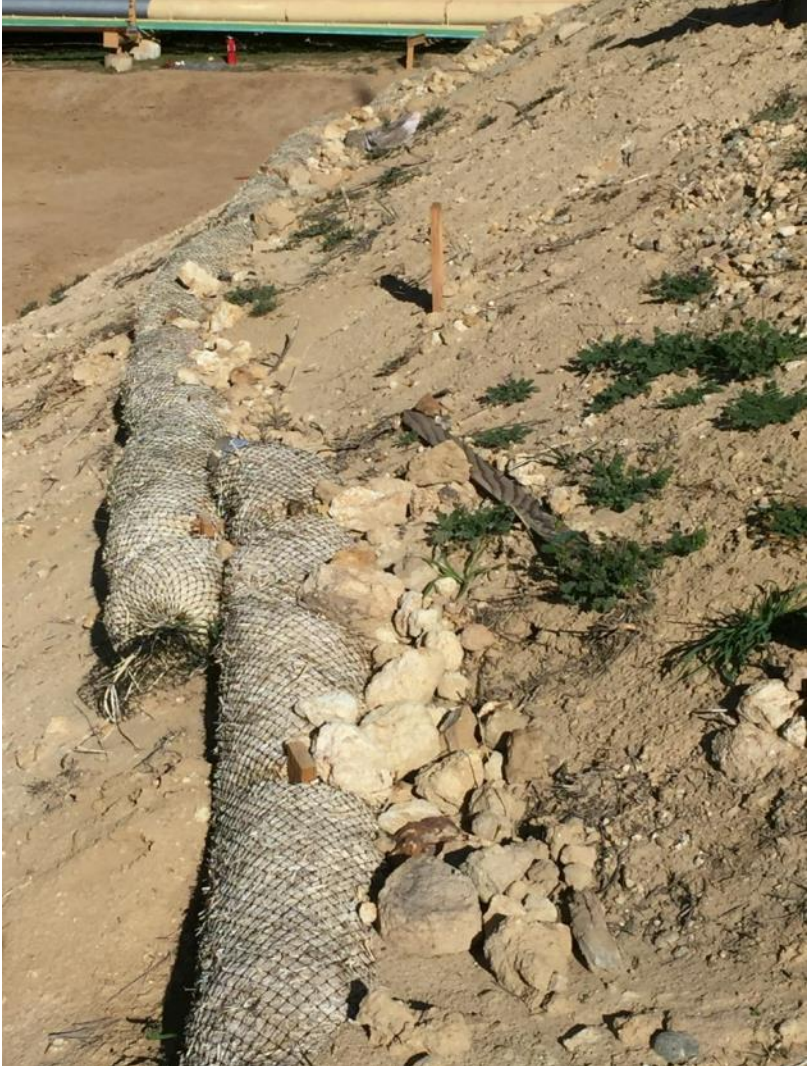
<p>BMPs above the CCS require maintenance or need to be replaced; these are the plastic-covered wattles.</p>

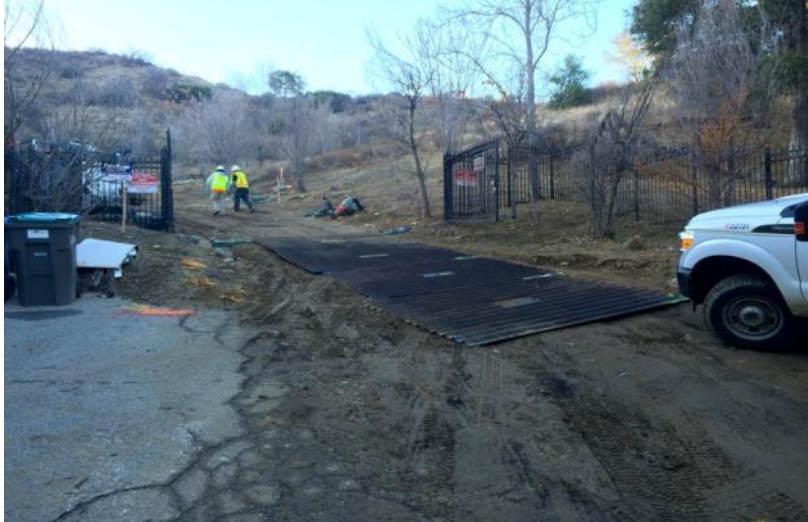
Rumble plates at the entrance to the access road.
12/23/15	TSP 7

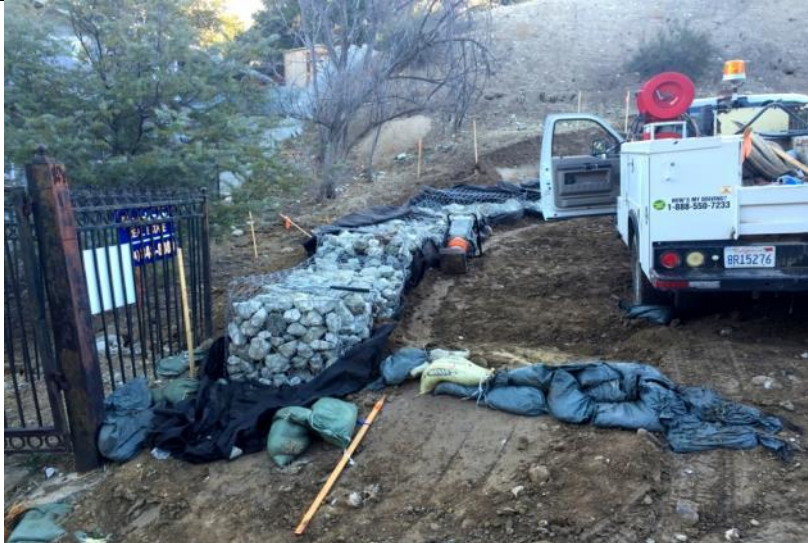
Road stabilization work along the access road.
12/23/15	TSP 7 staging area

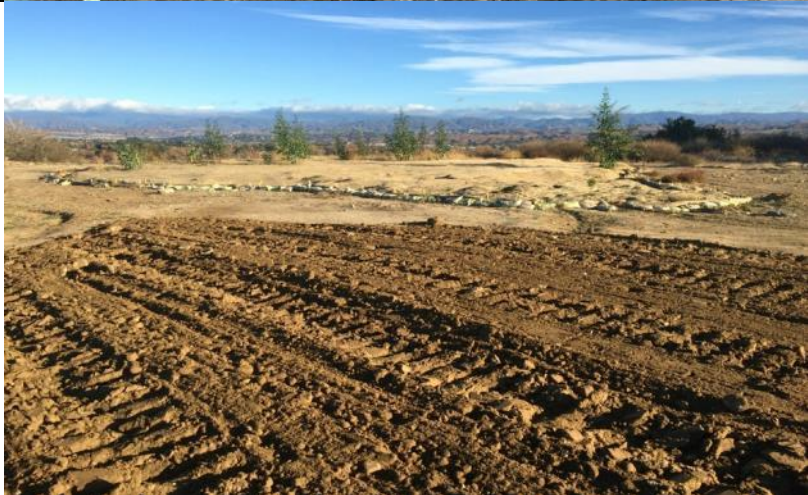
Photo shows the stockpiled topsoil in the background and some fill dirt placed in the staging area.

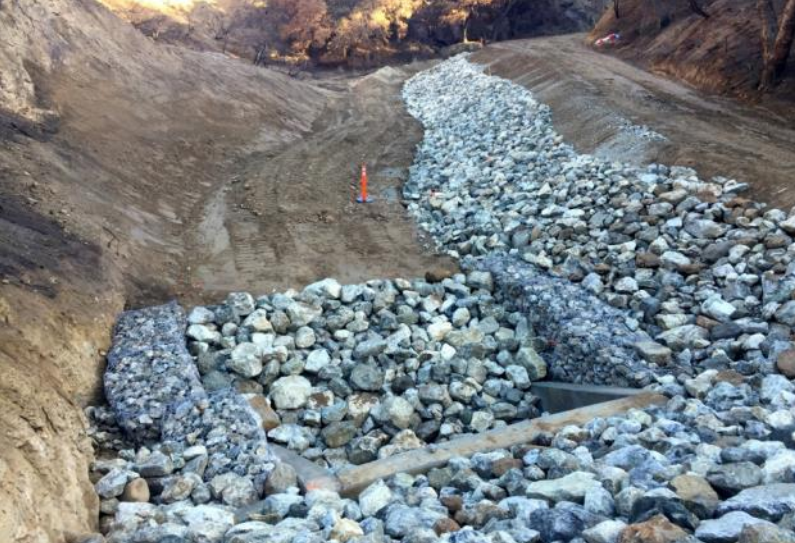
Crews are installing rock along the drainage. Excess soil remains in the drainage.
12/23/15	Drainage #4 TSP 24/25 access road

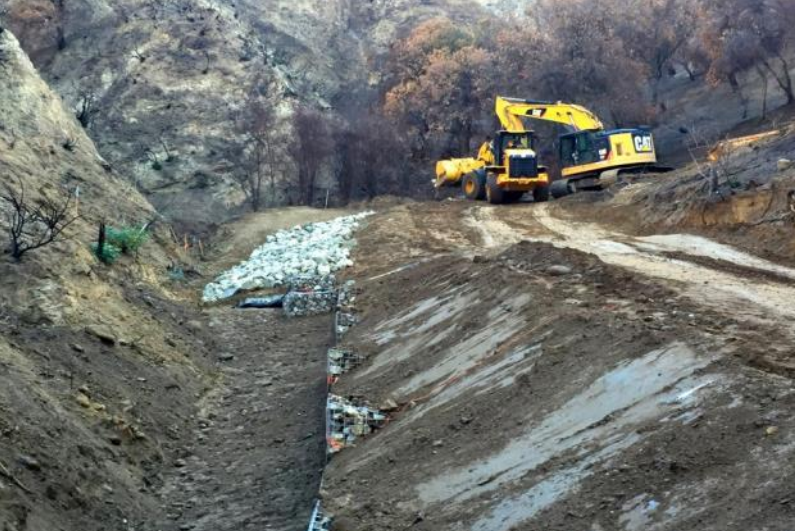
The Hilfiker wall is complete, and crews are putting in some rock along the access road.
12/23/15	Drainage #4 TSP 24/25 access road

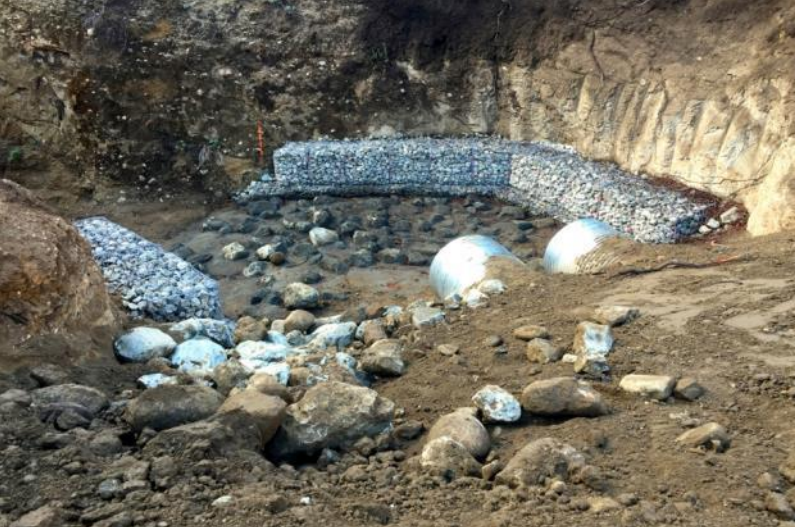
Culvert work is done; some BMPs are needed on the soil slope above the culvert.

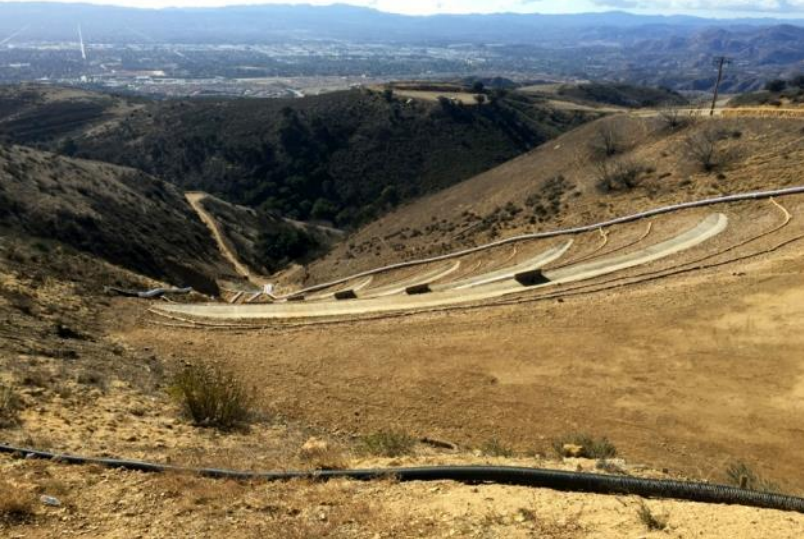
Work continues on the permanent BMPs.
12/23/15	PS-42 Fill Site

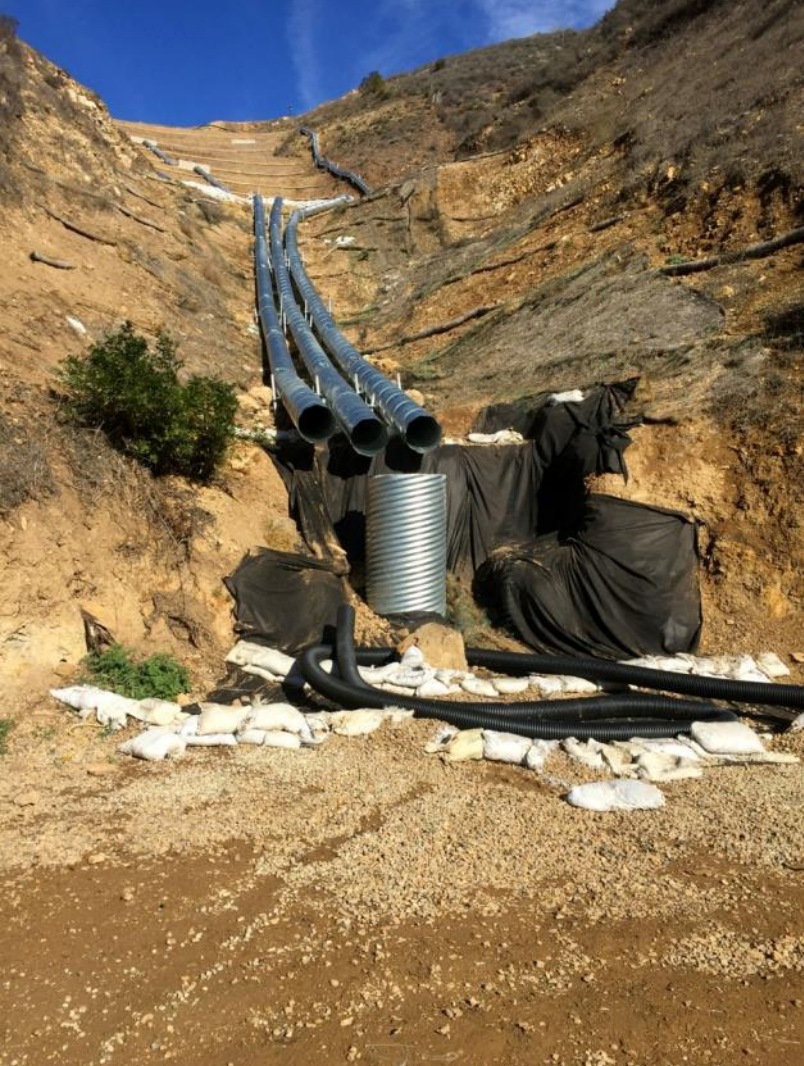
I observed the work being conducted at the PS-42 Fill Site where plastic diversion piping was being replaced with permanent metal piping. The one concern I had with the piping was that it was not directed into the road culvert at the bottom of the PS-42 Fill Site (see photo). If any significant rain came down over the four-day weekend, the rainwater runoff would spill onto the roadway. I talked with Amandeep Singh about this issue and he said no storm systems were predicted for the next week and they were going to address this issue soon.

Diversion piping; note the pipes do not direct water into the road culvert.

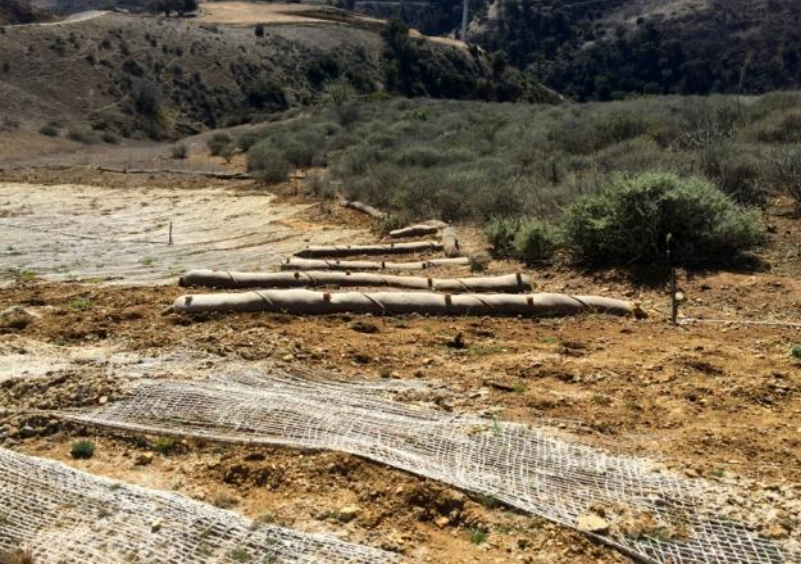
An erosion problem area has been addressed by the SWPPP team.
12/23/15	Natural Substation

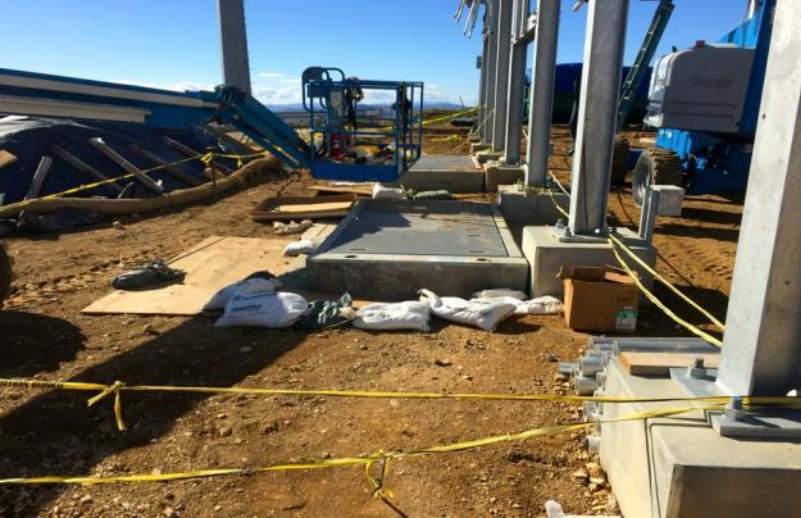
At the Natural Substation, significant work was taking place, including some trenching through the site (see photo). A paleontological monitor was onsite overseeing this work. The areas previously documented with covered excavations have equipment placed in them (see photo). I discussed the project's progress at the Natural Substation with Dave Wehman (SCE). I also checked one area along the access road where some erosion had been noted, but this had been fixed by the SWPPP crews.

Equipment has been installed in the previously-excavated areas.

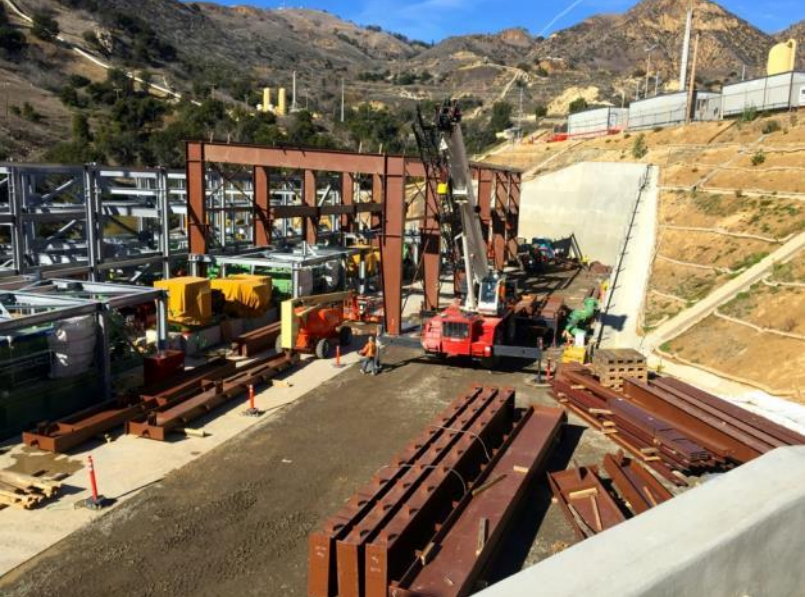
Equipment and building installation is ongoing.
