Re: Monthly Report Summary #29 for Aliso Canyon Turbine Replacement Project

Aliso Canyon Turbine Replacement Project CPUC Site Inspection Form

Project:	Aliso Canyon Turbine Replacement	Date:	August 2, 2016
Project Proponent:	Southern California Gas Company and Southern California Edison	Report #:	VS113
Lead Agency:	California Public Utilities Commission	Monitor(s):	Vince Semonsen
CPUC PM:	Andrew Barnsdale, Energy Division	AM/PM Weather:	Sunny, warm, and hazy.
E & E CM:	Lara Rachowicz	Start/End time:	1000 to 1045 at SCE components. 1100to 1330 at the Aliso Canyon Natural Gas Storage Field (Aliso Storage Field).
Project NTP(s):	The new Admin/IM Building (NTP-2), Central Compressor Station (CCS) (NTP-3), PS-42 Fill Site, and the Natural Substation (NTP-3 and NTP-A). Tubular Steel Poles (TSPs) 2 through 42 (NTPs A, C, and D).

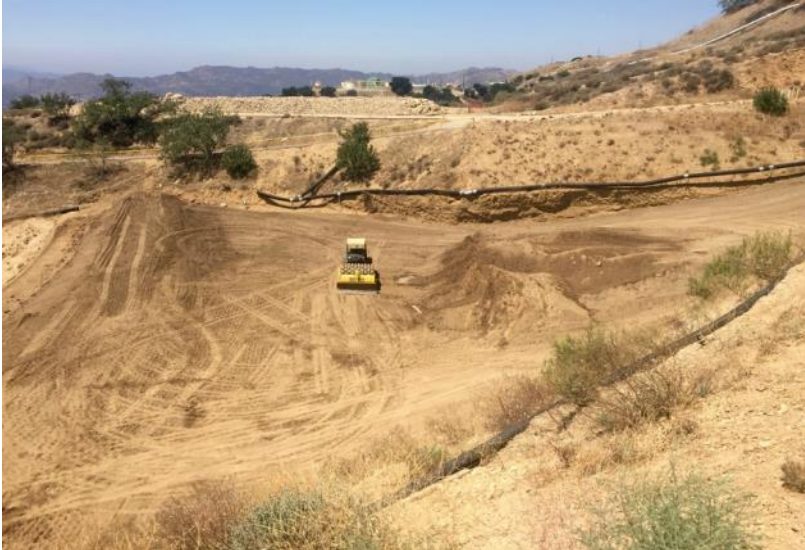
At the PS-42 Fill Site, crews were spreading and compacting the soil that had been delivered to the site (Photo 4). I noted numerous old BMPs lining the well pad above the PS-42 Fill Site (Photo 5), including a long line of netting-covered straw wattle.

Photo 4 – Imported soil is being spread and compacted in the PS-42 Fill Site.
8/02/16	Well Pad Above the PS-42 Fill Site

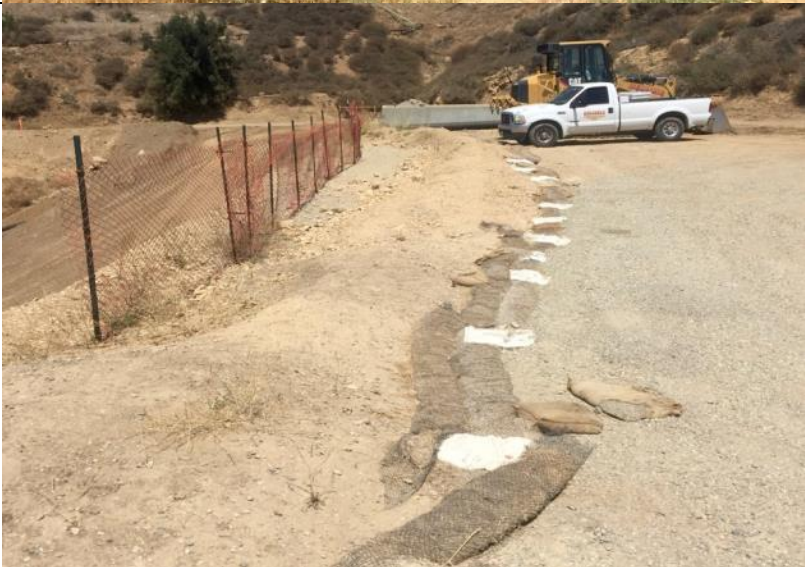
Photo 5 – Old BMPs remain along the well pad; most of the wattle is the older netting-covered straw wattle.

Clean-up of all old BMPs, especially the netting-covered straw wattles.

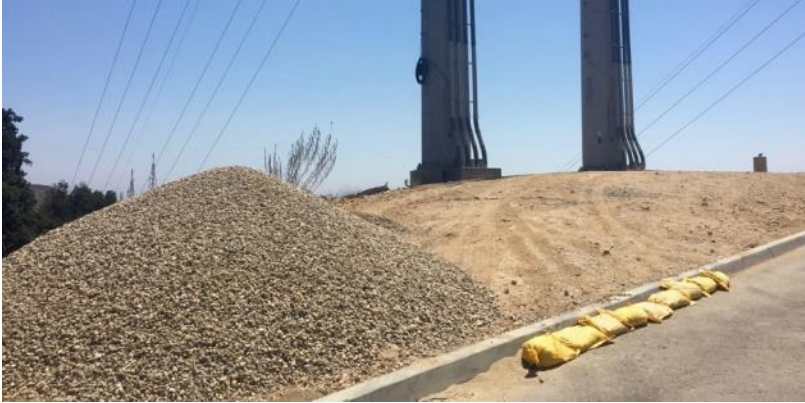
I drove along the Natural Substation access road and observed crews working within the Natural Substation. A crew was also bringing gravel to the 12-kV A1 poles (Photo 7) to be spread around under the two poles.

Photo 7 – Crews are delivering gravel to the site to be spread under the poles.
8/02/16	Natural Substation Access Road

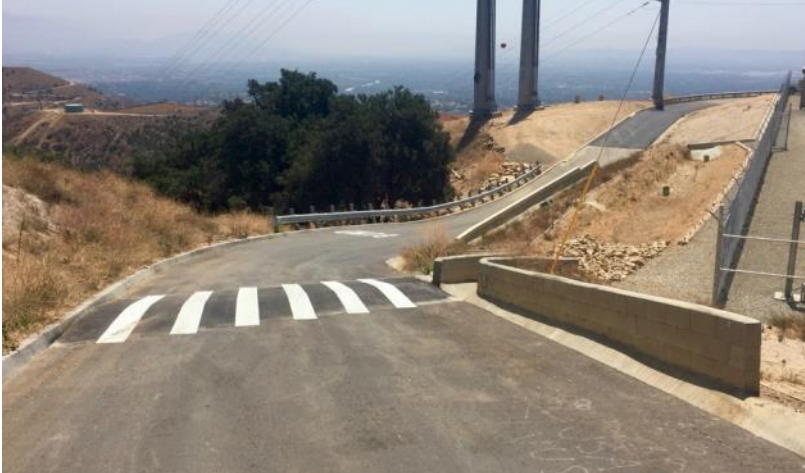
An asphalt water bar had been installed near the bottom of the Natural Substation access road, diverting rainwater runoff from the roadway into the Natural Substation biofiltration unit (Photo 8). This is not likely to reduce the amount of water running down through the oak swale following a substantial rainfall event, however.

Photo 8 – An asphalt water bar has been installed near the base of the access road.

Possible redirection of rainwater runoff coming down the Natural Substation access road. Possible energy dissipater/catch basin where the oak swale drainage meets the A2 access road.

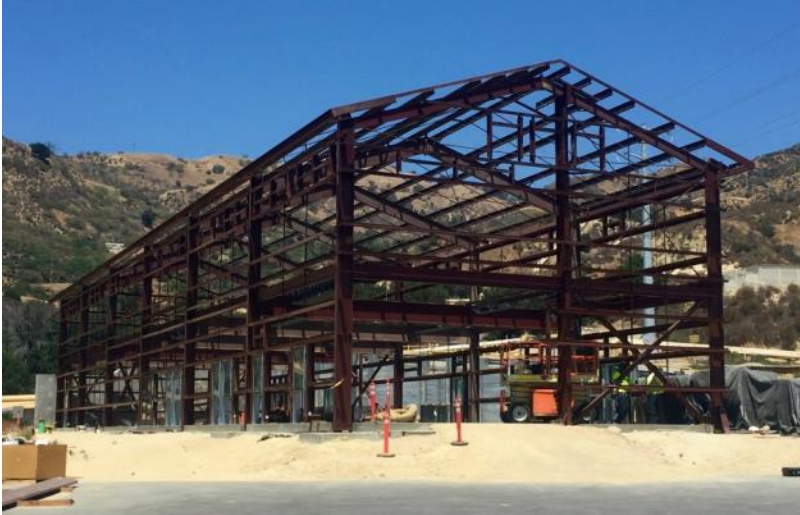
I checked in at the new Admin/IM Building where construction was ongoing at the new office buildings (Photo 9). Biological monitor Juan Miranda (SCG) was onsite and we discussed the herpetofauna caught in the bird netting. He said he had removed several snakes after hearing from construction workers of an unpleasant smell around the new Admin/IM Building—the snakes had been dead for a long time. There was a large amount of extra netting at the base of the stockpiled materials, and the netting used to cover equipment was also piled onsite (Photo 10).

Photo 9 – Construction of the new office buildings continues.
8/02/16	New Admin/IM Building

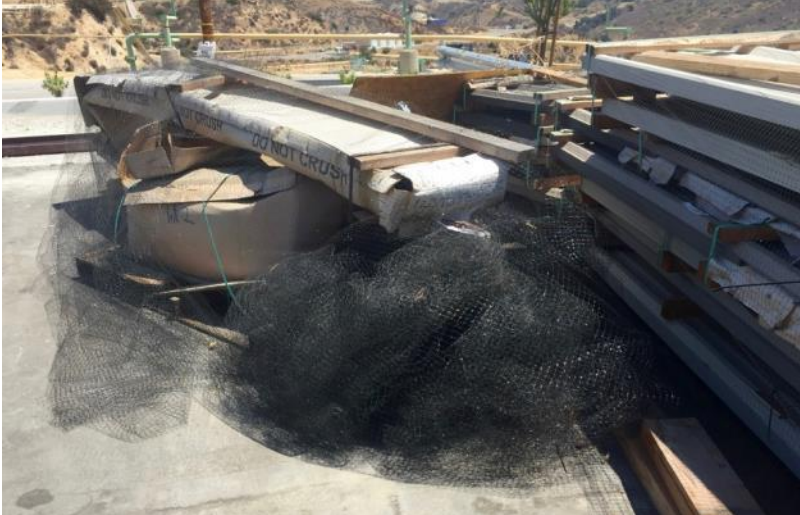
Photo 10 – Bird netting used to cover equipment is piled onsite.
8/02/16	12-kV PPL A2 Pad

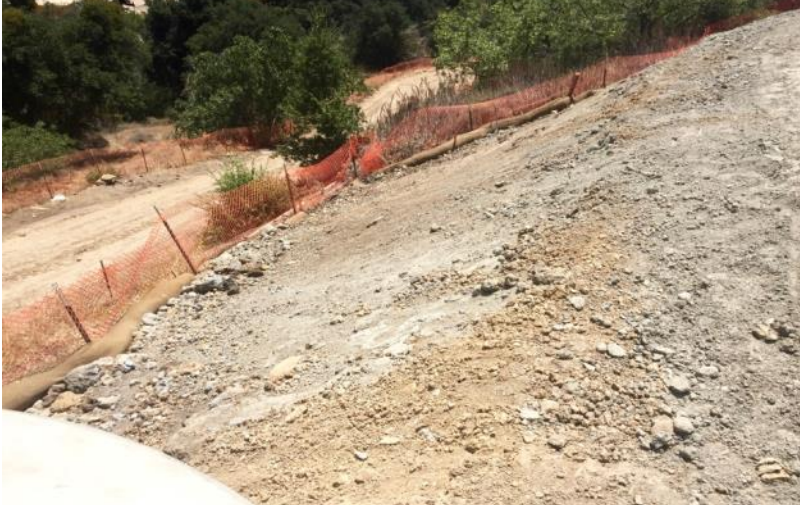
Juan Miranda and I traveled to the 12-kV A2 pole site where most of the restoration work has been completed (Photo 12). Some additional work was needed on the slope just south of the pole (Photo 11), and some pruning of the sapling oak is recommended once the construction fencing is removed (Photo 13). Photo 14 shows bottom of the oak swale drainage where it flows onto the A2 access road. This area needs some attention; otherwise, rainwater runoff will likely again flow down the access road. A catch basin could be used to slow the flow and redirect it into the historic drainage channel to the right of the access road.

Photo 11 – This slope, located immediately south of the new pole, requires some maintenance.

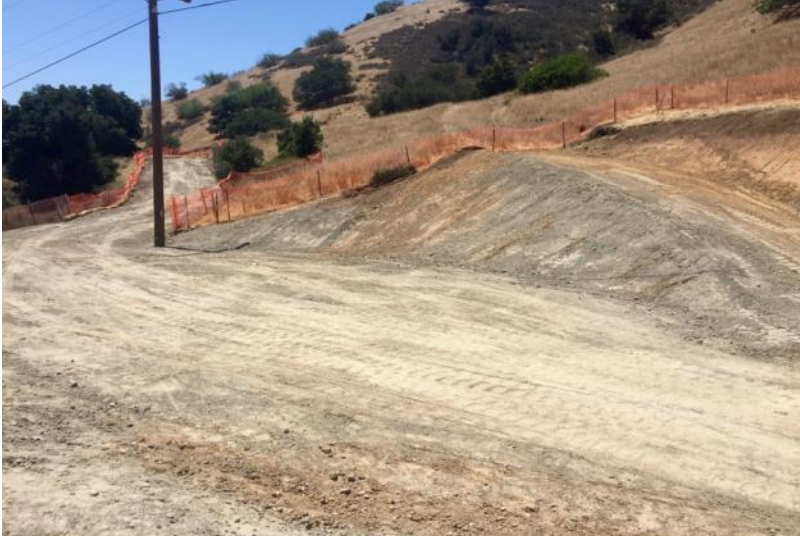
Photo 12 – Restored crane pad.
8/02/16	12-kV PPL A2 Pad

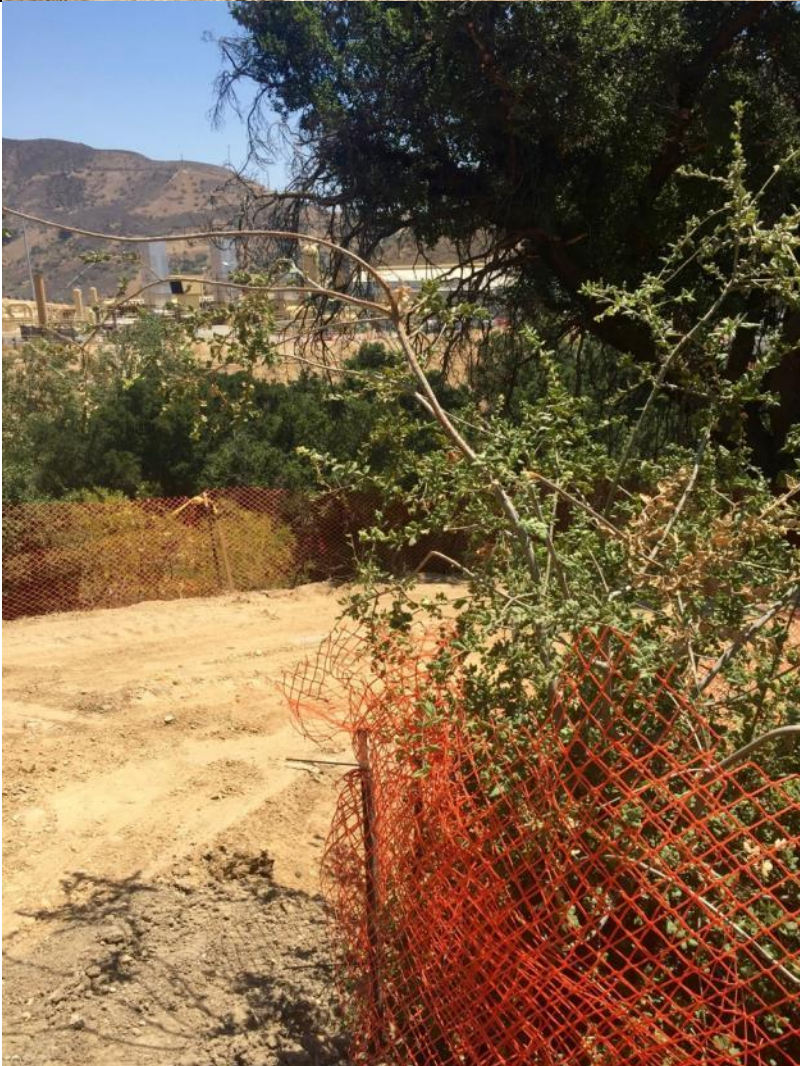
Photo 13 – Oak sapling; pruning is recommended once the fencing is taken down.

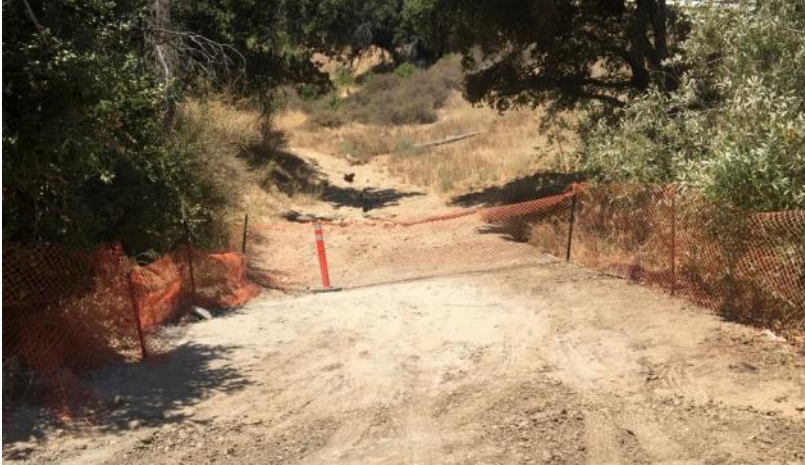
<p>Photo 14 – Outfall for the oak swale is likely to flow onto the 12-kV A2 pole access road. The historic drainage channel is to the right of the roadway, just above the construction fencing.</p>
8/02/16	CCS

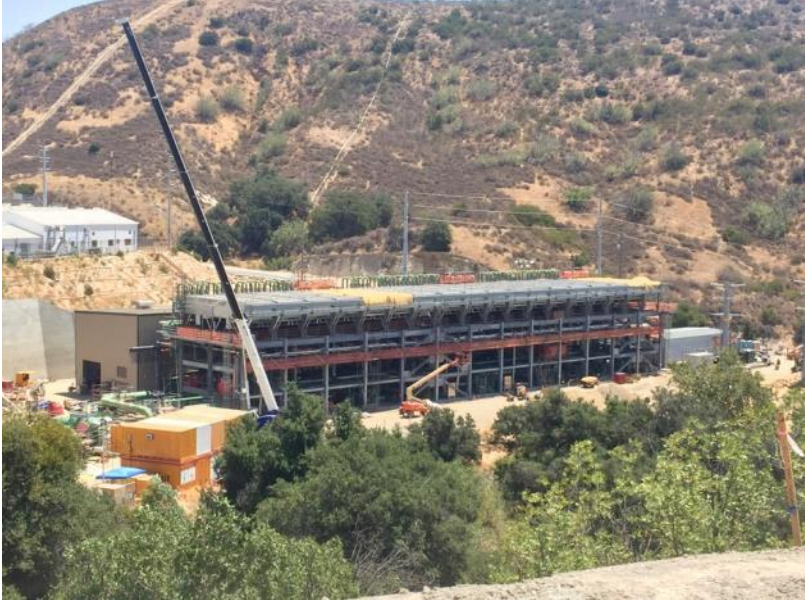
Photo 15 is an overview shot of the CCS from the A2 crane pad; I did not go into the CCS.

<p>Photo 15 – Overview of the CCS looking from the 12 kV PPL A2 pad.</p>

An evaluation of the rainwater runoff draining through the CCS facility is recommended.

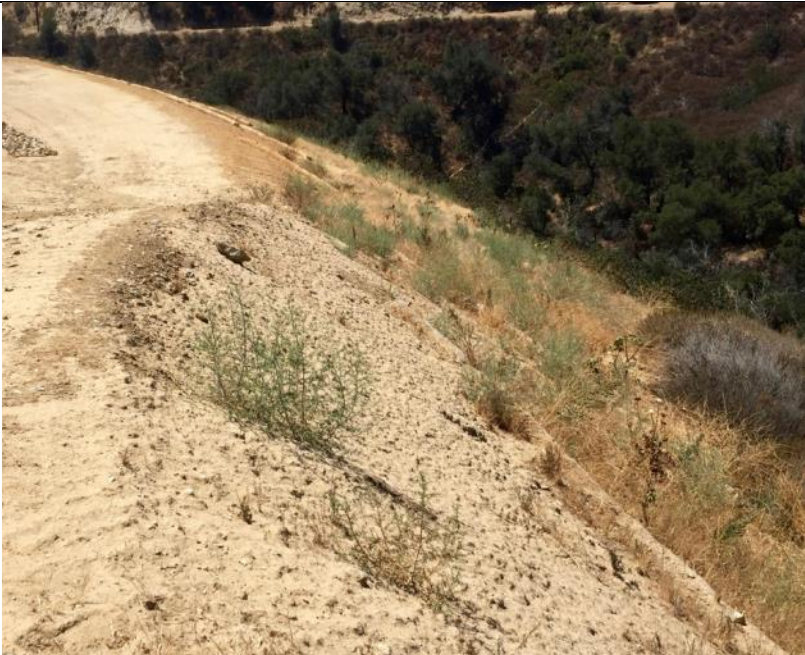
I checked on the weeding work along the slopes of the P-32 Fill Site. Most of it looked good; however, the northern portion of the site, just below the access road, still needs to be addressed (Photo 1). I noted castor bean, milk thistle, mustard, and Russian thistle at this location.

Photo 1 – Weeds remain along one portion of the P-32 Fill Site.
8/17/16	PS-42 Fill Site

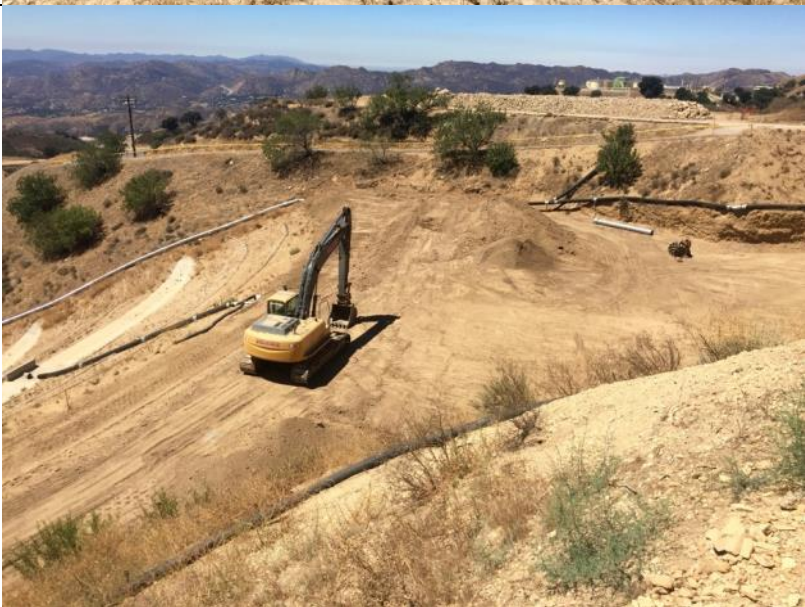
Photo 2 – Soil continues to be brought into the PS-42 Fill Site.

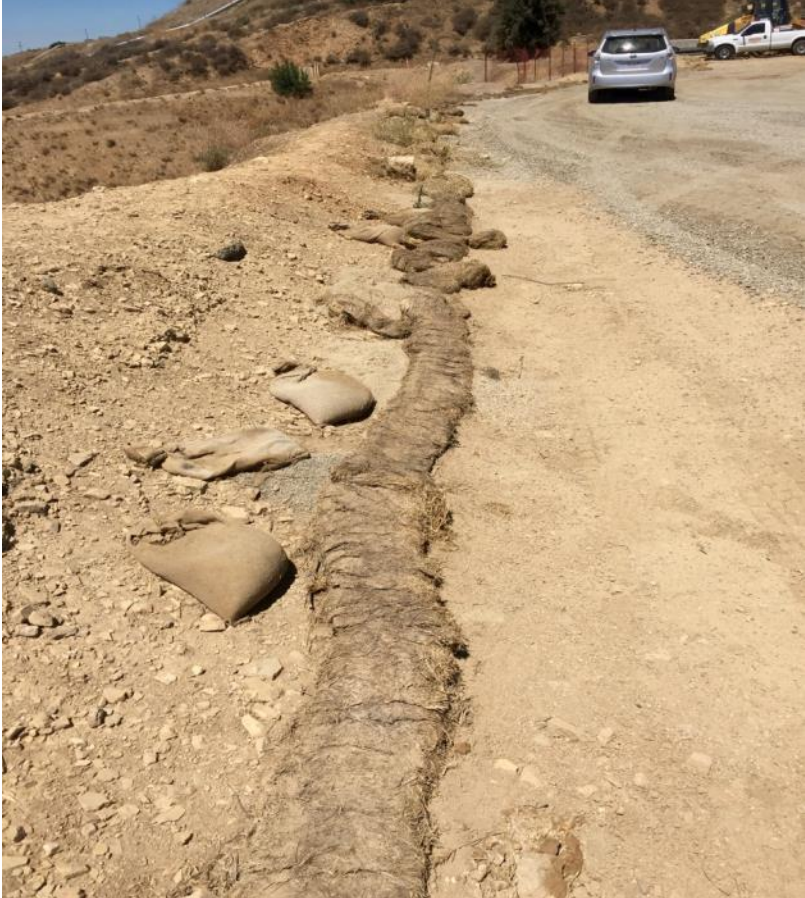
Photo 3 – Crews have removed the plastic covering from straw wattles.
8/17/16	PS-42 Fill Site

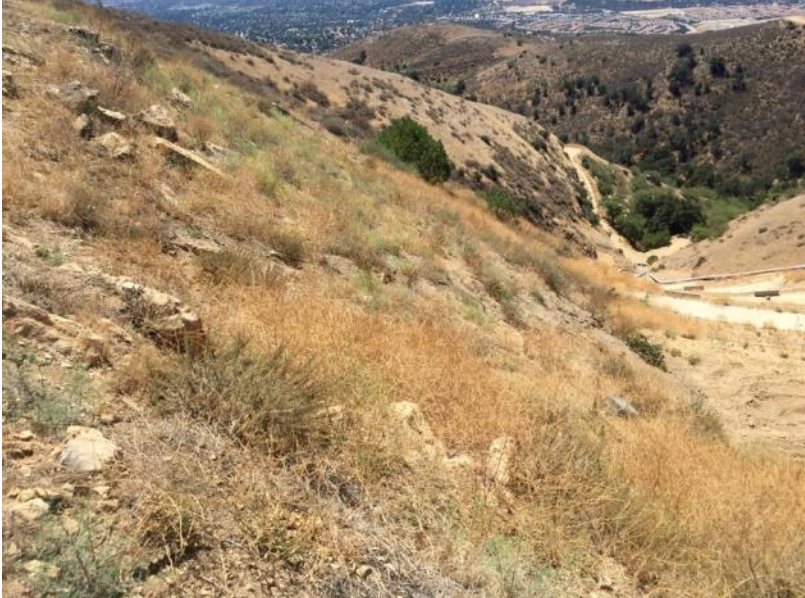
Photo 4 – A variety of weeds are growing on the upper southeast portion of the PS-42 Fill Site.

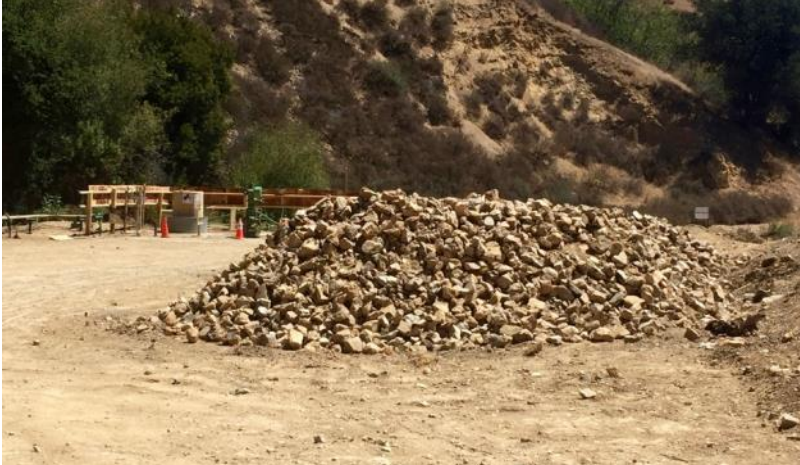
Photo 5 – Several piles of rock remain on the well pad.
8/17/16	A1 12-kV Poles

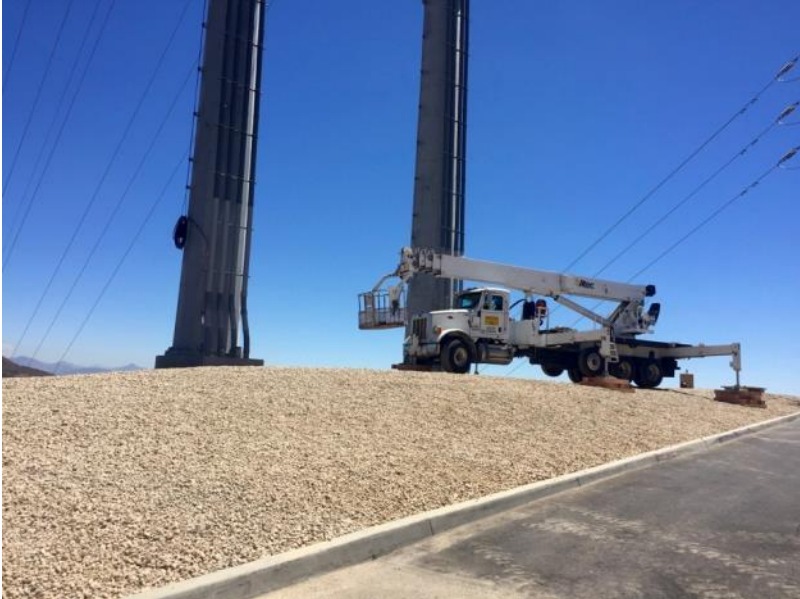
Photo 6 – Gravel has been spread around under the poles, and a lift truck is parked onsite.
8/17/16	Oak Tree Mitigation Site

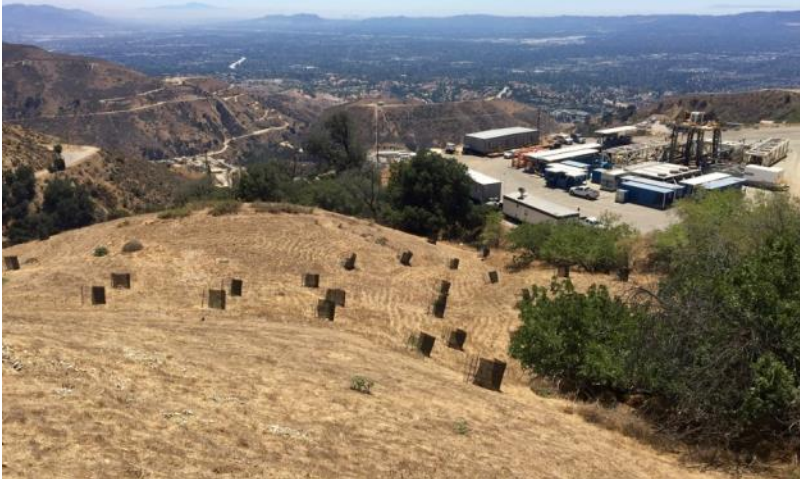
I checked the Oak Tree Mitigation Site, and the oak trees were in good condition; however, I did notice a couple of cages with dead trees (Photo 7).

Photo 7 – Oak trees.

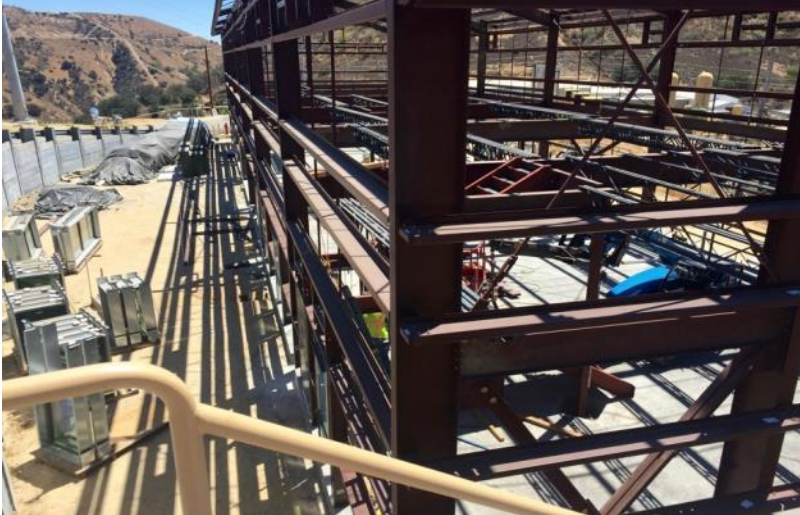
Photo 8 – Construction continues on the new office buildings.
8/17/16	Limekiln Creek

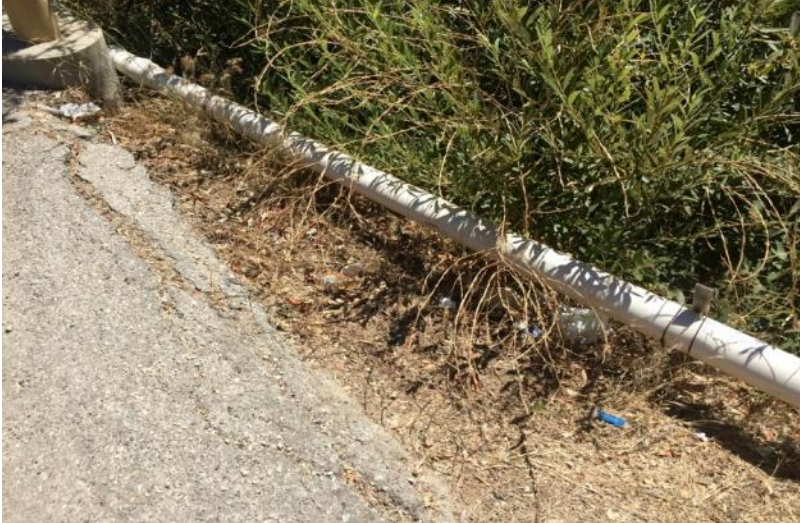
I parked on the west side of Limekiln Creek and noted a fair amount of trash building up along the silt fencing and along the edge of the creek channel (Photo 9). Photo 10 shows some of the ongoing work at the CCS. I noticed that a fair amount of water had entered the box culvert below the CCS (Photo 11). Ray Romero arrived onsite and I asked him about the water. He said they had a water release within the old CCS facility that made its way under the new CCS, down the box culvert, and into the creek. An evaluation of the amount of water potentially flowing through the new CCS drainage system is recommended.

Photo 9 – Trash is accumulating along the edge of Limekiln Creek; maintenance is recommended.
8/17/16	CCS

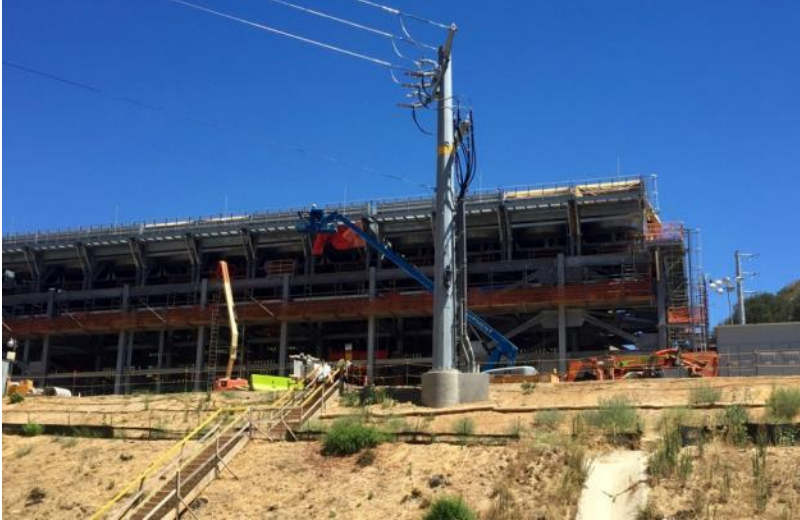
Photo 10 – Construction continues on the CCS.

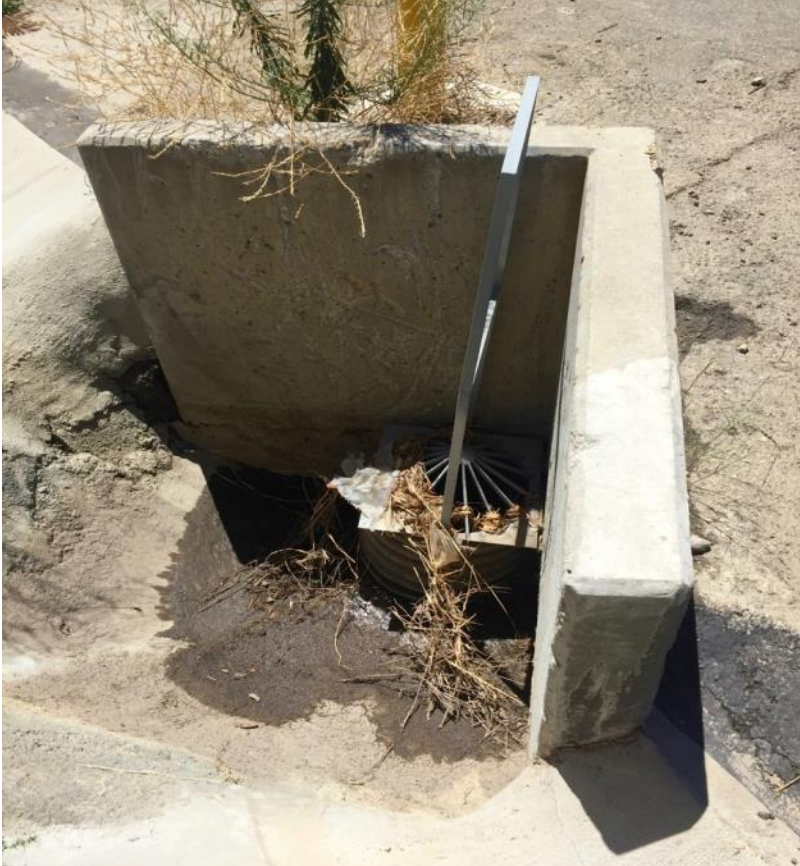
Photo 11 – Water and debris indicate a large quantity of water entered the drain inlet. This inlet drains directly into Limekiln Creek.
8/17/16	Upper Sedimentation Basin/Newt Pond

An evaluation of the rainwater runoff draining through the CCS facility is recommended.

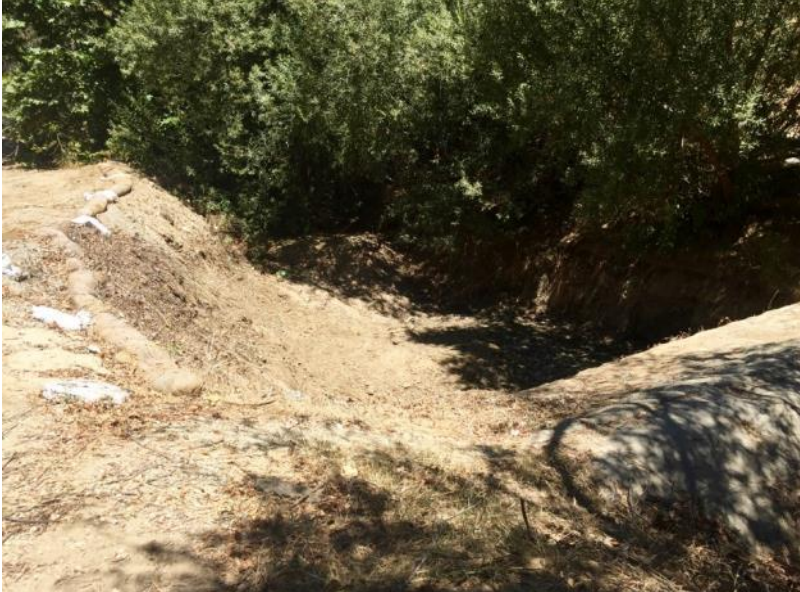
Photo 12 – Cleared out upper sedimentation basin/newt pond; the upper sedimentation basin/newt pond is dry.

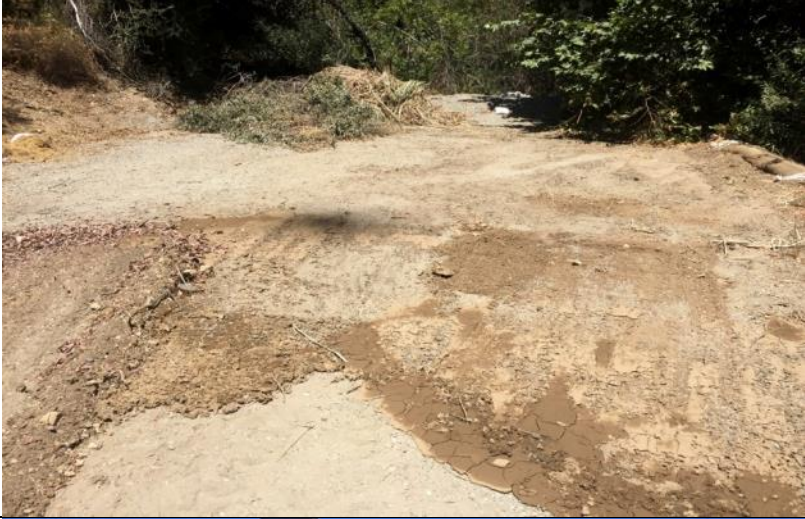
Photo 13 – Vegetation and sediments pulled from the upper sedimentation basin/newt pond.
8/17/16	12-kV PPL A2 Pad

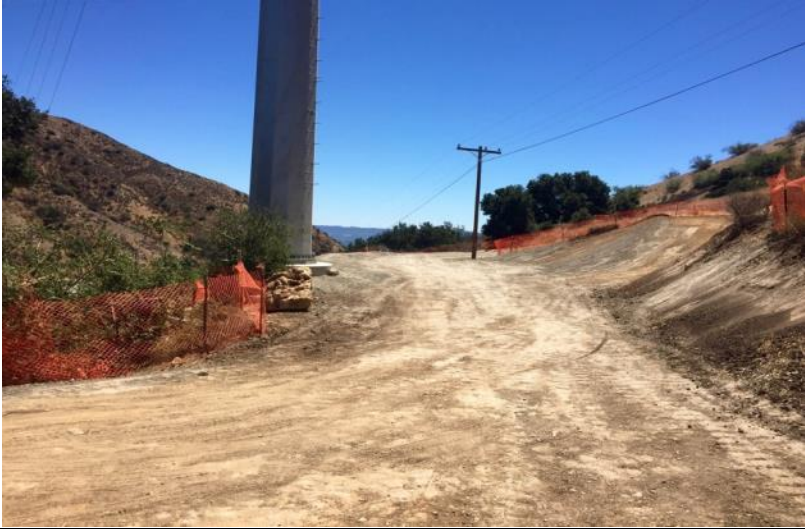
Photo 14 – Access road and restored crane pad.
8/17/16	12-kV PPL A2 Pad

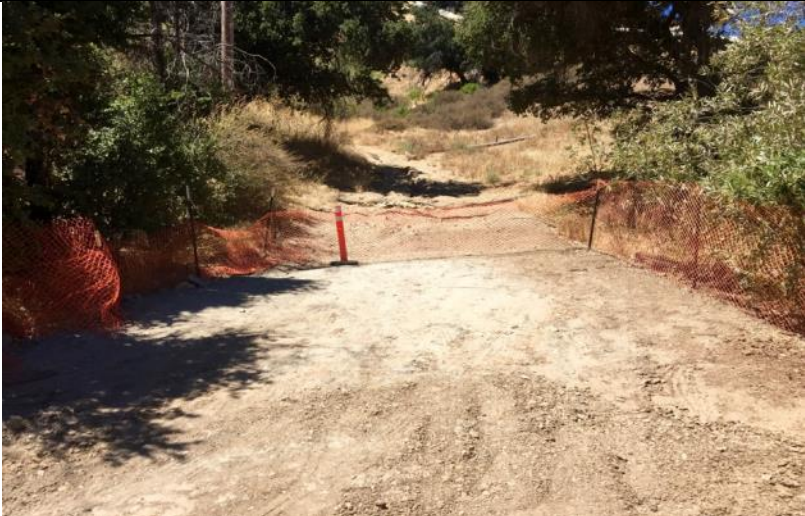
Photo 15 – Outfall for the oak swale flows onto the 12-kV A2 pole access road. The historic drainage channel is to the right of the roadway, just above the construction fencing.

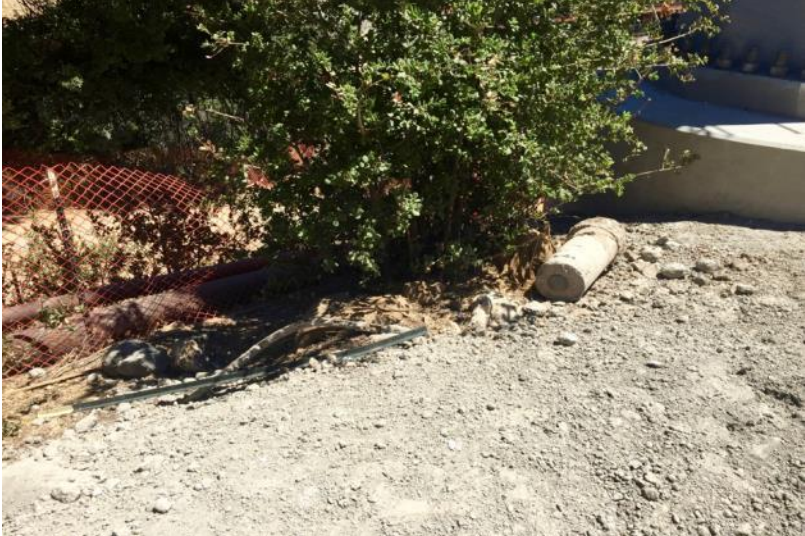
Photo 16 – Some clean-up of construction materials is needed around the poles.
8/17/16	P-37 Kiewit Staging Area

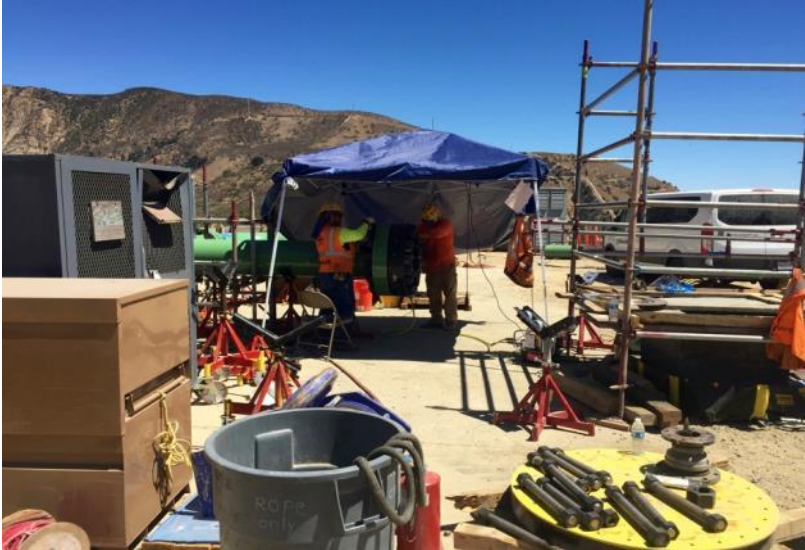
At the P-37 Kiewit staging area, a crew was working on piping (Photo 17). I had not been to this site previously, and noted a large amount of construction materials stored at the site (Photo 18). Some old plastic-covered straw wattles were lining a portion of the staging area, and one of the drain inlets needed additional BMPs, given how much exposed soil could be seen (Photo 19).

Photo 17 – Crews are working on pipes.
8/17/16	P-37 Kiewit Staging Area

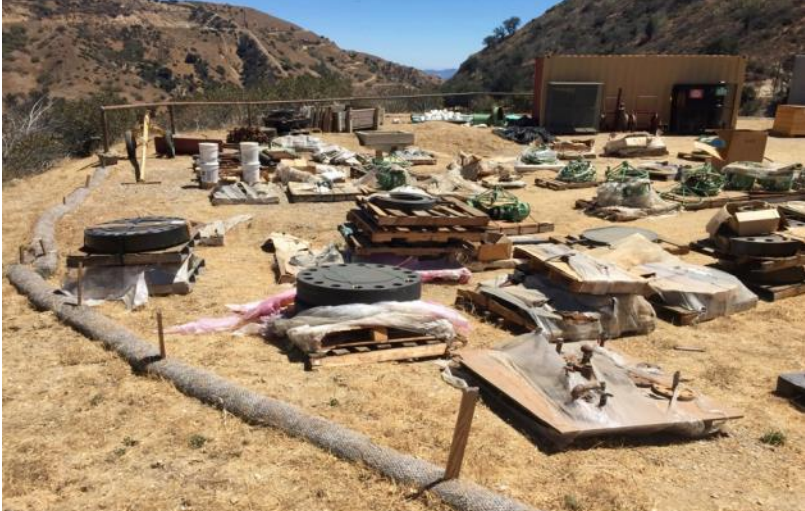
Photo 18 – Large amounts of equipment is being stored at the site; old plastic covered straw wattles line a portion of the site.

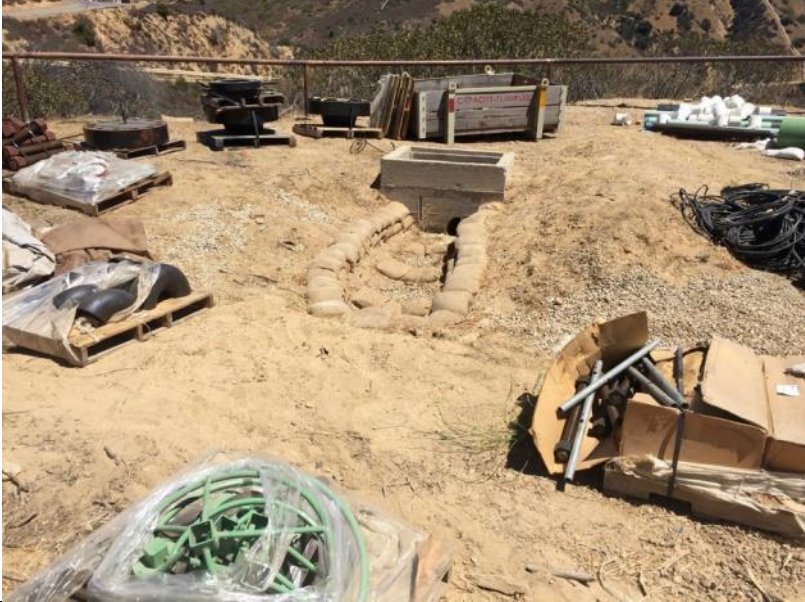
Photo 19 – A drain inlet within the P-37 Kiewit staging area. There is a lot of exposed soil within the site, but very little is being done in the way of BMPs to control potential sediment runoff.

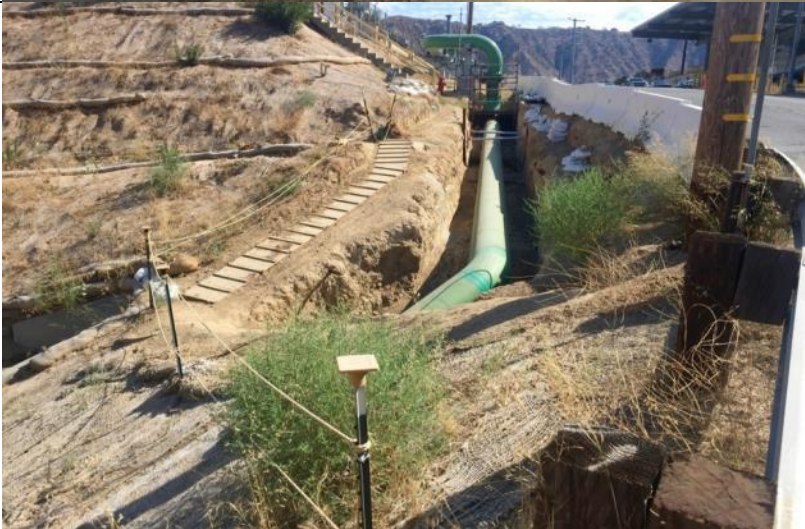
I went for the Aliso Storage Field, and my first stop was the CCS. Photo 2 shows a portion of the piping that remained in the trench and was uncovered. I noted that there was an exit ramp at the downslope portion of the trench. Weeds were continuing to grow on the eastern slope of the CCS (Photo 3). I noted large amounts of mustard, along with Russian thistle, tree tobacco, and some fountain grass. Some of the straw wattle around the CCS and the P-37 Kiewit staging area was the old plastic-covered type.

Photo 2 – A section of the pipeline coming out of the CCS remains exposed in the trench. A ramp is located in the downslope portion of the trench.
8/22/16	CCS

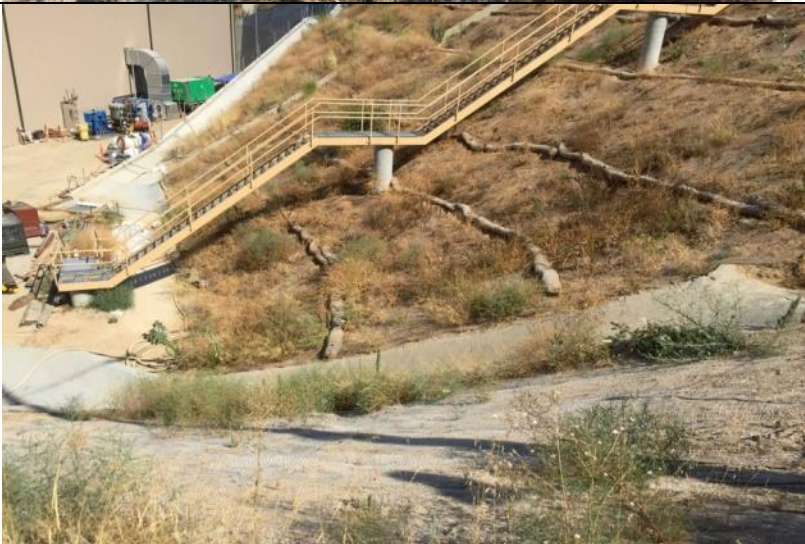
Photo 3 – Weeds are dominating the eastern slope of the CCS; species noted include mustard, Russian thistle, tree tobacco, and fountain grass.

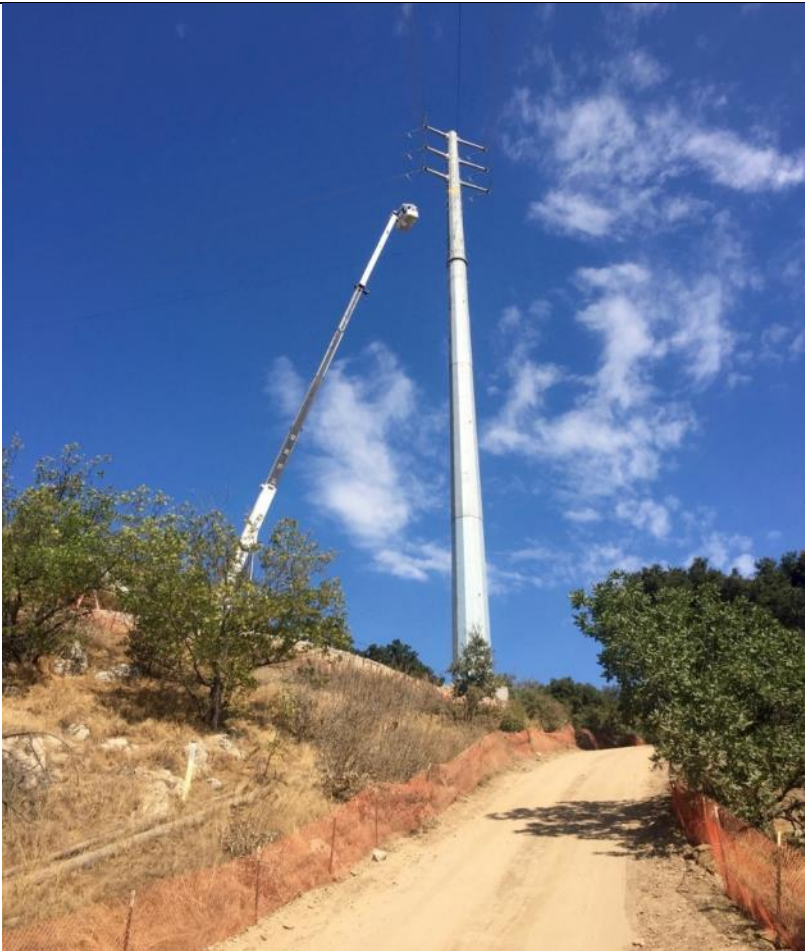
Photo 4 – Crews continue to work on the 12-kV wires.
8/22/16	12-kV A2 Pole Crane Pad

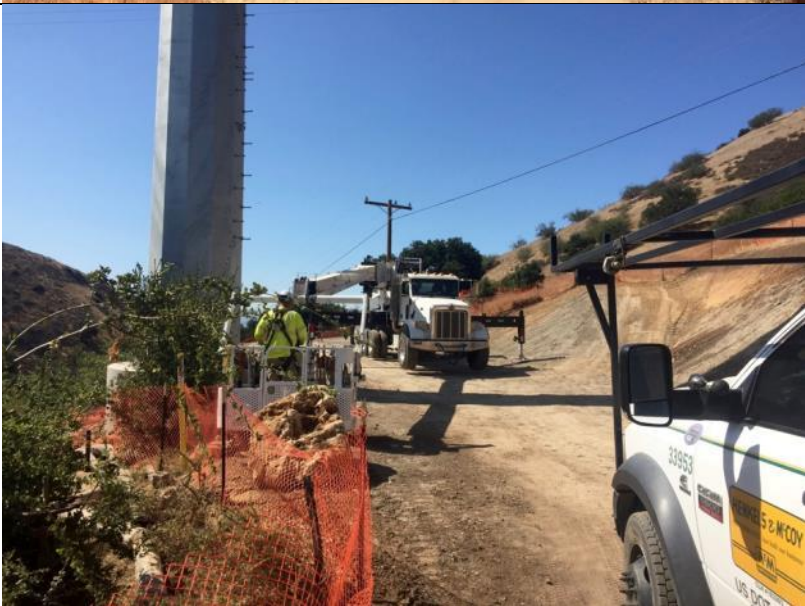
Photo 5 – Crews utilizing the crane pad near the A2 pole.
