### **Re: Monthly Report Summary #18 for Aliso Canyon Turbine Replacement Project**

## Aliso Canyon Turbine Replacement Project CPUC Site Inspection Form

Project:	Aliso Canyon Turbine Replacement	Date:	September 3, 2015
Project Proponent:	Southern California Gas Company and Southern California Edison	Report #:	VS069
Lead Agency:	California Public Utilities Commission	Monitor(s):	Vince Semonsen
CPUC PM:	Andrew Barnsdale, Energy Division	AM/PM Weather:	Partly cloudy and cool in the morning; clearing and warming later in the day.
E & E CM:	Lara Rachowicz	Start/End time:	0700 to 0930 at TSPs 12 through 25. 1000 to 1230 at the Aliso Canyon Natural Gas Storage Field.
Project NTP(s):	Guard House and Road Widening (NTP-1). The new Admin/IM Building (NTP-2) and Central Compressor Station (CCS) (NTP-3). P-41 Fill Site (NTP-2), PS-42 Fill Site, P-32 Fill Site (NTP-3), and the Natural Substation (NTP-A, NTP-D). TSPs 2 through 42 (NTPs A, C, and D) and the SCE 210 Freeway Yard.

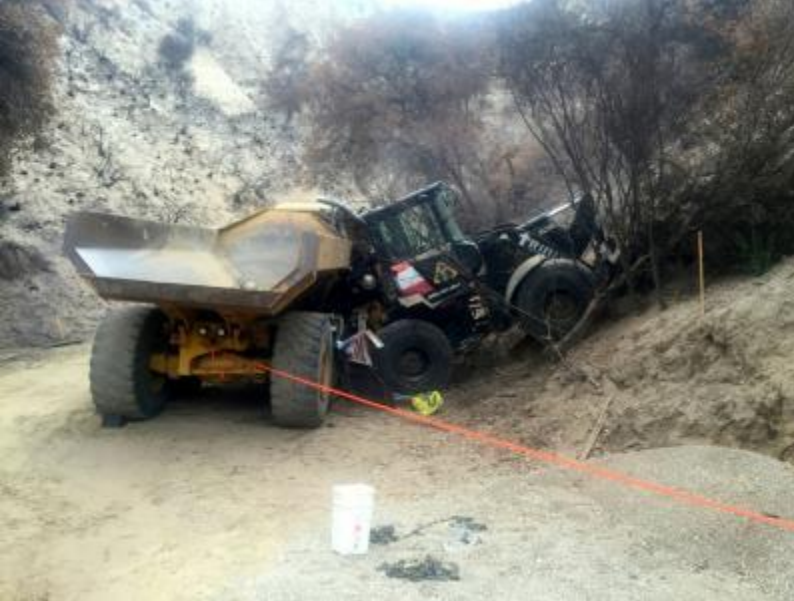
Date	Location	Photo	Description
9/03/15	Access road to TSP 25

I traveled with Daniel Smith along the access road to observe construction progress and noted the incident at the TSP 25 site – see photos. While it was not immediately evident what caused the incident near TSP 25, a front loader and a Polaris ATV had slid off the access road near TSP 25 and had fallen down the embankment to the lower portion of the same access road.

Front loader rolled down the hill and collided a haul truck.
9/03/15	Access road to TSP 25

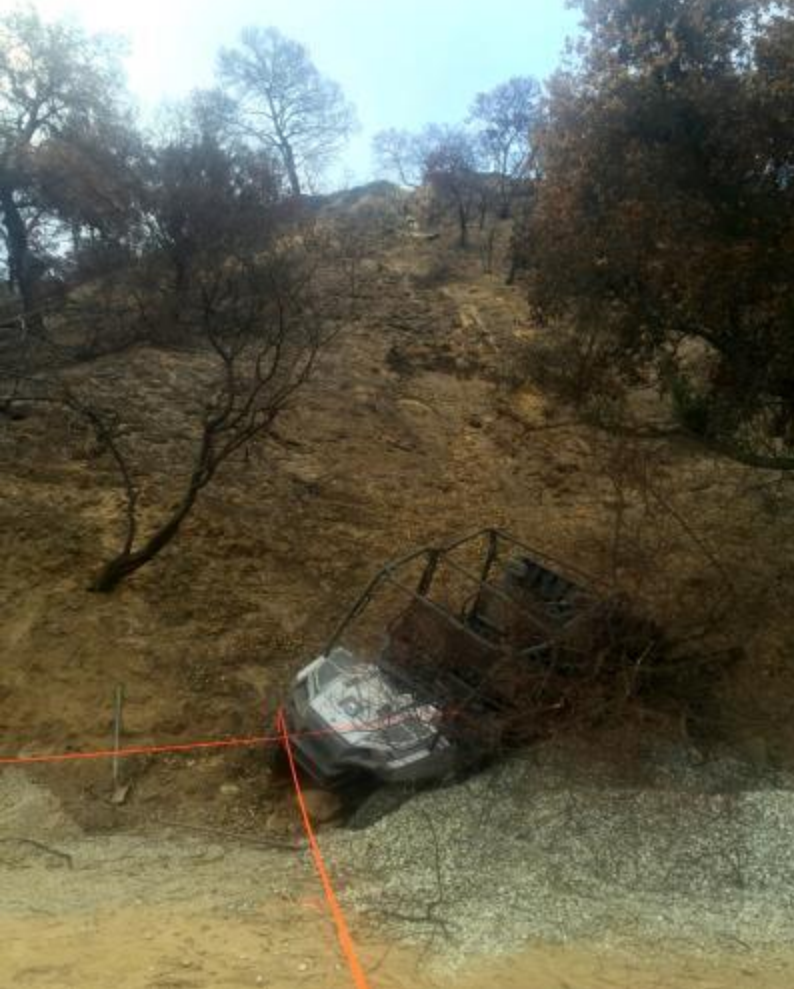
- On September 2, 2015, the emergency brake on a skip loader failed while the vehicle was parked on the access road near TSP 25. The unoccupied skip loader slid down the access road and hit a Polaris all-terrain vehicle (ATV). Both vehicles continued to slide down an embankment for several hundred feet. The skip loader came to rest after colliding with a dump truck. The Polaris ATV came to rest on the access road. No injuries occurred. Three quarts of motor oil from the skip loader and two gallons of radiator fluid from the dump truck were spilled. The spilled material and surrounding soil were collected and moved offsite for proper disposal. SCE conducted a stand down meeting with the contractor and implemented the following changes: larger chocks will be placed behind the tires of parked vehicles; operators will stay with vehicles/equipment when parking on inclines; vehicles/equipment will be parked on level ground if left overnight; and wheels will be turned to face the uphill portions of slopes. SCE completed an incident report the day after the accident and submitted the report to the CPUC.

Polaris ATV that rolled down the hill.

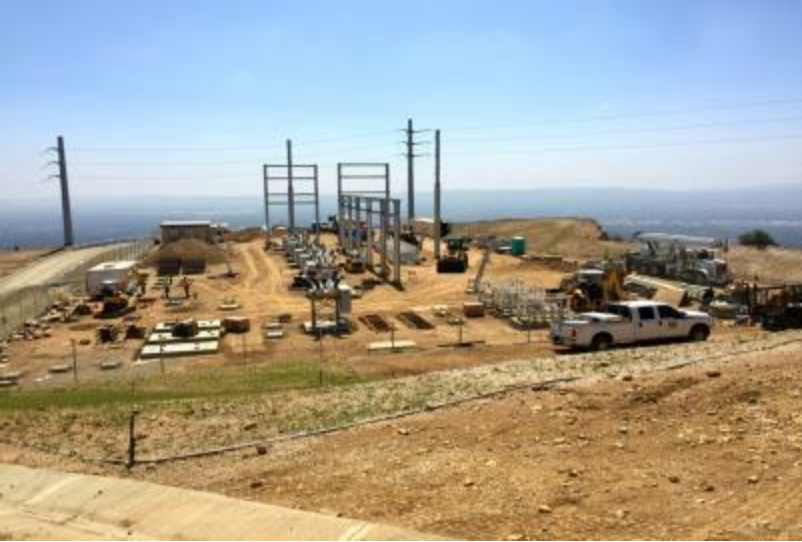
REPRESENTATIVE SITE PHOTOGRAPHS			
Date	Location	Photo	Description
9/03/15	Natural Substation

Overview of the Natural Substation.
9/03/15	Access road to TSP 40

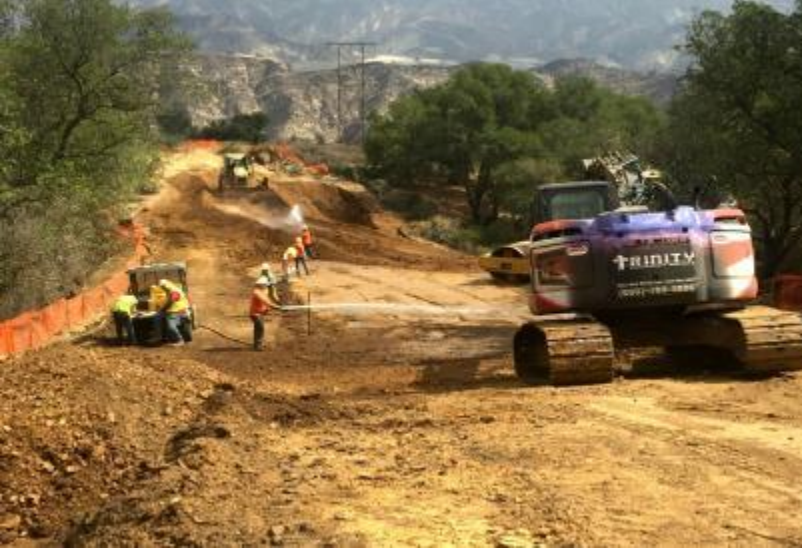
Work on the access road to TSP 40.
9/03/15	Access road to the TSP 40 area

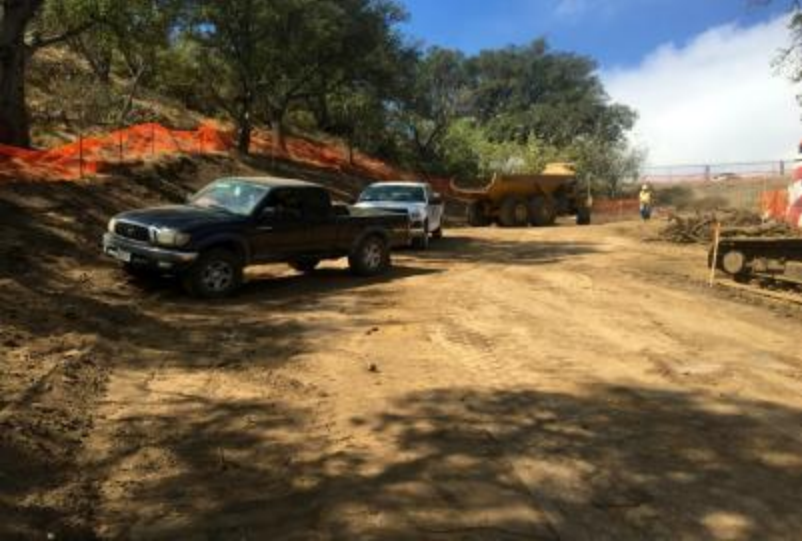
Finished access road.

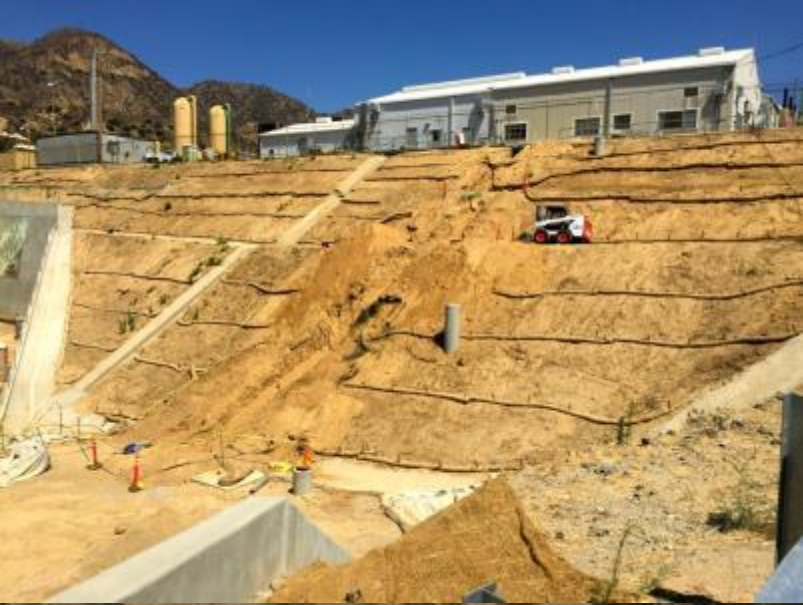
REPRESENTATIVE SITE PHOTOGRAPHS			
Date	Location	Photo	Description
9/03/15	CCS

Pipe installation above the facility.
9/03/15	CCS

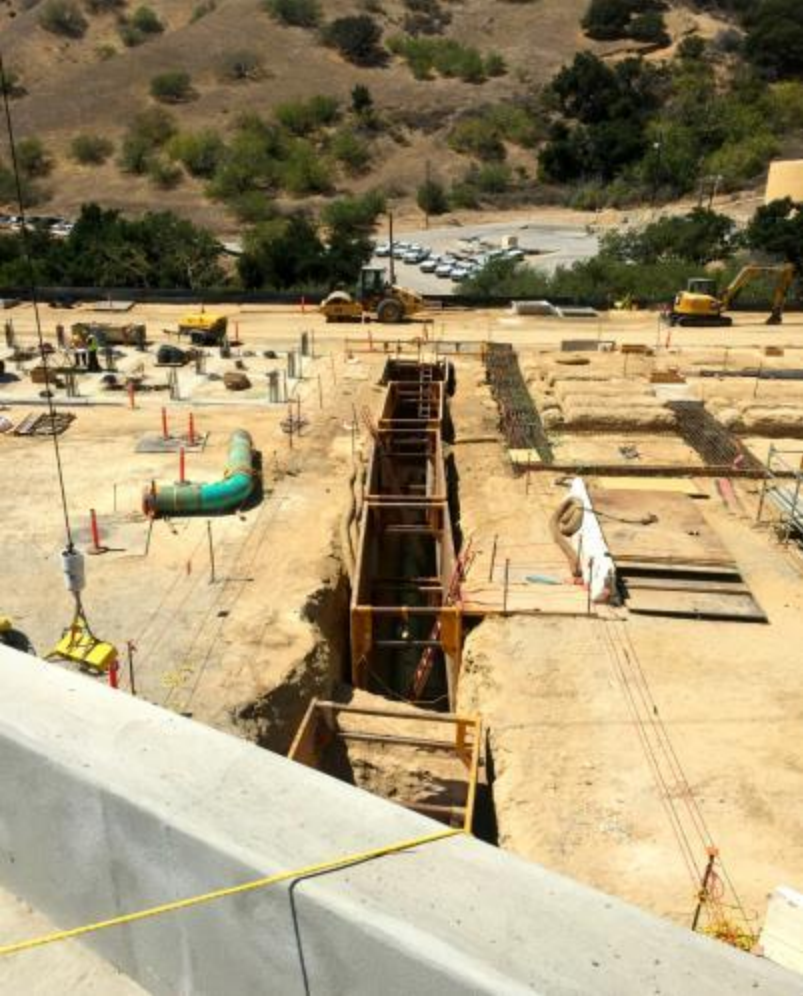
Installation of conduit, along with excavation and pouring of foundations.

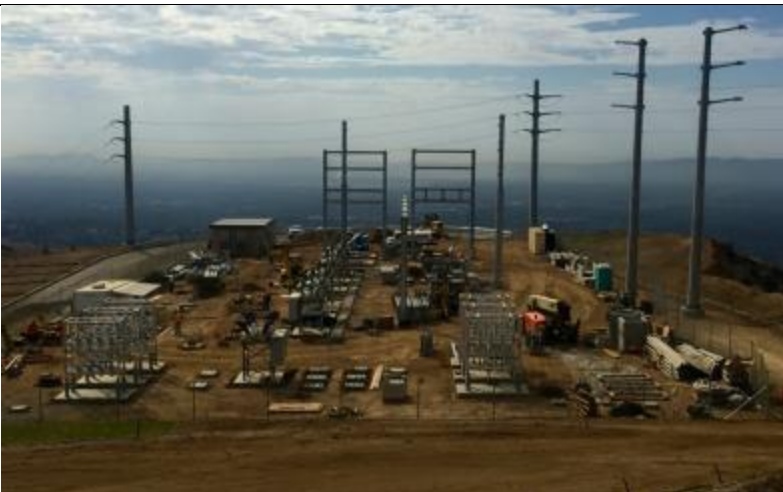
Date	Location	Photo	Description
9/10/15	Natural Substation

Overview of the Natural Substation.
9/10/15	Natural Substation

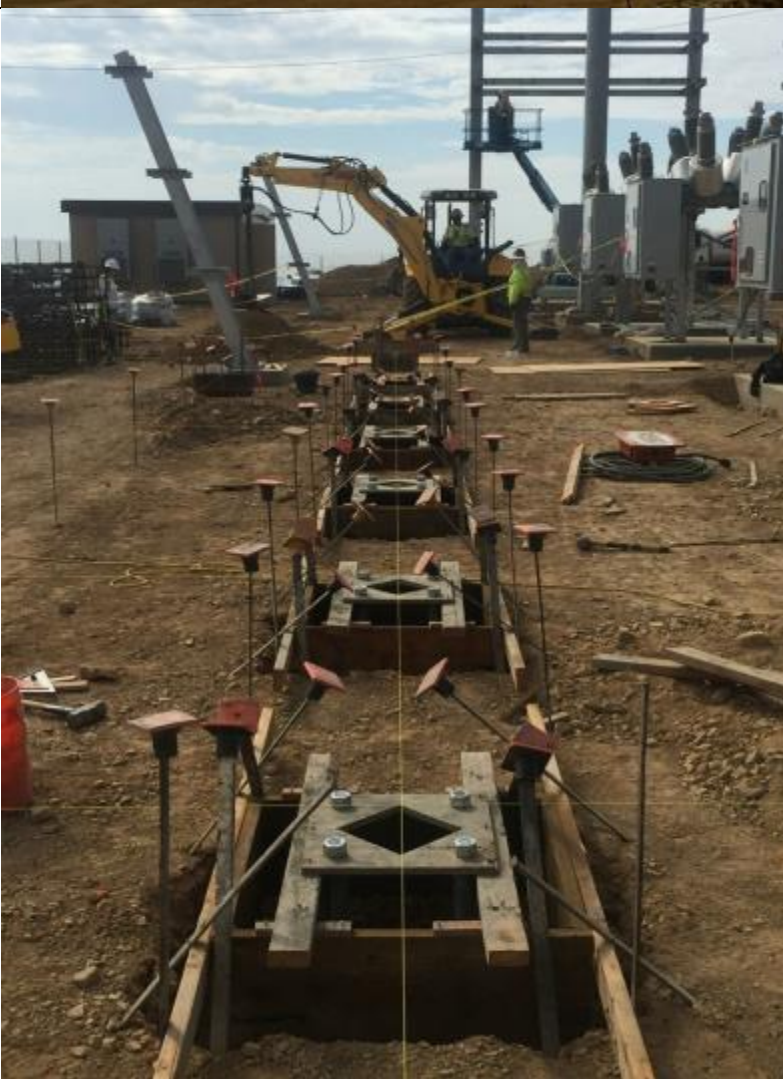
Drilling, forming, and pouring continue within the Natural Substation.

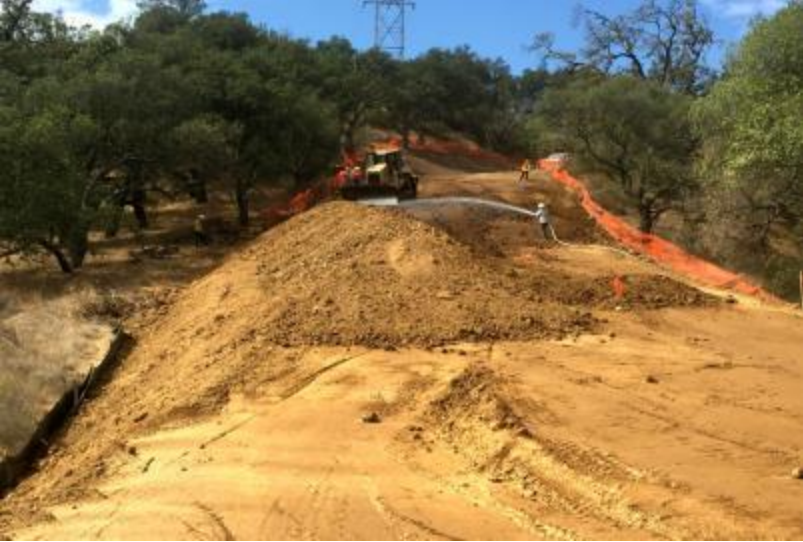
REPRESENTATIVE SITE PHOTOGRAPHS			
Date	Location	Photo	Description
9/10/15	Access road to TSP 40

Work on the access road to TSP 40.
9/10/15	Access road to TSP 40

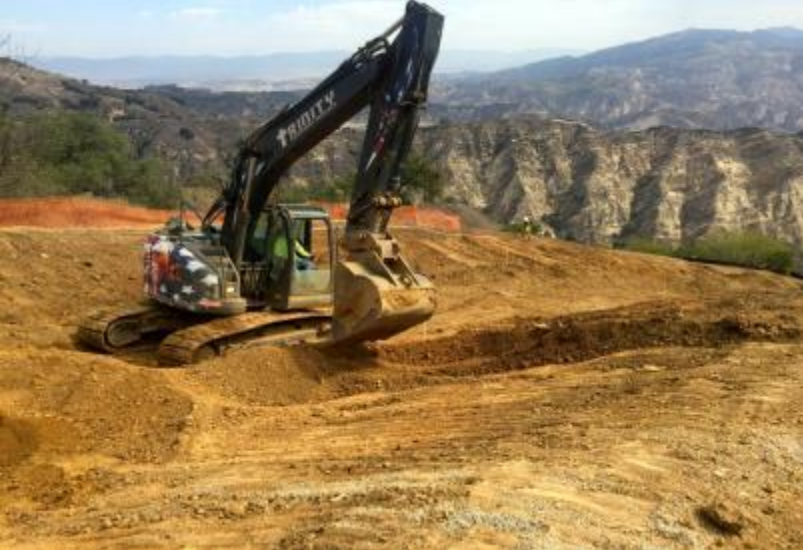
Work on the access road to TSP 40. Work is being observed by a paleontological monitor.
9/10/15	Access road to TSP 40.

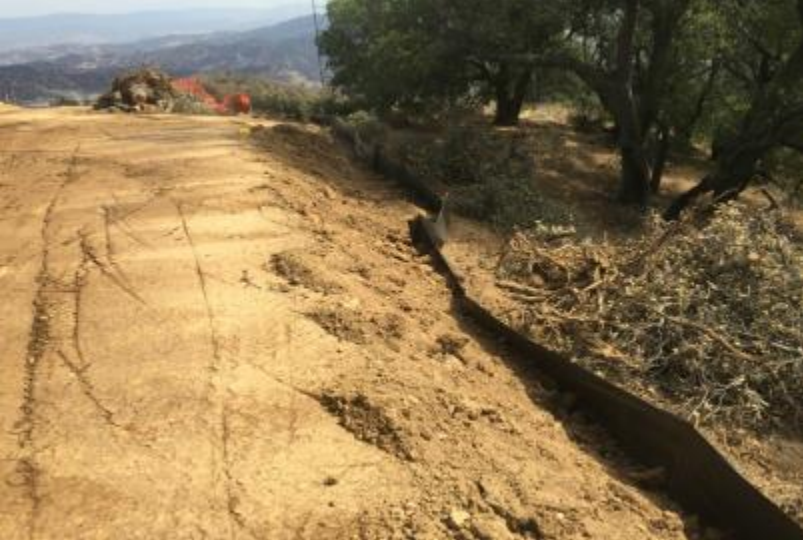
Silt fencing along the access road.

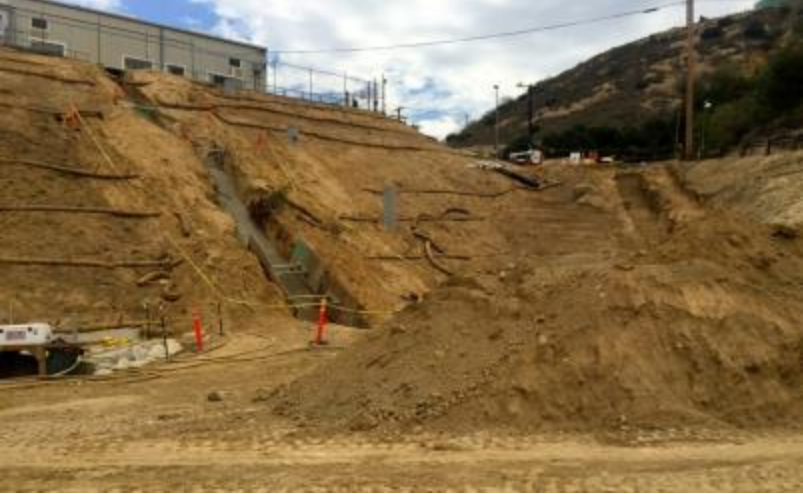
REPRESENTATIVE SITE PHOTOGRAPHS			
Date	Location	Photo	Description
9/10/15	CCS

Pipe installation above the facility.
9/10/15	CCS

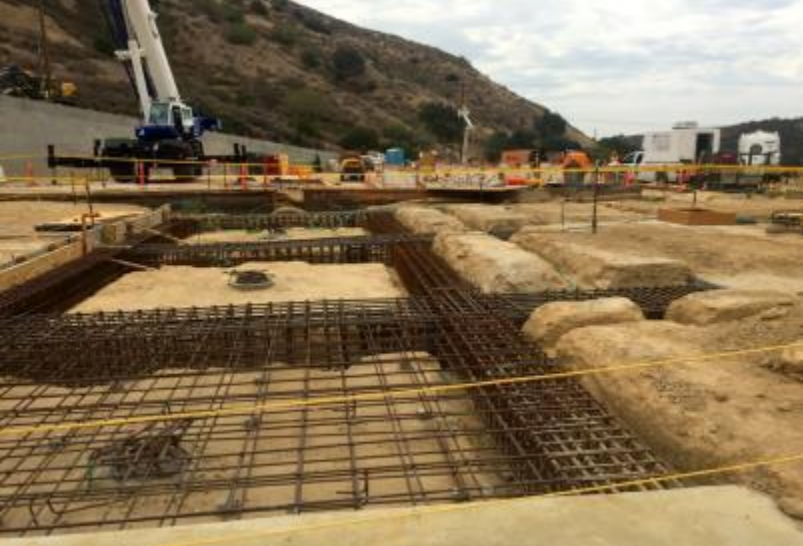
Excavation, installation of rebar, forming, and pouring continue within the CCS site.
9/10/15	CCS

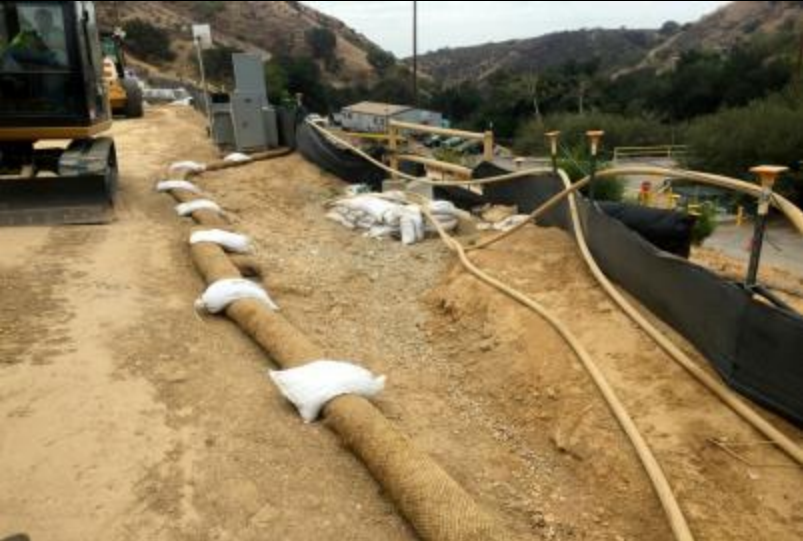
BMP catch basin for the CCS site.

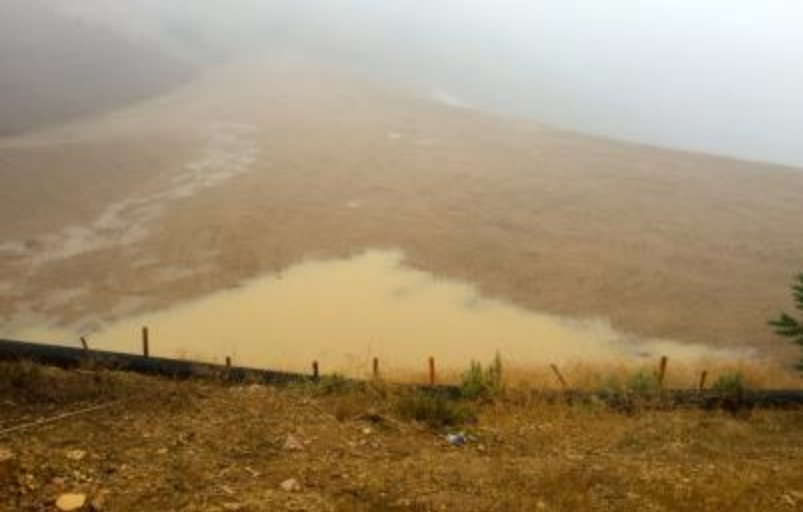
Ponded water in the topmost fill key.
9/15/15	Well pad near the PS-42 Fill Site	 	Gravel bags around the drain inlet are functioning (i.e., holding back water to allow sediment to settle out).

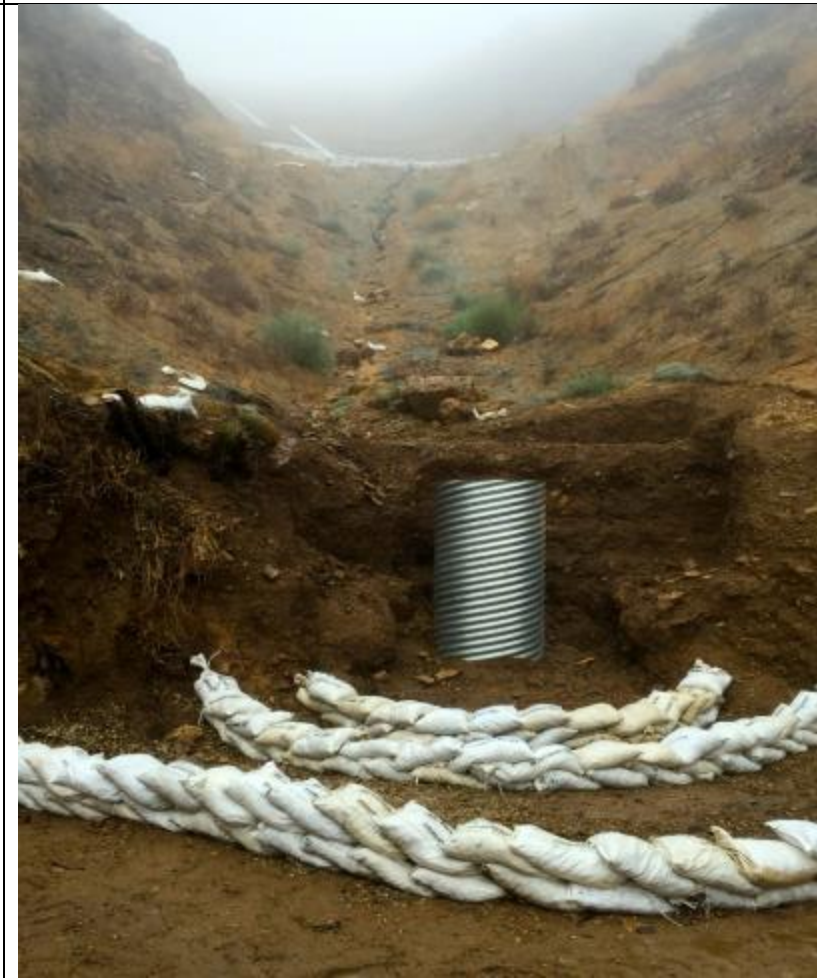
Date	Location	Photo	Description
9/15/15	PS-42 Fill Site

Lower portion of the PS-42 Fill Site seemed to have weathered the rain quite well.
9/15/15	Natural Substation

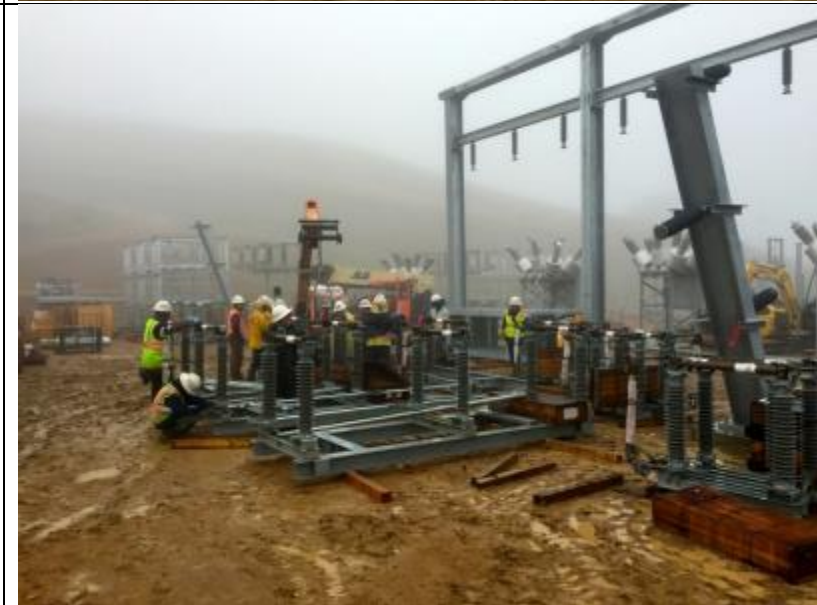
A crew is installing equipment.

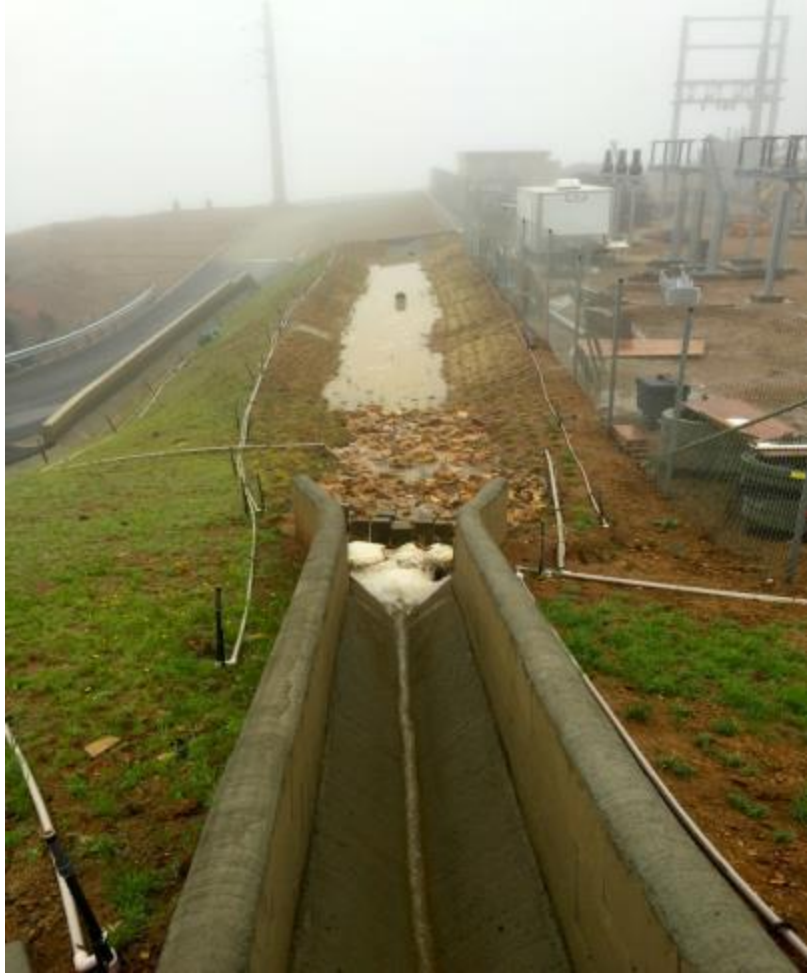
REPRESENTATIVE SITE PHOTOGRAPHS			
Date	Location	Photo	Description
9/15/15	Natural Substation access road

Biofiltration unit.
9/15/15	Natural Substation

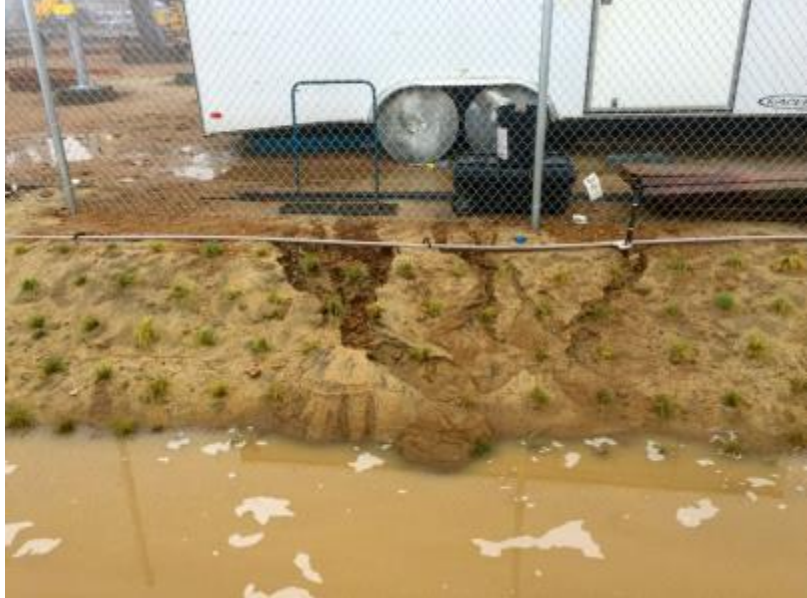
Erosion from sheet flow across the Natural Substation.

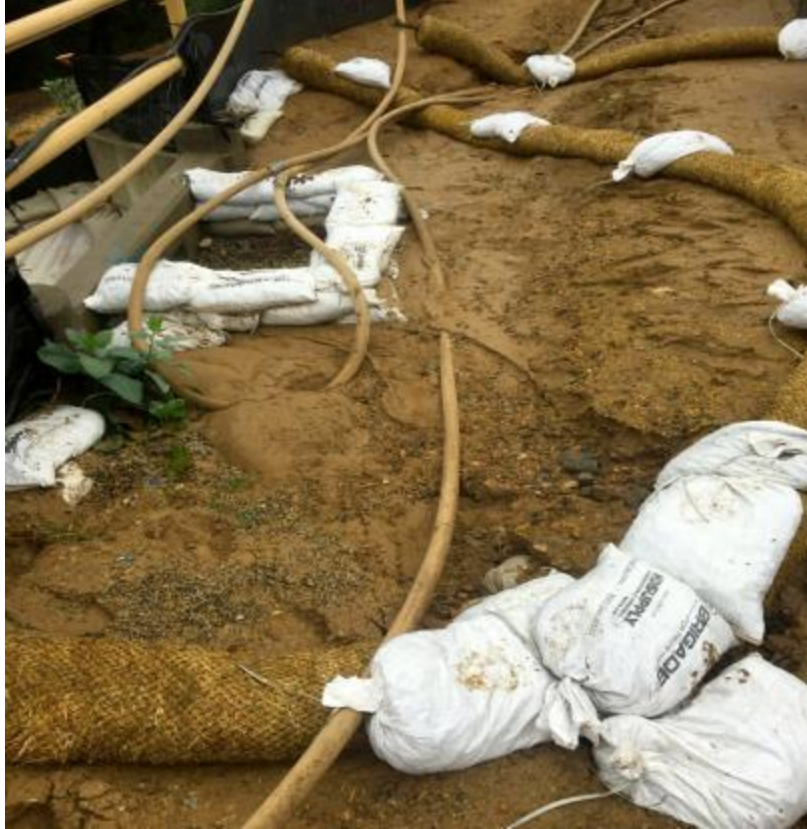
Date	Location	Photo	Description
9/15/15	CCS

The main catch basin for the CCS site was not sufficient to manage the heavy rainfall.
9/15/15	CCS

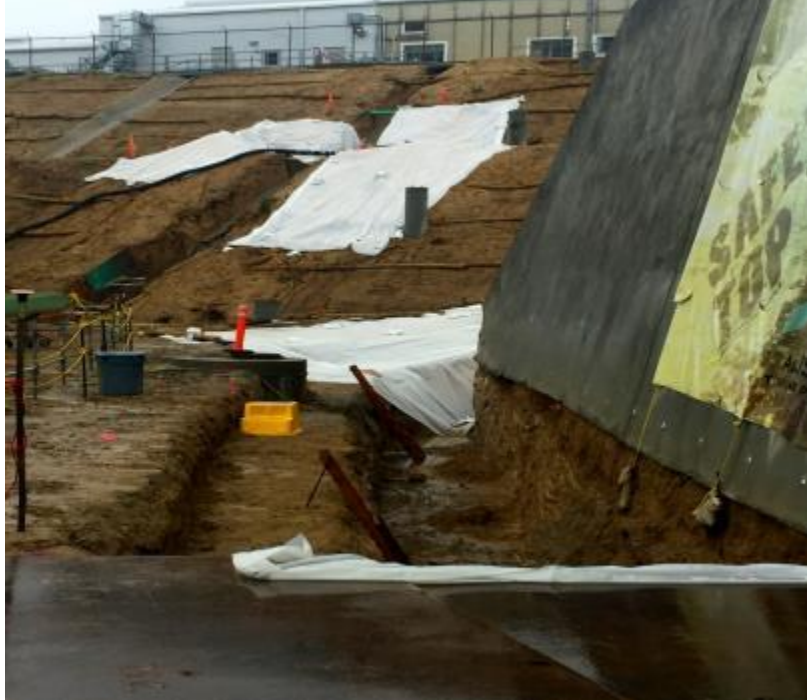
Open ground and open trenches within the CCS site.

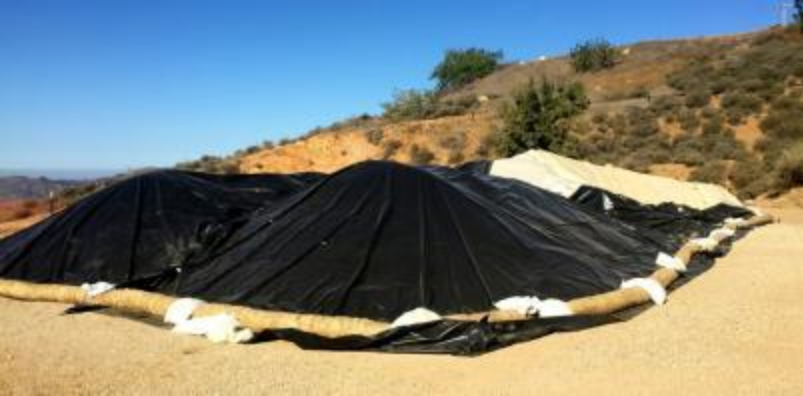
REPRESENTATIVE SITE PHOTOGRAPHS			
Date	Location	Photo	Description
9/24/15	Well pad above the PS-42 Fill Site

Spoil piles have been covered.
9/24/15	PS-42 Fill Site

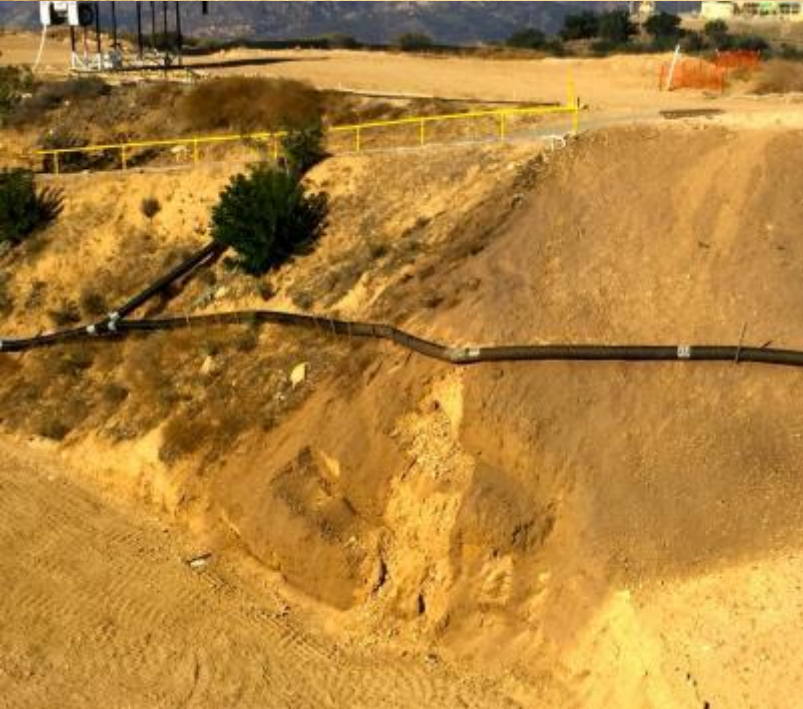
The temporary drainage pipe leaked during the last rain event and caused some erosion on the slope.
9/24/15	Natural Substation access road

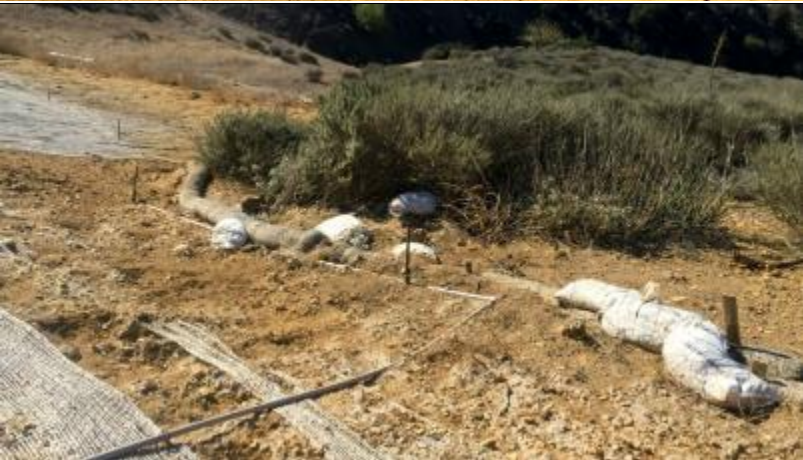
BMPs along the access road need some maintenance.

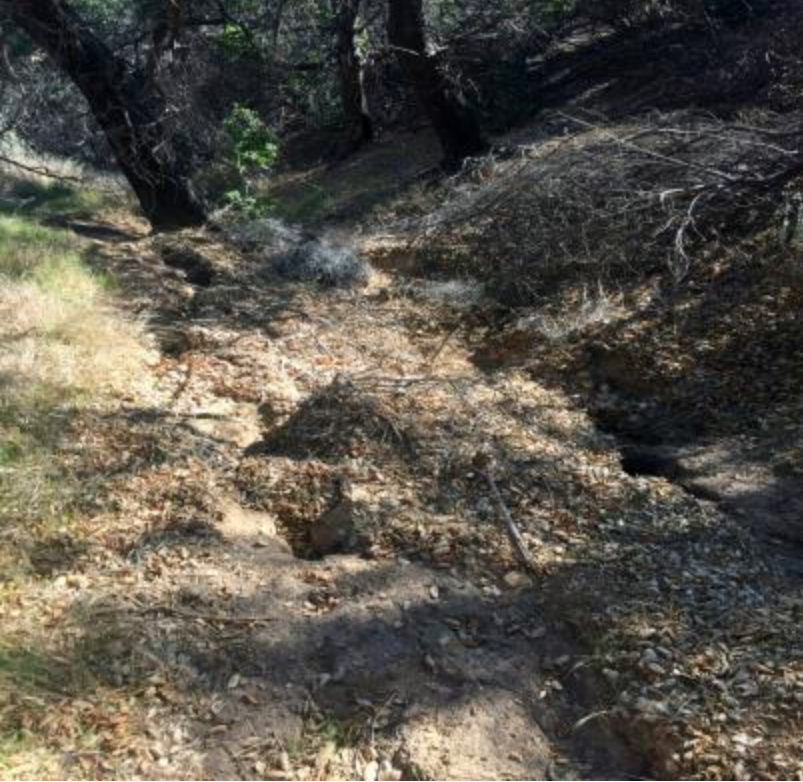
REPRESENTATIVE SITE PHOTOGRAPHS			
Date	Location	Photo	Description
9/24/15	Access road to the Natural Substation

Oak swale below the access road – showing some erosion rills.
9/24/15	Natural Substation

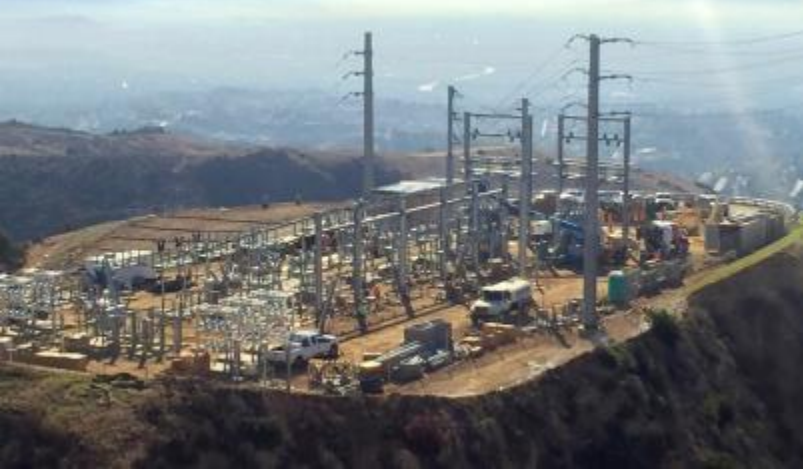
Site overview.
9/24/15	CCS site

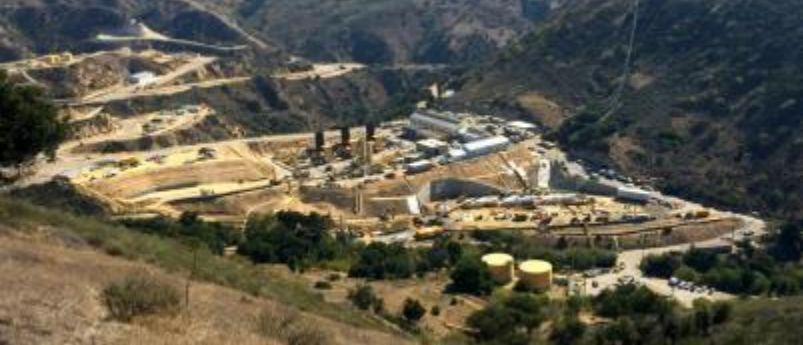
Overview of the CSS site looking down from the Natural Substation.

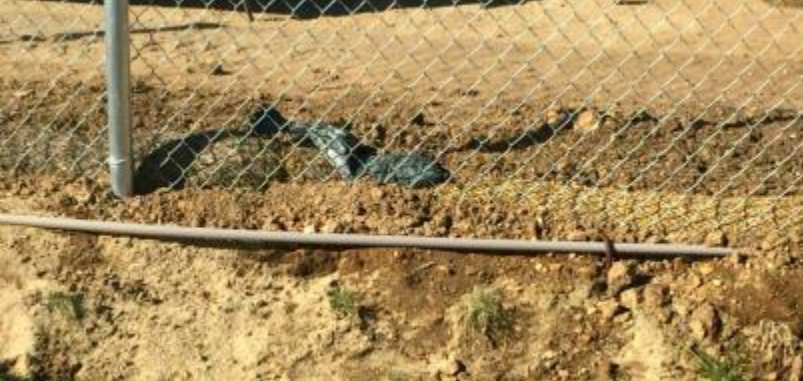
REPRESENTATIVE SITE PHOTOGRAPHS			
Date	Location	Photo	Description
9/24/15	Natural Substation

BMPs (wattles) have been added along the project boundary fence; a portion of the wattles were installed too deep.
9/24/15	TSP 49 area

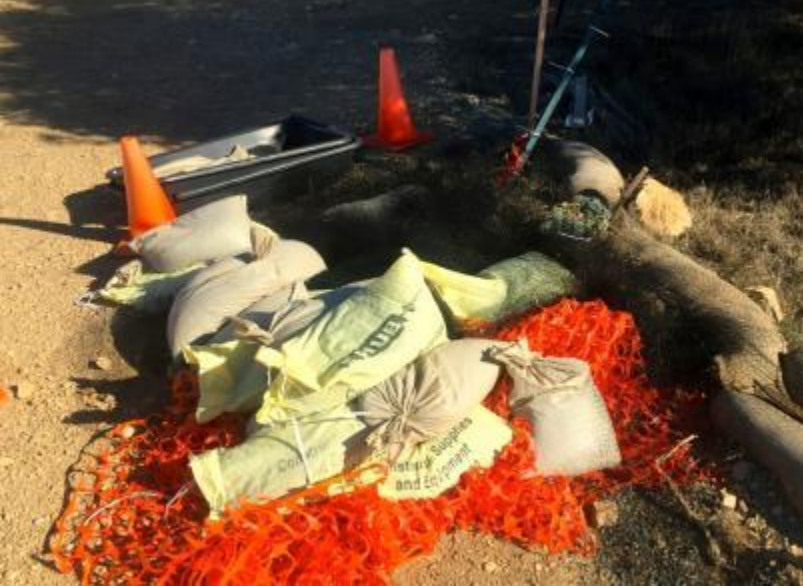
Trash at the TSP 49 area.
9/24/15	TSP 49

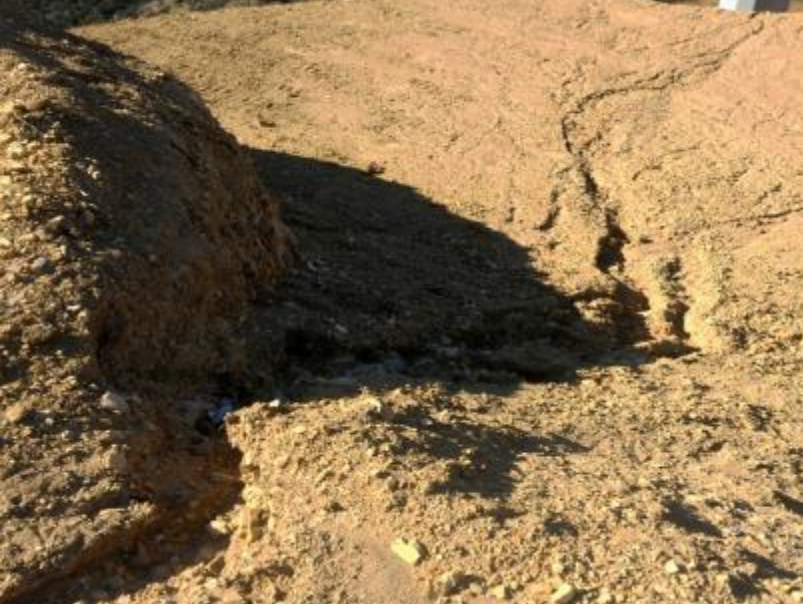
Erosion rills on the TSP 49 access road and crane pad.

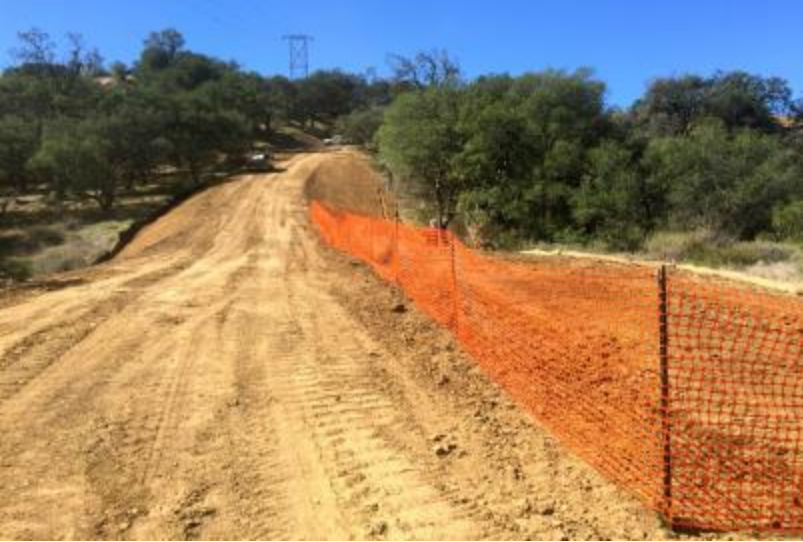
REPRESENTATIVE SITE PHOTOGRAPHS			
Date	Location	Photo	Description
9/24/15	Access road at TSP 40

Access road upgrades are nearly complete. Construction fencing is protecting the road bank restored with salvaged VSS topsoil.
9/24/15	Access road at TSP 40

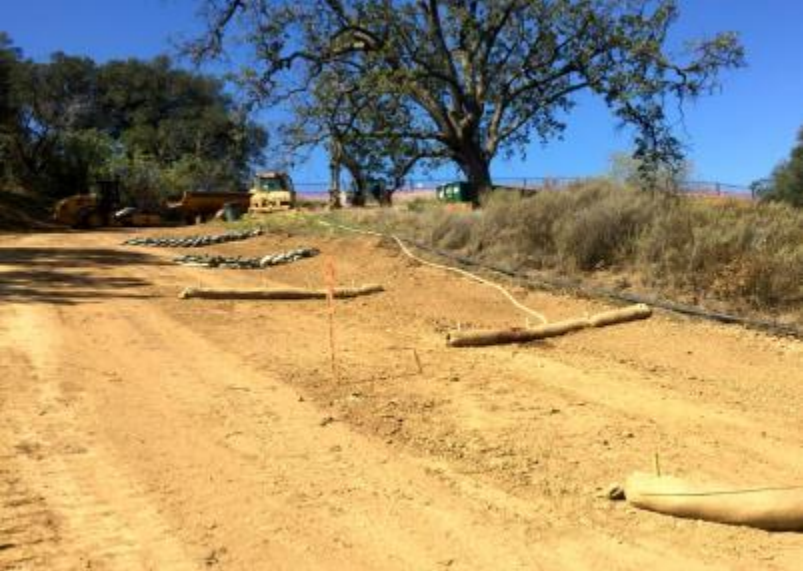
BMPs being installed along the access road.
9/24/15	Access road at TSP 40

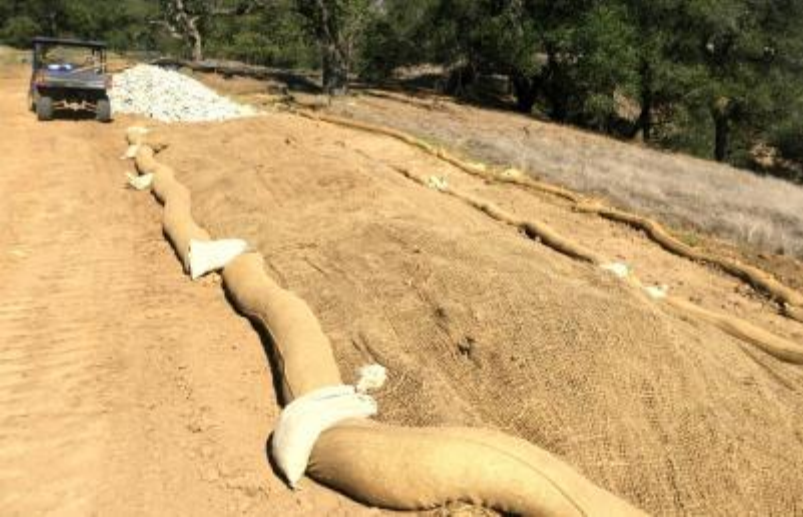
Mariposa lily topsoil preserved under jute netting.

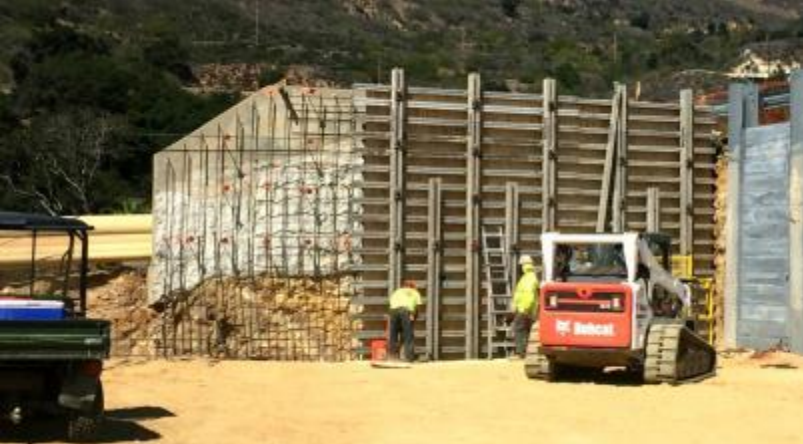
REPRESENTATIVE SITE PHOTOGRAPHS			
Date	Location	Photo	Description
9/24/15	Admin/IM Building

Work on the wall continues.
9/24/15	CCS

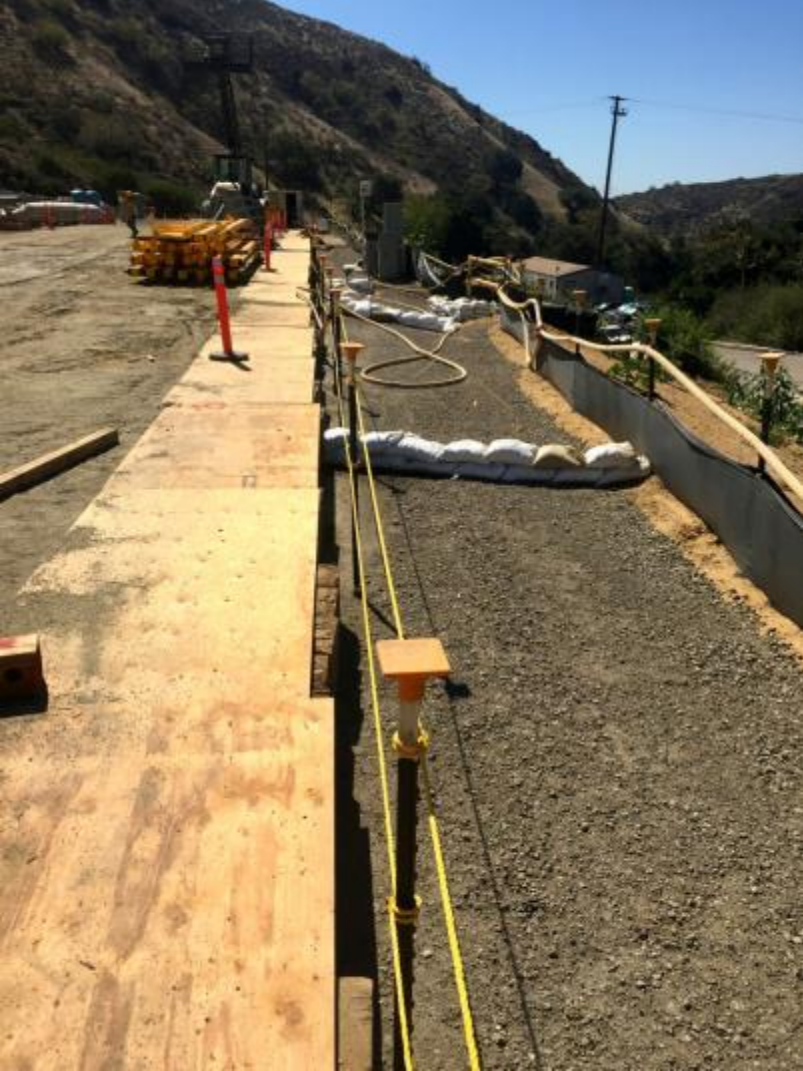
Main catch basin for the CCS site has been changed and upgraded.

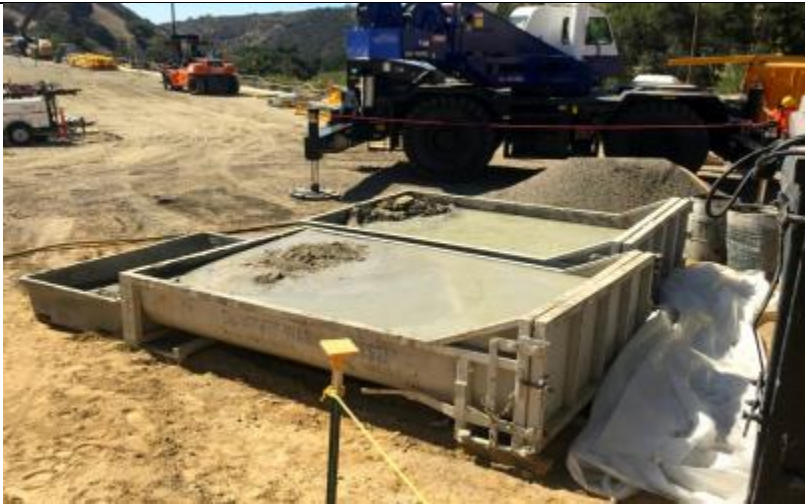
Several very full concrete washouts.
9/24/15	TSP 24/25 access road

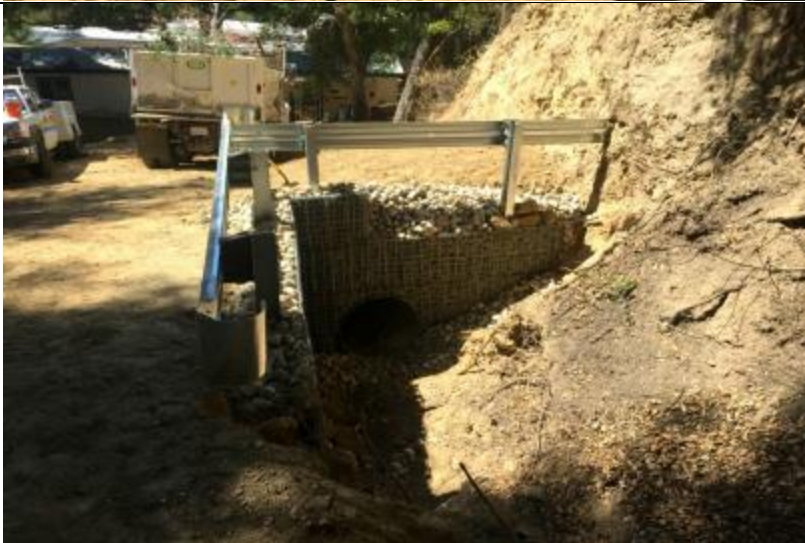
Culvert replacement work has been completed. LADPW crews are installing debris barriers.

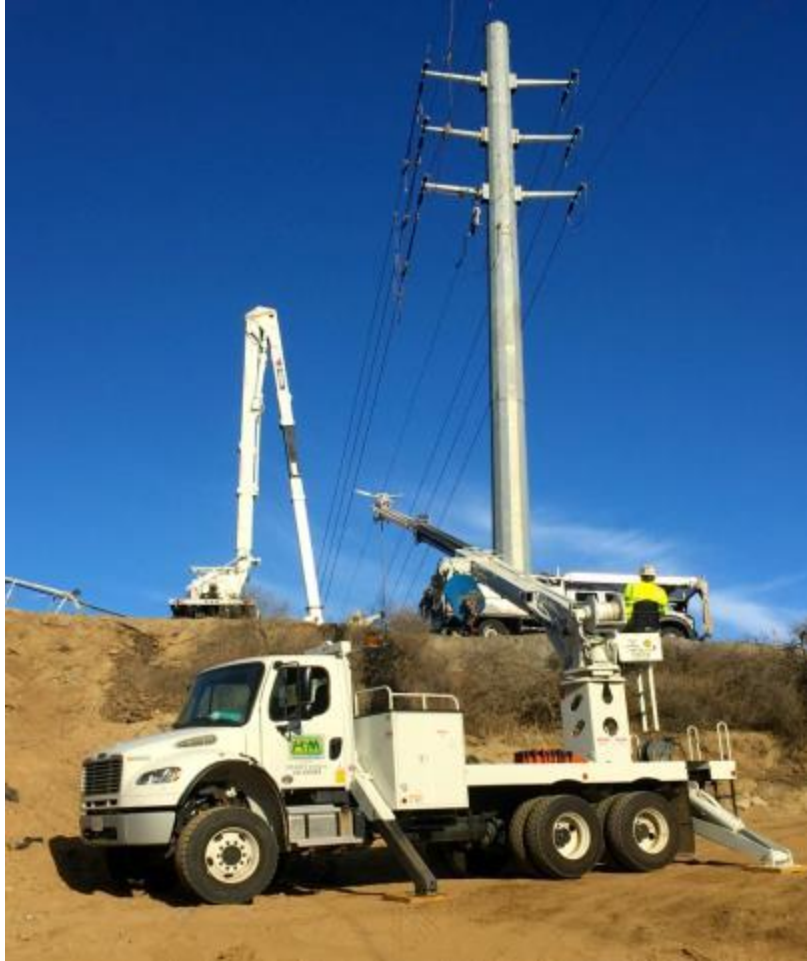
REPRESENTATIVE SITE PHOTOGRAPHS			
Date	Location	Photo	Description
9/30/15	TSP 21

SCE civil crews are pulling wire.
9/30/15	Pull site between TSP 21 and TSP 22

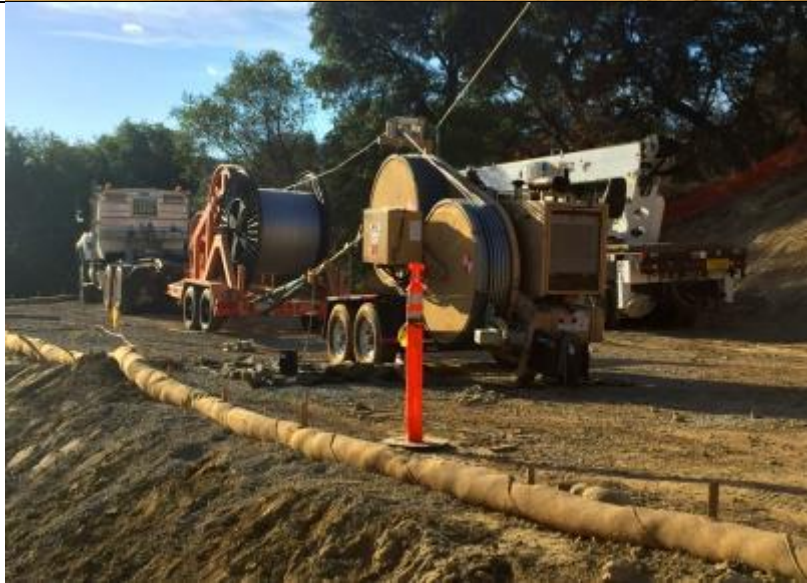
Wire pulling equipment on the pull site.

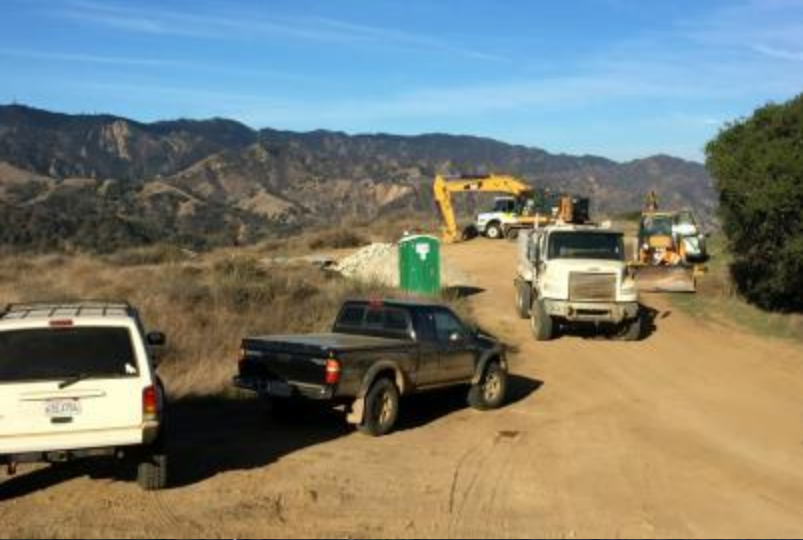
REPRESENTATIVE SITE PHOTOGRAPHS			
Date	Location	Photo	Description
9/30/15	Helicopter pad near TSP 30

Equipment parked on the helicopter pad; work is expected to begin in the next week for preparation of the helicopter site.
9/30/15	TSPs 28 and 29	 	Crews are installing TSPs 28 and 29.
9/30/15	Drainage between TSPs 24 and 25	 	Crews are installing gabion streambed protection measures.

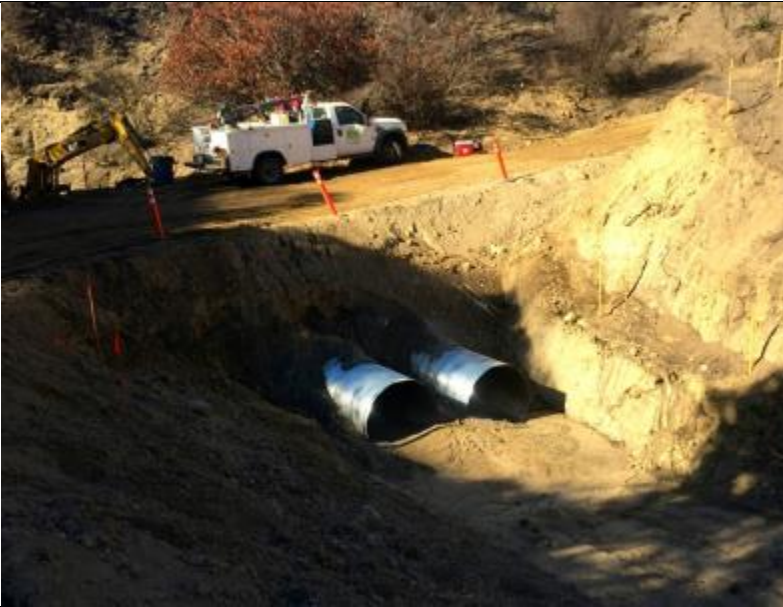
Date	Location	Photo	Description
9/30/15	Drainage between TSPs 24 and 25

New culverts under the access road; note the sediment that accumulated after the last storm.
9/30/15	Drainage between TSPs 24 and 25
