### **Re: Monthly Report Summary #18 for Aliso Canyon Turbine Replacement Project**

## Aliso Canyon Turbine Replacement Project CPUC Site Inspection Form

Project:	Aliso Canyon Turbine Replacement	Date:	September 3, 2015
Project Proponent:	Southern California Gas Company and Southern California Edison	Report #:	VS069
Lead Agency:	California Public Utilities Commission	Monitor(s):	Vince Semonsen
CPUC PM:	Andrew Barnsdale, Energy Division	AM/PM Weather:	Partly cloudy and cool in the morning; clearing and warming later in the day.
E & E CM:	Lara Rachowicz	Start/End time:	0700 to 0930 at TSPs 12 through 25. 1000 to 1230 at the Aliso Canyon Natural Gas Storage Field.
Project NTP(s):	Guard House and Road Widening (NTP-1). The new Admin/IM Building (NTP-2) and Central Compressor Station (CCS) (NTP-3). P-41 Fill Site (NTP-2), PS-42 Fill Site, P-32 Fill Site (NTP-3), and the Natural Substation (NTP-A, NTP-D). TSPs 2 through 42 (NTPs A, C, and D) and the SCE 210 Freeway Yard.

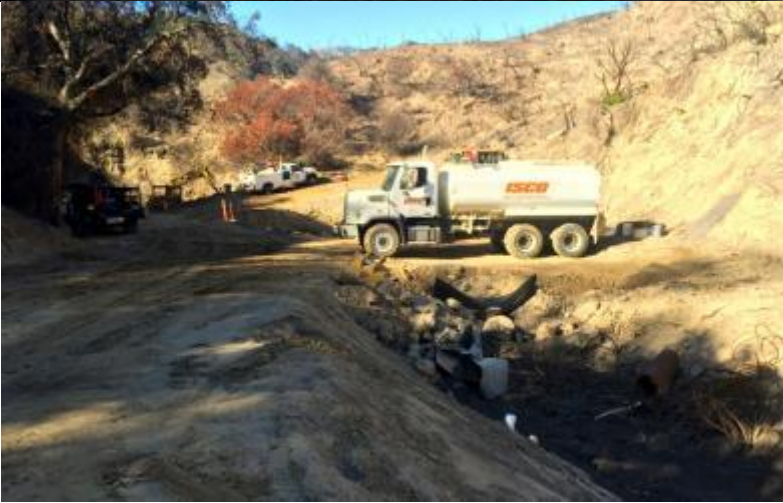
The drainage is blocked above the culverts.

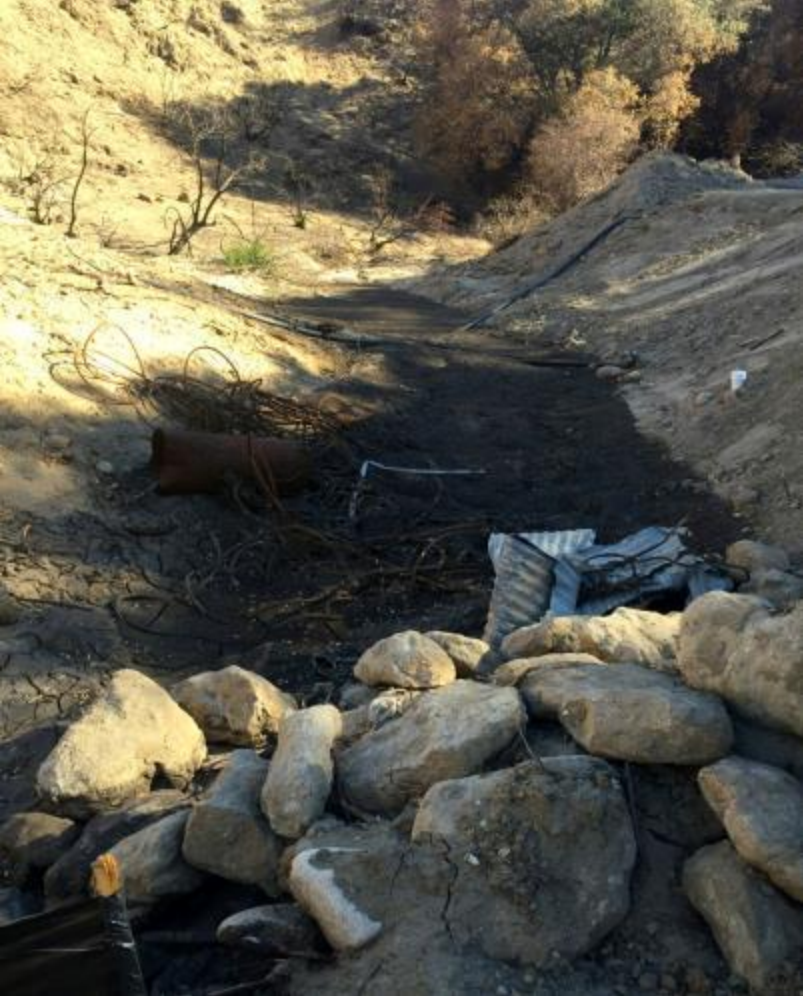
REPRESENTATIVE SITE PHOTOGRAPHS			
Date	Location	Photo	Description
9/30/15	Drainage between TSPs 24 and 25

Above the blocked drainage, there is trash and ash-laden sediment.
9/30/15	PS-42 Fill Site

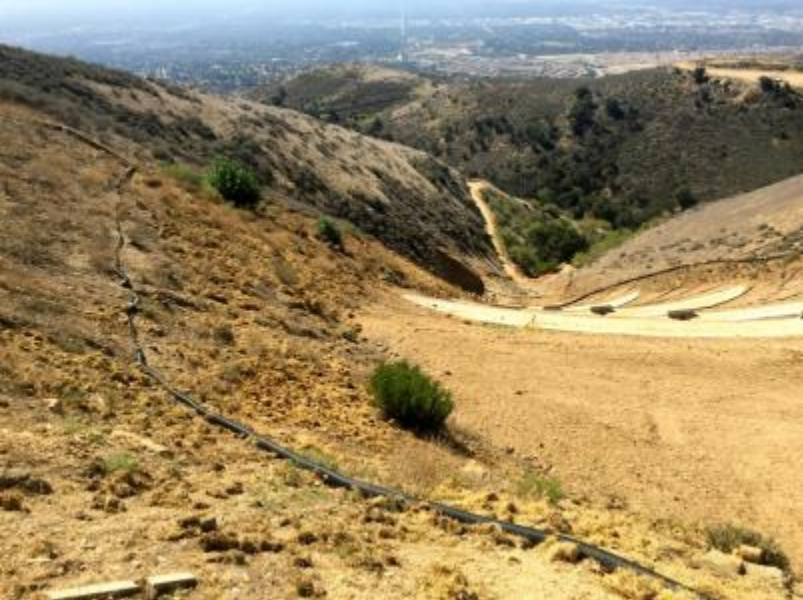
Crews have begun to replace the old BMPs in preparation for the upcoming rainy season.

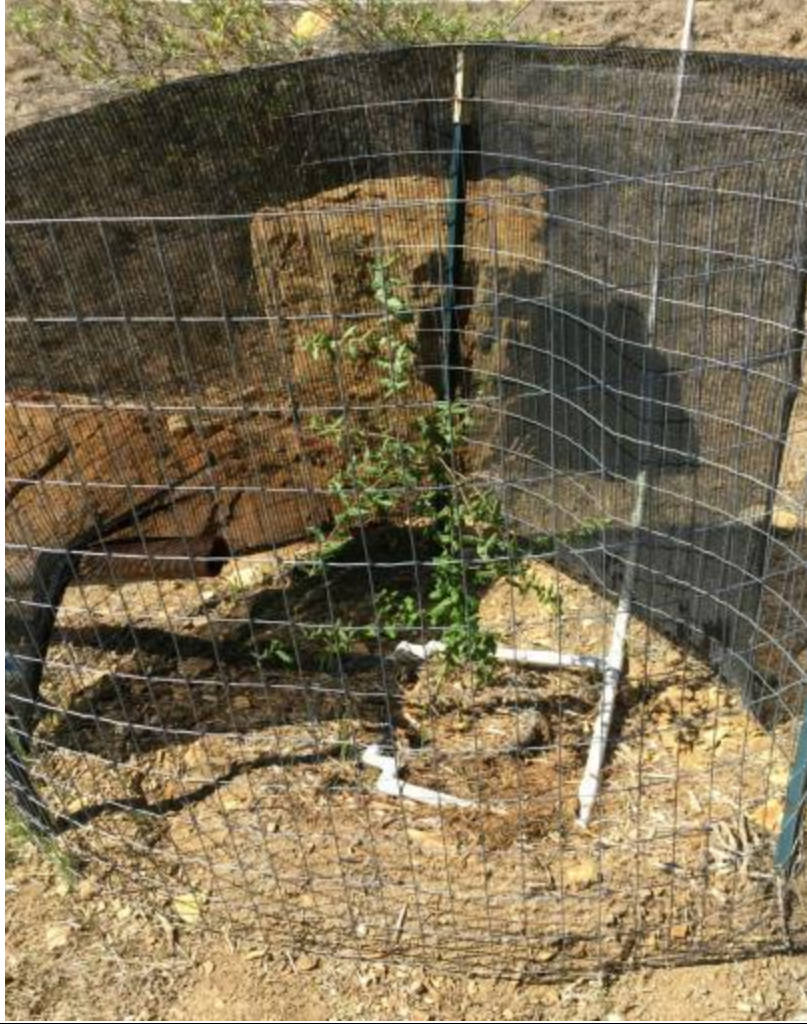
REPRESENTATIVE SITE PHOTOGRAPHS			
Date	Location	Photo	Description
9/30/15	Oak Tree Mitigation Site

Oak trees look healthy and are still putting out new growth.
9/30/15	Natural Substation

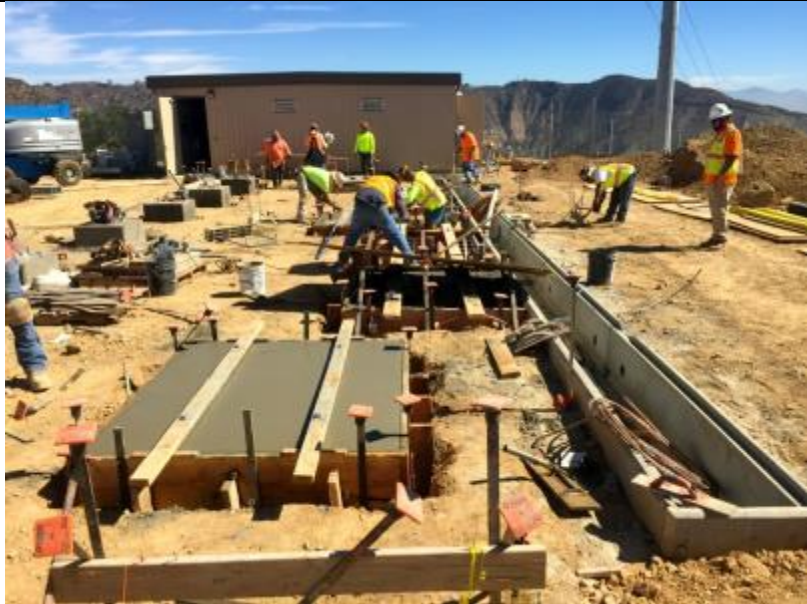
Excavation, forming, and pouring continues within the facility.

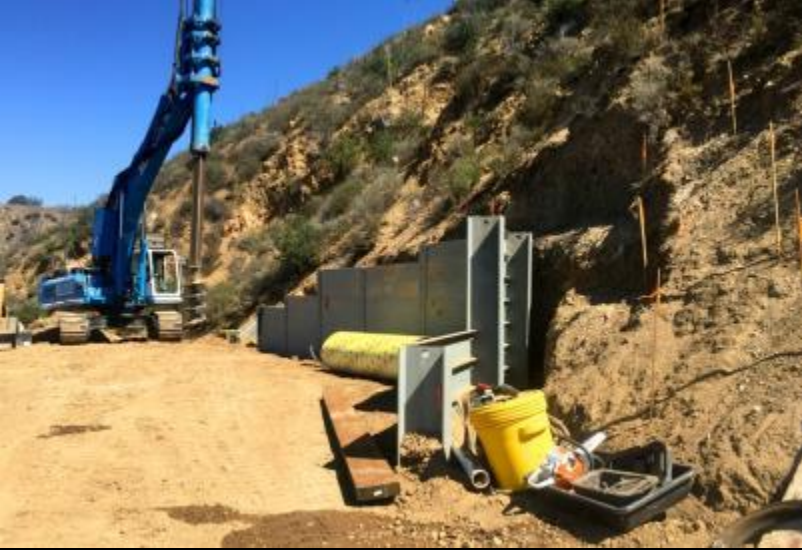
REPRESENTATIVE SITE PHOTOGRAPHS			
Date	Location	Photo	Description
9/30/15	TSP 43

Site preparation continues with drilling and shoring work.
9/30/15	TSP 43

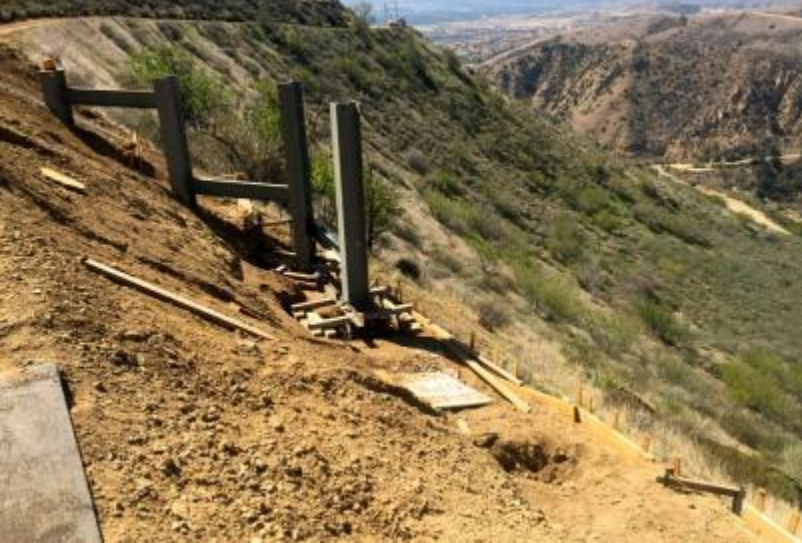
Shoring being installed below the pole site.
9/30/15	TSP 43

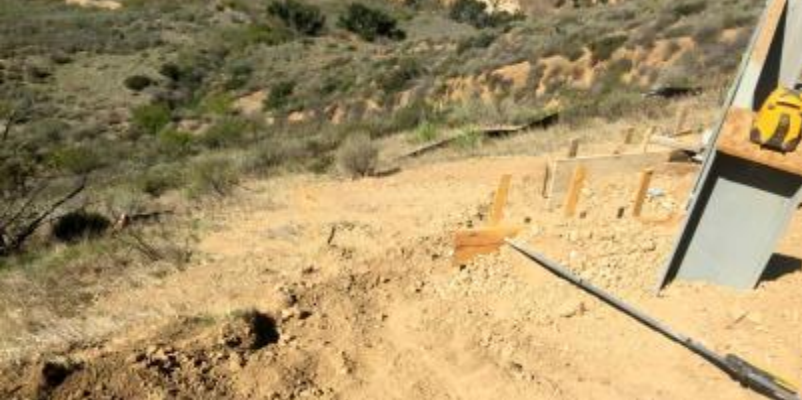
Silt fencing is in need of repairs where dirt is sloughing down the slope.

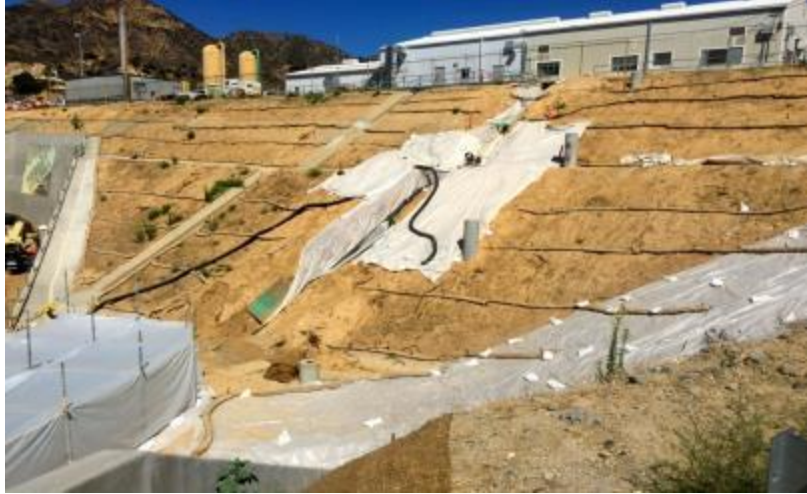
REPRESENTATIVE SITE PHOTOGRAPHS			
Date	Location	Photo	Description
9/30/15	CCS

Large areas of open ground and open trenches remain within in the CCS site.
9/30/15	CCS

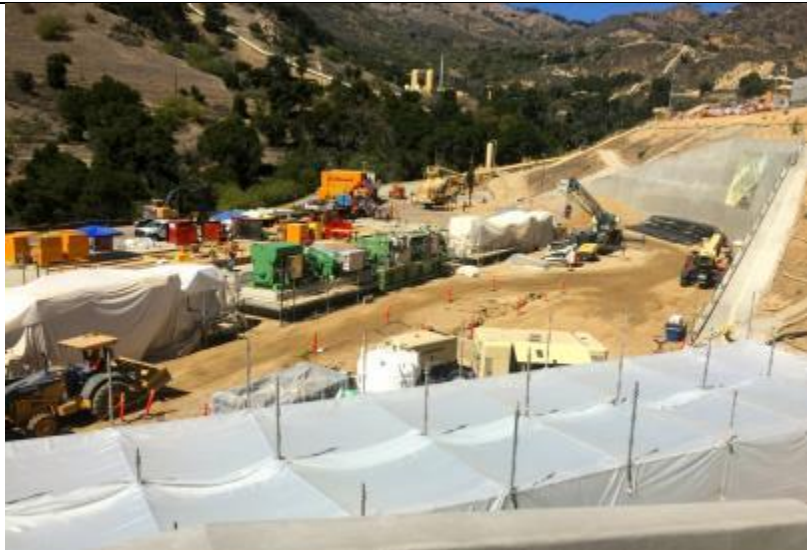
Site overview.
9/30/15	CCS

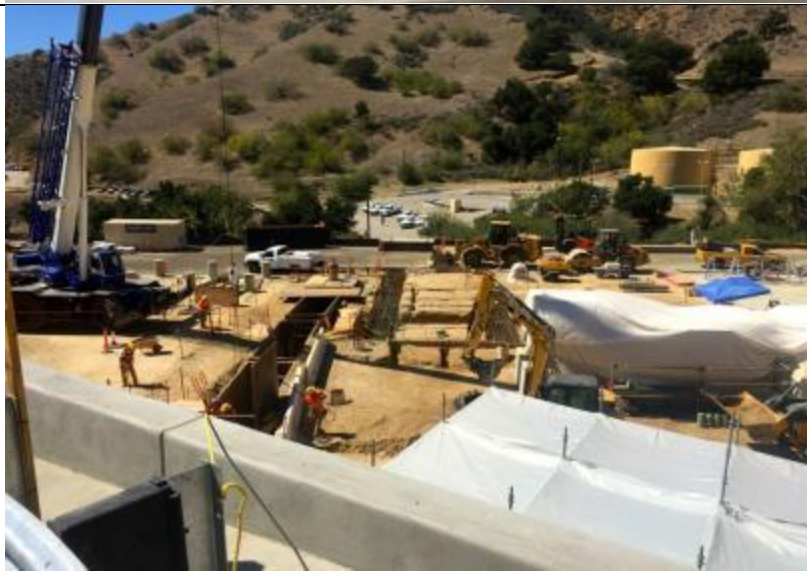
Site overview.
