Re: Monthly Report Summary #24 for Aliso Canyon Turbine Replacement Project

Aliso Canyon Turbine Replacement Project CPUC Site Inspection Form

| Project: | Aliso Canyon Turbine Replacement | Date: | March 1, 2016 |

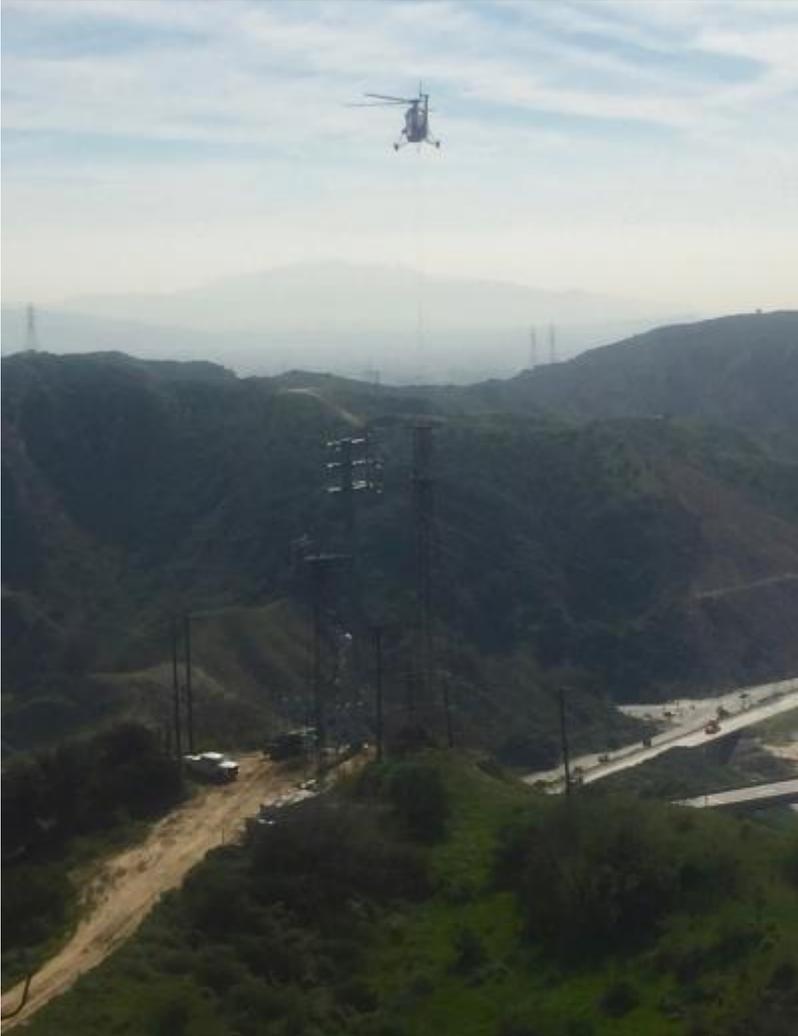
With the use of a helicopter, a crew was removing portions of the old lattice work towers at TSP 33 and placing them in the staging area – see photo. The helicopter backdraft was very strong and generated large quantities of dust. As a result, Todd White (Arcadis) spoke with the crew about getting a water truck to wet down the site again. A water truck arrived onsite as we were getting ready to leave. A fire crew was observing the tower removal operation. At several other locations, hand crews were working on the removal of the old tower foundations. It appeared that all operations were moving forward as planned.

| Date | Location | Photo | Description |
|---|--|--|--|
| 3/01/16 | TSP 33 | | Helicopter removing the old lattice work towers. |

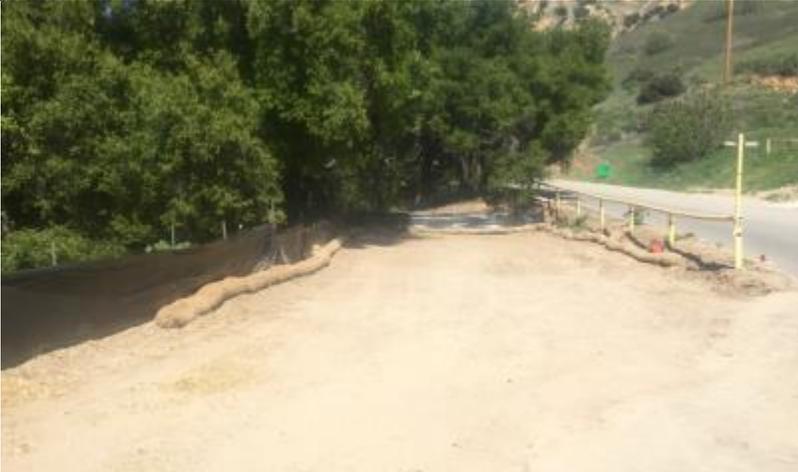
I drove to the Aliso Storage Field and arrived at approximately 1130. I noted that the exclusion fencing has been removed from along Limekiln Creek, east of the Guard House. The fencing remained along the creek near the lower sedimentation basin/newt pond (near the Guard House), and the spoil pile had been removed from the small staging area – see photo.

| Date | Location | Photo | Description |
|---|--|--|--|
| 3/01/16 | Lower sedimentation basin/newt pond near the Guard House | | Fencing to protect the newts has been repaired. |

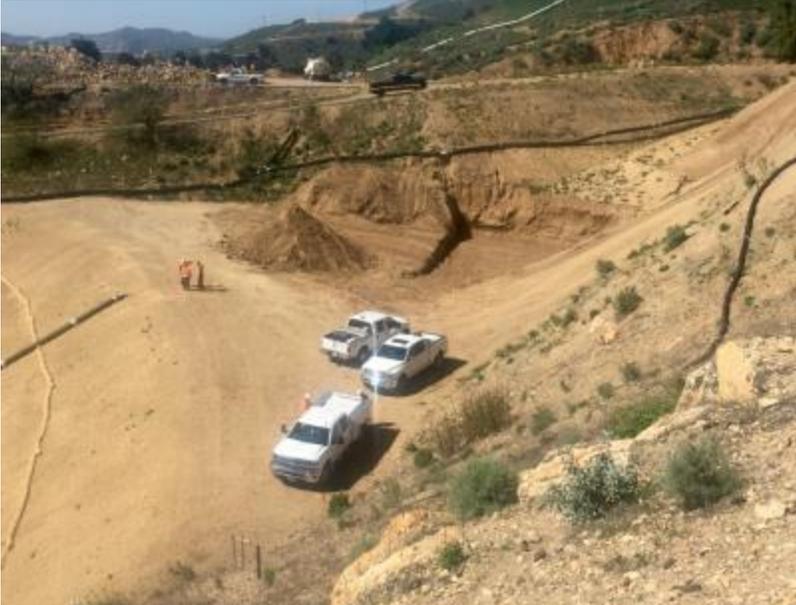
While driving to the PS-42 Fill Site, I noticed a crew conducting maintenance work on the best management practices (BMPs) around the first relief well (for a previous well leak not associated with the ACTR Project). At the PS-42 Fill Site, a crew was working on preparing the site to accept more soil – see photo.

| Date | Location | Photo | Description |
|---|---|---|---|
| 3/01/16 | PS-42 Fill Site | | Site preparation to accept more soil. |

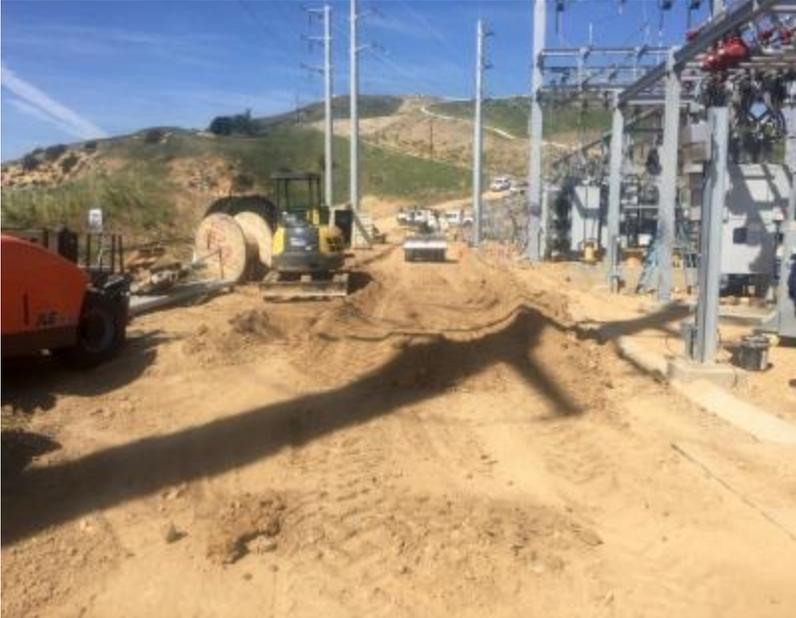
| Date | Location | Photo | Description |
|---|---|---|---|
| 3/01/16 | Natural Substation | | Grounding wire installation. |

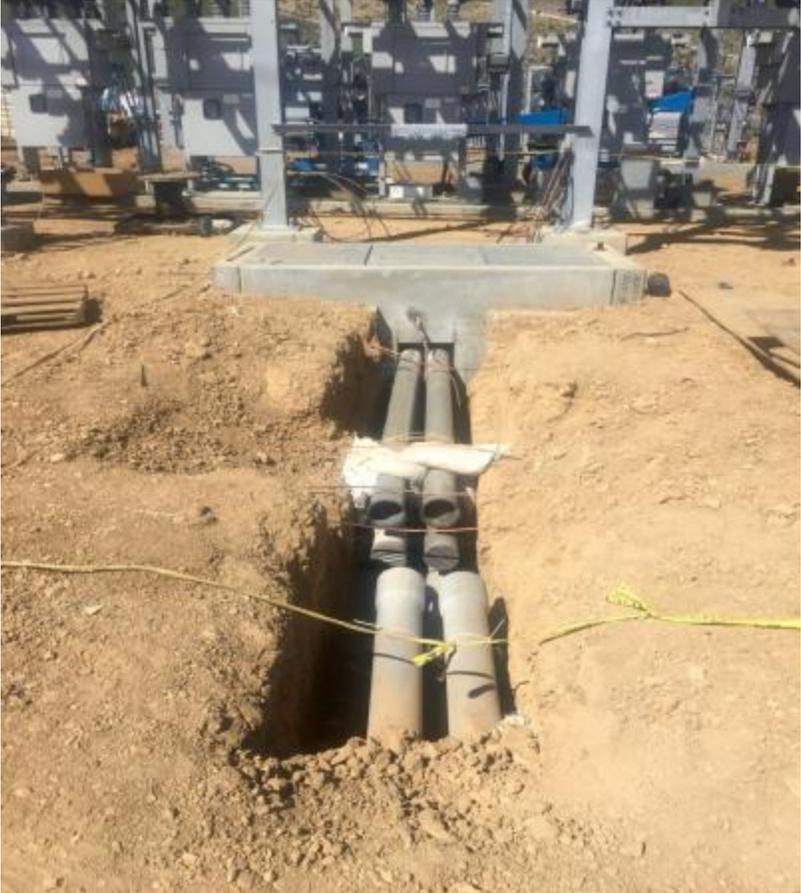
| Date | Location | Photo | Description |
|---|---|--|---|
| 3/01/16 | Natural Substation | | Conduit installation continues. |

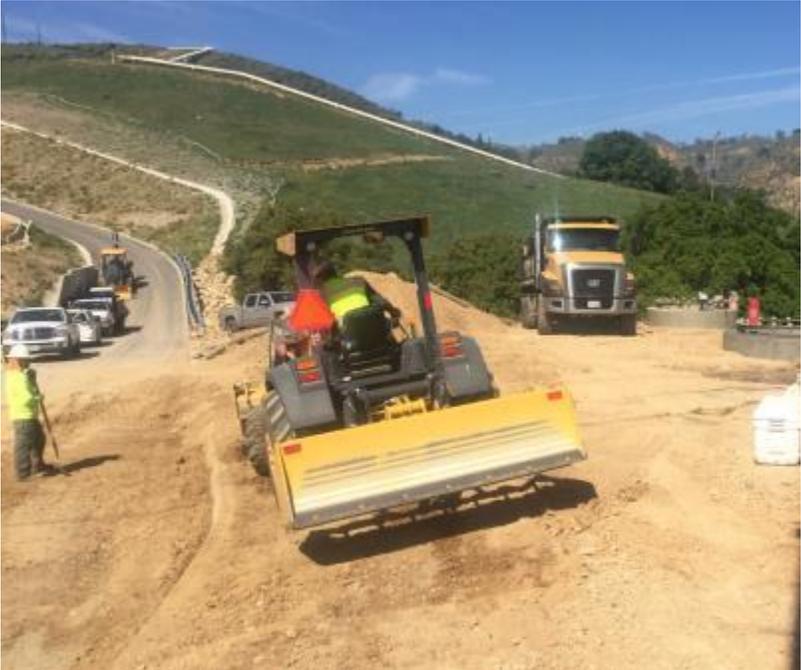
| Date | Location | Photo | Description |
|---|---|--|---|
| 3/01/16 | Natural Substation | | Clean-up work after the 12-kV plant power line foundation installation. |

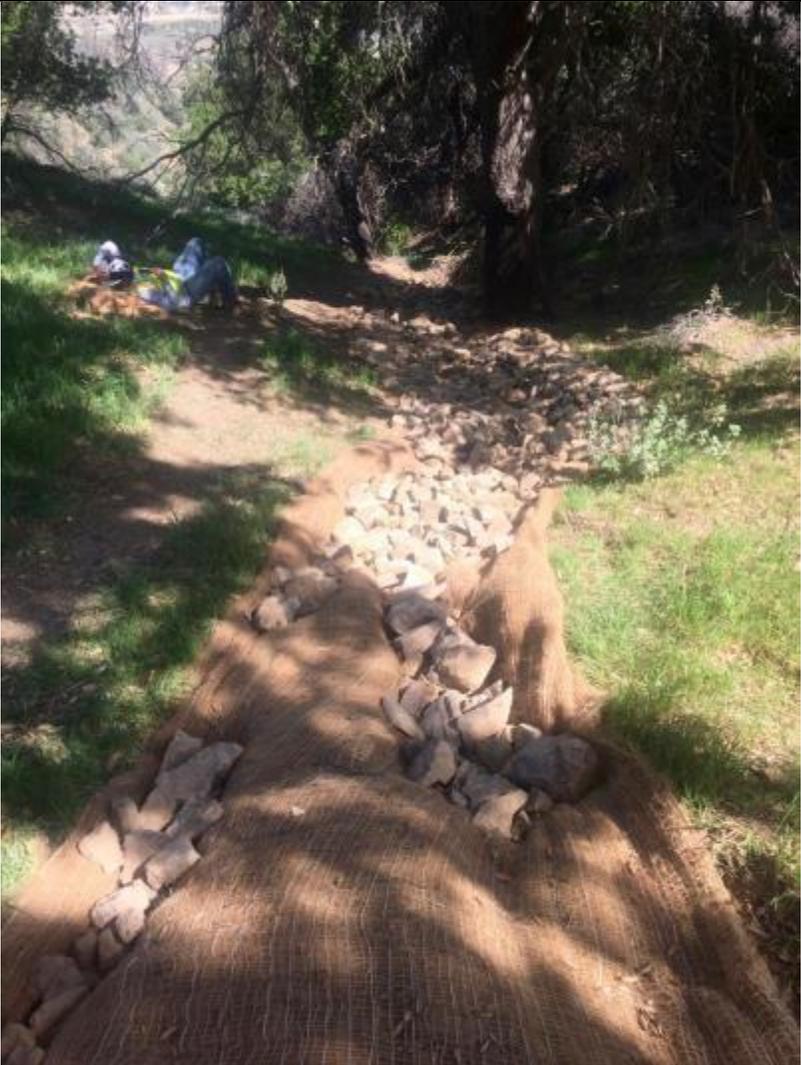
At the Natural Substation, crews continue to trench for and install conduit and grounding wire – see photo. A small crew with a skip loader was conducting clean-up work after the 12-kV power plant line foundation installation just south of the oak swale. The crew was collecting the excess soil into a pile in preparation for moving the soil to the PS-42 Fill Site – see photo. Within the oak swale, a crew was laying coconut fiber blankets in the erosion rills and filling them in with rock (APM GE-2) – see photo.

| Date | Location | Photo | Description |
|---|--|--|--|
| 3/01/16 | Natural Substation access road – oak swale | | Crews have been conducting repair work on the erosion rills through the oak swale. |

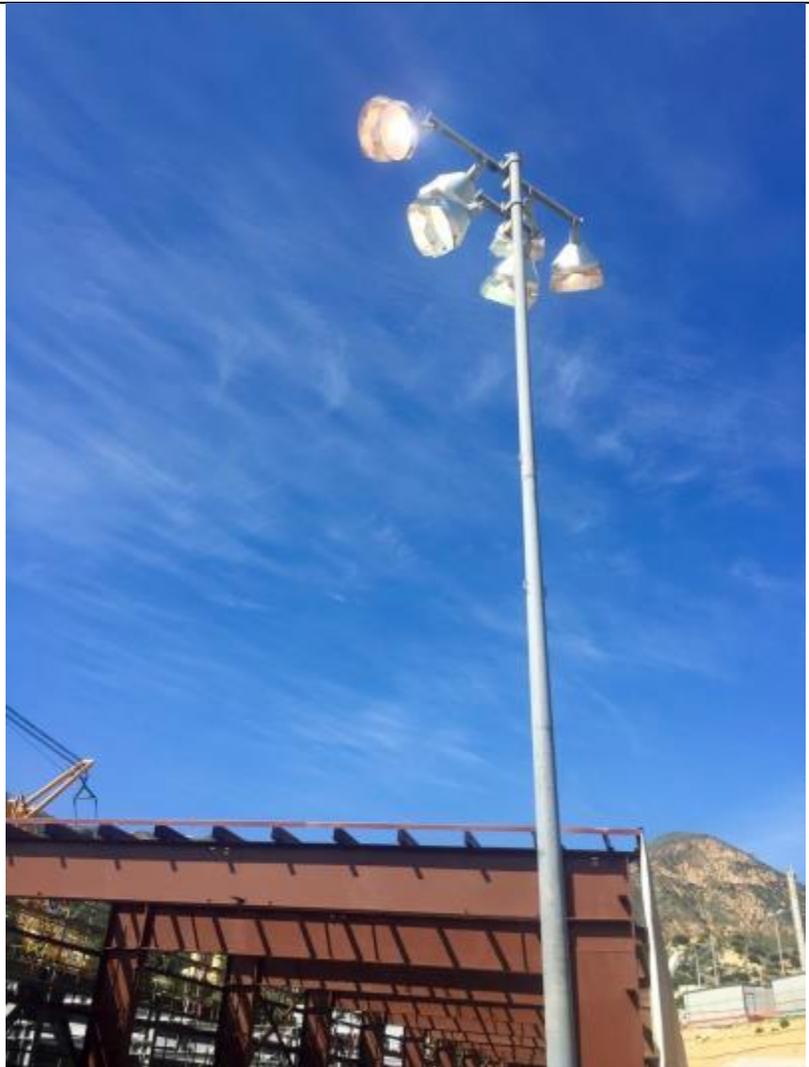
| Date | Location | Photo | Description |
|---|---|---|---|
| 3/01/16 | CCS | | One of two large light poles within the CCS; lights were on during the daytime. |

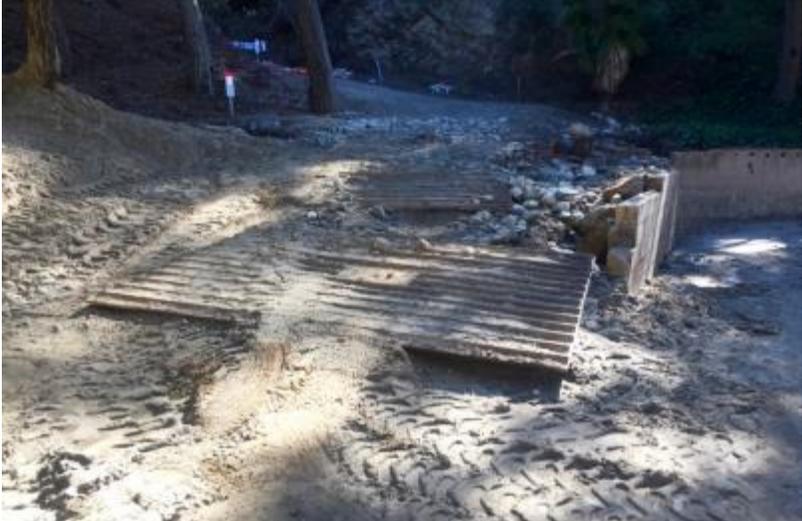
I drove past the entrance roads to the TSP 21 and TSP 24 access roads. The entrance/exit at TSP 21 was in good condition with no material tracked out onto the paved roadway (APM AQ-7). Approximately 2 inches of rain had fallen earlier in the week, and the entrance/exit to the TSP 24/25 access road had suffered some damage from the rainwater runoff – see photo. It appeared that the first culvert under the access road had clogged with sediment, thereby diverting water down the access road and almost washing out the gravel and rumble plates. No work activities were taking place along Drainage #4.

| Date | Location | Photo | Description |
|---|---|--|--|
| 3/10/16 | TSP 24/25 access road entrance | | <p>The rumble plates at the entrance to the access road need maintenance following the last storm system.</p> |

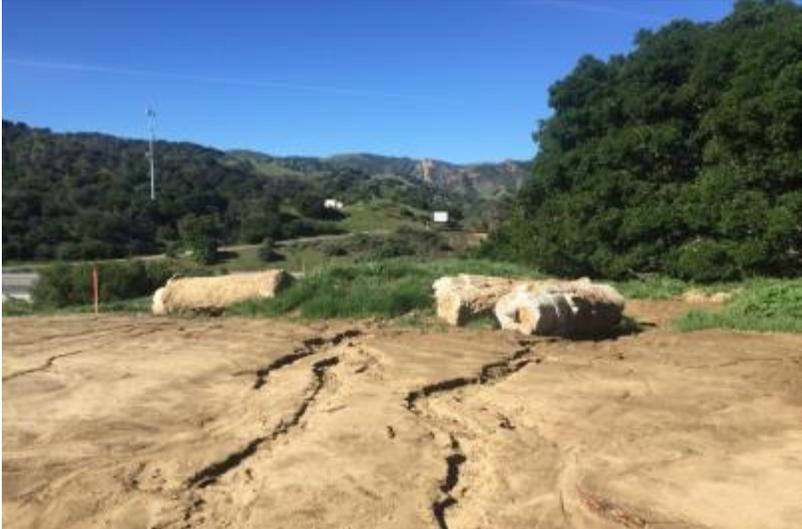
I drove along the access road from TSP 27 to TSP 30; the road had some erosional rilling, but it was drivable. At TSP 27, the old lattice work tower had been dismantled, but the concrete foundations remained onsite – see photo; this material will be collected and removed (APM PS-1). There is some minor rilling at the TSP 27 pad. SCE's avian biologist, Brian Karpman (Jericho Systems), was conducting nesting bird surveys along this stretch of the work area (APM BR-1c, MM BR-8).

| Date | Location | Photo | Description |
|---|---|--|--|
| 3/10/16 | TSP 27 | | <p>The old lattice work tower is gone, but the foundation plugs remain onsite. Some erosion rills run through the TSP pad.</p> |

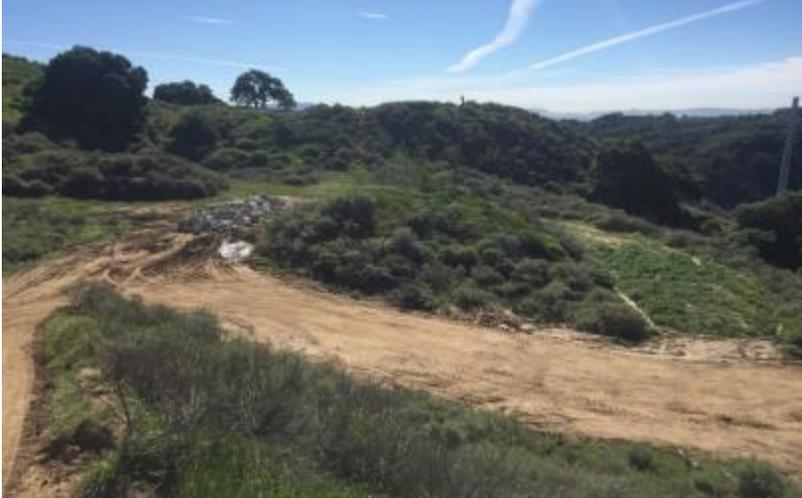
| Date | Location | Photo | Description |
|---|---|--|--|
| 3/10/16 | TSP 30 staging area | | <p>Rock is onsite for repair of the jurisdictional drainage; topsoil remains.</p> |

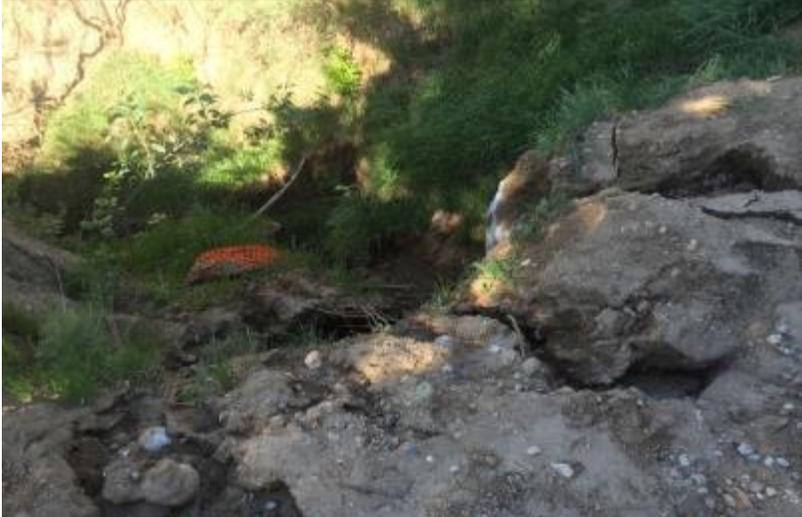
| Date | Location | Photo | Description |
|---|---|--|---|
| 3/10/16 | TSP 30 | | <p>Jurisdictional drainage along TSP 30 access road. Photo is looking down into the downstream side of the access road.</p> |

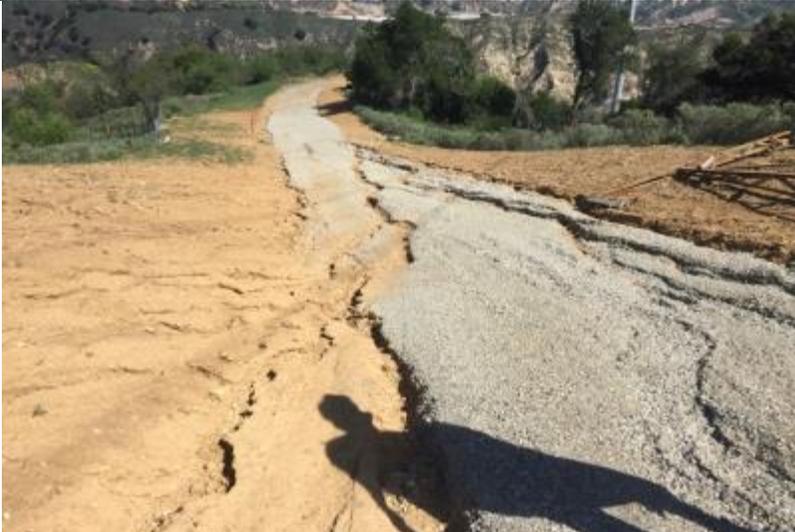
I drove to the Aliso Storage Field and travelled to the top of the mountain to meet with Todd White (Arcadis) and then travelled with Todd White to the TSP 39 through TSP 42 locations. I had not been to this area since before the winter rains and the roads, road shoulders, and tower pads were in good condition. There was some erosional rilling on the access roads, but they were all drivable – see photos. The location with the most rilling was at the bottom of a very steep section coming down to TSP 39 – see photo. The rainwater runoff coming down toward TSP 39 is directed into a McCarthy drain, but the amount of water has been causing problems below the McCarthy drain outlet. Todd White is aware of the situation, and the SWPPP crew has implemented some temporary fixes.

| Date | Location | Photo | Description |
|---|---|--|--|
| 3/10/16 | TSP 40 access road | | Erosion rills along the access road. |

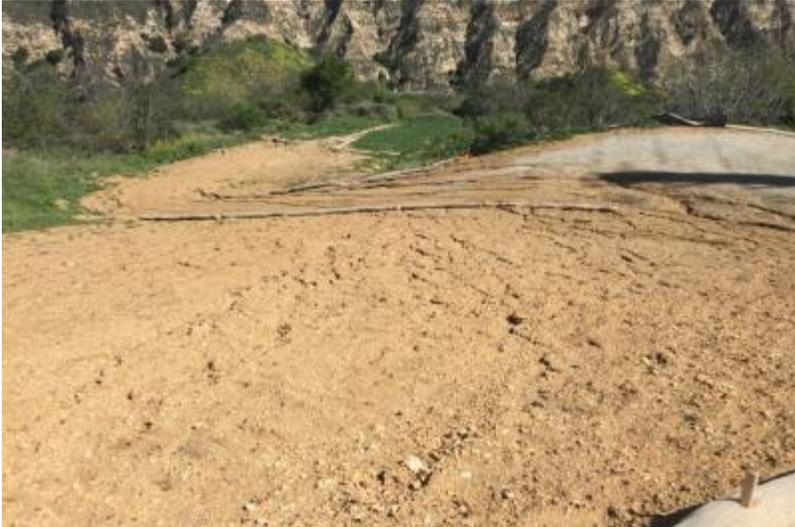
| Date | Location | Photo | Description |
|---|---|--|--|
| 3/10/16 | TSP 39 | | Large road shoulder area that needs restoration. Topsoil is still stockpiled below this slope. |

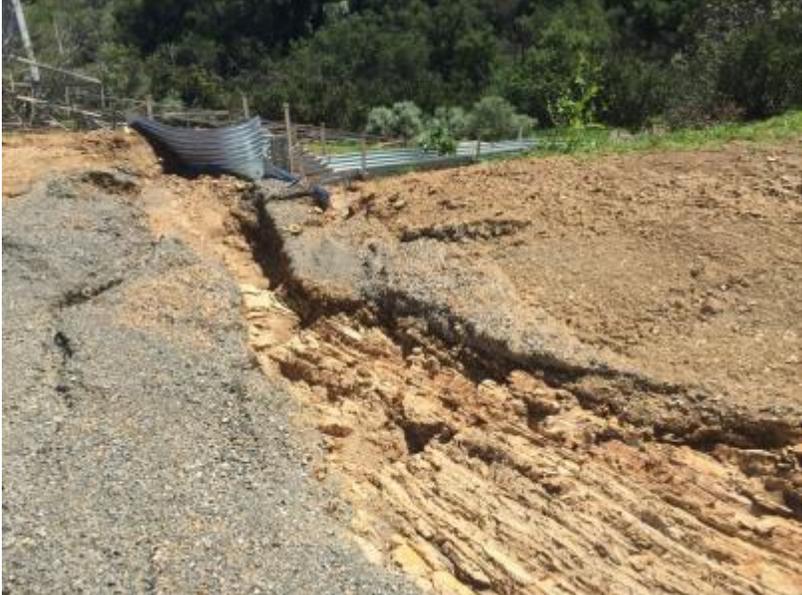
| Date | Location | Photo | Description |
|---|---|--|---|
| 3/10/16 | TSP 39 | | <p>Rainwater runoff coming down the access road is directed into the McCarthy drain just above TSP 39. The erosion rill is evidence that large quantities of water flow down this portion of the access road.</p> |

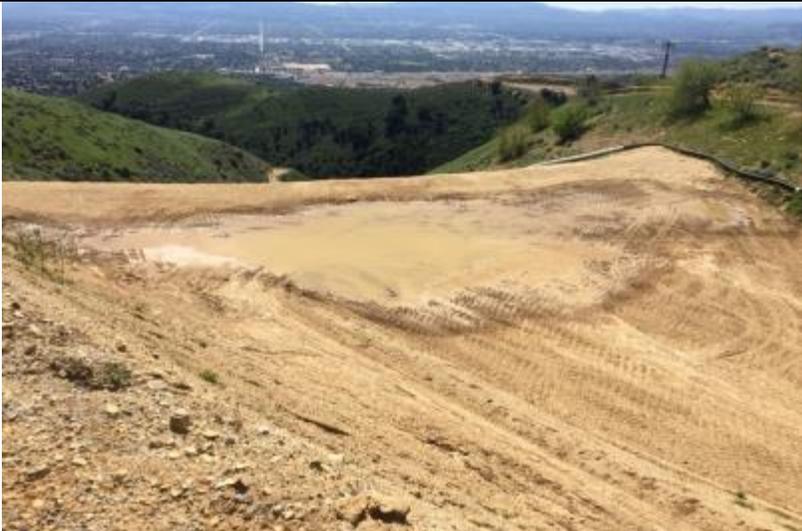
binoculars and saw no erosion issues. A biologist was walking around the oak tree cages and taking notes (MM BR-15). I then stopped to examine the PS-42 Fill Site where water remained ponded on top of the site – see photo; the slopes of the PS-42 Fill Site were in good condition and no rilling was noted.

| Date | Location | Photo | Description |
|---|---|--|---|
| 3/10/16 | PS-42 Fill Site | | <p>Some ponding of rainwater on the top of the PS-42 Fill Site.</p> |

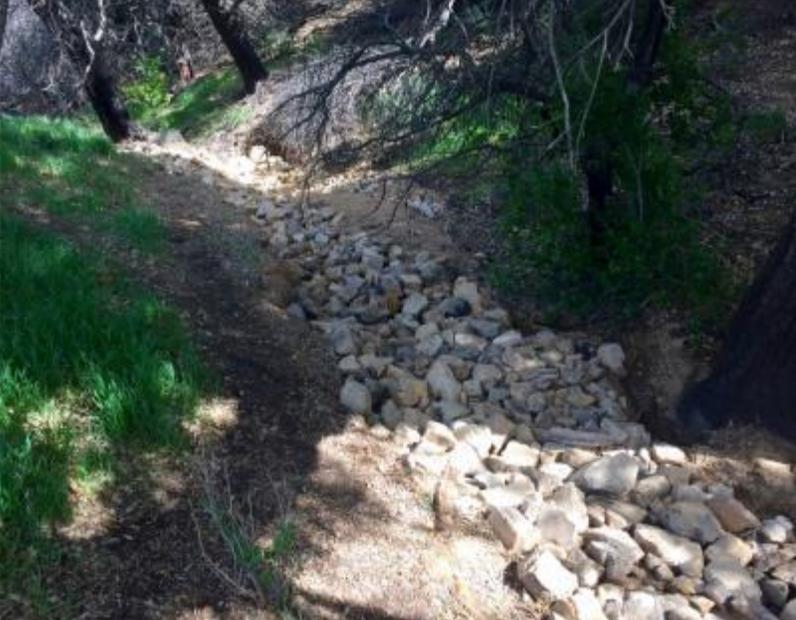
| Date | Location | Photo | Description |
|---|--|--|--|
| 3/10/16 | Natural Substation access road – oak swale | | <p>Repair work has been completed on the erosion rills through the oak swale.</p> |

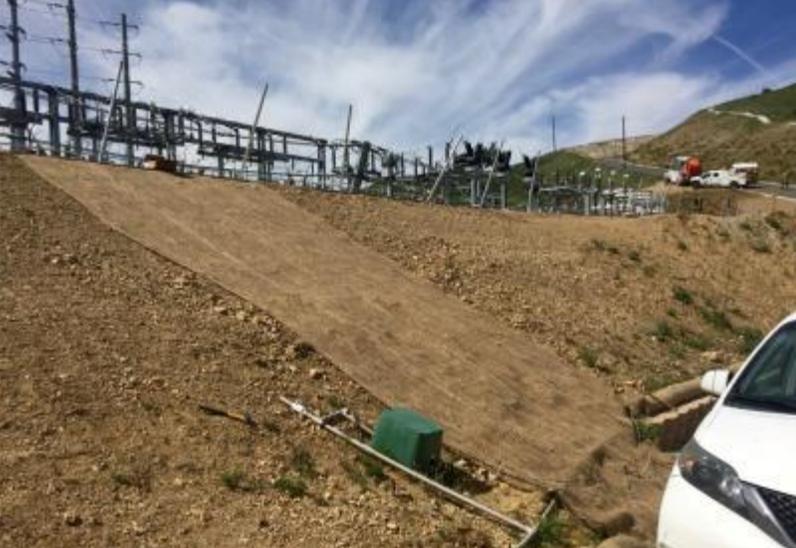
| Date | Location | Photo | Description |
|---|--|--|--|
| 3/10/16 | Natural Substation | | <p>The SWPPP crew is placing jute netting on the east-facing slopes of the Natural Substation.</p> |

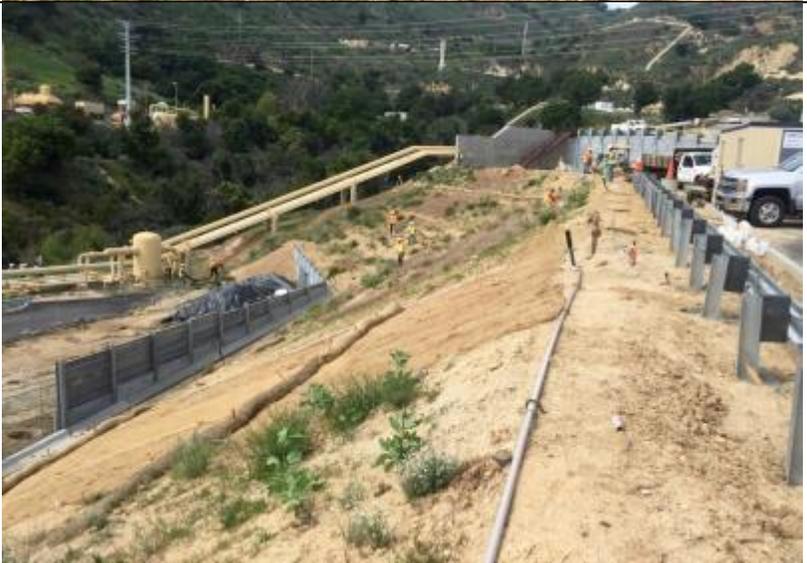
| Date | Location | Photo | Description |
|---|---|---|---|
| 3/10/16 | New Admin/IM Building | | Crews are upgrading the erosion control measures on the slopes. |

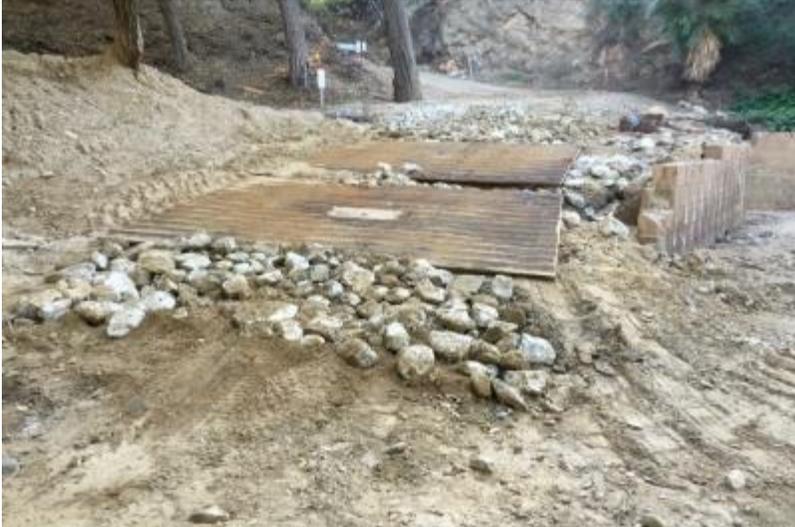
| Date | Location | Photo | Description |
|---|---|--|---|
| 3/18/16 | TSP 24/25 access road entrance | | <p>The rumble plates and road have been reset; it appears vehicles have been traveling on the road.</p> |

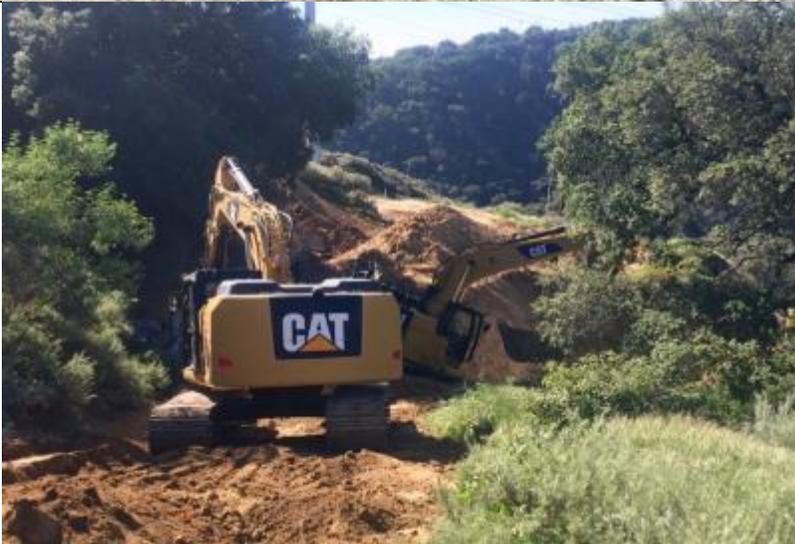
| Date | Location | Photo | Description |
|---|---|--|---|
| 3/18/16 | TSP 30 | | <p>Jurisdictional drainage at TSP 30 is being upgraded.</p> |

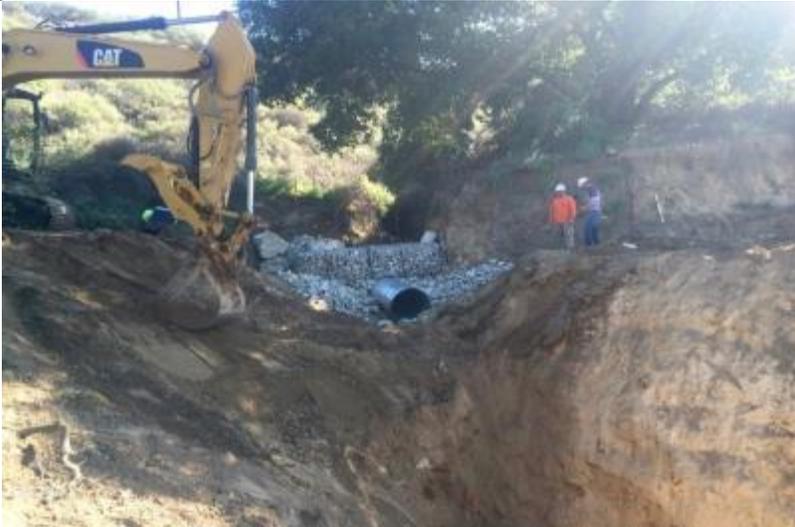
| Date | Location | Photo | Description |
|---|---|--|---|
| 3/18/16 | TSP 30 | | <p>Crews are installing rock gabions and a culvert in the jurisdictional drainage.</p> |

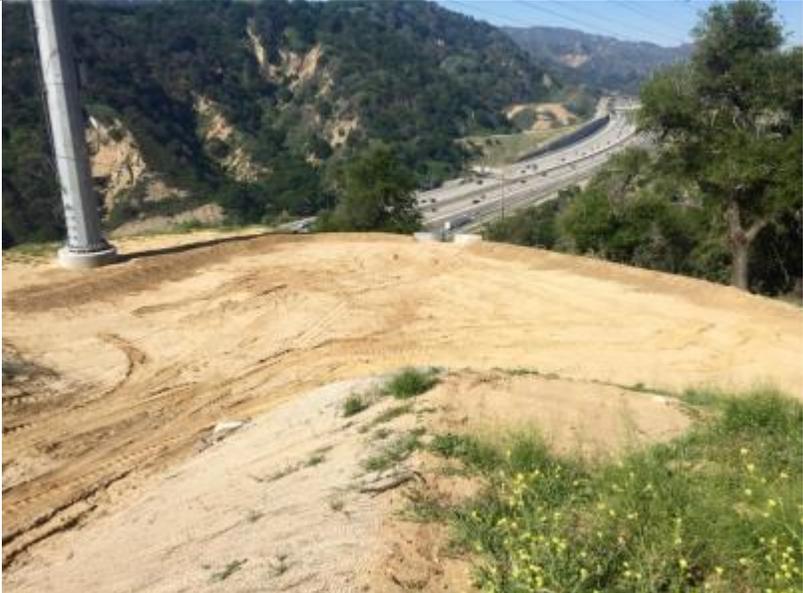
At TSP 32, a crew had completed minor grading of the pole pad and had added a small berm to direct rainwater runoff into the McCarthy drain – see photo. The old construction equipment and the exclusion fencing was cleaned up and removed from the site (APM PS-1). Weeds (black mustard, milk thistle) were growing in the work areas; this had been previously noted at a number of locations.

| Date | Location | Photo | Description |
|---|---|--|---|
| 3/18/16 | TSP 32 | | <p>A berm has been created to direct water into the McCarthy drain. Weedy growth seems to have established within some of the construction areas.</p> |

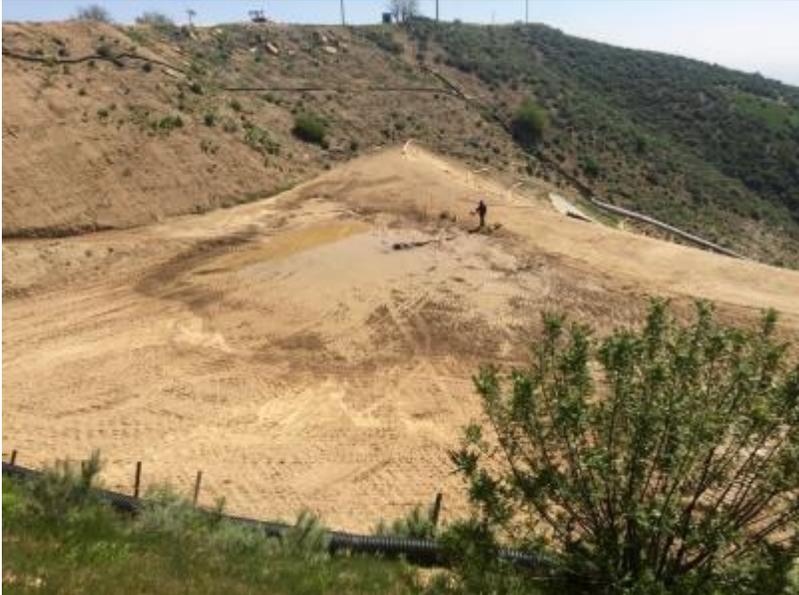
I checked the PS-42 Fill Site where water was still ponded on top of the site – see photo. A small crew was pumping out the water and sending it down through the culverts on the front slope of the PS-42 Fill Site. The water looked clear, though the bottom of the pool was mud. I checked the SS-30 staging area near the PS-42 Fill Site and observed a small crew breaking up rock. The crew had access to water and were occasionally watering the rock to reduce dust.

| Date | Location | Photo | Description |
|---|--|--|---|
| 3/18/16 | PS-42 Fill Site | | <p>Water continues to pond on the top of the PS-42 Fill Site. A crew is pumping the water and sending it through the drainage system.</p> |

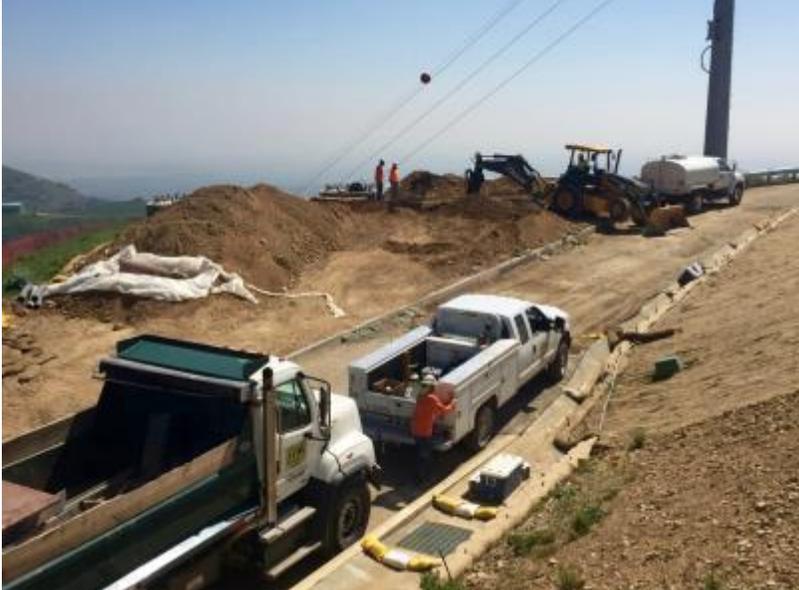
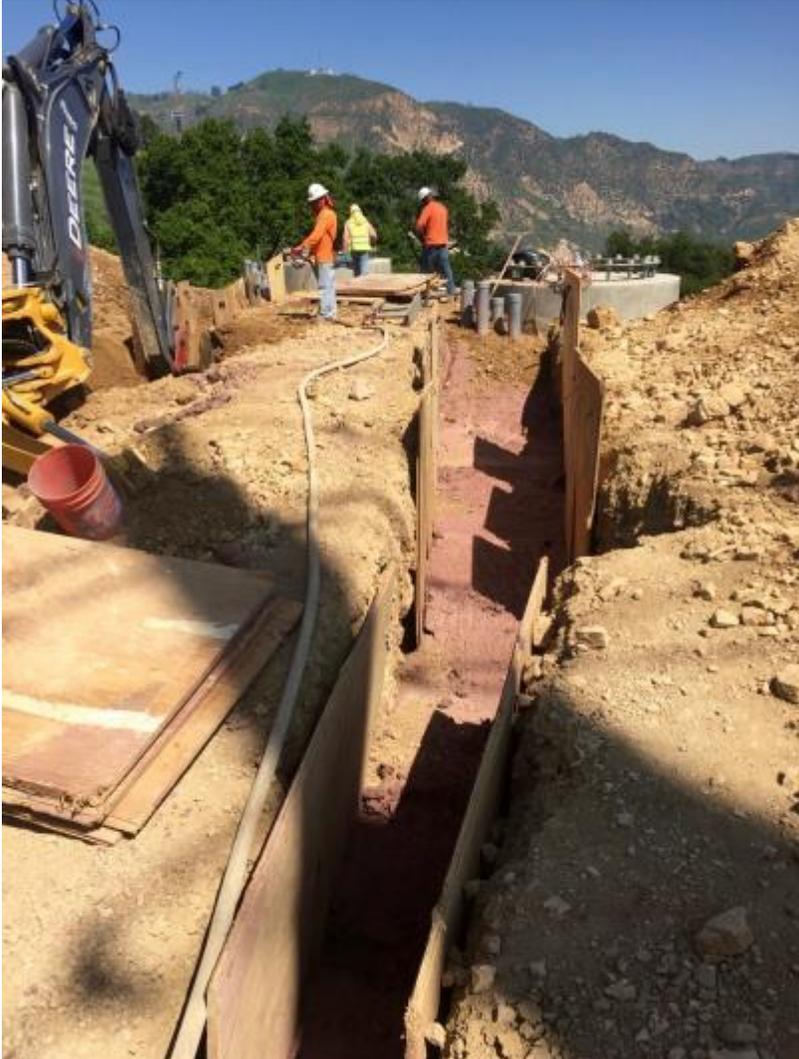
A small crew was working on the 12-kV plant power line near the Natural Substation where they were excavating for and installing the ductbank – see photos. This conduit was covered with a colored slurry. I asked Seth Rosenberg (SCG) if the crew would complete the backfilling by the end of the day and he responded that the crew would finish the backfilling. I walked into the oak swale and noted that the rocked erosion rill was holding up well and had begun to capture sediment and vegetative debris.

| Date | Location | Photo | Description |
|---|--|--|---|
| 3/18/16 | 12-kV plant power line at the Natural Substation | | <p>Backfilling of the ductbank.</p> |

| Date | Location | Photo | Description |
|---|--|--|--|
| 3/18/16 | 12-kV plant power line at the Natural Substation | | Slurry and backfilling of the ductbank. |

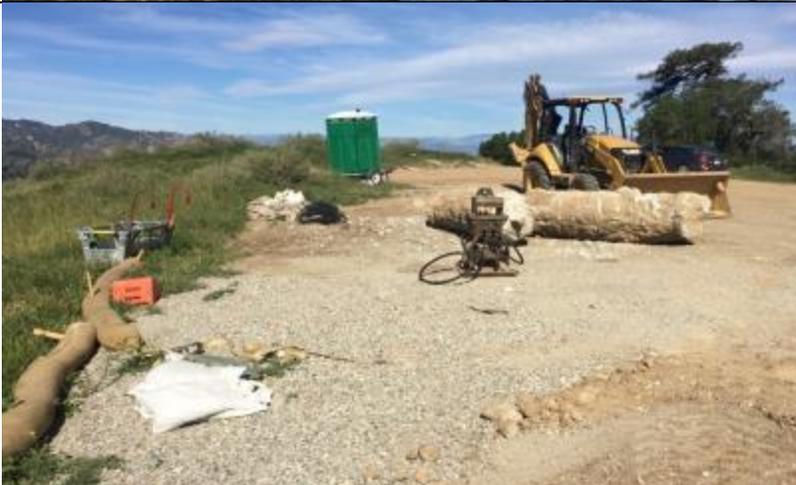
| Date | Location | Photo | Description |
|---|---|--|--|
| 3/25/16 | TSP 30 staging area and helipad | | Construction equipment and trash remain on the helipad. |

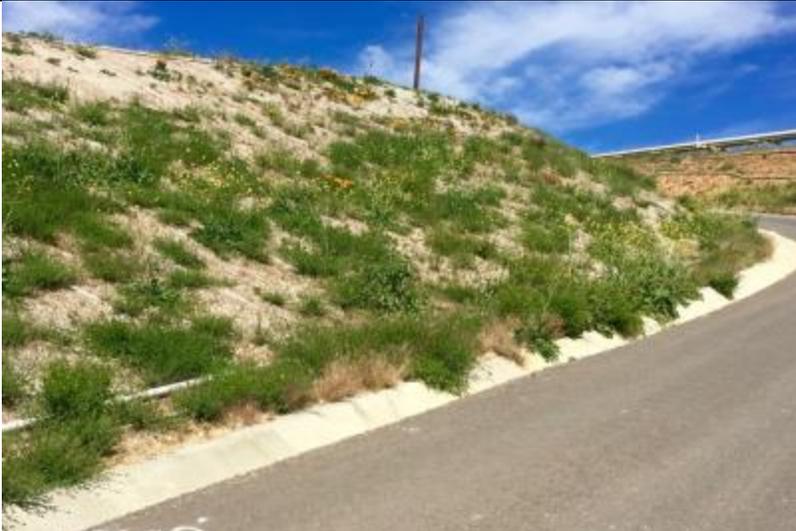
| Date | Location | Photo | Description |
|---|---|--|---|
| 3/25/16 | Natural Substation access road | | Vegetation growth along the access road; invasive black mustard is coming in along this area. |

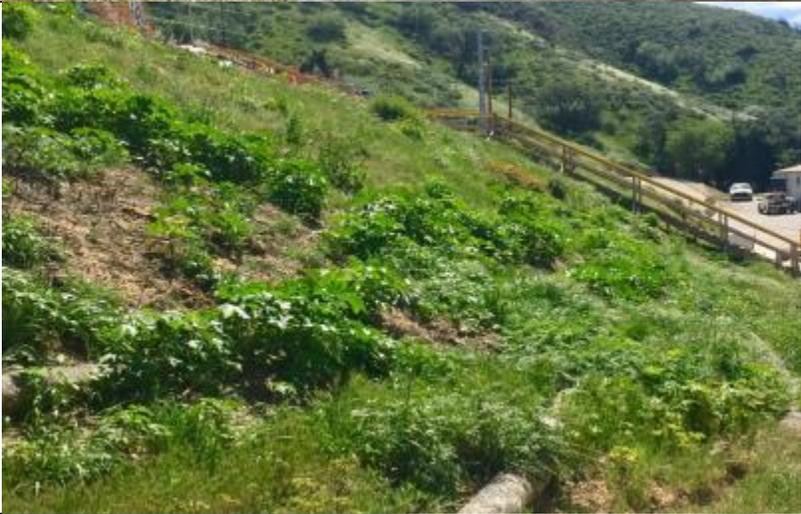
| REPRESENTATIVE SITE PHOTOGRAPHS | | | |
|---|---|--|--|
| 3/25/16 | CCS | | Weed growth on the CCS slopes includes invasive castor bean and yellow star thistle. |

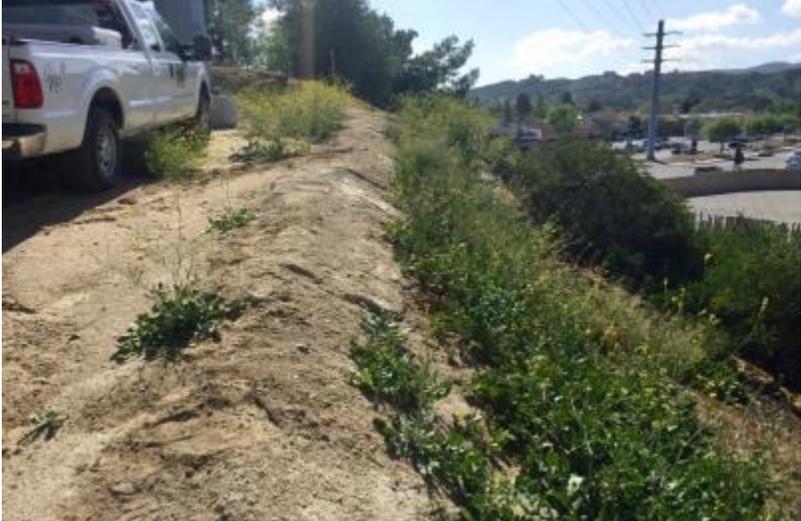
| REPRESENTATIVE SITE PHOTOGRAPHS | | | |
|---|---|--|--|
| 3/30/16 | TSP 2 | | Invasive mustard growth along the shoulder of the access road. |

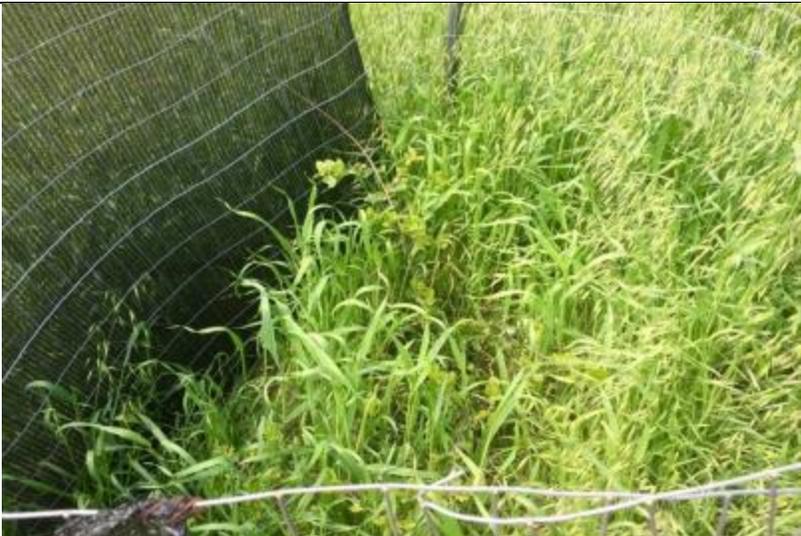
| Date | Location | Photo | Description |
|---|---|--|--|
| 3/30/16 | Oak cage | | Looking inside an oak cage; note the grass growth. |

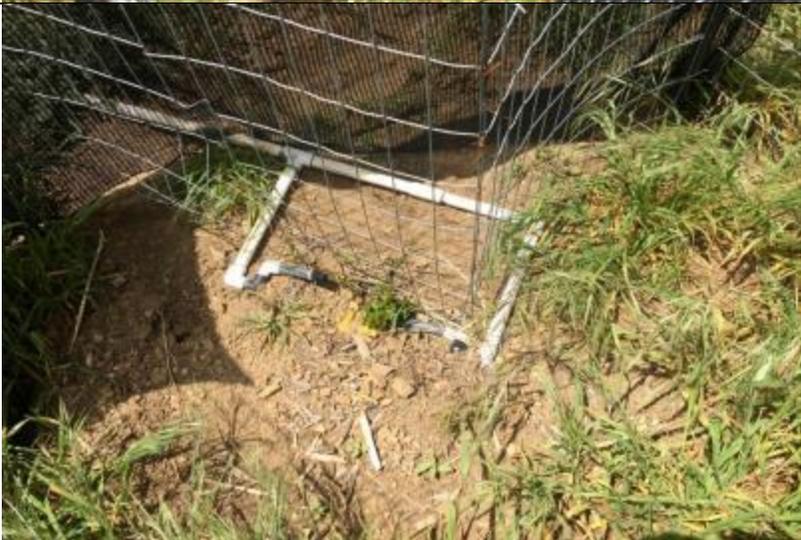
| Date | Location | Photo | Description |
|---|---|--|--|
| 3/30/16 | Oak cage | | The wire at cage #101 has been bent in and is sitting on the oak seedling. |

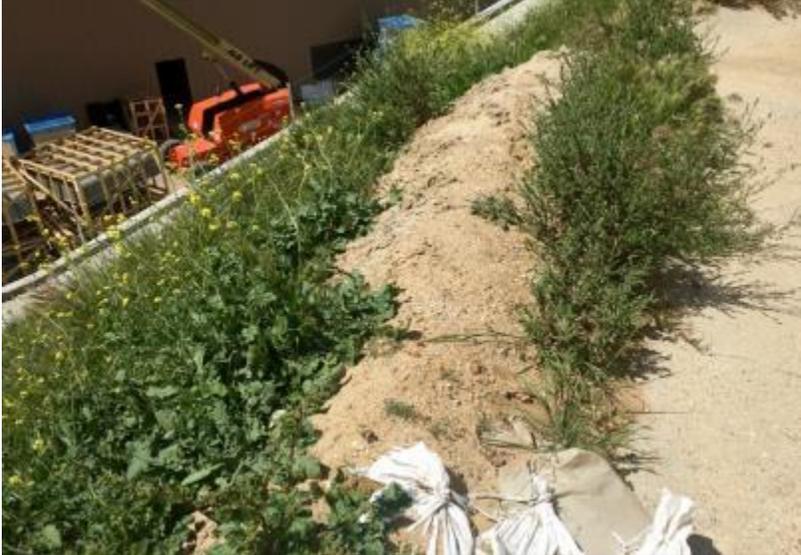
| Date | Location | Photo | Description |
|---|---|---|---|
| 3/30/16 | CCS | A photograph showing a dirt slope covered with dense green vegetation, including yellow star thistle and invasive mustard. The plants are growing in a sandy, disturbed area. In the background, there is a building and some construction equipment, including a yellow crane. The overall scene suggests a site with significant vegetation management needs. | Slope above the CCS has invasive mustard and yellow star thistle growing. |
