### **Re: Monthly Report Summary #6 for Aliso Canyon Turbine Replacement Project**

## Aliso Canyon Turbine Replacement Project CPUC Site Inspection Form

Project:	Aliso Canyon Turbine Replacement	Date:	September 5, 2014
Project Proponent:	Southern California Gas Company and Southern California Edison	Report #:	VS022
Lead Agency:	California Public Utilities Commission	Project Phase/NTP:	Guard House and Road Widening Component (NTP-1), The New Admin/IM Building & P-43 Fill Site (NTP-2), Leach Field (NTP-3), PS-42 Fill Site.
CPUC PM:	Andrew Barnsdale, Energy Division	AM/PM Weather:	Sunny, clear day with mild temps (69 to 73 degrees); no breeze.
E & E CM:	Lara Rachowicz	Start/End time:	0800 hrs to 1030 hrs
Monitor(s):	Vince Semonsen		
Project Component(s):	CPUC Oversight: Guard House, New Admin/IM Building, Temp trailer sites, PS-42 & P-43.

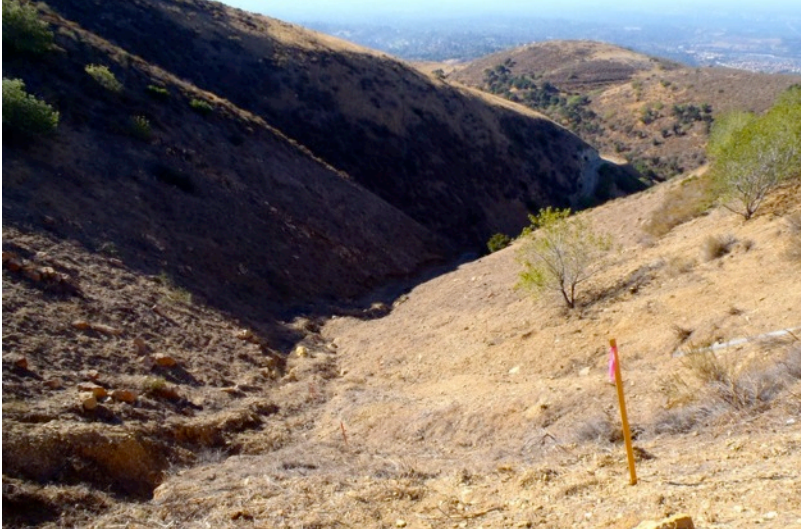
Date	Location	Photo	Description
9/05/14	PS-42

No vegetation clearing was occurring at the PS-42 fill site but I checked the site to see the progress and to verify that all the clearing was within the approved boundaries – see photo. Work will start up again next week.

Brush clearing at the PS-42 fill site; work is nearly done.
9/05/14	P-43 stockpile area

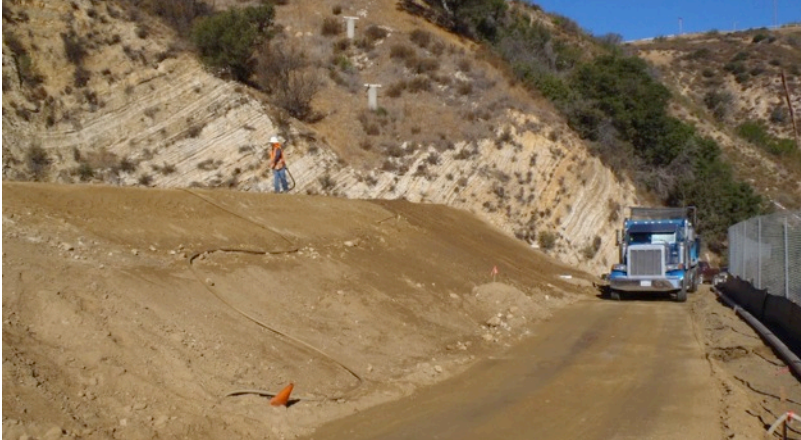
At the P-43 site, soil continues to be brought in from the New Admin/IM Building location using dump trucks that are covered while in transit. The dirt is dumped, watered down and compacted – see photo. This area is only spot-checked by the monitors but all the workers are trained and they understand the procedures well. Crews have been watering for dust control along the access roads – see photo.

Soil continues to be brought to the site. It is dumped, spread, watered, and compacted.
9/05/14	New Admin/IM Building – Leach field

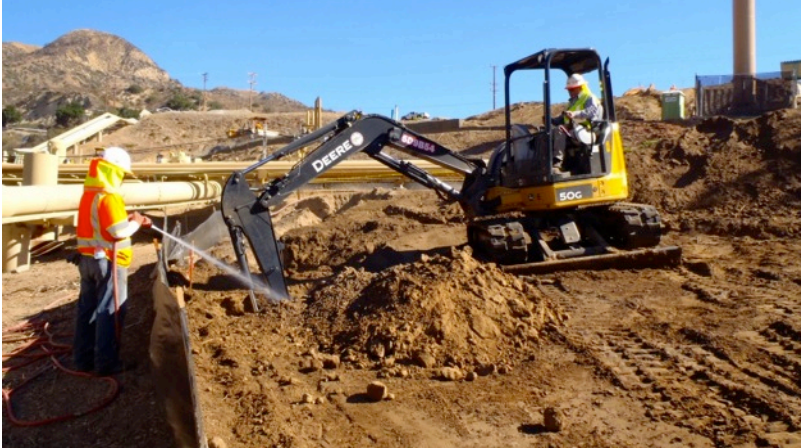
Crew working on pot-holing in the leach field.

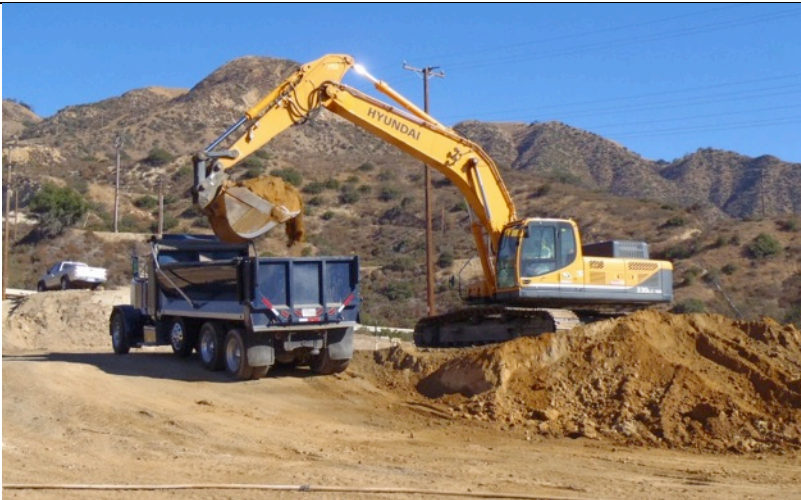
<p>An excavator continued to load dump trucks with dirt for transport to the P-43 fill site.</p>
<p>9/05/14</p>	<p>New Admin/IM Building</p>

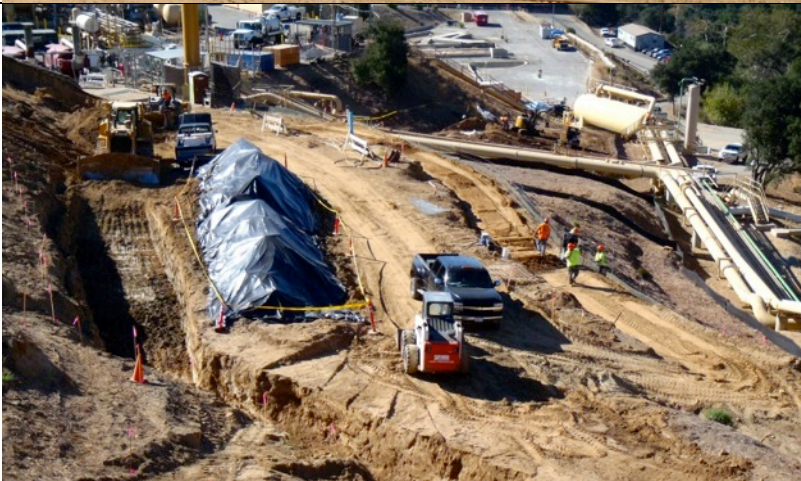
At the New Admin/IM Building area, soil is still being excavated and trucked to the P-43 site – see photo. More of the stained soil has been excavated at the site – this material was dug out, stockpiled onsite, fenced off, and covered with plastic. Based on visual inspection of the side walls of the excavated area, stained soil still remains. Crews are also continuing to work on the small roadway and are potholing in the leach field – see photos. Archeological/Paleontological monitor Olivia Tierk (MM CR-1, MM CR-3, MM CR-6 & MM CR-8) and Biological monitor Dave Lohr (APM BR-1d & APM BR-6) were spot-checking all construction sites, but the New Admin/IM Building area was their primary focus. Olivia said they are now excavating intact material but no fossils had been found. Dave has not seen any wildlife and therefore has not had to relocate any.

<p>Crews are working on building a roadway and more stained soil was found and removed. The soil has been fenced and placed under plastic.</p>
<p>9/05/14</p>	<p>Main office &amp; Existing trailers</p>

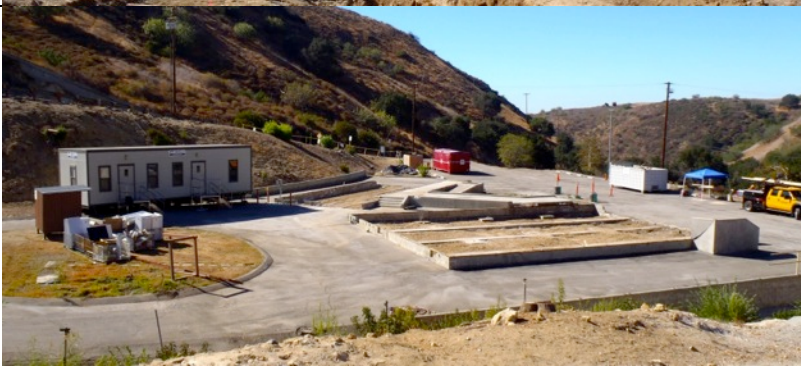
At the Main office/existing trailer site the trailers have been dismantled and all the hazardous material has been removed – see photo. Currently there was no work being done in this area.

<p>Crews have cleaned up and dismantled the old existing trailers.</p>

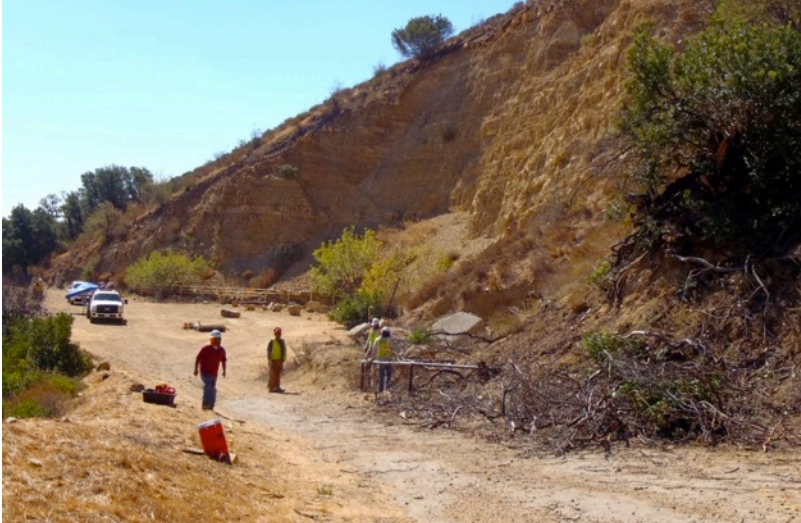
Date	Location	Photo	Description
9/18/14	P-41

Vegetation clearing has begun at the P-41 fill site with a crew of approximately six using hand tools to clear vegetation – see photo. According to Biological Monitor Juan Miranda (APM BR-1d & APM BR-6) no animals have been seen and/or relocated, however, one fairly fresh rattlesnake skin was found by the crew. Snakes have been relocated to this area from other project locations earlier in the year.

Brush clearing began at the P-41 fill site with a crew of six clearing vegetation.
9/18/14	P-43 stockpile area

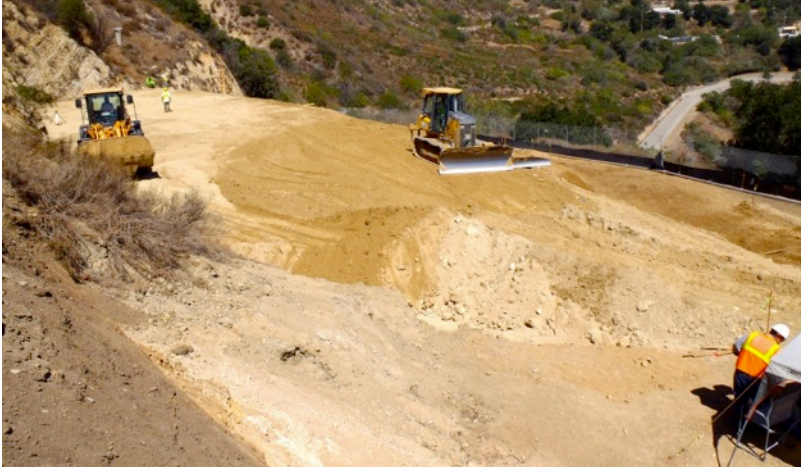
At the P-43 site equipment was spreading and compacting the soil but on the day of my site visit no new dirt was being brought to the site – see photo. There are no dust problems at the site and the area is spot checked by the environmental monitors.

Work at the P-43 stockpile site continues but no new soil was being brought to the site at the time of my site visit.
9/18/14	New Admin/IM Building

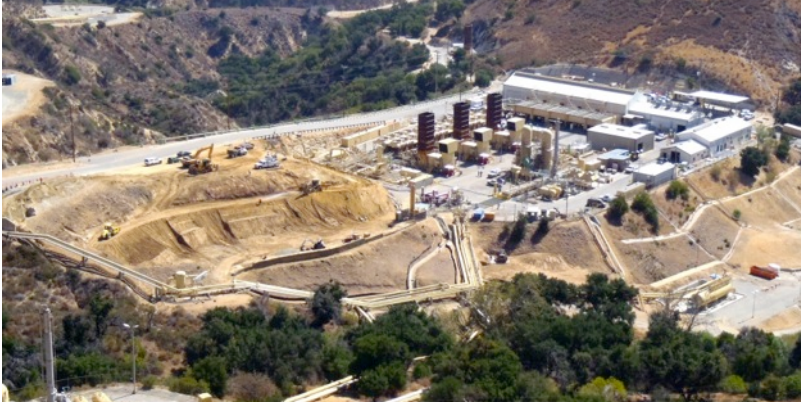
Overview of the Admin/IM area from the P-43 fill site.

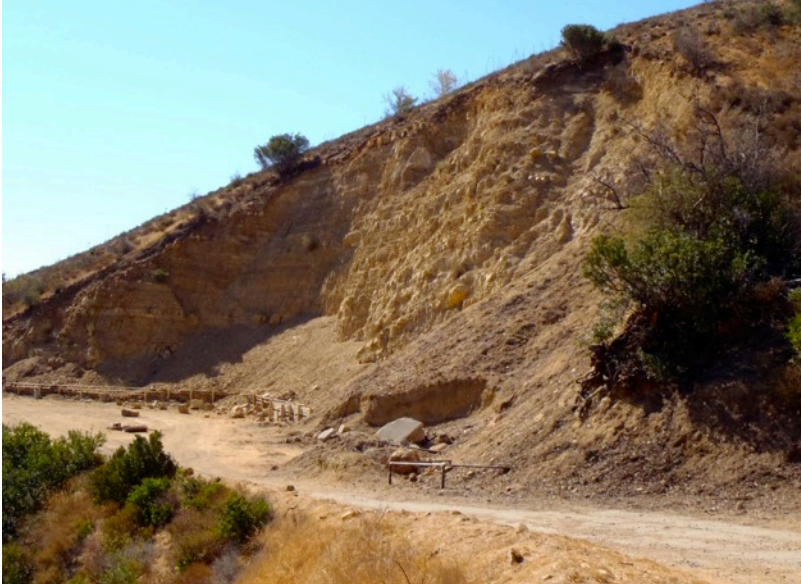
Date	Location	Photo	Description
9/25/14	P-41 Fill Site

Brush clearing at the P-41 fill site has been completed.
9/25/14	P-43 stockpile area

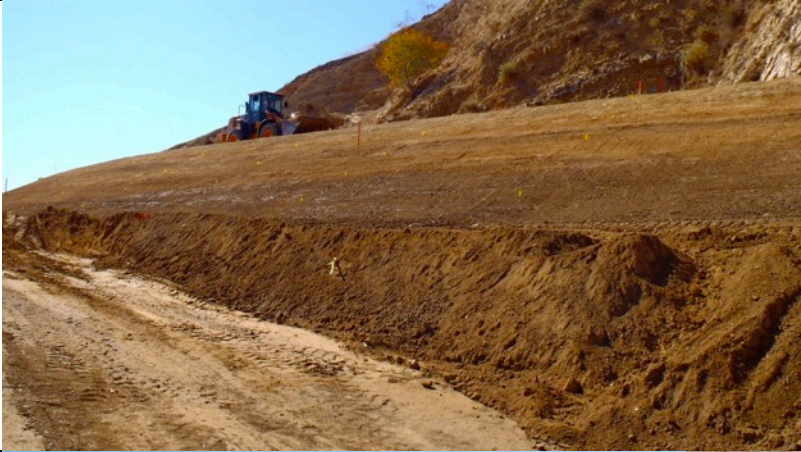
Work at the P-43 stockpile site continues but new soil is not being brought to the site. Crews are compacting the soil and prepping the slope.
9/25/14	PS-42 Fill Site

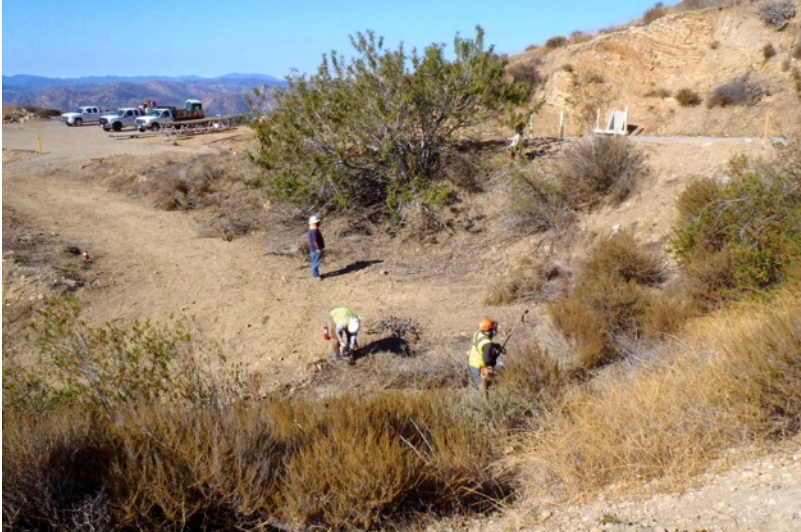
Brush clearing begins again within the expanded site plan. This work is expected to take 3-4 days to complete.

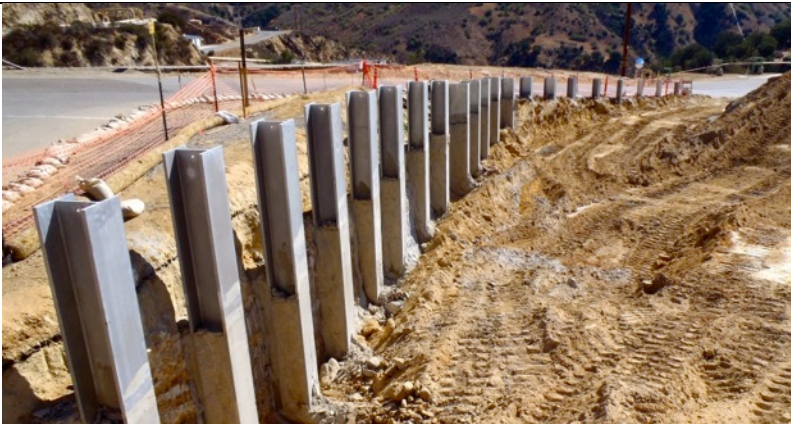
<p>Excavation work along the newly installed caissons.</p>
<p>9/25/14</p>	<p>New Admin/IM Building</p>

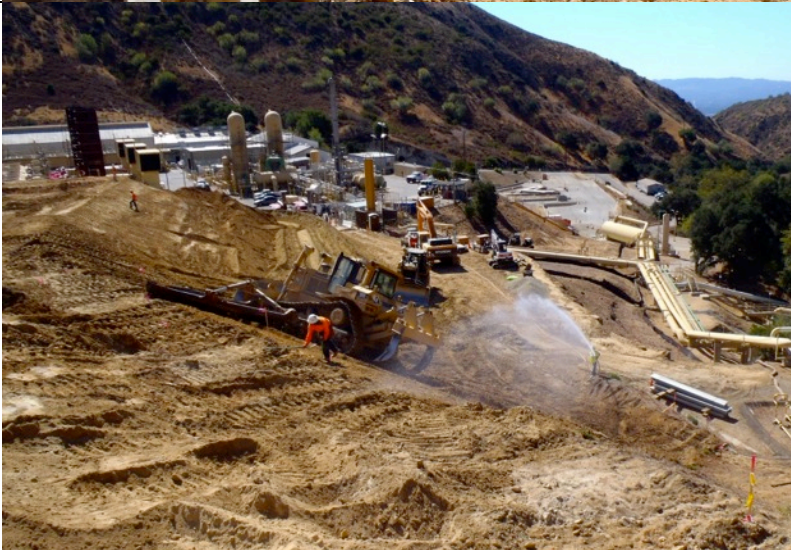
<p>Earth moving continues at the New Admin/IM Building site.</p>
<p>9/25/14</p>	<p>Guard House</p>	 	<p>Work at the guard house continues under the existing roadway.</p>
