**Re: Monthly Report Summary #17 for Aliso Canyon Turbine Replacement Project**

## Aliso Canyon Turbine Replacement Project CPUC Site Inspection Form

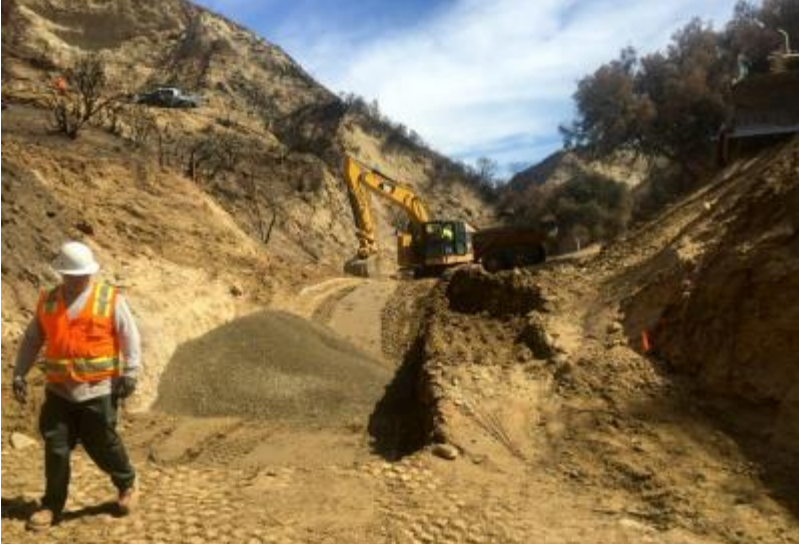
Date	Location	Photo	Description
8/05/15	Access Road to TSP 25

Excavation for the culvert begins – gravel is brought in for the culvert bedding.
8/05/15	Access Road to TSP 25

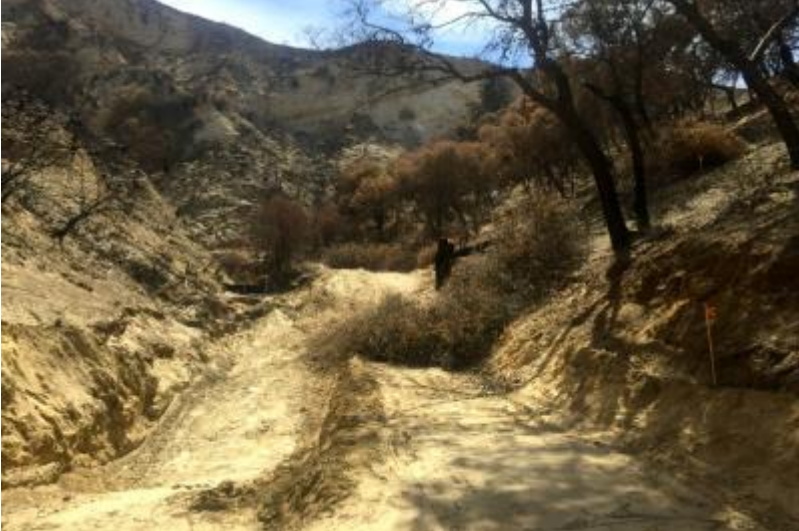
Oak pruning has begun – one tree along the road will be removed. All of the trees and numerous shrubs are showing new growth post-fire.
8/05/15	TSP 22

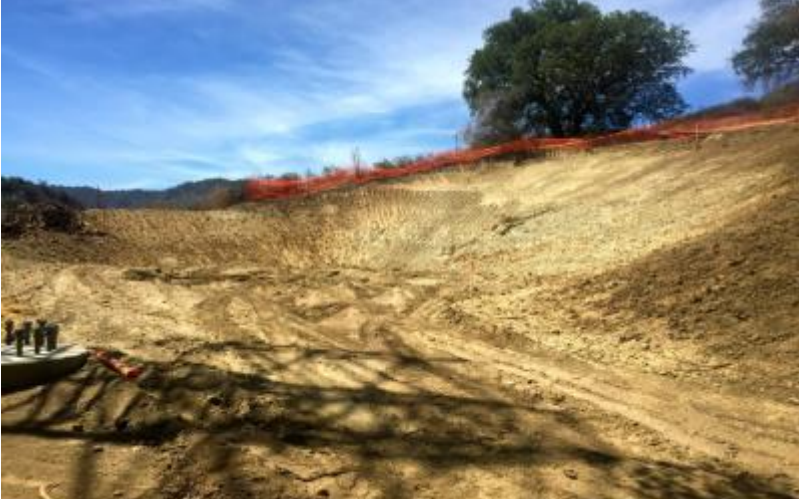
Excavation of the pull site at TSP 22 has been completed.

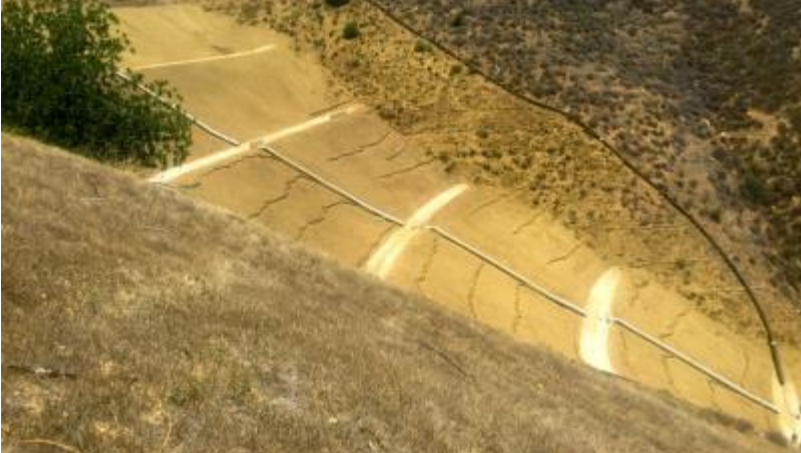
<p>The slopes have been hydroseeded and were being watered during the site visit.</p>
8/05/15	PS-42 Fill Site	 	<p>The culvert has been installed under the lower roadway.</p>

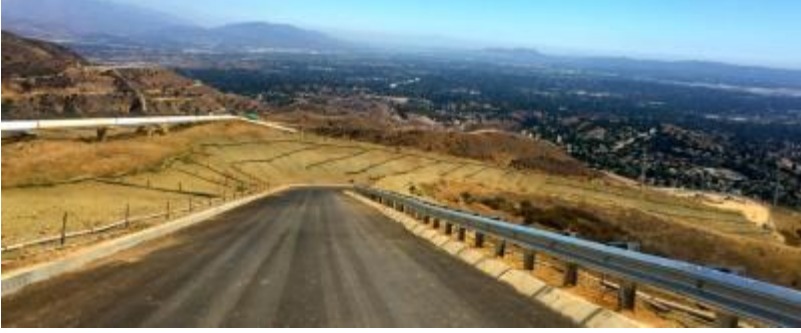
Date	Location	Photo	Description
8/05/15	Natural Substation Access Road

<p>The cut banks have been hydroseeded. An irrigation system is providing water.</p>
8/05/15	Natural Substation

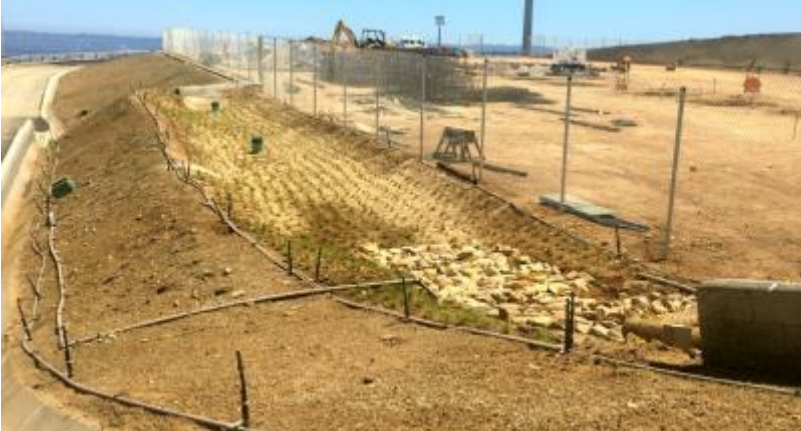
<p>The small bioswale has been planted.</p>
8/05/15	CCS

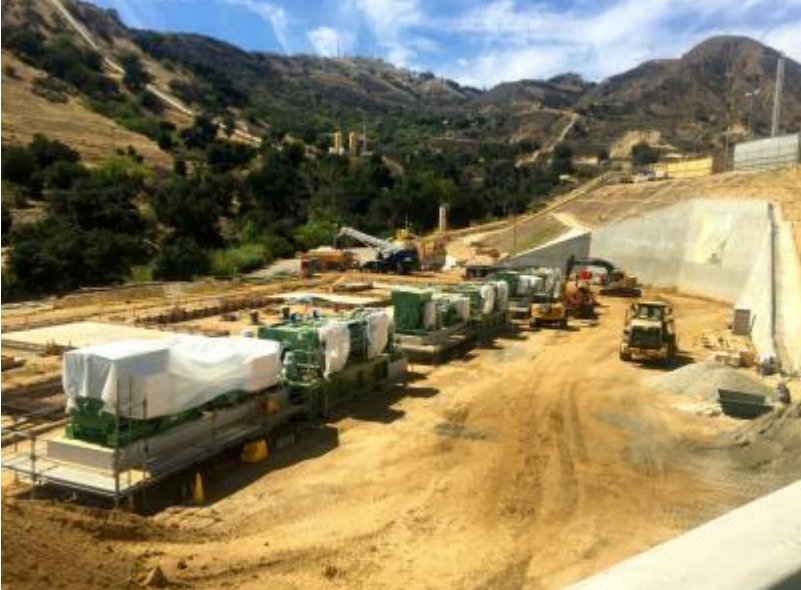
<p>Equipment continues to be brought in. Areas are being excavated and foundations are being poured.</p>

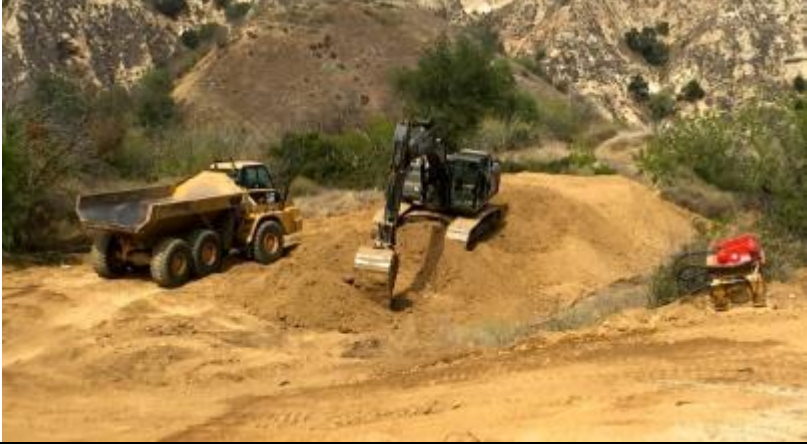
The access road to TSP 39 is being used to stockpile and mix dirt that is being placed into the Hilfiker wall.

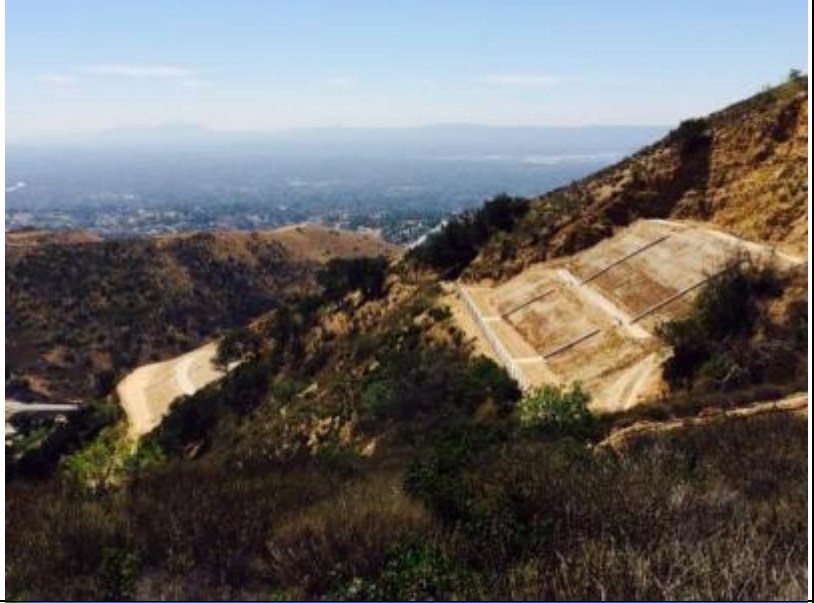
Vegetation cover is substantially greater on the P-41 Fill Site (to the right) compared to the P-43 Fill Site (to the left and below).
8/12/15	Photo 3 Oak Tree Mitigation Site

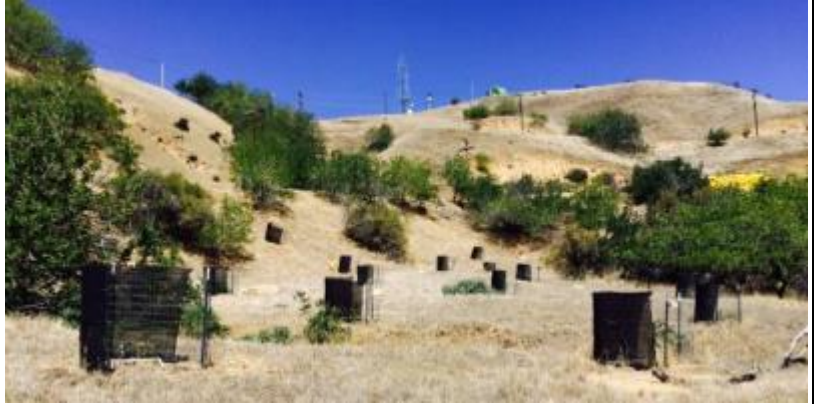
At the Oak Tree Mitigation Site, weeds around the cages had been removed; no mustard was evident, and oaks were being watered regularly. Some rodent burrows were evident in the area, but none were observed within the root zone of oak trees (Photo 3, 4). SCG relayed that 114 trees of the 115 planted were healthy.

The Oak Tree Mitigation Site has been cleared of weeds and invasive plants.

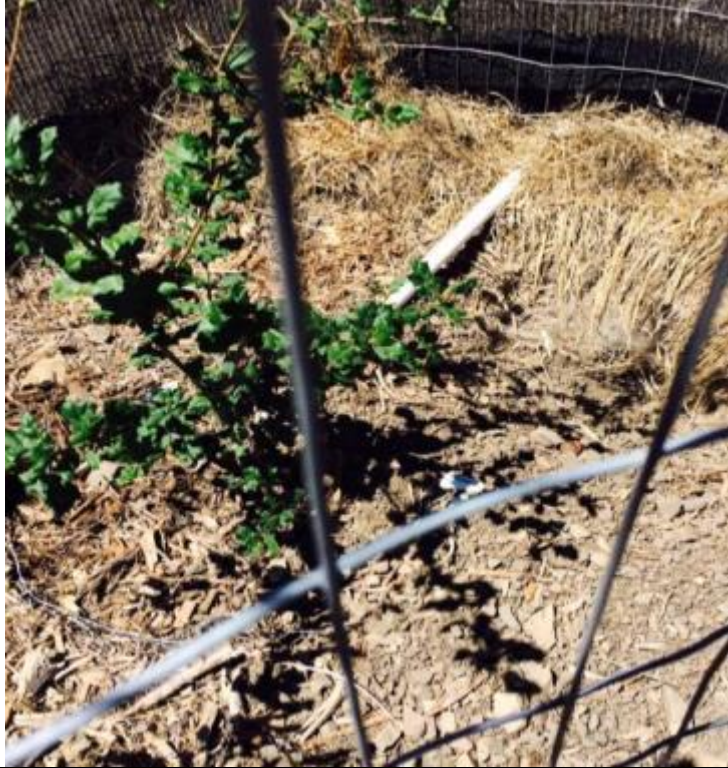
Date	Location	Photo	Description
8/12/15	Photo 4 Oak Tree Mitigation Site

Healthy oak tree sapling with rodent burrow (in upper right section of photograph).
8/12/15	Photo 5 PS-42 Riprap

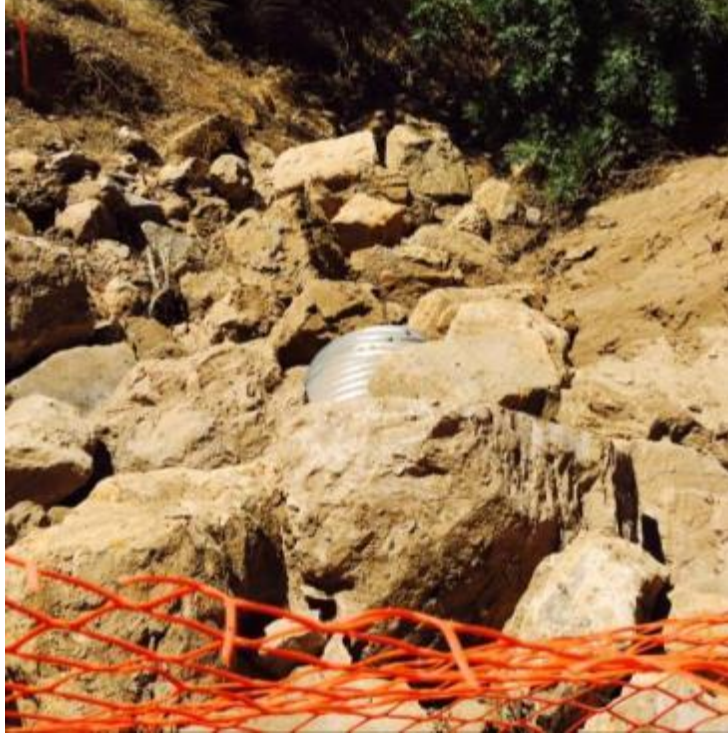
Culvert and riprap leading to the drainage below the PS-42 Fill Site.

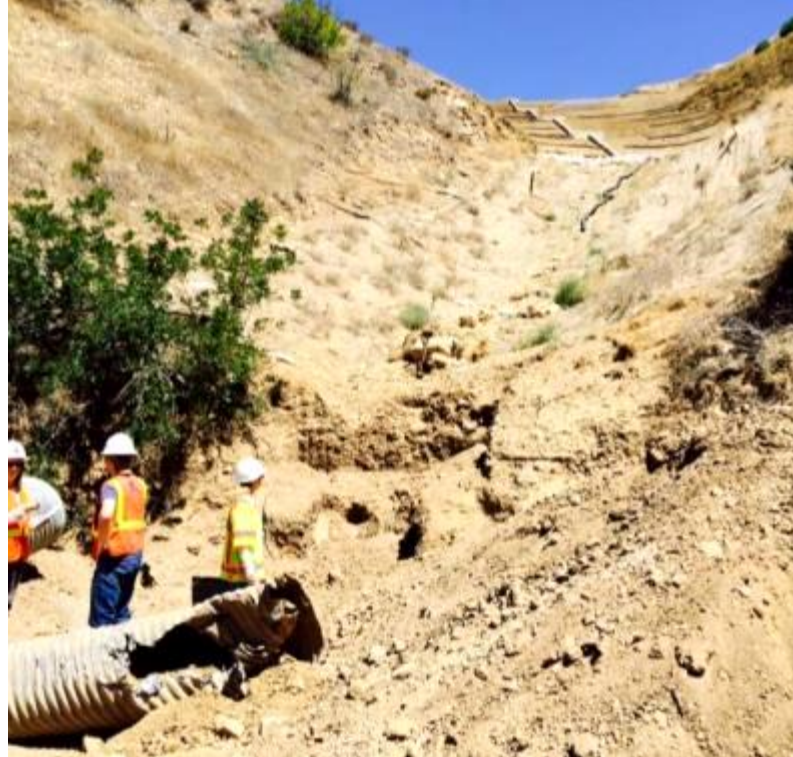
Date	Location	Photo	Description
8/12/15	Photo 6 PS-42 Fill Site

Looking up at the PS-42 Fill Site. Crew is spraying water in the upper fill key; plants have grown through the jute netting in the middle of the frame; and the disturbed earth in the foreground will be for the drain box.
8/12/15	Photo 7 Crescent Valley Mobile Estates

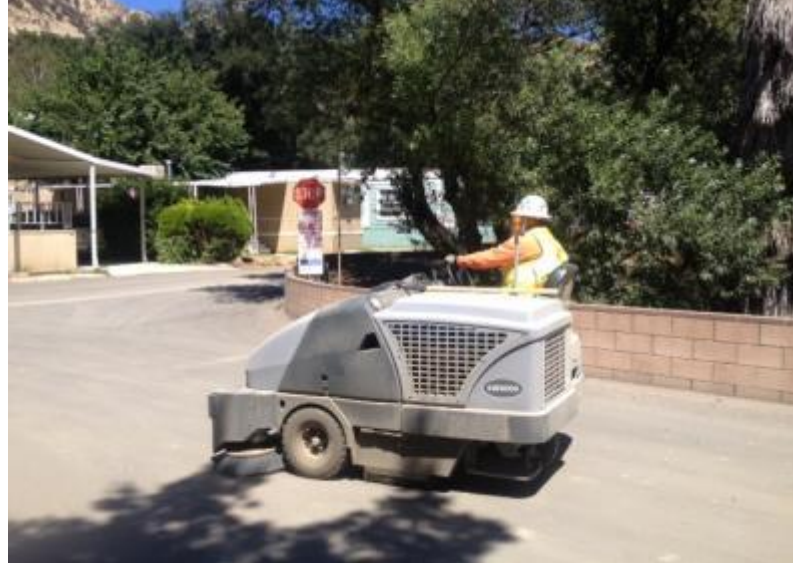
Mechanical sweeper regularly making rounds through the Estates to sweep up trackout.

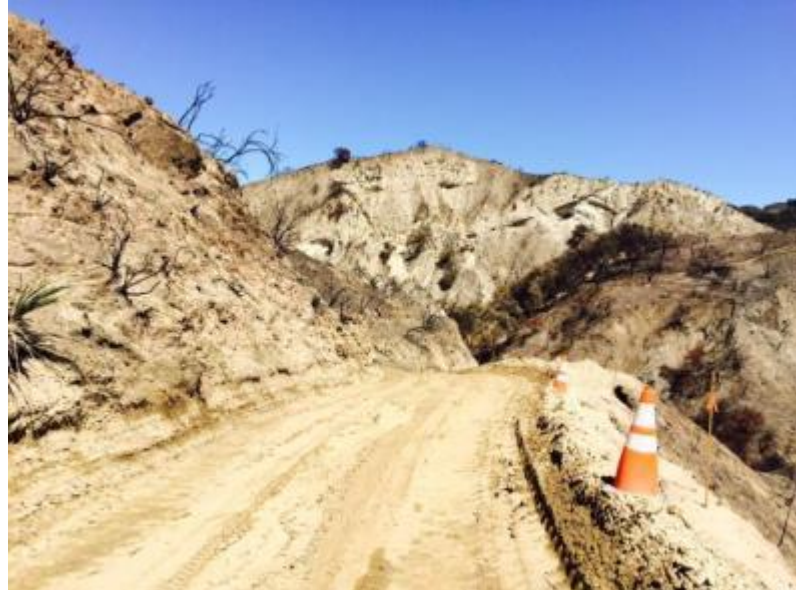
Date	Location	Photo	Description
8/12/15	Photo 8 Access Road for TSPs 24 and 25

Dry, dusty conditions and barren ground after the fire between TSPs 24 and 25.
8/12/15	Photo 9 Access Road for TSPs 24 and 25

Dust control is an ongoing issue and should be regularly evaluated.

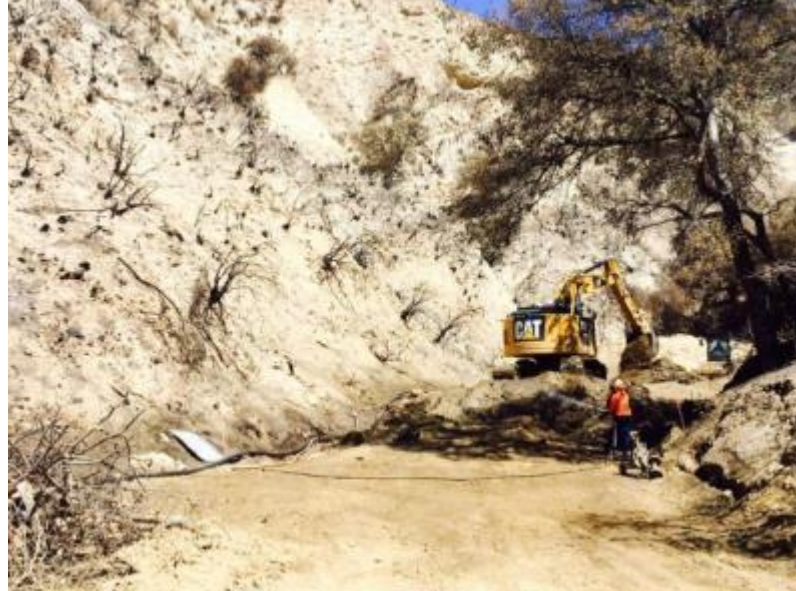
Grading, excavating, and compacting work along the access road.

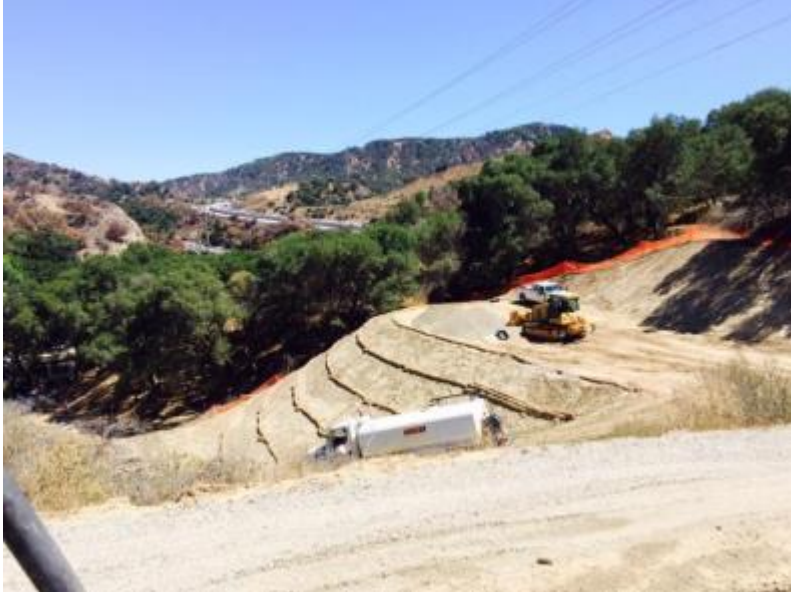
Date	Location	Photo	Description
8/12/15	Photo 10 TSP 22 Access Road

After observing activities at the Aliso Canyon Natural Gas Storage Field Todd White and Chris May accompanied us as we visited TSPs 1 and 2—near the Newhall Substation—and TSPs 3 through 6 along Wiley Canyon Road. At 1330, we traveled to the Crescent Valley Mobile Estates (Estates) to view the updated dust control measures and see the recently burned area near TSPs 24 and 25. On the Estates' property, two mechanical sweepers were continually driving through and cleaning up dirt (Photo 7). Two groups of two crew members were also sweeping up dust. There was very little trackout observed inside the Estates. We rode with Todd White and a biological monitor in a Kubota on the access road leading to TSP 22. A mining truck and excavator were clearing dirt. The installed aggregate road base reduced dust, and a water truck was onsite. We drove through the Estates and observed the oak tree that had been damaged by a vehicle and reported by SCE in July. As the arborist reported, the injuries appeared to be superficial and not structural. We drove to TSP 23 (Photo 11), where aggregate road base had been placed, as well. The site was clean and free of dust. Todd White then took us along the access road leading past TSP 24 towards TSP 25. This area was burned near the end of July 2015, and the entire area was devoid of vegetation and covered in ash and dust (Photo 8). As we drove along the access road to observe road work near TSP 25, new growth was visible on many of the oak trees and near the base of the burned bushes. While vegetation is rapidly returning to the site, if a substantial amount of ground cover is not present before the winter rains, much of this area will likely washout. Crews were working the soil and compacting the road to TSP 25. Crews were spraying water to reduce dust (Photo 10).

Gravel base and straw wattles near TSP 22 are minimizing dust.
8/12/15	Photo 11 Crescent Valley Mobile Estates

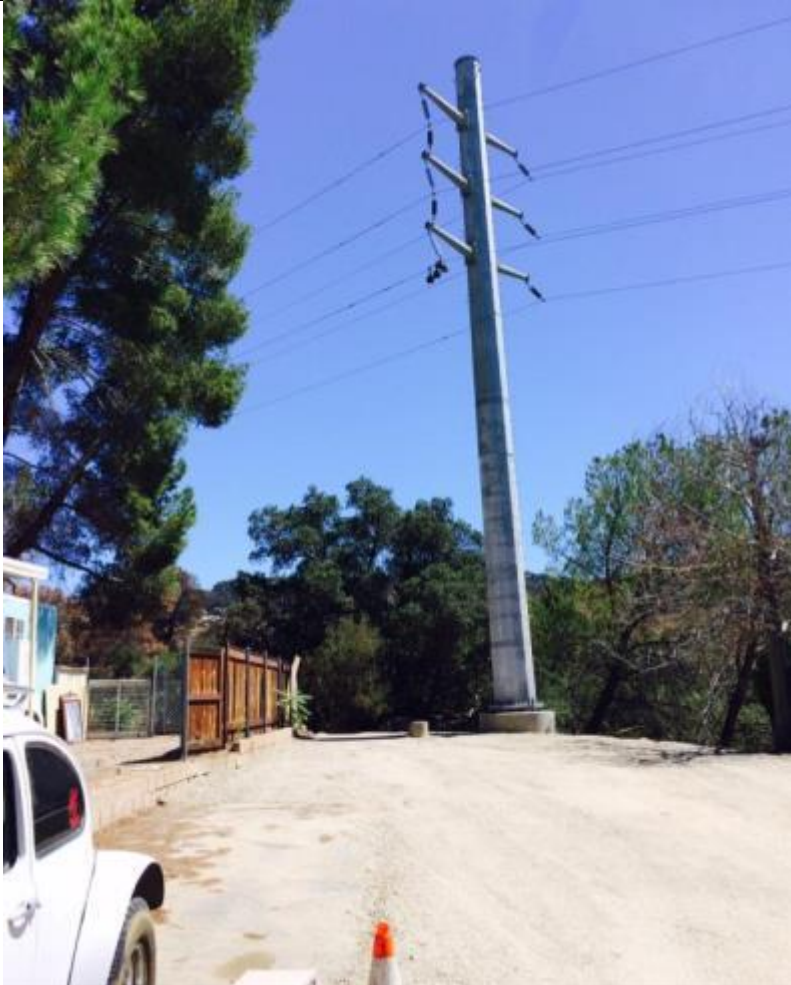
The TSP 23 site has been cleaned up and has had road base applied.

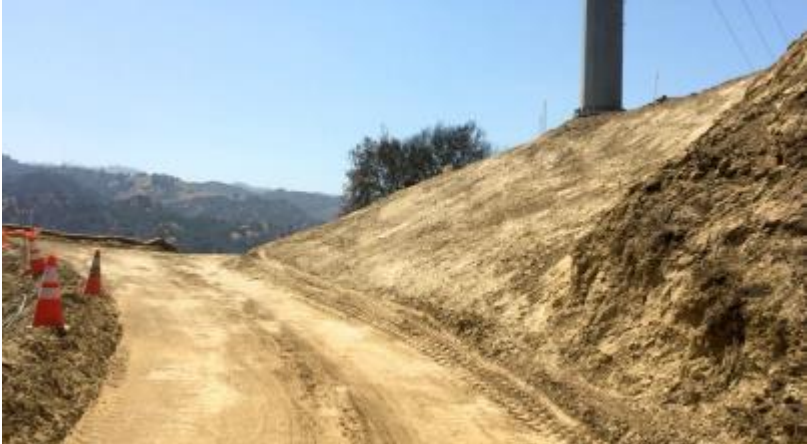
REPRESENTATIVE SITE PHOTOGRAPHS			
Date	Location	Photo	Description
8/20/15	TSP 24

The slope below TSP 24 has been regraded and will be covered with an erosion control blanket.
8/20/15	TSP 24 and Access Road to TSP 25

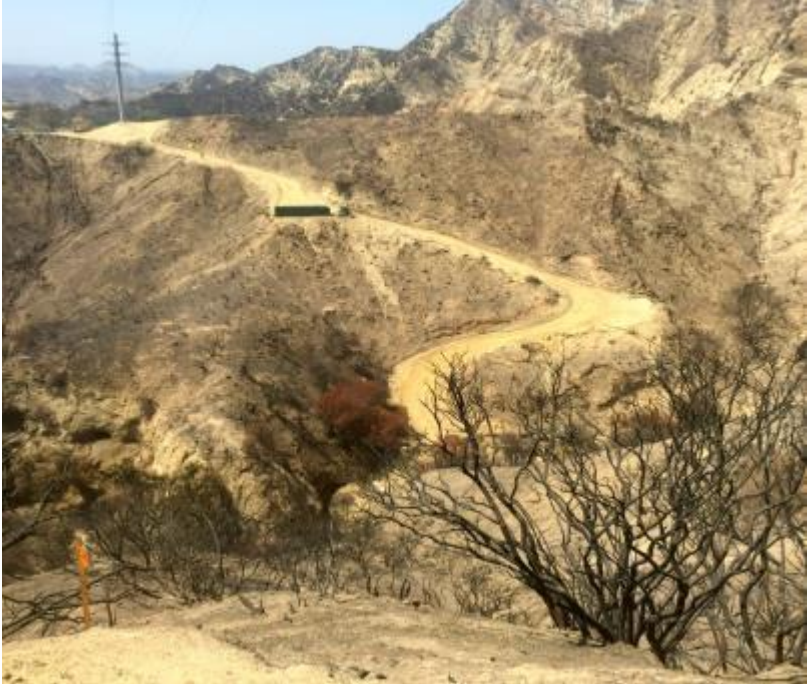
Looking north from the TSP 25 site - TSP 24 can be seen in the distance.
8/20/15	Access Road to TSP 25

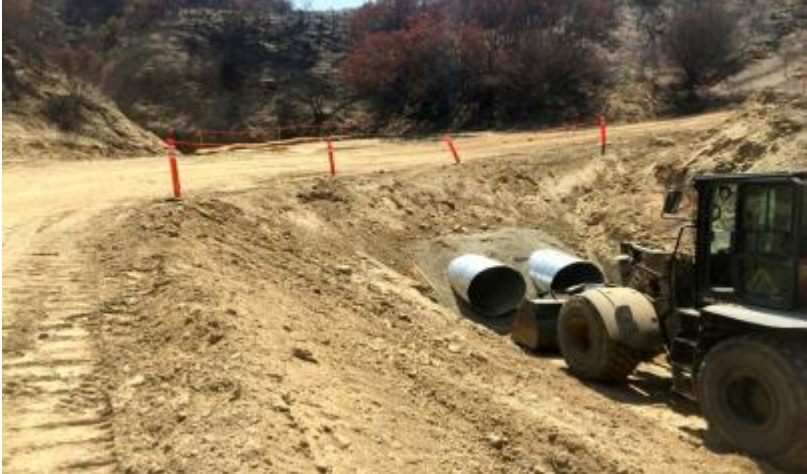
Culverts have been installed under the access road.

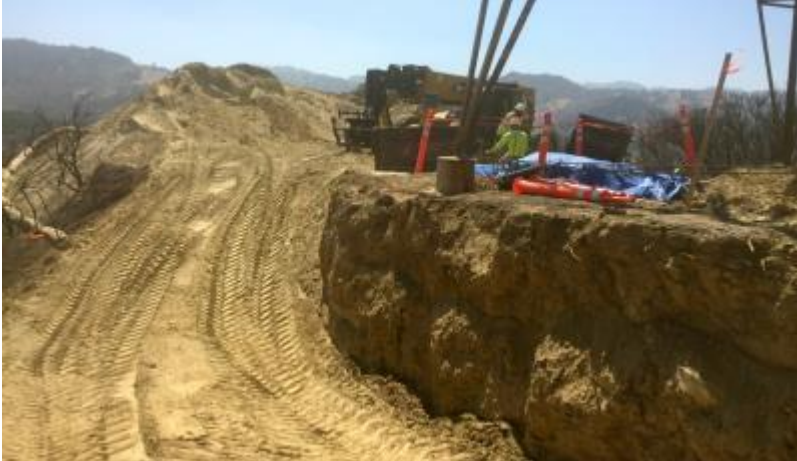
Date	Location	Photo	Description
8/20/15	TSP 25

<p>The pole site was graded, drilled, and the cage was set in the foundation hole.</p>
8/20/15	TSP 25

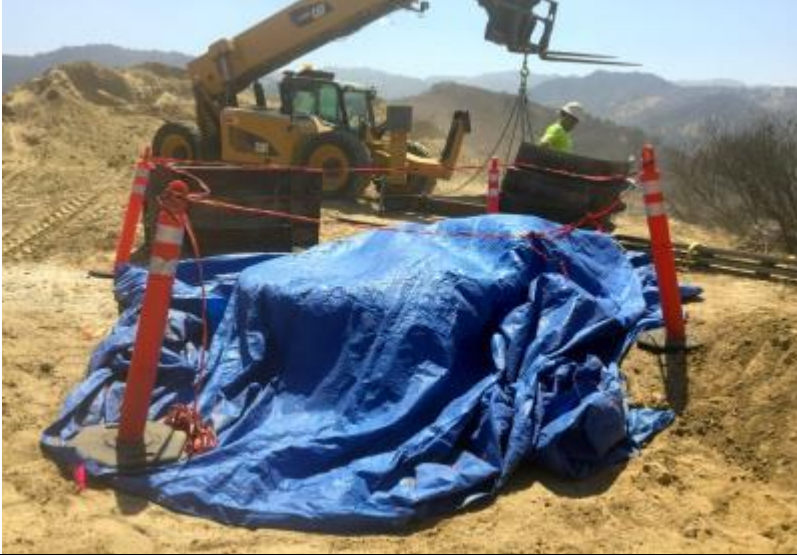
<p>The open hole was covered with a tarp and would be sealed before the end of the day.</p>
8/20/15	TSP 22

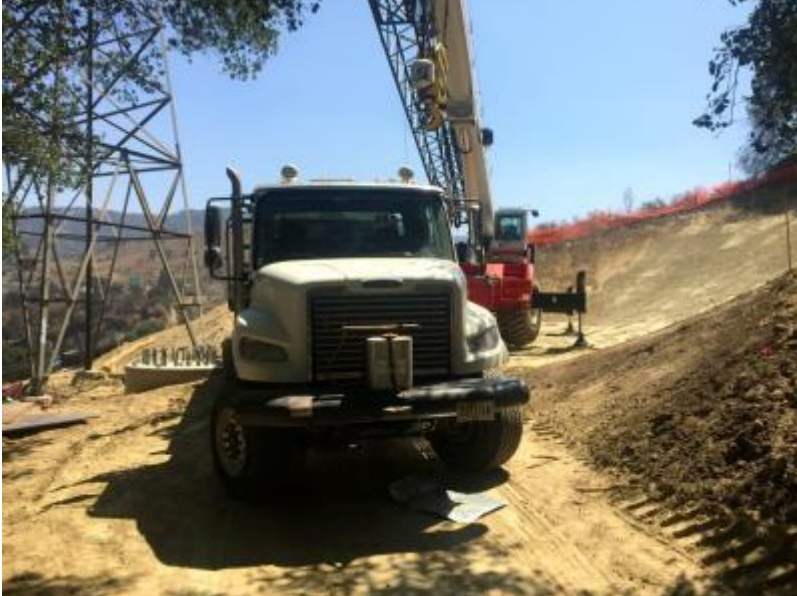
<p>Equipment is onsite to set the pole, but there was no crew onsite at the time of the site visit.</p>

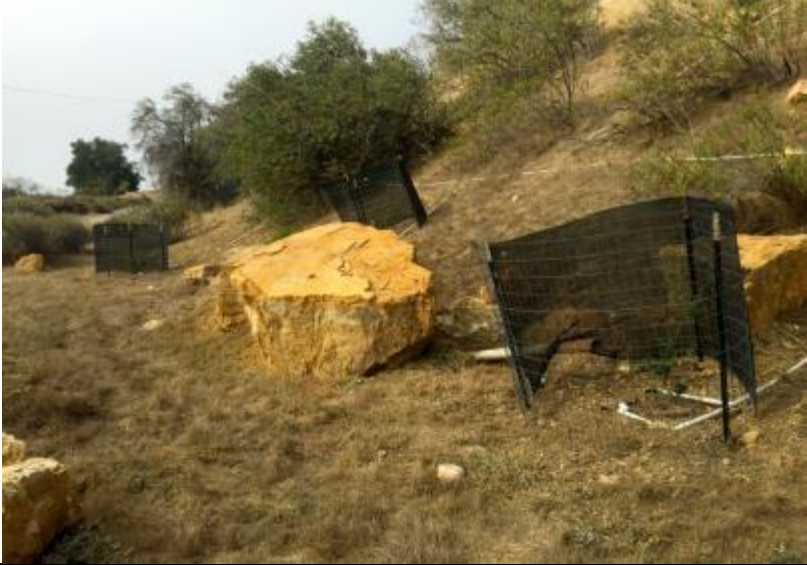
Date	Location	Photo	Description
8/20/15	Oak Tree Mitigation Site

Oak cages – note the lack of mustard around them.
8/20/15	PS-42 Fill Site

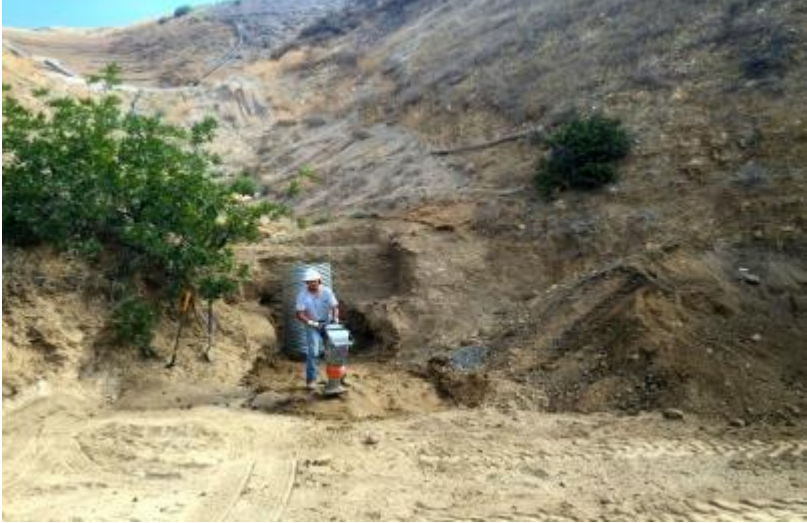
The culvert has been installed and the final compaction work is being completed.
8/20/15	PS-42 Fill Site

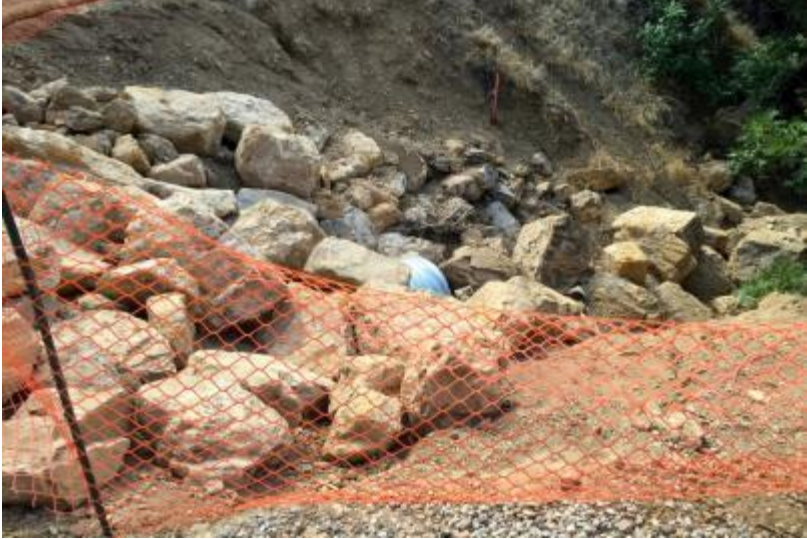
Riprap has been added to the area around the culvert outfall.

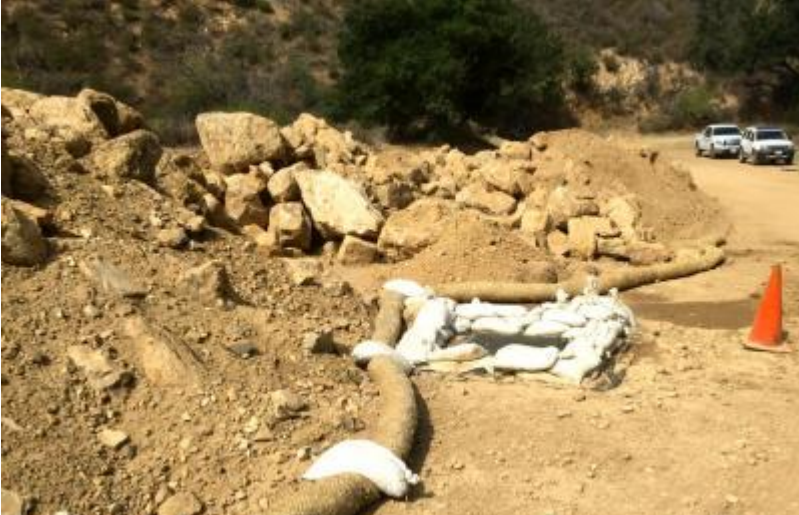
Date	Location	Photo	Description
8/20/15	PS-42 Fill Site

Dirt and rock stockpiled on the well pad below the fill site. BMPs have been installed.
8/20/15	Natural Substation

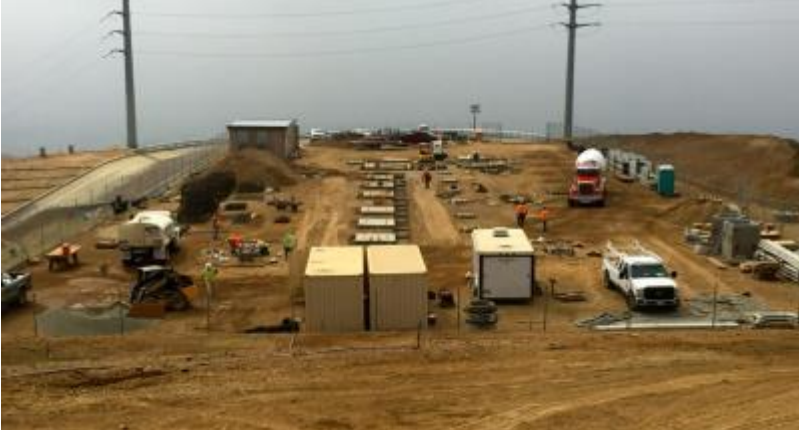
Crews continue to build forms for the foundations, and concrete trucks are pouring the foundations.
8/20/15	Natural Substation

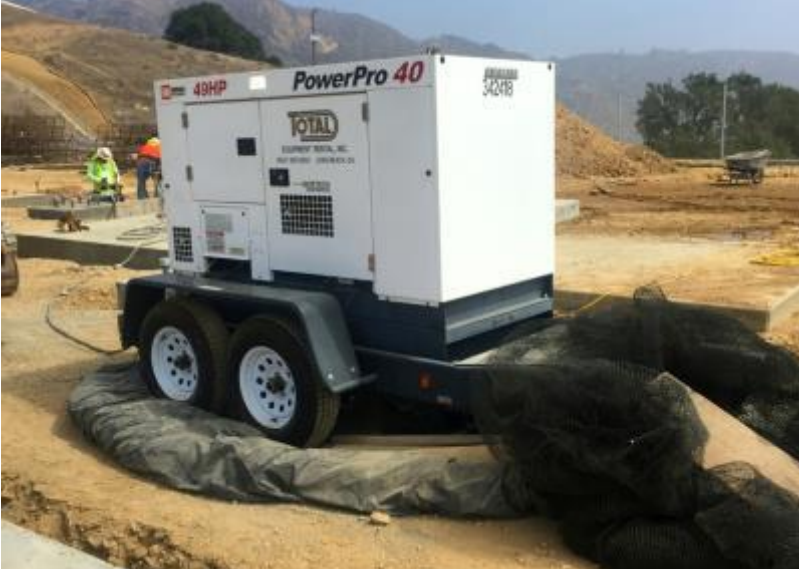
All generators have been placed in containment structures. Bird netting is nearby to cover equipment after hours.

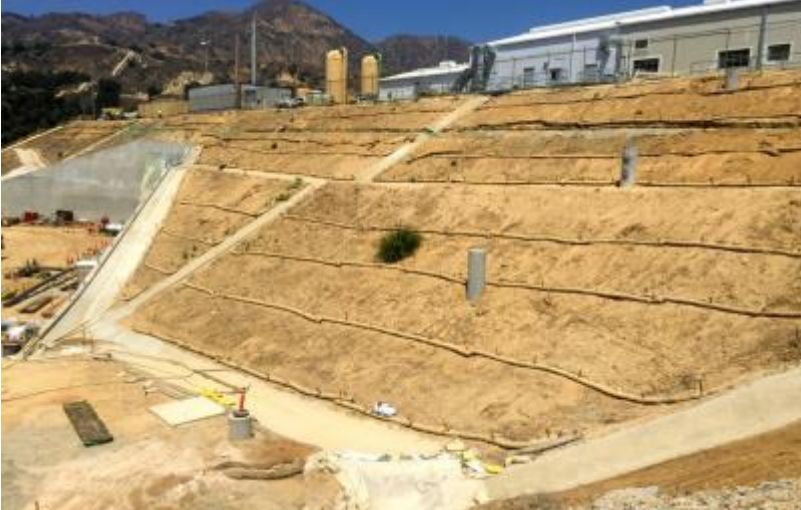
Date	Location	Photo	Description
8/20/15	CCS

Some BMP work is being conducted on the fill slope above the CCS.
8/20/15	CCS

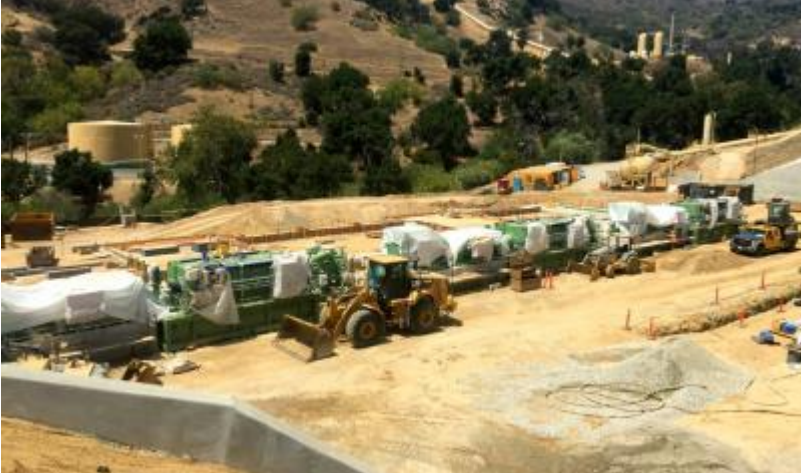
Equipment continues to be brought in, and areas are still being excavated and foundations are being poured.
8/20/15	CCS

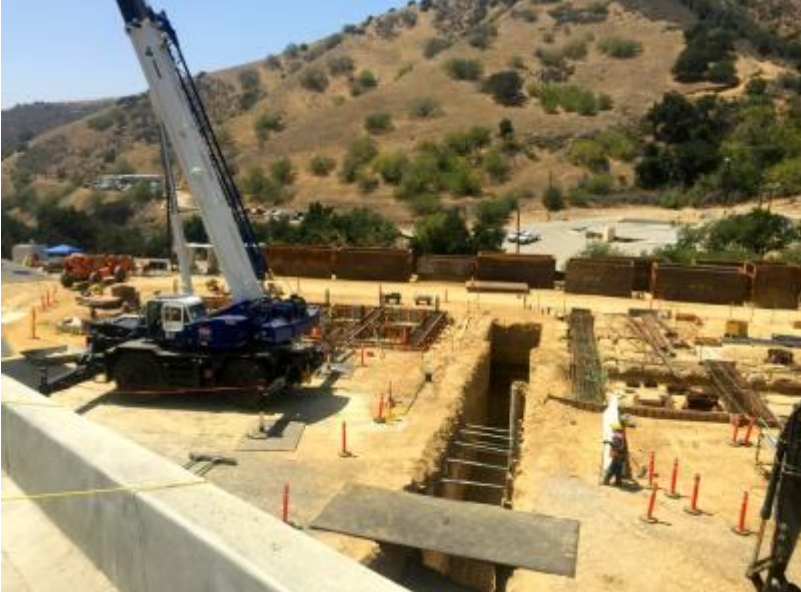
At the CCS area, trenching continued and was followed by conduit installation and the forming and pouring of foundations. Concrete and slurry trucks arrived regularly, and washout basins were strategically located within the facility – see photos. Open holes and trenches were covered with plates (MM BIO-11).

Steel plates are being installed over a deep trench.

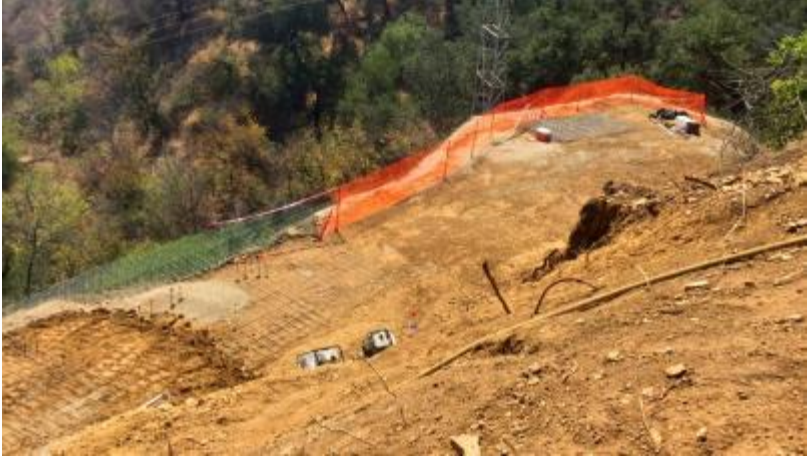
Date	Location	Photo	Description
8/20/15	TSP 40

The Hilfiker wall is nearing completion.
8/20/15	Access Road to TSP 40

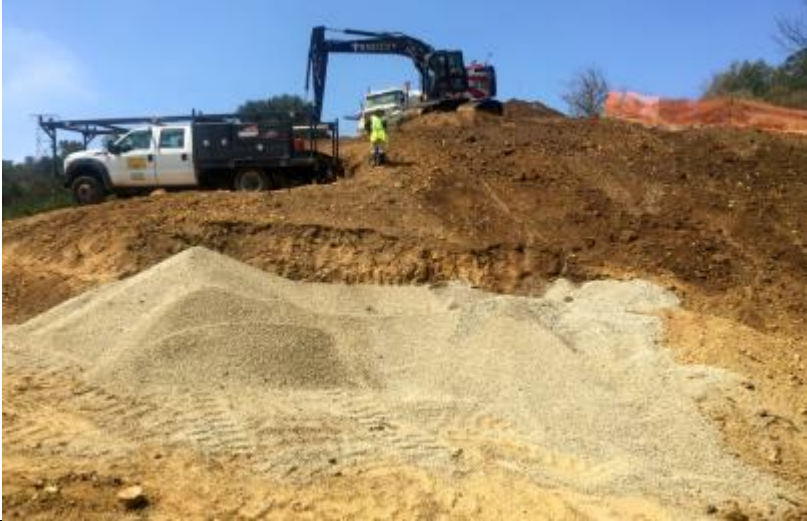
The access road to TSP 40 is being constructed, with oversight by the paleontological monitor.
8/20/15	Access Road to TSP 40

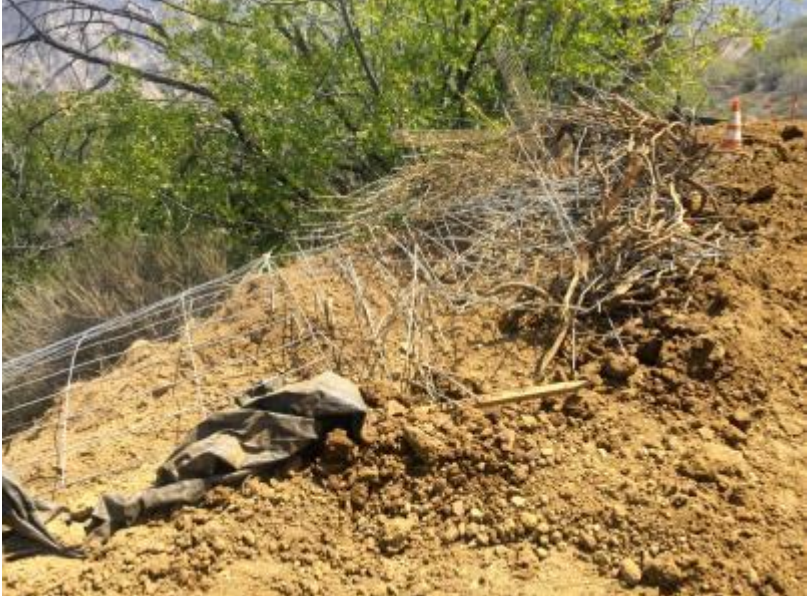
Dirt and materials are spilling outside of the construction limits.

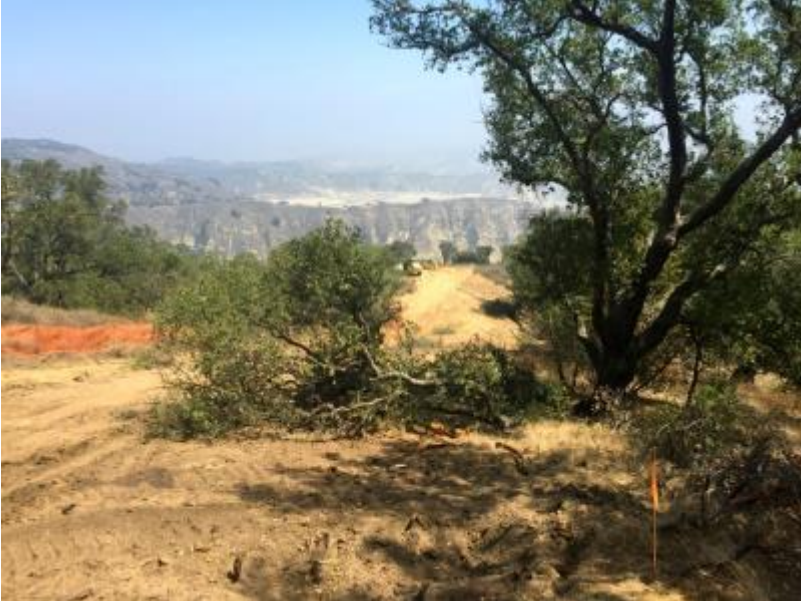
Date	Location	Photo	Description
8/20/15	Access Road to TSP 40

The last of the oak tree pruning along the access road.
8/20/15	Access Road to TSP 40	 	Clearing the access road near TSP 41.

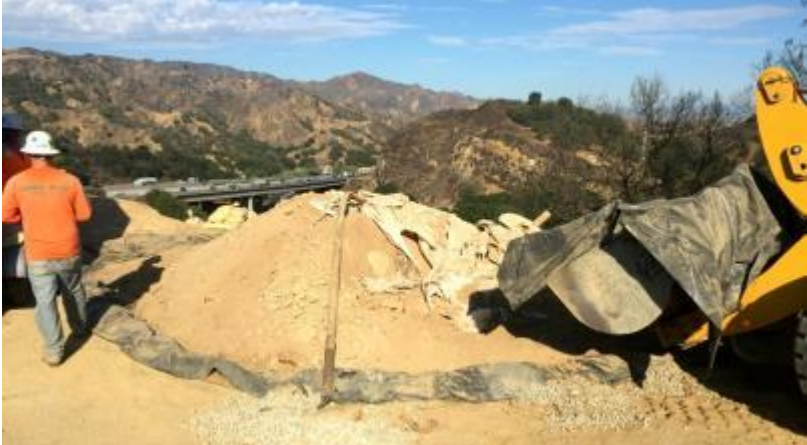
Date	Location	Photo	Description
8/26/15	TSP 24

Contaminated soil being transported to a dumpster.
8/26/15	Access Road to TSP 25

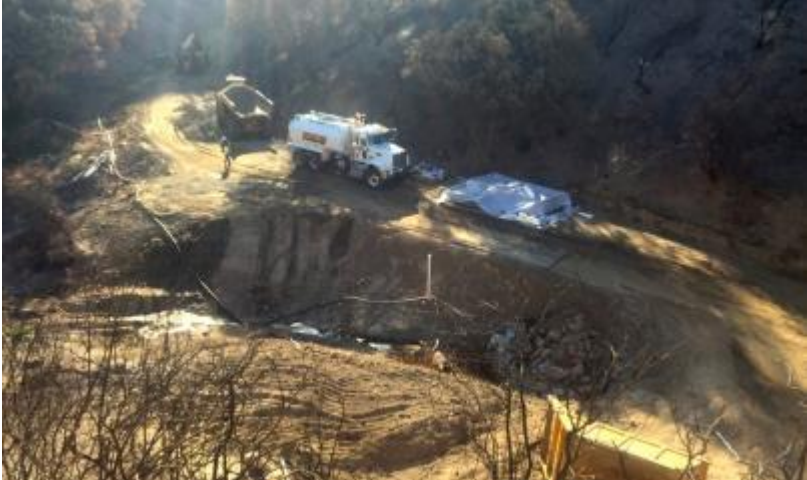
TSP 25 access road with water truck and concrete washout dumpsters.
8/26/15	Access Road to TSP 25

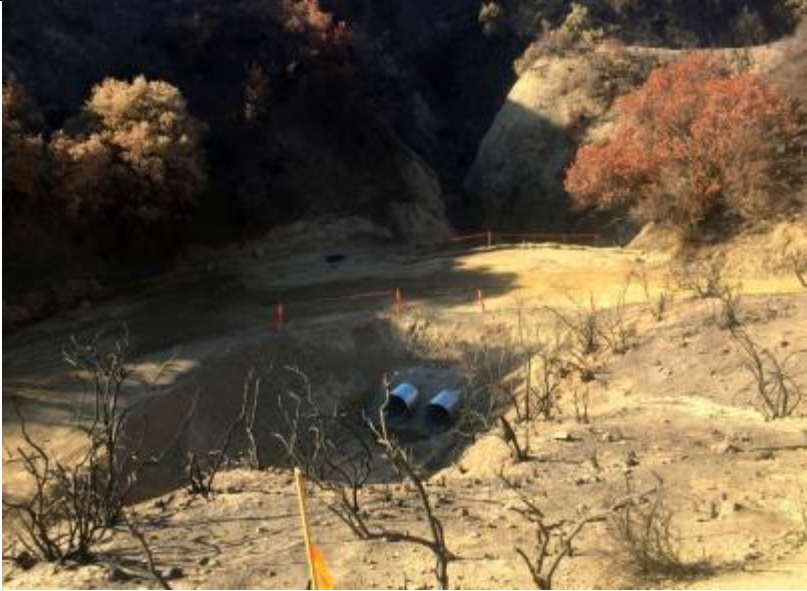
Culverts have been installed under the access road.

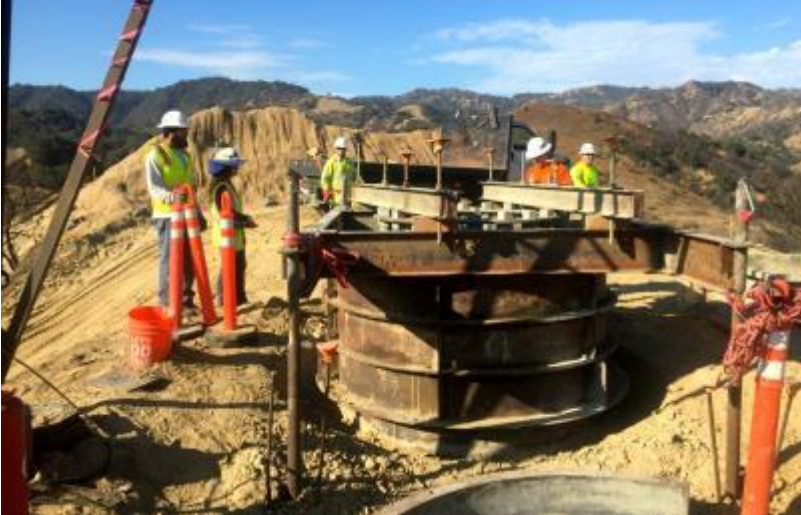
Date	Location	Photo	Description
8/26/15	TSP 25

The TSP 25 foundation had been poured the previous day, and a crew was doing cleanup work at the site – see photo. After the pour, at least three concrete washout bins were needed to wash out all the hoses since crews were required to use a pumper truck to move the concrete up the steep slope to the pole site – see photo. The dirt pile from the drilling work had been covered with jute netting and water was being used to reduce dust (APM AQ-3, APM AQ-6). Dirt will be used to recontour the area around the TSP. A fire crew was onsite (MM HZ-2), even though this area had previously burned and there was only minimal vegetation remaining.

A photograph of a construction site for TSP 25. Several workers in high-visibility vests and hard hats are visible. A large concrete structure is being poured or finished. The background shows a hilly landscape under a clear blue sky.	The TSP site foundation has been poured and crews are conducting cleanup.
8/26/15	TSP 22

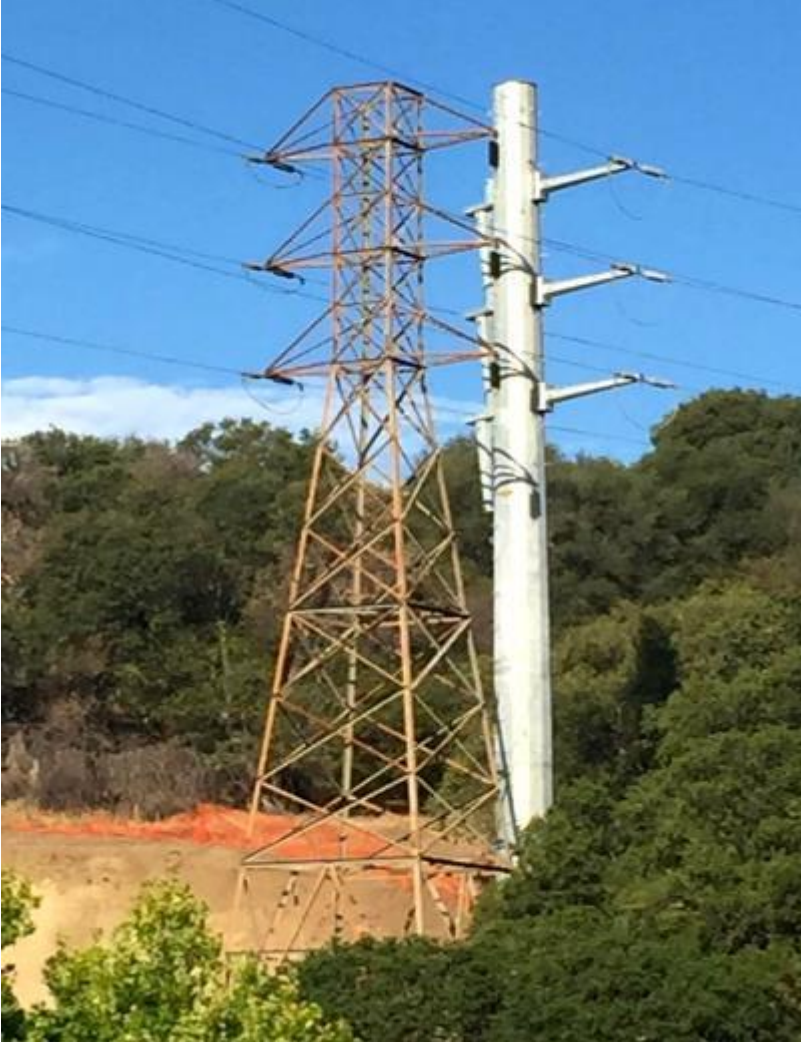
A photograph of a completed tower structure for TSP 22. The tower is a tall, lattice-structured metal tower with a central vertical pipe. It is situated in a wooded area with a clear blue sky in the background.	The TSP has been set.

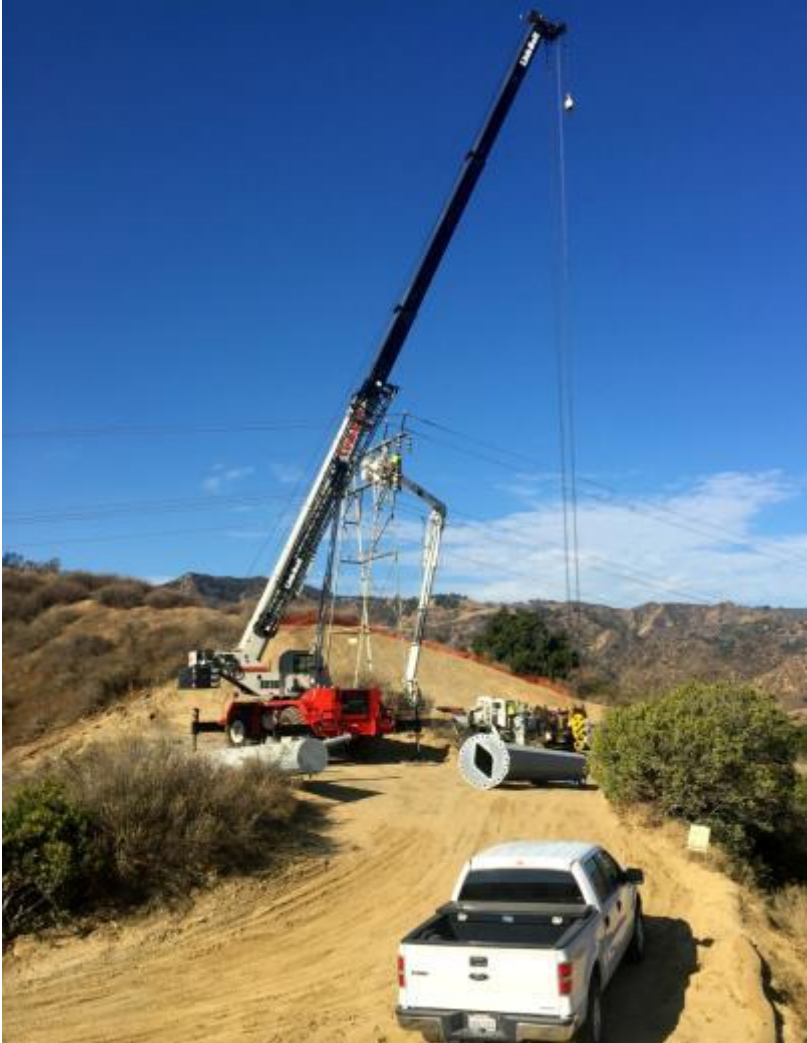
Date	Location	Photo	Description
8/26/15	TSP 21

A crew is installing the TSP and will be moving the wires.
8/26/15	TSP 21/22 Pull Site

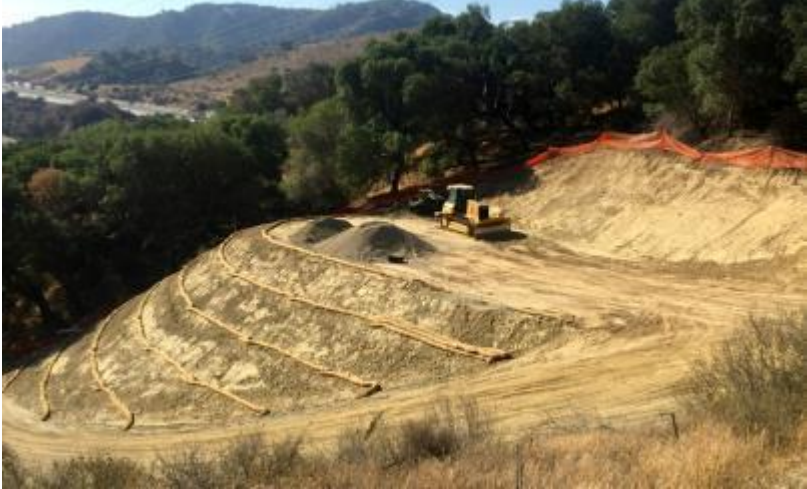
No work has been conducted since the previous site visit.

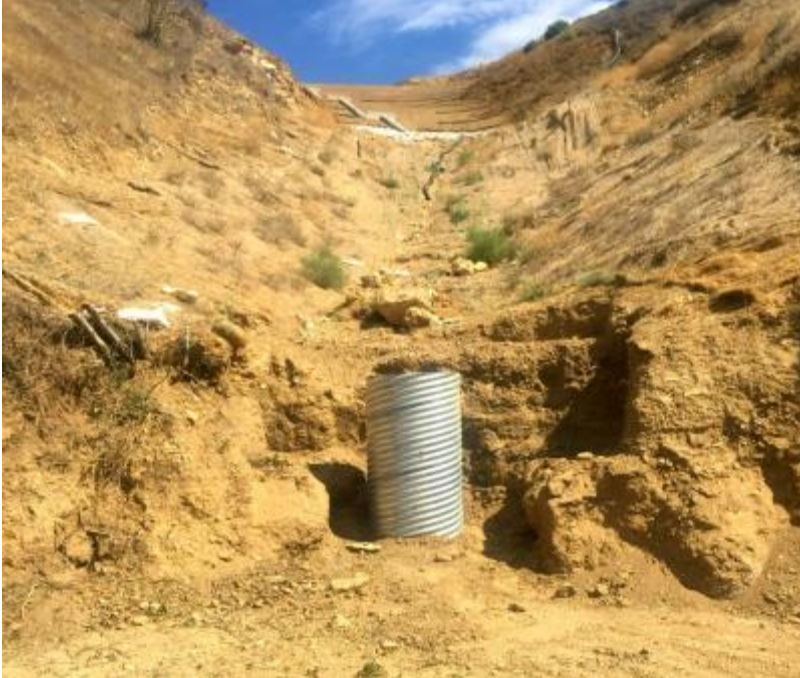
Date	Location	Photo	Description
8/26/15	PS-42 Fill Site

Culvert has recently been installed.
8/26/15	PS-42 Fill Site
