**Re: Monthly Report Summary #17 for Aliso Canyon Turbine Replacement Project**

## Aliso Canyon Turbine Replacement Project CPUC Site Inspection Form

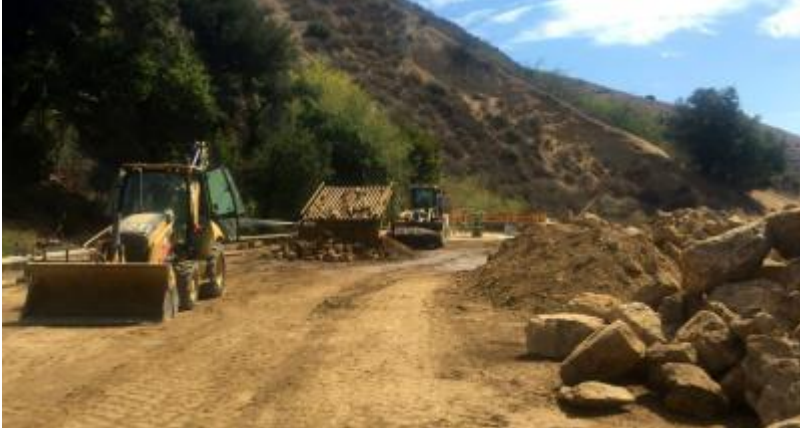
Dirt and rock are being separated on the well pad below the PS-42 Fill Site. BMPs have been installed.
8/26/15	Natural Substation

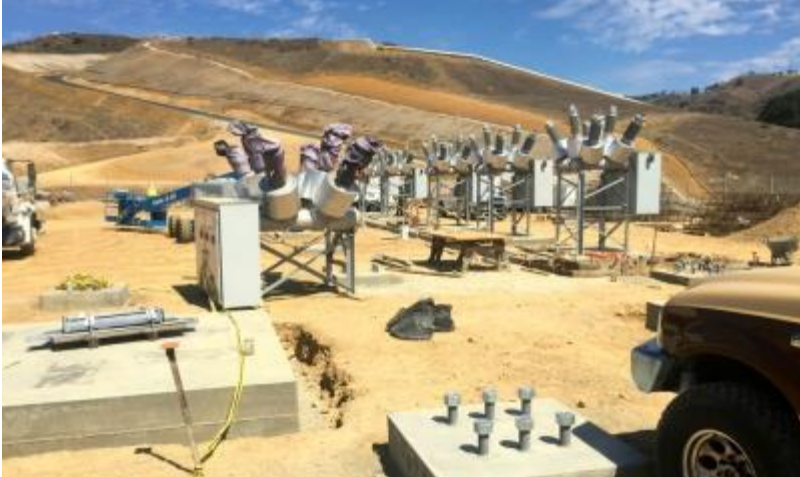
Transformers are being delivered and installed.

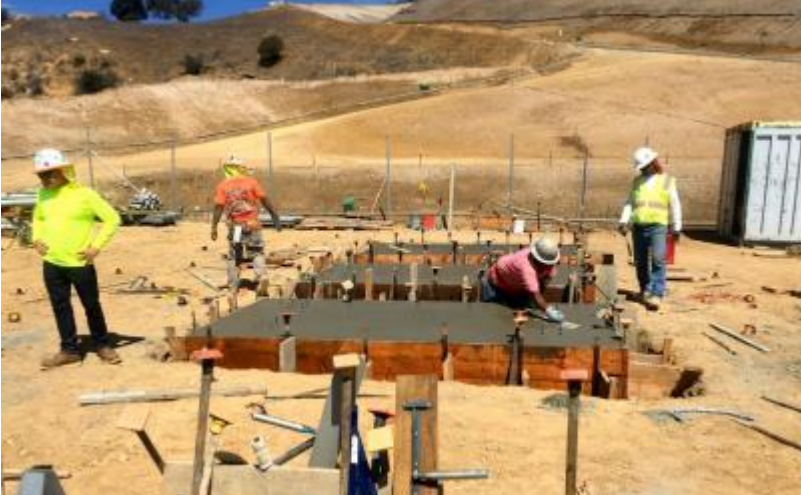
Date	Location	Photo	Description
8/26/15	Natural Substation

Foundations continue to be built and poured.
8/26/15	CCS

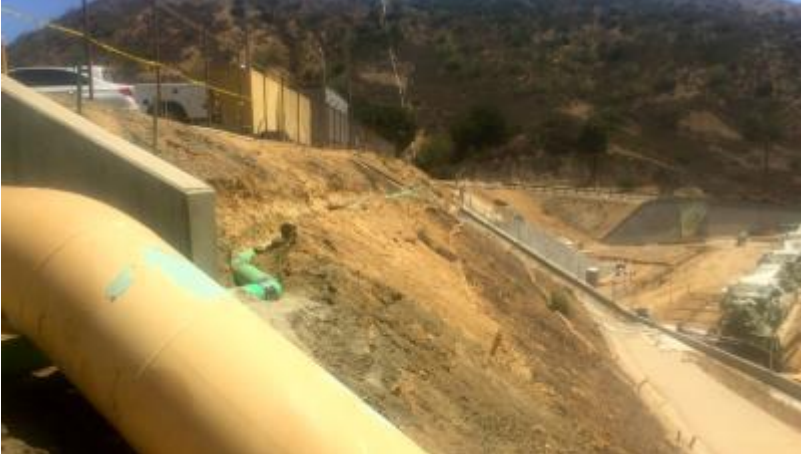
Pipe installation above the facility.
8/26/15	CCS

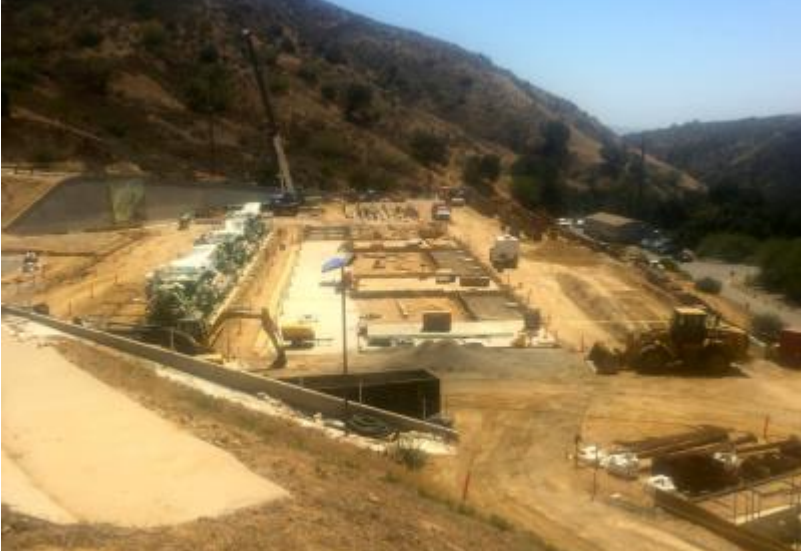
Equipment continues to be delivered. Areas are being excavated and foundations are being poured.

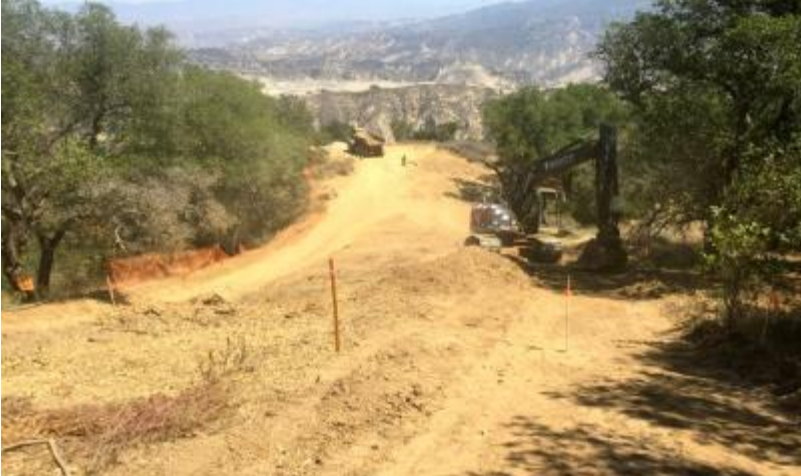
Date	Location	Photo	Description
8/26/15	Access Road to TSP 40

An excavator is stockpiling topsoil.
8/26/15	Access Road to TSP 40	 	Excavation of the access road between TSPs 41 and 42.
