Re: Monthly Report Summary #2 for Aliso Canyon Turbine Replacement Project

Aliso Canyon Turbine Replacement Project CPUC Site Inspection Form

Project: Aliso Canyon Turbine Replacement **Date:** May 1, 2014
Project Proponent: Southern California Gas Company and Southern California Edison **Report #:** VS005
Lead Agency: California Public Utilities Commission **Project Phase/NTP:** Guard House and Road Widening Component (NTP-1)
CPUC PM: Andrew Barnsdale, Energy Division **AM/PM Weather:** Warm to Hot temperatures, clear skies and very windy conditions.
E & E CM: Jennifer Siu **Start/End time:** 0815 hrs to 1100 hrs
Monitor(s): Vince Semonsen
Project Component(s): CPUC Oversight: Guard House and Evaluation of possible fill sites.

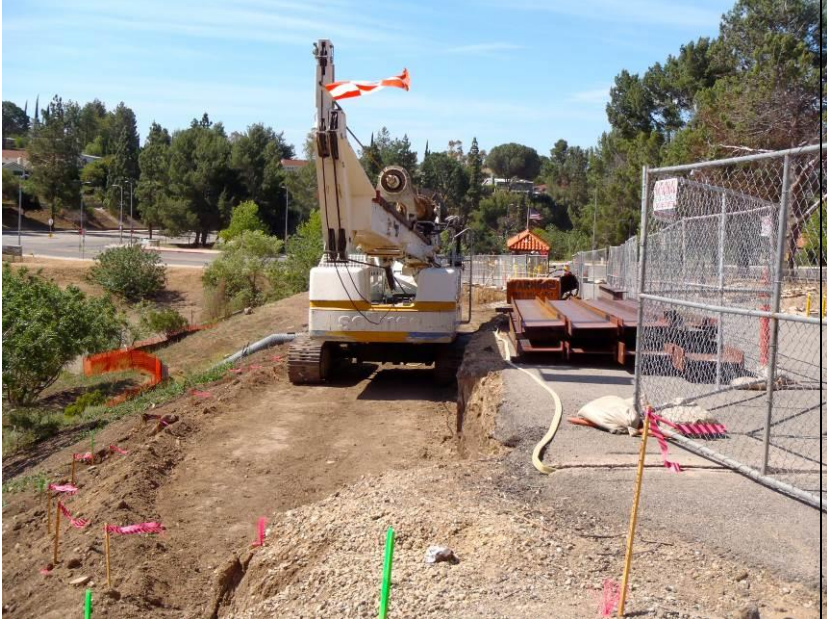
REPRESENTATIVE SITE PHOTOGRAPHS			
Date	Location	Photo	Description
5/1/14	Guard house

A small backhoe is using a breaker bar to remove large pipe from along the entrance of the Limekiln Creek access road
5/1/14	Staging & stockpile area at the north end of the work area.

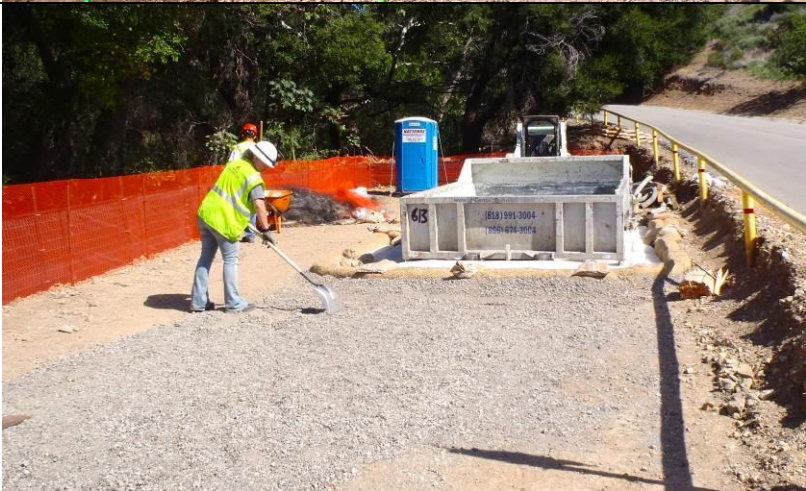
Installation of concrete washout containment in the stockpile area along Limekiln Canyon Rd.
5/1/14	Soil stockpile area.

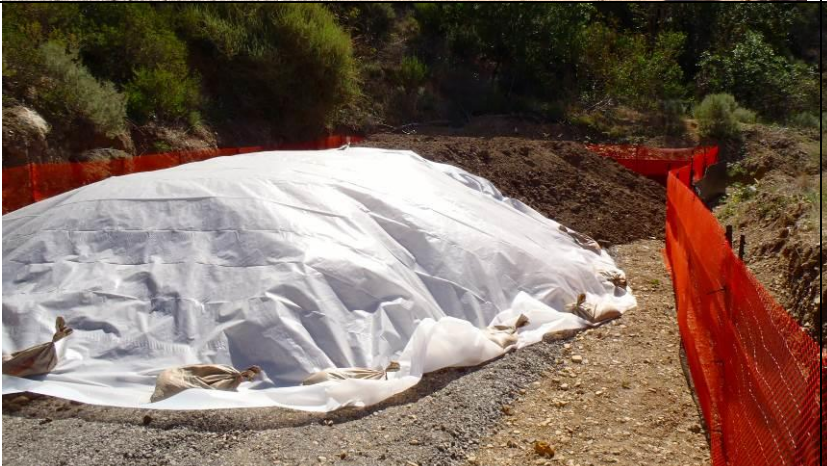
Soil piles were being covered to prevent dust from leaving the site – see photo – however there was not enough plastic to cover the entire pile (APM AQ-6).

Stockpile of soil within the designated stockpile area at the north end of the project site.

Recommended follow-up: Check covering on the soil stockpiles. Soil piles will need continued watering until sufficient coverings are in place to prevent dust.

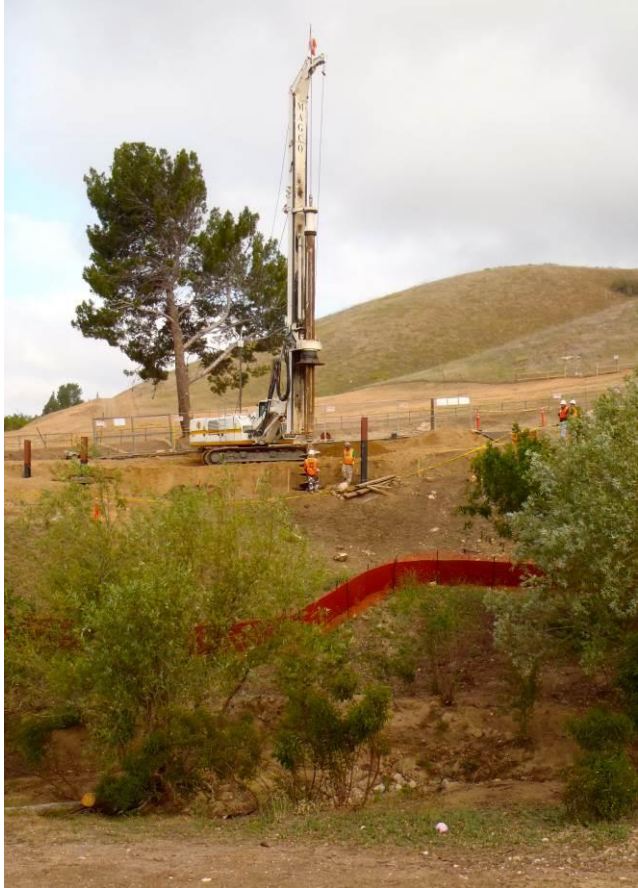
REPRESENTATIVE SITE PHOTOGRAPHS			
Date	Location	Photo	Description
5/8/14	Guard house

<p>Drilling rig excavating for and setting the caissons along the Limekiln Creek access road.</p> <p>Note the exclusion fencing and the fuel modification work in the riparian corridor. The photo was taken from across Limekiln Wash looking west toward the project area.</p>
5/8/14	Guard House

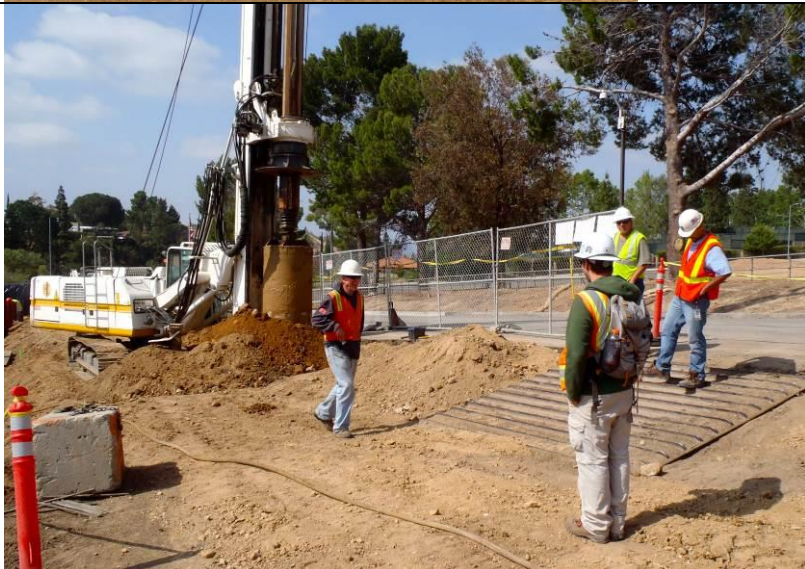
<p>Drilling rig operating with oversight by construction personnel and Paleontological monitor, Dave Schroeder.</p>

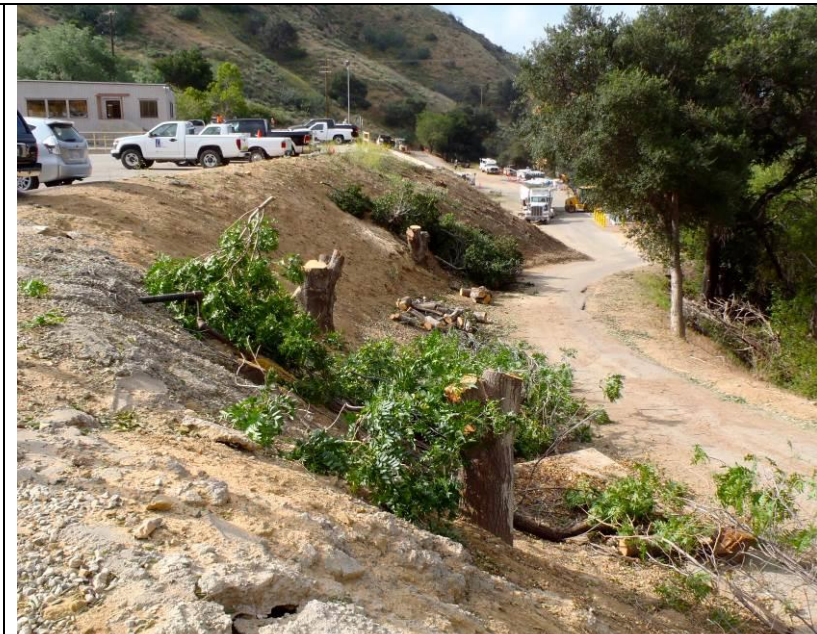
5/8/14	Central Compressor Station (CCS) near the office and crew-shift buildings

Tree removal near the CCS project area - specifically around the office and crew-shift buildings. Photo is looking south from the parking area.
5/8/14	(CCS)

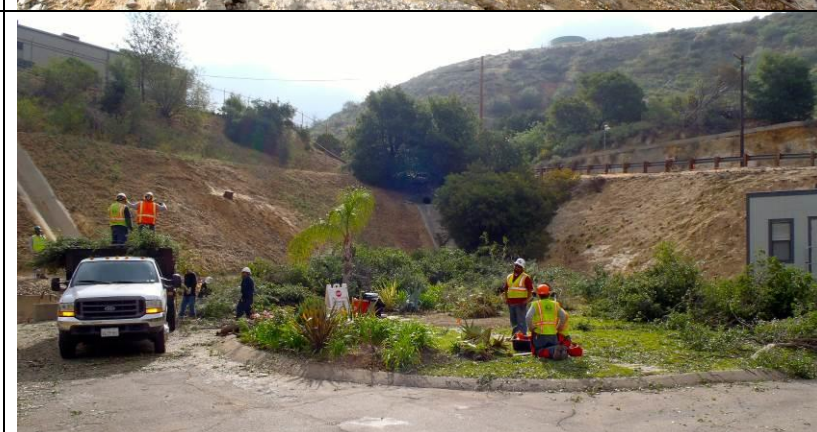
Tree removal near the CCS project area - specifically around the office and crew-shift buildings.

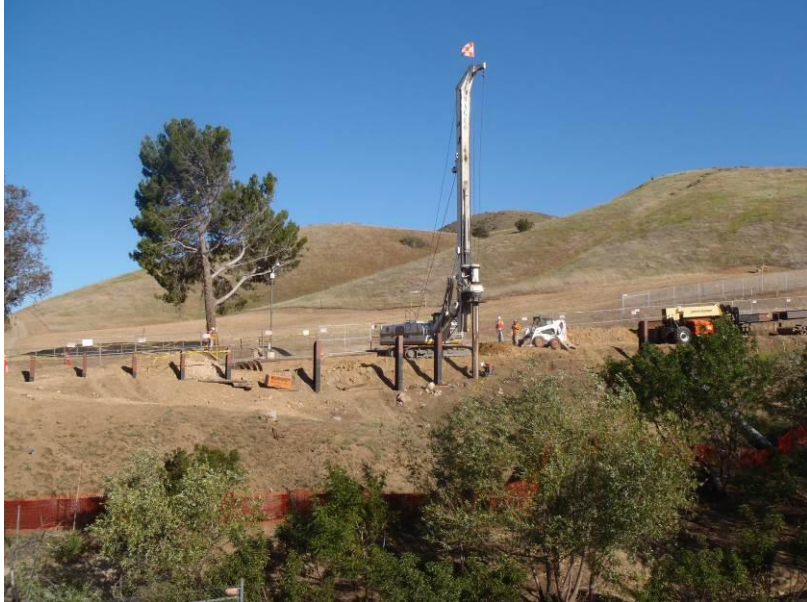
REPRESENTATIVE SITE PHOTOGRAPHS			
Date	Location	Photo	Description
5/15/14	Guard house

Drilling rig excavating for and setting the caissons along the Limekiln Creek access road. The photo was taken from across Limekiln Wash looking west toward the project area.
5/15/14	Guard House

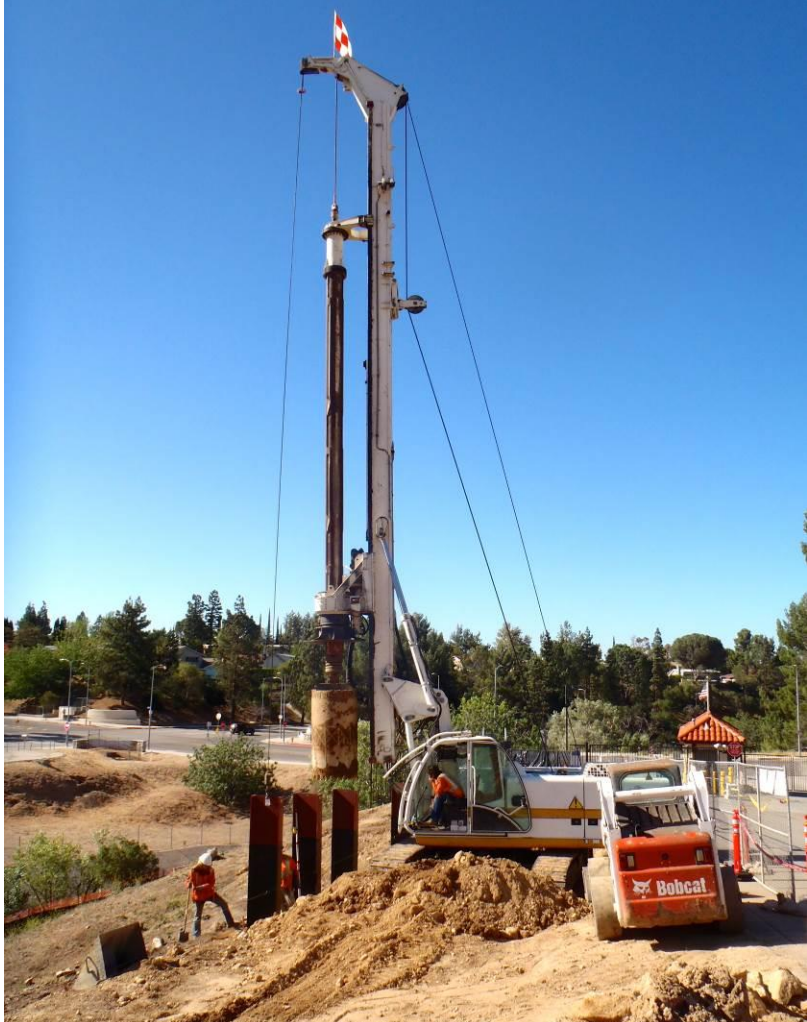
Drilling rig operating with oversight by construction personnel, Paleo monitor and Bio monitor. The photo was taken from the cut bench looking south toward the guard house.

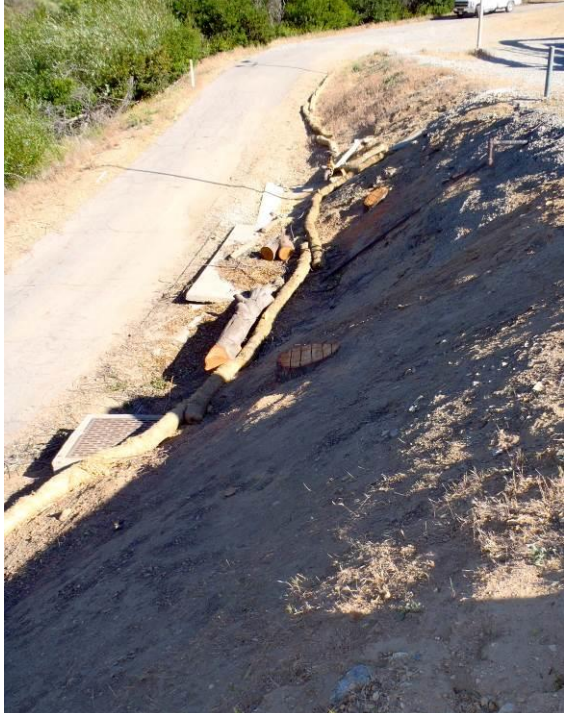
<p>5/15/14</p>	<p>Central Compressor Station (CCS) near the office and crew-shift buildings</p>

<p>BMP's installed (straw wattle at the base of the slope) after the VSS and Oak Tree removal near the CCS project area. Photo is looking northwest from the parking area.</p>
<p>5/15/14</p>	<p>Central Compressor Station near the office and crew-shift buildings</p>

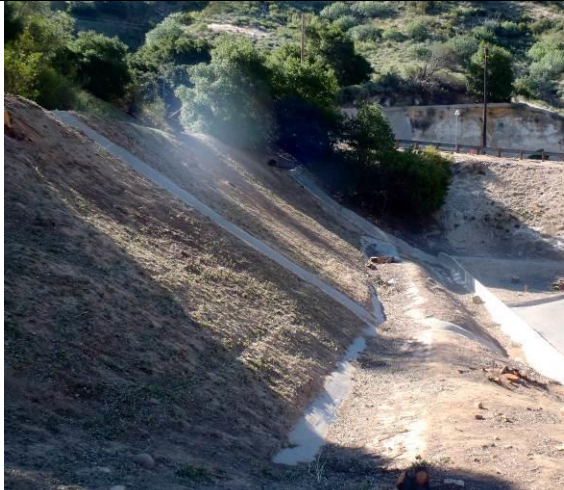
<p>Completed VSS and Oak Tree removal near the CCS project area – BMP's have not been installed here but according to Amadeep this will happen soon.</p>
<p>5/15/14</p>	<p>Upper stockpile area for the Guard house project</p>

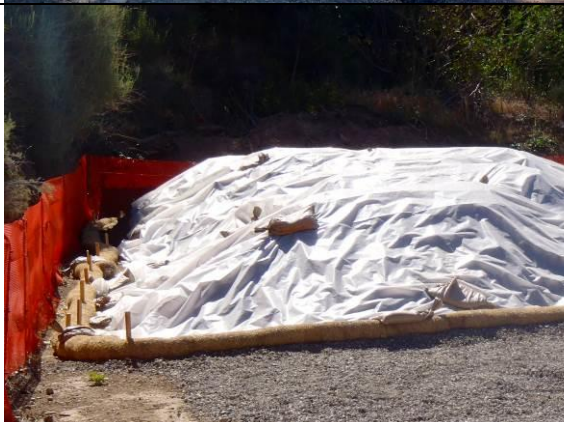
The soil stockpile has now been completely covered with plastic thereby reducing the chance of generating dust during the windy conditions – see photo (APM AQ-6).

<p>Soil piles covered with plastic.</p>

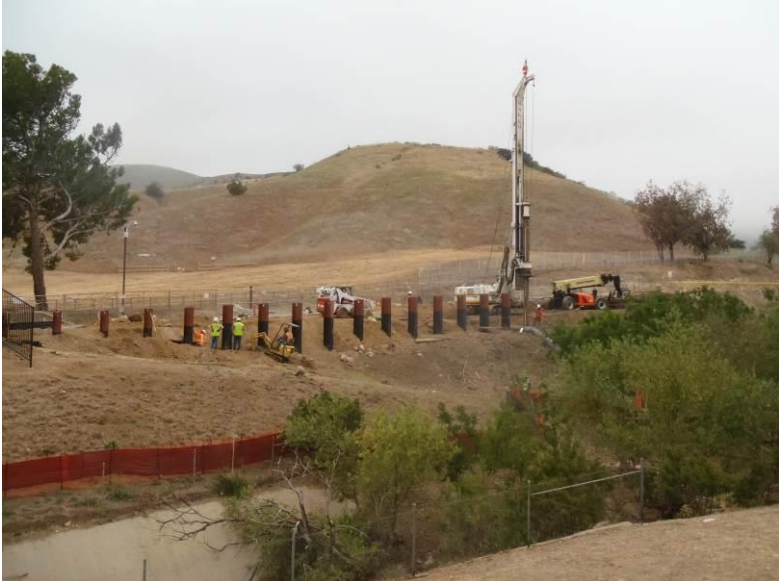
REPRESENTATIVE SITE PHOTOGRAPHS			
Date	Location	Photo	Description
5/22/14	Guard House

Drilling rig excavating for setting the caissons along the Limekiln Creek access road. The photo was taken from across Limekiln Wash looking west toward the project area.
5/22/14	Guard House

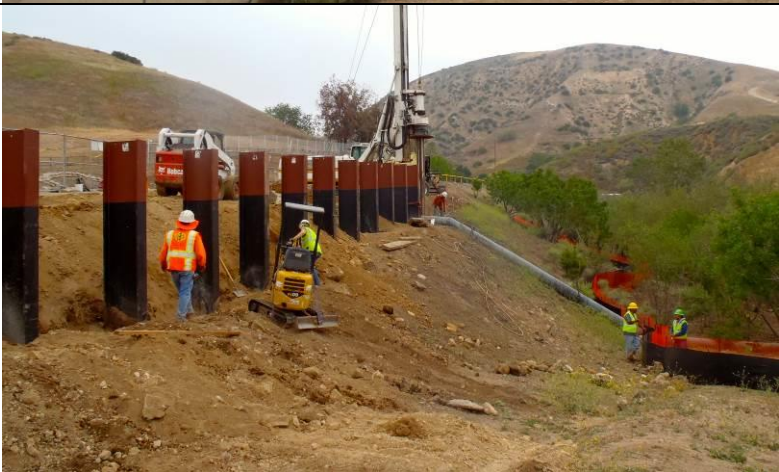
Caisson installation looking north from the guardhouse. Note the exclusion fencing and the Environmental monitors.
5/22/14	Guard House

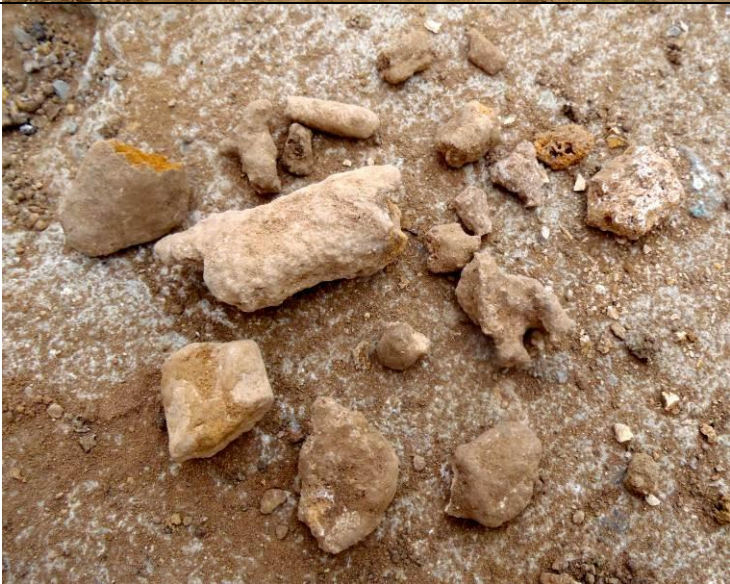
David Schroeder was onsite acting as both the Archeological and Paleontological monitor (MM CR-1, MM CR-3, MM CR-6 & MM CR-8). David had found some bone-like material in the drilling spoils when the drilling was between 5 and 10 feet deep – see photo. He called his boss to get direction and was hoping to have the drilling slow down a bit for the next caisson through the afore mentioned depth.

Possible bones found in the drilling spoils at a depth of about 5 to 10 feet deep.

Recommended follow-up: Ensure that workers have slowed drilling through the 5 to 10 foot range for closer archeological and paleontological inspection

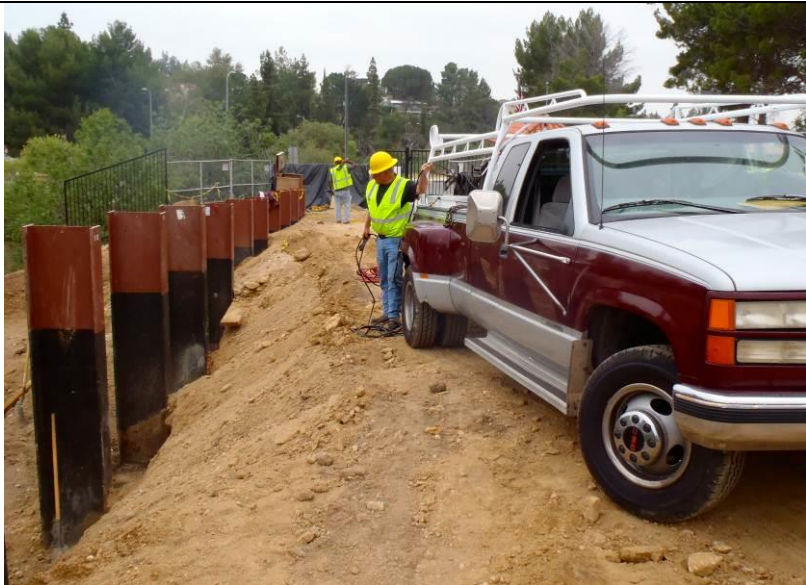
Guard House

Welders arrived onsite to work on the caissons. They have been trained and the area was wetted down in preparation for hot work.

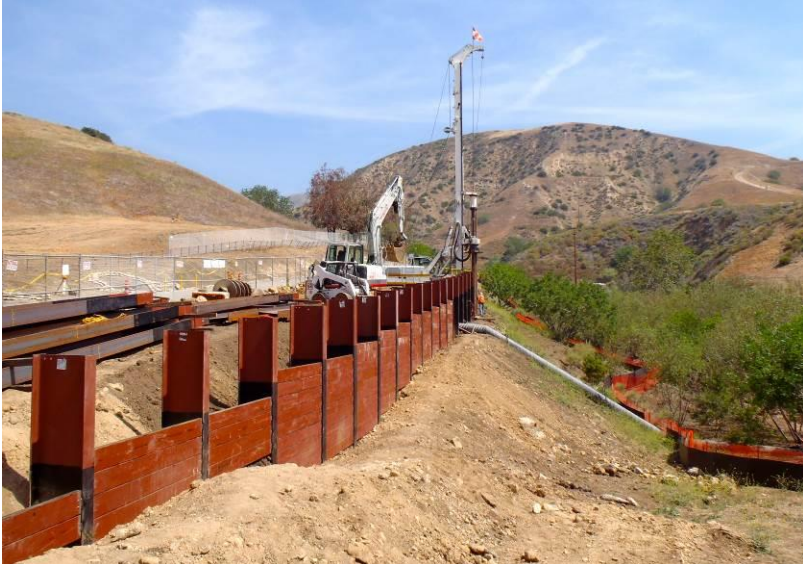
REPRESENTATIVE SITE PHOTOGRAPHS			
Date	Location	Photo	Description
5/29/14	Guard House

Drilling rig and caissons along the Limekiln Creek access road. Welders have been installing the cross beams between the caissons.
5/29/14	Guard House

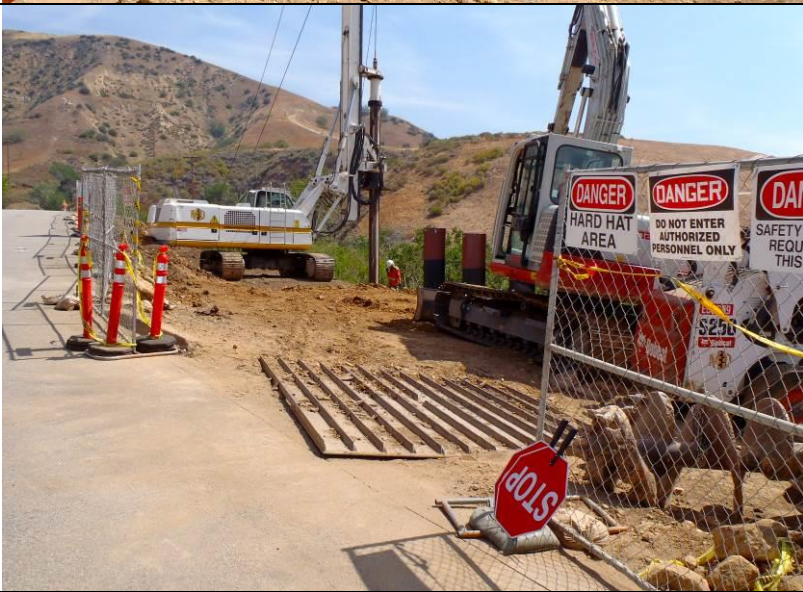
Access to the drilling operation has a rumble plate and the crew regularly sweeps the Limekiln Creek access road.
5/29/14	Access road to the PS-42 site

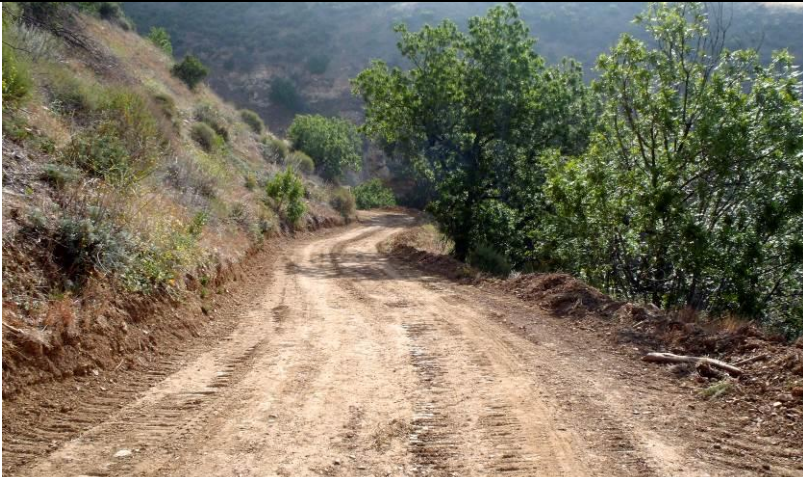
Minor grading conducted along an existing roadway was required to allow equipment to reach the PS-42 site.
