**Re: Monthly Report Summary #32 for Aliso Canyon Turbine Replacement Project**

## Aliso Canyon Turbine Replacement Project CPUC Site Inspection Form

Project:	Aliso Canyon Turbine Replacement	Date:	November 11, 2016
Project Proponent:	Southern California Gas Company and Southern California Edison	Report #:	VS123
Lead Agency:	California Public Utilities Commission	Monitor(s):	Vince Semonsen
CPUC PM:	Andrew Barnsdale, Energy Division	AM/PM Weather:	Partly cloudy and calm with mild temperatures
E & E CM:	Lara Rachowicz	Start/End time:	0900 to 0930 at SCE components 0930 to 1200 at the Aliso Canyon Natural Gas Storage Field (Aliso Storage Field)
Project NTP(s):	The new Admin/IM Building (NTP-2), Central Compressor Station (CCS) (NTP-3), and PS-42 Fill Site. Tubular Steel Poles (TSPs) 2 through 42 (NTPs A, C, and D).

Project:	Aliso Canyon Turbine Replacement	Date:	November 16, 2016
Project Proponent:	Southern California Gas Company and Southern California Edison	Report #:	VS124
Lead Agency:	California Public Utilities Commission	Monitor(s):	Vince Semonsen
CPUC PM:	Andrew Barnsdale, Energy Division	AM/PM Weather:	Hazy, cool, and calm.
E & E CM:	Lara Rachowicz	Start/End time:	0930 to 1

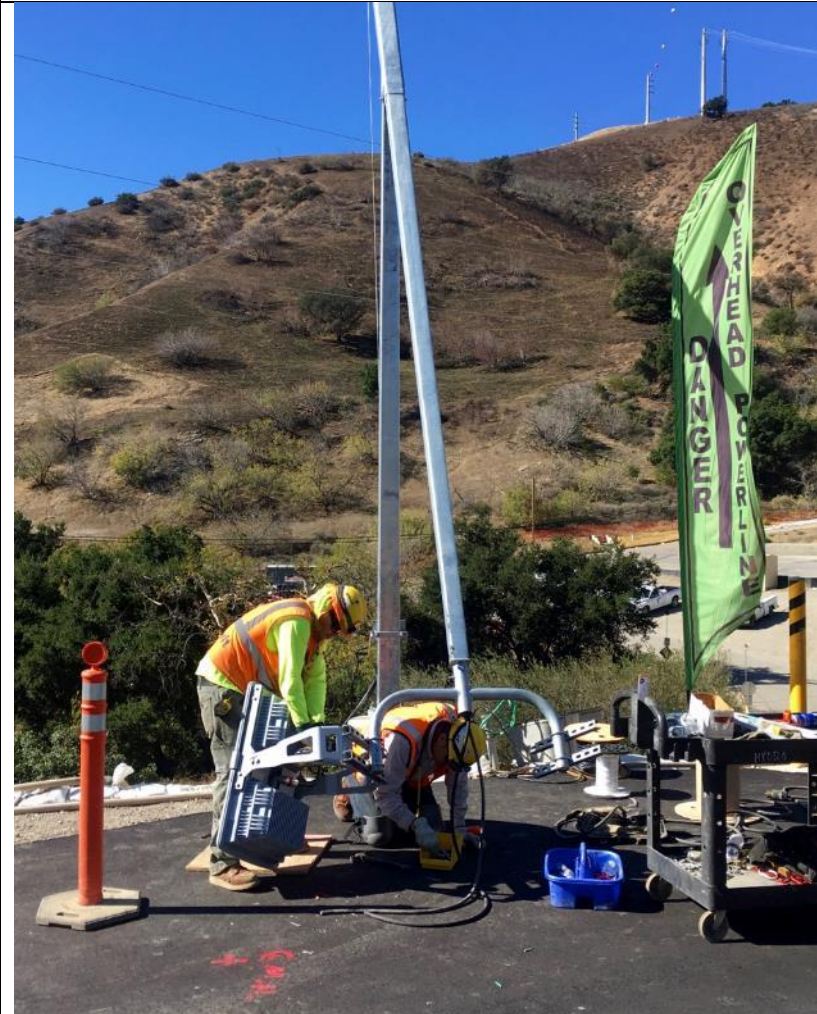
Photo 8 – Crew working on light poles.
11/11/16	CCS

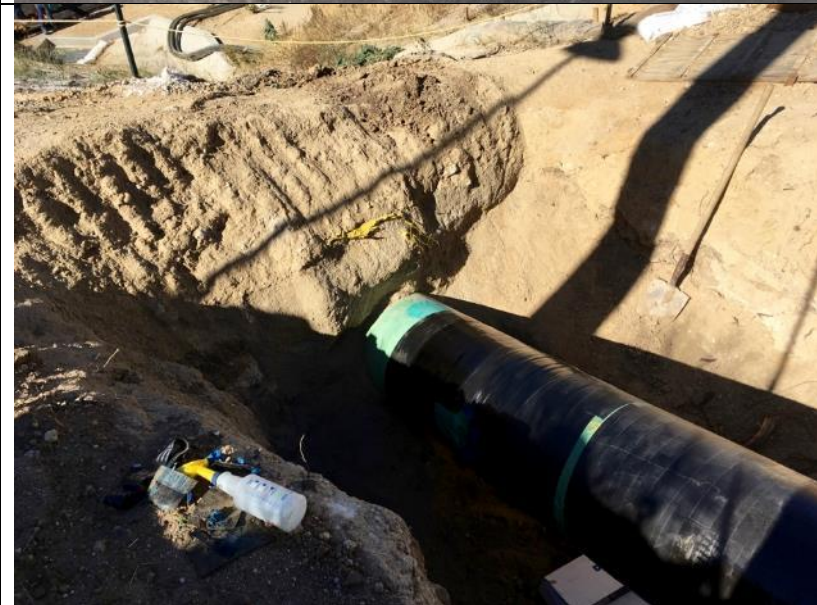
On November 14, Mr. Semonsen emailed these compliance concerns to SCG. On November 16, Mr. Semonsen conducted another site visit and noted that BMPs were actively being upgraded but an exit ramp was still needed in the blowdown pipe trench.

Photo 9 – Blowdown pipe trench is still open and needs a ramped climbing exit.

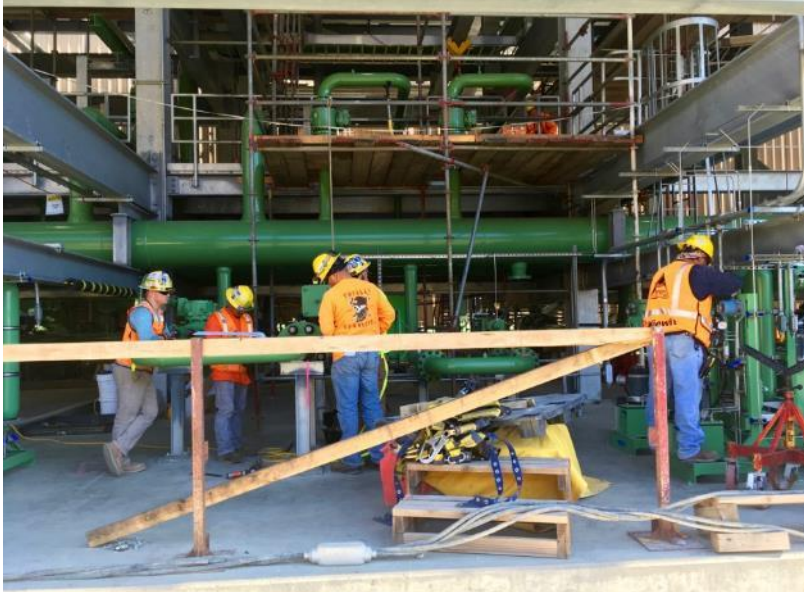
Photo 10 – Work continues within the CCS.
11/11/16	CCS

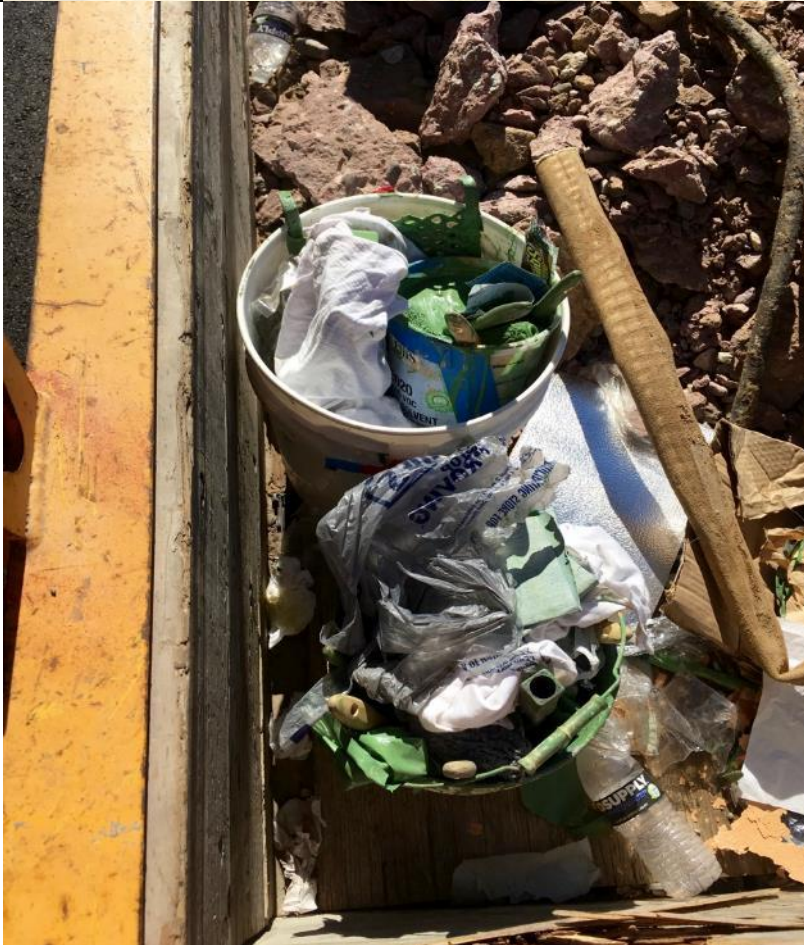
Photo 11 – Discarded painting supplies in the trash bin.

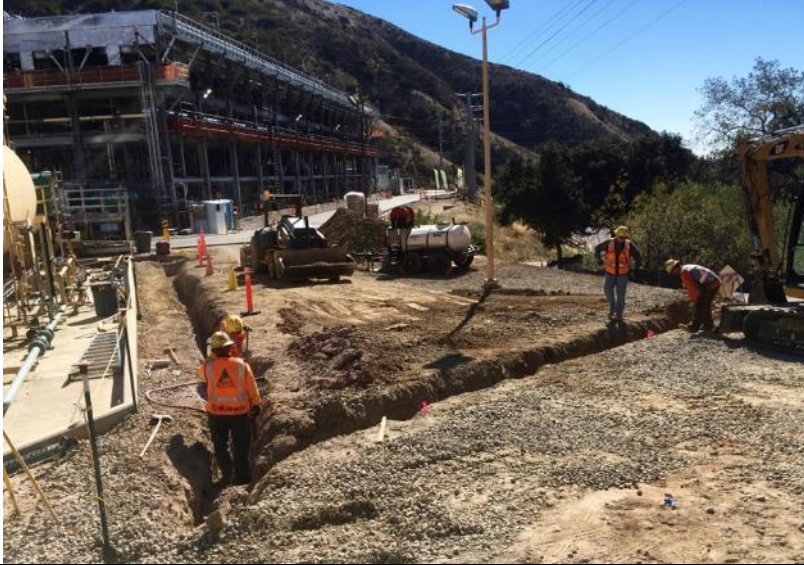
Photo 12 – Trenching work being conducted.
11/11/16	CCS

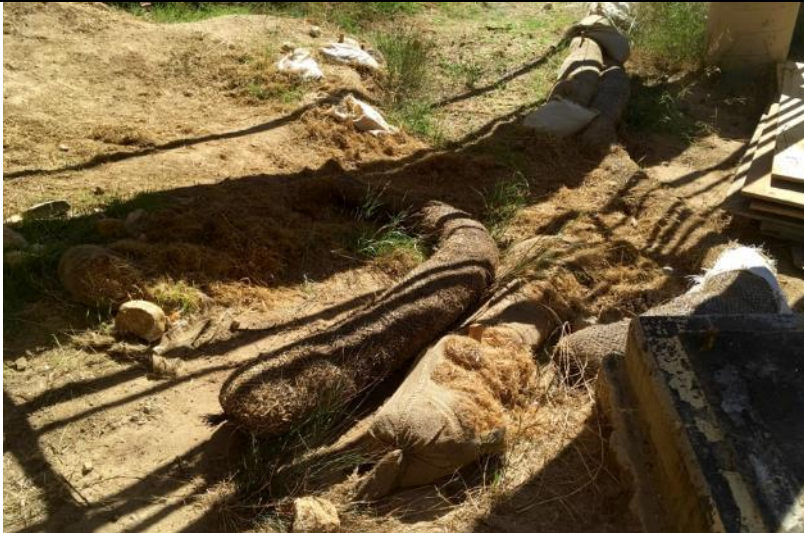
Photo 13 – BMPs in need of maintenance/ replacement.

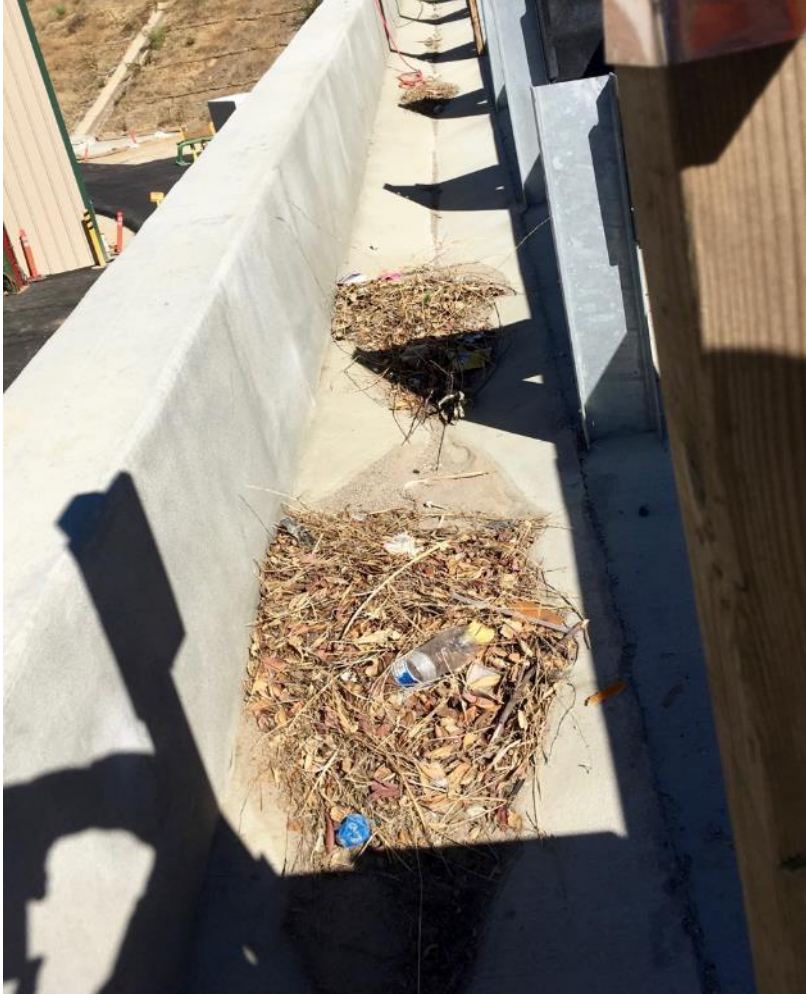
Photo 14 – Drainage ditch with sediment, debris, and trash.
11/11/16	New Admin/IM Building

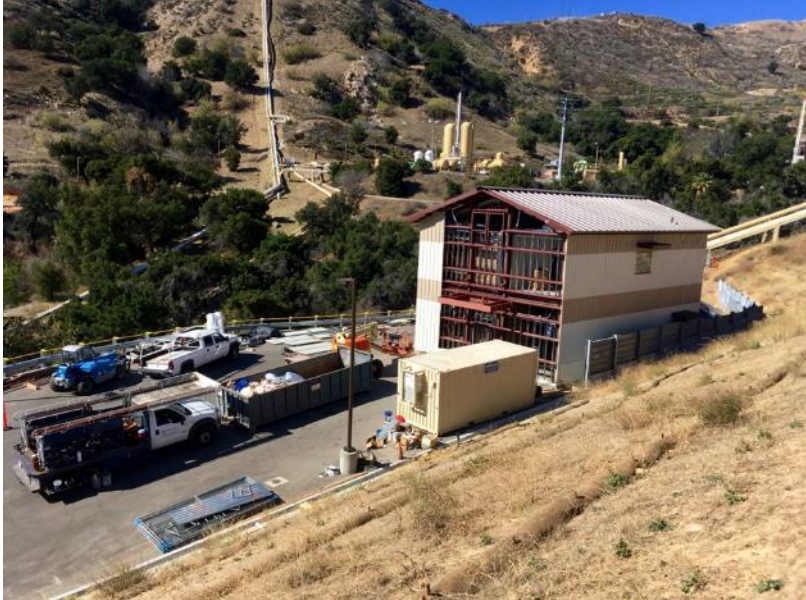
Photo 15 – Overview of the lower building.

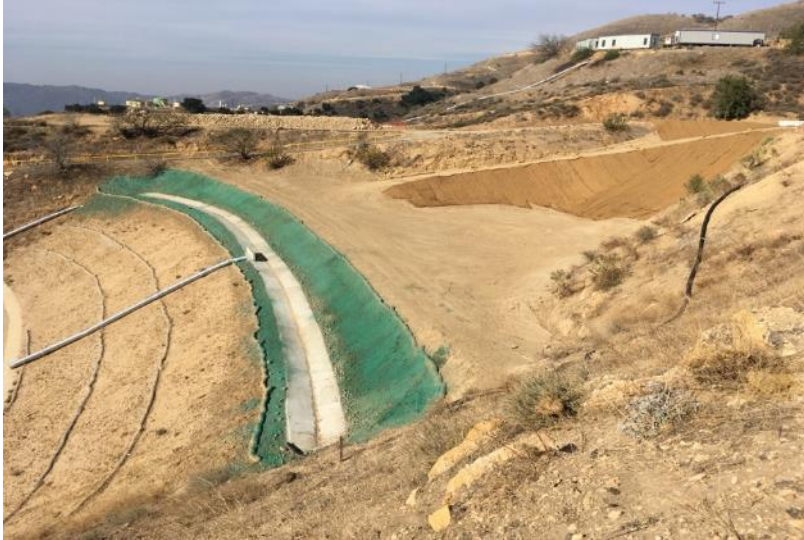
Photo 1 – Hydroseeding of the last “V” ditch at the PS-42 Fill Site.
11/16/16	PS-42 Well Pad

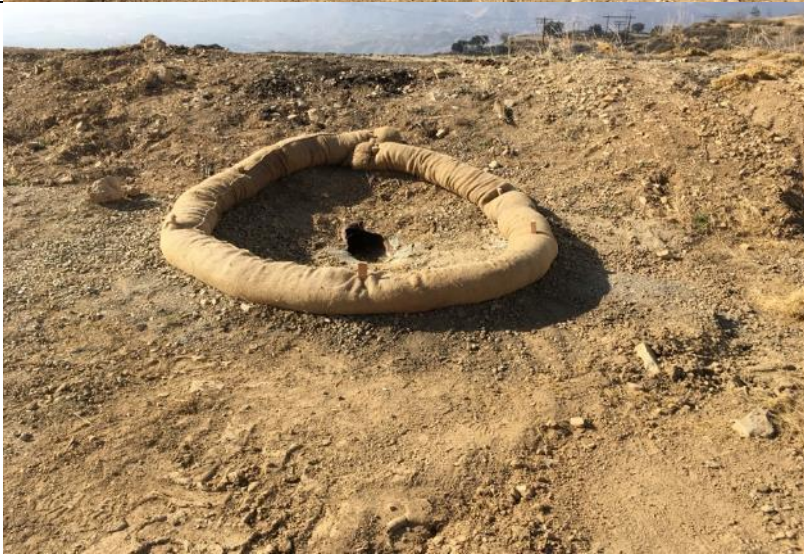
Photo 2 – New BMPs have been installed around the drain inlets.
11/16/16	Limekiln Creek (Upper Sedimentation Basin/Newt Pond)

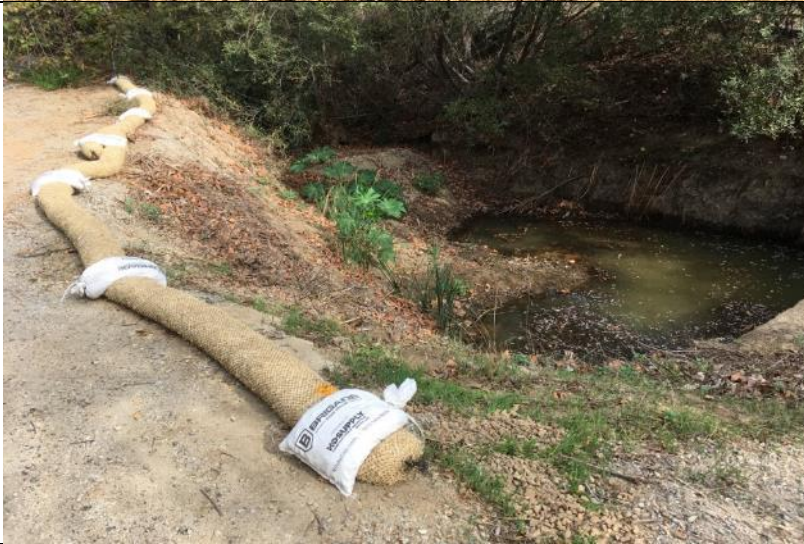
Photo 3 – Some water has now ponded in the lower sedimentation basin/new pond; new BMPs have been installed.

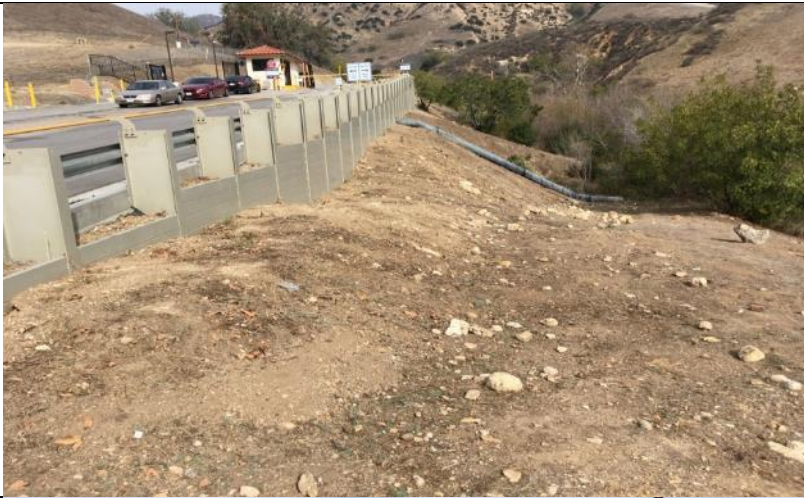
Photo 4 – Russian thistle and castor bean have been removed.
11/16/16	CCS	 	Photo 5 – Crews are installing new BMPs around the facility.
