Re: Monthly Report Summary #36 for Aliso Canyon Turbine Replacement Project

CPUC Site Inspection Report
March 23 and April 24, 2017

Aliso Canyon Turbine Replacement Project CPUC Site Inspection Form

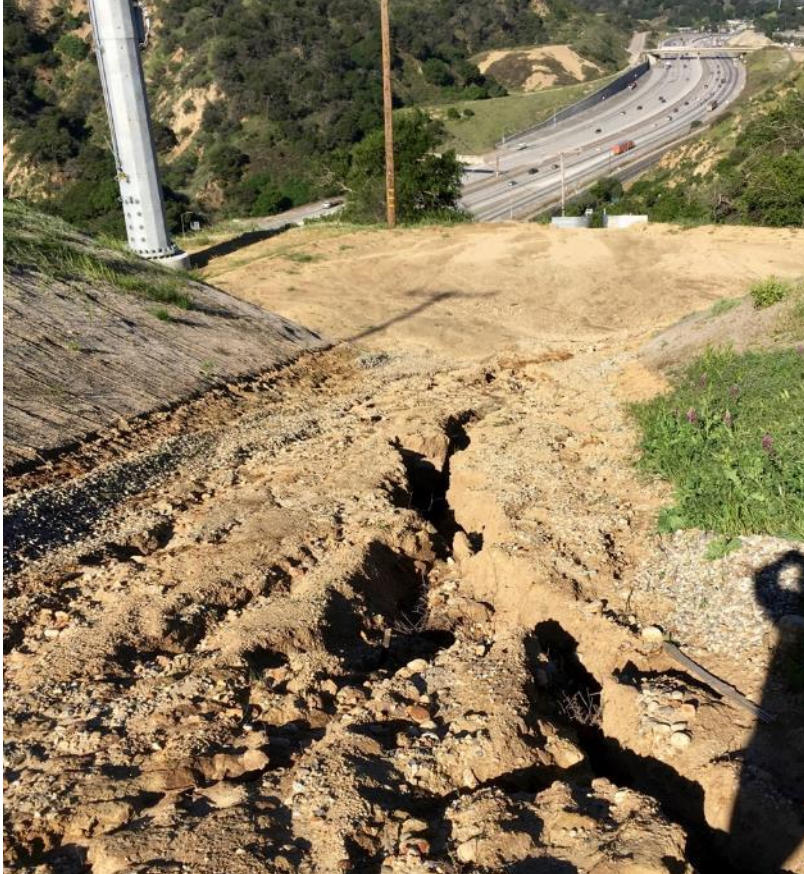
I stopped at the SCE Project area along Highway 5 in the morning, beginning with TSP 32. The short access road to the pole site had extensive erosion, and I observed an approximately 2.5-foot-deep rill in the middle of the road (Photo 1). Sediment from the access road's erosion appeared to have been deposited onto the TSP pad, and the rainwater runoff had flowed offsite via the McCarthy drain. The restored cut banks looked stable and had good vegetation growth with very few weeds. From this vantage point I used 10x40 binoculars to scan TSPs 39, 40, and 41 and the adjacent access road. I did not observe any obvious erosion problems.

Photo 1 – Erosion rills on the access road to the TSP pad.
3/23/17	Culverts under the TSP 24/25 Access Road

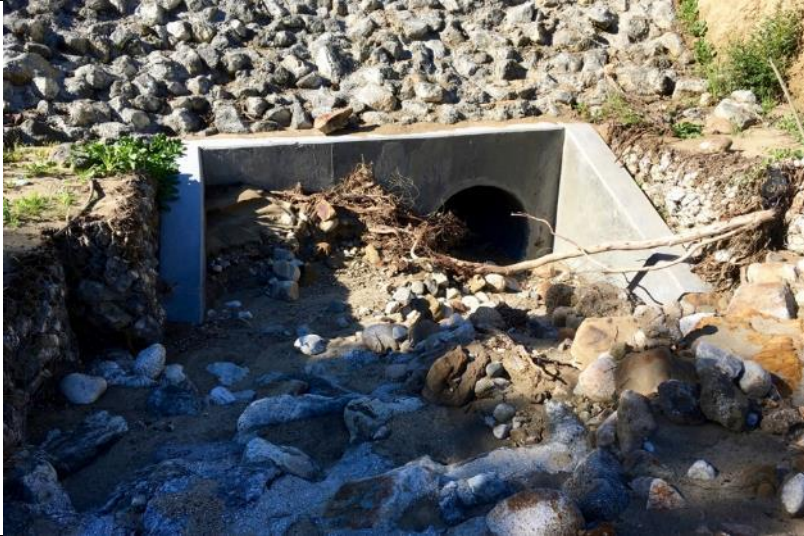
I hiked into the drainage between TSPs 24 and 25. One of the new culverts was completely blocked by rock and debris (Photo 2). Willow cuttings planted within the drainage above the culverts appeared to be doing well and showed extensive amounts of new growth (Photo 3). There was significant erosion along the Hilfiker wall, but it was not affecting the access road (Photo 4). The steep section of the access road heading up to TSP 25 was blocked by a number of fallen branches and downed trees. This road also had a large erosion rill that made it impassible (Photo 5).

Photo 2 – One of the two culverts is blocked by rock and debris.

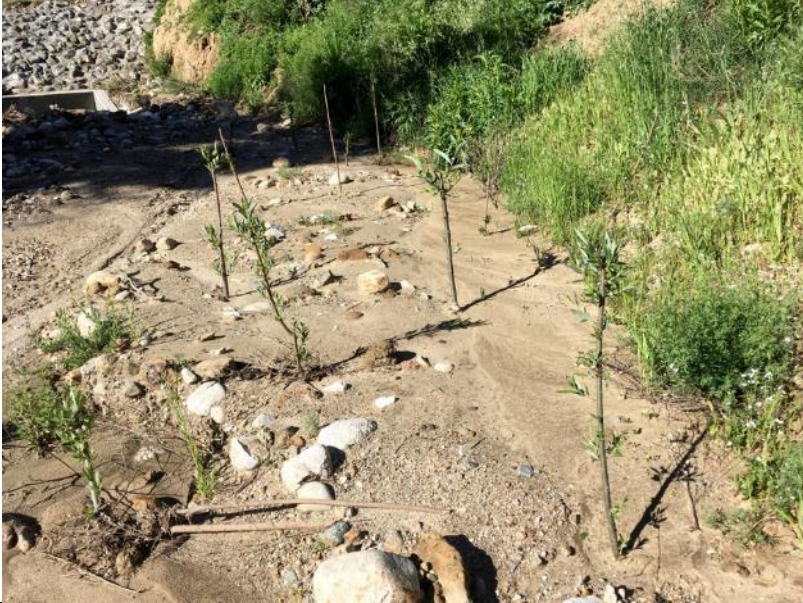
Photo 3 – Willow cuttings planted within the drainage are doing well.
3/23/17	TSP 24/25 Access Road

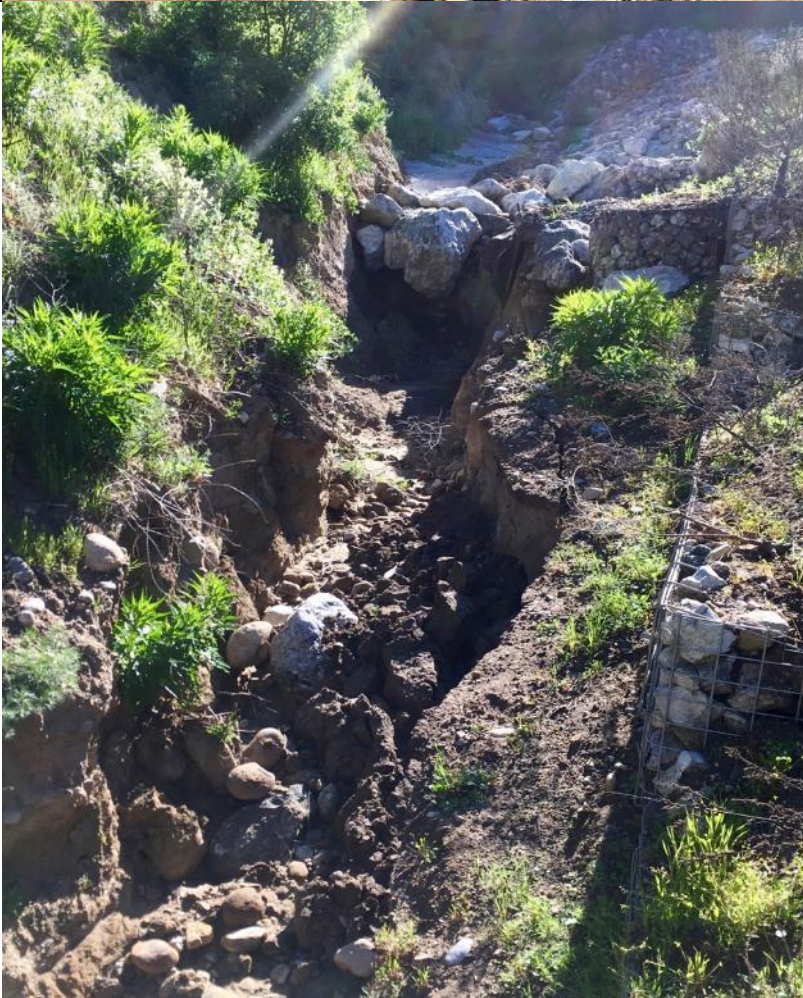
Photo 4 – Erosion along the Hilfiker wall.

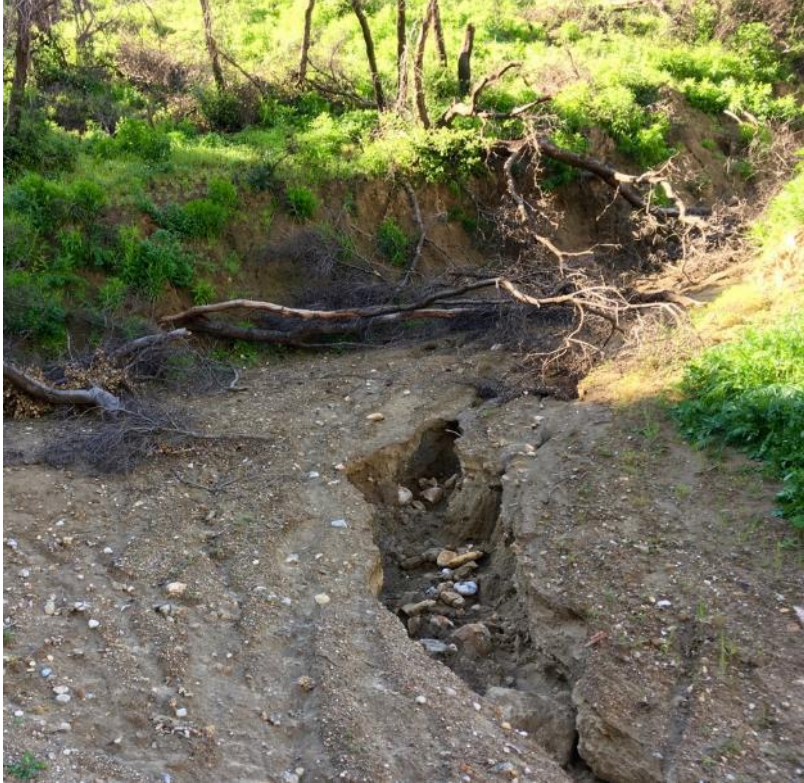
Photo 5 – Downed trees and erosion rills are blocking the access road.
3/23/17	PS-42 Fill Site

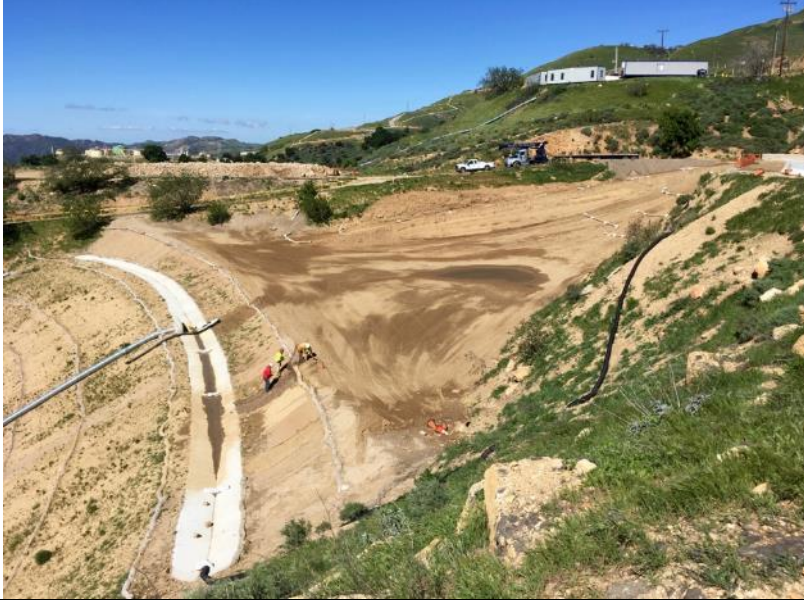
At the PS-42 Fill Site, a small crew was repairing BMPs (Photo 6). Crews were regrading the PS-42 Well Pad, located above the PS-42 Fill Site, to redirect rainwater runoff into the existing drainage system (Photo 7).

Photo 6 – Minor repairs to the site BMPs were being conducted.

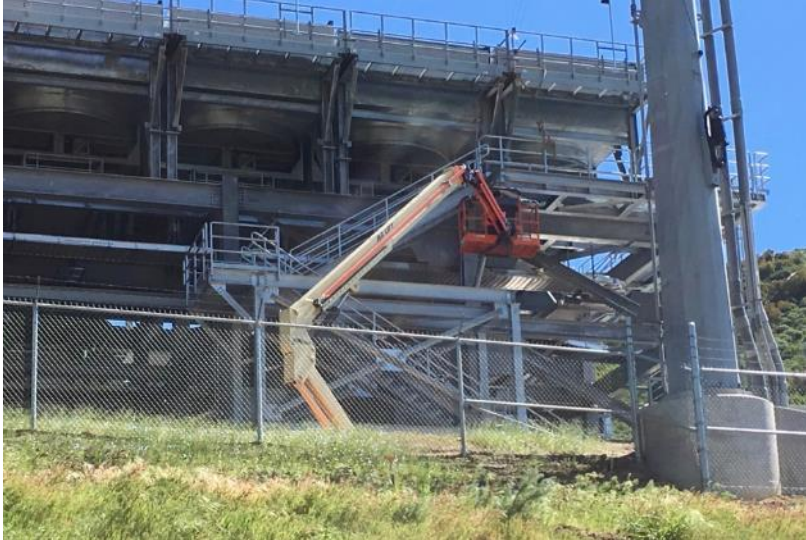
Photo 10 – Ongoing work at the CCS.
3/23/17	Limekiln Creek

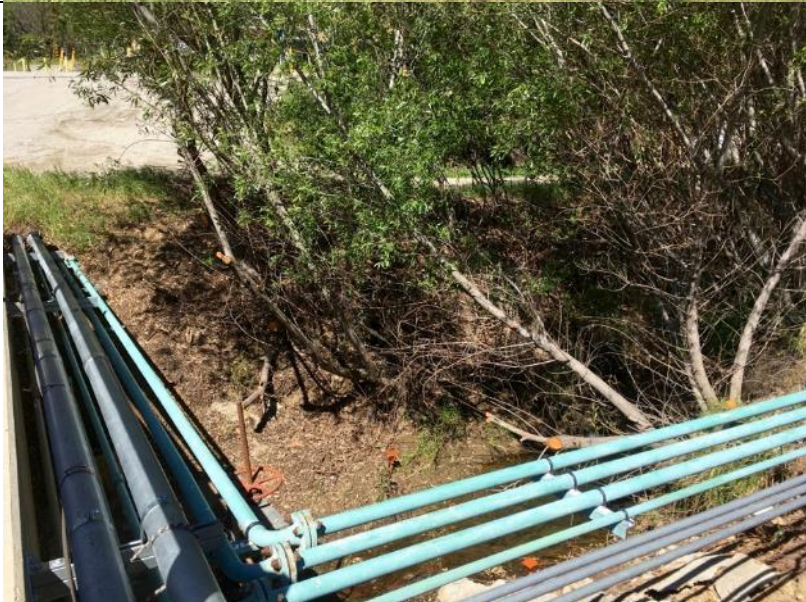
I noted that vegetation was pruned from within Limekiln Creek and was removed from both sides of the bridge (Photo 11).

Photo 11 – Some willow pruning has been conducted on both sides of the bridge crossing Limekiln Creek.

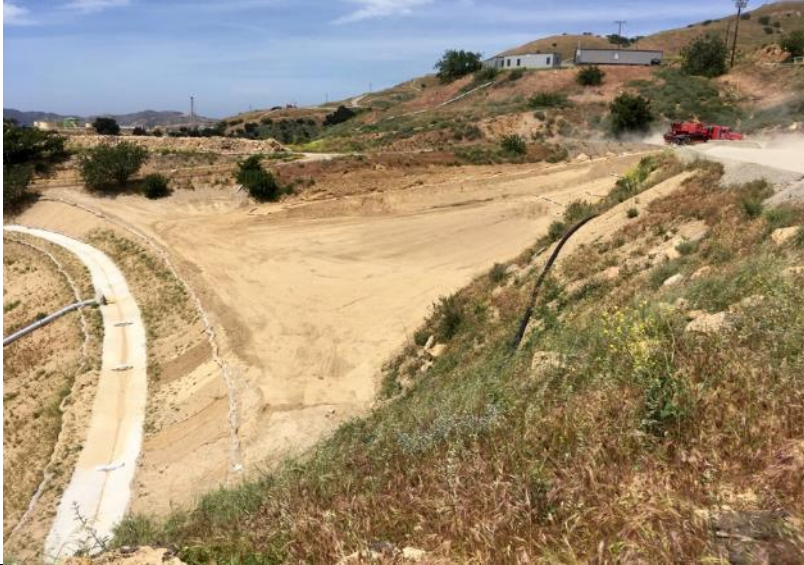
No work was being conducted at the PS-42 Fill Site. Soil import was nearly complete; however, final restoration remained to be completed (Photo 1). A segment of old straw wattle was caught on one of the drain pipe stakes just west of the PS-42 Fill Site. I noted a number of old wattles along the paved access road that runs around the PS-42 Fill Site, and it appeared that the wattle caught on the drain pipe originated from this location. These wattles are old and without an adequate amount of straw remaining in them, thereby leaving exposed plastic that can trap animals. I spoke with SCG's biological monitor Ray Romero (AECOM) about this issue and also sent a text to Derek Rodgers (SCG); they indicated that the wattles would be removed.

Photo 1 – No work at the PS-42 Fill Site; final restoration remains to be completed.
4/24/17	PS-42 Well Pad

Bird nesting season is upon us; surveys and oversight need to be verified.
Removal of all the old plastic covered straw wattles is recommended.

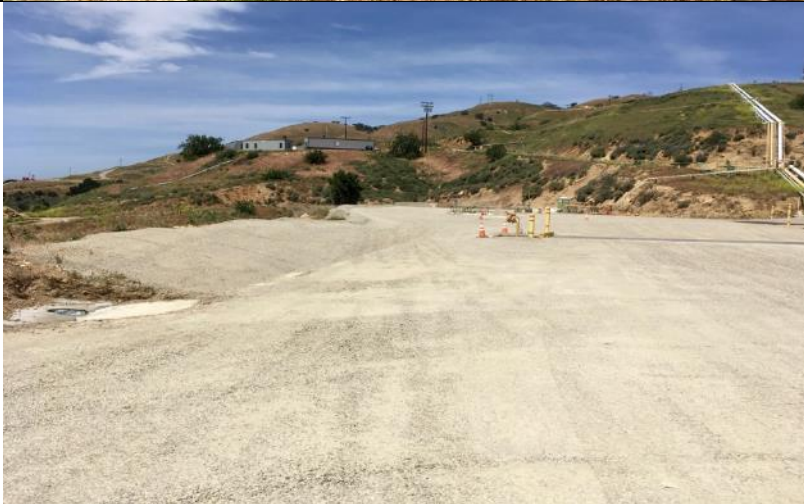
The PS-42 Well Pad above the PS-42 Fill Site had been regraded and was covered in road base (Photo 2). The PS-42 Well Pad drainage was in good condition, and the road base will reduce the sediment loads from any future rainwater runoff.

Photo 2 – Work on the PS-42 Well Pad appears to have been completed, with road base laid down on the pad.
4/24/17	Natural Substation

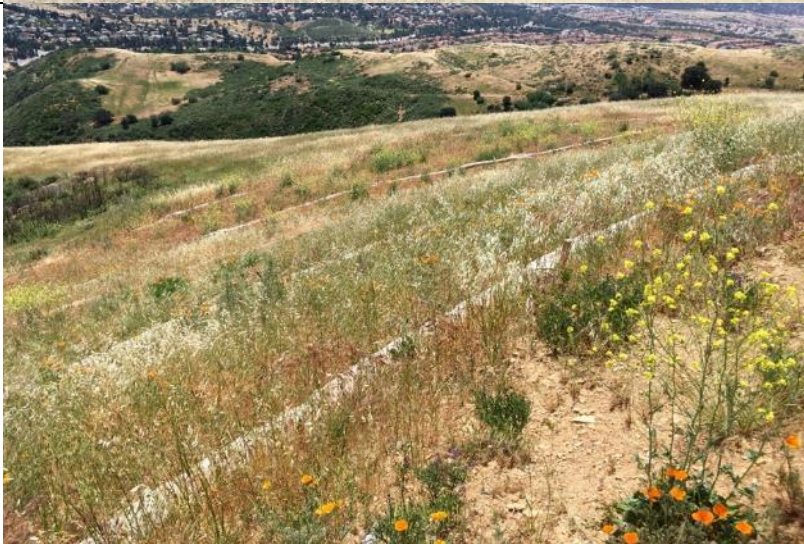
Photo 3 shows the vegetation growth on the slope below the Natural Substation. This area had burned last year, but has recovered with extensive vegetation and very few weeds.

Photo 3 – Slope below (south of) the Natural Substation appears to be stable with excellent vegetation growth and minimal weeds. This area had burned last year.

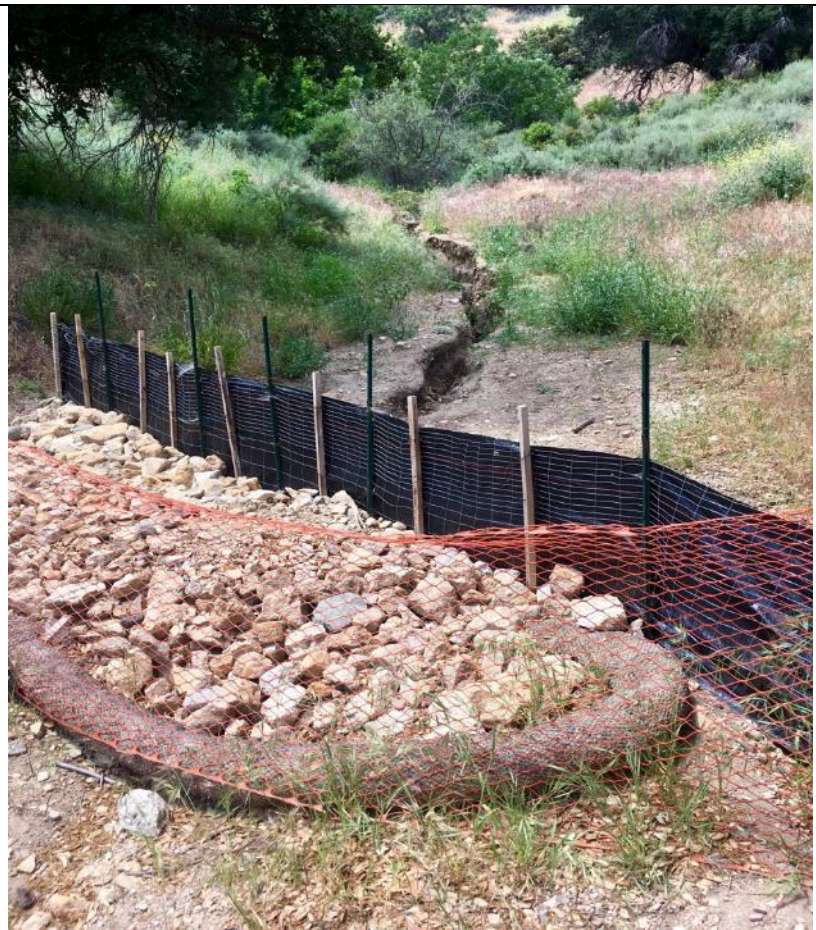
The diversion fence near the A2 access road was in place and appeared to be in good condition (Photo 6). The erosion rills above and below the fence remained and appeared stable.

Photo 6 – Diversion fence within the oak swale drainage appears to be in good condition. No work has been done on the erosion rills.
4/24/17	A2 Pole Site

Check the A2 access road work and keep track of the oak swale erosion repairs.

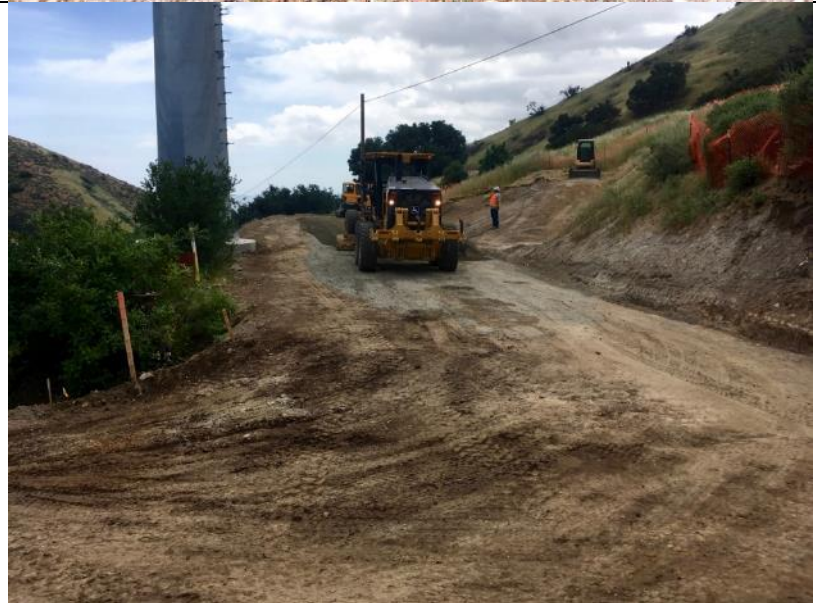
Work was being conducted on the 12-kV/TSP A2 access road (A2 access road), and water trucks were onsite to help with compaction and dust suppression (Photo 5). The road had been graded, and a crew was bringing in road base in preparation for paving (Photo 7). SCG's avian biologist (Wayne Woodroof) was onsite and monitoring the nearby nesting birds. SCG's arborist (Ann Boroughs) was also onsite to check the work around the oak trees.

Photo 7 – Road base being brought to the TSP pad.
