Re: Monthly Report Summary #39 for Aliso Canyon Turbine Replacement Project

CPUC Site Inspection Report
February 21, 2018

Aliso Canyon Turbine Replacement Project CPUC Site Inspection Form

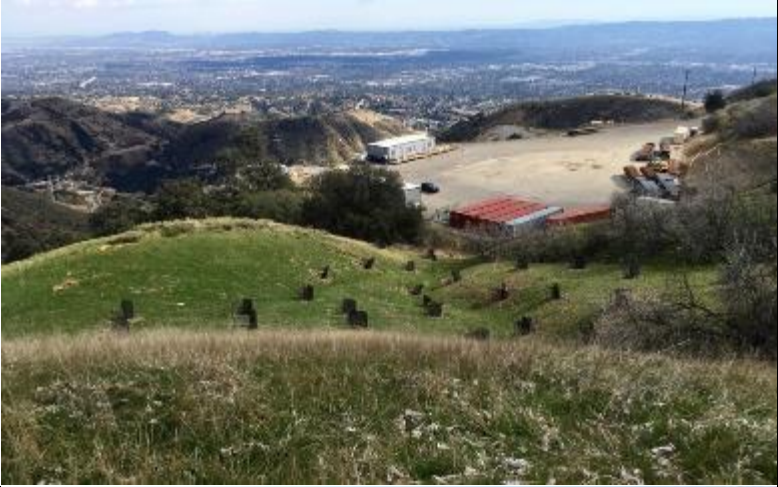
We drove to the Oak Tree Mitigation Site, noting that the trees looked healthy and well maintained – Photo 1.

Photo 1 – The oak trees appear healthy; the area has been mowed and the cages are in good repair.
2/21/18	PS-42 Fill Site

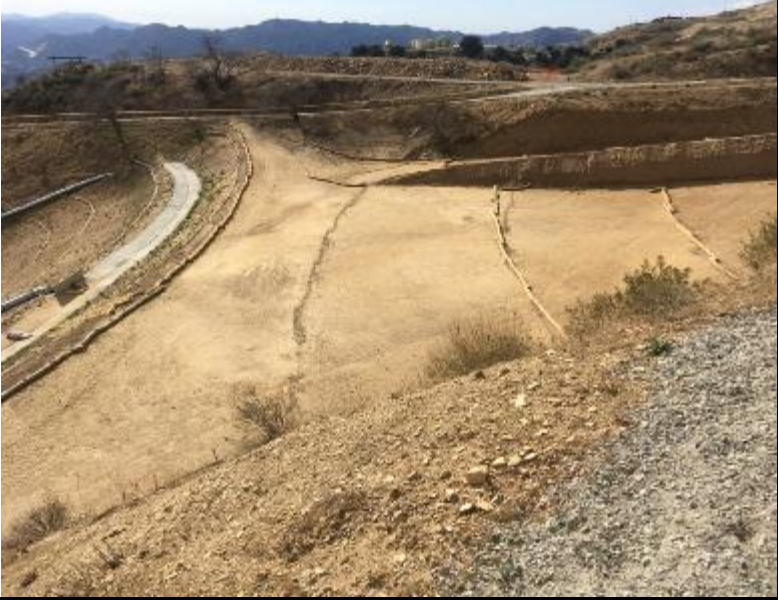
Coming back down the hill, we stopped at the PS-42 Fill Site. The site looked stable and had numerous native seedlings coming in on the slope; however, the top portion of the site was devoid of vegetation – Photo 2.

Photo 2 – The PS-42 Fill Site is stable and well maintained.

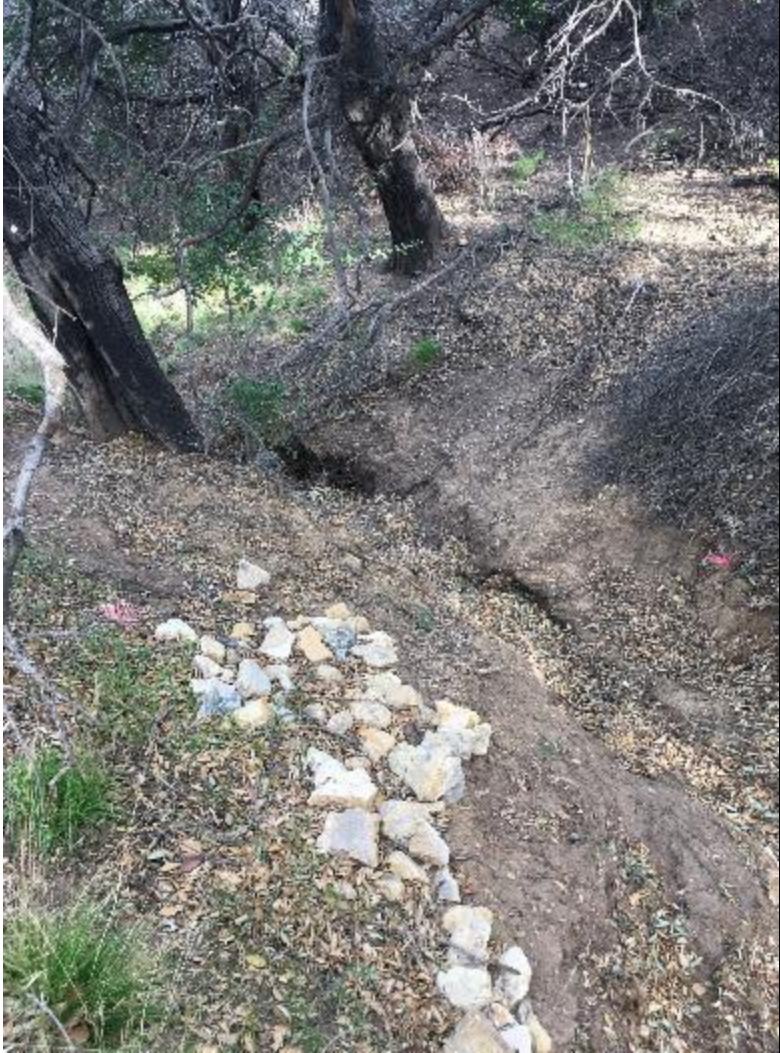
The access road to the Natural Substation looked stable and well vegetated. The upper portion of the oak swale near the Natural Substation had most of its temporary erosion control measures damaged or compromised in some way – Photos 3 and 4.

Photo 4 – A deteriorated coconut blanket and rocks have been washed away.
2/21/18	A2 Tubular Steel Pole and Access Road

Check the oak swale erosion repairs.

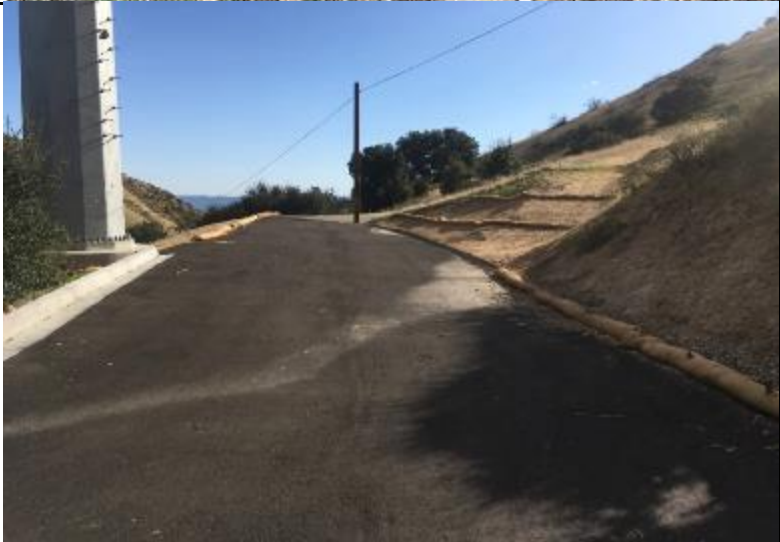
The 12-kV/TSP A2 access road (A2 access road) and disturbed area around the A2 TSP site appeared to be stable, with best management practices (BMPs) in place and vegetation being reestablished – Photo 5. The lower portion of the oak tree swale near the A2 access road appeared unchanged, with fairly deep (5 foot) erosion gullies remaining both above and below the access road – Photos 6, 7, and 8.

Photo 5 – Paving and BMPs are in place.

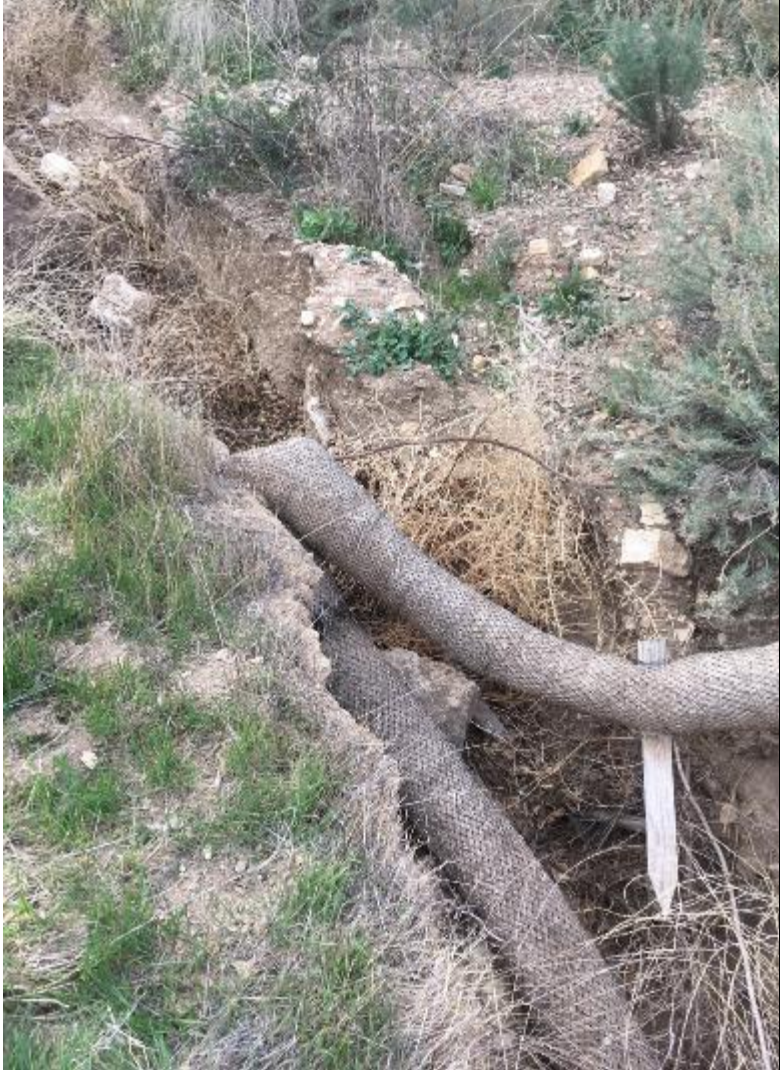
Photo 7 – Erosion upstream of the access road.

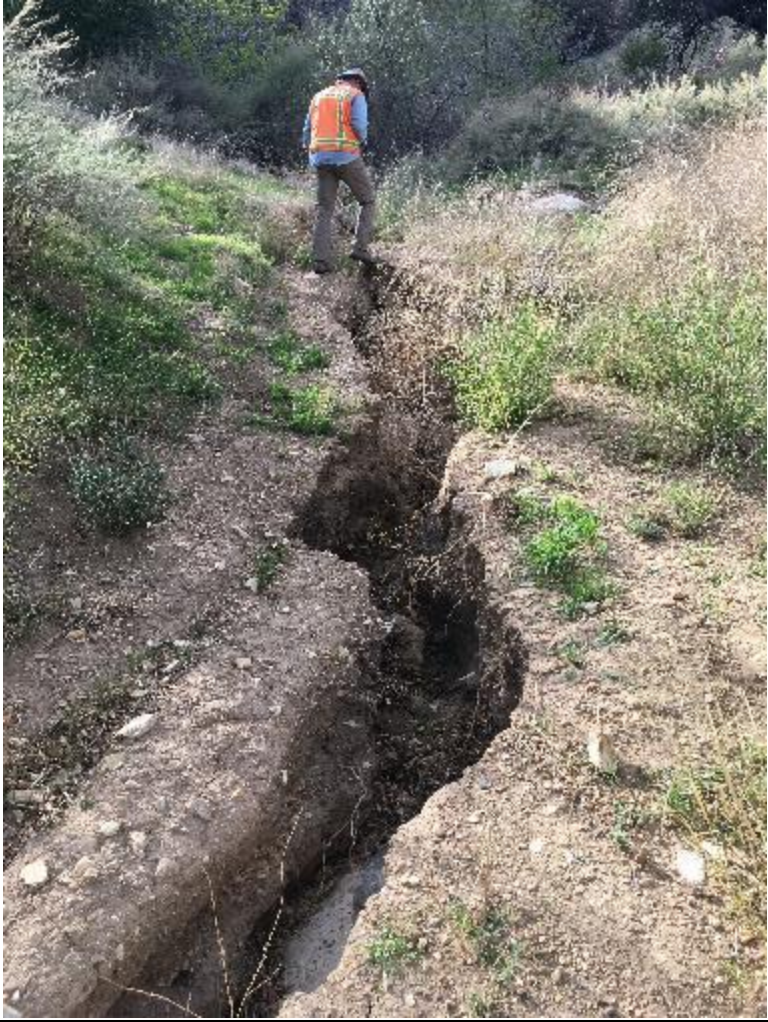
Photo 8 – Large erosion gully.
