Re: Monthly Report Summary #16 for Aliso Canyon Turbine Replacement Project

Aliso Canyon Turbine Replacement Project CPUC Site Inspection Form

| Project: | Aliso Canyon Turbine Replacement | Date: | July 2, 2015 |

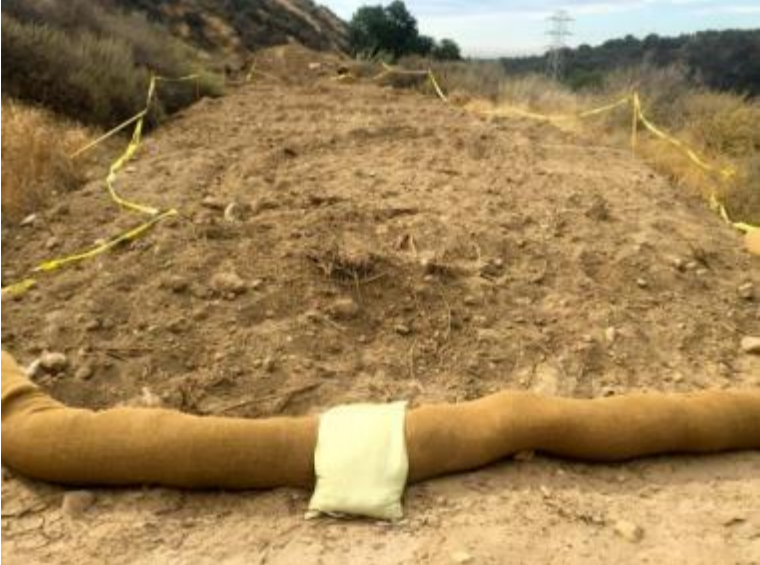
| Date | Location | Photo | Description |
|---|---|--|--|
| 7/02/15 | TSP 30 | | Stockpiled topsoil. |

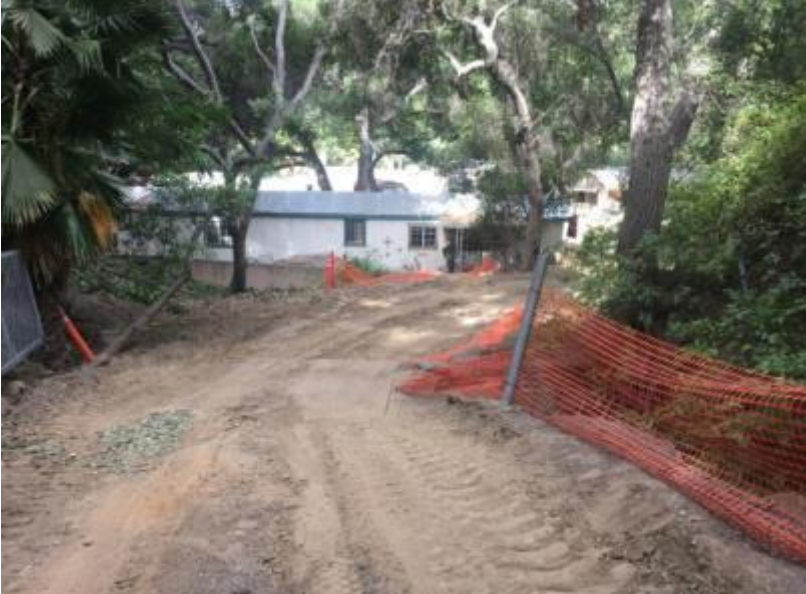
At TSP 24, the new pole was being installed and very little grading was needed at this site; however, access was difficult due to the steep, twisting access road. The jurisdictional drainage near Crescent Valley Mobile Estates (Estates) was checked – see photo. No work was taking place there. The burnt watershed will complicate runoff into this drainage once rain falls again.

| Date | Location | Photo | Description |
|---|---|--|--|
| 7/02/15 | TSP 24 access road | | Jurisdictional drainage near Crescent Valley Mobile Estates. |

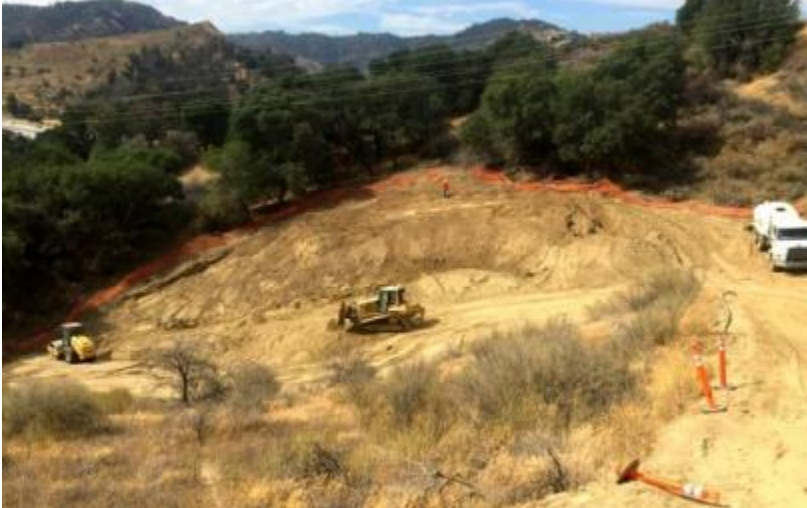
| Date | Location | Photo | Description |
|---|---|---|--|
| 7/02/15 | TSP 21 | | Grading continues for the TSP 21 pull site. |

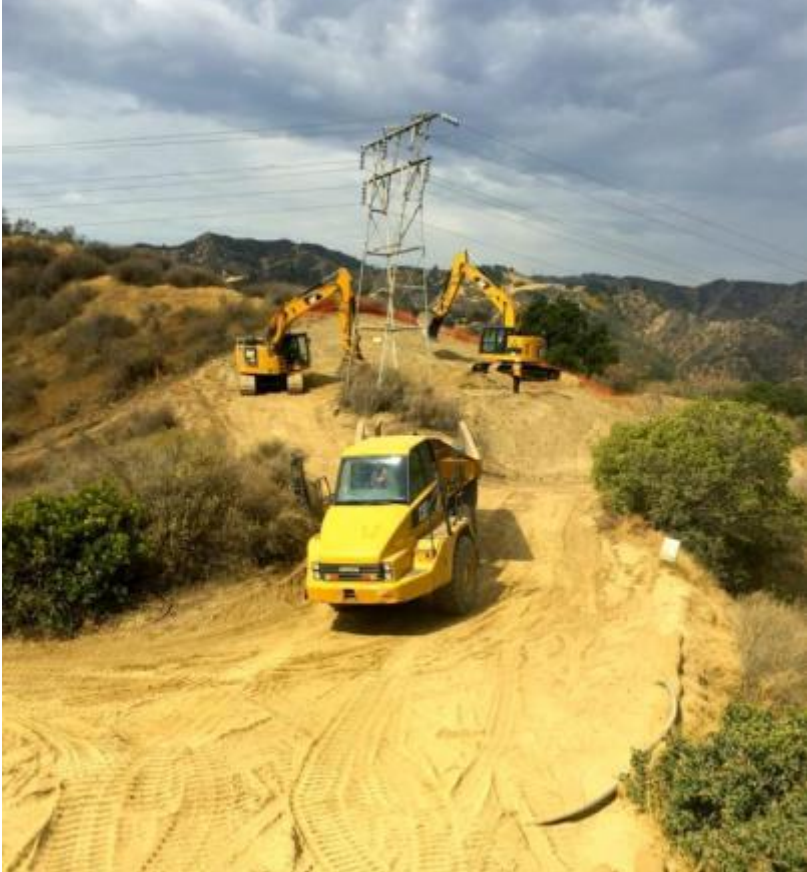
| Date | Location | Photo | Description |
|---|---|---|--|
| 7/02/15 | TSP 21 | | TSP 21 excavation work continues. Topsoil has been removed and stockpiled at TSP 15; excess spoil is being hauled off. |

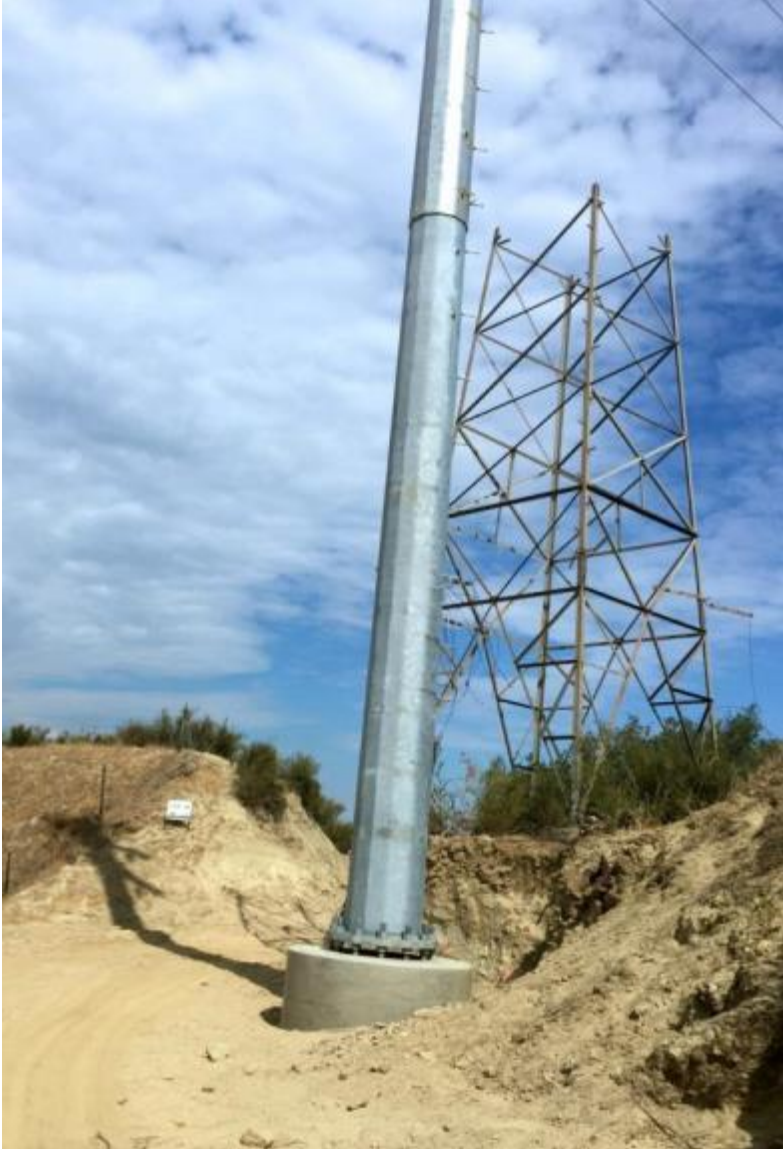
The TSP 18 site was ready for drilling, with the drill rig parked onsite. Topsoil has been restored on the cut banks, with the addition of some BMP materials – see photo. The new TSP 14 pole has been installed, wires have been relocated, and some of the old tower has been removed. TSP 13 is partially complete, and the TSP 12 foundation has been installed – see photos. The small eroded area along the access road to TSP 12 has been repaired – see photo. The access road from TSP 14 to TSP 12 was in immediate need of watering to settle the dust.

| Date | Location | Photo | Description |
|---|---|---|---|
| 7/02/15 | TSP 14 | | The new pole has been installed, wires have been transferred, and a portion of the old lattice work tower has been removed. |

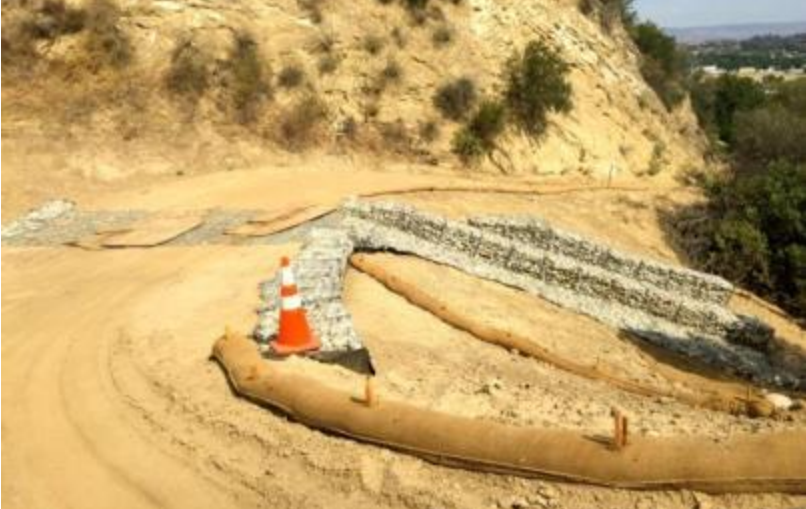
| Date | Location | Photo | Description |
|---|---|--|---|
| 7/02/15 | Access road to TSP 12 | | Road stabilization work has been completed. |

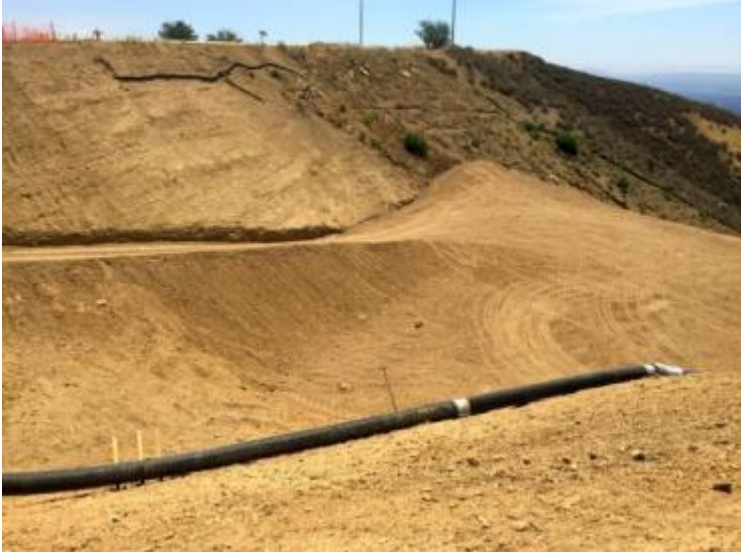
| Date | Location | Photo | Description |
|---|---|--|---|
| 7/02/15 | PS-42 Fill Site | | Work to seal up the fill site continues, with hydroseeding expected in the next few days. |

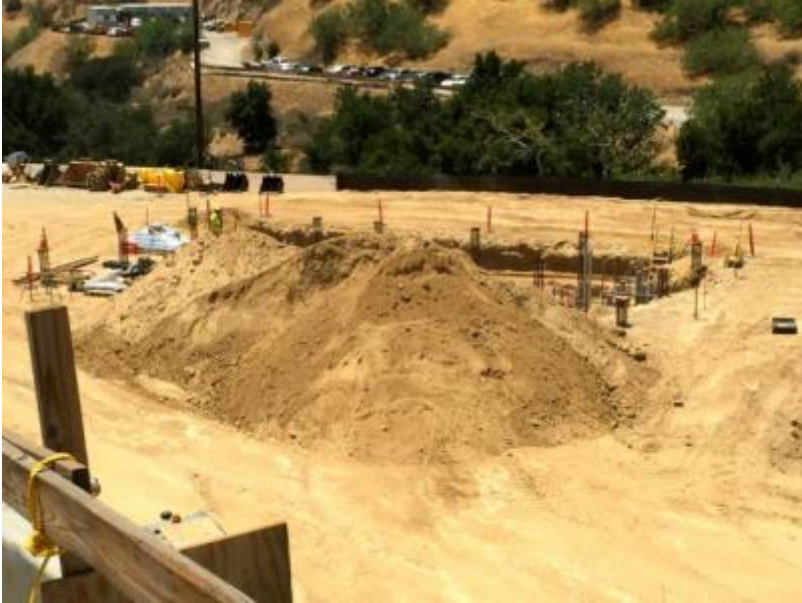
At the CCS, crews continue to work on the foundations and conduit throughout the site – see photos. At the time of the site visit, crews were pouring slurry into the excavated area. A small amount of earthwork was being completed at the Guard House. This activity was being monitored by biological monitor Anna Lohr – see photo.

| Date | Location | Photo | Description |
|---|---|---|---|
| 7/02/15 | CCS | | Excavated area with slurry being poured. |

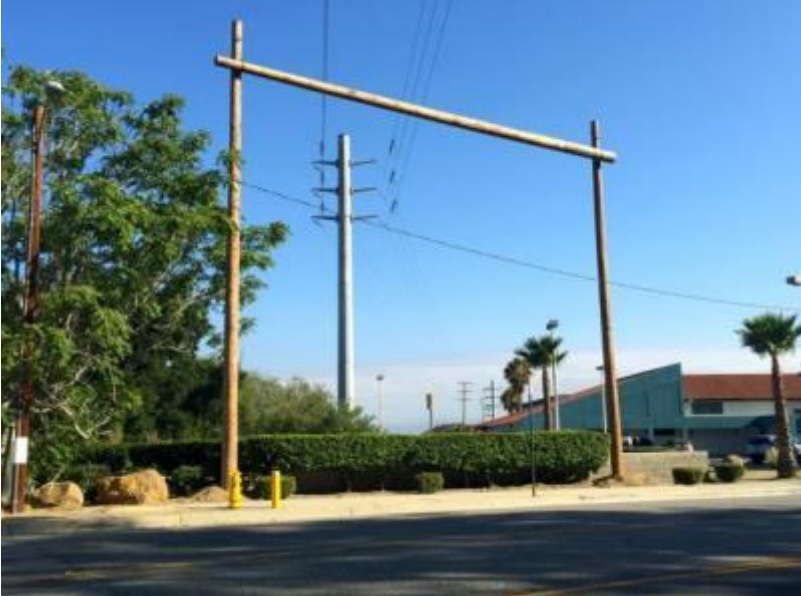
| Date | Location | Photo | Description |
|---|---|--|---|
| 7/10/15 | TSP 11 | | Temporary poles prevent wires from falling onto the road. |

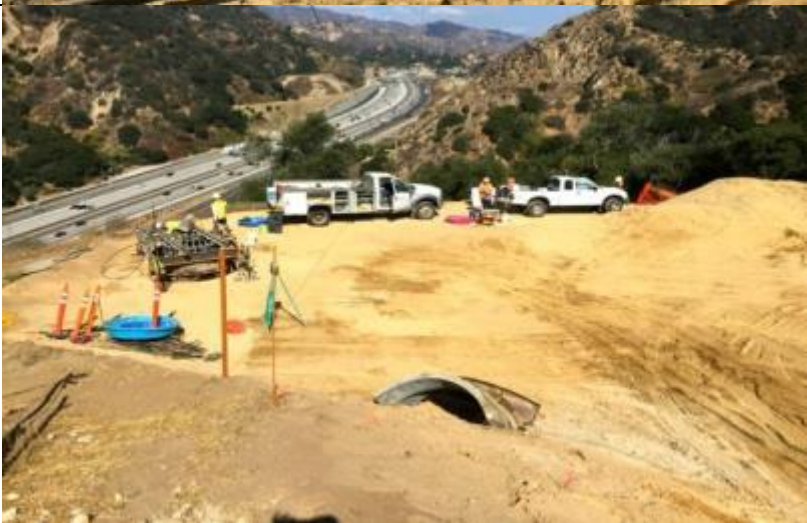
At TSP 32, the site had been drilled, the cage had been set, and the crew was pouring the foundation while I was onsite - see photo. The excess spoil had been hauled off and a fire crew was onsite.

| 7/10/15 | TSP 32 | | The site has been drilled and concrete trucks are coming in to pour the foundation. |

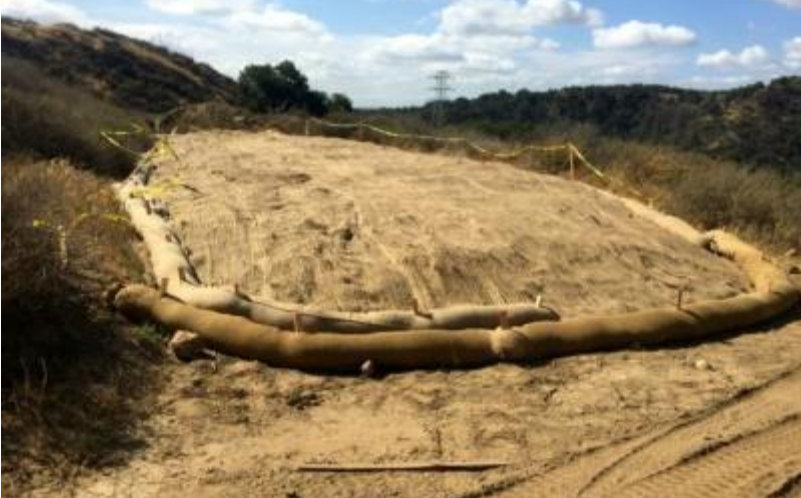
| <p>7/10/15</p> | <p>TSP 30</p> | | <p>Stockpiled topsoil has been covered with jute netting.</p> |

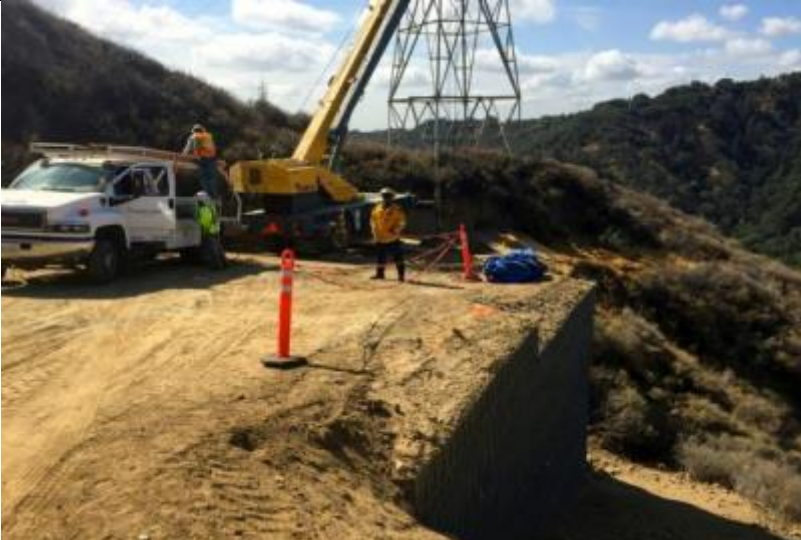
At TSP 30 the Hillfiker wall had been finished and the foundation hole had been drilled – see photo. A crew was setting the rebar cage, with the concrete to be poured soon. The topsoil piled had been covered with jute netting.

| <p>7/10/15</p> | <p>TSP 30</p> | | <p>Hillfiker wall was finished and the hole has been drilled. Crews are setting the rebar cage.</p> |

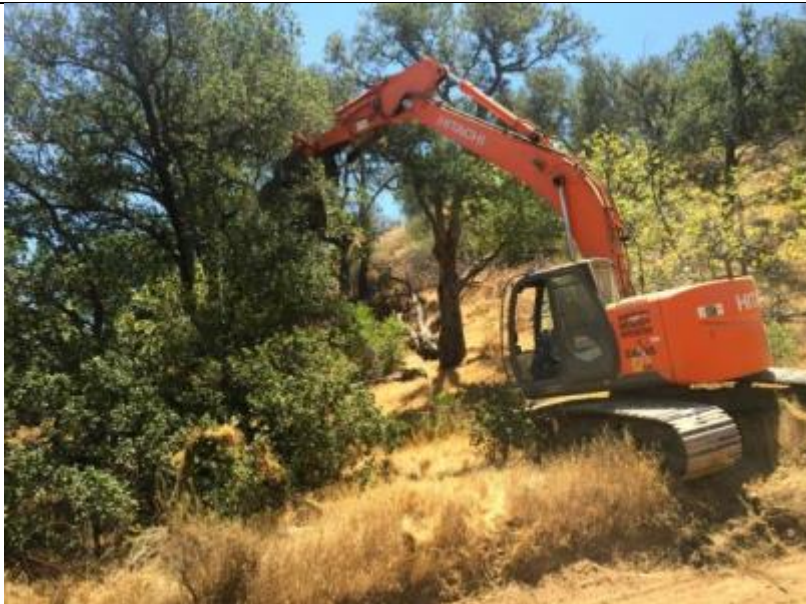
| <p>7/10/15</p> | <p>Access road between TSP 40 and TSP 42</p> | | <p>Excavator removing an oak tree.</p> |

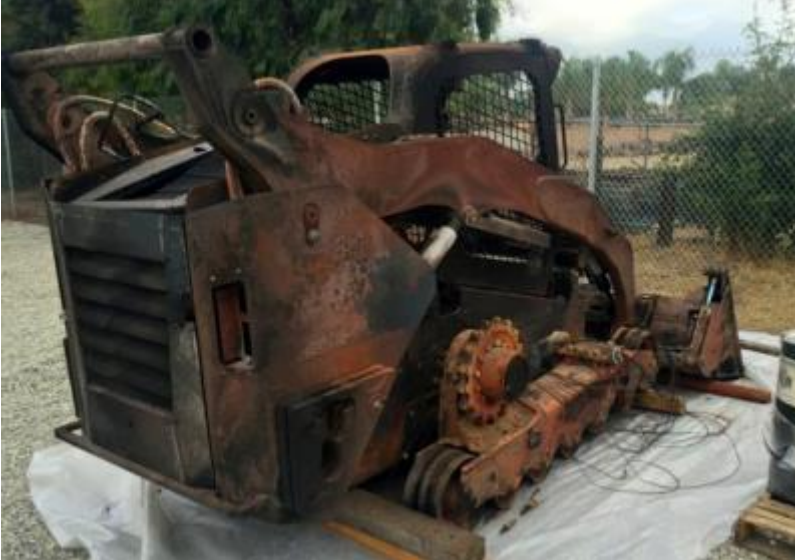
SCE has cleared, fenced, and laid gravel in the expanded 210 Freeway Yard. SCE is now using the site – see photo. The piece of equipment (a bobcat) that burned during the June fire is stored in the yard – see photo.

| Date | Location | Photo | Description |
|---|---|--|--|
| 7/15/15 | SCE 210 Freeway Yard | | <p>Equipment (bobcat) that was burned during in the June fire.</p> |

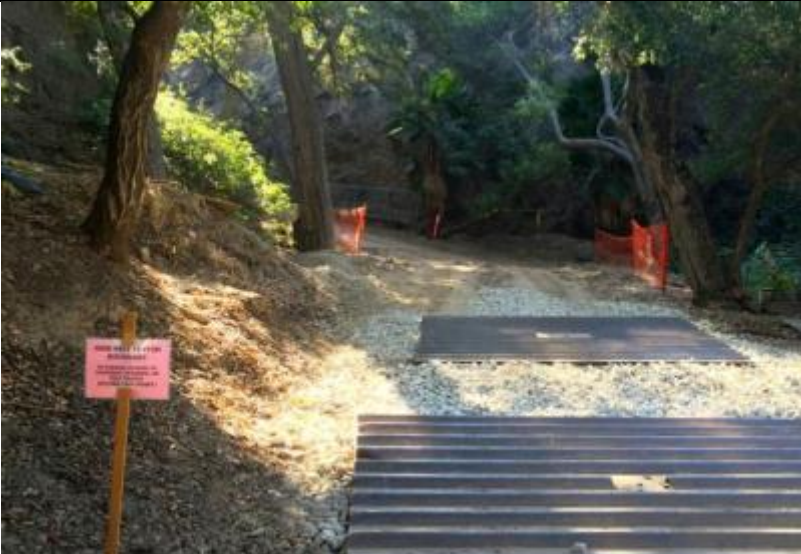
Drove to the access road for TSP 24/25 to look at the nest and nest buffer signs. Observed a pair of hooded orioles that have a nest in a palm tree located next to the road and approximately 20 feet from the Jurisdictional Drainage – see photo. According to biologist Shay Lawrey the birds are on eggs.

| Date | Location | Photo | Description |
|---|---|--|--|
| 7/15/15 | Access road to TSP 24 and TSP 25 | | Rumble plates and nest buffer at the entrance to the TSP 24 and TSP 25 access road. |

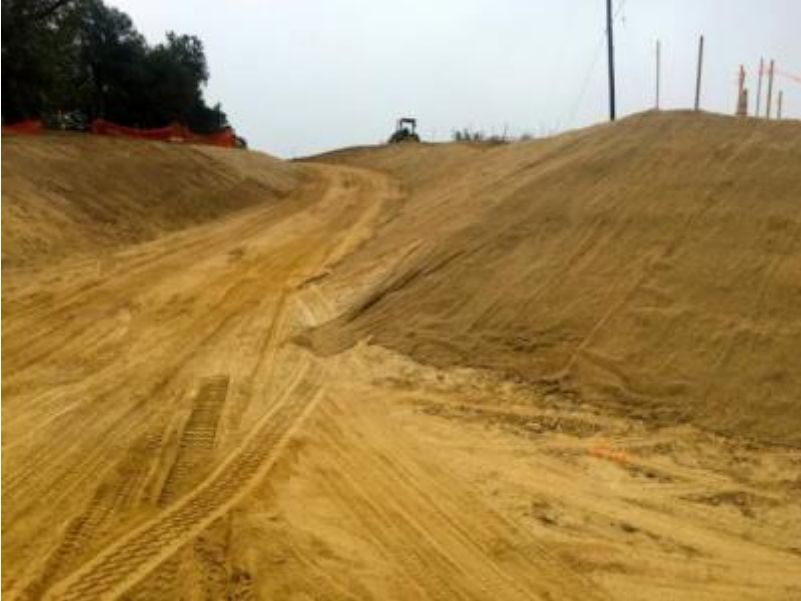
| Date | Location | Photo | Description |
|---|---|---|--|
| 7/23/15 | TSP 32 | | <p>Access road to the TSP 32 pad has had jute netting installed on one of the cut banks.</p> |

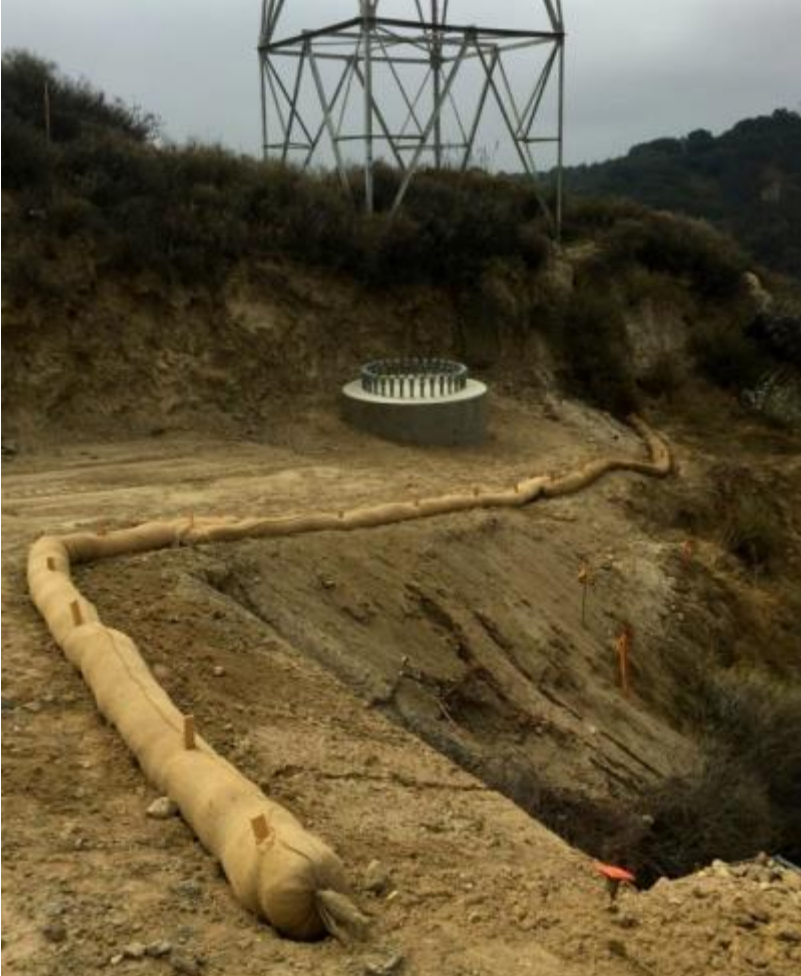
| Date | Location | Photo | Description |
|---|---|---|--|
| 7/23/15 | TSP 30 | | <p>The site is ready for the pole installation. Final restoration, including topsoil replacement, is still needed.</p> |

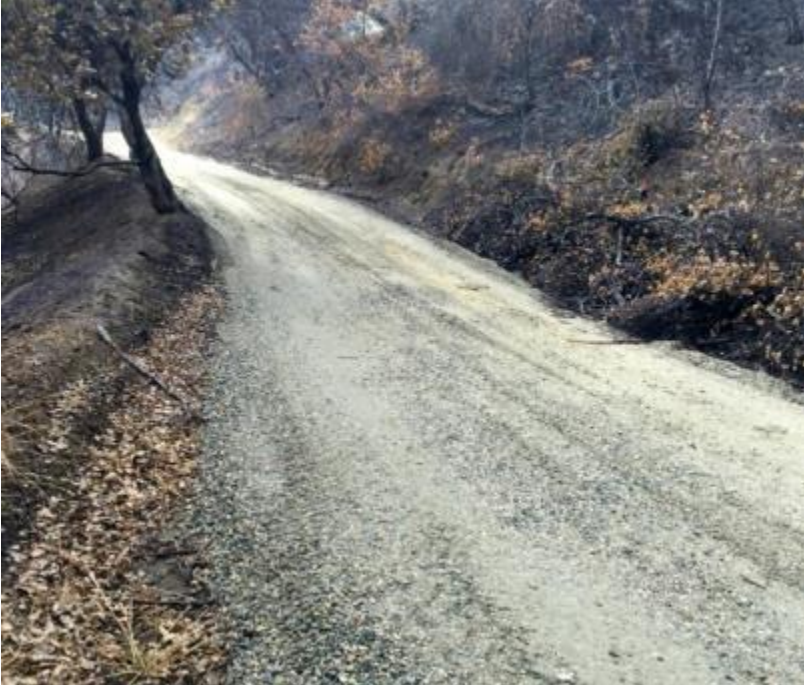
| Date | Location | Photo | Description |
|---|---|---|--|
| 7/23/15 | Access road to TSPs 24 and 25 | | Road base has been laid down on the access road to improve vehicle access and to prevent dust. |

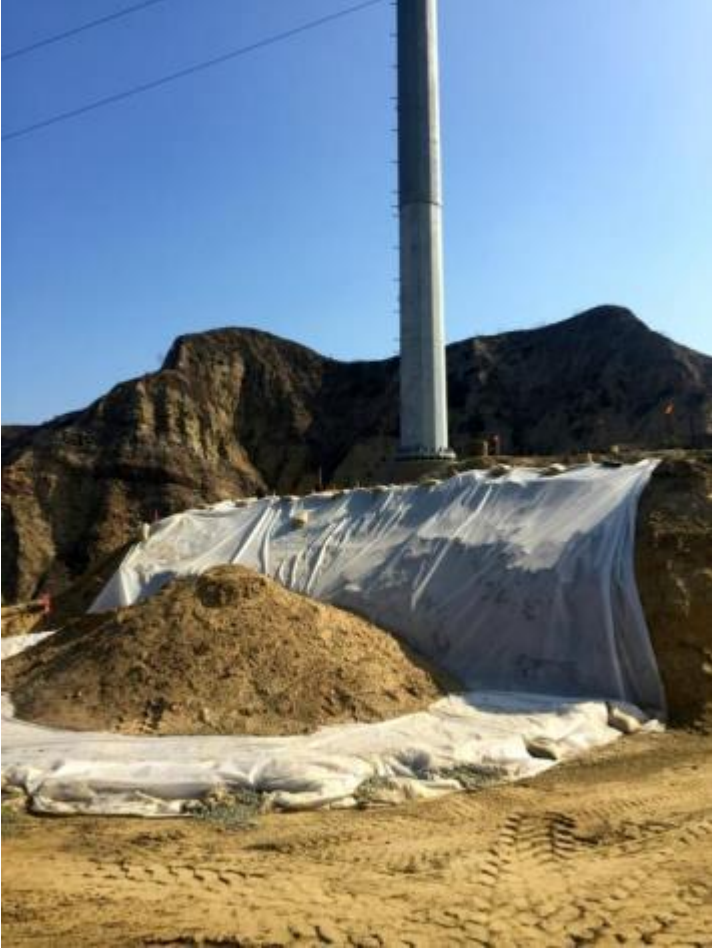
| Date | Location | Photo | Description |
|---|---|---|--|
| 7/23/15 | TSP 24 | | Some hydrocarbon contaminated soil was unearthed near TSP 24. The soil has been stockpiled on visqueen. The soil has been tested, and results will determine how the soil will be disposed of. |

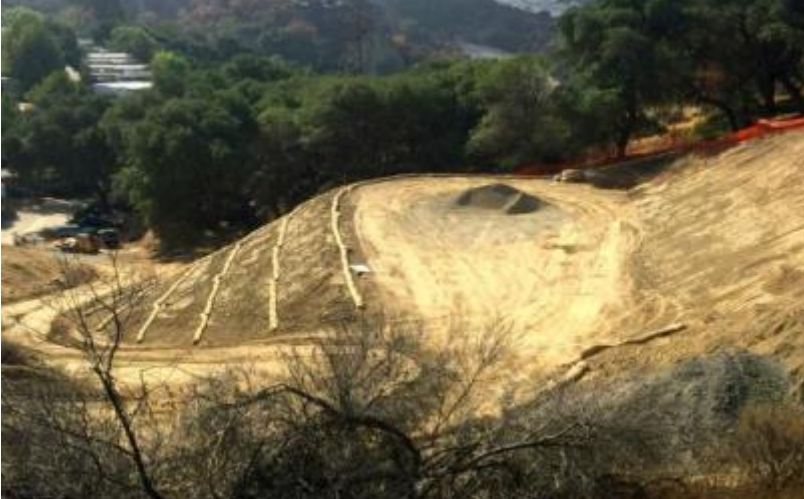
| Date | Location | Photo | Description |
|---|---|--|--|
| 7/23/15 | Pull site between TSP 22 and TSP 21 | | The grading for the pull site has been finished, with some of the BMP materials installed. Topsoil still needs to be returned to the slopes. |

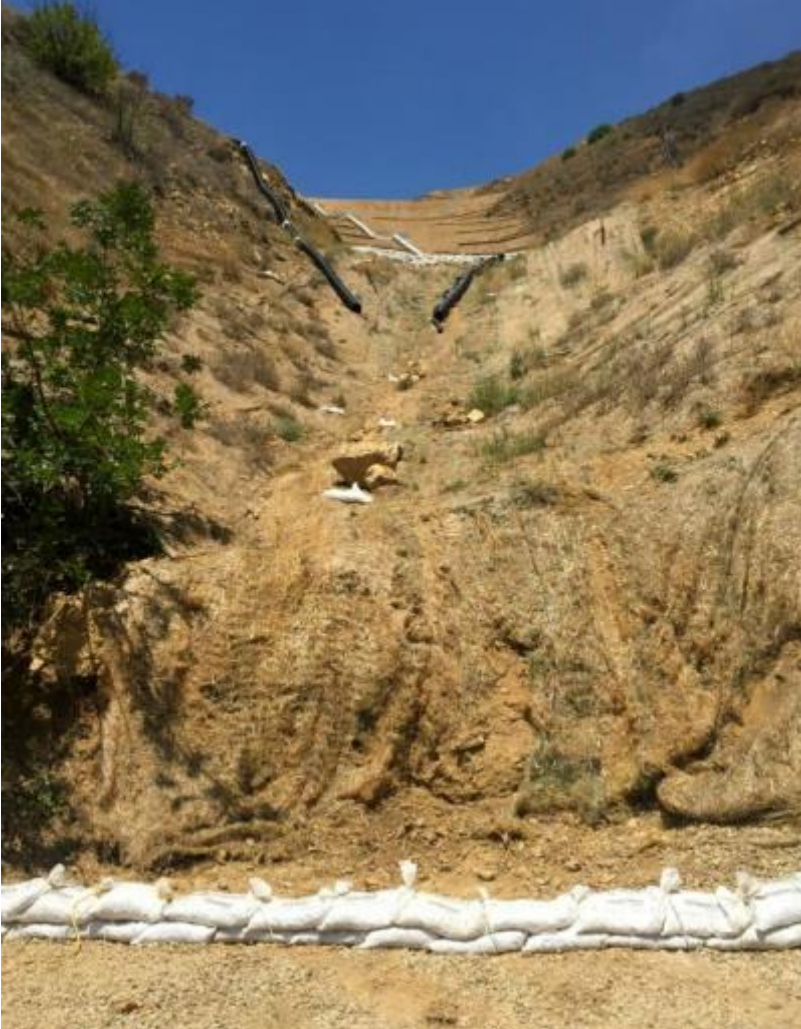
| Date | Location | Photo | Description |
|---|---|---|---|
| 7/23/15 | PS-42 Fill Site | | Lower portion of the fill site; some BMP materials were installed prior to the rain event that came through over the weekend. |

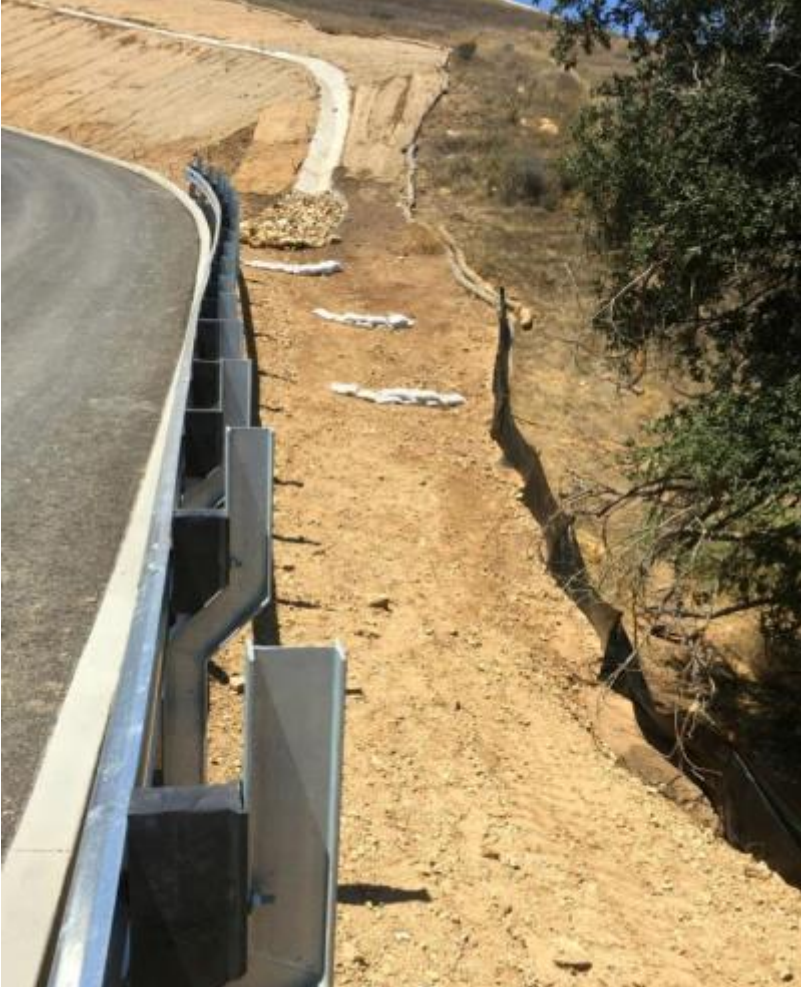
| Date | Location | Photo | Description |
|---|---|--|--|
| 7/23/15 | Natural Substation access road | | Rainwater runoff moved sediment along the outside of the access road; the sediment was caught by the silt fence. |

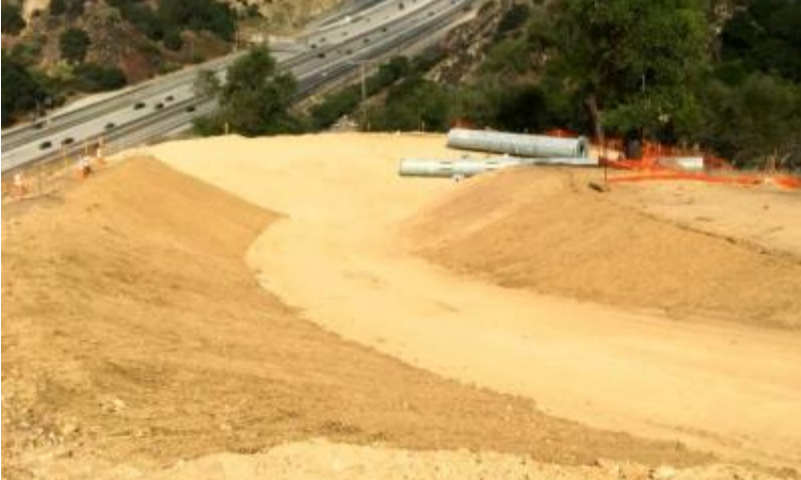
| Date | Location | Photo | Description |
|---|---|--|--|
| 7/30/15 | TSP 32 | | Some additional jute netting has been installed, but the work has not been completed. |

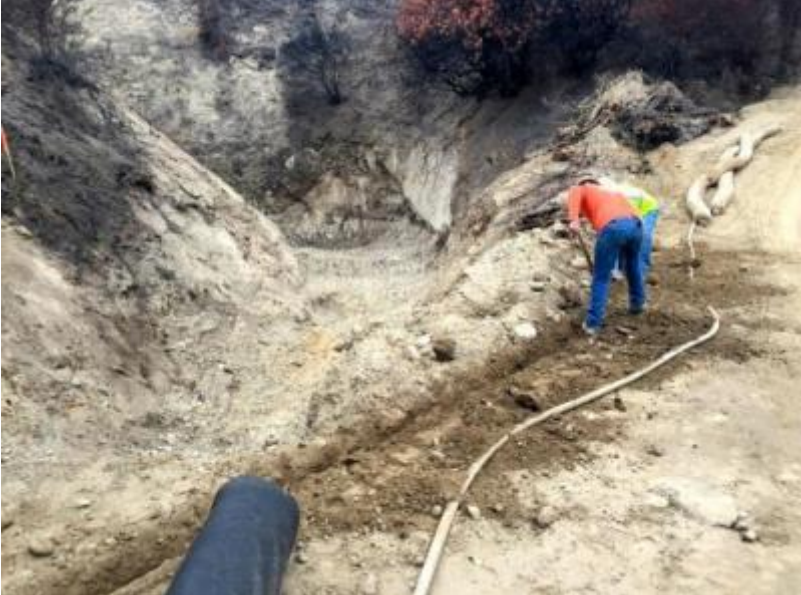
| Date | Location | Photo | Description |
|---|---|--|--|
| 7/30/15 | Access road to TSP 25 | | BMP material installation along the access road, above the jurisdictional drainage. |

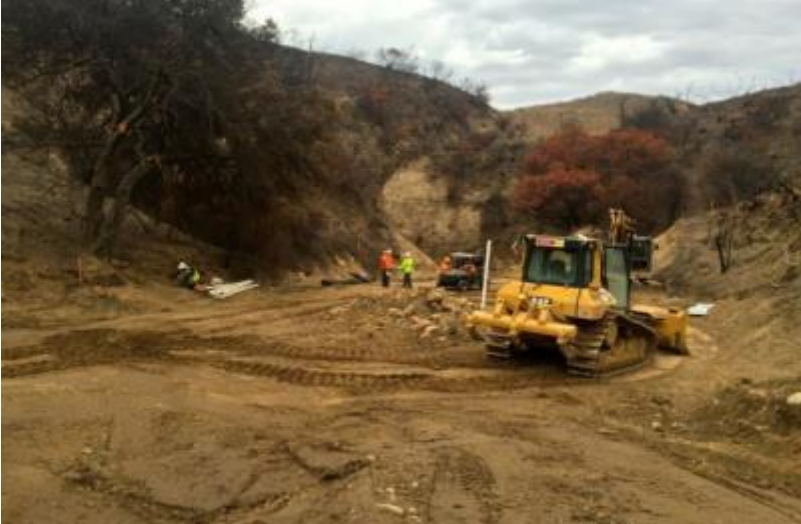
| Date | Location | Photo | Description |
|---|---|--|--|
| 7/30/15 | Access road to TSP 25 | | The drainage along the access road has been excavated and backfilled with more soil coming in from TSP 22. |
