Re: Monthly Report Summary #27 for Aliso Canyon Turbine Replacement Project

Aliso Canyon Turbine Replacement Project CPUC Site Inspection Form

Project:	Aliso Canyon Turbine Replacement	Date:	June 3, 2016
Project Proponent:	Southern California Gas Company and Southern California Edison	Report #:	VS106
Lead Agency:	California Public Utilities Commission	Monitor(s):	Vince Semonsen
CPUC PM:	Andrew Barnsdale, Energy Division	AM/PM Weather:	Clear, sunny, and hot with a slight breeze.
E & E CM:	Lara Rachowicz	Start/End time:	0900 to 1200 at the Aliso Canyon Natural Gas Storage Field (Aliso Storage Field)
Project NTP(s):	The new Admin/IM Building (NTP-2), Central Compressor Station (CCS) (NTP-3), PS-42 Fill Site, and the Natural Substation (NTP-3 and NTP-A). TSPs 2 through 42 (NTPs A, C, and D) and the SCE 210 Freeway Yard. Telecommunications Route 2 (NTP-E).

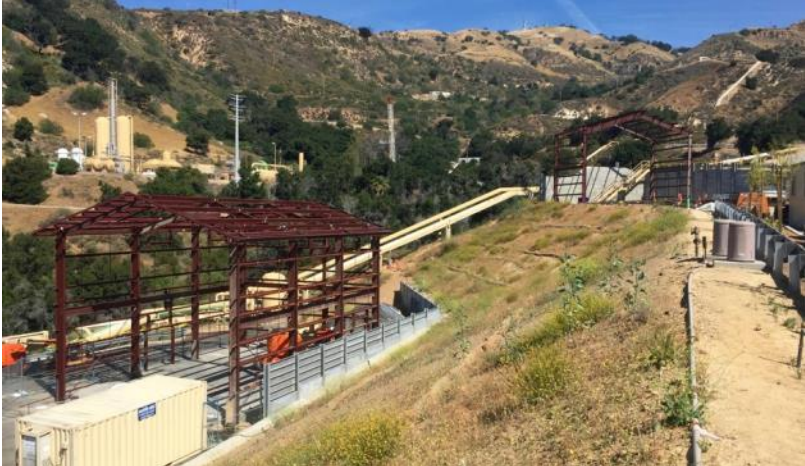
I stopped at the new Admin/IM Building where construction was being conducted – see Photo 1. Included is a photo of the bioswale for the new Admin/IM Building – see Photo 2.

Photo 1 – Buildings going up.
6/3/16	New Admin/IM Building

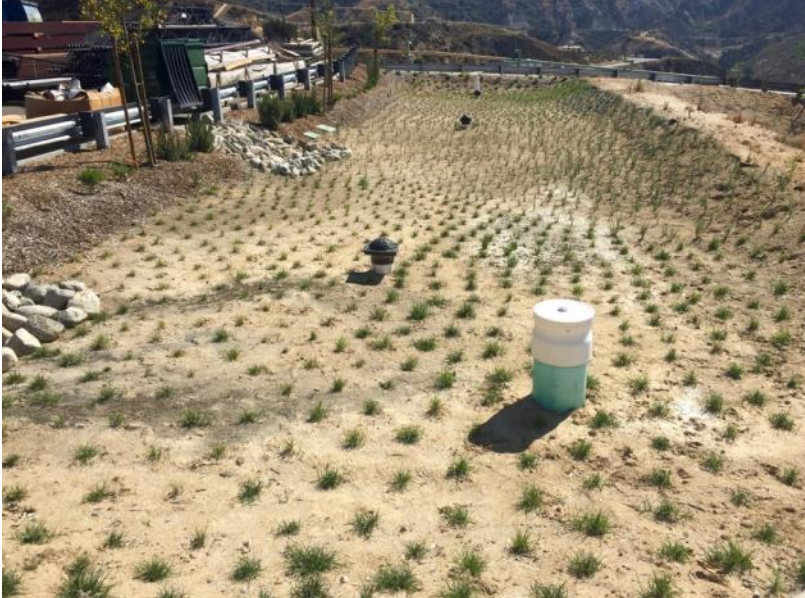
Photo 2 – Bioswale with plantings.
6/3/16	Natural Substation

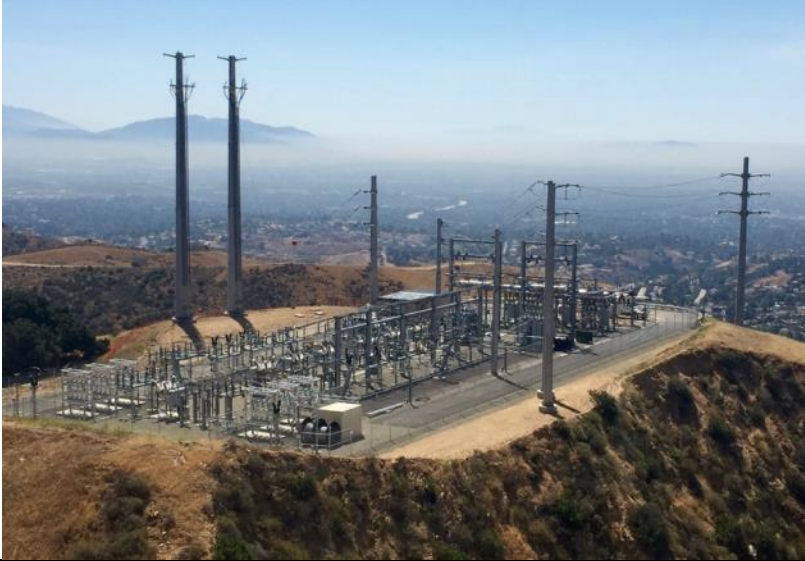
At the Natural Substation, the electrical equipment was being tested – see Photo 3.

Photo 3 – Overview.

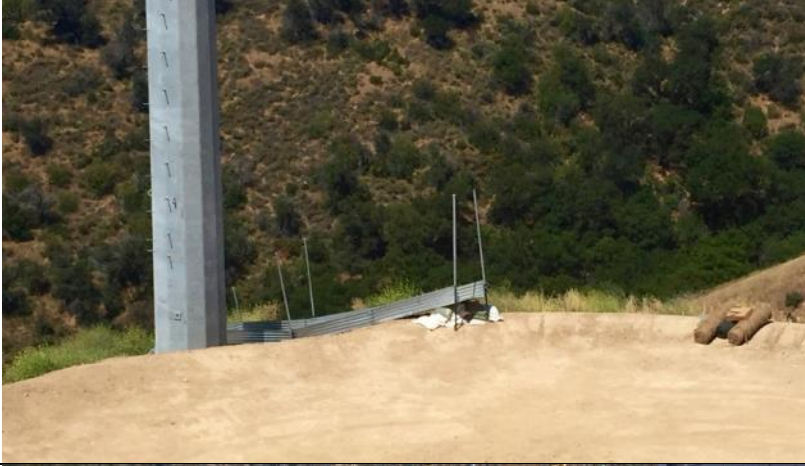
Work on the TSP 49 erosion repair was scheduled to begin; however, there was a delay, and no crews were at the site – see Photo 4. No work was being conducted at the PS-42 Fill Site. Stockpiled soil remained on the well pad above the site. This soil eventually may be placed in the PS-42 Fill Site.

Photo 4 – Early phase of the erosion repair work.
6/3/16	CCS

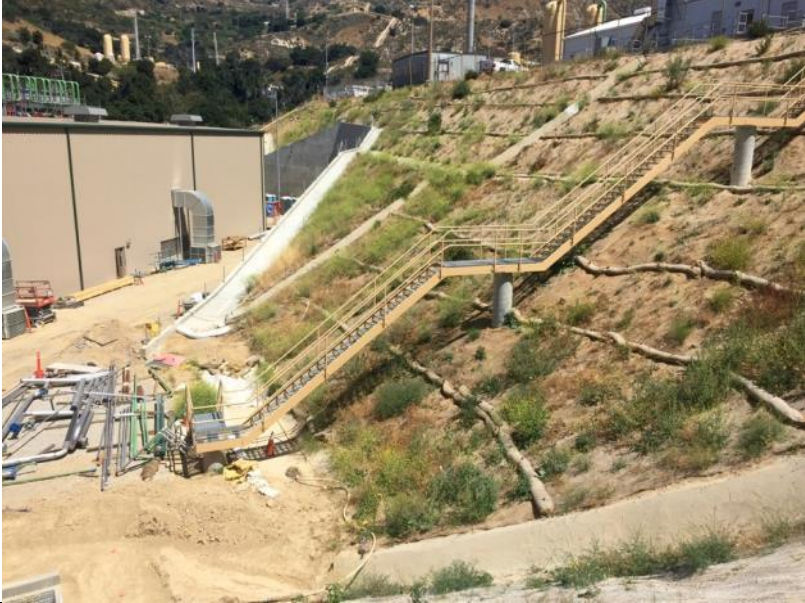
At the CCS, crews were working on the drainage system, building construction, and on installation of the blowdown line. Mustard plants are again dominating the slopes above and below the CCS – see Photos 5 and 7. As indicated in a previous monitoring report, it appears that rainwater runoff from a large area around the CCS drains through the facility. Photo 6 shows the drainage outfall from the facility.

Photo 5 – Slope above the CCS facility; note the mustard is returning.
6/3/16	CCS

Check on 12 kV PPL pole installation and possible weed control work.

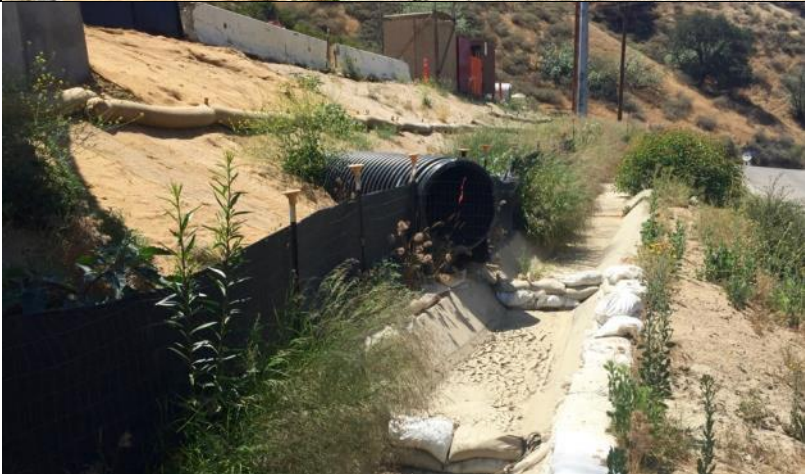
Photo 6 – Drainage culvert outfall for the CCS and surrounding areas.

An evaluation of the rainwater runoff draining through the CCS facility is recommended.

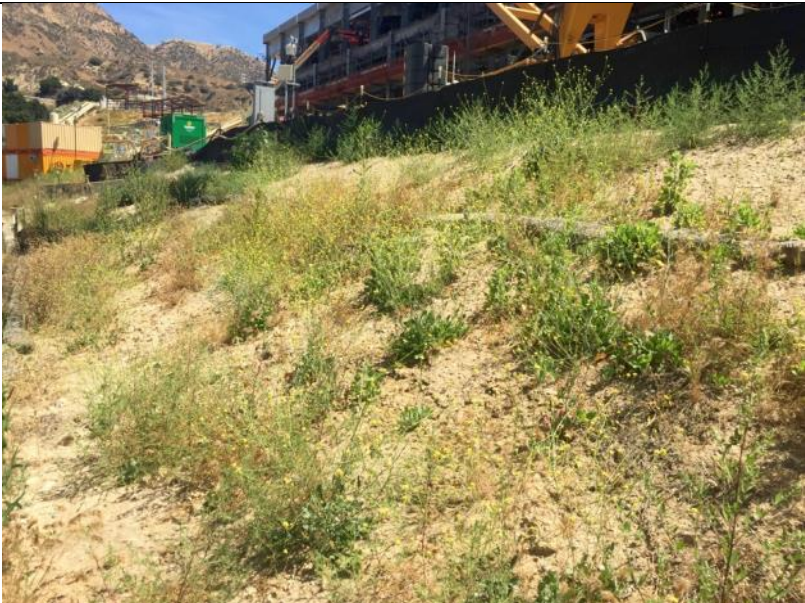
Photo 7 – Mustard growing on the slope below the CCS.
6/3/16	12 kV PPL Work at the A2-1 Location

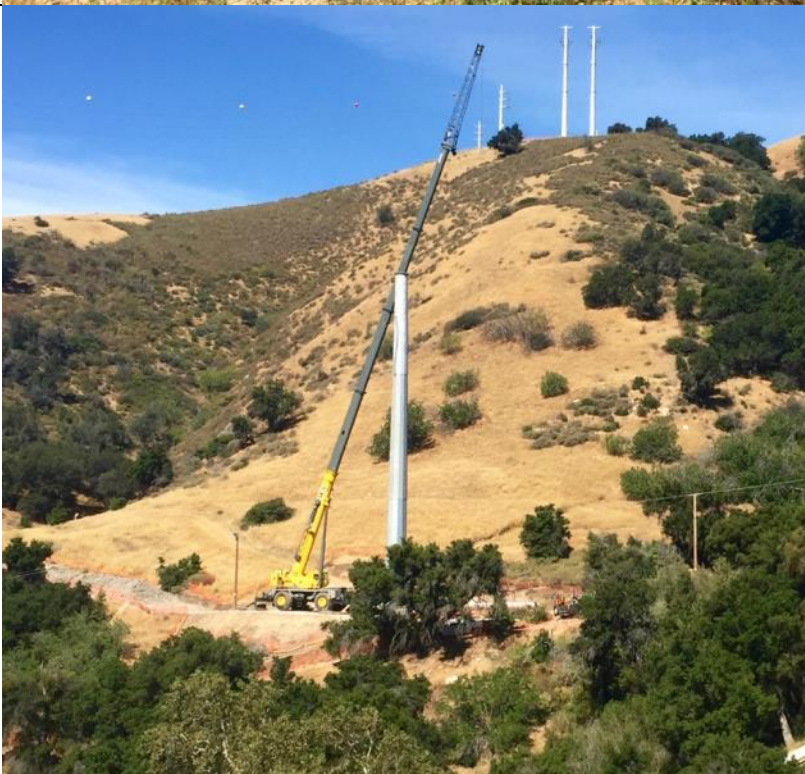
At the 12 kV PPL, pole A2-1 work crews have installed most of the TSP – see Photo 8. The crane had a mechanical problem, and the crew asked if they could flip up the top section of the TSP and lean it on the slope in order to allow vehicular access to the crane – Photo 9. Because there was the possibility of impacting vegetation outside of the construction limits, I called Seth Rosenberg (SCG). We discussed the situation and he called Andres Estrada (E & E). We all agreed that the impacts would be minimal, so the tower section was temporarily placed on the slope – see Photo 10 – and there was minimal impact to vegetation. Juan Miranda (SCG) is the daytime onsite biological monitor.

Photo 8 – Installation of the TSP.

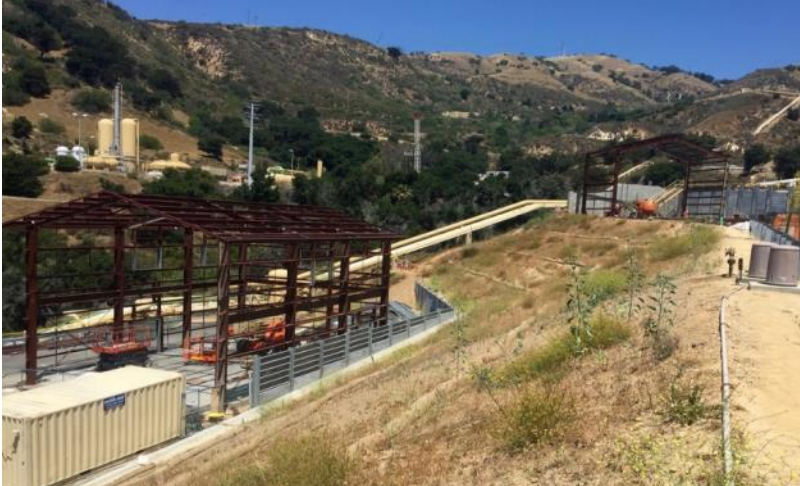
Photo 1 – Buildings going up.
6/13/16	Oak Tree Mitigation Site

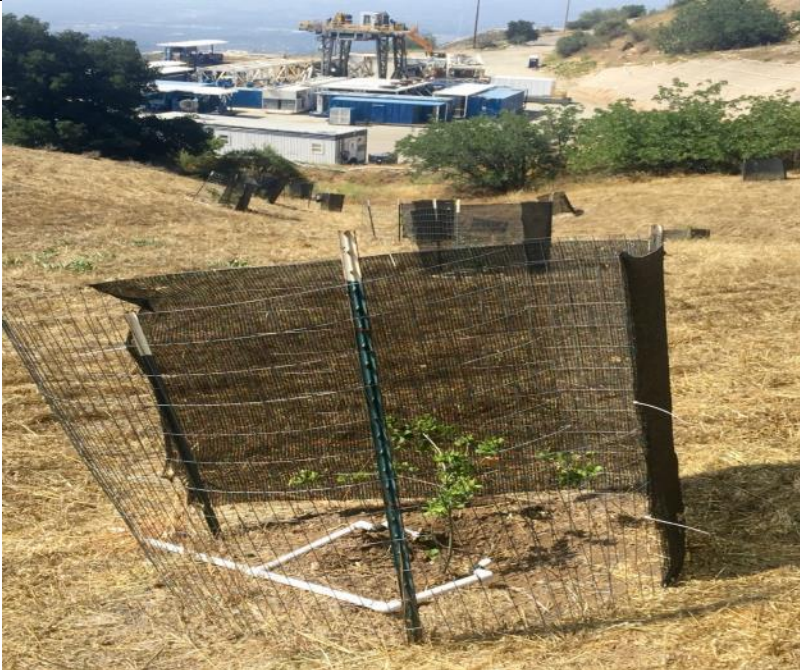
I drove to the Oak Tree Mitigation Site to look at some of the cages, and they all appeared to be in good condition – see Photo 2. One nest buffer had been set up around a small stand of trees within the Oak Tree Mitigation Site – see Photo 3.

Photo 2 – Oak tree cages.
6/13/16	Oak Tree Mitigation Site

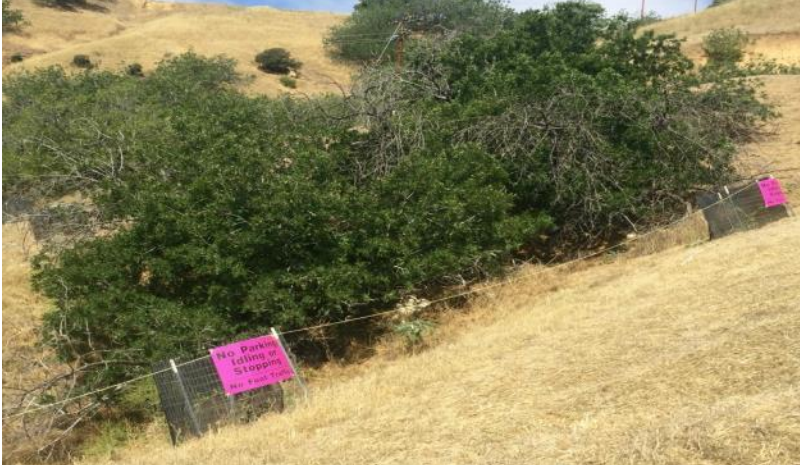
Photo 3 – Oak tree cages with a nesting bird buffer around a small stand of trees.

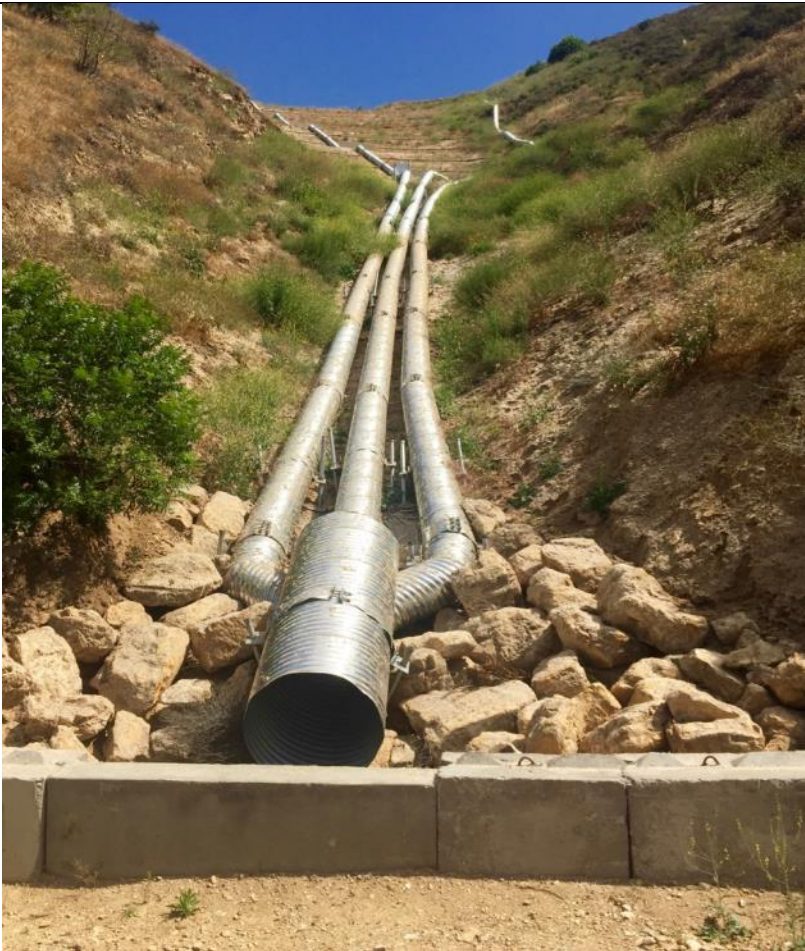
Photo 4 – Lower portion of the PS-42 Fill Site showing mustard growing.
6/13/16	PS-42 Fill Site

Weed control work.

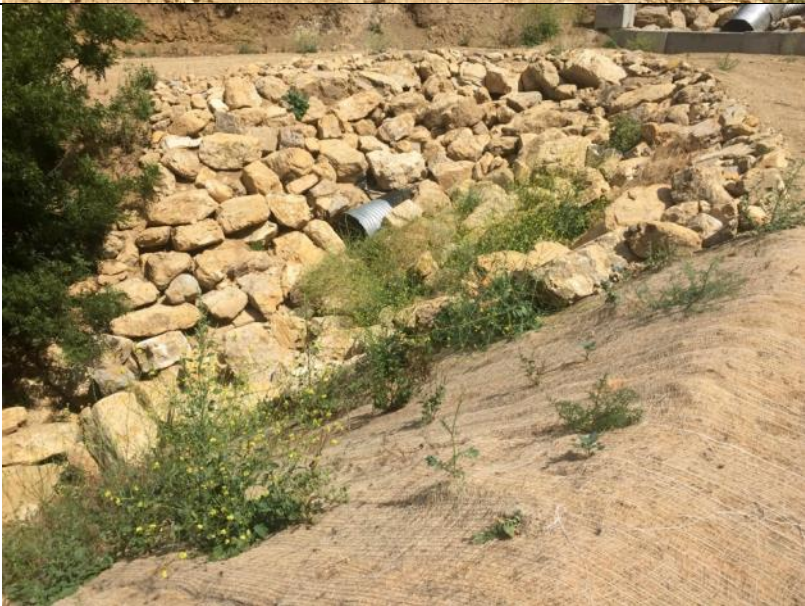
Photo 5 – Riprap culvert area below the PS-42 Fill Site showing moderate amounts of weed growth.

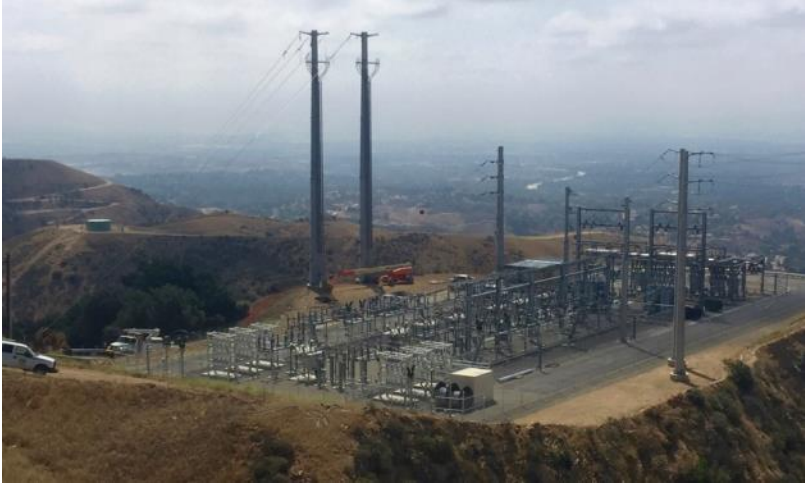
Photo 6 – Overview of the Natural Substation.
6/13/16	TSP 49

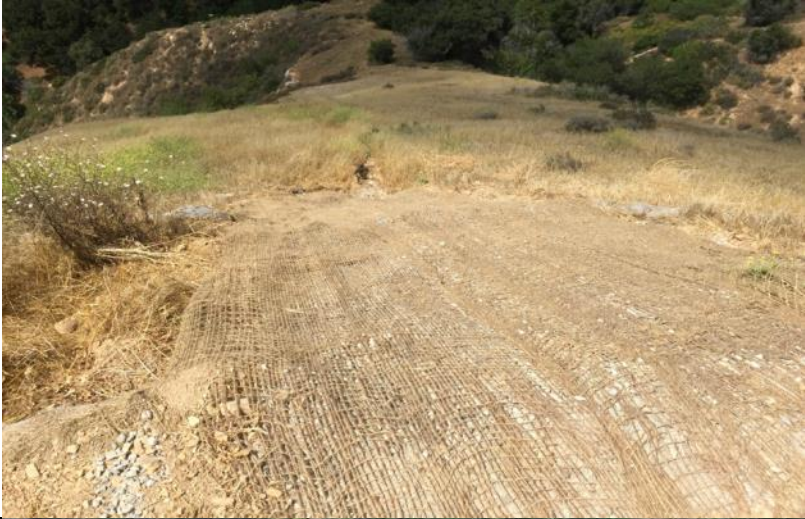
Work on the TSP 49 erosion repair was finished, with road base used to fill the rill and jute netting used as a covering – see Photo 7. I also noted that the old tower foundation remained in place near the new tower – see Photo 8. I sent a follow-up email to Chris May (SCE) inquiring about the use of road base and the fate of the old foundation, and she replied that the road base was used because they felt it would be difficult to compact dirt in the steep area and that the foundation would be left in place to help stabilize the slope.

Photo 7 – Filled rill below the pole site.
6/13/16	TSP 49

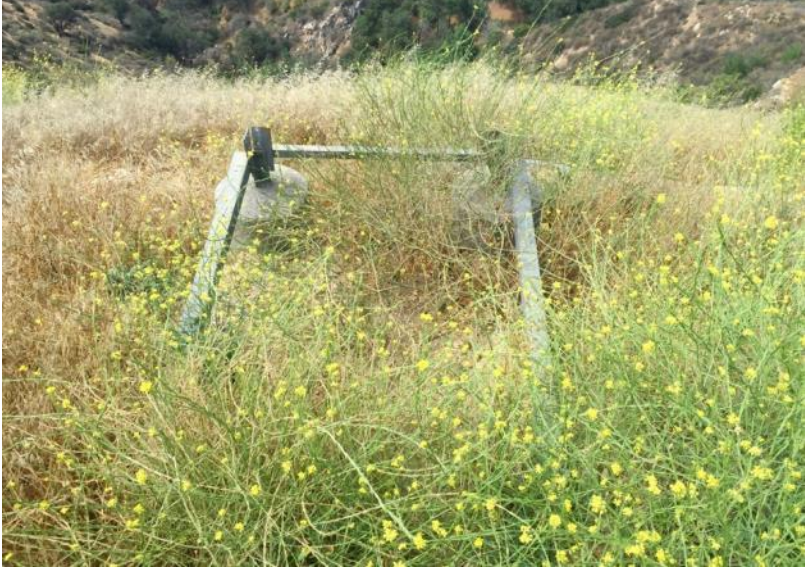
Photo 8 – Old pole foundation remains near the new TSP location.

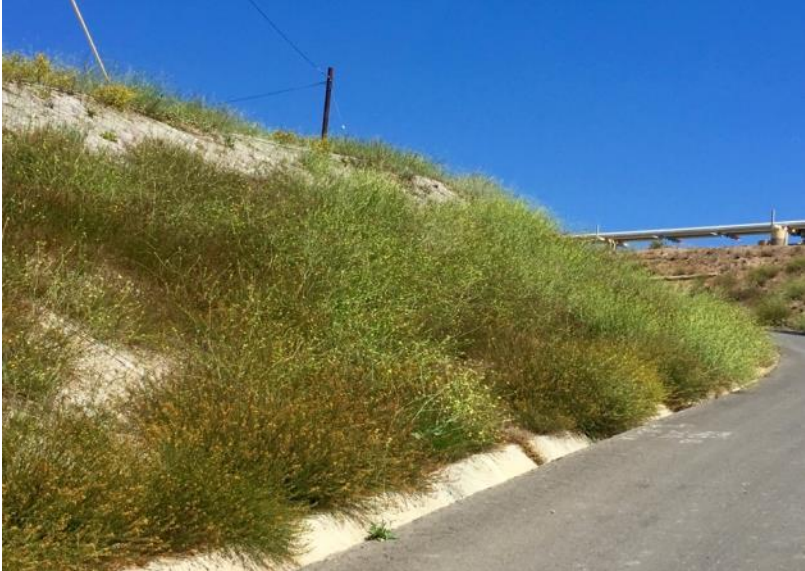
Photo 9 – Mustard is returning along the Natural Substation access road.
6/13/16	12 kV PPL Work at the A2-1 Location

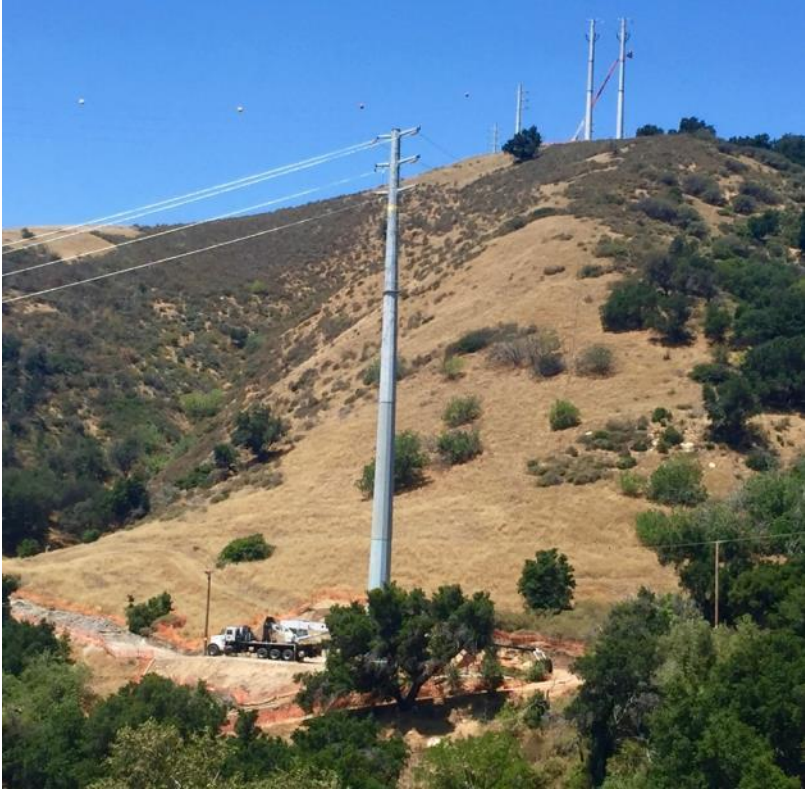
At the 12 kV PPL, A2-1 pole crews have finished installing the TSP, and a helicopter crew strung the wires on the morning of Sunday, June 12 – see Photo 10. Juan Miranda (SCG) is the daytime onsite biological monitor and he said that both he and avian biologist Rob Conohan (SCG) surveyed the slope for nesting birds between the 12 kV PPL pole sites before the helicopter flight. Wire stringing is continuing – see Photo 13. A man lift is parked below the A2-1 TSP and it is covered with bird netting – see Photo 11. I noted some of the construction stakes and fencing along the access road and around some small oaks have been knocked over – see Photo 12. I mentioned this to Amandeep Singh (AECOM), and he said he would ask the contractor to repair the fencing as soon as possible.

Photo 10 – Poles are in place and wire is being strung.

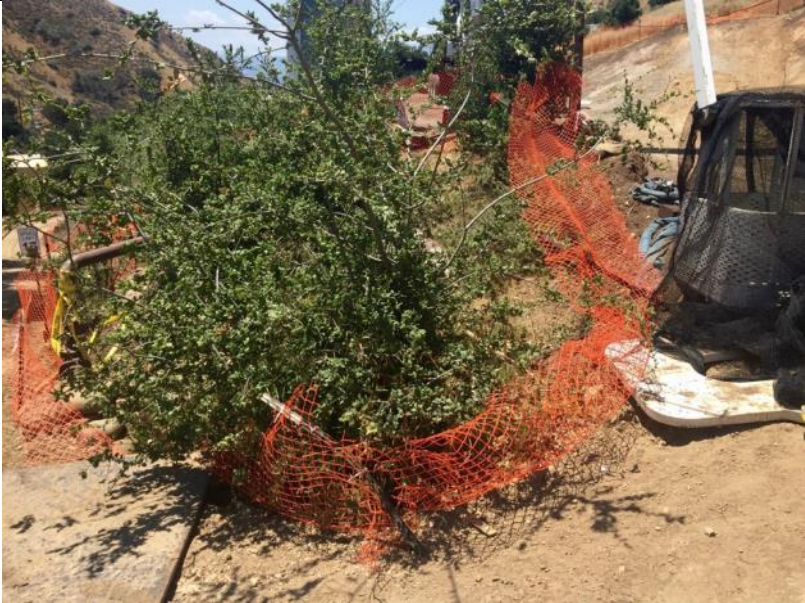
A photograph showing a section of orange plastic boundary fence that has been knocked over. The fence is lying on the ground near a man lift. The background shows a dirt area and some green vegetation.	Photo 12 – Boundary fence that has been knocked over.

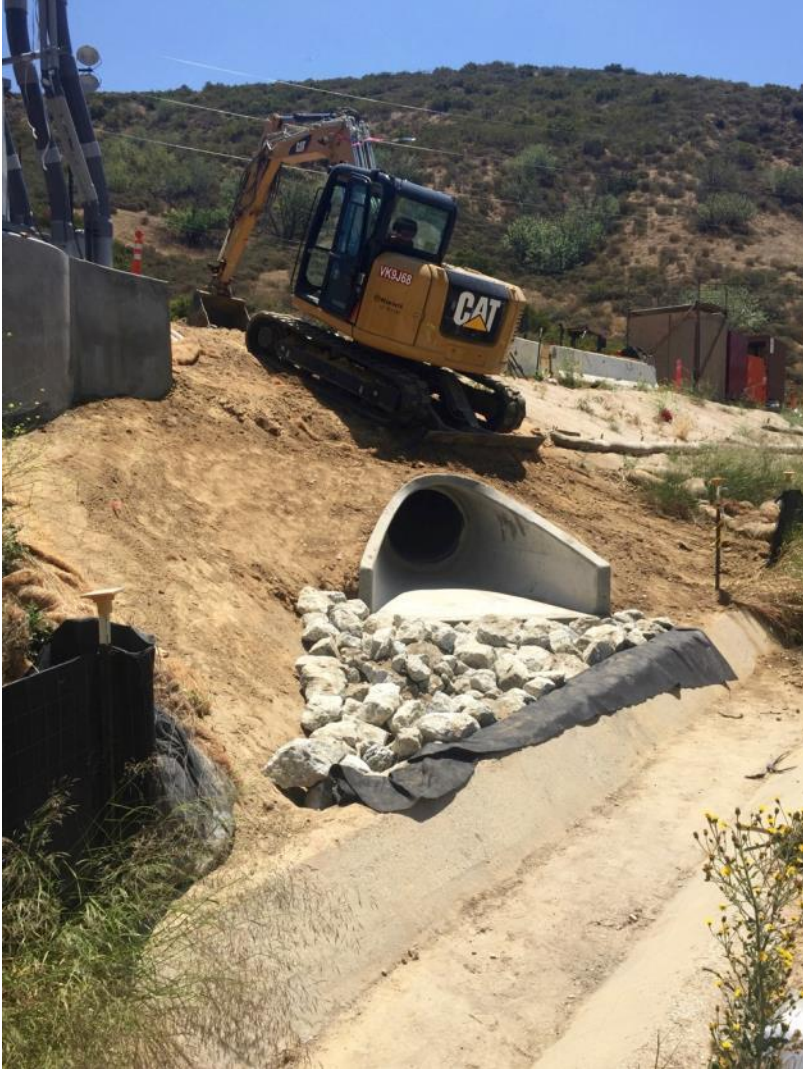
Photo 14 - Work on site drainage system.

An evaluation of the rainwater runoff draining through the CCS facility is recommended.

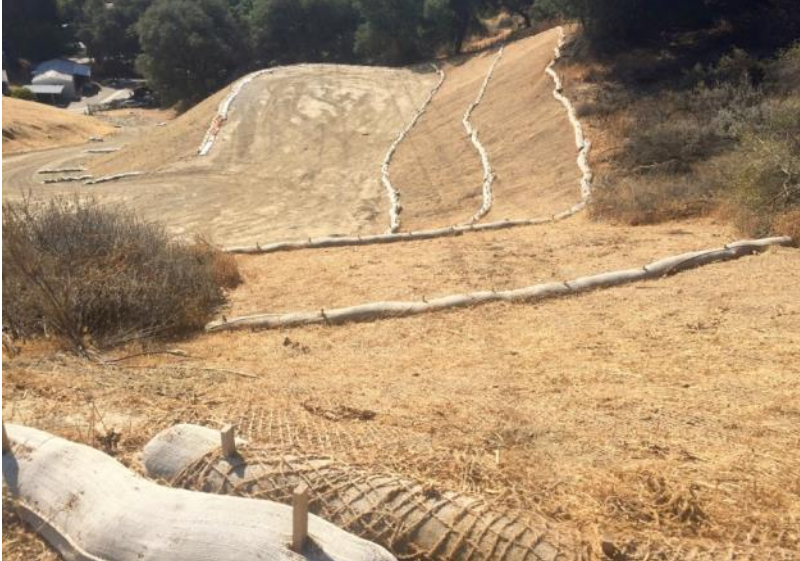
Photo 1 – Results of the weed removal at the pull site and along the access road.
6/21/16	TSP 21

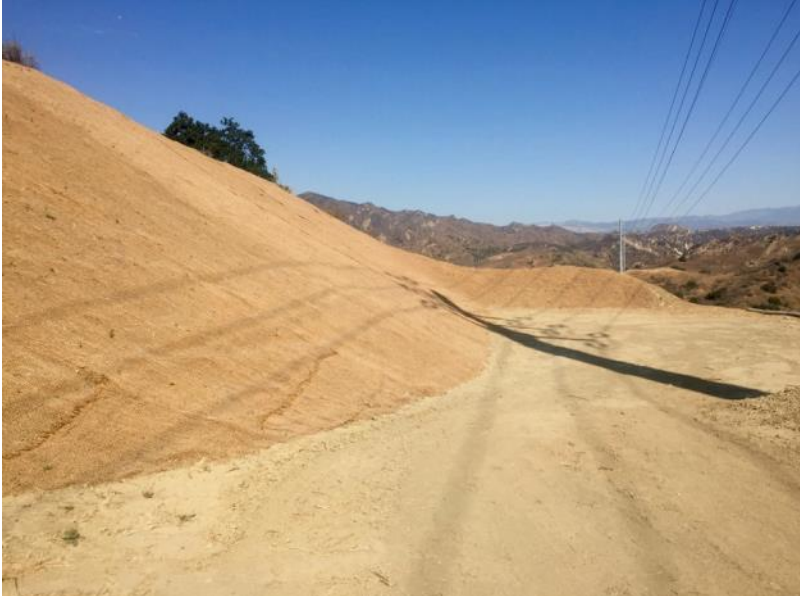
Photo 2 – TSP pad and restored slopes
6/21/16	TSP 12	 	Photo 3 – Weed removal at TSP 12.

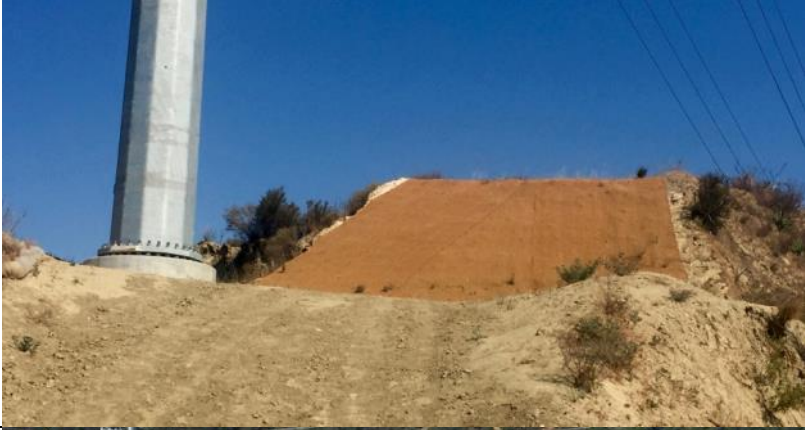
Photo 4 – Weed removal at TSP 13.
6/21/16	TSP 15

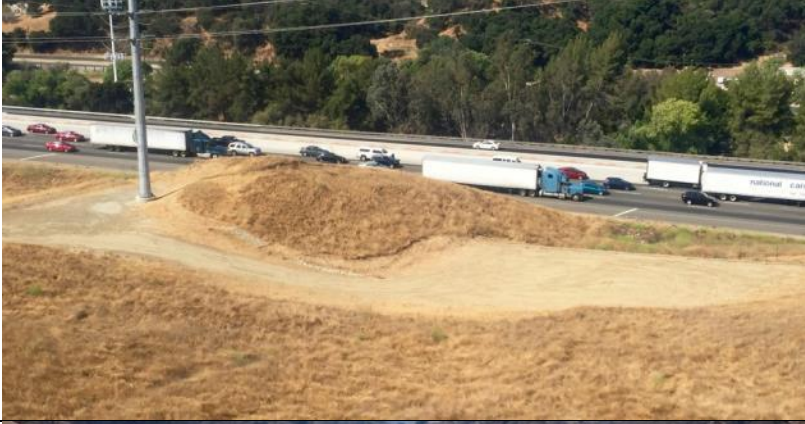
Photo 5 – Weed removal around the TSP 15 pad and staging area.
6/21/16	TSP 16

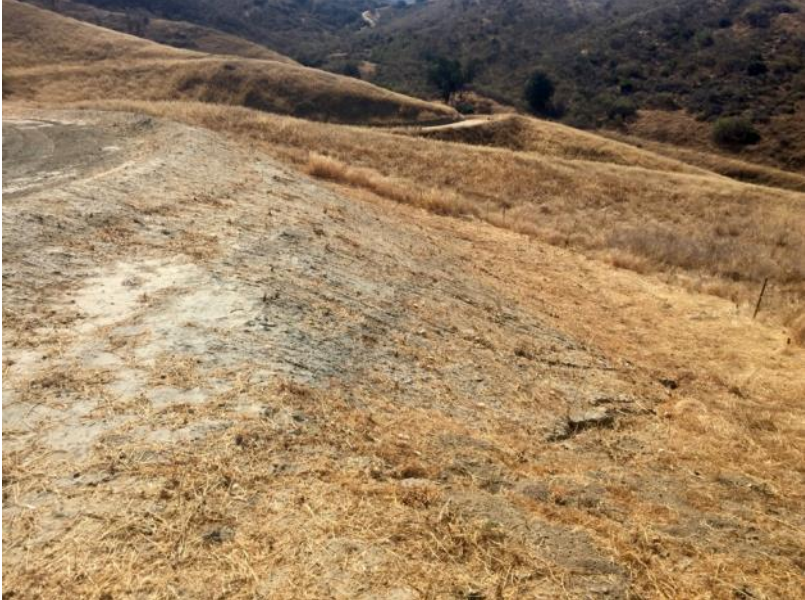
Photo 6 – Weed removal on the slopes of the pole pad.

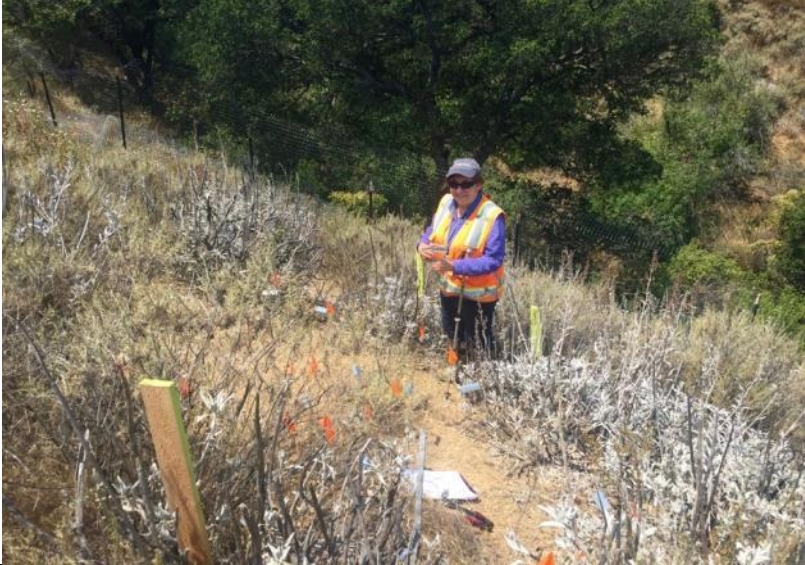
Photo 10 – Botanist Mary Carroll surveying the revegetation.
6/21/16	PS-42 Fill Site

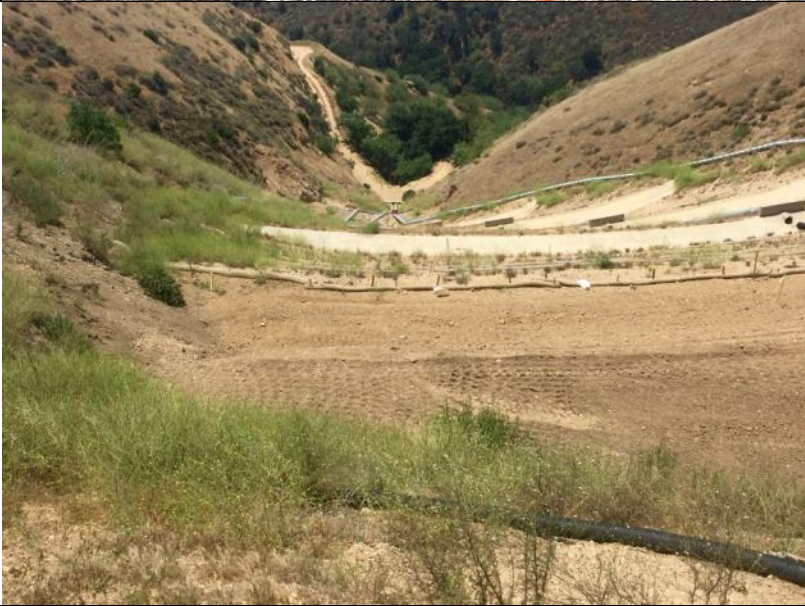
Photo 11 – PS-42 Fill Site showing the mustard growing in the disturbed areas.
6/21/16	New Admin/IM Building

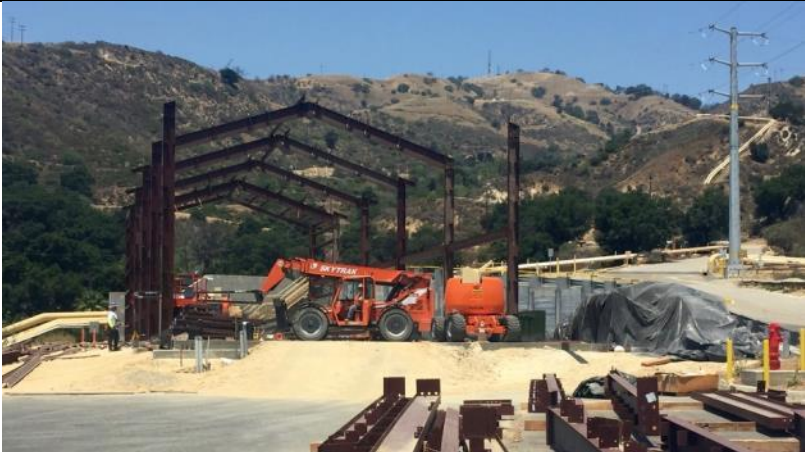
Photo 12 – Buildings continue to be erected.

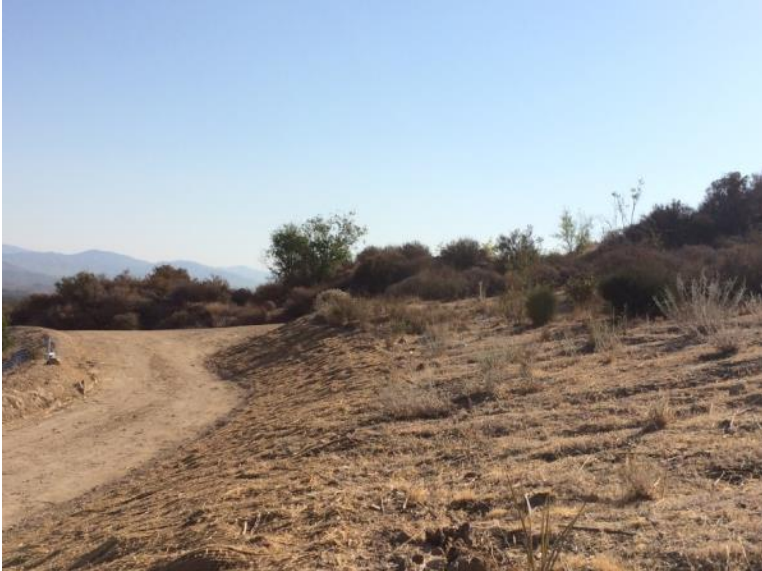
Photo 1 – Crews have completed non-native plant management and left some native vegetation.
06/27/16	TSP 21

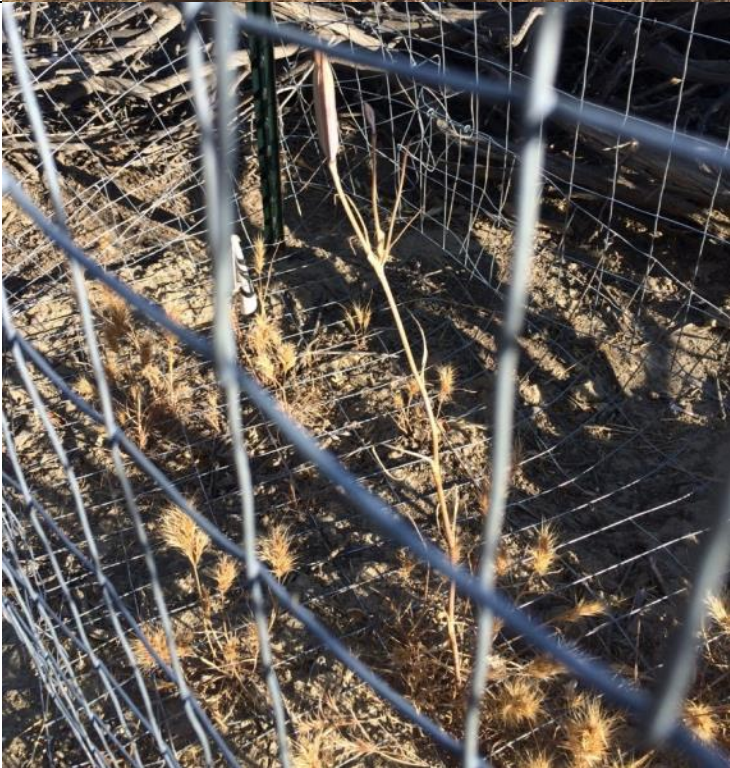
Photo 2 – A mature Mariposa lily seed capsule from a replanted bulb.

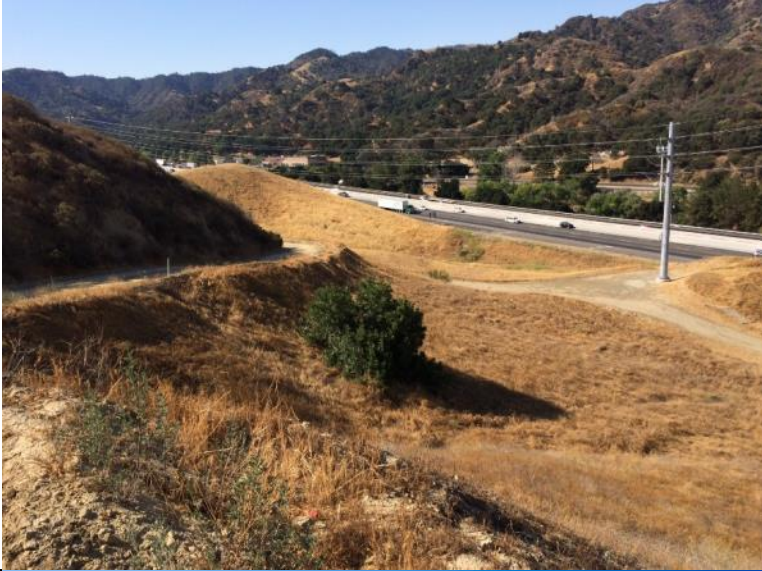
Photo 3 – Access roads and TSP pads cleaned of non-native vegetation.
06/27/16	Sunshine Canyon Landfill

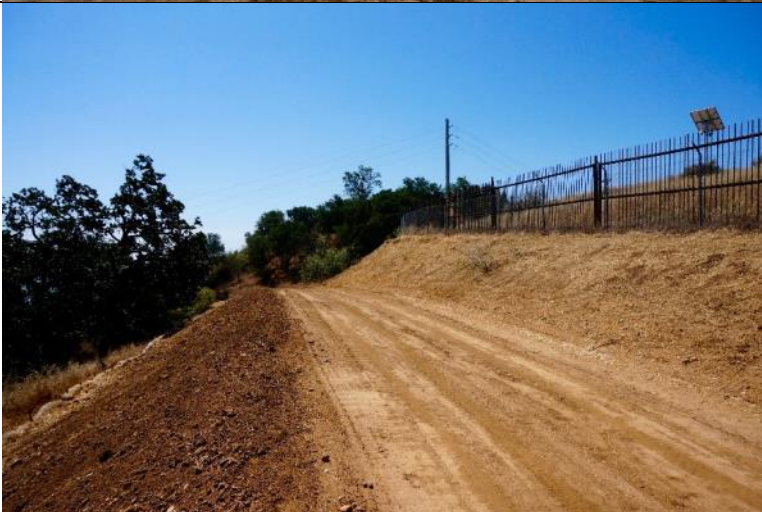
Photo 5 – Access road near TSP 42 that has been cleared of non-native vegetation.

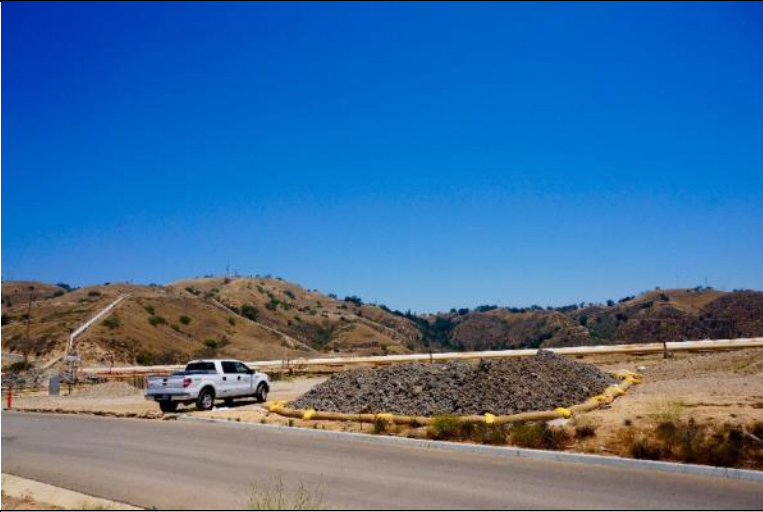
Photo 7 – Soil stockpile at the P-40 staging area.
06/27/16	Oak Tree Mitigation Site

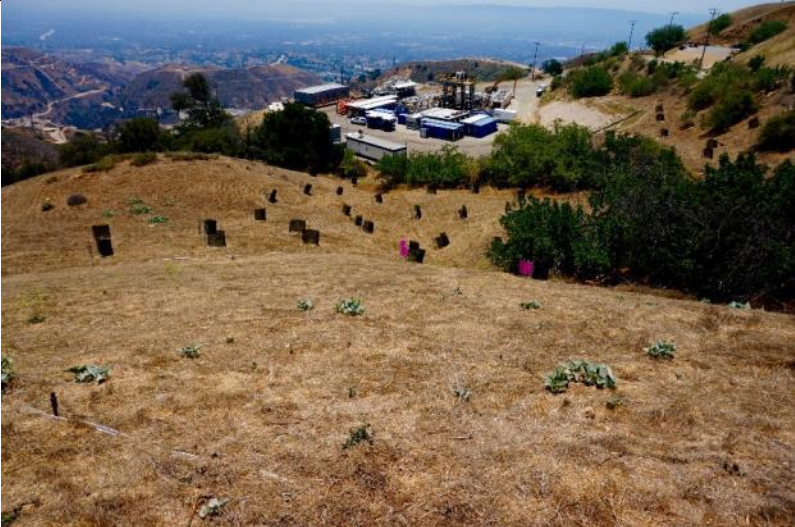
We drove to the Oak Tree Mitigation Site where the young trees appeared healthy – Photo 8. The area had been mowed about a month prior to my visit, and I noted very sporadic non-native plants. Next, we checked the new Admin/IM Building. Steel structures were up, and crews continued to work – Photo 9. The biofiltration unit was well vegetated with planted plants. There were patches of non-native plants on the slope between the new Admin and IM Buildings, as well as some natives, such as California poppy.

Photo 8 – Oak trees with bird buffer and well pad in background.

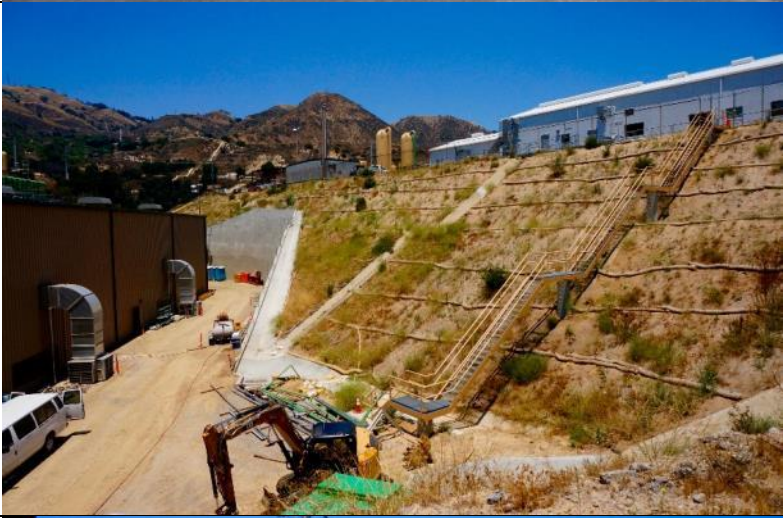
Photo 10 – Slopes above CCS with non-native mustard and straw wattles.
6/27/16	12 kV PPL

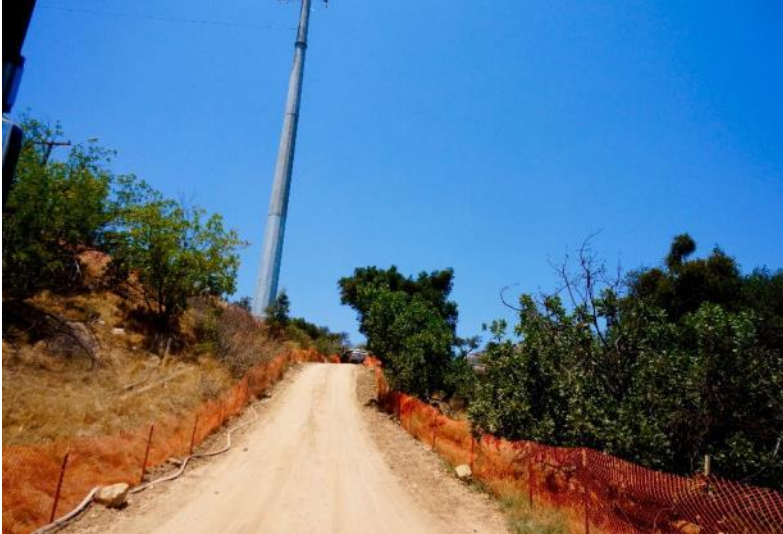
Photo 11 – Well maintained orange fencing at the TSP A2 road.
