Re: Monthly Report Summary #28 for Aliso Canyon Turbine Replacement Project

CPUC Site Inspection Reports
July 7, 13, 20, and 28, 2016

Aliso Canyon Turbine Replacement Project CPUC Site Inspection Form

Project:	Aliso Canyon Turbine Replacement	Date:	July 7, 2016
Project Proponent:	Southern California Gas Company and Southern California Edison	Report #:	VS109
Lead Agency:	California Public Utilities Commission	Monitor(s):	Vince Semonsen
CPUC PM:	Andrew Barnsdale, Energy Division	AM/PM Weather:	Overcast and cool in the morning, clearing to sunny and warm.
E & E CM:	Lara Rachowicz	Start/End time:	1000 to 1030 at the SCE towers. 1100 to 1300 at the Aliso Canyon Natural Gas Storage Field (Aliso Storage Field).
Project NTP(s):	The new Admin/IM Building (NTP-2), Central Compressor Station (CCS) (NTP-3), PS-42 Fill Site, and the Natural Substation (NTP-3 and NTP-A). TSPs 2 through 42 (NTPs A, C, and D) and the SCE 210 Freeway Yard.

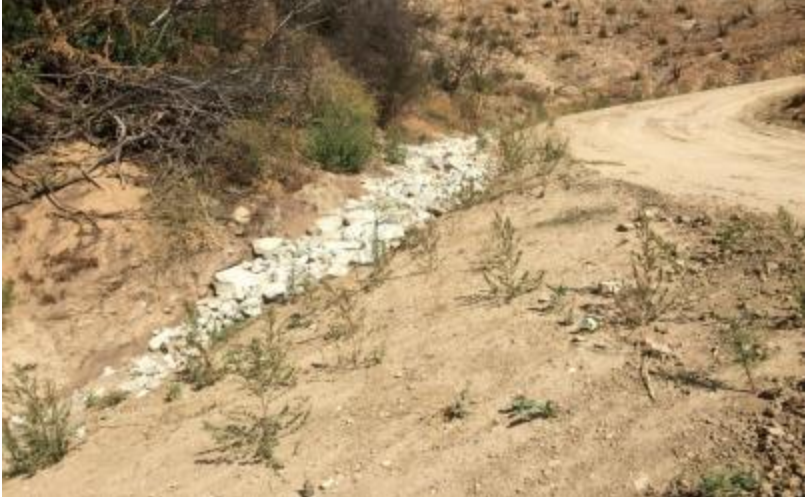
Photo 1 – Ditch stabilization along the TSP 24/25 access road just north of the creek drainage.
7/7/16	TSP 24/25 Access Road

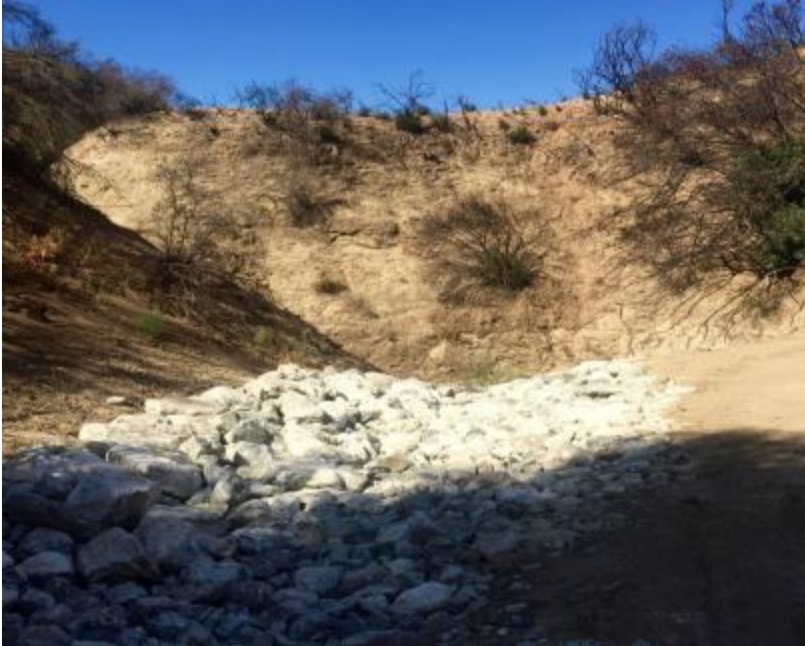
Photo 2 – Ditch stabilization along the TSP 24/25 access road, on the south side of the creek drainage.
7/7/16	TSP 24/25 Access Road

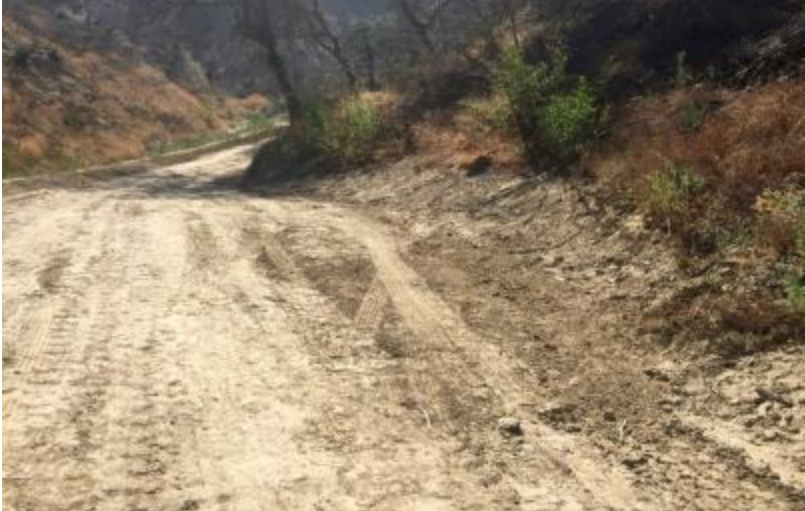
My first stop was at the TSP 24/25 access road where the nesting birds had fledged, thereby allowing crews to enter the site and finish the clean-up work. Stabilization of the road drainage channels had been completed on both the north and south sides of the creek crossing. Rock was strategically placed on the downstream sides of the road to slow the flow of rainwater runoff into the creek and prevent erosion of the road banks (Photos 1 and 2). A small pile of lunch trash remained in the area, near the southern rock work. Farther up the access road, an area of stockpiled rock and soil had been removed (Photo 3).

Photo 3 – Stockpiled soil and rock has been removed from this area of the access road.

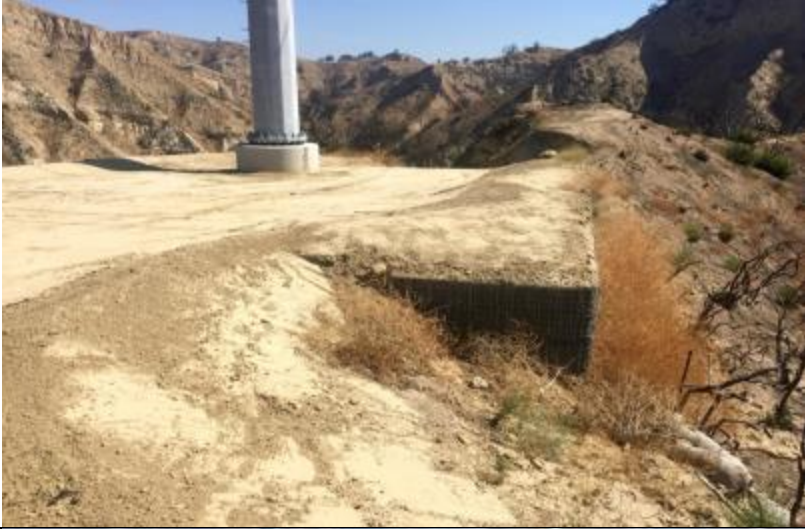
The TSP 25 pad area was completely clear of construction debris. A healthy stand of mustard remained at the base of the Hilfiker wall (Photo 4); this stand was noted in an earlier report.

Photo 4 – The TSP 25 pad area has been cleaned of all construction debris. A stand of mustard remains at the base of the Hilfiker wall.
7/7/16	Oak Tree Mitigation Site

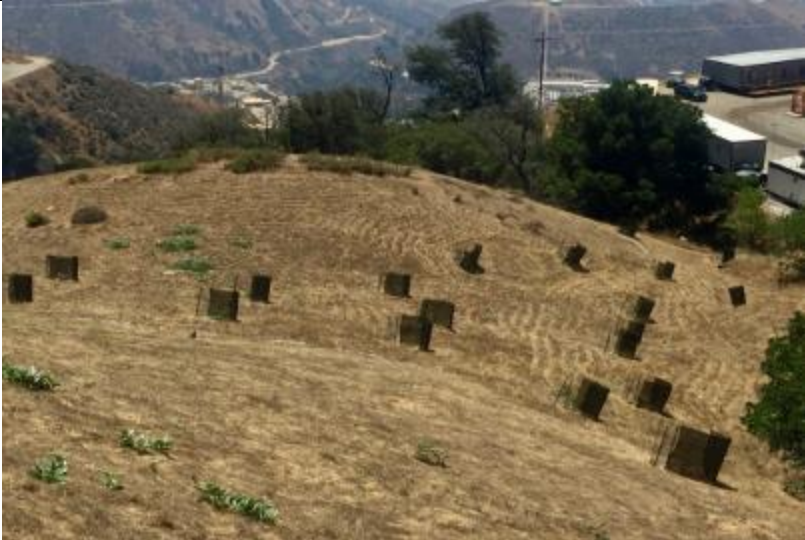
At the Aliso Storage Field, I drove to the Oak Tree Mitigation Site. No maintenance activities were being conducted (Photo 5). I noted pink flagging within the mitigation area. SCG's lead environmental monitor Amandeep Singh (AECOM) said that one of the AECOM biologists had flagged the native vegetation so maintenance crews would avoid these plants.

Photo 5 – Maintenance of the Oak Tree Mitigation Site continues; native plants have been flagged for avoidance by the weeding crew.
7/7/16	PS-42 Fill Site

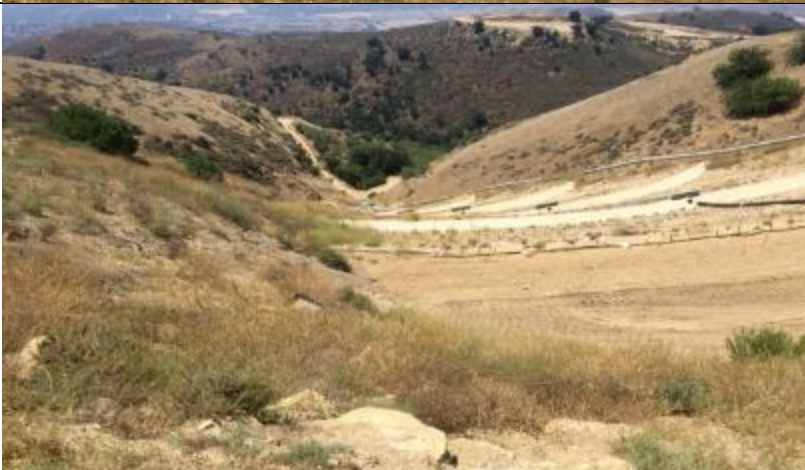
No new soil had been brought into the PS-42 Fill Site (Photo 6). Tailings from the 12 kV drilling work remained stockpiled on the P-40 Well Pad above the PS-42 Fill Site (Photo 7). This soil has been slated for deposition into the PS-42 Fill Site.

A variety of weedy vegetation remained along portions of the PS-42 Fill Site. Seth Rosenberg and Jennifer Campbell (both from SCG) stated that this issue would be addressed soon. Amandeep Singh (AECOM) stated that they had found a nesting California towhee within the vegetation near the base of the PS-42 Fill Site; therefore, any weed removal would be postponed until the chicks had fledged.

Photo 6 – No new fill material has been brought to the site; note the weed growth along the disturbed banks.

Weed control work at the PS-42 Fill Site and along the Natural Substation access road.

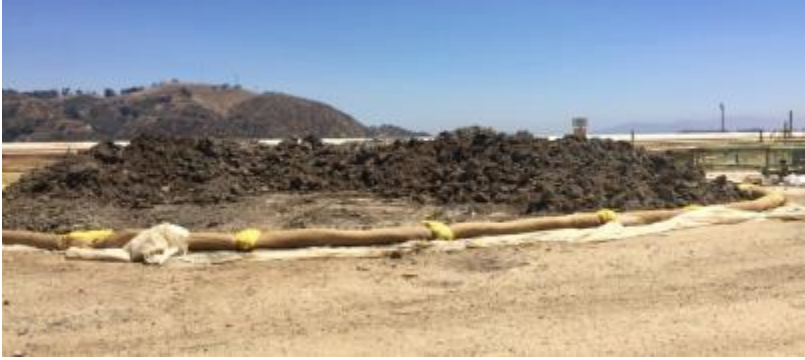
Photo 7 – Tailings from the 12 kV drilling activity have been stockpiled on this well pad.
7/7/16	12 kV PPL

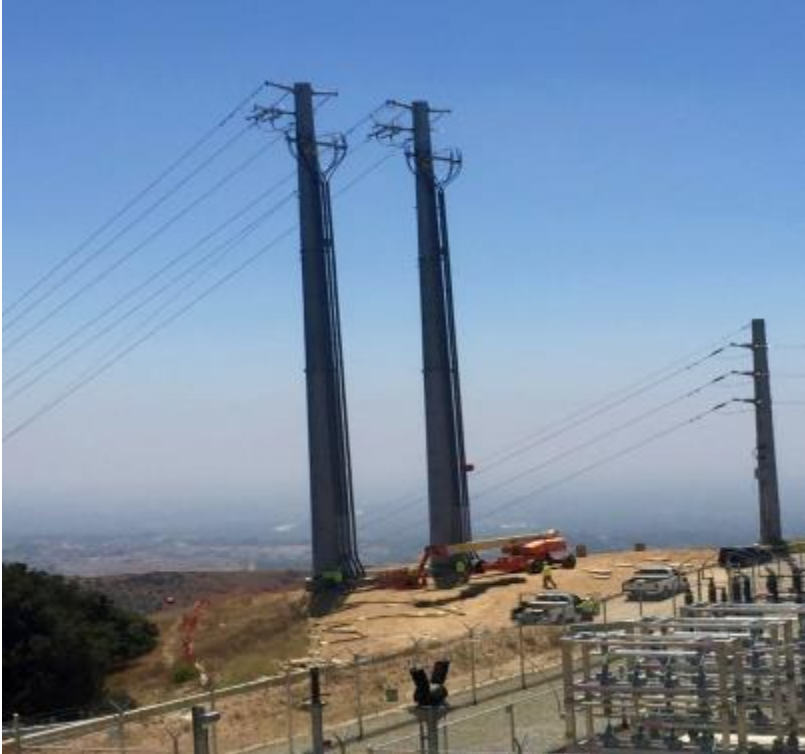
Photo 8 – Crews are working on the poles near the Natural Substation.
7/7/16	Natural Substation

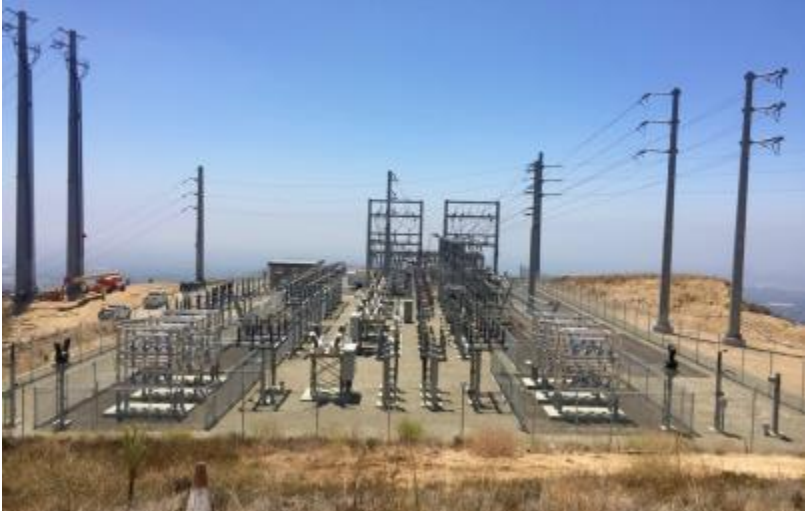
Photo 9 – Crews continue to work within the Natural Substation.

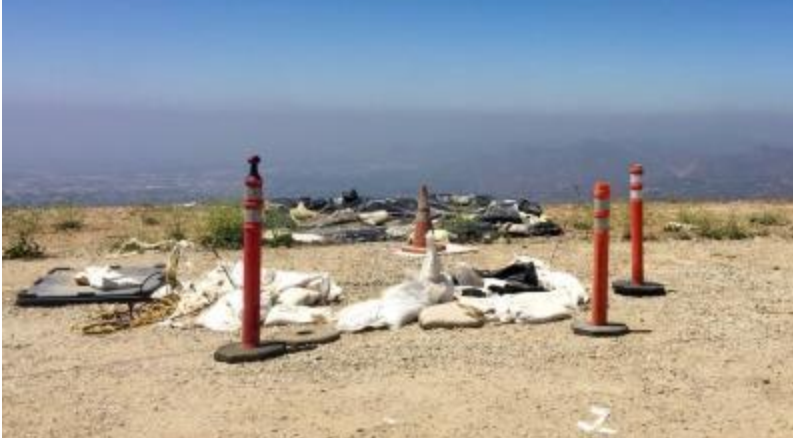
I drove to the Natural Substation access road and noted a crew working on the 12 kV poles and a crew working within the Natural Substation (Photos 8 and 9). The Natural Substation construction trailers had been removed from the well pad; however, I did notice a small pile of construction debris, and best management practice (BMP) materials still remained at that location (Photo 10).

<p>Photo 10 – Construction trailers have been removed from the well pad above the Natural Substation; construction debris and some BMP materials remain.</p>
7/7/16	12 KV PPL

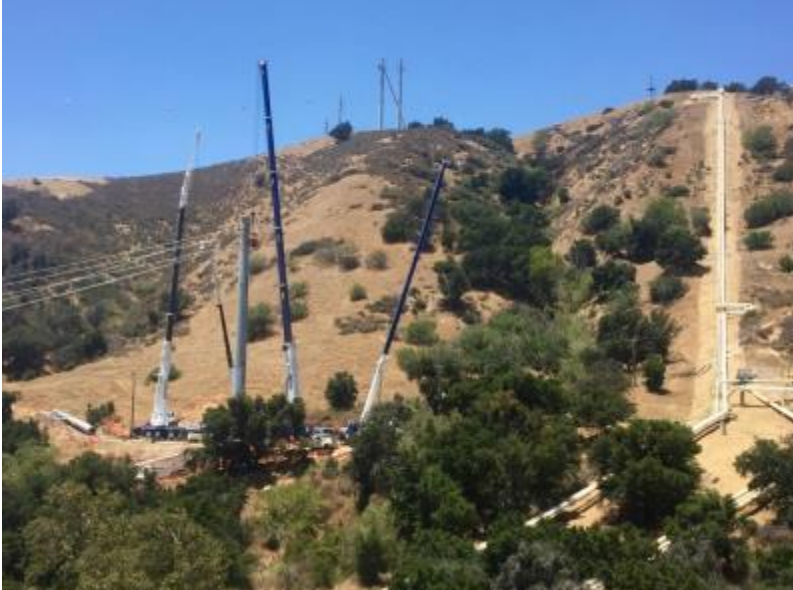
<p>Photo 11 – Crews with three cranes are working on the middle pole site.</p>

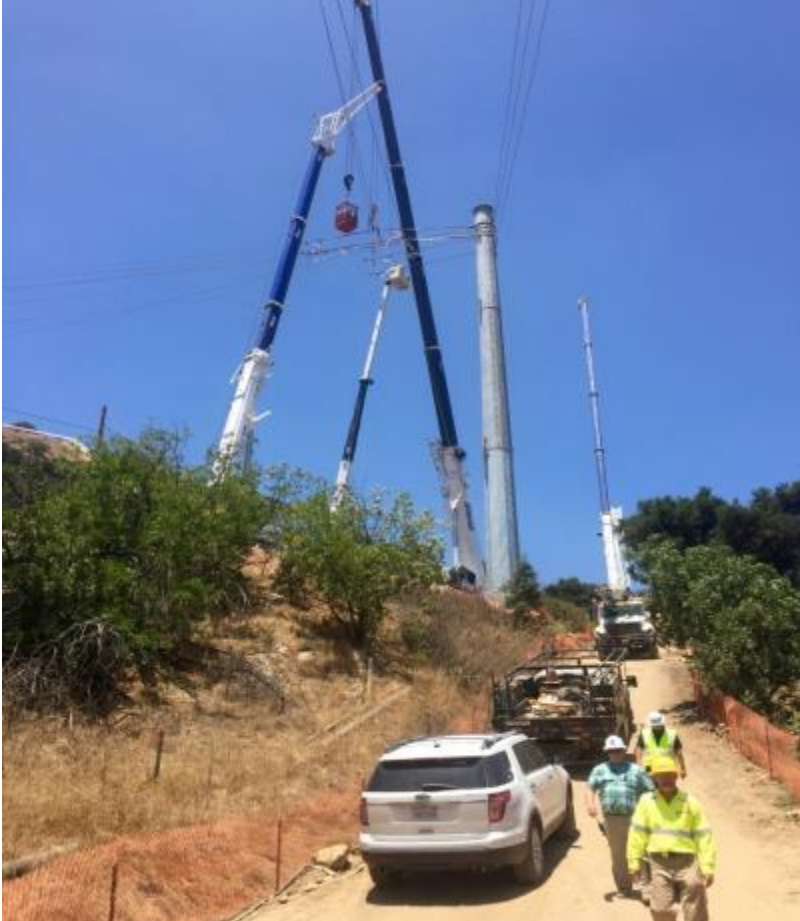
Photo 12 – Crews with three cranes are working on the middle pole site.
7/7/16	New Admin/IM Building

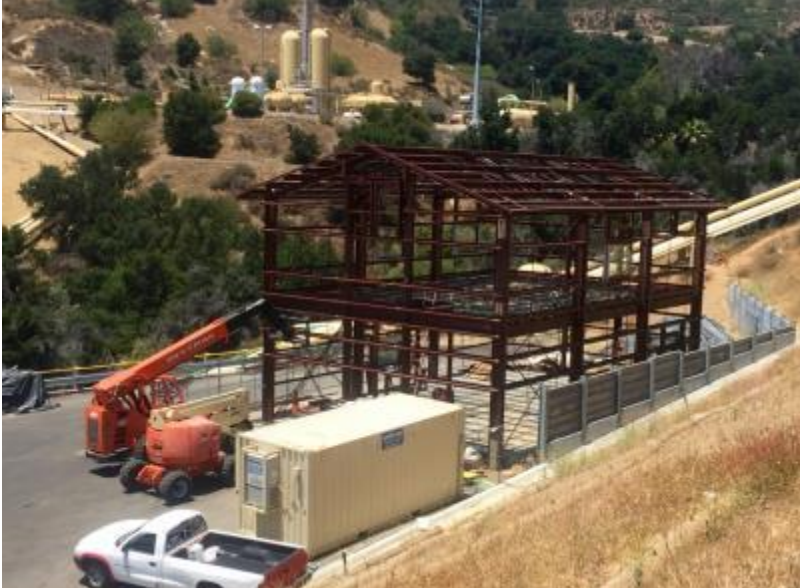
Photo 13 – Building construction continues.

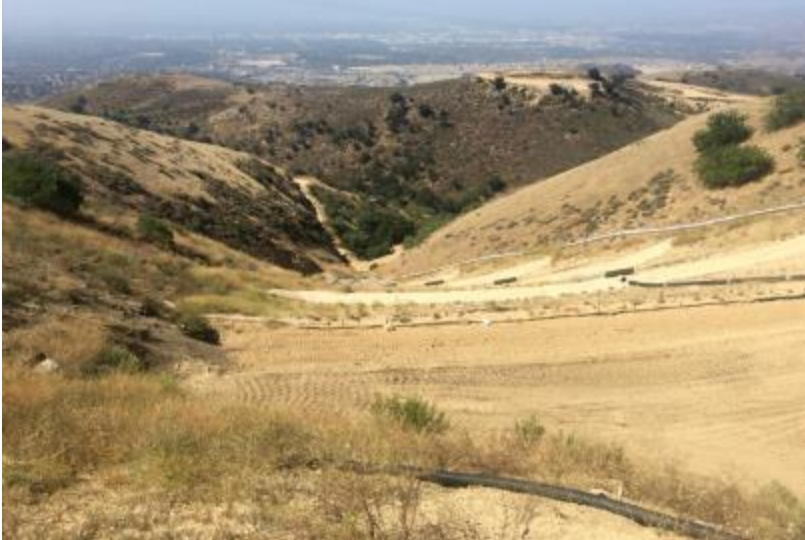
Photo 1 – Conditions have not changed at the PS-42 Fill Site since the last site visit; no new fill material has been brought to the site, and no weed removal has been conducted.
7/13/16	Natural Substation and 12 kV poles

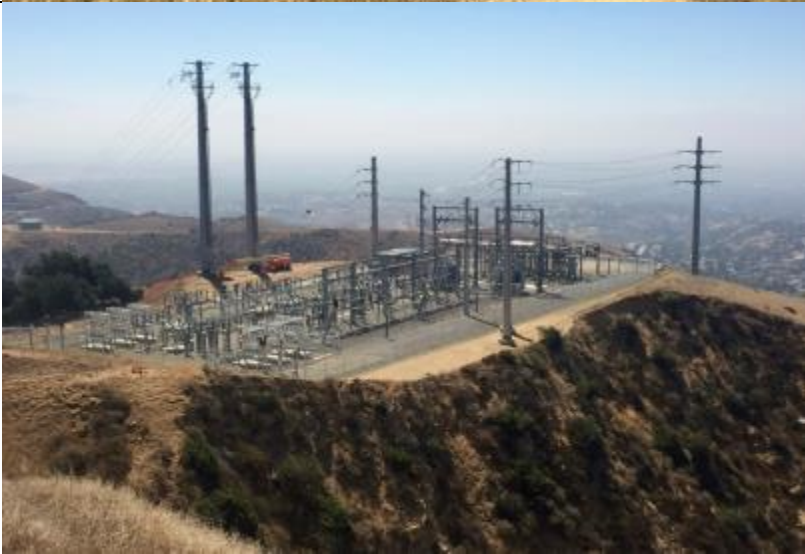
Photo 2 – Crews continue to work at both the 12 kV poles and within the substation.
7/13/16	P-41 Fill Site

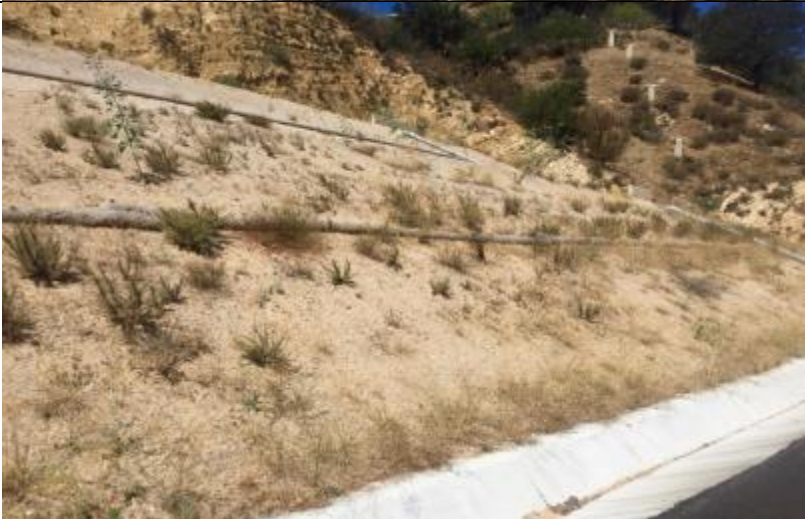
I drove to the P-41 Fill Site to look at the slope revegetation, which was in good condition (Photo 3).

Photo 3 – Restored and revegetated fill material.

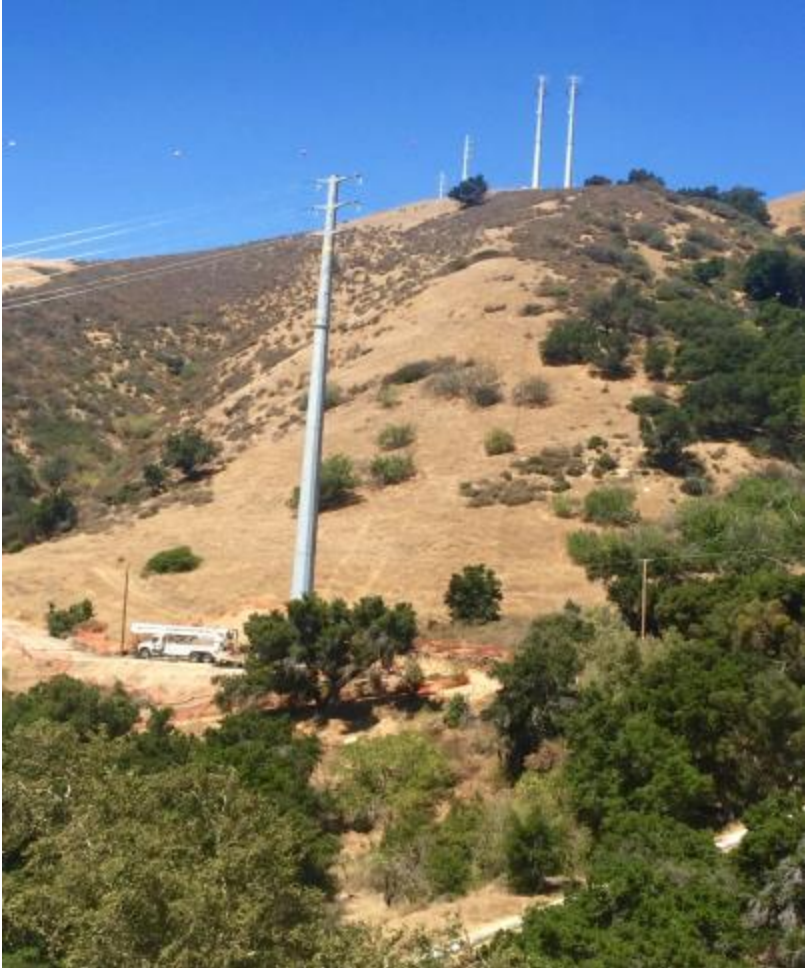
Photo 4 – Wires have been restored to the poles; note the marks in the grass where the wires were placed.
7/13/16	12 kV PPL A2 Pad

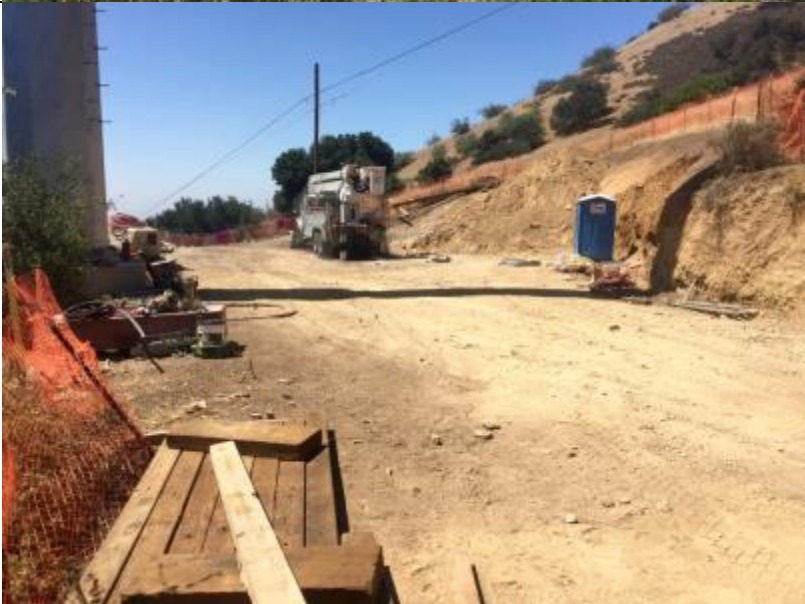
Photo 5 – Equipment remains onsite.

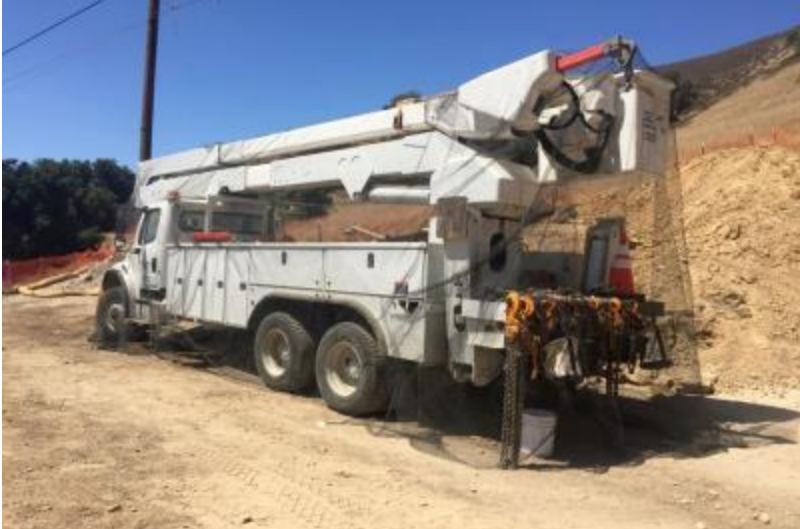
Photo 6 – Bird netting installed over a boom truck.
7/13/16	12 kV PPL A2 Pad

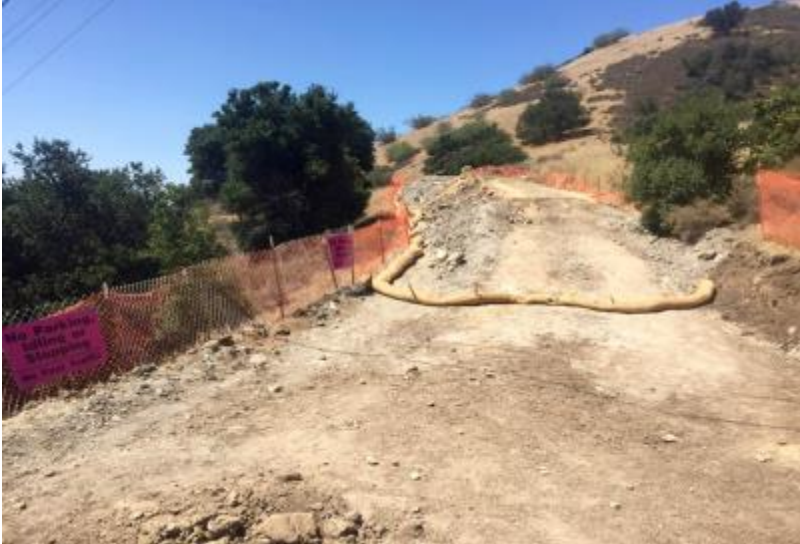
Photo 7 – Tailings from the drilling operation remain onsite and will be used during restoration of the crane pad.
7/13/16	New Admin/IM Building

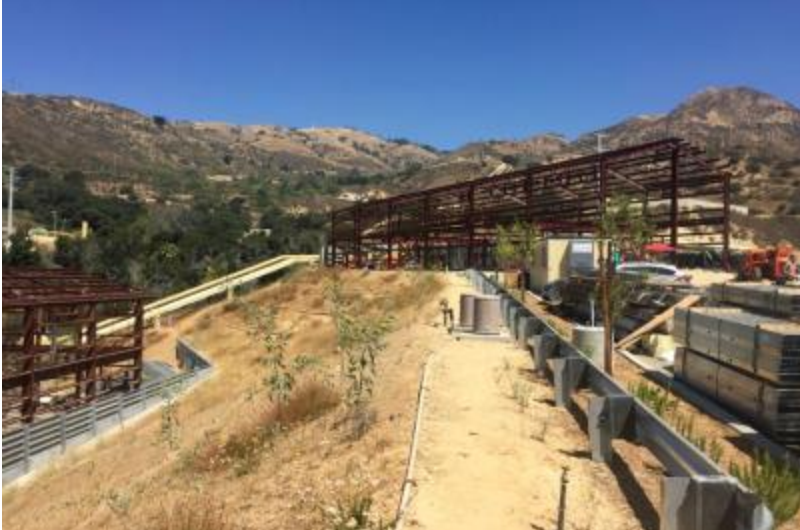
Photo 8 – Building construction continues.

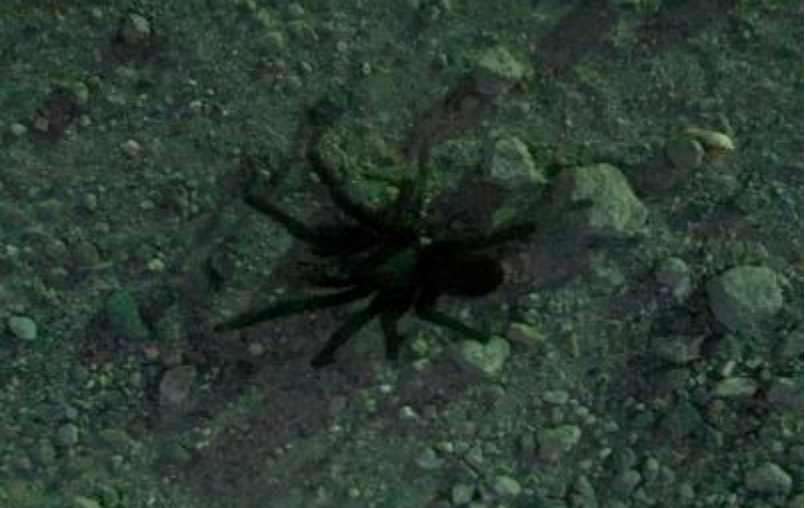
Photo 1 – Large tarantula seen on the road between the CCS and Limekiln Creek.
7/20/16	CCS

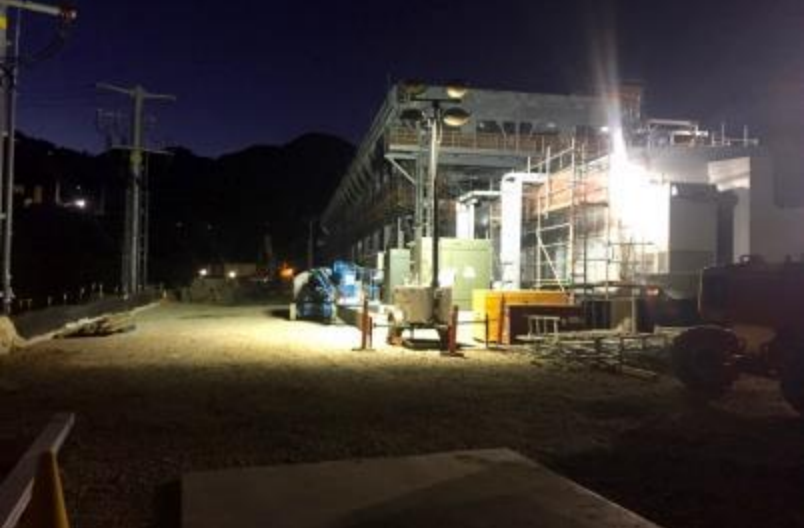
Photo 2 – Night lighting is shielded and directed downwards.
7/20/16	CCS

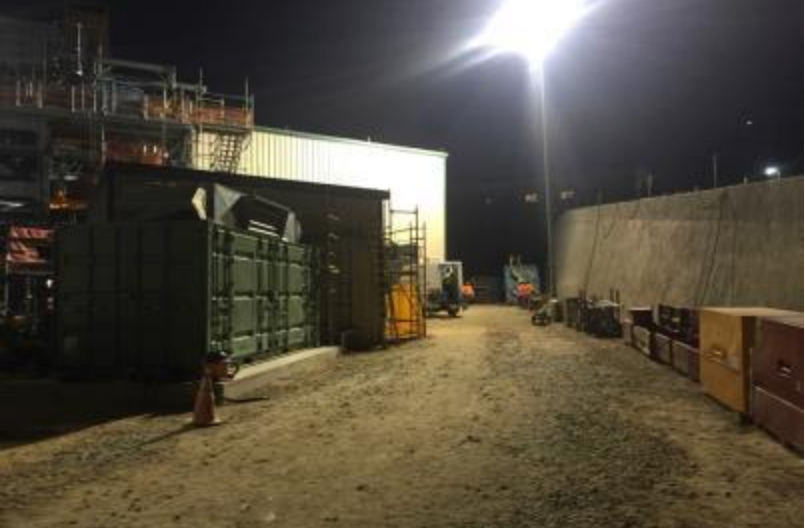
Photo 3 – The work space around the CCS is well-organized and free of trash.

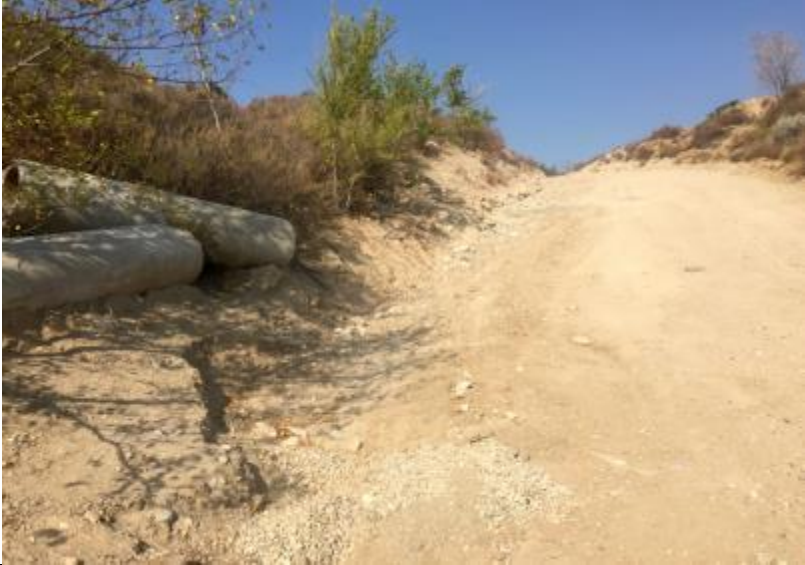
My first stop was the TSP 7 access road, pole location, and the staging area. Issues I noted at the access road include the lack of any erosion control measures on the steep portion of the road (Photo 1) and the pile of gravel bags stacked at the entrance gate (Photo 4). While neither are currently pressing issues, the TSP 7 access road has had problems with erosion during the rainy season, and this will continue until a solution is implemented. These gravel bags were used during the previous winter and, therefore, will not function properly by the next rainy season. The bags should be disposed of, or the gravel should be rebagged for next winter. The area around TSP 7 had been weeded and appeared to be in good condition, with abundant native plant recruitment (Photo 2). The staging area had some construction materials stockpiled at the site (Photo 3).

Photo 1 – Steep portion of the TSP 7 access road; no erosion control measures are in place.
7/28/16	TSP 7

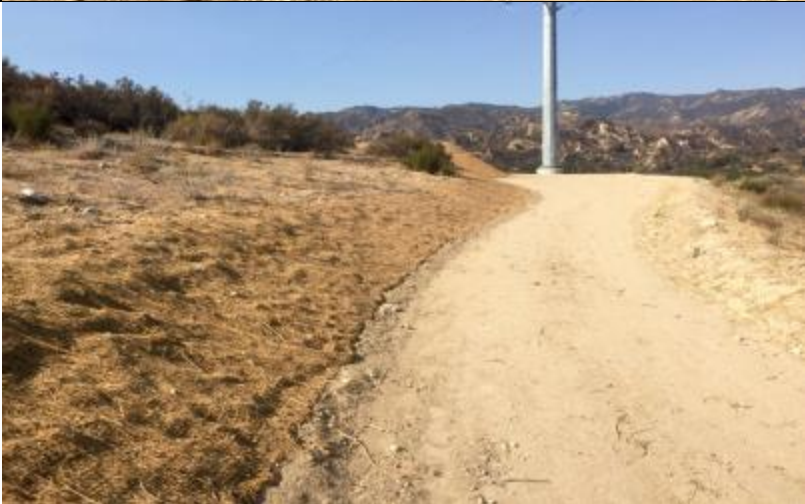
Photo 2 – Weeding work appears to be adequate along the roadway to the pole site.
7/28/16	TSP 7 Staging Area

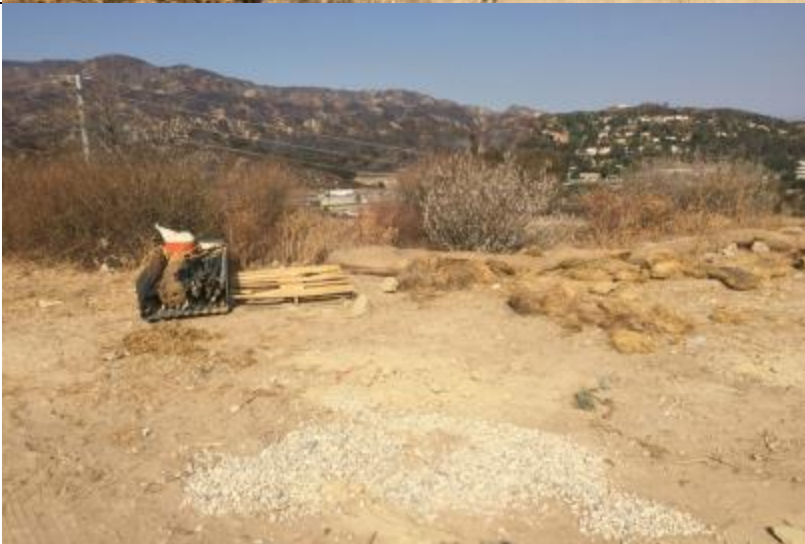
Photo 3 – Some BMP materials and some McCarthy drain metal remains within the staging area.

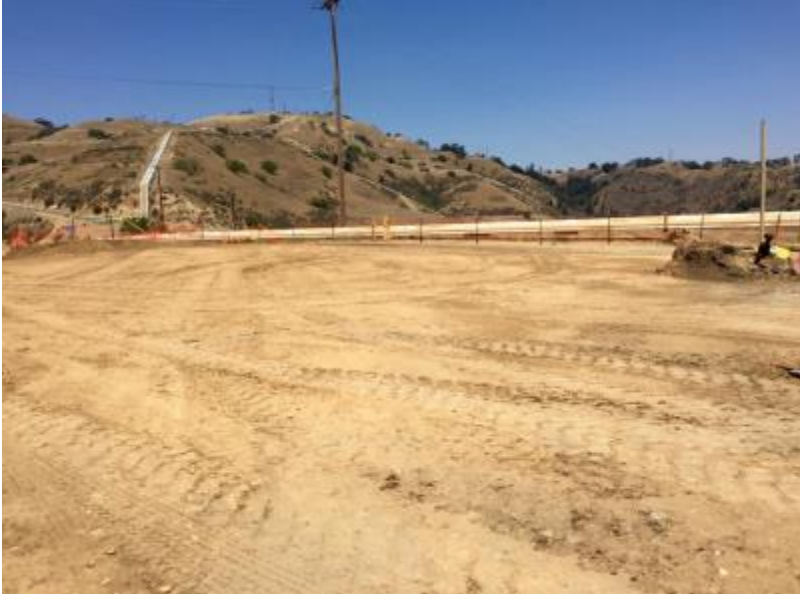
<p>Photo 10 – Location where soil was stockpiled for eventual disposal in the PS-42 Fill Site.</p>
