Aliso Canyon Turbine Replacement Project Construction Non-Compliance Report

| January 12, 2016 | Location: | Wiley Canyon – Drainage No. 4 (near TSP 25) GPS: 34.349294 - 118.534475 |

NCR-09

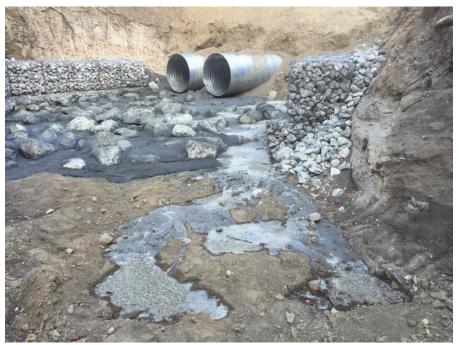
On November 4, 2015, a subcontractor to Henkel's & McCoy (H&M) – Southern California Edison's (SCE's) subtransmission construction contractor – was working in Drainage No. 4 (adjacent to the TSP 24/25 access road). This subcontracting crew was installing a concrete headwall in the drainage using a concrete truck. After the headwall had been poured the subcontracted concrete truck pump operator released approximately 20 gallons of concrete washout wastewater into the drainage. Over half (approximately 12 gallons) of the wastewater spread onto the installed drainage apron while the rest (approximately 8 gallons) flowed onto the dirt floor of the drainage (Attachment 1).

Photo 1: Concrete washout wastewater pooling in Drainage 4. November 4, 2015.

As described in H&M's report of the incident (Attachment 2), the operator did not understand that he was supposed to keep the washout wastewater in the machine's hopper and haul it off site for disposal because he did not receive adequate Worker Environmental Awareness Program (WEAP) Training. The CPUC Compliance Manager was notified of this incident separately by the CPUC's Compliance Monitor and by SCE's Environmental Coordinator on November 5, 2015, the day after the incident occurred. During the CPUC's follow-up with SCE's Environmental Coordinator, it was explained that the subcontractor cement truck driver and pump operator received an abbreviated WEAP because of their status as "delivery drivers". This abbreviated training was given under the assumption that the driver and operator would only deliver concrete and leave the site. After the spill was noticed by other crew members, cleanup was initiated. The contaminated soil was picked up and removed from the site for proper disposal. After it dried, the residual washout layer was cleaned off of the drainage apron with wire brushes and scrapers, and then vacuumed for proper disposal.

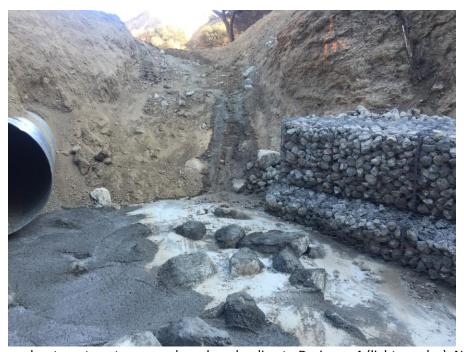
Photo 2: Concrete washout wastewater poured on slope leading to Drainage 4 (lighter color). November 4, 2015.
