Aliso Canyon Turbine Replacement Project Construction Non-Compliance Report

Incident Date:	<u>December 15 to 29, 2016</u>	Report No.:	<u>NCR-12</u>
Date Submitted:	<u>2/28/2017</u>	Location:	<u>Aliso Canyon Natural Gas Storage Field</u>
Level:	<u>Level 3 Non-Compliance</u>	Relevant Plan/Measure:	<u>MMCRP; NPDES General Permit (SWPPP); APM GE-2</u>
Current Land Use:	<u>Disturbed</u>	Sensitive Resources:	<u>Hydrology, Biology: drainages, riparian</u>

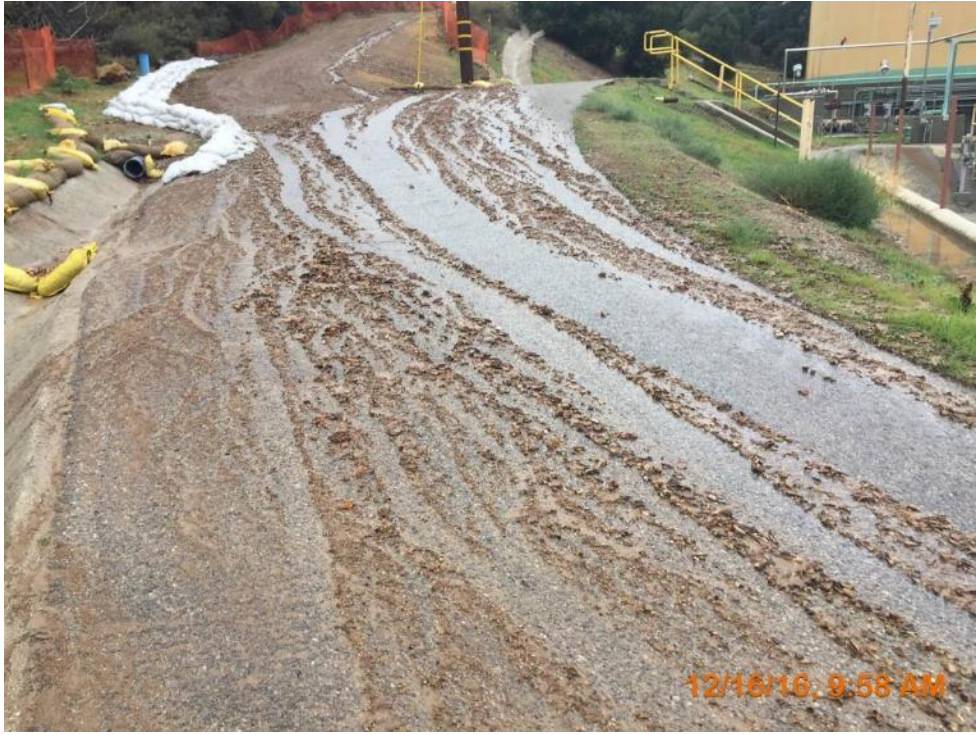
December 15-16 Storms. The first of these storms was December 15-16 and SCG reported 2.5 inches of rain. SCG conducted a 24-hour storm inspection on Friday December 16 and identified several BMP deficiencies, including sediment on the paved road that leads to the TSP-A2/12kV access road (Attachment 1: Photo 1). Photo 2 shows a close-up of some of the sediment that came off the access road; the BMPs in this photo do not appear to have sufficiently captured sediment. SCG noted in the SWPPP inspection that maintenance was scheduled for Monday December 19. Photos from December 19 indicate that the sediment was cleared off the road and from straw wattles and check dams. In response to the large amount of sediment that ran off the access road, SCG placed gravel check dams along a rill that formed (Photo 3).

Photo 1: Stormwater runoff from the 12kV/TSP-A2 access road (in distance) onto the paved road. Sediment from the TSP-A2 dirt access road appears to have been moved by stormwater and deposited on paved road. December 16, 2016 (photo by SCG)

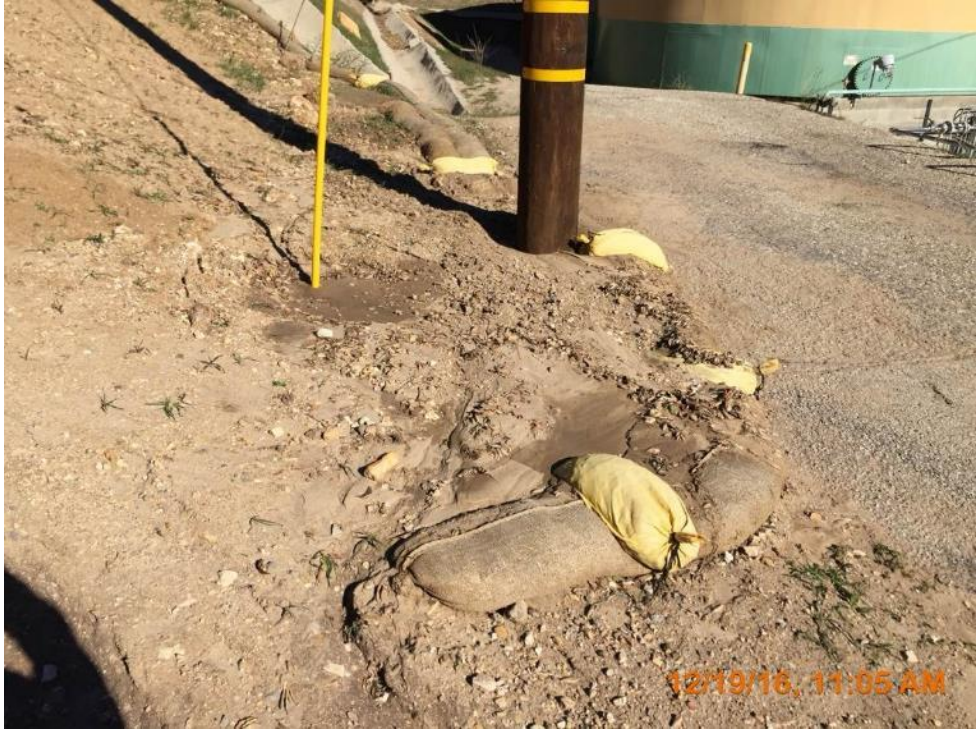
Photo 2: Sediment build-up on straw wattles at the base of the 12kV/TSP-A2 access road, where it meets the paved road. December 19, 2016 (photo by SCG)

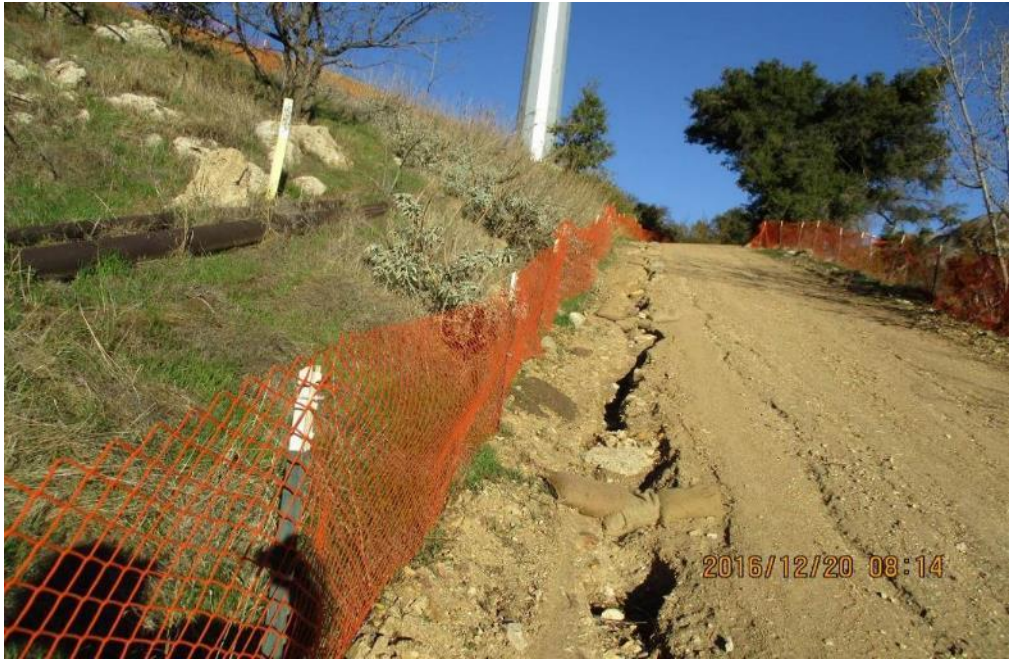
Photo 3: Gravel bag check dams placed along a rill that was formed by stormwater erosion. December 20, 2016 (photo by SCG)

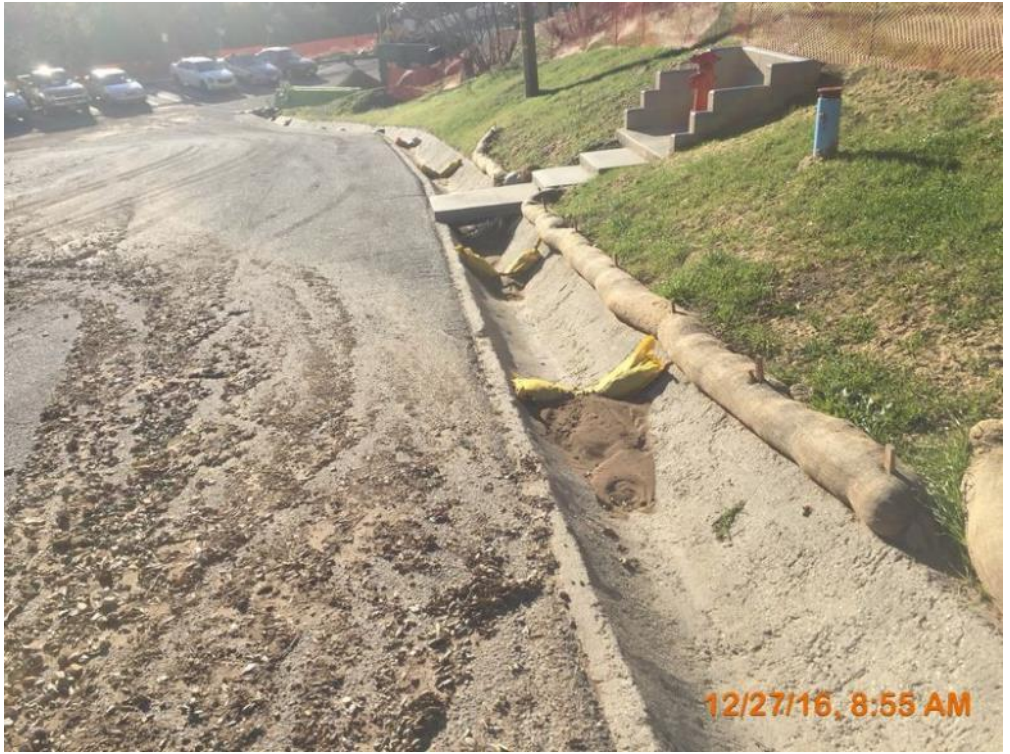
SCG reported to the CPUC/E&E Team in their December 21 email (Attachment 2) that since the rain event of December 21-22 and the upcoming predicted rain event for December 23-24 were within 48 hours, the conditions of their SWPPP consider these one storm. Because the QSP conducted a 24-hour inspection on December 22, and no construction would occur from December 23 to 26, the QSP would conduct the post-storm inspection on December 27. On December 27, SCG noted an additional 2.4 inches for a total of 3.35 inches over the December 21-27 time period. The post-storm SWPPP inspection report on December 27 and the BMP tracker do not indicate sediment on the paved road below the TSP-A2/12kV access road; however, SCG's photo (Photo 4) does show part of the paved road covered in sediment.

Photo 4: Sediment on the paved road below the TSP-A2 access road and sediment accumulated on check dams. December 27, 2016 (photo by SCG)

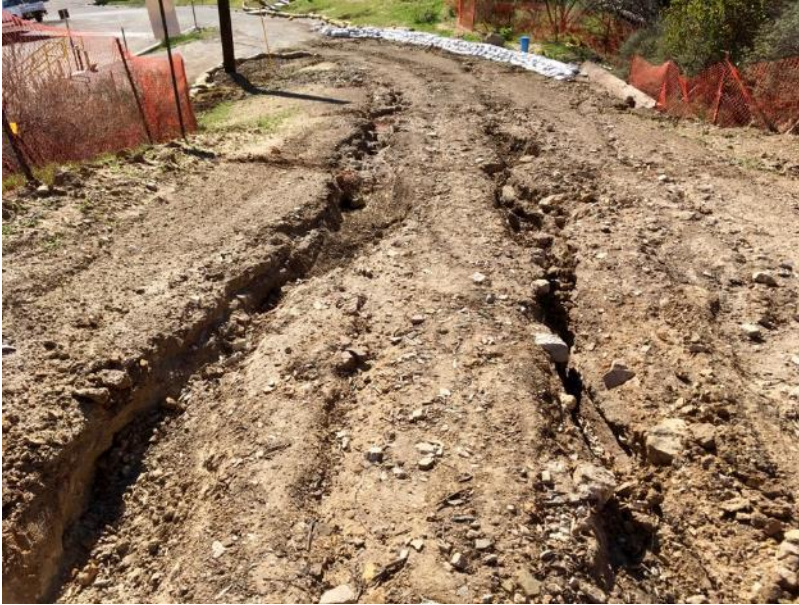
Photo 5: 12kv/TSP-A2 access road with deep rills. December 29, 2016 (photo by CPUC)

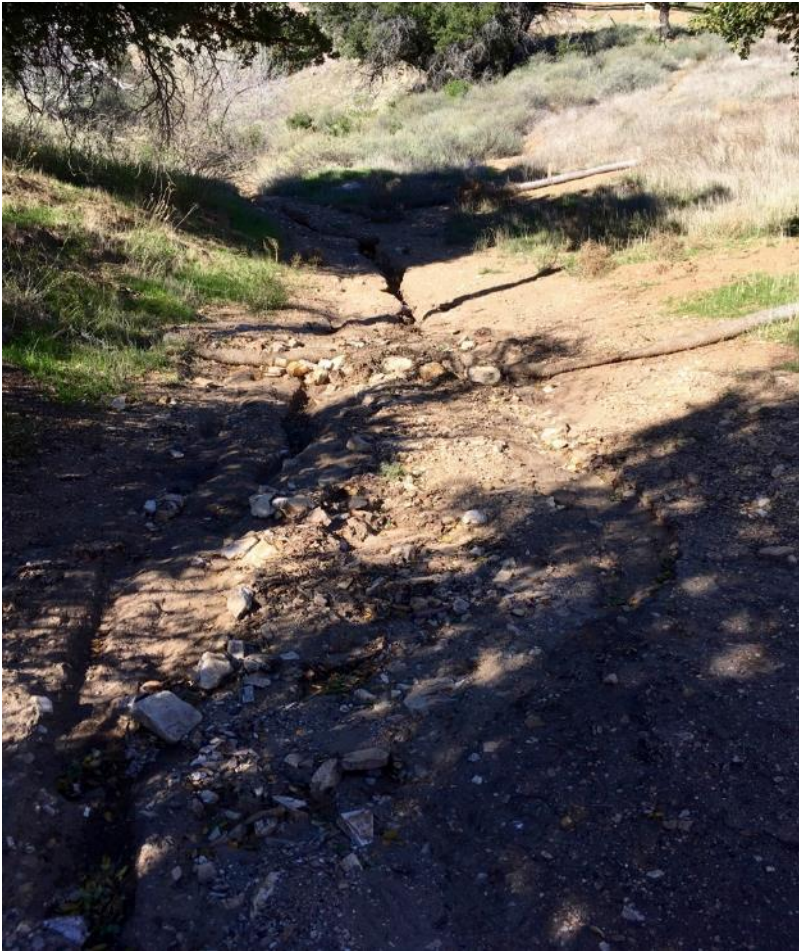
Photo 6: Erosion and rills where the oak swale meets the 12kv/TSP-A2 access road. December 29, 2016 (photo by CPUC)

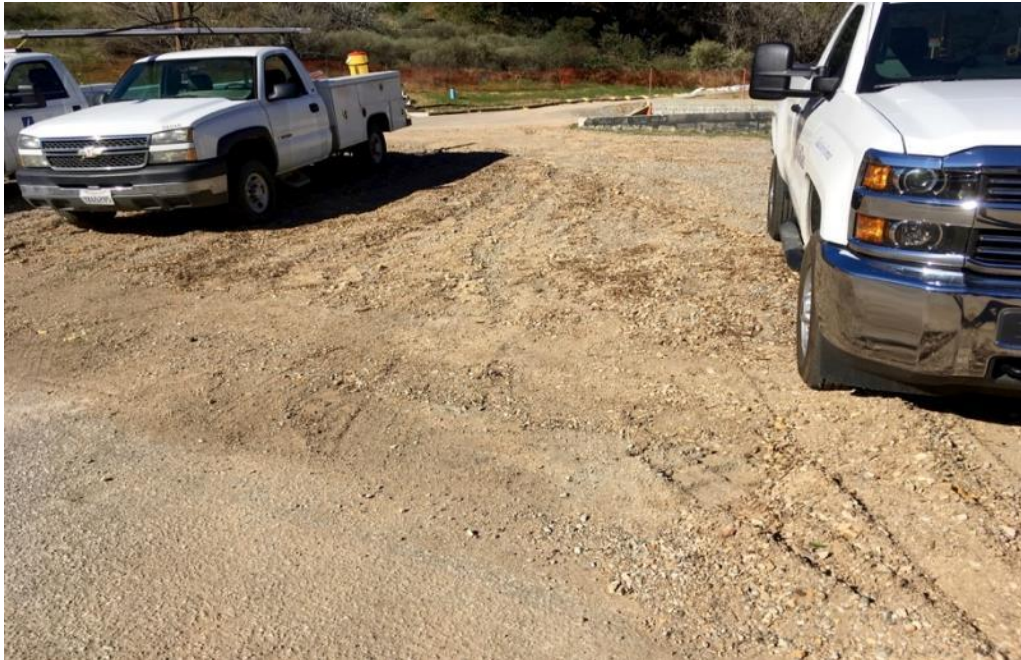
Photo 7: Sediment traveled from the TSP-A2 access road, in the background, through the parking area. December 29, 2016 (photo by CPUC)

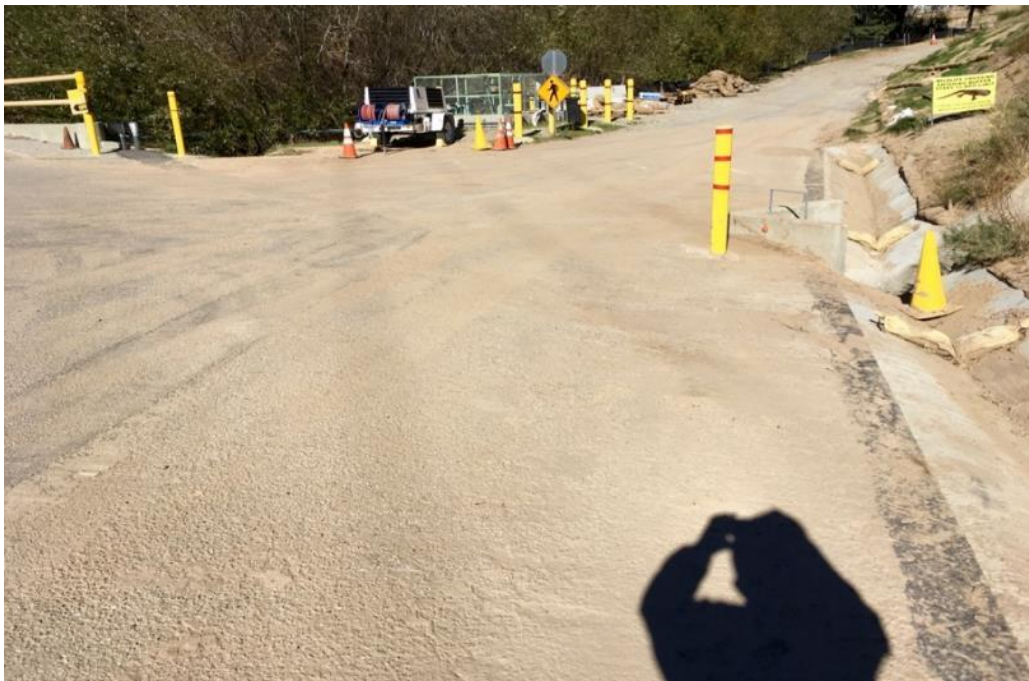
Photo 8: Sediment accumulated at the base of the CCS. December 29, 2016 (photo by CPUC)

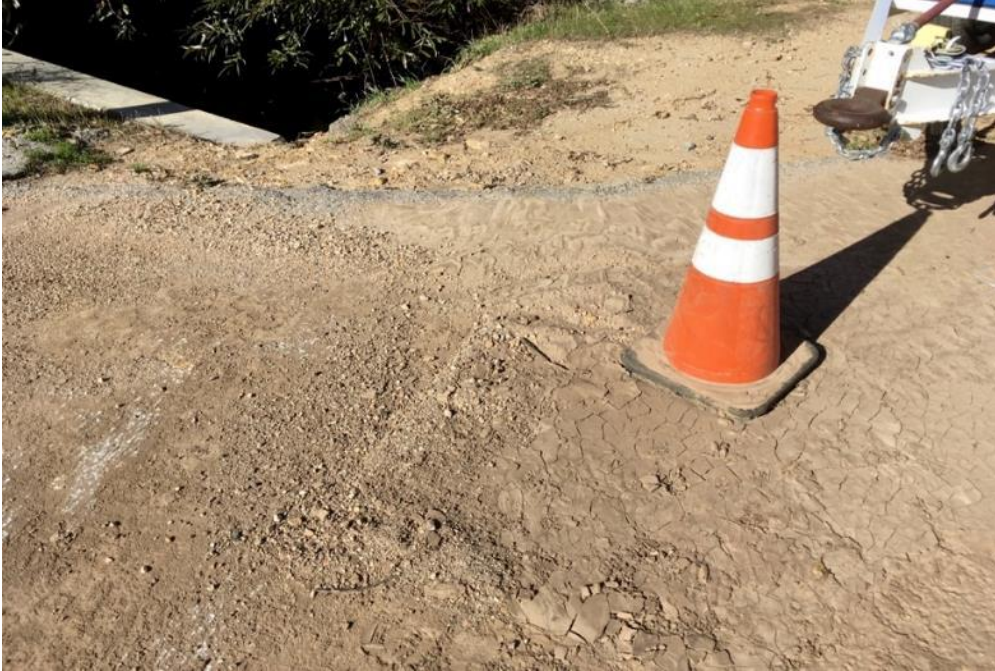
December 29 CPUC/E & E Compliance Monitor Inspection. On December 29 the CPUC/E & E Compliance Monitor visited the storage field and reported that erosion had occurred above and on the TSP-A2/12kV access road and sediment appeared to have traveled off the road and down toward Limekiln Creek. There was evidence that erosion occurred within the oak swale below the Natural Substation and continued all the way down the TSP-A2/12kV access road. The CPUC/E & E Compliance Monitor noted that the access road was badly eroded with deep rills up to 2 feet deep (Photo 5). It appeared from remaining mud and sediment that muddy water and sediment then traveled from the access road to the parking area below, across the Limekiln Creek bridge, and to the base of the Central Compressor Station, where the water ponded (Photos 6-8). The CPUC/E & E Compliance Monitor also noted that mud had accumulated on the edge of the creek, indicating that muddy water and sediment likely flowed into the creek (Photo 9).

Photo 9: Sediment accumulated near the upper retention pond and likely flowed into the pond. December 29, 2016 (photo by CPUC)
