January 14, 2020

Re: Monthly Report Summary #20 for the Mesa 500-kV Substation Project

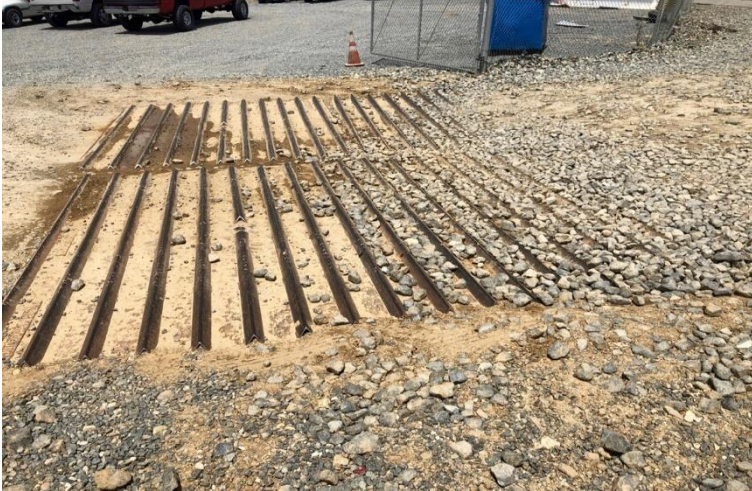
- On May 6, 14, 20, and 30 2019, the CPUC Compliance Monitor observed the entry/exit rumble plates at the main entrance filled with mud and rock. The CPUC Compliance Monitor recommended increasing the frequency of maintaining the rumble plates clean when safe to do so.

Photo 1 – Rubble plate at the project entrance.
5/06/19	Mesa Substation

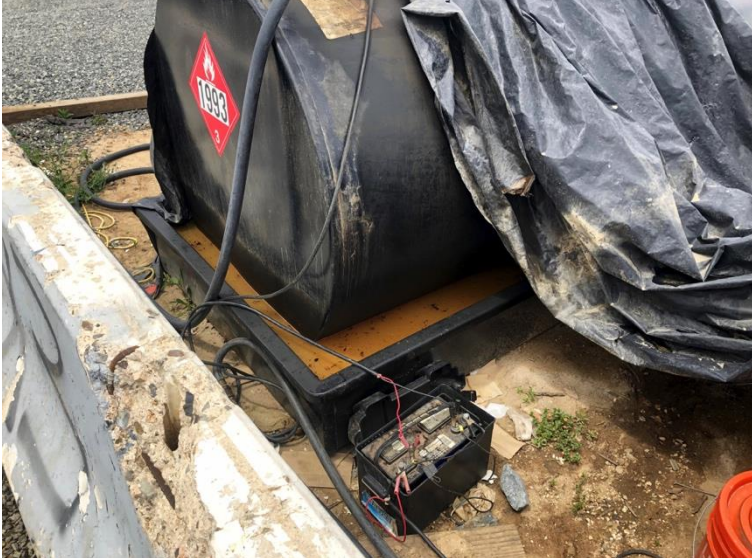
There were two fuel tanks near the project entrance, both of which sat in secondary containment bins. I noted that the bins were nearly full of brownish-colored oily water – Photo 3. I spoke to Power Grade personnel Craig Pernot and foreman Willie Clark about the level of fluid in these containment bins; both indicated that they would have them pumped out. Willie Clark mentioned that the brown coloring of the water was likely due to rust, and the liquid would be properly disposed.

Photo 3 – Fuel tank containment is nearly full.

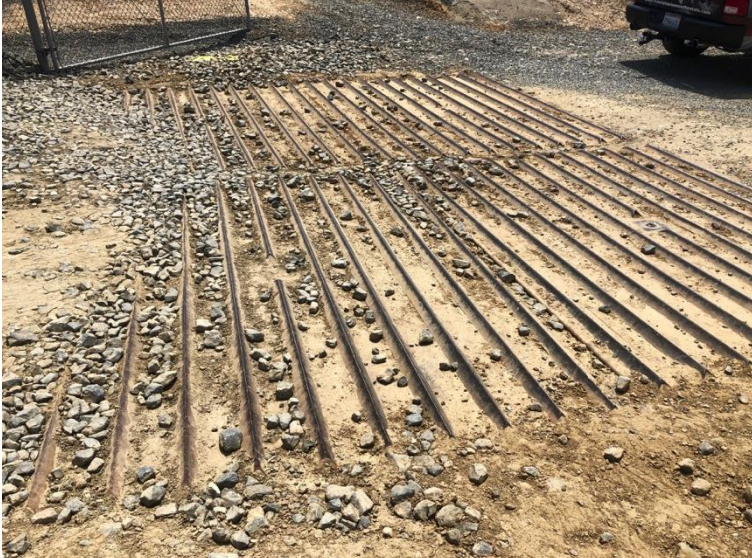
Photo 1 – Rumble plate at the project entrance.
5/14/19	Mesa Substation

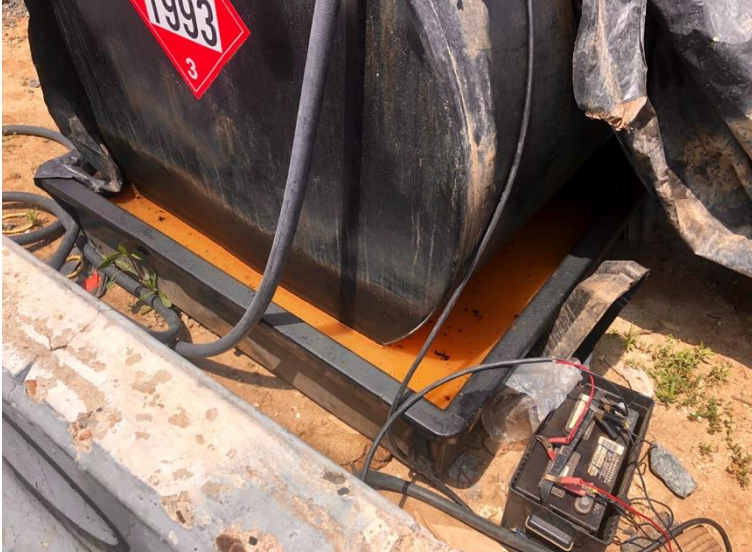
- On May 14, 2019, the CPUC Compliance Monitor noted. The CPUC Compliance Monitor spoke to onsite personnel and recommended getting secondary containment pumped out, especially since there was a rainstorm predicted later in the week.

Photo 3 – Fuel tank containment is nearly full.

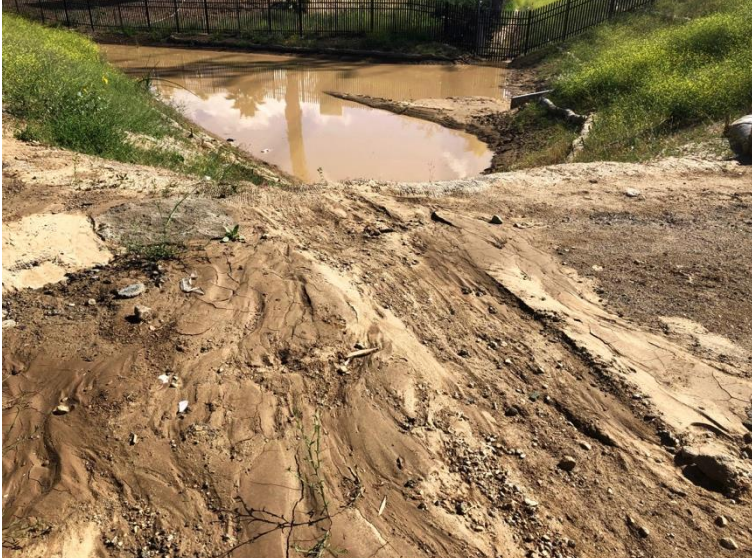
- On May 20 12, 2019, the CPUC Compliance Monitor inspected the small triangle retention basin full of muddy water. He noted that no BMPs were placed to slow and divert stormwater runoff coming down from the southern portion of the project site; the berm that had been diverting this water into the detention basin was gone. Fortunately, the small concrete curb poured at the Markland exit diverted the water north and into the triangle retention basin. Thus, it appeared that the stormwater runoff did not run out onto the public road, however lots of mud (3 to 4 inches deep) dropped out in front of the Markland curb and sediment laden water exited the site via the standpipe in the retention basin. The CPUC Compliance Monitor notified onsite personnel of these concerns and recommended upgrading BMPs in this area to avoid potential runoff offsite.

<p>Photo 15 – Triangle retention basin is full – note the flow lines where water entered the basin. Photo facing north.</p>
5/20/19	Mesa Substation

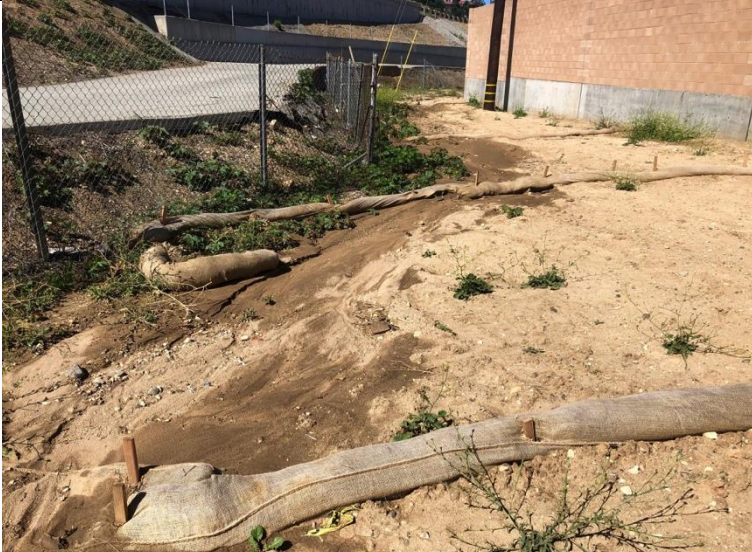
Stormwater runoff also flowed down along the outside of the southern boundary wall. The BMPs were not repaired; therefore, sediment-laden water did not slow down as it approached the drain inlet – Photos 16 & 17 – and a piece of filter fabric was

<p>Photo 17 – BMPs south of the southern wall. Photo facing southwest.</p>

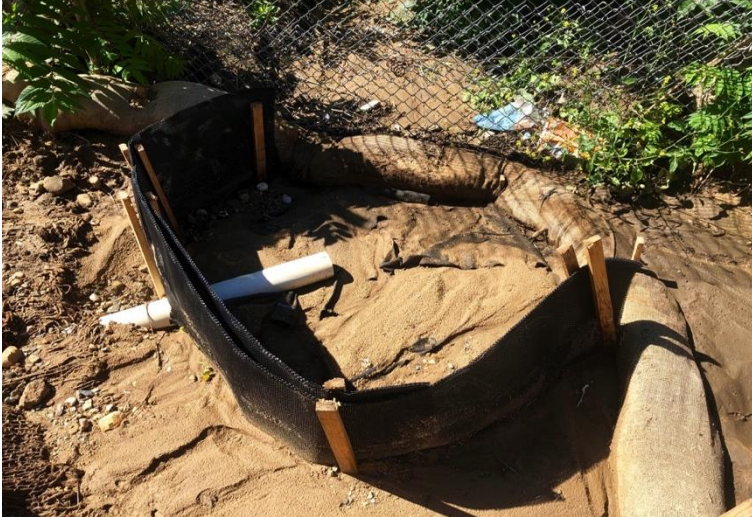
Photo 19 – Project drain inlet blocked by sediment and filter fabric.
5/20/19	Mesa Substation

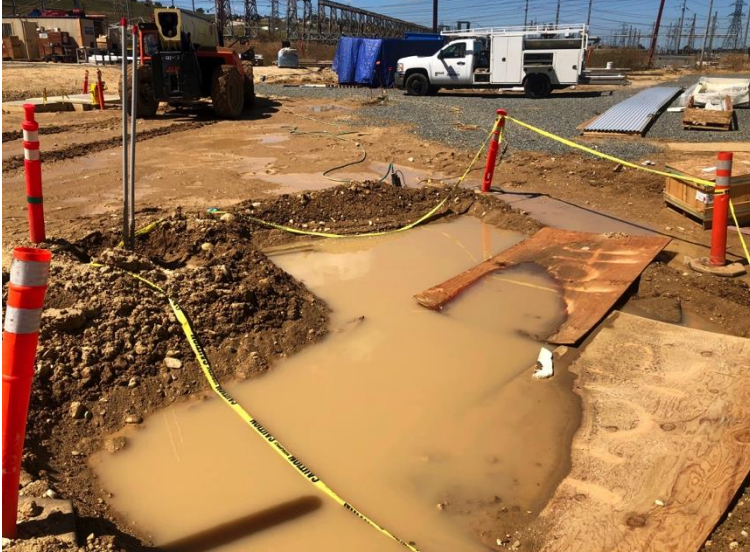
Photo 22 – Poned water within the Mesa Operations Building site. Photo facing west.
5/20/19	Mesa Substation – Mesa Operations Building

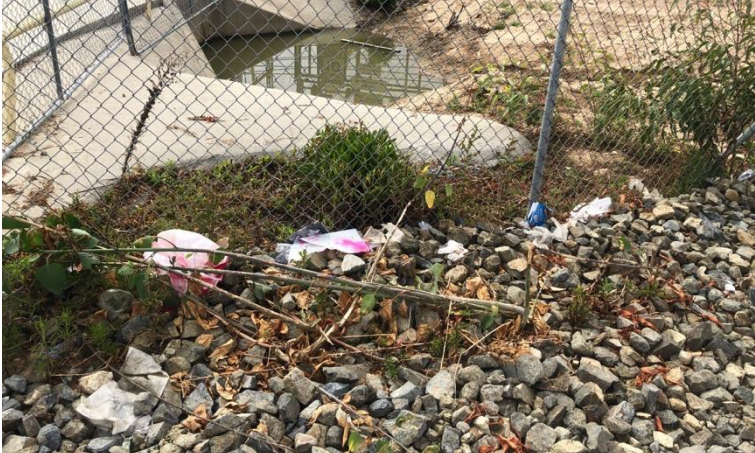
- On May 30, 2019, the CPUC Compliance Monitor noted a large quantity of trash accumulating along the fencing near the entrance. The CPUC Compliance Monitor notified onsite personnel about the trash buildup.

Photo 1 – Trash accumulation along the entry fence.
5/30/19	Mesa Substation

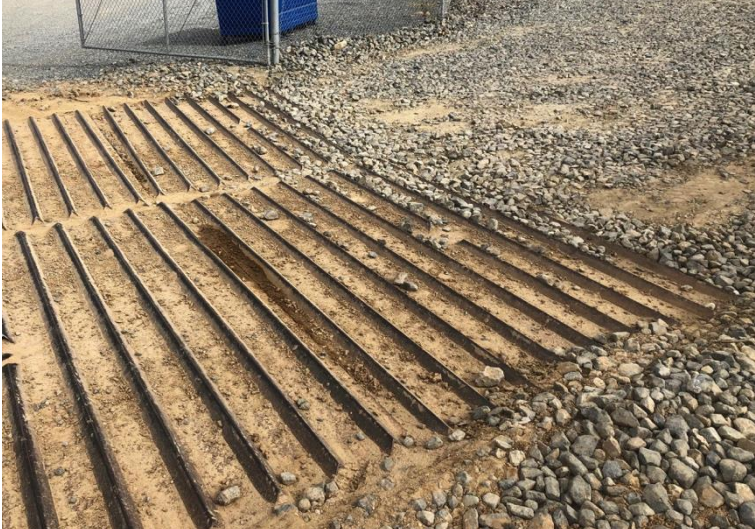
Photo 2 – Exit/Entry BMP needs minor maintenance.
5/30/19	Mesa Substation

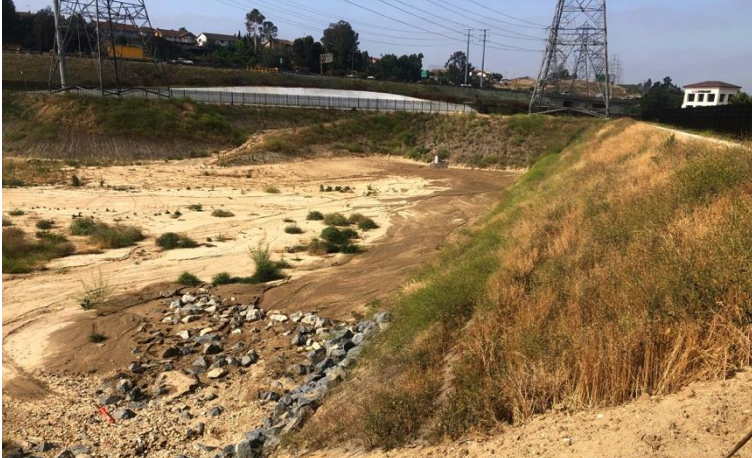
Photo 11 – Detention basin – note the muddy conditions and the weed growth on the banks. Photo facing southwest.
5/30/19	Mesa Substation

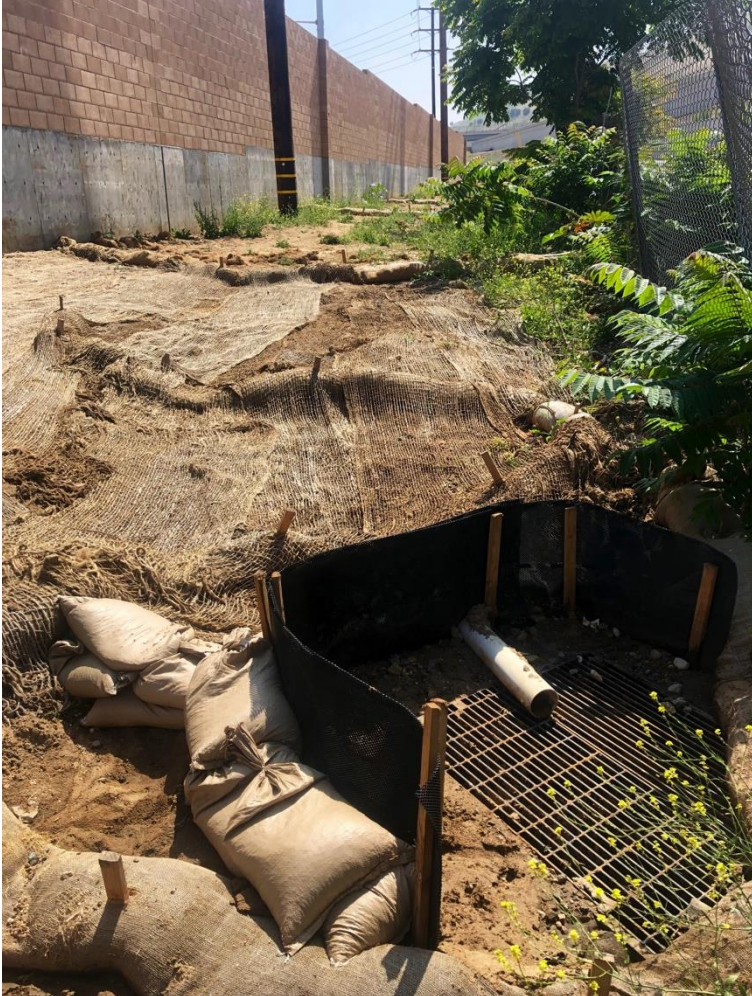
<p>Photo 14 – BMPs outside of the southern wall – only a few minor upgrades were installed. Photo facing east.</p>
