**Re: Monthly Report Summary #44 for the Mesa 500-kV Substation Project**

## Mesa 500-kV Substation Project CPUC Site Inspection Form

<b>Project:</b>	Mesa 500-kV Substation Project	<b>Date:</b>	May 6, 2021
<b>Project Proponent:</b>	Southern California Edison (SCE)	<b>Report #:</b>	VS166
<b>Lead Agency:</b>	California Public Utilities Commission (CPUC)	<b>Monitor(s):</b>	Vince Semonsen
<b>CPUC PM:</b>	Connie Chen, Energy Division	<b>AM/PM Weather:</b>	Sunny, mild, and calm
<b>WSP CM:</b>	Silvia Yanez	<b>Start/End time:</b>	1130 to 1330
<b>Project NTP(s):</b>	Notice to Proceed (NTP)-1, NTP-2

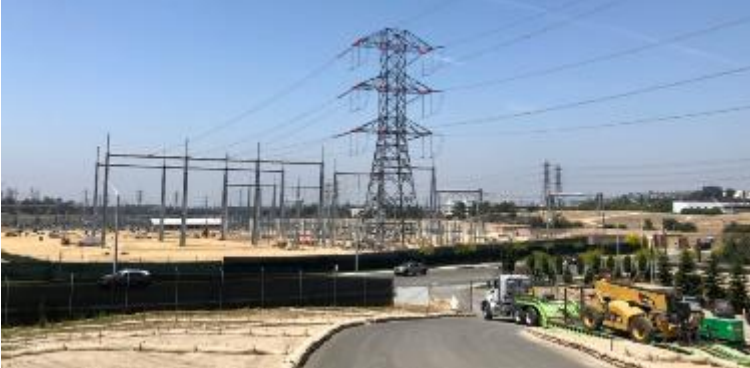
Grande Drive entrance for a brief tailboard meeting before heading into the work area. At the construction trailers I spoke briefly with the SCE project manager. Photo 1 shows an overview of the project site from the construction trailers.

<p>Photo 1 – Overview of the 500-kV substation work facing west from the construction trailers.</p>
05/06/21	Mesa Substation

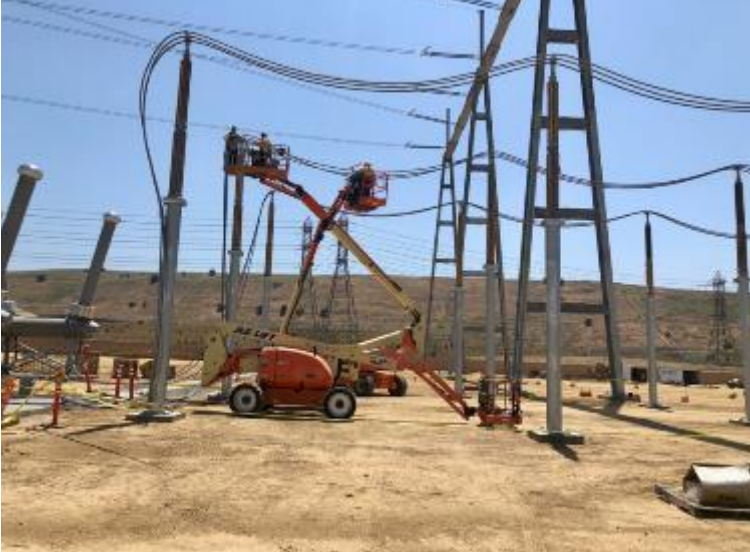
Most of the crews were working within the Phase 4 area. Crews were stringing wire and/or cable from the newly erected infrastructure (Photo 2) and installing more of the substation infrastructure (Photo 3). A drill rig was onsite excavating foundation holes (Photo 4); other crews were installing the rebar cages in the foundation holes prior to the concrete pour (Photos 5 and 6).

<p>Photo 2 – Wire work within the 500-kV substation area. Photo facing south.</p>
05/06/21	Mesa Substation

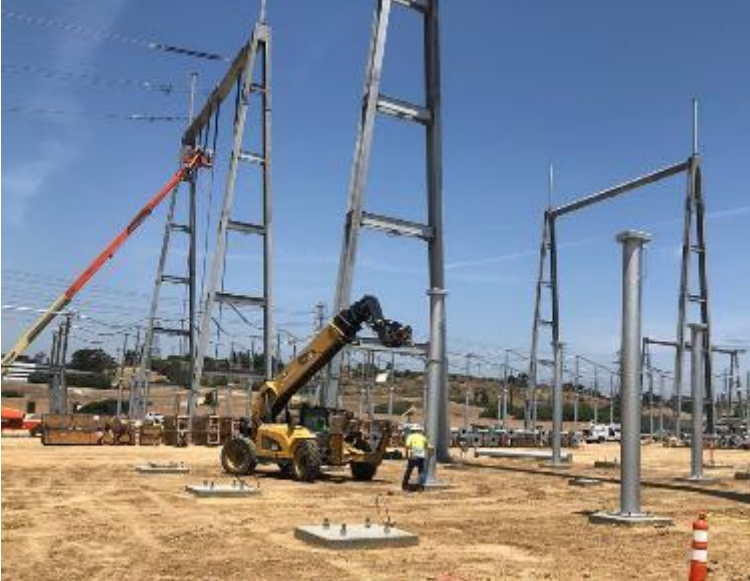
<p>Photo 3 – Erecting the substation infrastructure. Photo facing north.</p>

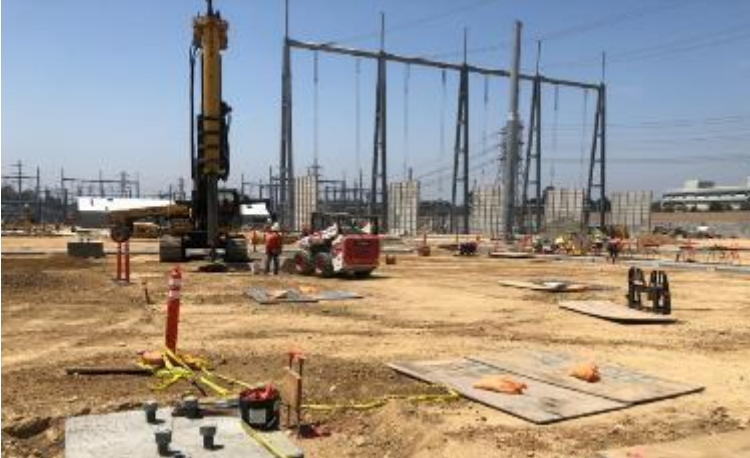
Photo 4 – Foundation hole drilling continued. Photo facing west.
05/06/21	Mesa Substation

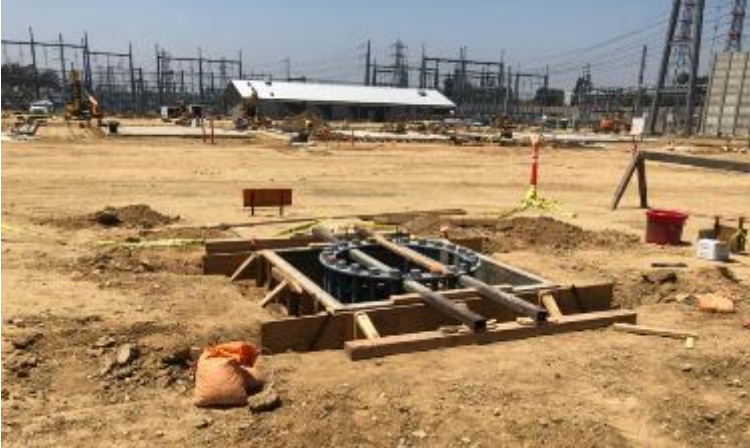
Photo 5 – Rebar cages installed in the foundation holes. Photo facing west.
05/06/21	Mesa Substation

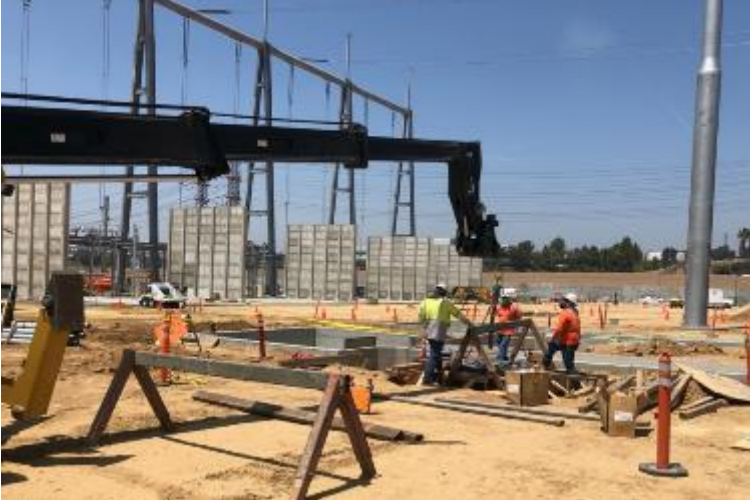
Photo 6 – Crews installed rebar cages in the foundation holes. Photo facing north.

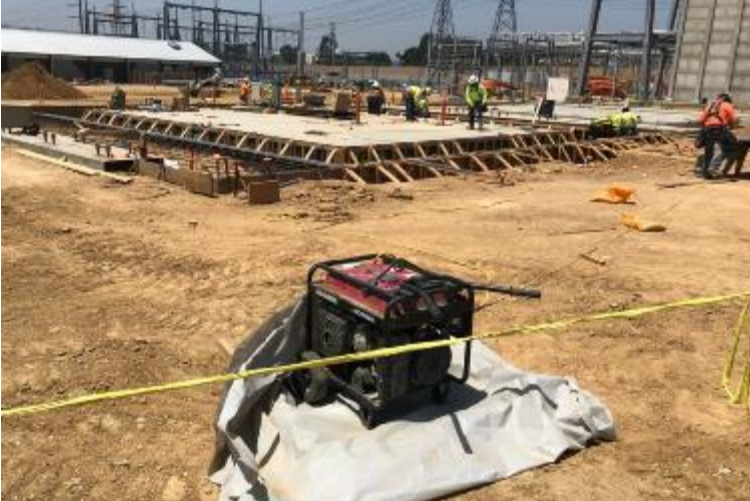
Work on the transformer foundations continued with all gas-powered generators sitting in plastic lined catch basins (Photo 7).

Photo 7 – Transformer foundation forms with containment under the gas-powered generators. Photo facing northwest.
05/06/21	Mesa Substation

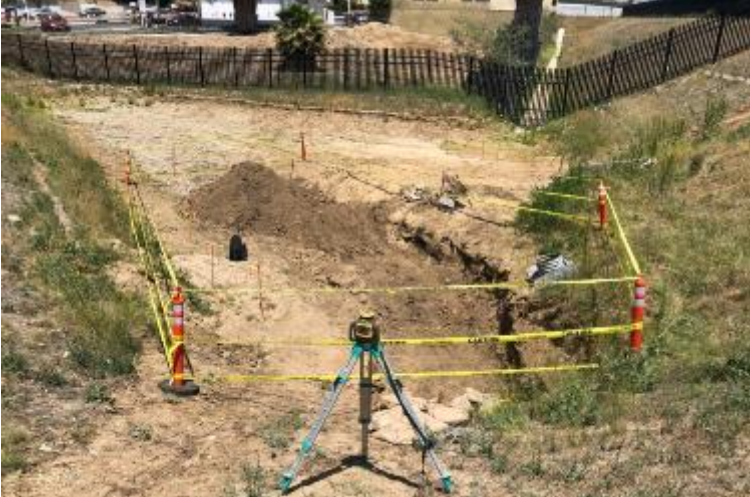
Sediment removal had begun in the small triangular catch basin (Photo 8). Issues arose with the catch basin elevations, so a survey crew was working at the site.

Photo 8 – Sediment removal in the triangular catch basin. Photo facing north.

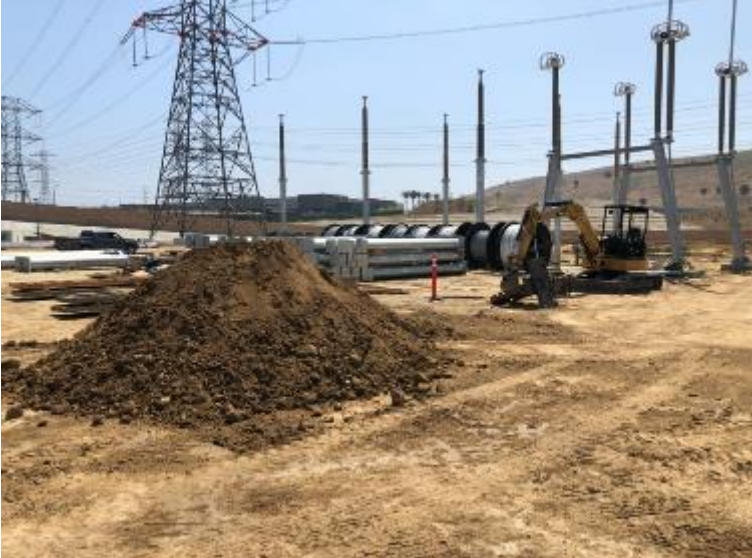
Photo 1 – Excess soil from conduit trench excavation. Photo facing southeast.
05/12/21	Mesa Substation

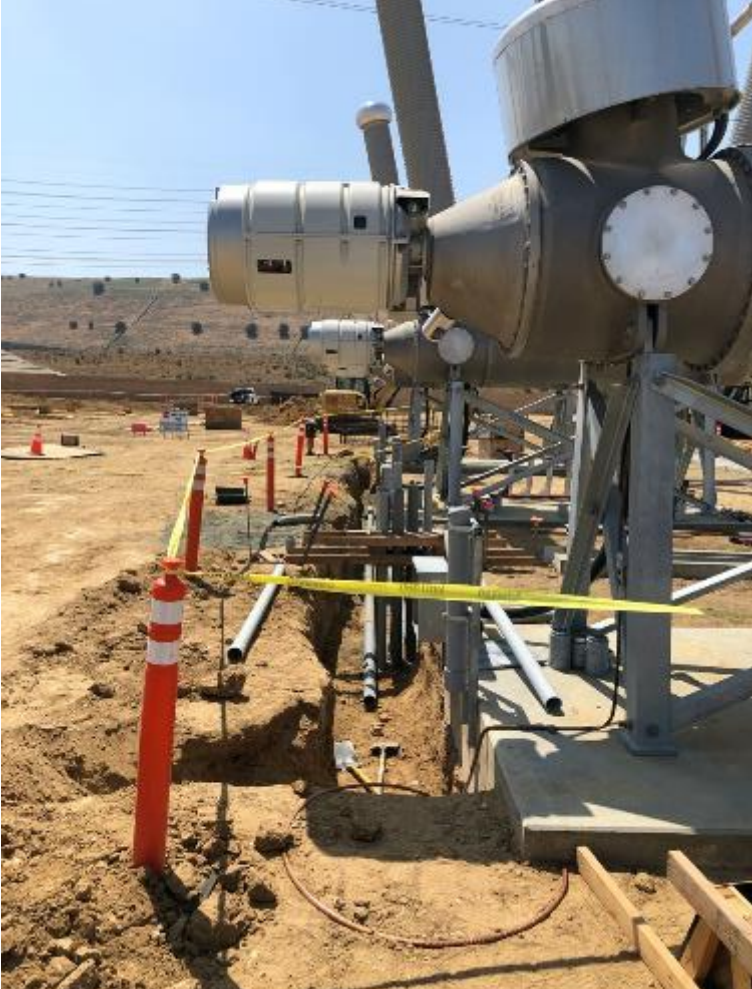
Photo 2 – Conduit installation around the 500-kV infrastructure. Photo facing south.

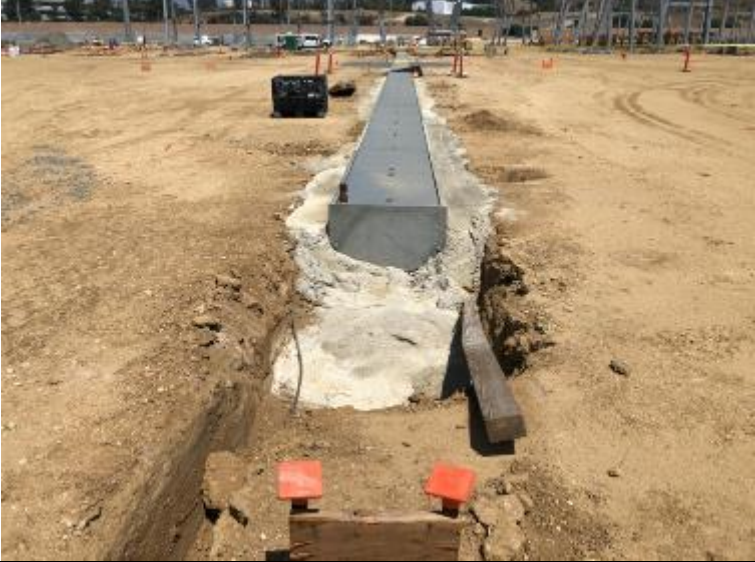
Photo 3 – Cable tray installation. Photo facing north.
05/12/21	Mesa Substation

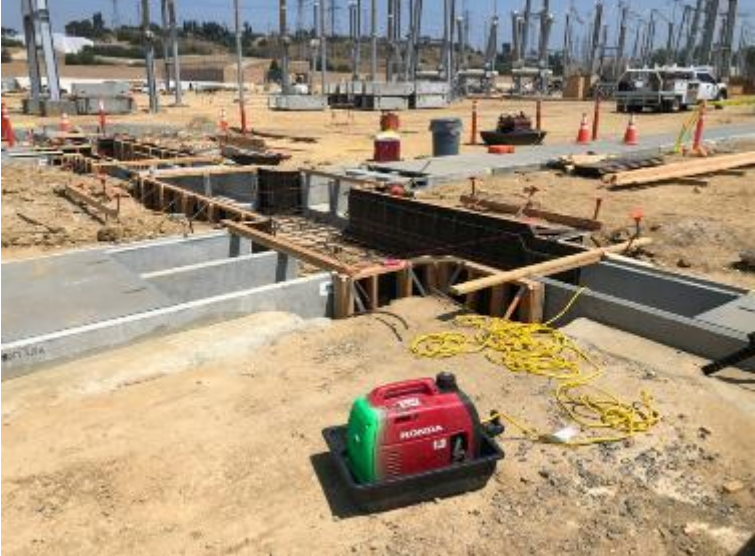
Photo 4 – Cable tray installation with the gas-powered generators contained. Photo facing northeast.

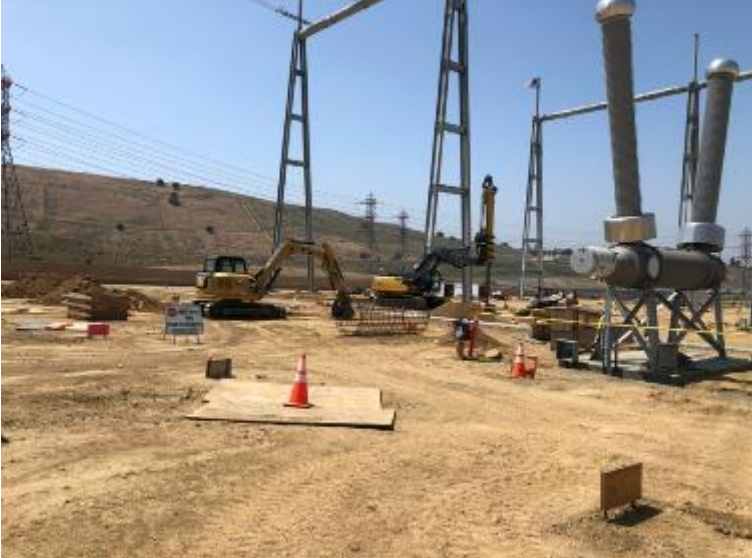
Drilling foundation holes continued, with the holes covered with plywood when not being worked on (Photo 5). Newly poured tower foundations were observed within the Phase 4 area (Photo 6)

Photo 5 – Drilling for tower foundations. Photo facing southwest.
05/12/21	Mesa Substation

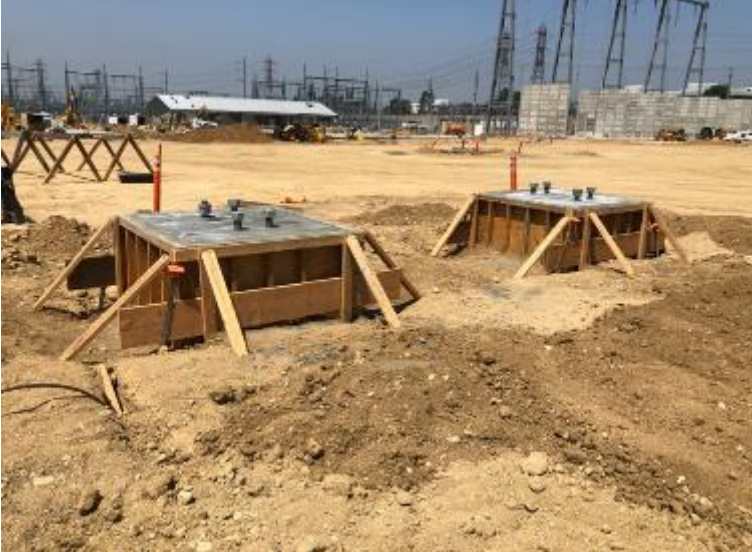
Photo 6 – Newly poured tower foundations. Photo facing northwest.

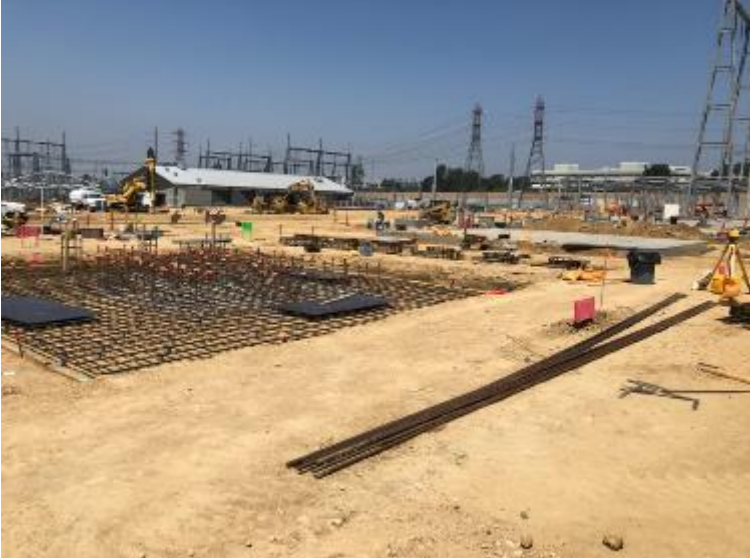
Work on the transformer foundations continued with the gas-powered generators sitting in plastic lined catch basins (Photo 7).

Photo 7 – Ongoing transformer foundation installation work. Photo facing northwest.
05/12/21	Mesa Substation	 	Photo 8 – Mourning doves nesting in the dumpster with cones in place. Photo facing west.

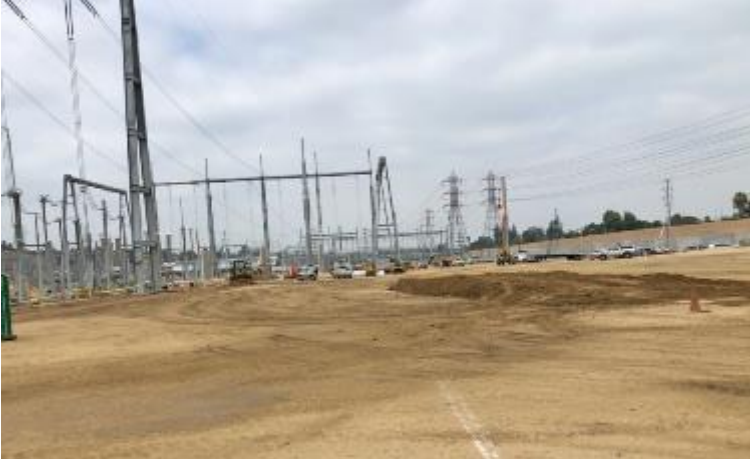
The excavation for foundations and cable trenches, along with the drilling for tower foundations, was generating excess soil that was stockpiled onsite (Photos 1 and 2). This soil was transported with a belly scraper and was regularly sprayed by the water truck. This soil would be transported offsite in the near future.

Photo 1 – Temporary stockpile of excess soil from conduit trench excavation. Photo facing west.
05/19/21	Mesa Substation

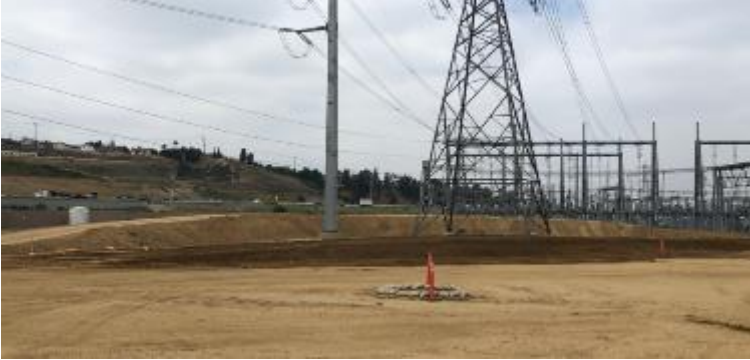
Photo 2 – The main excess soil stockpile near the southwestern portion of the Phase 4 area. Photo facing southwest.
05/19/21	Mesa Substation

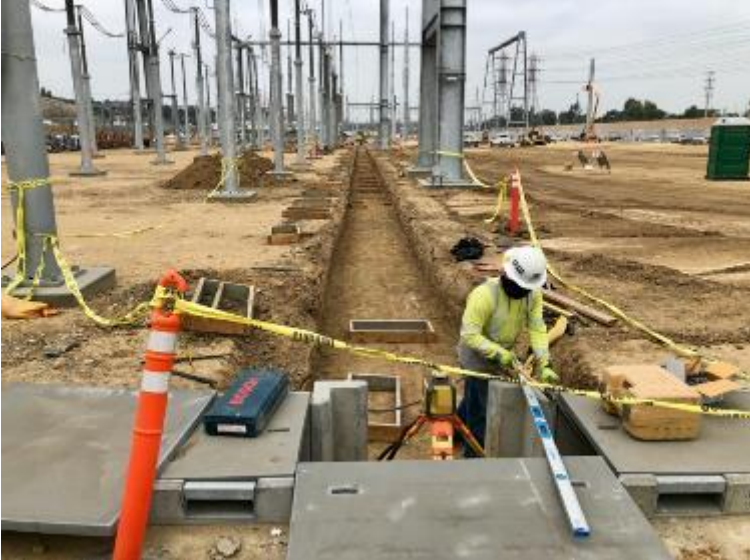
Photo 3 – Cable tray installation. Photo facing west.

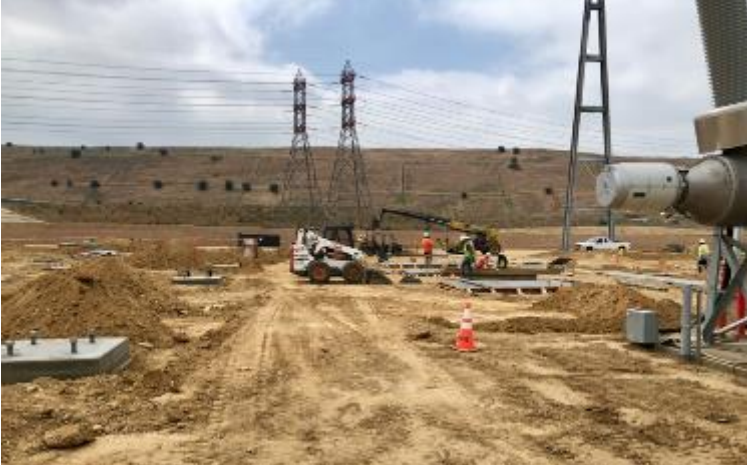
Photo 4 – Infrastructure foundation work. Photo facing south.
05/19/21	Mesa Substation

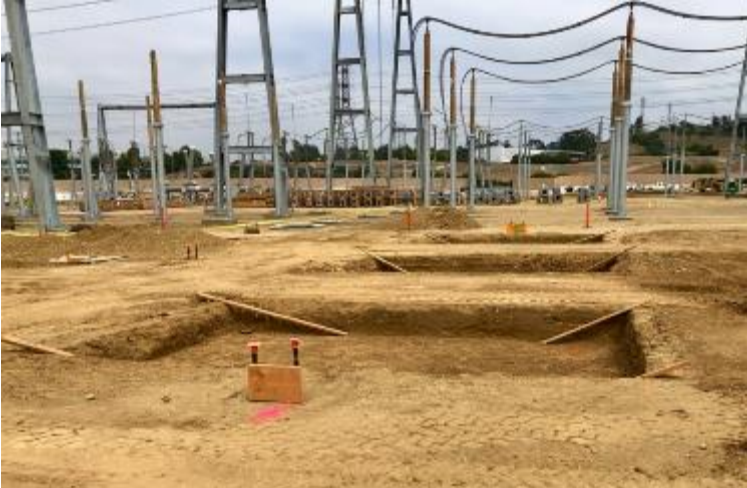
Photo 5 – Foundation holes with climbing structures installed. Photo facing north.
05/19/21	Mesa Substation

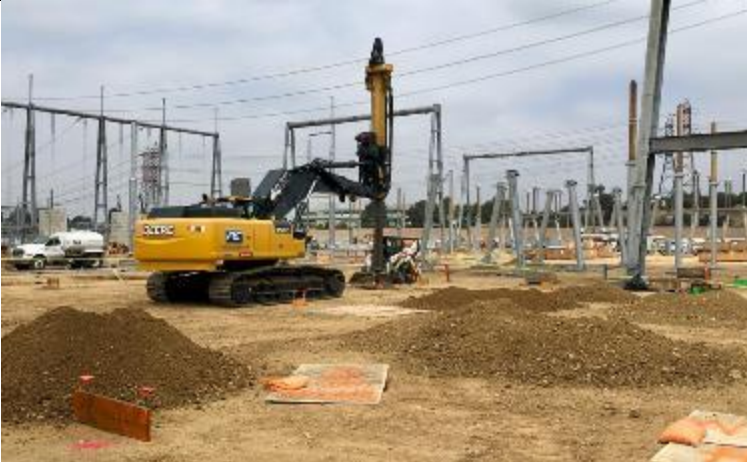
Photo 6 – Drilling work for tower foundations. Photo facing northwest.

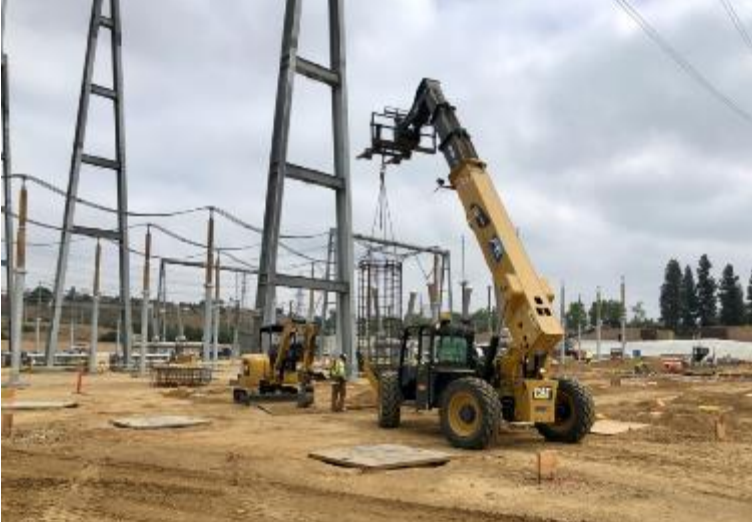
Photo 7 – Installation of rebar cages in the newly drilled holes. Photo facing northwest.
05/19/21	Mesa Substation

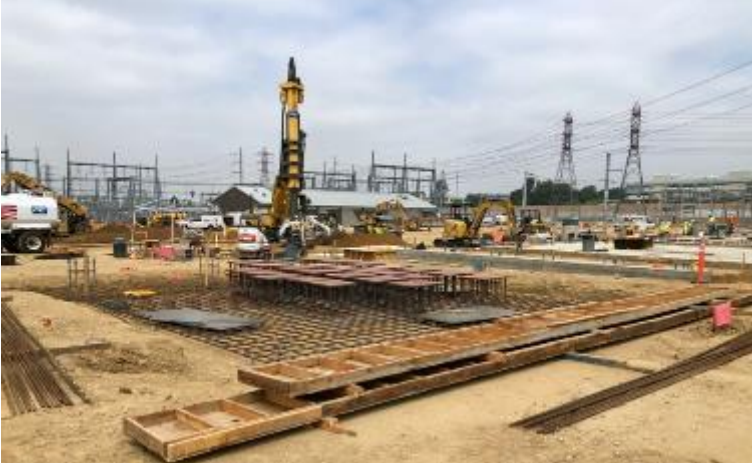
Photo 8 – Transformer foundation work. Photo facing northwest.
05/19/21	Mesa Substation

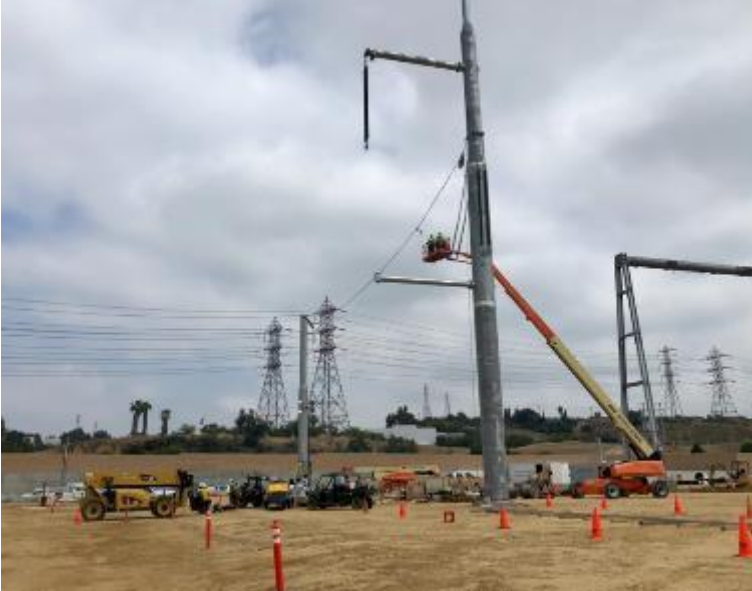
Photo 9 – Wire pulling was underway. Photo facing north.

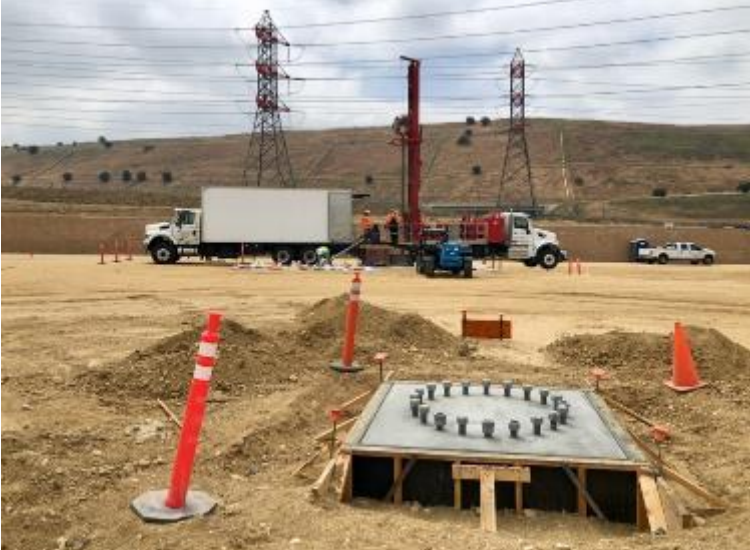
Photo 10 – Water well monitoring station being installed near the southern boundary wall. Photo facing south.
05/19/21	Mesa Substation

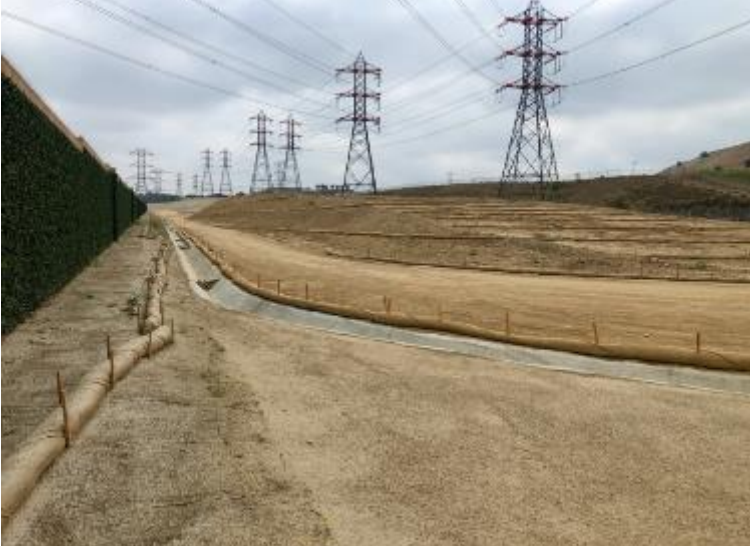
I inspected the best management practices (BMPs) on the soil stockpile outside of the southern boundary wall; they appeared adequate and in good condition (Photo 11).

Photo 11 – BMPs in and around the soil stockpile outside of the southern boundary wall. Photo facing east.

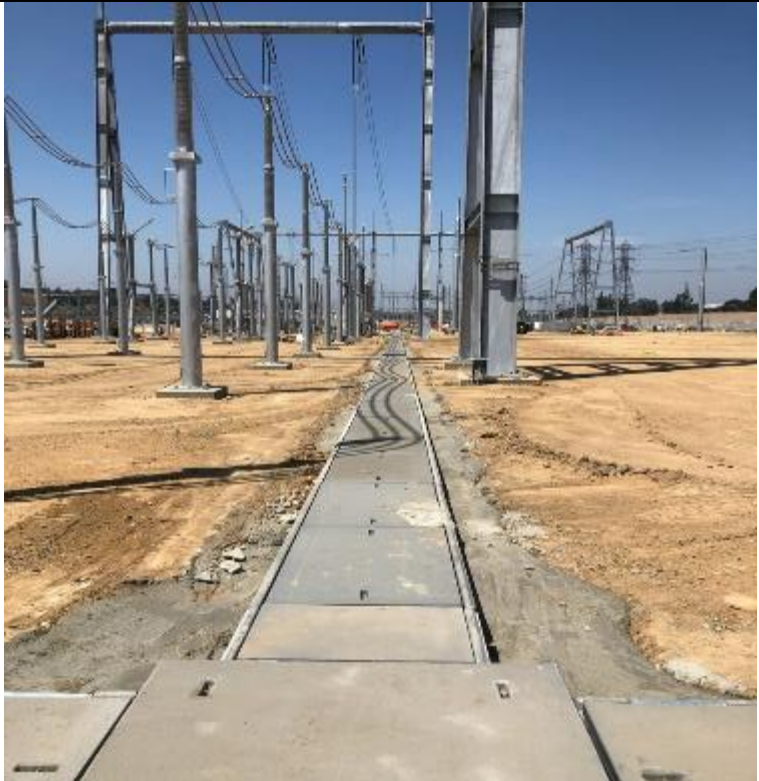
Photo 1 – New cable tray trenches installed. Photo facing west.

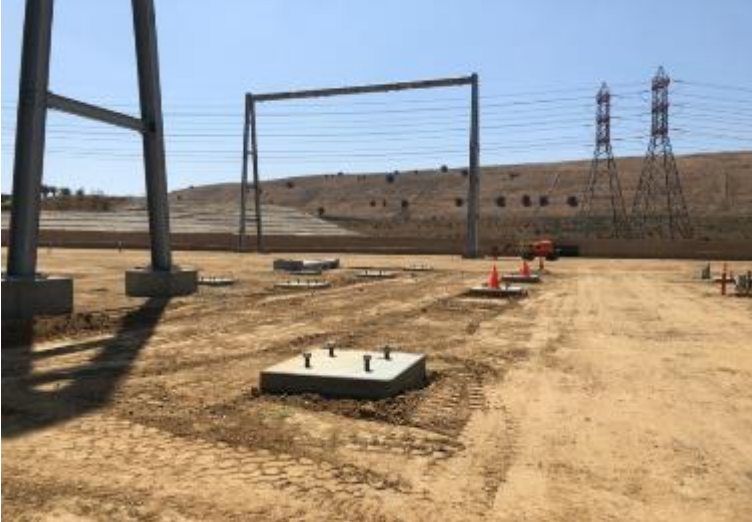
Photo 2 – Substation foundations were poured. Photo facing south.
05/28/21	Mesa Substation

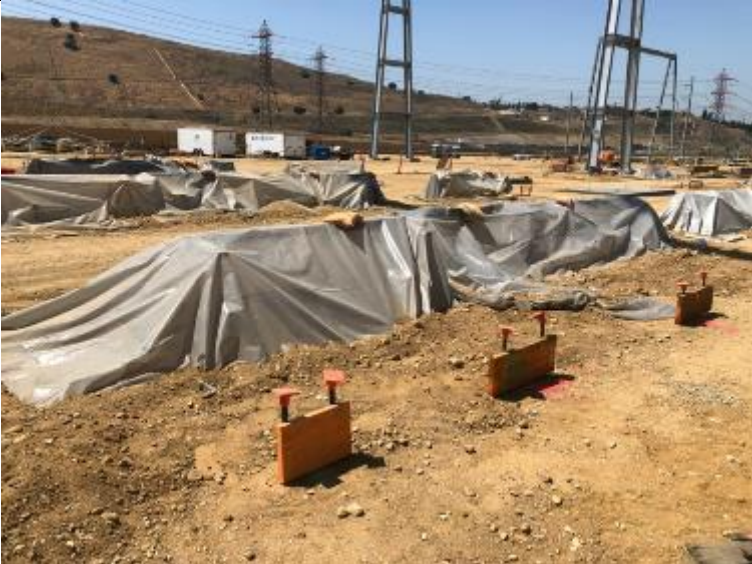
Photo 3 – Covered excavations. Photo facing southwest.
05/28/21	Mesa Substation

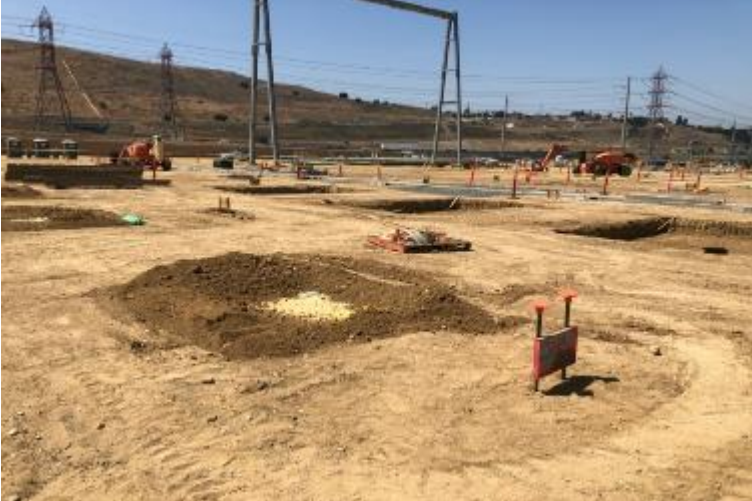
Photo 4 – Covered foundation holes and shallow excavation with climbing structures. Photo facing southwest.

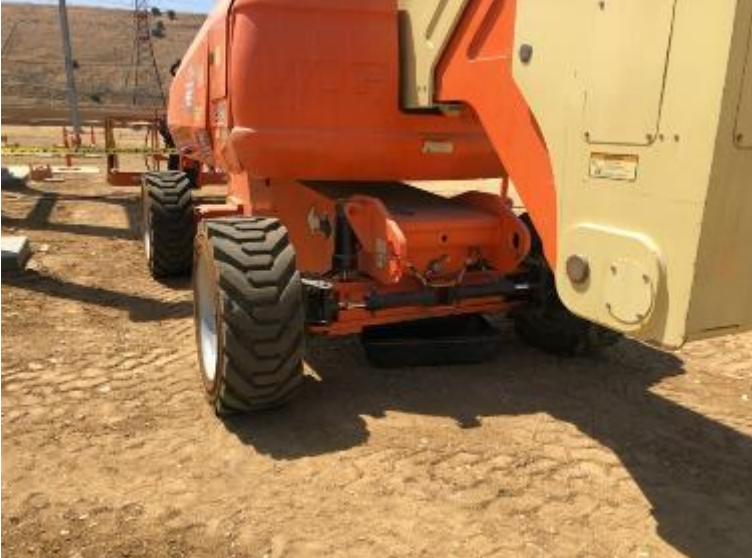
Photo 5 – Drip pans were in place under parked equipment. Photo facing south.
05/28/21	Mesa Substation

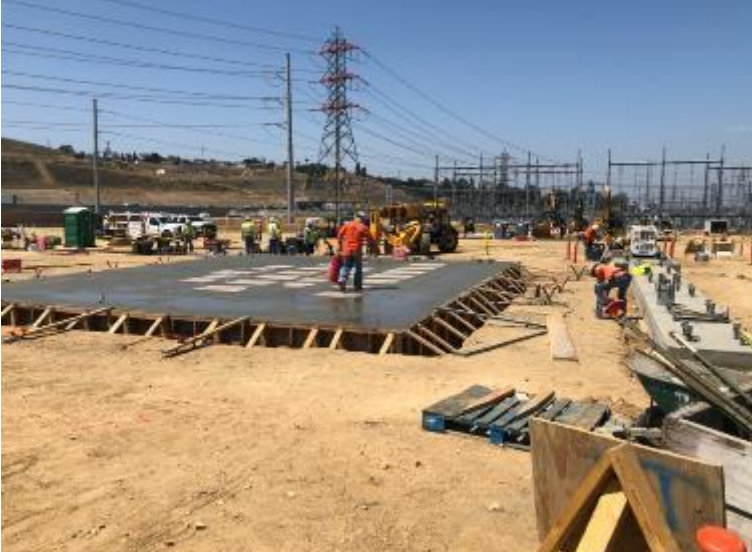
One crew was still onsite completing pouring concrete for transformer foundation (Photo 6). Cable tray work was completed since my last site visit (Photo 1), along with foundation installation (Photo 2). The site was in good condition with drip pans in place and excavations either covered or with climbing structures in place (Photos 3, 4, and 5). Substation infrastructure was being stockpiled onsite (Photo 7).

Photo 6 – Transformer foundation work. Photo facing west.
