**Re: Monthly Report Summary #45 for the Mesa 500-kV Substation Project**

CPUC Site Inspection Reports

## Mesa 500-kV Substation Project CPUC Site Inspection Form

<b>Project:</b>	Mesa 500-kV Substation Project	<b>Date:</b>	June 8, 2021
<b>Project Proponent:</b>	Southern California Edison (SCE)	<b>Report #:</b>	VS170
<b>Lead Agency:</b>	California Public Utilities Commission (CPUC)	<b>Monitor(s):</b>	Vince Semonsen
<b>CPUC PM:</b>	Connie Chen, Energy Division	<b>AM/PM Weather:</b>	Partly cloudy and mild with a slight breeze
<b>WSP CM:</b>	Silvia Yanez	<b>Start/End time:</b>	1100 to 1245
<b>Project NTP(s):</b>	Notice to Proceed (NTP)-1, NTP-2

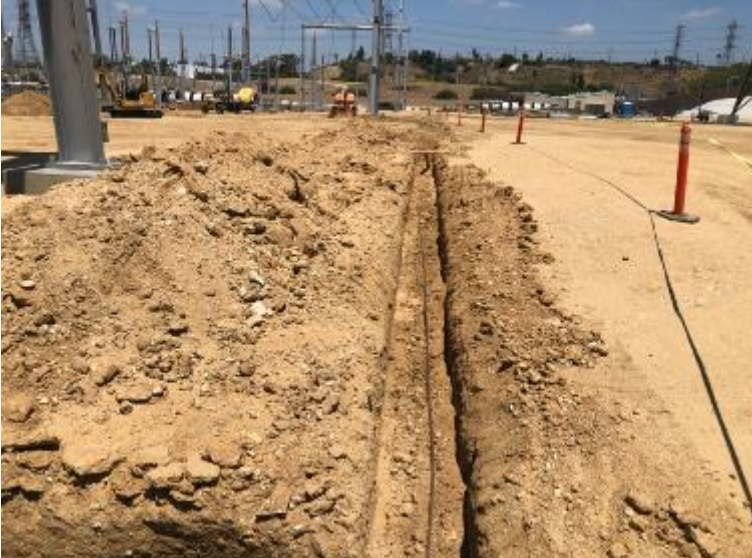
Grounding wire trenches were being excavated and copper wires were installed (Photo 2). Climbing structures were placed in the trenches for wildlife.

Photo 2 – Trenching and installation of copper grounding wire. Photo facing north.
06/08/21	Mesa Substation

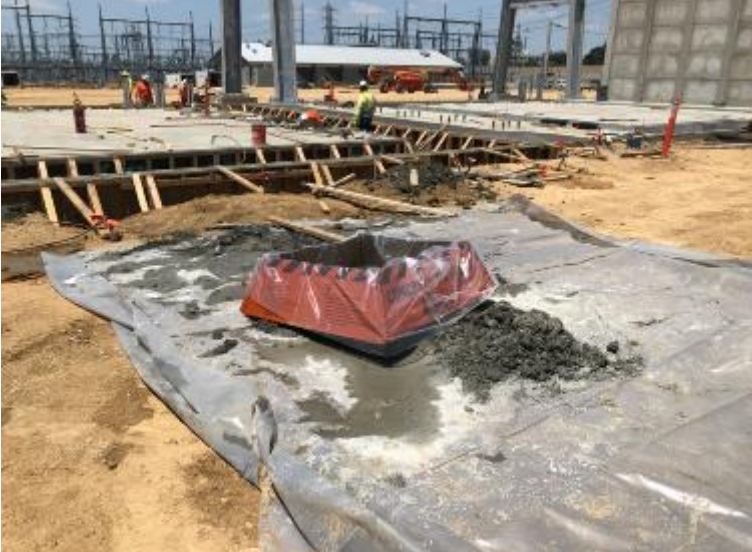
Portions of the transformer foundations were being poured. Concrete washout was messy but was captured on plastic sheeting and cleaned up (Photos 3 and 4). Another transformer location had been excavated in preparation for forms, rebar, and concrete (Photo 5).

Photo 3 – Concrete washout was messy but was contained by plastic sheeting. Photo facing west.

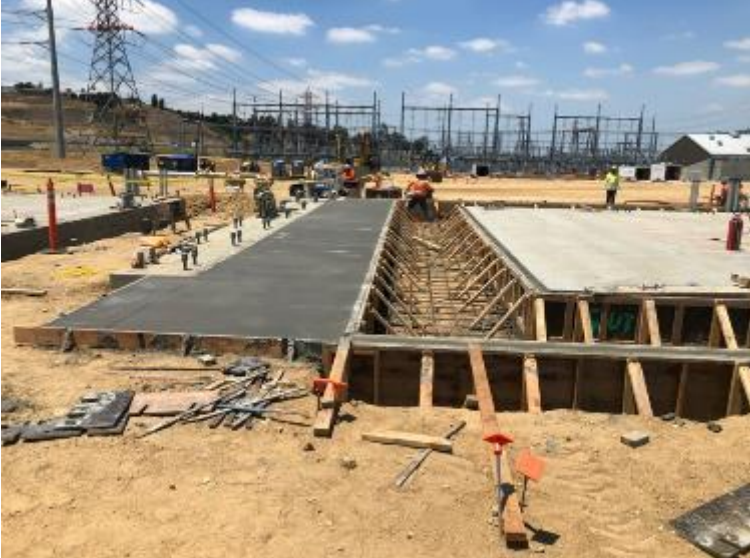
A wide-angle photograph of a construction site for transformer foundations. In the foreground, a long, narrow concrete slab is being poured, supported by wooden forms. Workers in safety gear are visible around the site. In the background, several high-voltage power line towers stand against a blue sky with scattered clouds. The ground is sandy and uneven.	Photo 4 – Pouring transformer foundations. Photo facing west.
06/08/21	Mesa Substation

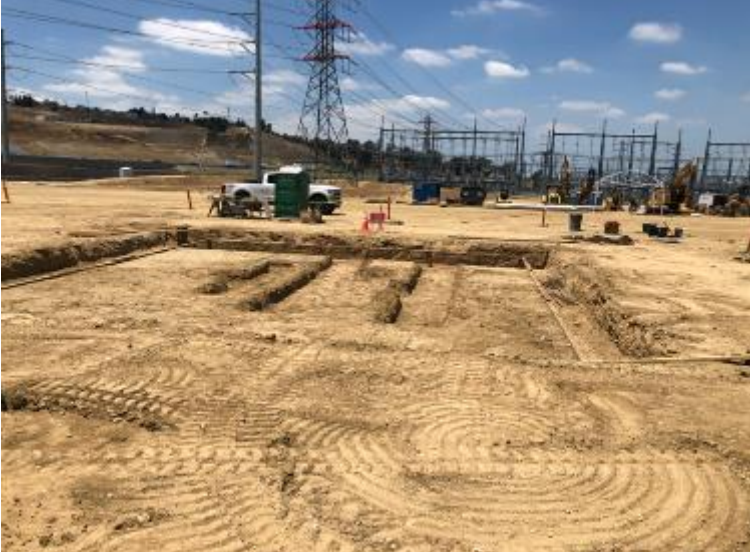
A photograph of an excavation site. The ground is sandy and shows deep, parallel tracks from heavy machinery. In the background, there are power line towers and a clear blue sky. The excavation area is rectangular and appears to be prepared for a new foundation.	Photo 5 – Excavation for an additional transformer foundation. Photo facing southwest.

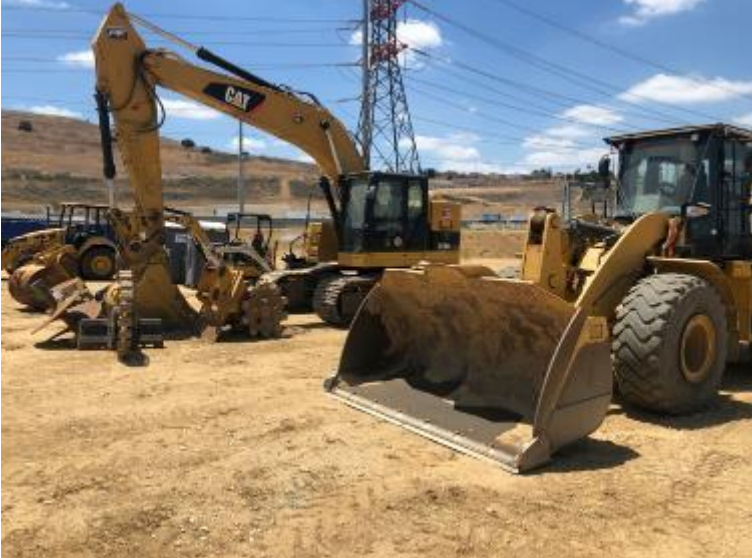
Parked equipment all had adequate secondary containment in place (Photo 6).

Photo 6 – Parked equipment with adequate secondary containment. Photo facing south.
06/08/21	Mesa Substation

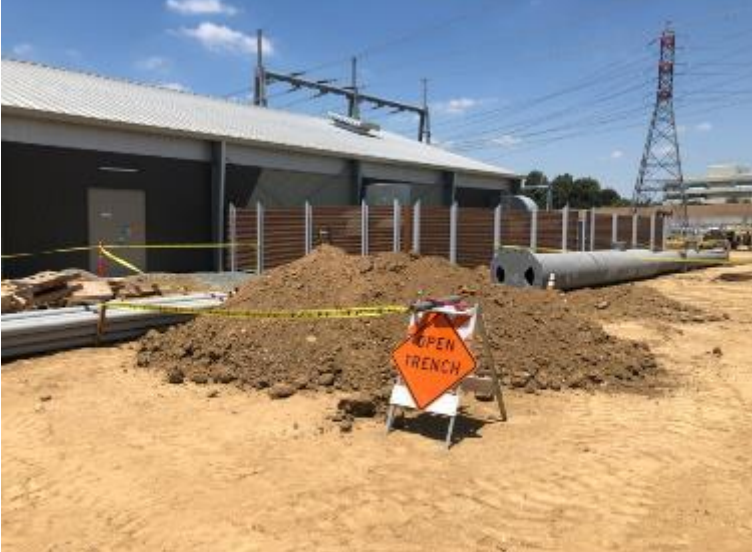
Excavation work was underway near the east side of the Senior Mechanical Electrical Equipment Room (MEER) building (Photo 7).

Photo 7 – Excavation activities near the east side of the Senior MEER building. Photo facing north.

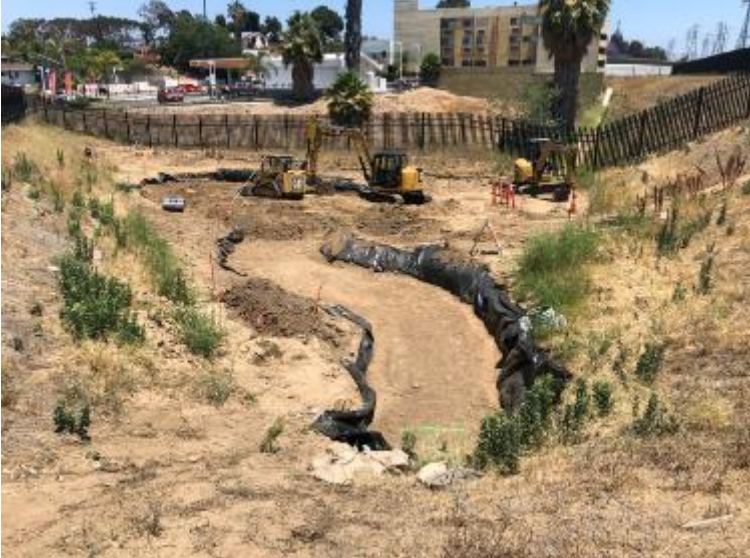
Sediment removal was being completed in the small triangular catch basin (Photo 8).

Photo 8 – Sediment removal from the small triangular catch basin. Photo facing northeast.
06/08/21	Mesa Substation

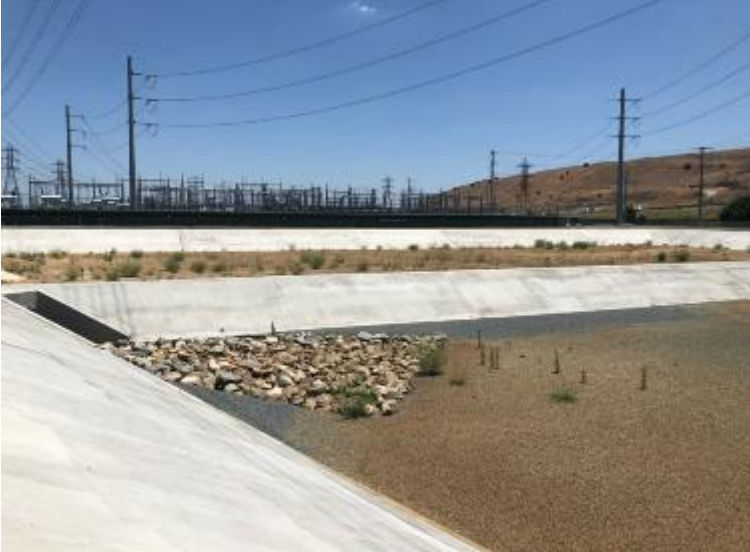
I inspected the detention basins, both of which had vegetation growing in them (Photo 9). A pair of ravens (*Corvus corax*) were nesting high in one of the towers near the detention basin; they did not appear disturbed by the construction activities.

Photo 9 – Detention basins with vegetation growing inside. Photo facing east.

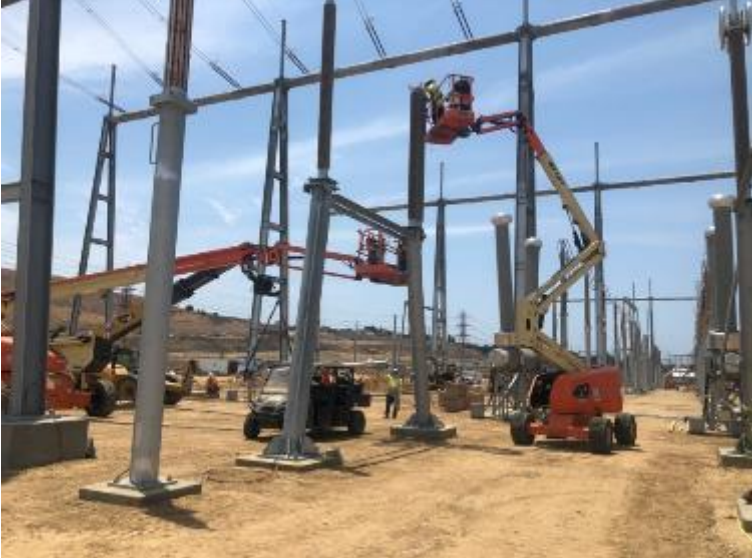
Within the Phase 4 construction area, several crews were installing aboveground infrastructure (Photos 1 and 2).

Photo 2 – Infrastructure installation. Photo facing southwest.
06/16/21	Mesa Substation

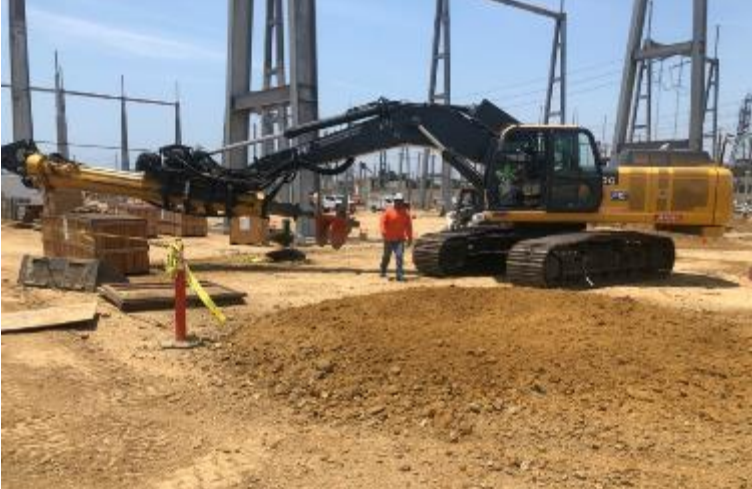
A drill rig was excavating foundation holes (Photo 3) and crews were installing rebar cages in these holes (Photo 4).

Photo 3 – Ongoing foundation drilling. Photo facing northwest.
06/16/21	Mesa Substation

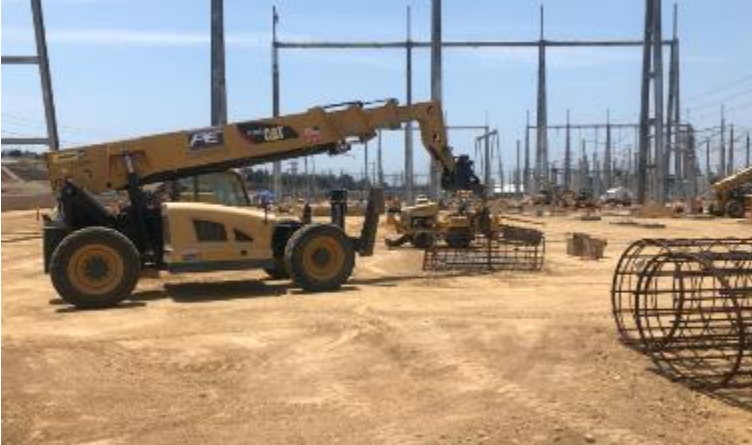
Photo 4 – Installation of rebar cages in the foundation holes. Photo facing west.

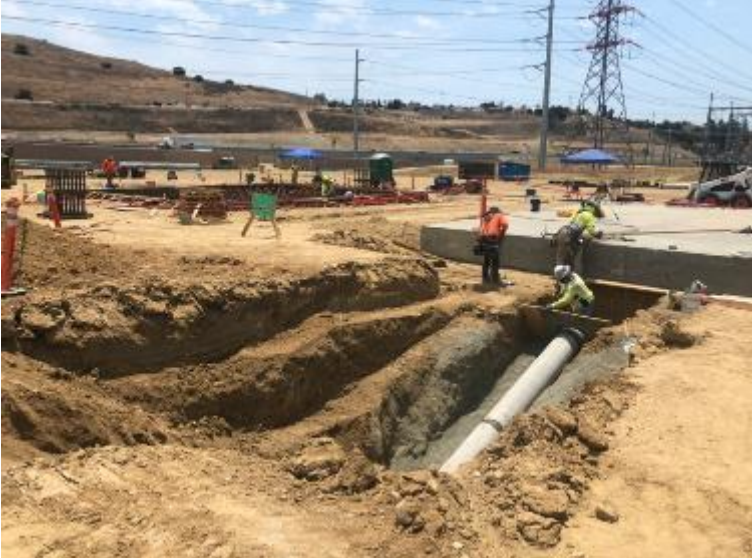
Trenching work was underway near the transformer foundations and work continued on the additional foundations (Photo 7). The first of many transformers was moved into the 500-kilovolt (kV) substation and placed on its foundation (Photo 8). A second transformer was prepared to move into the new substation (Photo 9).

Photo 7 – Trenching work east of the transformer foundation. Photo facing south.

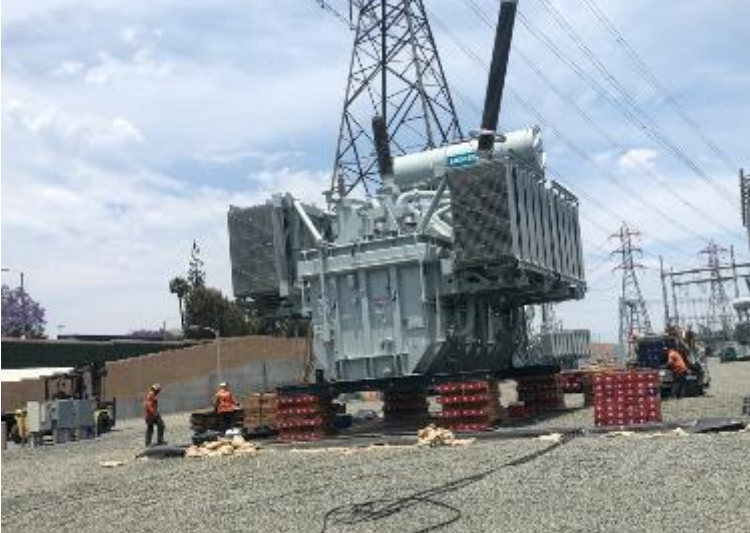
<p>A second large transformer is being prepared for transport. It is mounted on a heavy-duty trailer or transport cradle and is being moved across a gravel pad. In the background, there are high-voltage power lines and towers under a blue sky with some clouds. Several workers in orange safety gear are visible near the transformer.</p>	<p>Photo 9 – A second transformer being prepared for transport to the 500-kV substation. Photo facing east.</p>

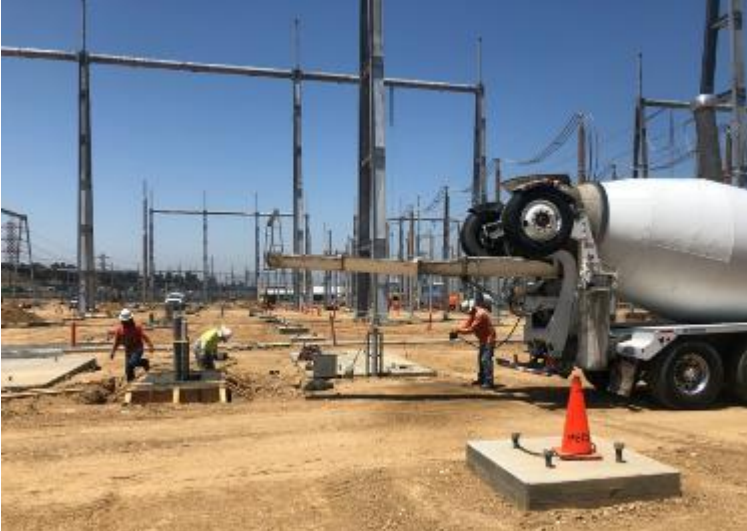
Concrete was being poured for additional foundations (Photo 2). The concrete pouring area appeared clean with the trucks washing out in the designated washout locations.

A concrete mixer truck is positioned at a construction site. The truck is white with a large rotating drum. In the background, there is a complex steel structure of vertical and horizontal beams, likely for a substation. Several workers in safety gear are visible on the ground. The ground is dirt and there are some concrete foundations laid out.	Photo 2 – Concrete pouring of infrastructure foundations. Photo facing west.
06/22/21	Mesa Substation

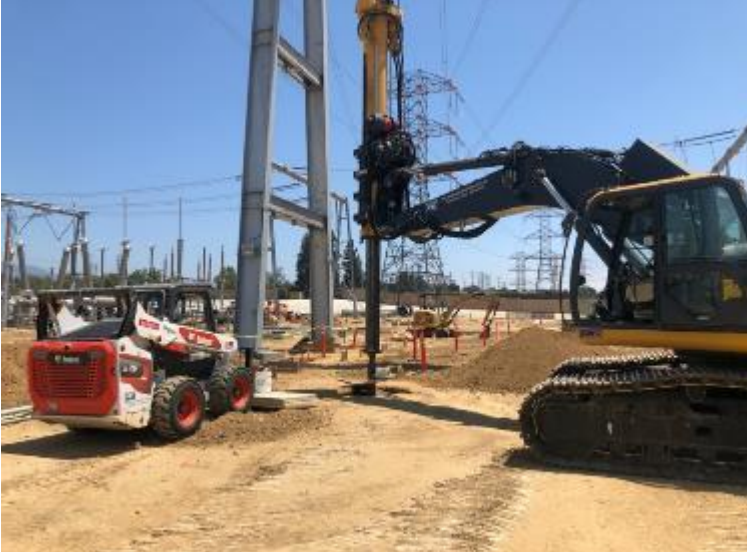
Drilling continued for foundation holes (Photo 3). Once the holes were drilled, they were covered with boards and soil, and if they had the rebar cages installed, they were covered with plastic and sealed with soil (Photo 4). Wire pulling was being completed in some areas.

A tracked drilling rig is the central focus, with its long vertical mast and drilling mechanism. To the left, a red and white skid steer loader is parked. The background shows the same steel infrastructure as in the first photo, along with power lines and towers in the distance. The ground is dirt and there are some mounds of earth.	Photo 3 – Ongoing foundation drilling. Photo facing north.

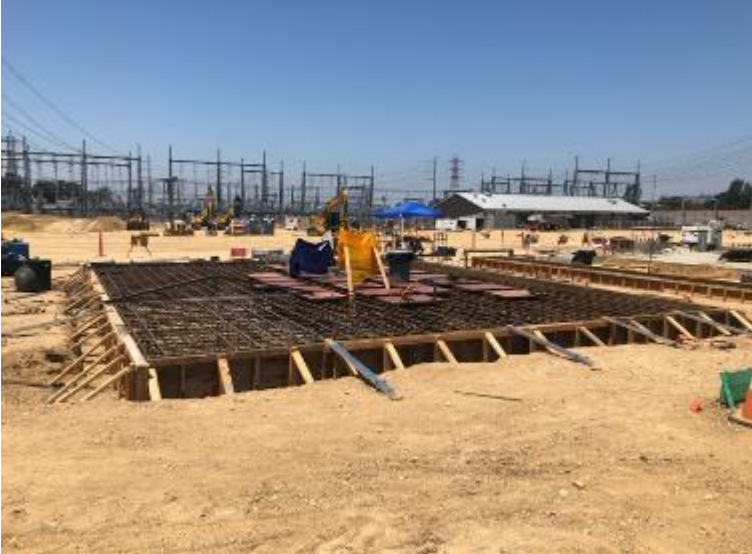
Work continued on the transformer foundations (Photo 6). Four large transformers were delivered and installed while I was onsite (Photo 7). The site representative said each transformer weighed approximately 537,000 pounds.

<p>Photo 6 – A new transformer foundation pad was ready for concrete. Photo facing west.</p>
06/22/21	Mesa Substation

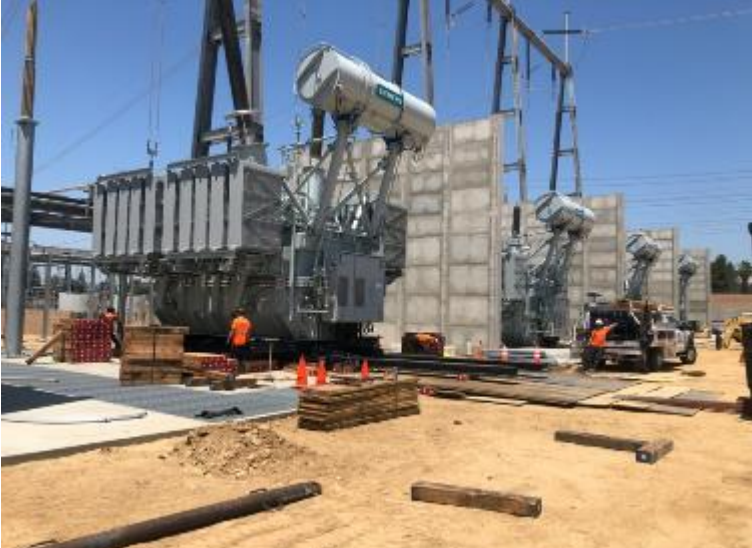
<p>Photo 7 – Transformer installation within the new 500-kV substation. Photo facing north.</p>

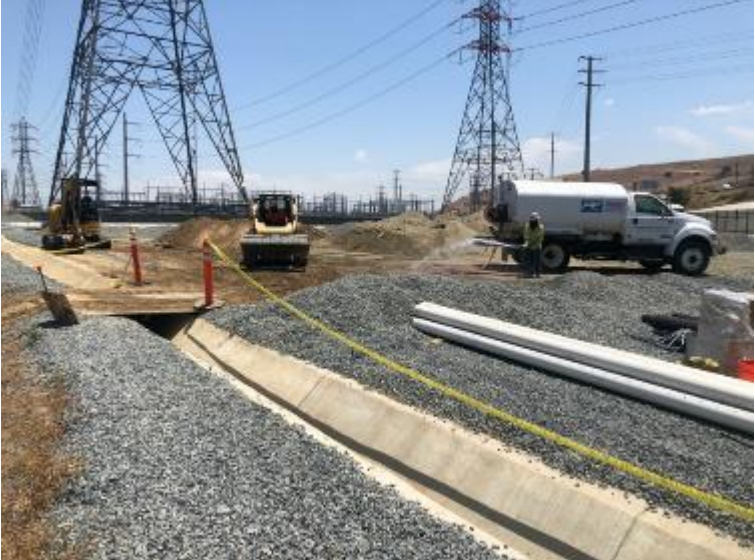
Photo 8 – Sediment removal and drainage channel construction by the small triangular catch basin, with a water truck onsite. Photo facing east.
06/22/21	Mesa Substation

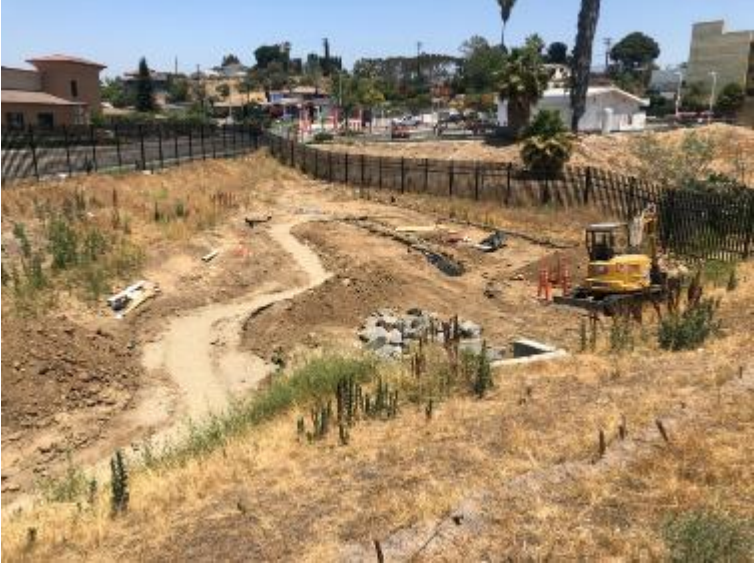
Photo 9 – Sediment removal and upgrades to the small triangular catch basin. Photo facing north.
